ARCHAEOLOGICAL MONITORING

REPLACEMENT GAS MAIN YARM BRIDGE YARM TEESSIDE

NAA 14/75
August 2014

Watching Brief Report

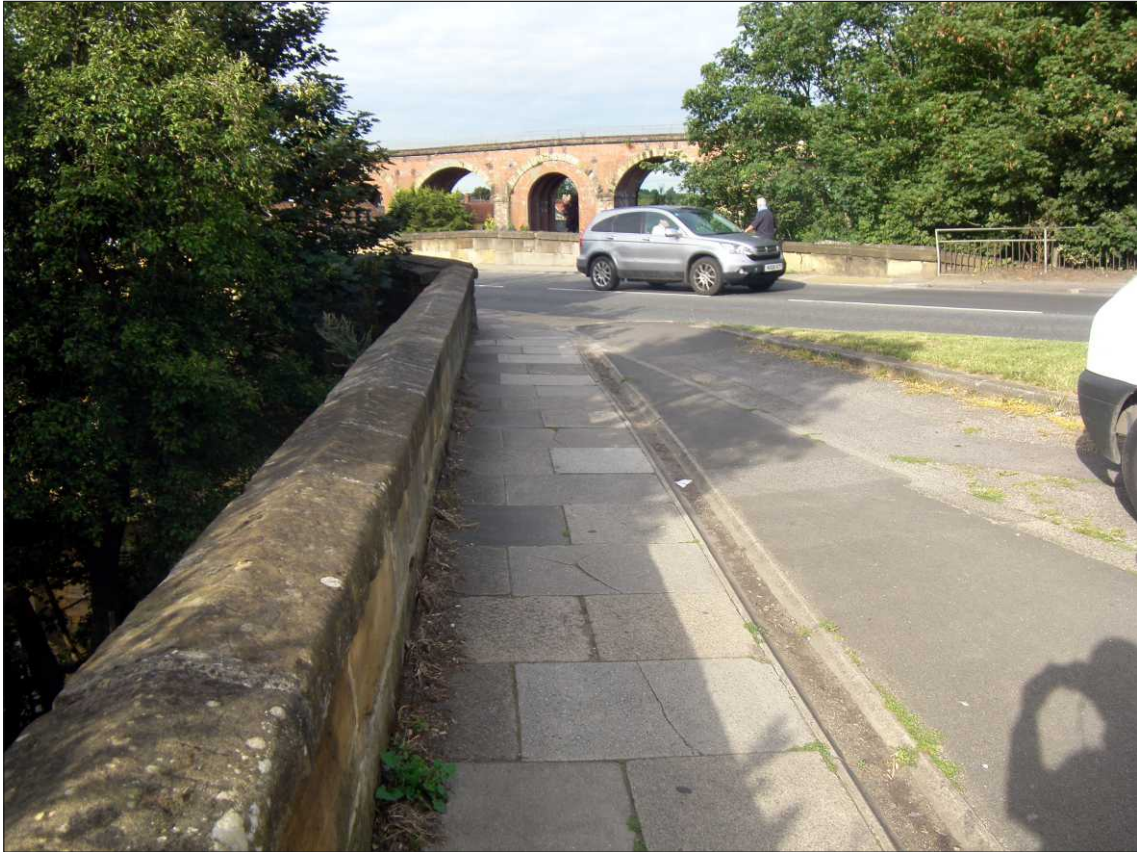
Plate 1

Pit 1 (Figure 2, Plate 1) was at the northern end of the bridge, in the footway on the eastern side of the road. Initially excavated as a test pit to locate the existing main, it was later extended to the north to facilitate insertion of the new main, culminating in a pit measuring approximately 6.5m by 1.5m (effectively equating in area to three pits). Possible natural silty clay was encountered only beneath the existing gas main, at a depth of 0.9m. The remainder of the pit was excavated through 'made ground' (Plate 2): up to 0.25m of mixed dark grey-brown silt with fragments of brick and tile and tarmac, overlain by a similar depth of paler grey-brown silt, again with brick and tile fragments, and 0.2m of 'type-1' sub-base supporting 0.15m of tarmac and the associated kerbs. There were no in-situ structural remains, although a number of sandstone blocks had been used to support the original cast iron main (Plate 3); of these, two were roughly-squared and may have derived from the earlier bridge structure.

Yarm Bridge: location of pit 1

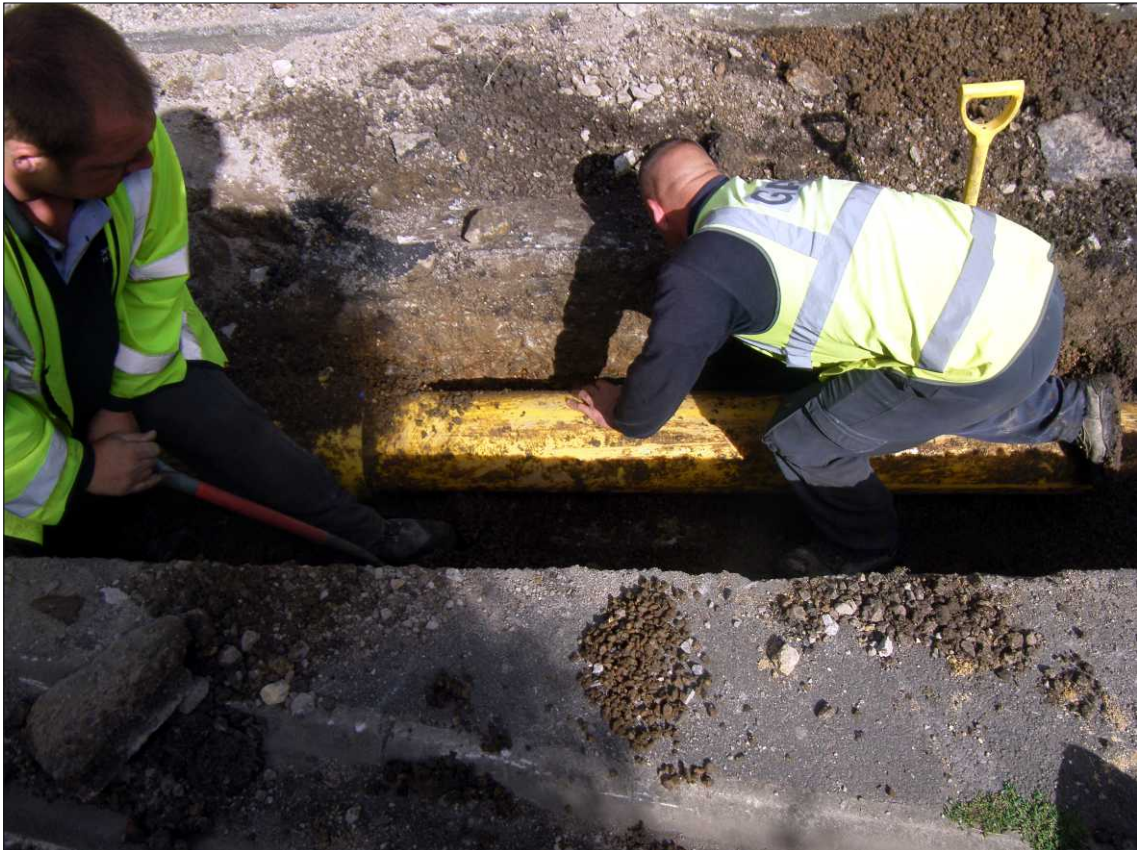
Plate 2

Yarm Bridge: made ground in Pit 1

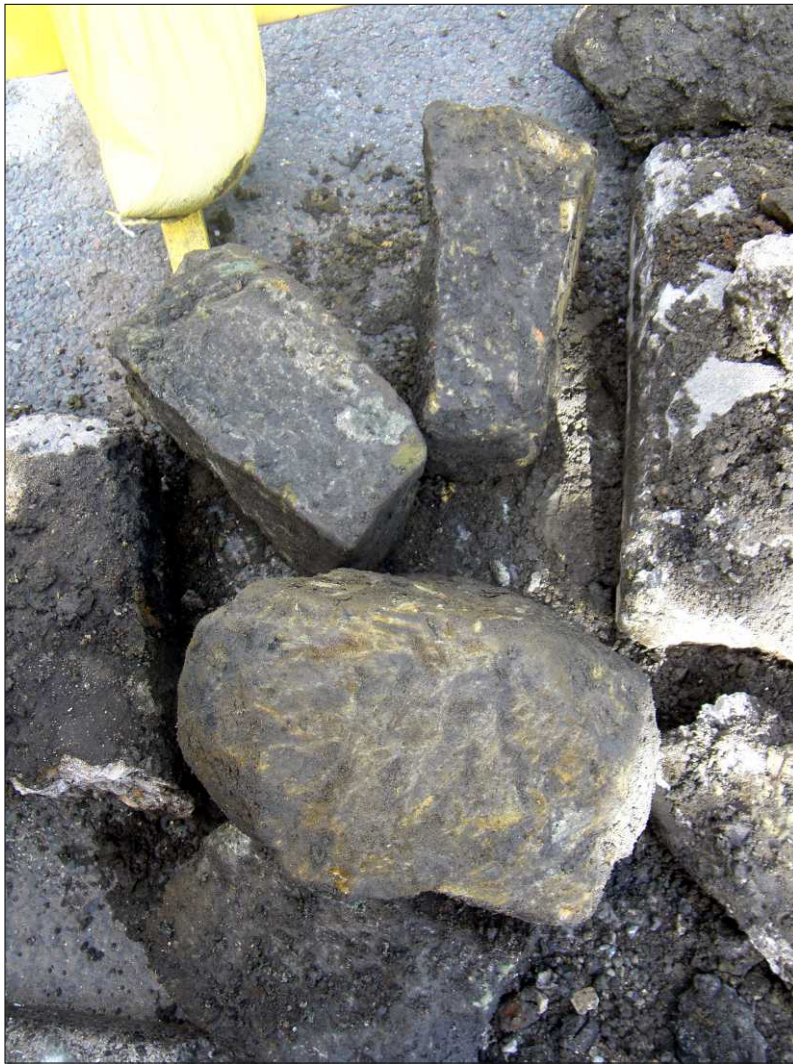
Plate 3

The services were at a relatively shallow depth and unlikely to have damaged the bridge structure, although it is possible that the few fragments of masonry from Pit 1 had formed part of the infill of the bridge. However, they were more likely to have derived from one of many episodes of repair and rebuilding during the 16th to 19th centuries.

*Yarm Bridge: displaced masonry
from bridge repairs*

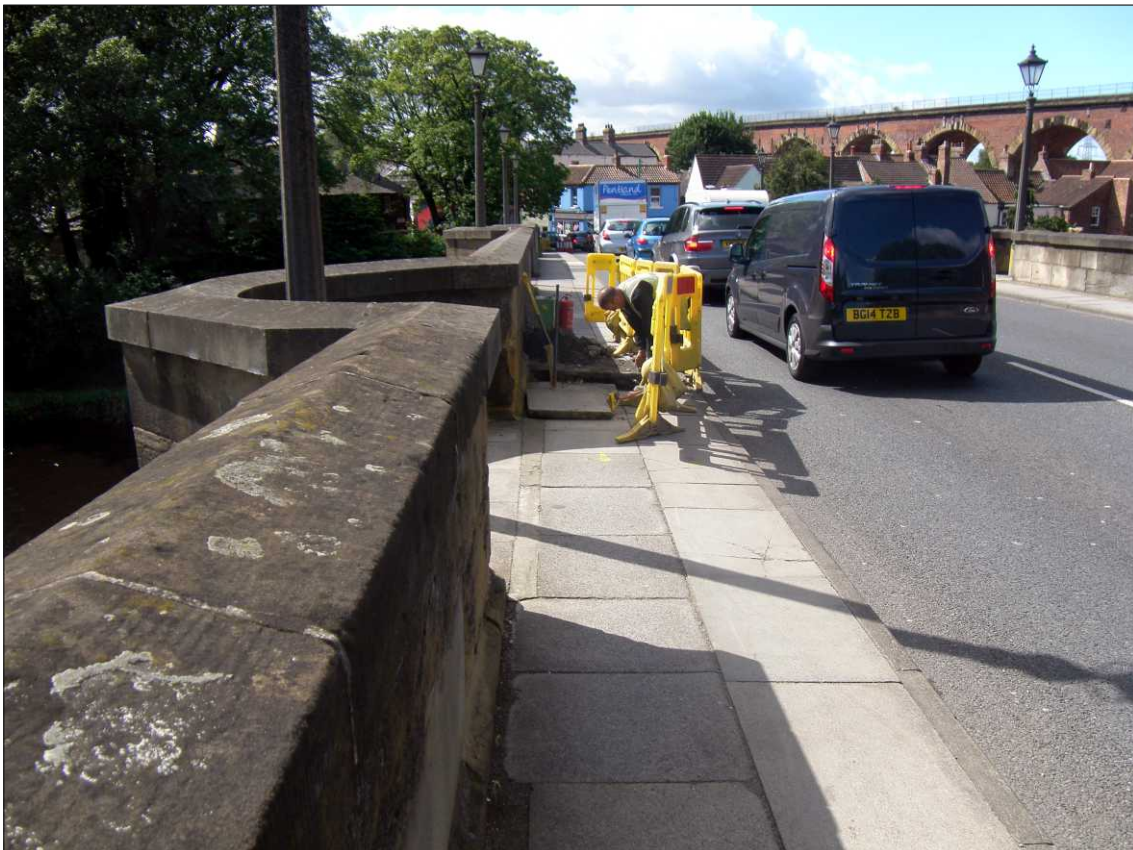
Plate 4

Pit 2 was excavated in the eastern pavement close to the crest of the bridge (Plate 4), and immediately to the south of the northern bridge pier. It measured 1m east to west by 0.5m, and was excavated for the insertion of a small camera. Consequently, the pit was excavated only as far as the existing main, a depth of 0.6m (Plate 5). Only the backfill of existing services (two water mains, two ducted tv cables and one electricity cable) was encountered.

Yarm Bridge: location of Pit 2

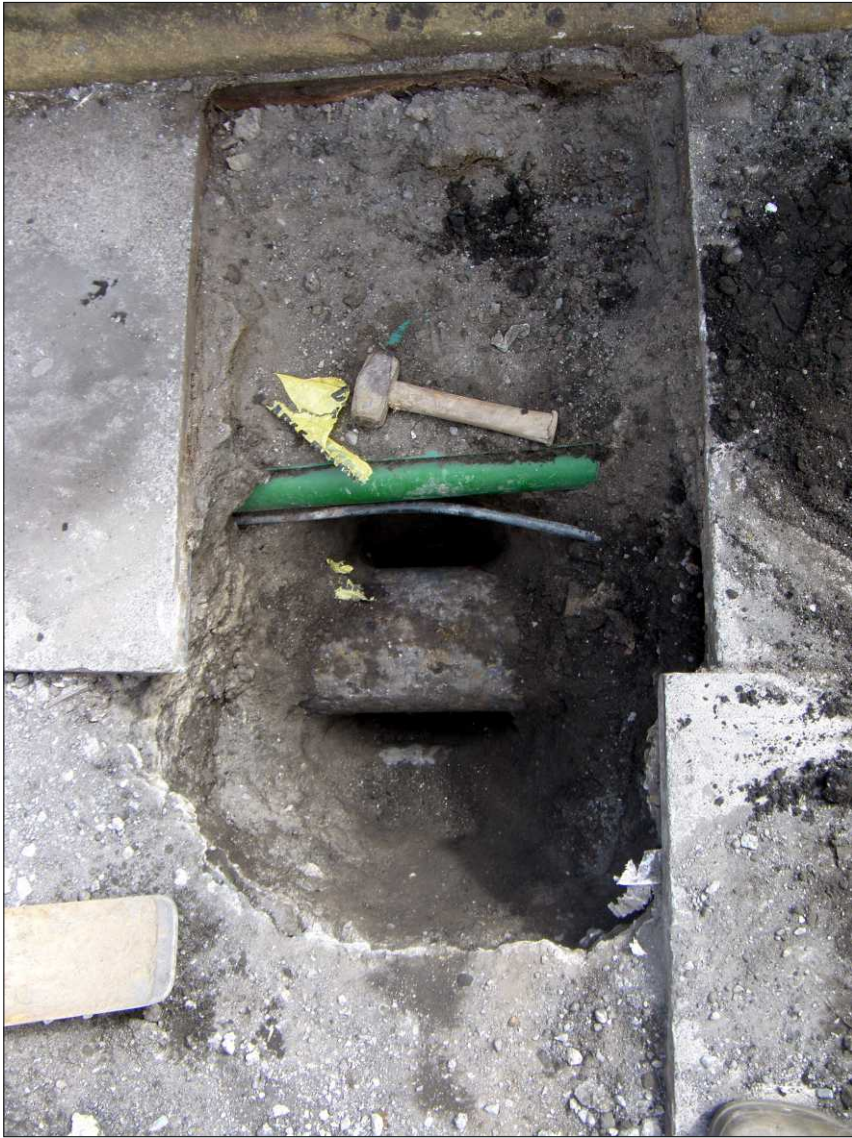
Plate 5

Yarm Bridge: Pit 2 from above

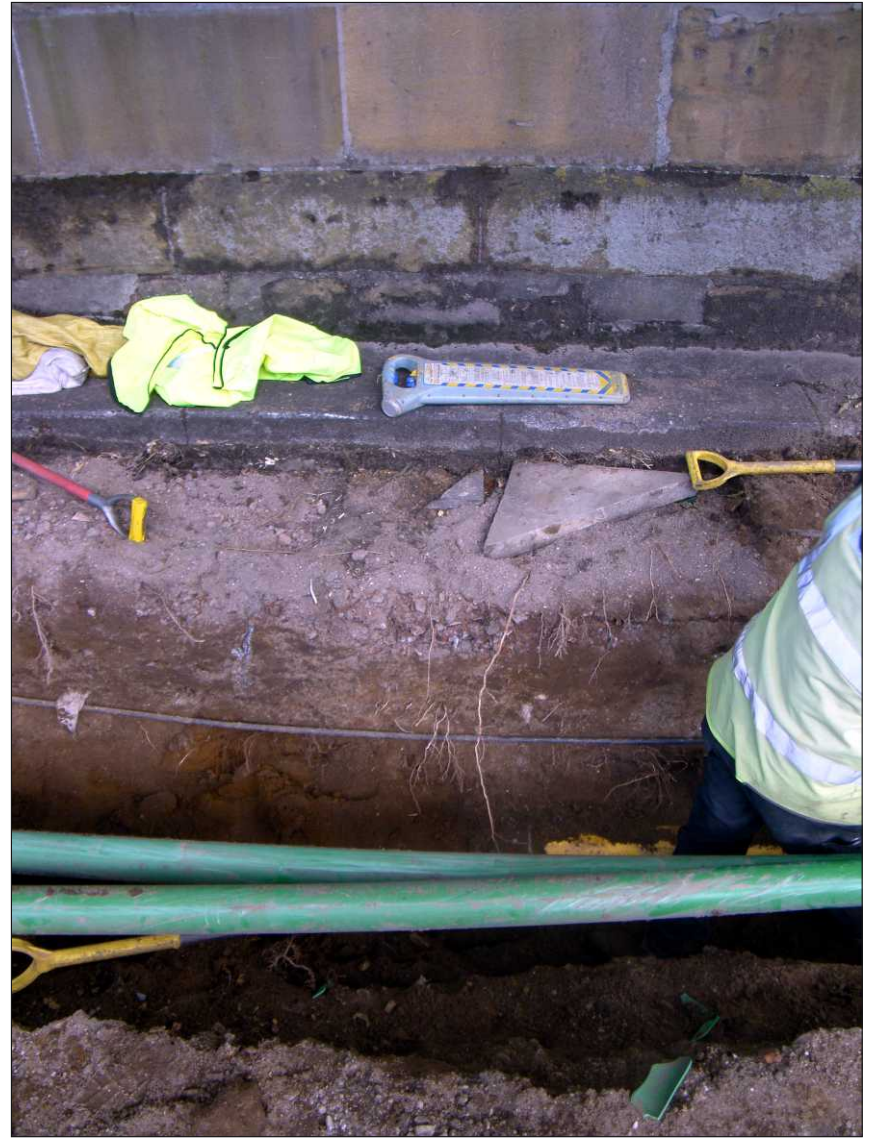
Plate 6

main had disturbed a 'lens' of 19th- to 20th-century debris (Plate 6), which had presumably been deposited along the roadside prior to its modern metalling. The lens was approximately 1m long, but no more than 0.05m deep, comprising fire ash/cinders with numerous fragments of brick and tile, scraps of whiteware and stoneware pottery and sherds of machine-made bottle glass. These have not been retained.

Yarm Bridge: Pit 5 showing lens of debris
