NEGATIVE WATCHING BRIEF REPORT

LAND AT ST JOHN THE BAPTIST
CHURCH, EGGLESCLIFFE,
STOCKTON-ON-TEES

NAA 31/22
August 2022

Site name: St John the Baptist Church **Grid reference:** NZ 42054 13222
Parish: Egglescliffe **District:** Stockton-on-Tees
County: Stockton
Administrative authority: Stockton-on-Tees Borough Council
Development: Repair to graveyard boundary wall
Client: Stockton-on-Tees Borough Council
Site supervisor: Holly Drinkwater **Project manager:** Cath Ross
Fieldwork date(s): 11th-12th July 2022 **NAA project number:** 2130 **Site code:** JBC22
NAA report number: 31/22 **Report date:** 08 August 2022

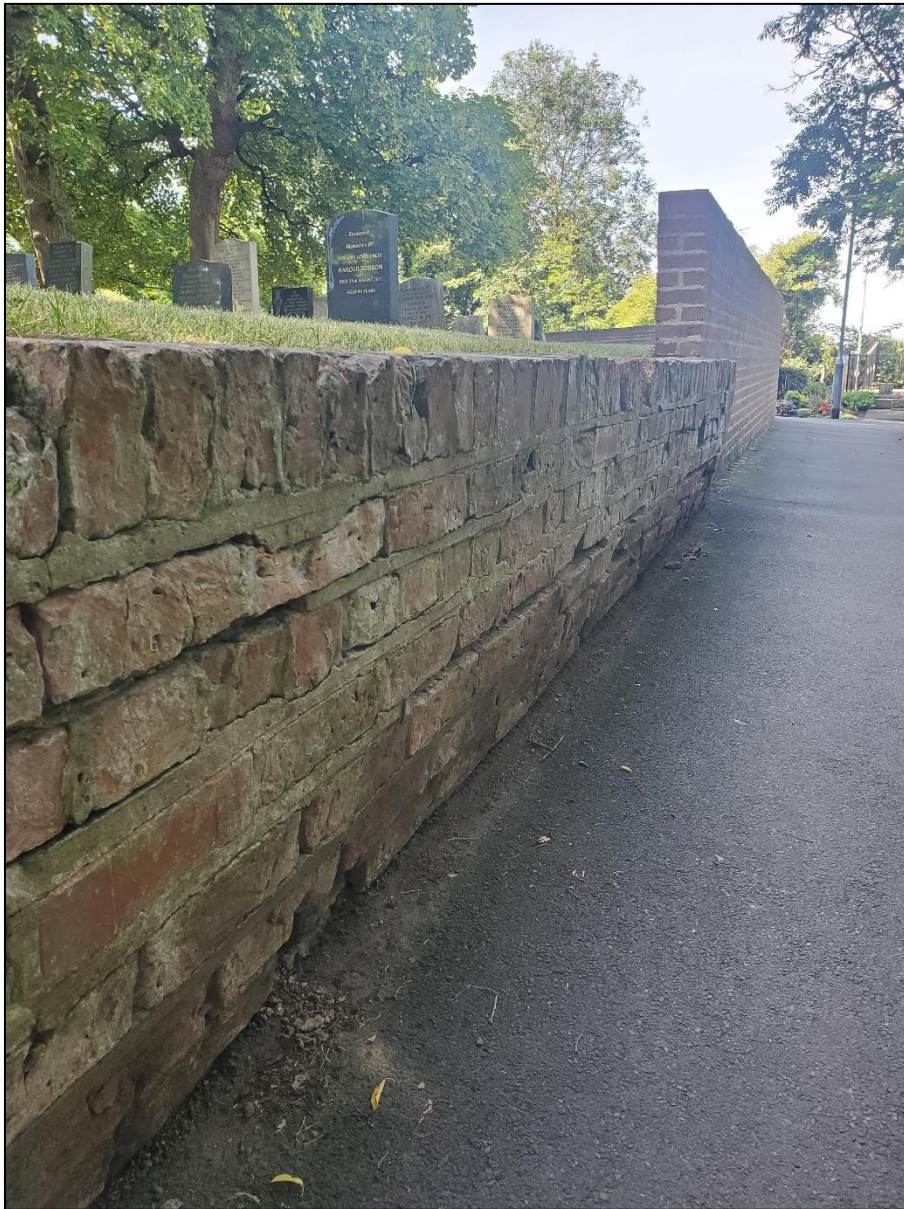
Plate 1: Bowing of the western boundary wall, looking south towards the 2007 reconstruction.

The span of brick wall to be demolished measured 0.6m in height and comprised seven visible courses above the level of the tarmac footpath that ran alongside. The wall had bowed outwards significantly to the south-west, presumably due to rooting from a removed hedge-line, the stumps of which remained in situ along the inner face (Plate 1). The brickwork was demolished by hand, down to the level of the tarmac, leaving an even platform for the reconstruction. The baulk of soil behind was then excavated along a 0.3m wide strip and the remnants of the defunct hedge-line removed (Plate 2).

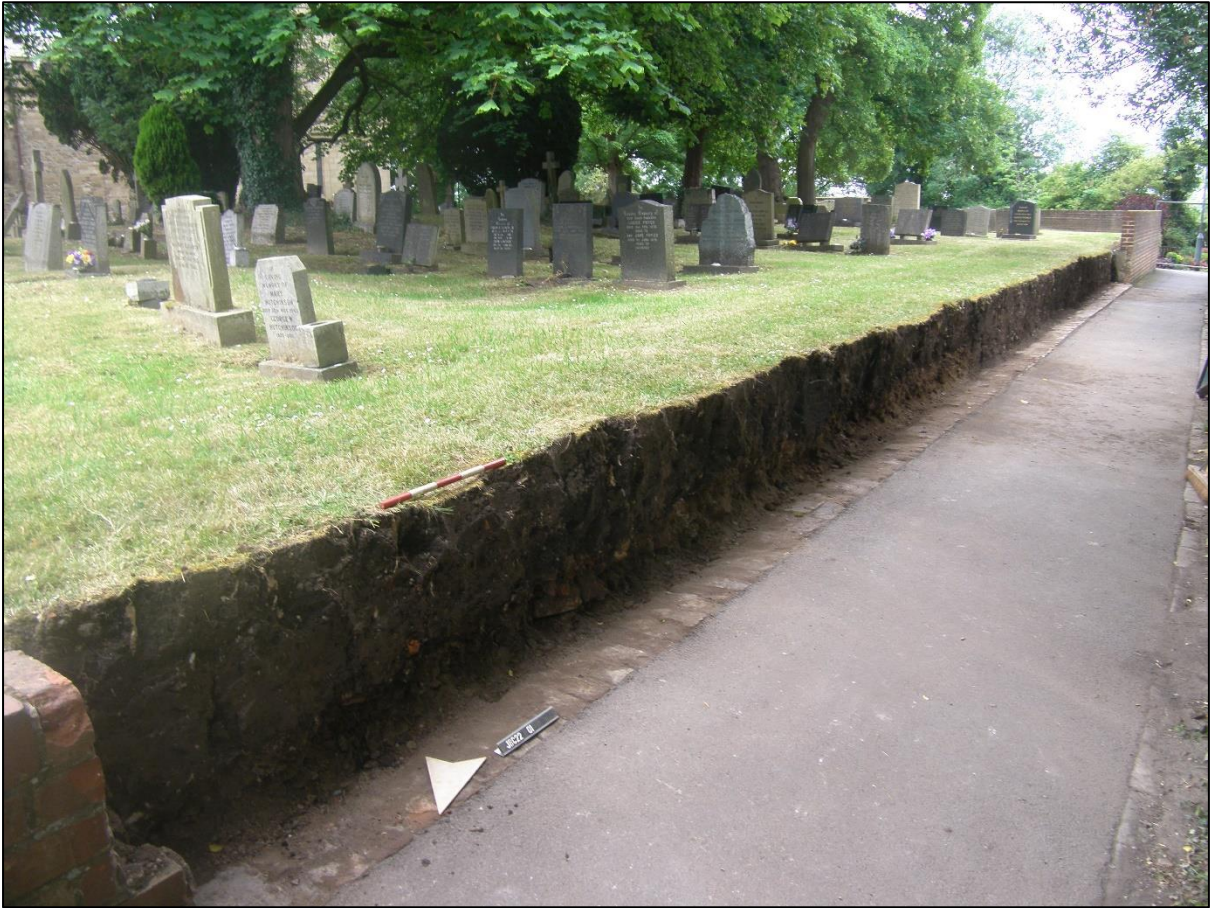
Plate 2: Baulk of graveyard soils revealed after removal of brick wall and residual hedge-line.

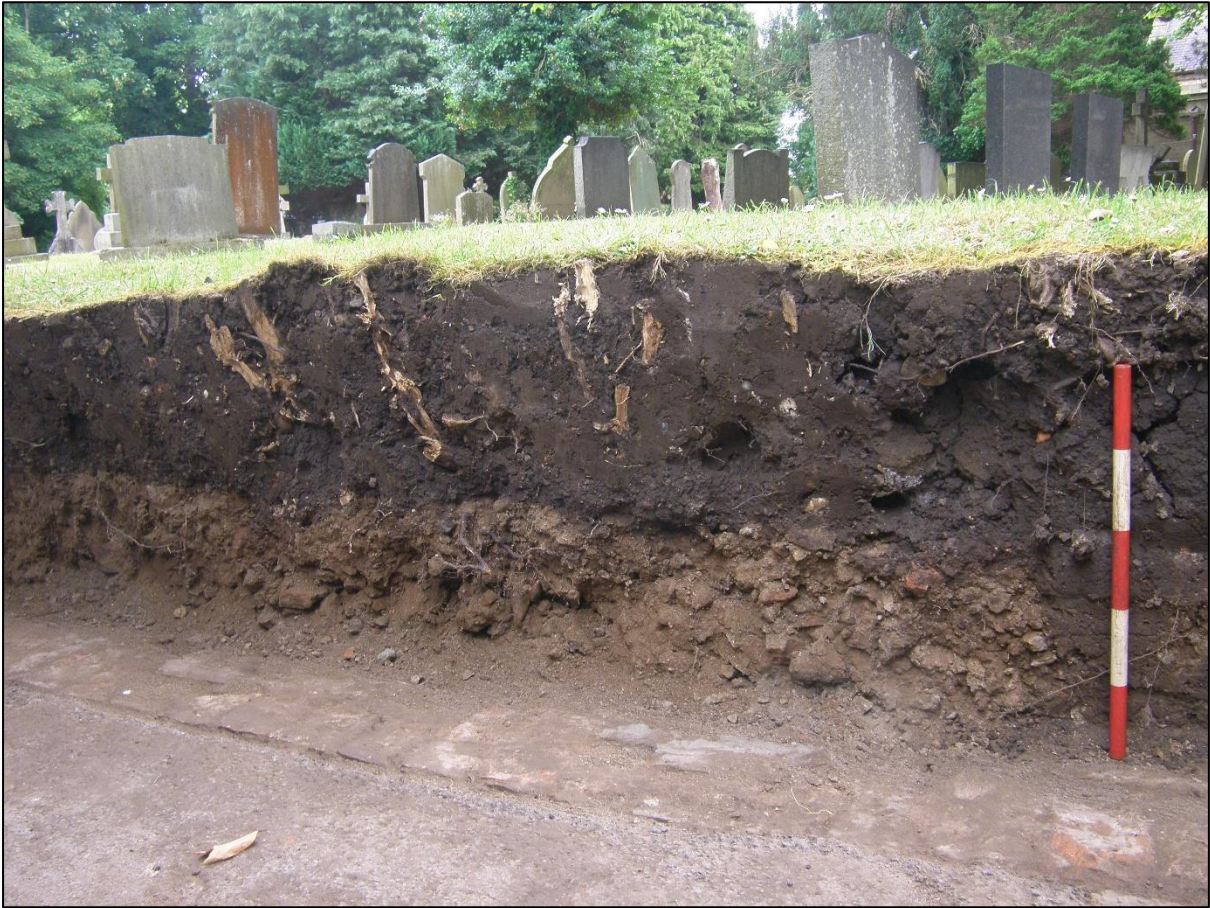
Plate 3: Topsoil overlying the horizon of post-medieval demolition rubble.

No significant archaeological remains were identified. The deposits behind the boundary wall comprised a 0.4m-thick horizon of topsoil that had been established upon a layer of post-medieval demolition rubble that primarily consisted of displaced bricks, sandstone fragments and lime mortar (Plate 3). It is probable that this rubble horizon related to an earlier boundary wall of brick and sandstone, a section of which remains in-situ along the southern edge of the churchyard (Wall BW8, Grahame 2008, 4). Several fragments of transfer-printed pottery and modern glass were found but not retained.
