**Sharpness Point  
Sewage Pumping Station  
Tynemouth, North Tyneside  
Archaeological Watching Brief**

**For ESH on behalf of  
Northumbrian Water**

**October 2022**

**Version:** v2  
**Issue Date:** October 2022  
**Report Number:** NAA 22/45

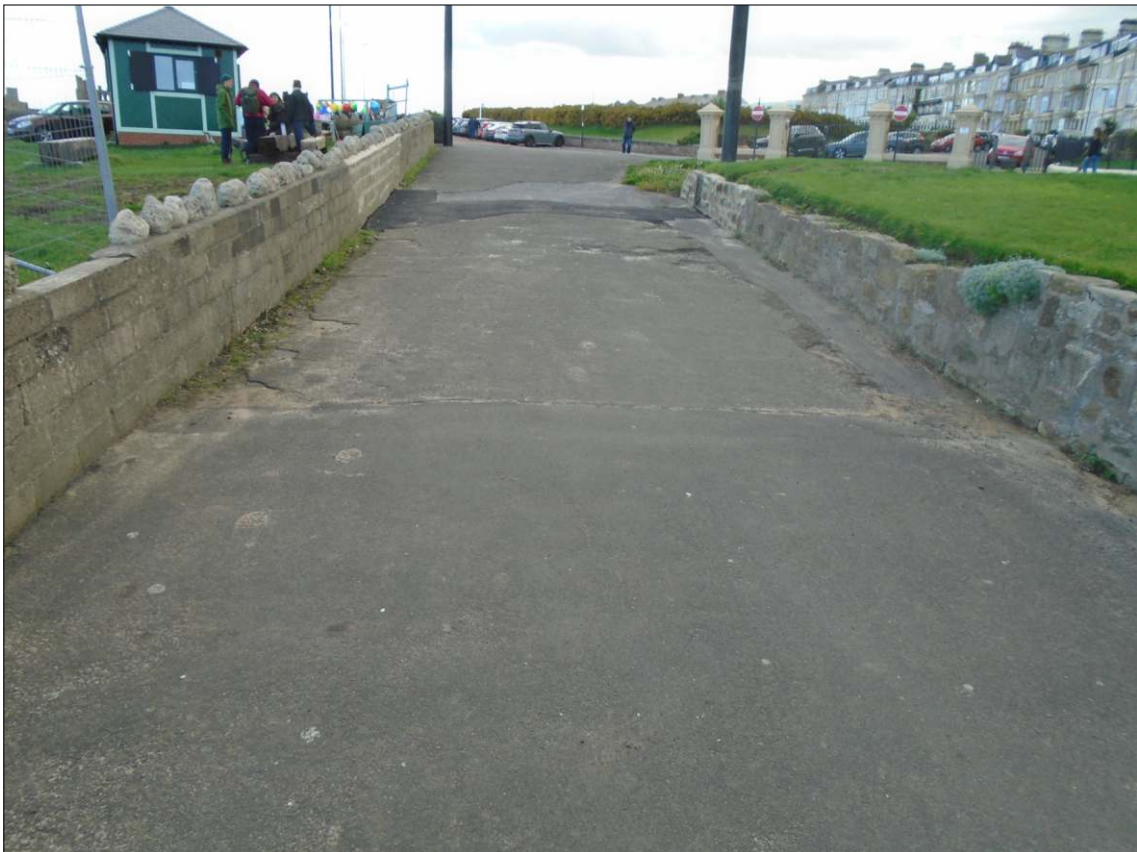
Plate 2

Sharpness Point Sewage Pumping Station, Tynemouth:  
pathway 2, facing south

- 4.4.1 The area was covered by c.0.1m of modern turf and topsoil (1; not illustrated). Near the western edge of the area this was crossed by a modern path (Plate 2) delineated by two low stone and concrete walls (7 and 8; not illustrated) and surfaced with tarmac (2; not illustrated) laid on a bedding of crushed limestone (4; not illustrated). One of the stone blocks (3; Plate 3) used in wall 7 comprised part of a broken carved panel of unknown date. It has been reinstated in wall 8 at the eastern side of the path. It was not clear what the panel depicts.
- 4.4.2 To the east of wall 8, the area was covered by a modern levelling deposit (11/15; not illustrated) of greyish brown or dark grey silty clay soil containing fragments of brick, concrete and 20th-century pottery. This was up to 0.40m thick. At the western edge of the monitored area (in the

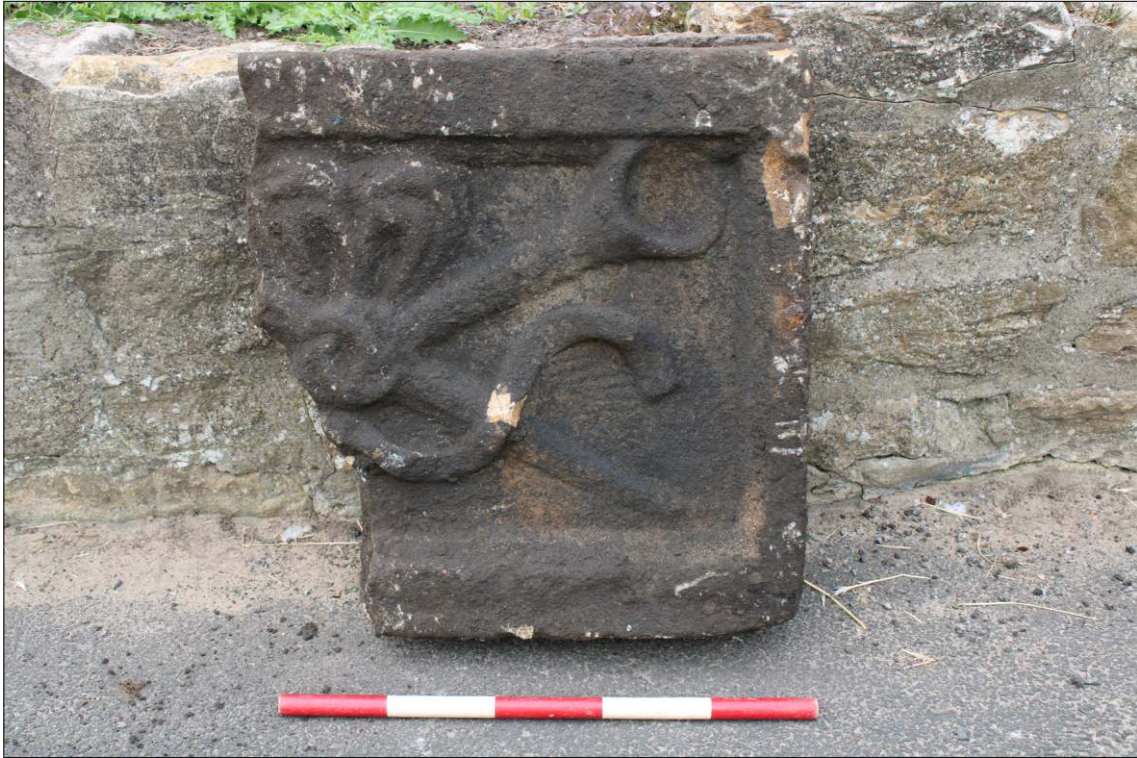
Plate 3

Sharpness Point Sewage Pumping Station, Tynemouth:  
carved stone panel 3

At the western edge of the area the pipe trench crossed a modern sunken tarmac pathway revetted to either side by low stone and concrete walls. One of these incorporated a broken stone slab carrying an elaborate carved design, of unknown date. This was recorded photographically and then reinstated into one of the walls.

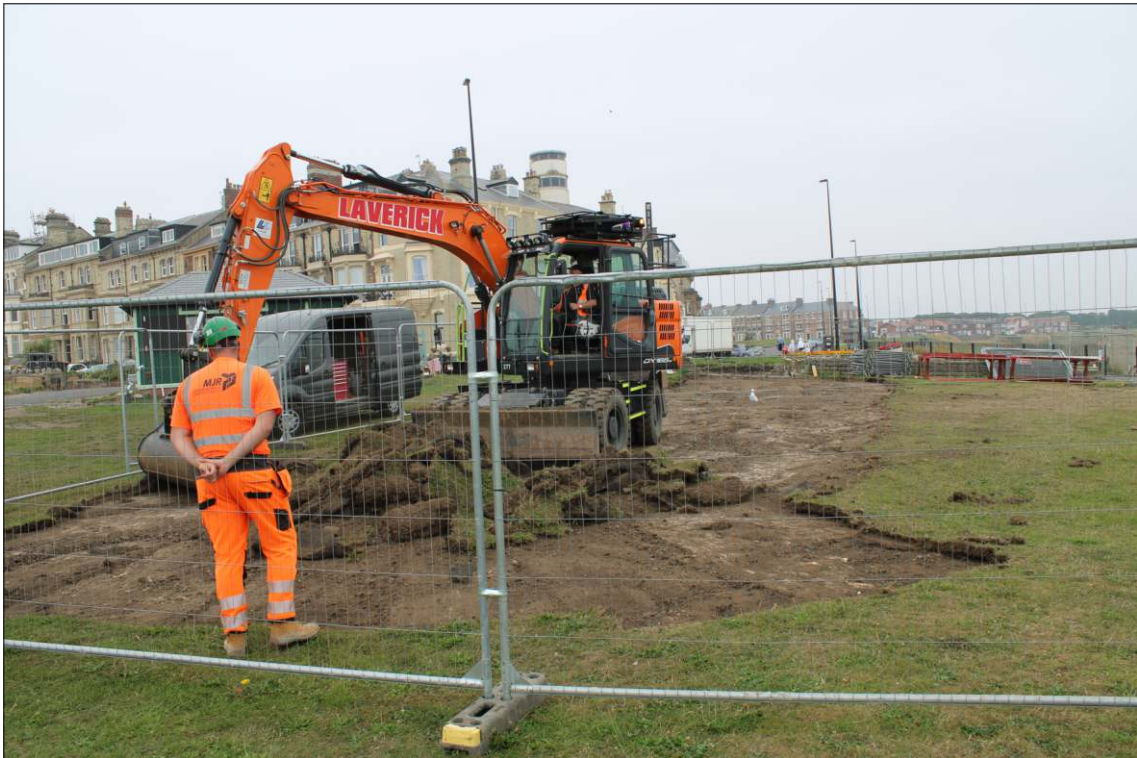
Plate 4

Sharpness Point Sewage Pumping Station, Tynemouth:  
site during soil stripping, facing west

- 4.4.3 To the west of the path, and following stripping turf from the working area (Plate 4), the new pipe trench was 1.0–1.3m wide and excavated to a depth of 1.2–1.65m. Below the subsoil, natural boulder clay (**6**; not illustrated) was recorded at depths ranging between 1.30–1.65m below the present ground level. The boulder clay comprised firm mid-brown clay containing occasional inclusions of bedrock fragments.

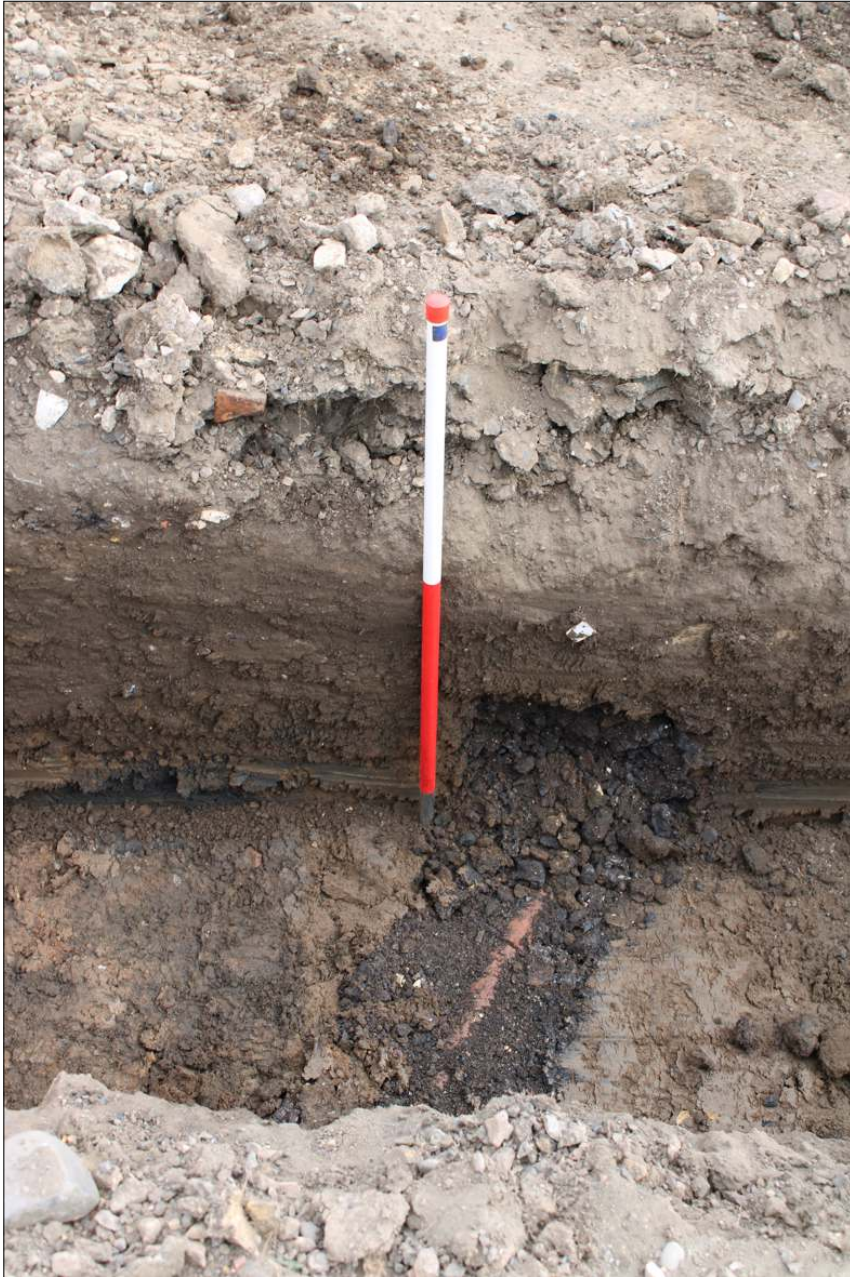
Plate 5

Sharpness Point Sewage Pumping Station,  
Tynemouth: land-drain 21 facing north, scale 1m

- 4.4.6 This buried soil was cut by several ceramic land-drains running from north to south (**17**, **18**, **19**, **20** and **21**; Plate 5). In the north-eastern part of the area, the new pipe trench exposed two more land drains (**25** and **26**; Fig. 3) running from east to west perpendicular to the others.

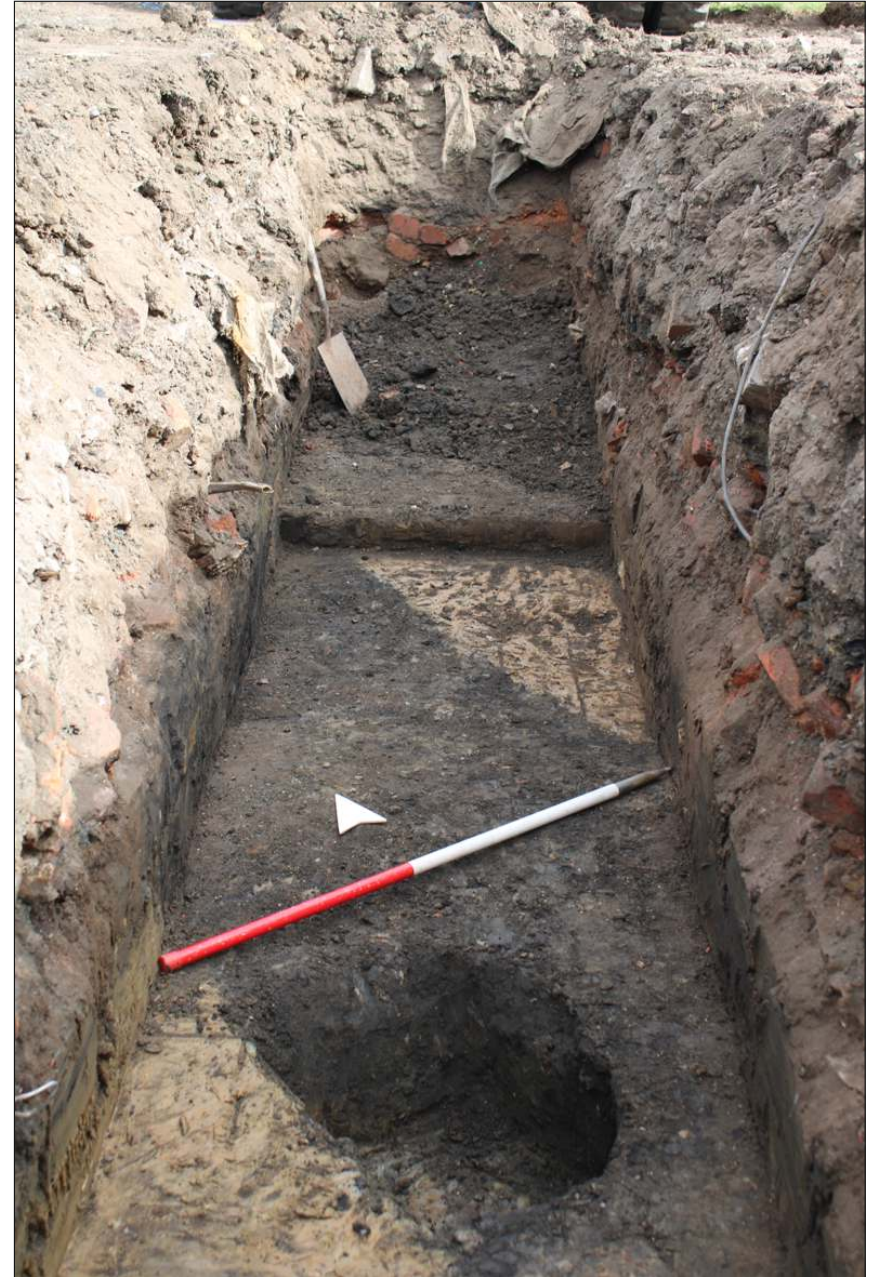
Plate 6

Sharpness Point Sewage Pumping Station,  
Tynemouth: possible wall footing trench 23  
facing north-east, scale 1m

- 4.4.7 The only other feature revealed by the new pipe trench was a linear cut (**23**) running approximately from north to south (Plate 6, Fig. 3). This cut 0.70m into the subsoil layer (**16**) and underlying natural boulder clay (**6**). It was up to 1.3m wide (mainly c.1.0m) and had steep sides that became vertical towards the flat base. It was filled with dark grey/black gritty coarse sandy silt (**22**) containing lenses of grey ash, flecks of coal and burnt waste including shells, glass and pottery. The upper part of the deposit included lumps of redeposited natural clay, indicating deliberate backfilling. The area immediately above this feature and some of the north to south land drains was covered by a layer up to 0.3m thick of demolition waste (**24**; not illustrated) consisting of brick, concrete and mortar rubble and metal fittings. The bricks were machine-made and stamped 'Lumley'.

- 5.1.3 No buildings have been recorded on Sharpness Point prior to or after the Second World War, whereas there were almost certainly such structures located there during the conflict. Equally, this is the only period during which the level of drainage represented by the series of closely spaced land drains (**12–21**, **25** and **26**) would have been required, given that the site slopes down towards cliffs on two sides. The uniform depth, orientation and materials of the land drains suggest that they represent a single episode. That they share the same orientation with the possible wall footing trench (**23**) does suggest that all the features represent a single short-lived episode of activity. Although any wall-footing had been completely removed, the layer of brick, concrete and metal rubble (**24**) sealing the area was consistent with demolition of a mid-20th-century structure. A date for this material can be suggested by the stamped bricks. The original Lumley Brick Company was associated with the Lumley 6th Pit, one of the mines in the local colliery, and operated from the 1870s to 1938. However, the Lumley mark on many of their products was surrounded by the outline of a fortified tower to denote Lumley Castle. The bricks

found at Sharpness Point lacked this feature and were therefore more likely produced by Lumley Brickworks Ltd, which operated from 1937 and continued production throughout the Second World War.
