NORTHERN ARCHAEOLOGICAL ASSOCIATES LTD

HOUGHTON NORTH FARM, HEDDON-ON-THE-WALL

Negative Watching Brief Report

Development: Repair to telecommunication ducting

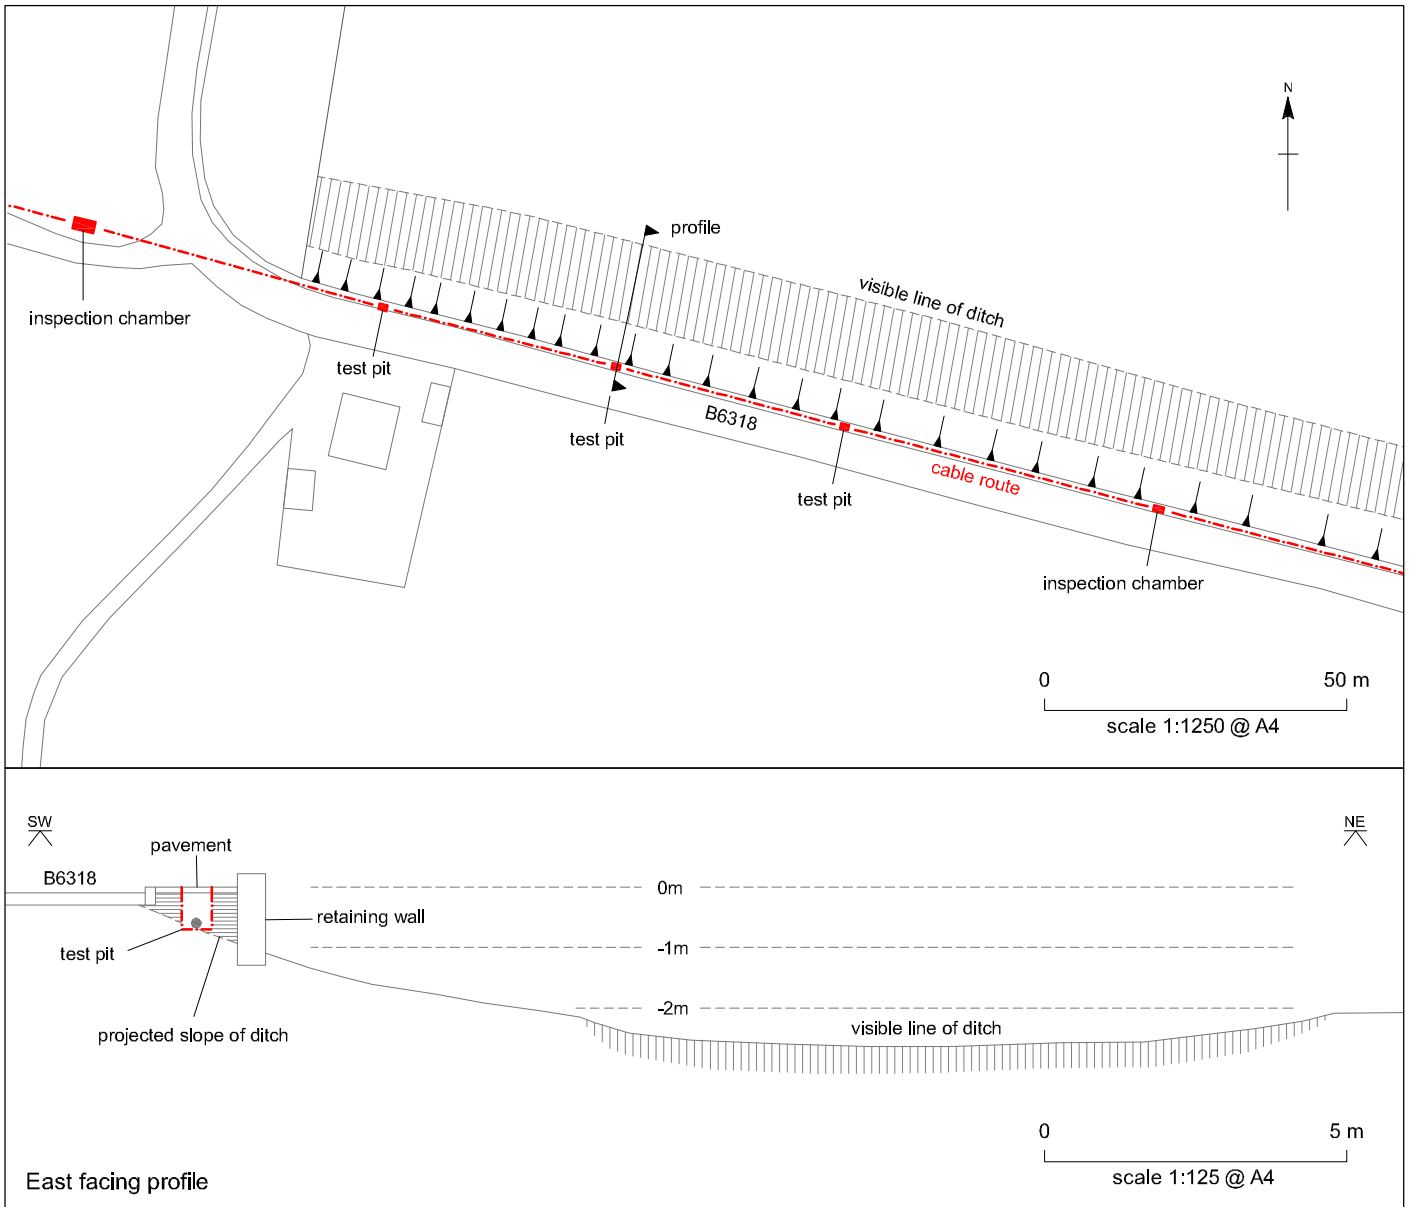
Figure 2

A profile across the ditch and pavement (Fig 2) shows the projected line of the ditch, with the pavement sitting on an area of made ground supported by the retaining wall.

Houghton North Farm: monitoring results

The three pits each measured approximately 0.5m x 0.7m, and up to 0.7m deep and were excavated directly above the Telecom and electric cables. The fill of the pits consisted of a mid-brown silty gravel, representing the backfill of the original duct trench, and no archaeological features or artefacts were encountered.

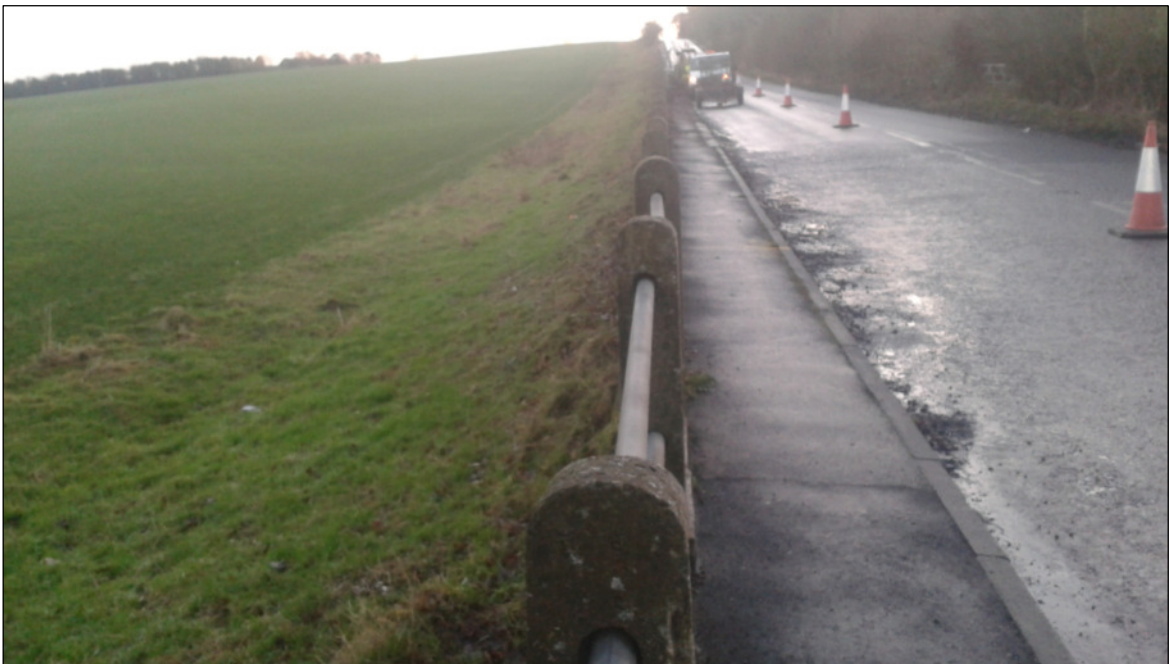
Plate 1

Houghton North Farm: site location showing wall ditch to north (left)

The work entailed the excavation of three pits in the north footway of the B6318/Military Road (Fig 2), over the existing BT Openreach ducting, to identify areas of collapse, and facilitate repairs. Scheduled Monument Consent for investigation work was obtained in advance (consent ref. S00090631). The footway abutted a retaining wall constructed along the south lip of the Wall ditch, which was visible as an earthwork to the north (Plate 1, Fig 2 profile).
