Binchester Hall, Binchester, Co. Durham Archaeological Monitoring Report

Report Title: Binchester Hall, Binchester, County Durham: Archaeological Monitoring Report

Version: 2.0
Issue Date: March 2023
Report Ref: 23-13

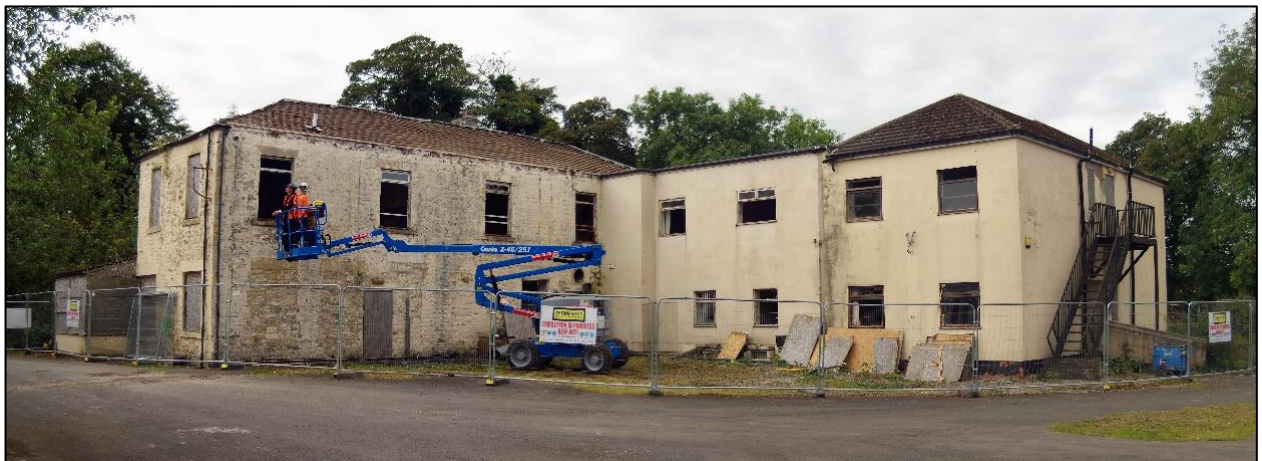
Plate 2: Binchester Hall, looking south-west. The buildings to the right of the mobile elevating work platform represent the 1970s extension.

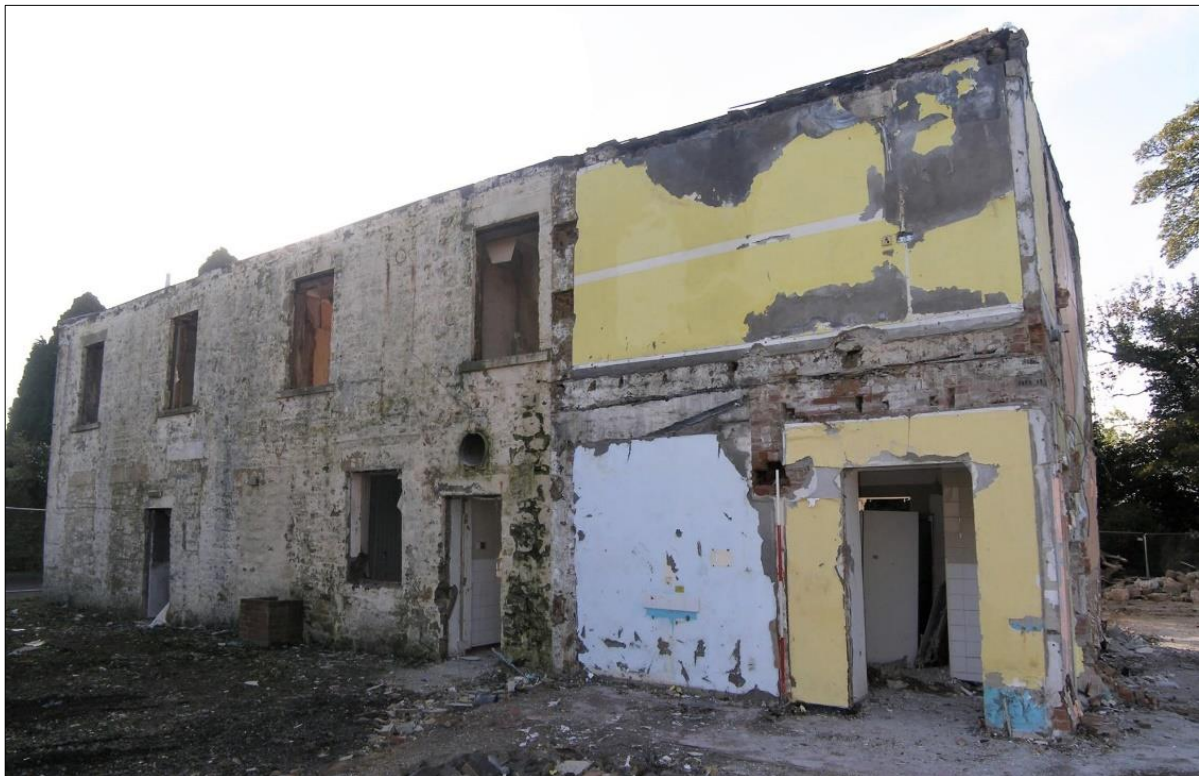
Plate 3: North-facing elevation of the 18th-century range after removal of later structures.

4.1.2 No heritage elements or previously unrecorded structural phases were identified during the demolition. The removal of later additions to the hall exposed the earliest iteration of the standing structure; however, the fabric of the building in these areas remained obscured by 20th-century plasterwork and internal decoration (Plate 3).

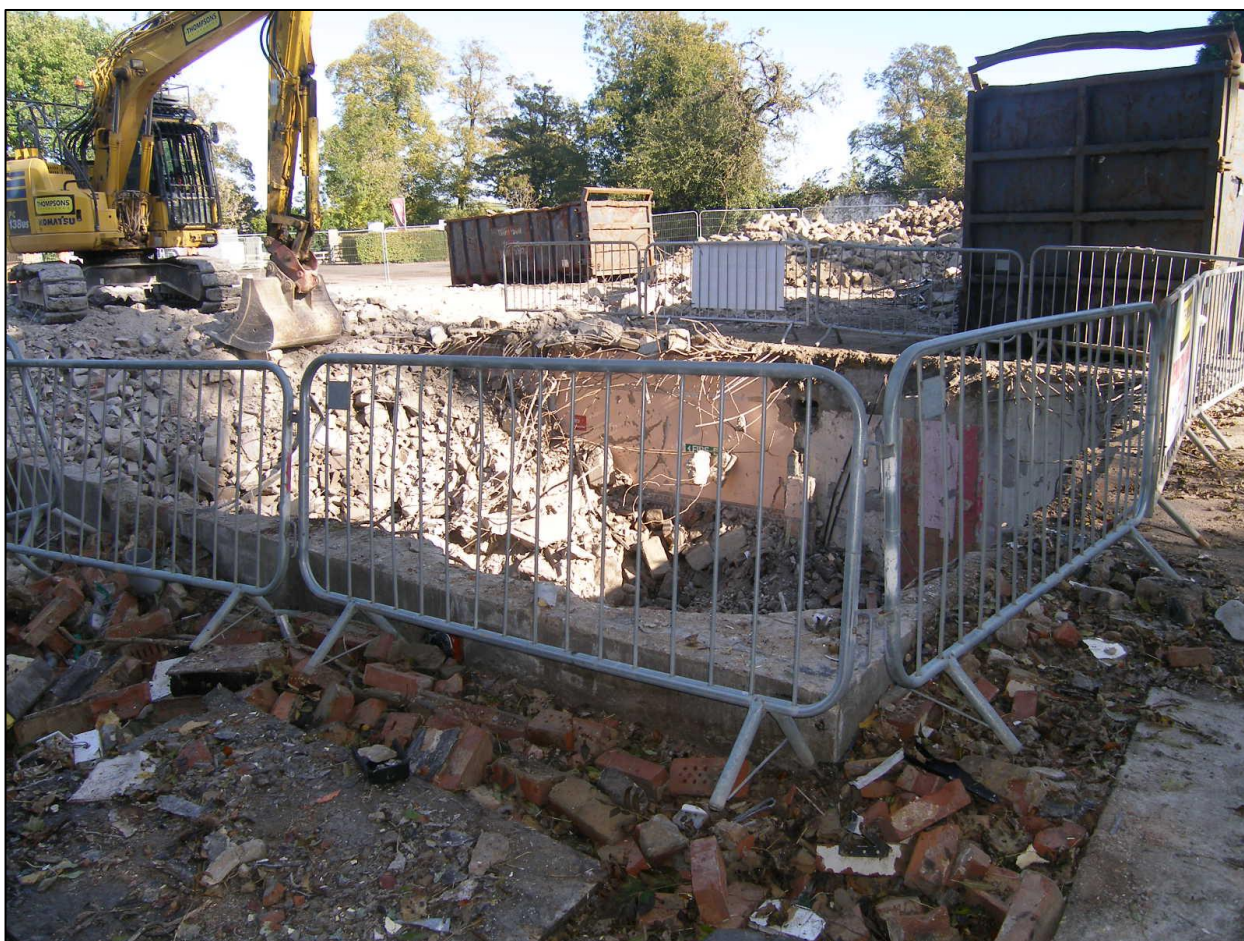
Plate 4: Infilling of the c.1970s cellar.

- 4.1.8 During the work, the cellar lining wall was left in situ (Stage 2). However, upon removal of the northern foundation slab and the overlying structure, the wall stood proud of ground level. In order to level the site, the upstanding wall was reduced using a hydraulic breaker to c.0.15m below ground level. Associated ground disturbance did not penetrate previously disturbed levels or topsoil, and therefore no archaeological features or deposits were exposed. The cellar was filled and compacted with building rubble (Plate 4).
- 4.1.9 The 18th-century range was footed upon foundations that were equivalent to the building material used to construct the walls, being faced and coursed sandstone rubble. Upon demolition of the late 18th-century structure, the foundations were left in situ and the site was levelled with demolition rubble.

- 5.1.2 The 20th-century cellar, which forms the focus of potential Stage 2 works, has been infilled with crushed rubble, and the lining walls remain in situ below ground level. It is not currently anticipated that the cellar walls will be removed; however, should this be required at future date, it is considered most likely that Roman period remains associated with the Fort would be exposed.

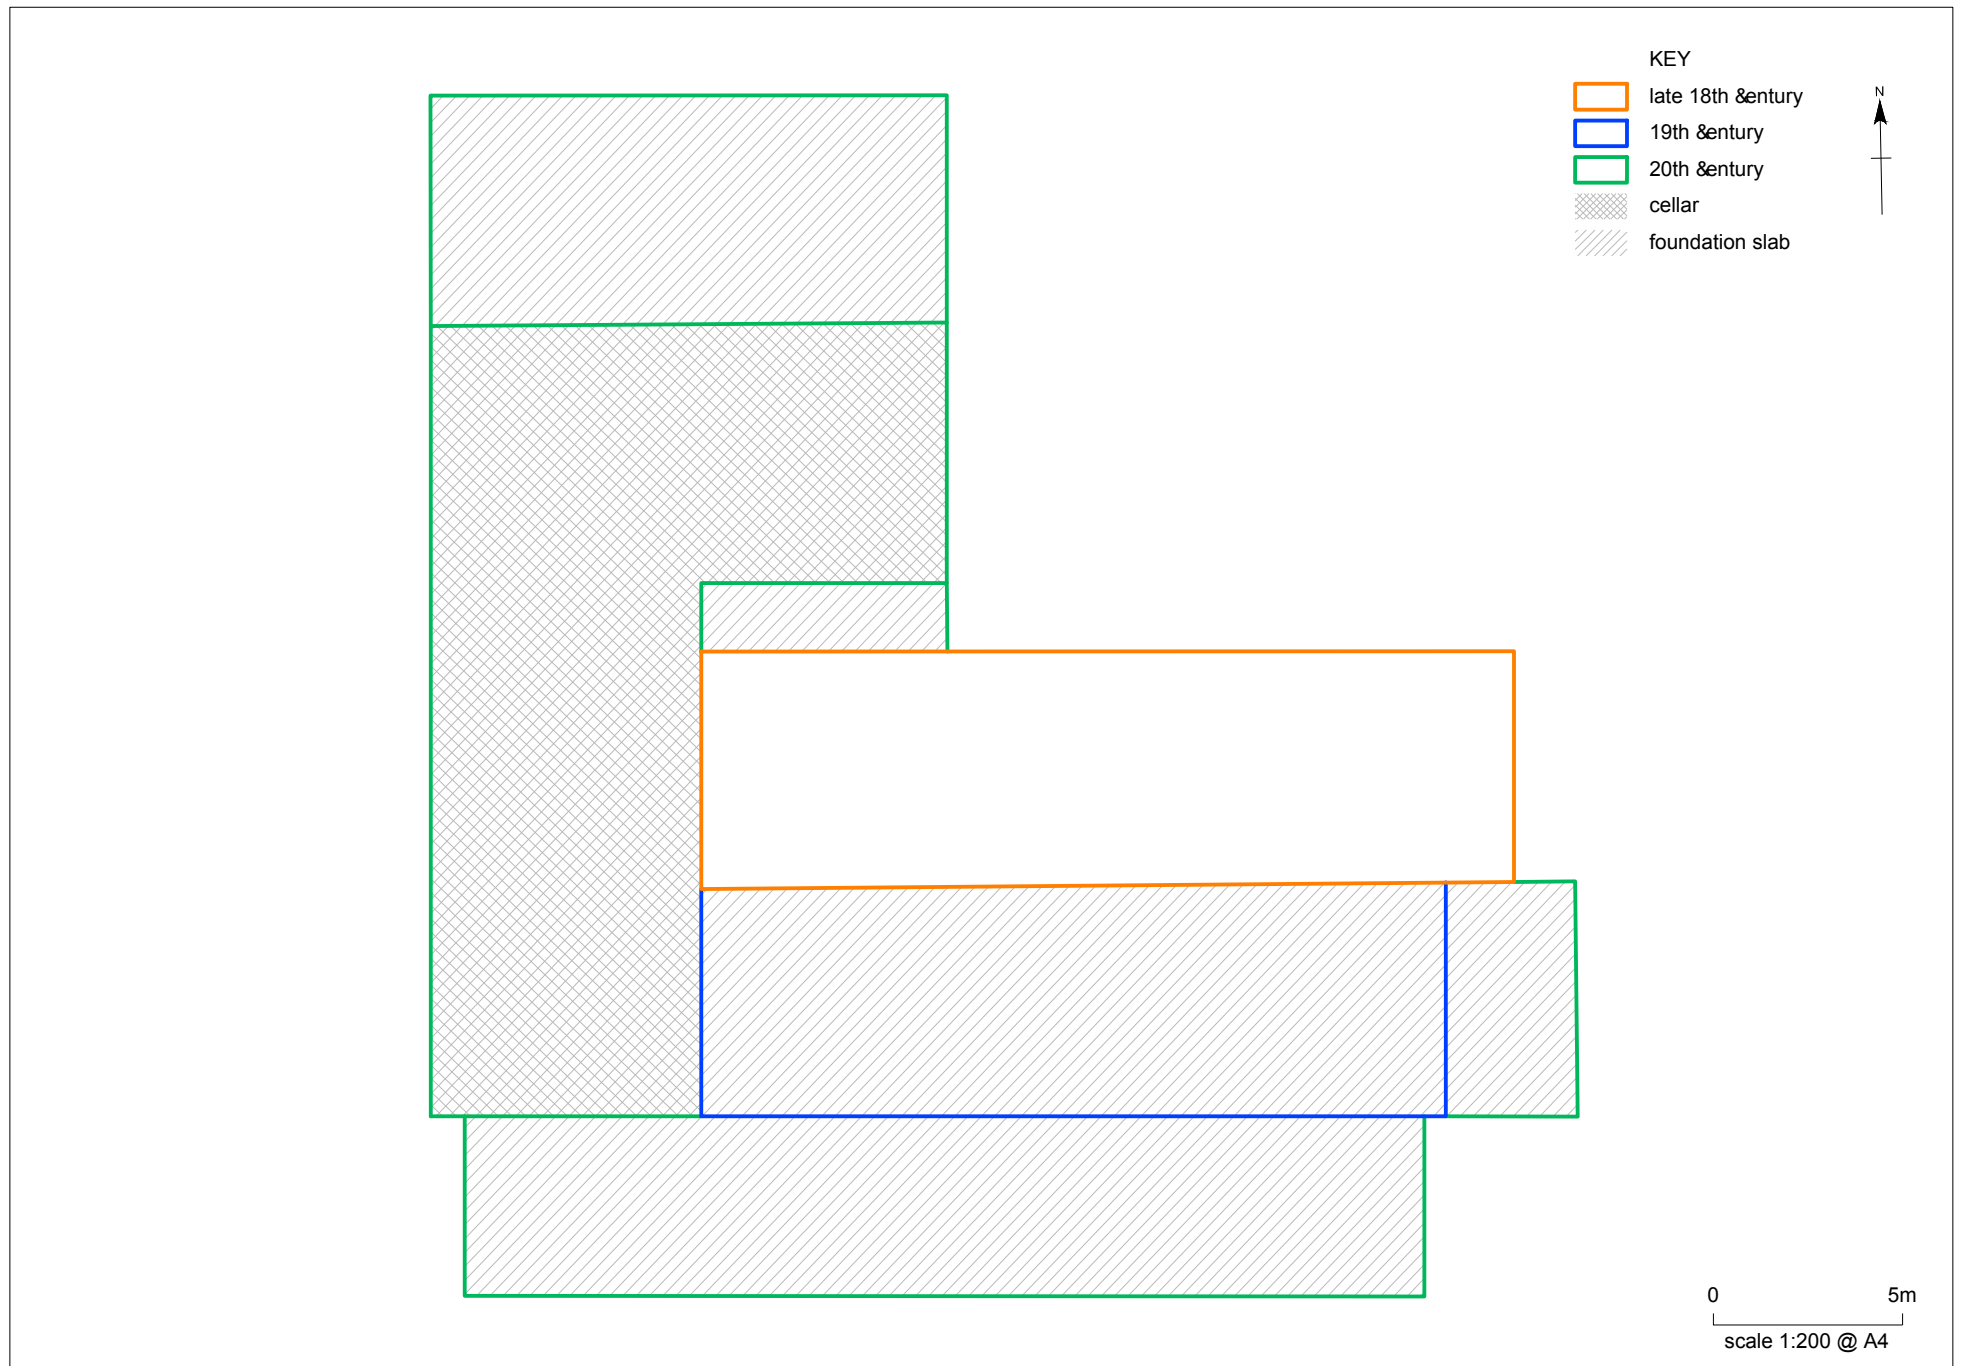
4.1.1 Binchester Hall was demolished using a tracked excavator fitted alternatively with a grab and toothed bucket. Structural components were removed according to building material, which resulted in the Hall being demolished in reverse chronological order to its construction. The 20th-century extensions were removed, followed by the removal of the 19th-century structure located to the south of the 18th-century range (Fig. 2). All demolition debris was removed from site.

4.1.3 Archaeological monitoring of the removal of foundation slabs and the reduction of other upstanding foundation components was focused on three areas. These included the removal of concrete slabs to the south of the late 18th-century core of the building, the removal of a concrete slab and associated foundation to the north of the structure, and the lowering of the 1970s concrete cellar lining wall (Fig. 2).

- 4.1.4 A tracked excavator fitted with a toothed bucket removed structural elements at, or above-ground level. Some shallow sub-surface structural components were removed in order to create a level surface. The c.1970s cellar wall lining was reduced but left largely intact (Fig. 2).
- 4.1.5 The area to the south of the late 18th-century structure included the removal of a 0.1m-thick concrete slab that supported the 20th-century southern extension, and a smaller slab located to the east that supported a lean-to type structure. All foundation slabs were laid directly upon topsoil representing an earlier ground surface.
- 4.1.6 The 19th-century extension had been constructed upon a series of individual concrete slabs, which formed the floor of the structure. The slabs were c.0.15m thick and were bedded onto topsoil.
