ARCHAEOLOGICAL  
MONITORING  
REPORT

NEW ROAD, WHIXLEY  
NORTH YORKSHIRE

Morrison Utility Services Ltd.

NAA 20/106  
December 2020

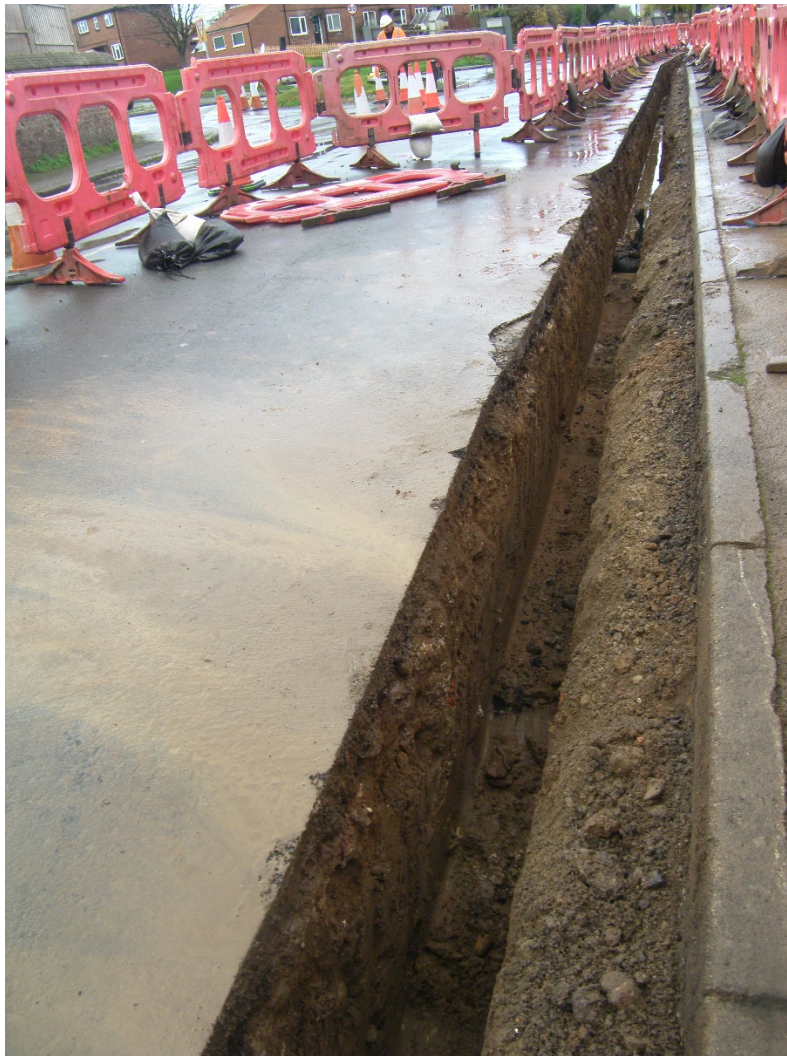
Plate 1: New Road pipeline trench, photo taken looking north-west.

- 6.1 The 50m-long pipe trench was excavated from north-west to south-east, commencing at the junction between Station Road/Rudgate and New Road. It was c.0.5m wide and was excavated to a depth of 0.9m.
- 6.2 The area around the junction was characterised by disturbance caused by services, but most of the length of the pipe trench was free from modern interventions. The trench section showed a deposit of red-brown clayey sand (Fig. 3; 1) directly underlying a thin layer of Type 1 gravel and the modern tarmac surface.

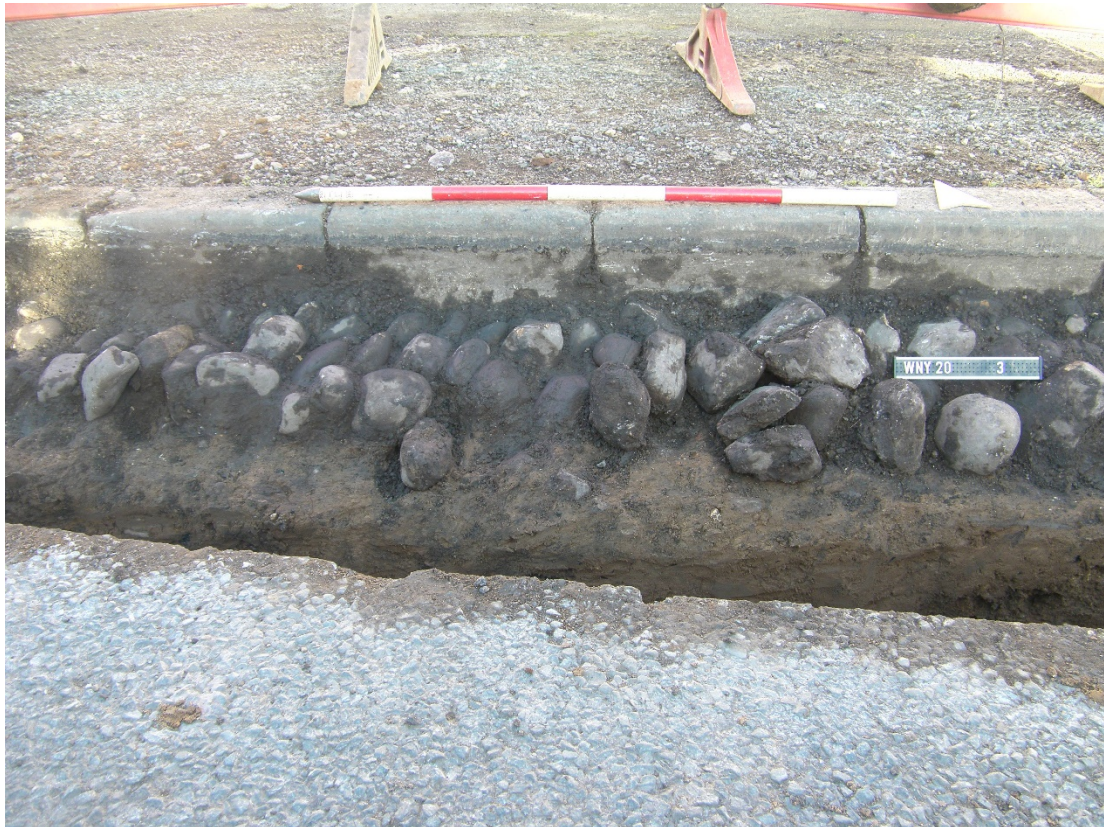
Plate 2: stone surface 3.

- 6.3 An area of cobbles directly underlying the modern road surface was encountered approximately 4m from the south-east end of the trench (Fig. 3). The stone surface (3) was made of natural rounded cobbles, each measuring up to 0.2m across. It was 2.5m wide in section, and a maximum of 0.2m deep, with two layers of cobbles at the east

end. The stone surface was overlying a thin (0.1m) layer of red-brown sand (2) which appeared to have been deliberately deposited. This deposit had been added over the layer of clayey sand (1) seen throughout the trench. The western part of surface 3 and deposit 2 had been truncated by the cut for a modern storm drain.

- 7.3 The exact form and function of the small segment of stone surface recorded within the pipe trench is unknown due to the limited area of excavation and the lack of dateable evidence associated with the feature. The presumption, however, is that this represents a small surviving section of the Roman Road, though this must remain speculative.

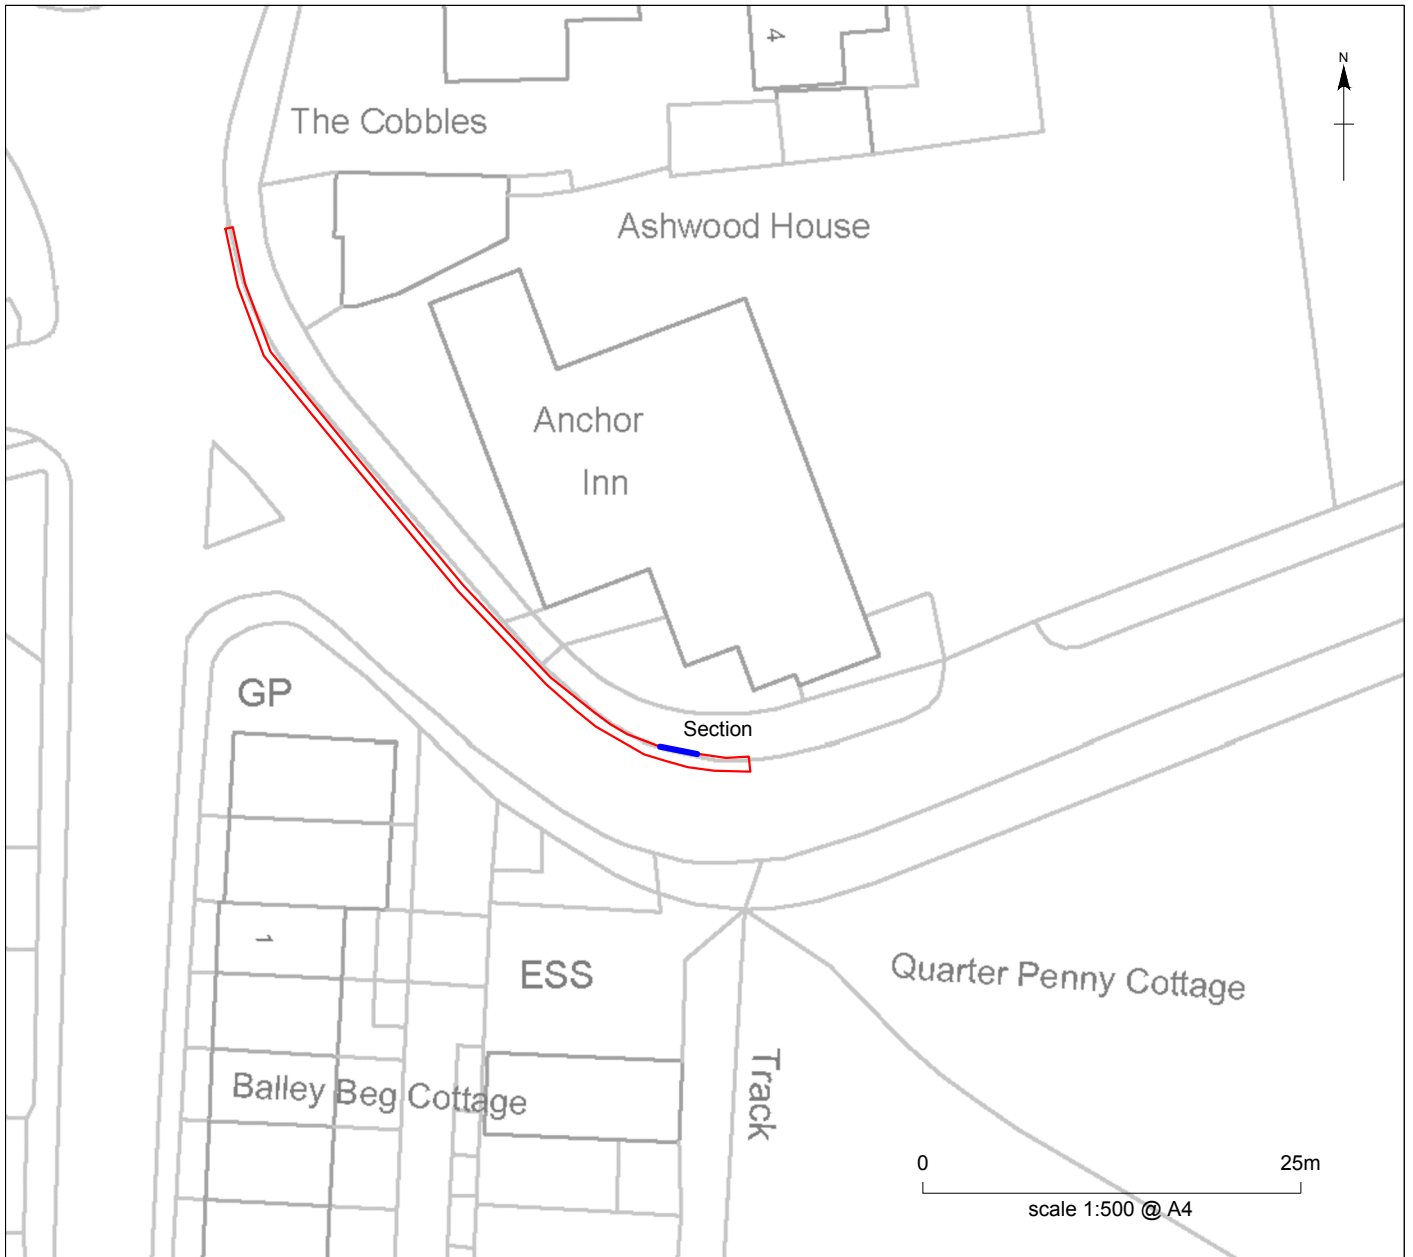
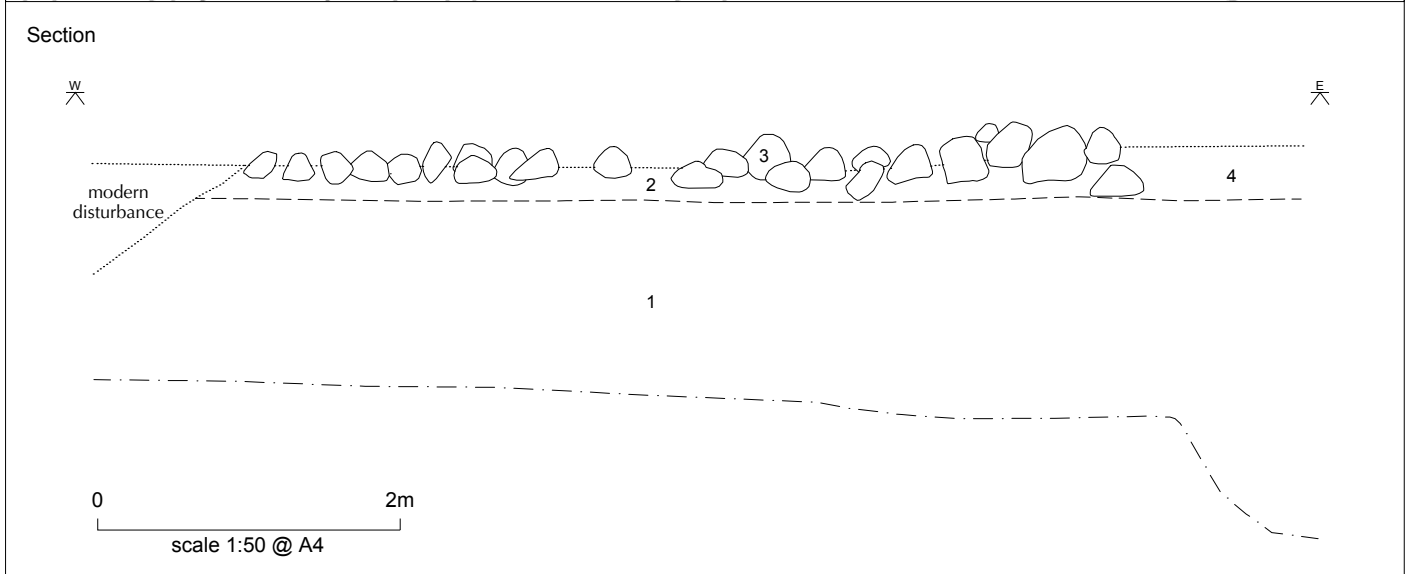
Figure 3: results of monitoring.
