NORTHERN ARCHAEOLOGICAL ASSOCIATES LTD
SHITTLEHOPE BURN FARM
Negative Watching Brief Report

Site name: Shittlehope Burn Farm **Grid reference:** NZ 0025 3845
Parish: Stanhope **County:** County Durham
Administrative authority: Durham County Council **Development:** Housing
Client: Gibson Building Contractors **Contractor:** Gibson Building Contractors
Planning application reference: DM/17/02436/FPA
Site supervisor: Holly Cooper **Project manager:** Matthew Town
Fieldwork Date(s): 12th-13th December 2017
NAA project number: 1407 **Site code:** SHB17
NAA report number: 18/03 **Report date:** 8/1/2017

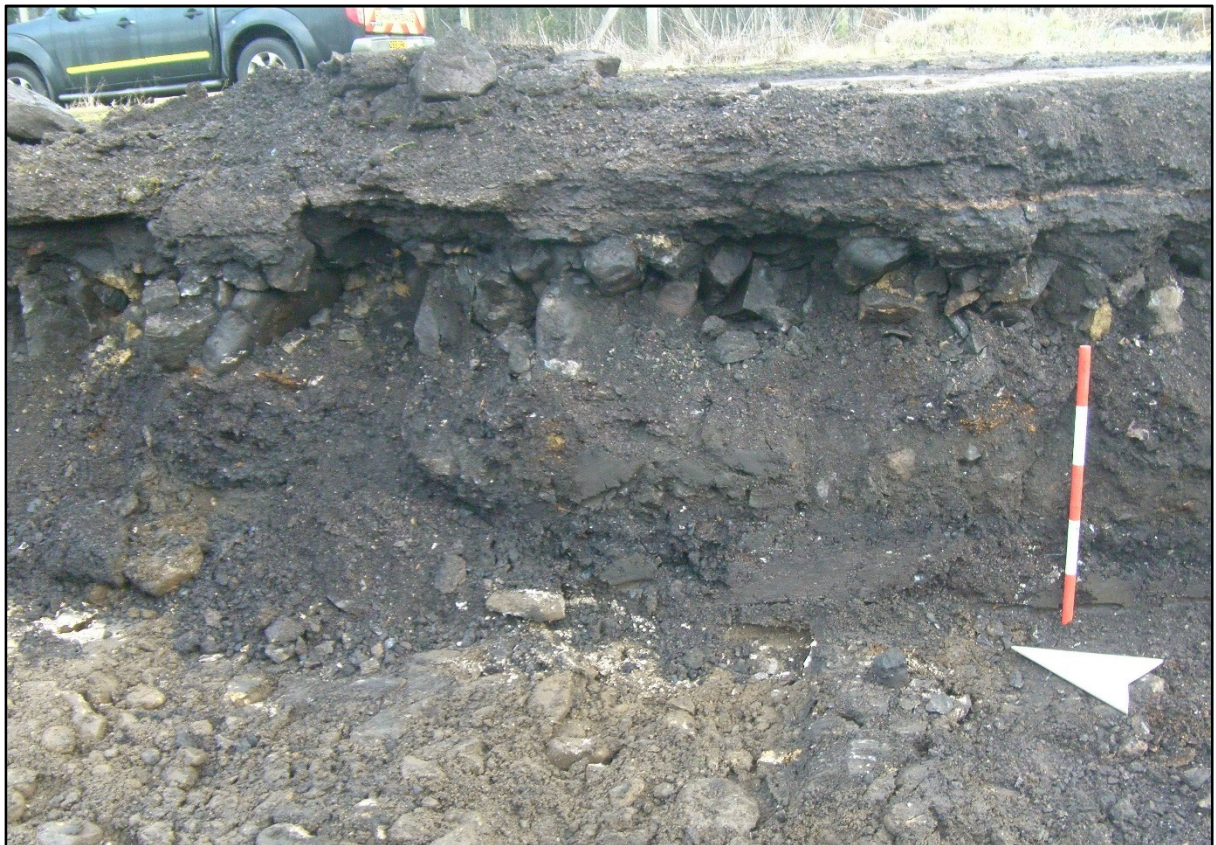
*Plate 1: Representative section showing the natural alluvial stony silt **01**, thick refuse deposit **02**, stone setts **03** and tarmac surface **04**.*

The natural alluvial silt **(01)** was encountered at a maximum depth of 0.9m, at the south-western corner of the development area, rising to a minimum depth of 0.3m in the north-east corner. There was no evidence of any archaeological features cut into this horizon.

Above the natural silt **(01)** was a site-wide black refuse deposit **(02)** which consisted of ashy material and clinker. This was thickest (0.6m) at the south-west corner, thinning to a minimum of 0.1m at the north-east, following the natural upward slope of the land. Within this deposit were frequent fragments of brick, sandstone and concrete rubble, which could have originated from structures within the WW1 PoW camp; however, all *in situ* structural evidence pre-dating deposit **02** had been removed. In addition to rubble, deposit **02** also contained large quantities of domestic refuse, primarily pottery and glass, many of which were branded and could therefore be dated to the late 19th/early 20th century (Plate 1, 5, 6, 7, 8, 9).

Overlying the well/borehole **(06)** and the modern drains **(09)** was a widespread rough surface of cobble setts and chipped stone bonded with bitumen **(03)**. The uneven and coarse nature of

this deposit indicates that it was more likely a bedding layer for the upper tarmac yard (04) than a surface in its own right (Plate 1).

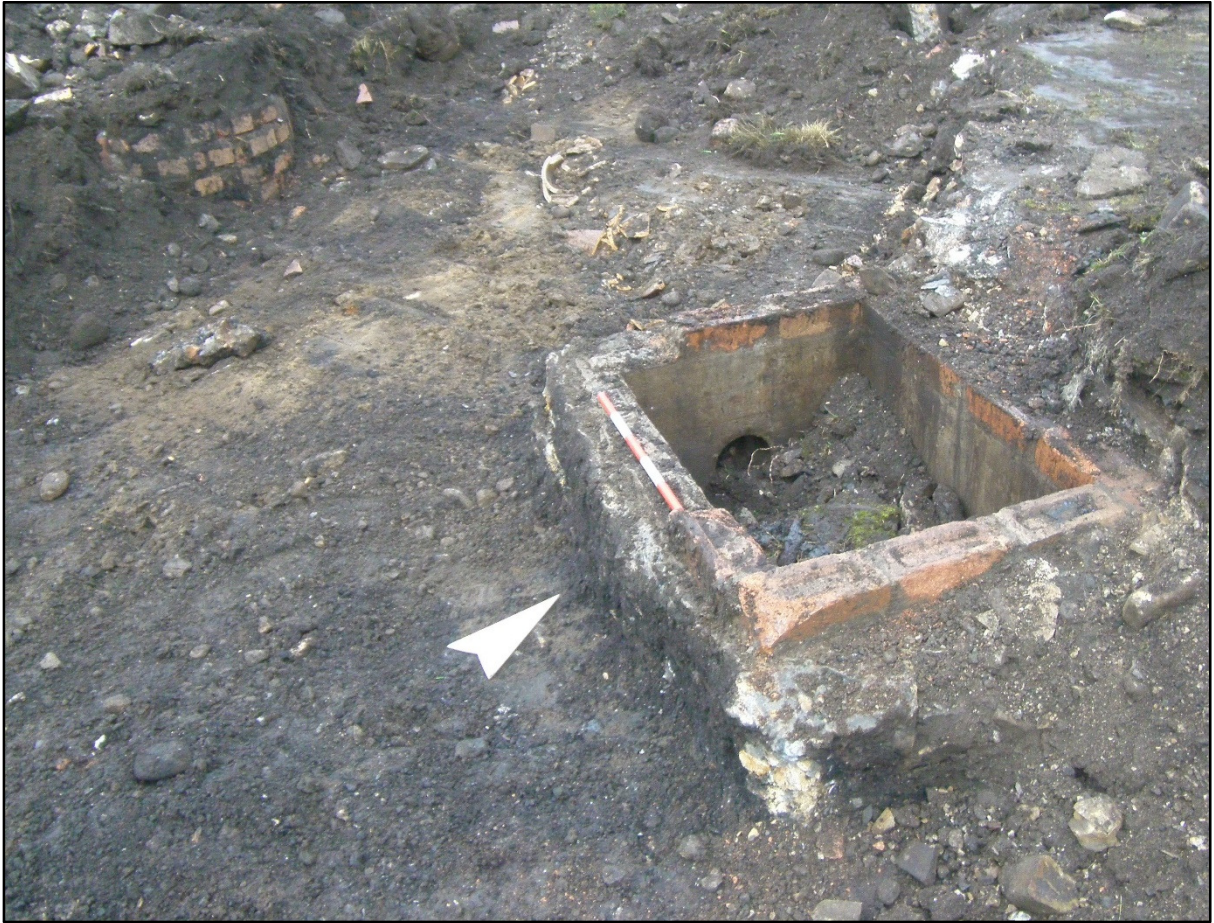
Plate 2: Modern brick and concrete inspection chamber and ceramic drains (09).

Two drains **(09)** were revealed running north-west to south-east along the line of machining, 0.6m in width and located approximately 4m apart, they were cut through clinker horizon **02**. No ceramic pipes were present and the cuts had been infilled with limestone chippings to aid drainage. A third drain was recorded running east to west, this one contained a ceramic pipe and was interrupted along its length by a concrete and brick inspection chamber (also listed under **09**). Within the fills of the drain cuts and the inspection chamber were fragments of plastic packaging, which attributed a modern date to all three of these features and they therefore post-date any remains of the early 20th century Prisoner of War camp (Fig. 2, Fig.3, Plate 2).

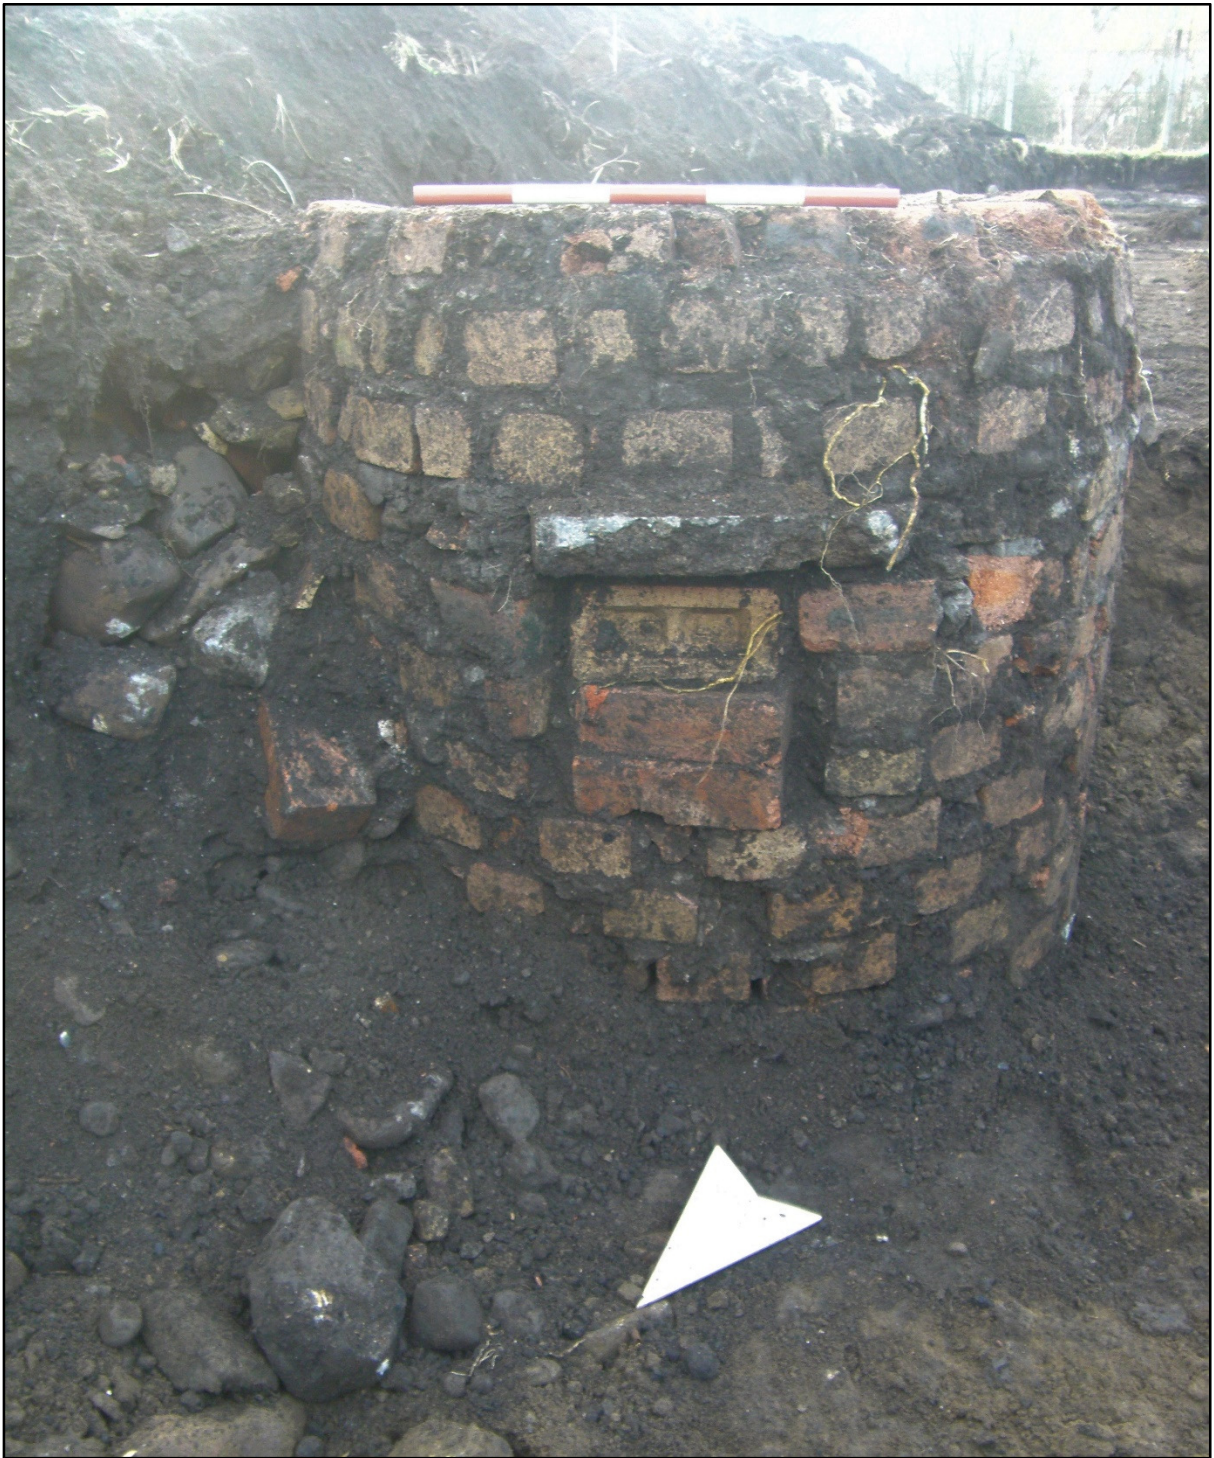
Plate 3: North-east facing elevation of brick well/borehole structure 06, showing square aperture blocked with later bricks and cut 05 infilled with cobbles and rubble (07).

Also cut through clinker horizon **02**, approximately 5m from the western edge of excavation, was a circular brick structure, apparently a well/borehole, **(06)** (Fig. 2, Fig. 3). The overall diameter of the structure was 1.1m, the bricks laid in header bond, which formed a central, circular, aperture 0.6m in diameter, capped with a circular sandstone slab. A square aperture (0.3m by 0.3m) with a concrete lintel had been built into the structure, facing north-east. This had been infilled at a later date with three bricks laid stretcher. Stamped "F & L" for Ferens and Love, these bricks were made locally at Cornsay Colliery and differed from those used in the main structure, which were frogged but unstamped. Well/borehole structure **06** was situated within a vertical sided cut 1.5m in diameter, infilled with a mixed deposit of rubble, medium natural cobbles and clinker, **(07)**. This cut was excavated to a depth of 1.5m below ground level, the full depth of cut **07** and structure **06** is unknown (Plate 3, Plate 4).

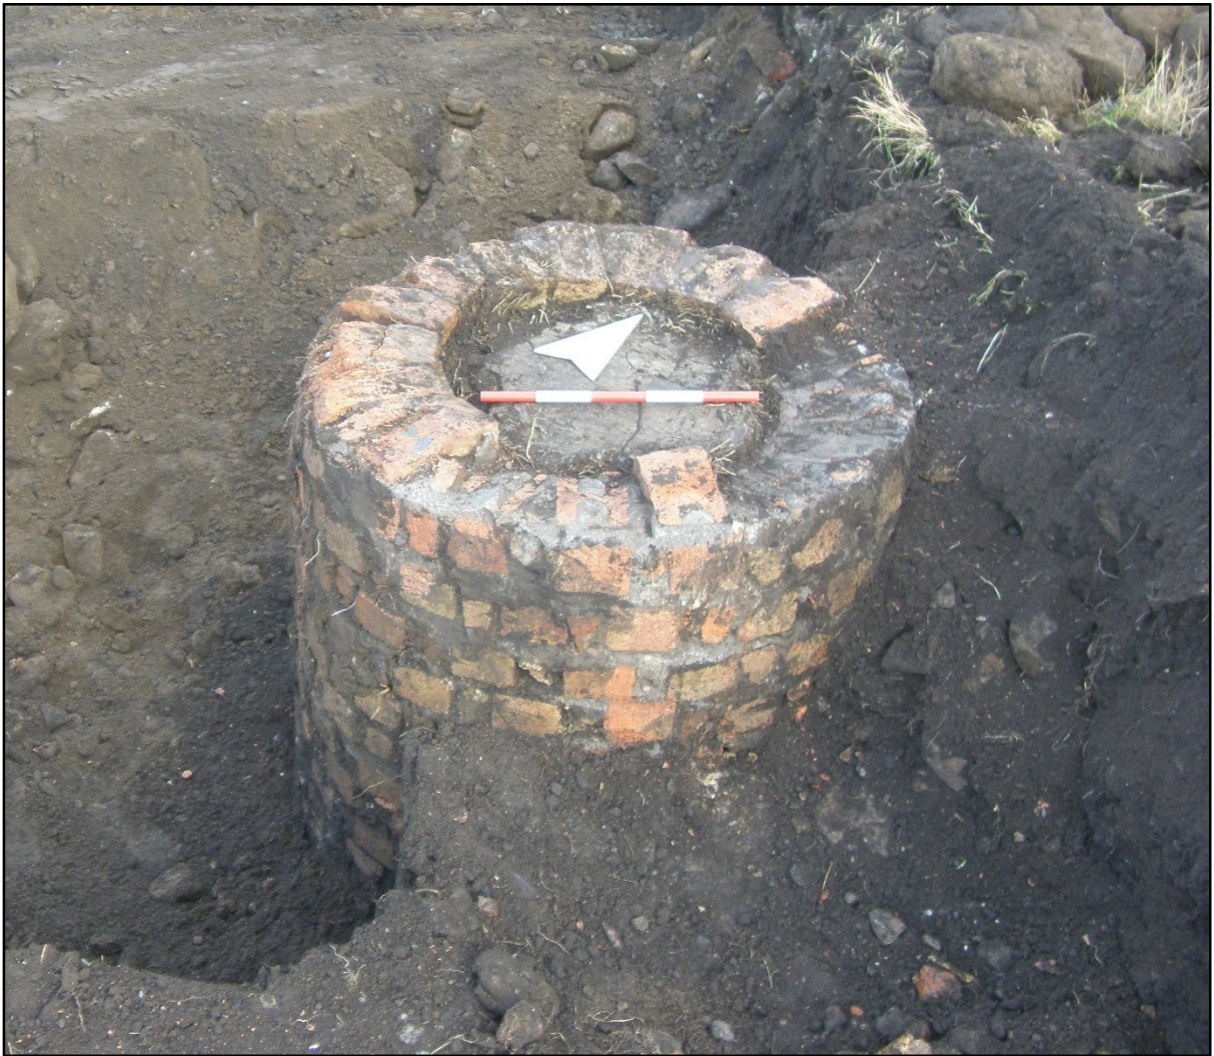
Plate 4: Overview of well/borehole structure 06 showing central aperture with sandstone cap.

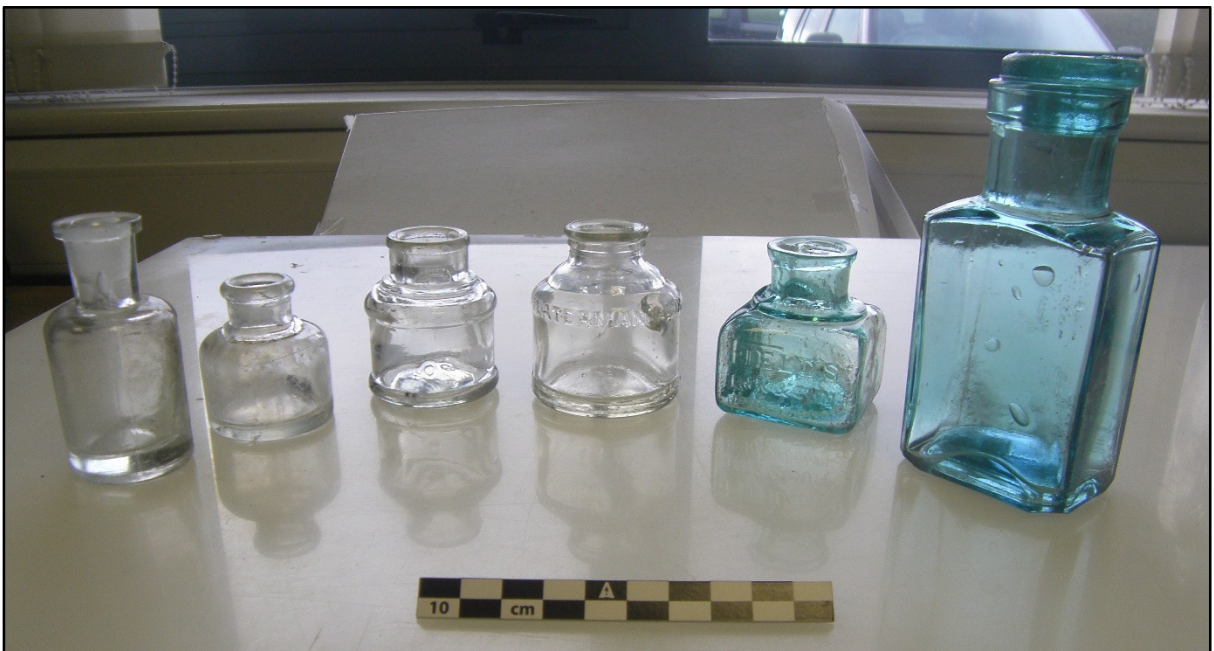
Plate 5: Assemblage of small glass bottles and inkwells from deposit 02.

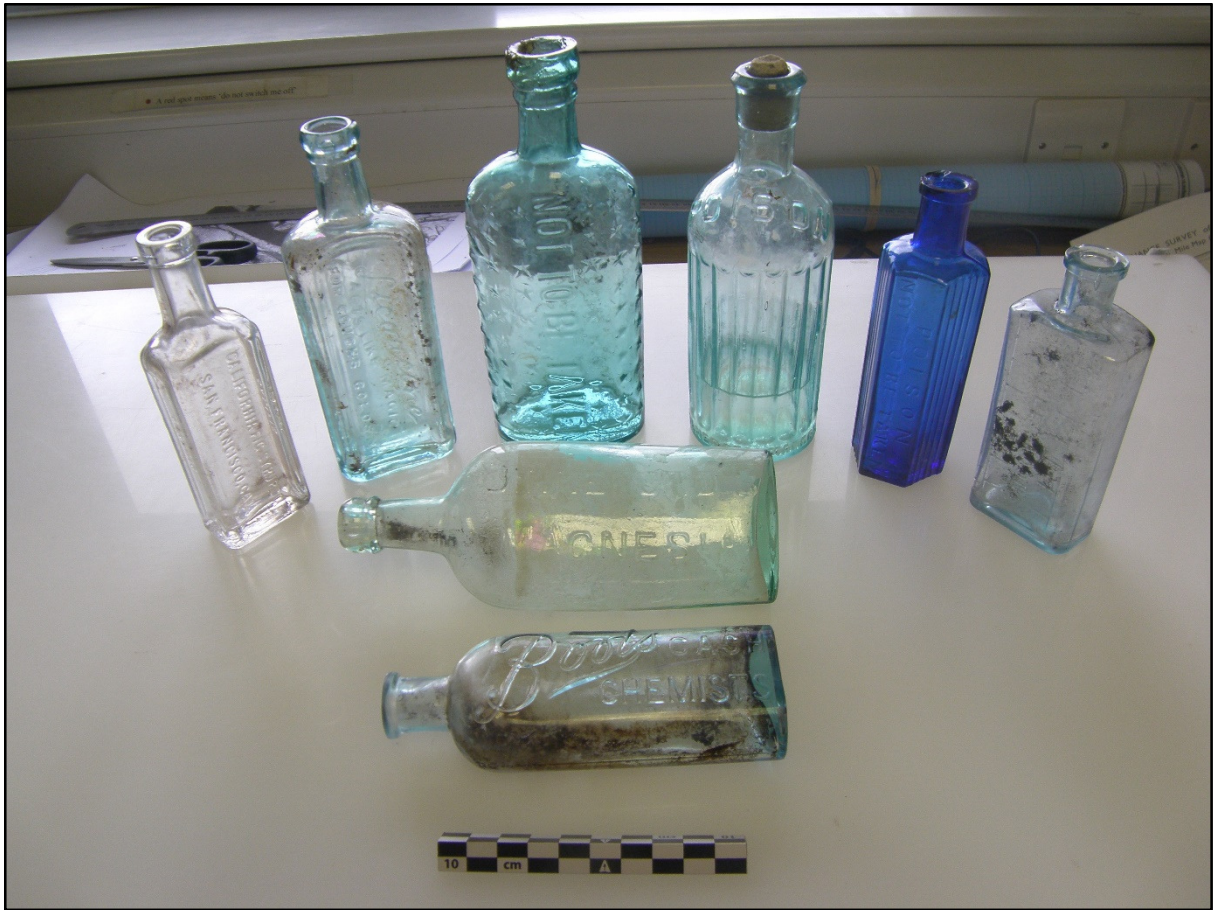
Plate 6: Assemblage of early 20th century medicine and poison bottles from deposit 02.

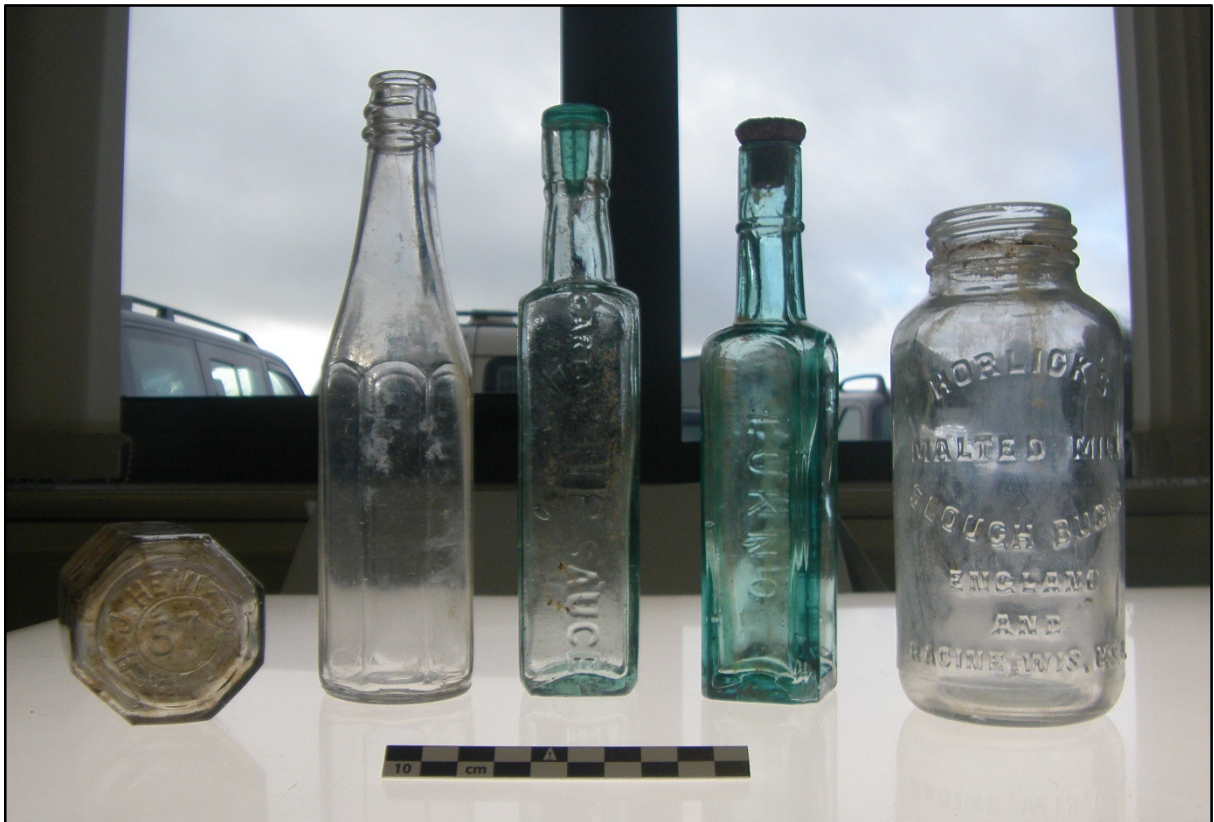
Plate 7: Assemblage of early 20th century condiment bottles from deposit 02.

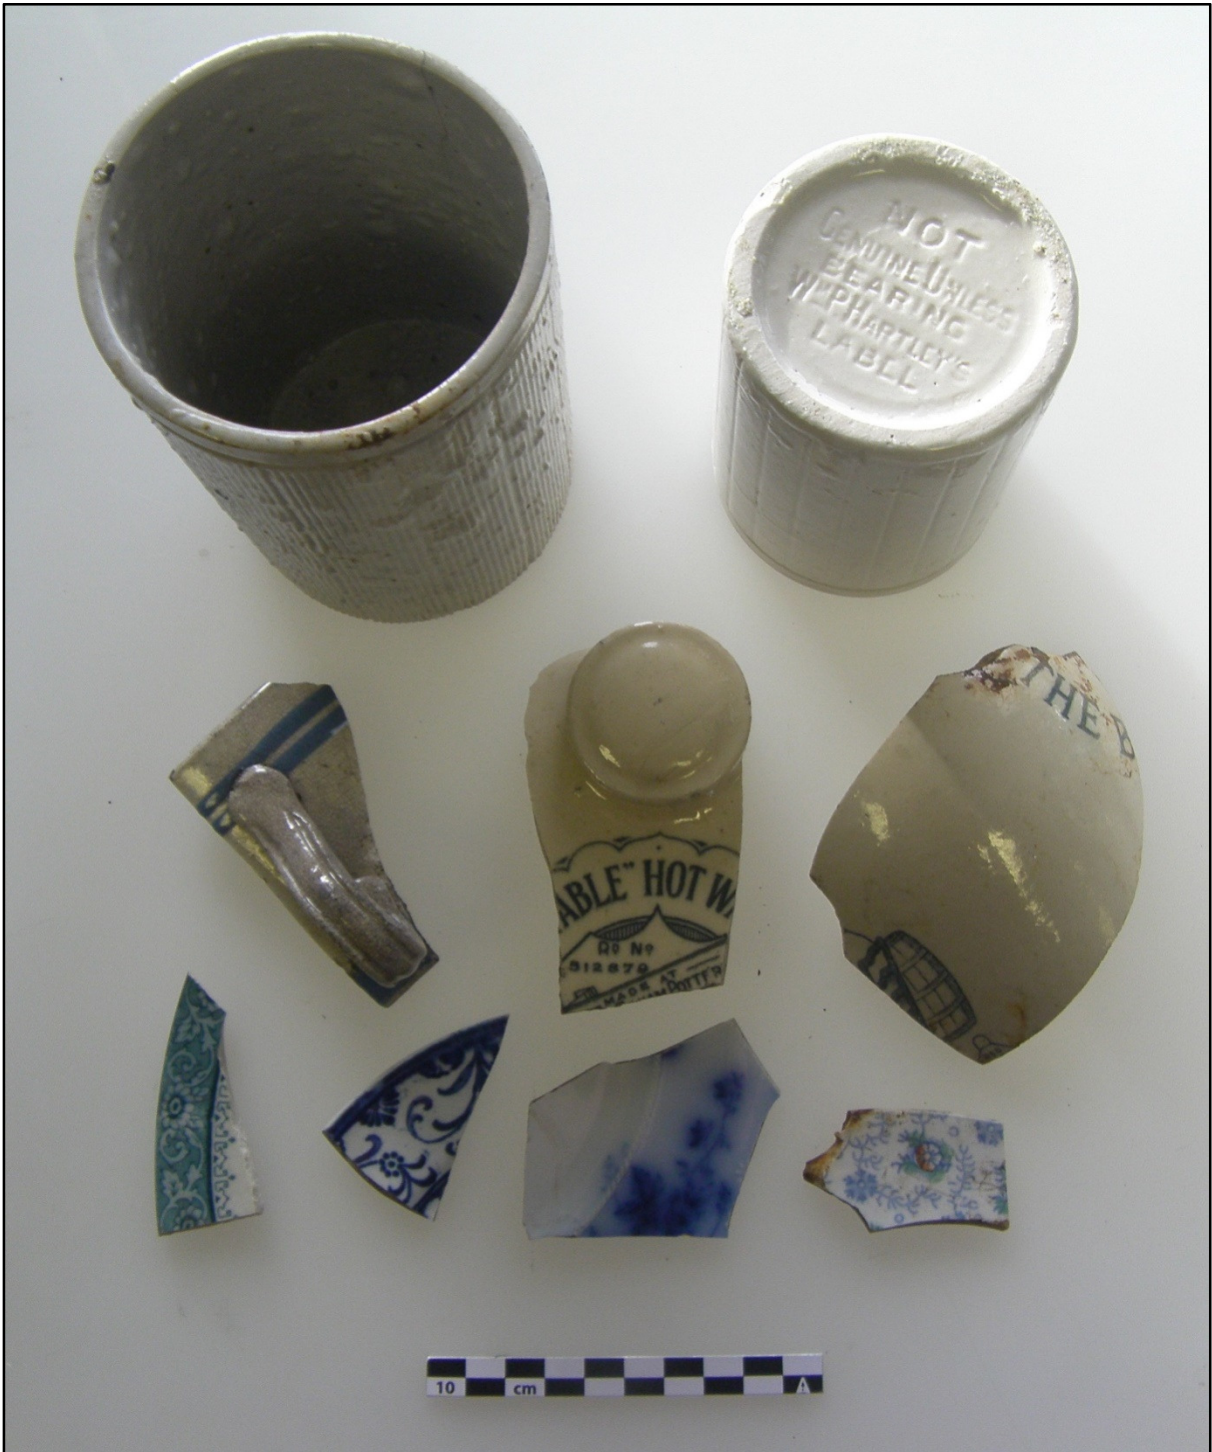
Plate 8: Assemblage of late 19th/early 20th century ceramics from deposit 02, including a fragment of an “Adaptable Hot Water Bottle & Bed Warmer” produced by The Old Fulham Pottery from 1904 onwards.

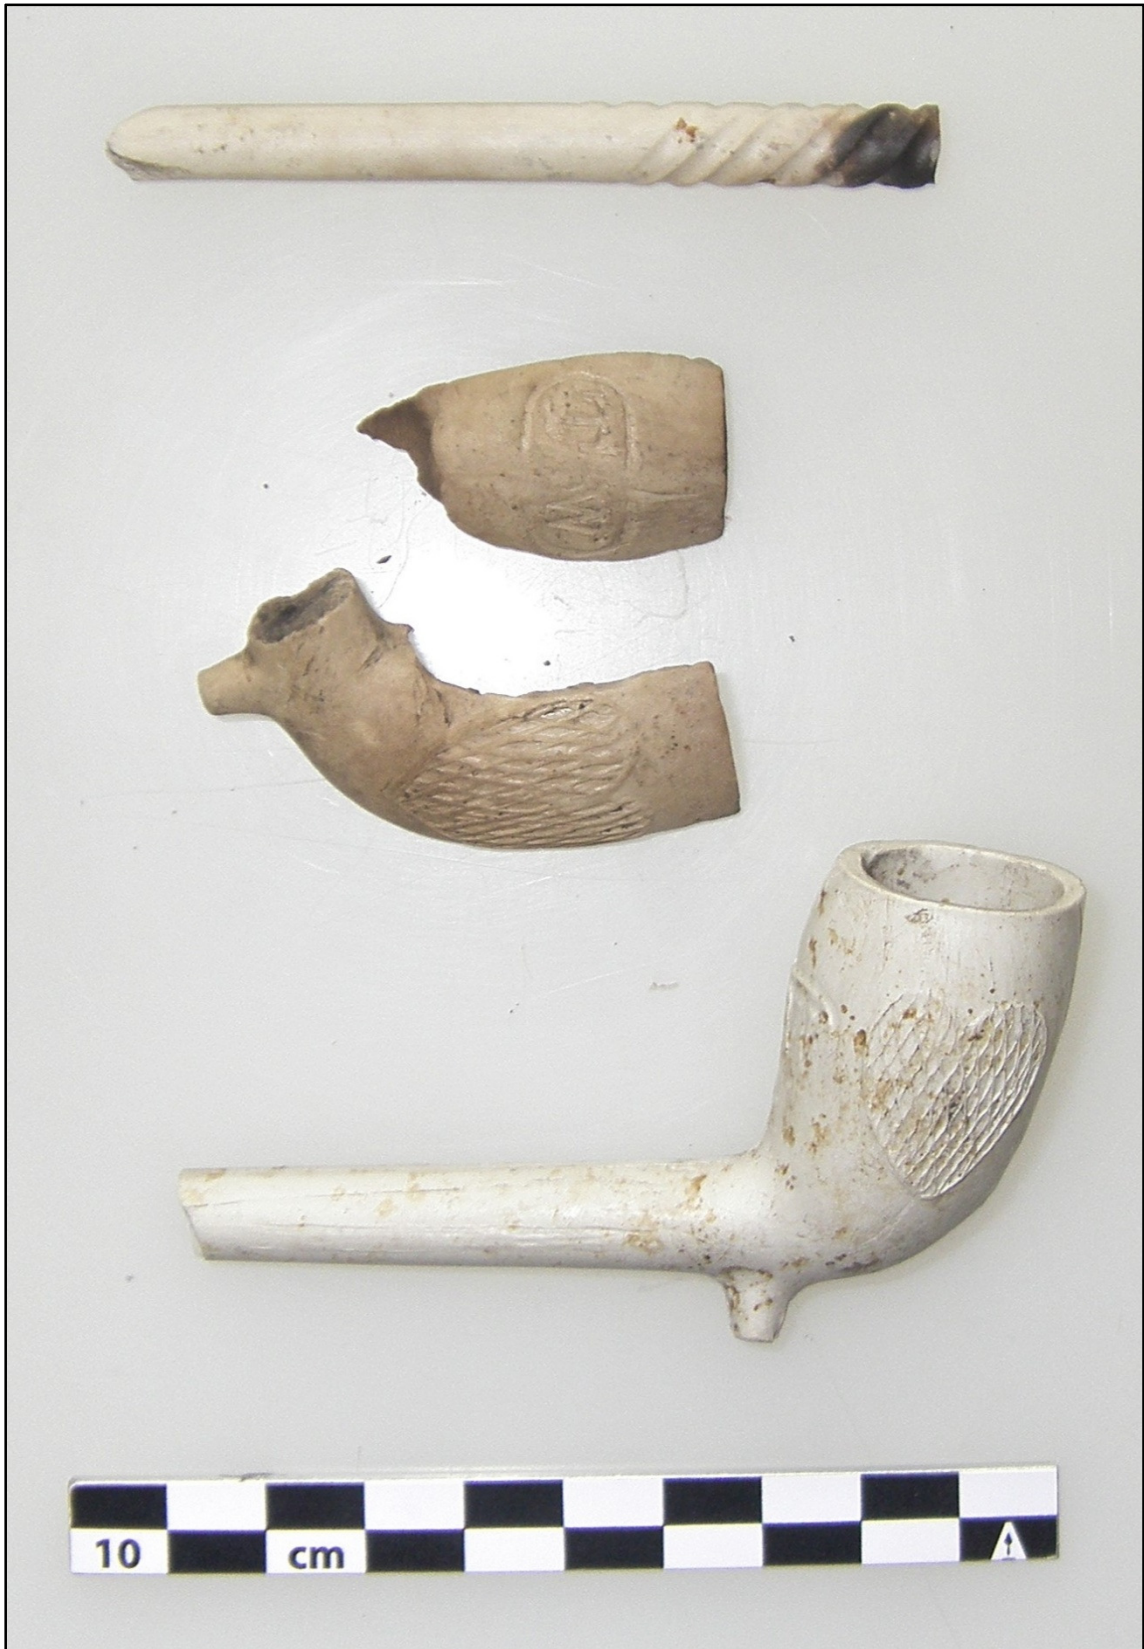
Plate 9: Fragments of late 19th/early 20th century decorative clay pipe bowls and stem from deposit 02, attributed to the factory of Tennant and Son, Tweedmouth.
