# **Kempsey Pumping Station, Worcestershire**

## **Archaeological Monitoring of Ground Investigation Works**

**September 2022**

## Ecus Ltd

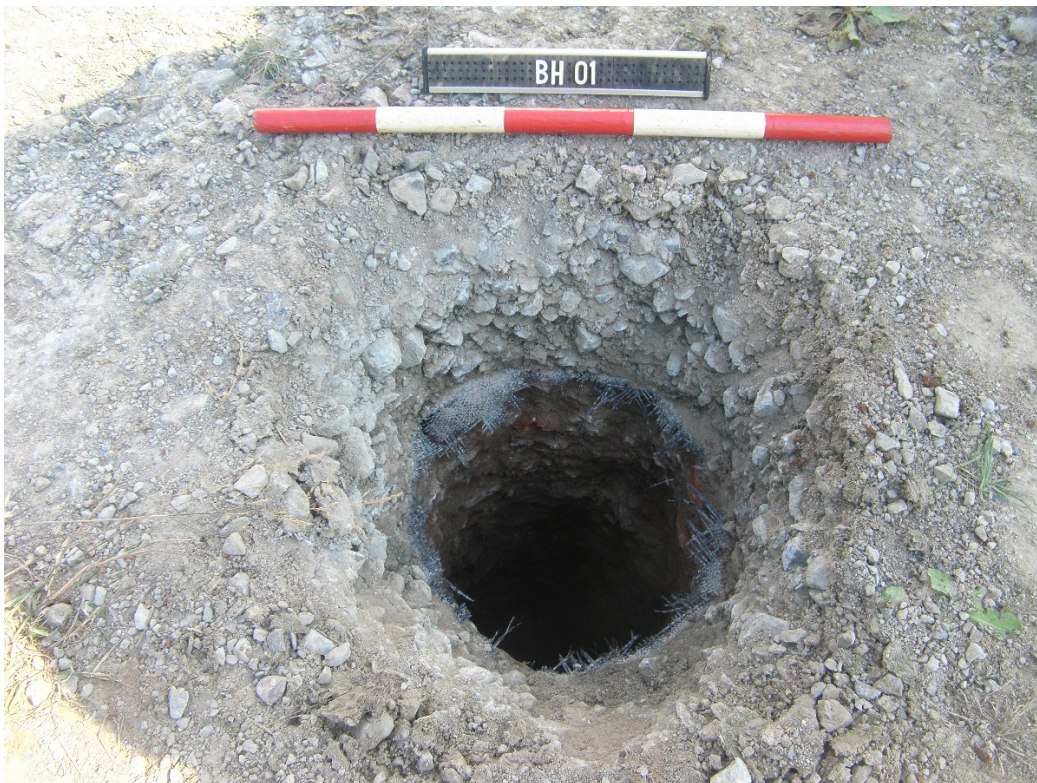
**Plate 1: BH01**

6.1.3 The starter pit for BH01 was excavated by hand through the hard standing in the central area of the pumping station. Below two layers of made ground, redeposited colluvium overlying alluvial clay was encountered at a depth of 1m. The starter pit was excavated down to a depth of 1.2m, after which drilling commenced.

Depth	Description
0-0.2m	Type 1 crushed limestone laid on a membrane
0.2-0.7m	Mixed sand/gravel with modern demolition rubble laid on a membrane.
0.7-1m	Brown-red silty sand colluvium (redeposited)
1-1.2m+	Blue-grey silty clay alluvium

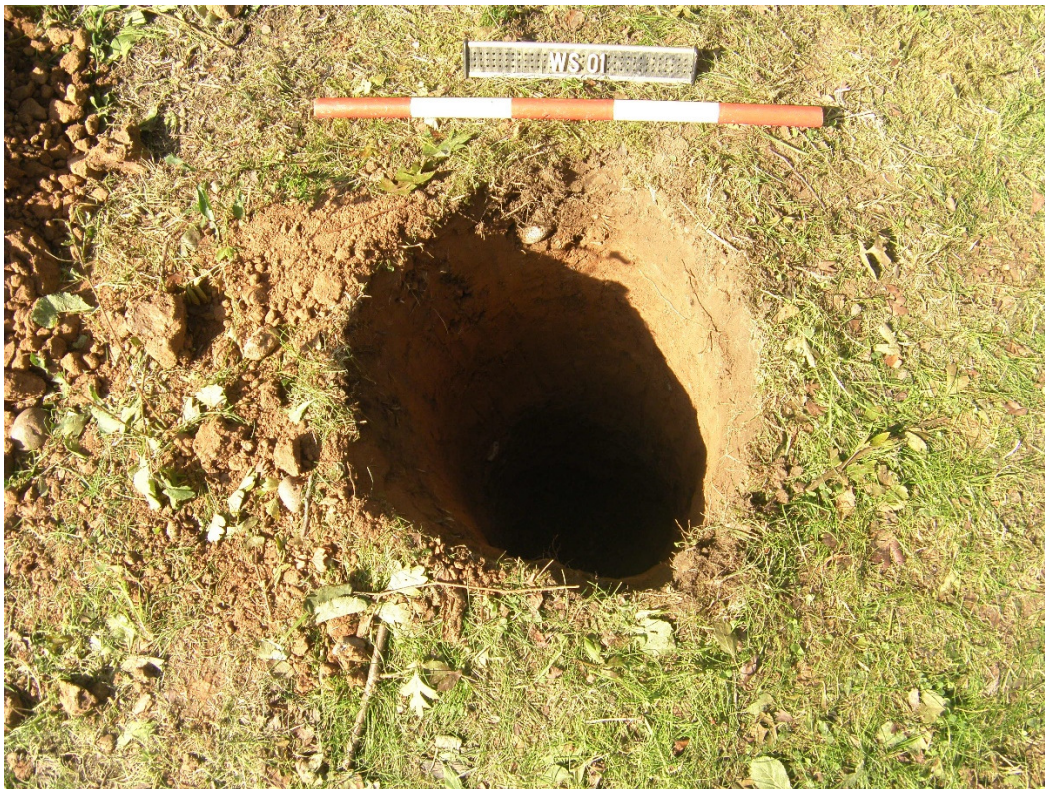
**Plate 2: WS01**

6.1.4 The starter pits for WS01 and WS02 were excavated at the top of a landscaped slope to the east of the pumping station buildings. The pits were excavated by hand to a depth of 1.2m, after which window sample drilling commenced. The cores were monitored for archaeological material and depth of deposits recorded. An unexpected service was encountered during excavation of the starter pit for WS01. Excavation ceased and the starter pit was relocated to a position 2.5m south-west of the original location. WS01 and WS02 showed a near identical sequence of deposition, with brown-red colluvium overlying alluvial clay deposits at depths of c. 2m. The upper levels of the colluvium appeared to have been disturbed by landscaping of the slope during construction of the pumping station.

Depth	Description
0-0.1m	Turf and topsoil
0.1-2m	Brown-red silty sand colluvium
2-2.5m	Brown-grey gravelly alluvial clay
2.5-4m	Red-brown sandy/silty alluvial clay
4-4.5m	Blue-grey silty alluvial clay with organic matter
4.5-5.3m	Red-purple clayey sand glacial till

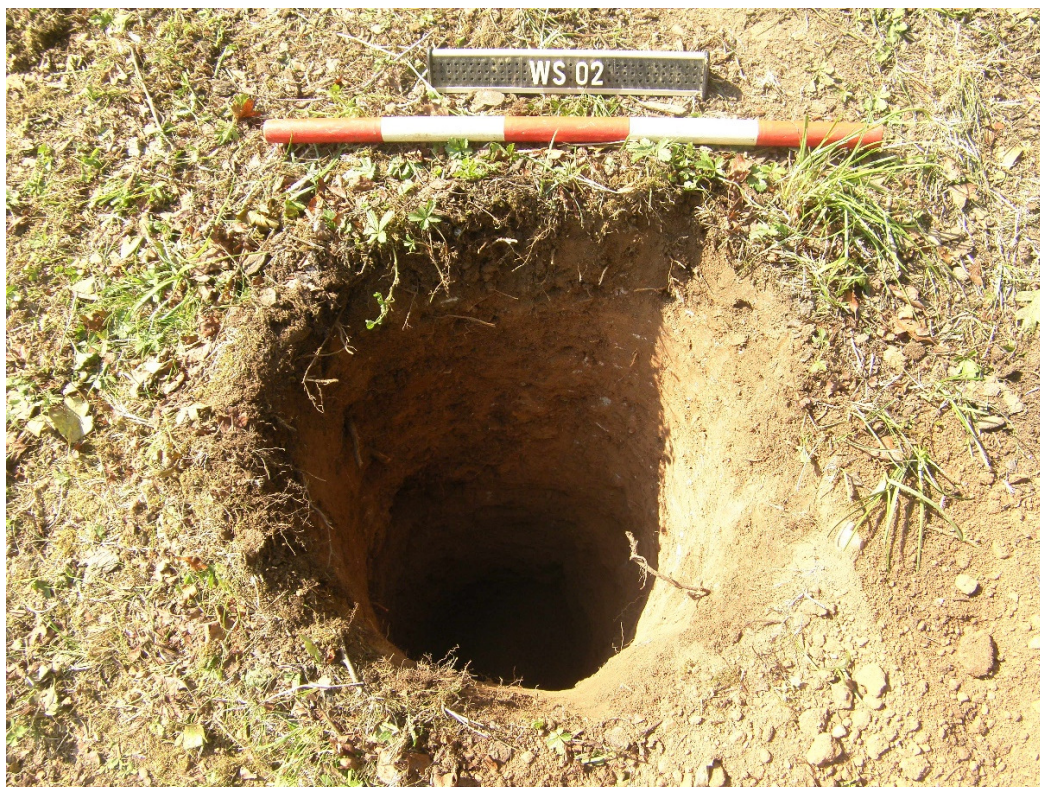
**Plate 3: WS 02**

0.1-2m	Brown-red silty sand colluvium
2-2.5m	Brown-grey gravelly alluvial clay
2.5-4m	Red-brown sandy/silty alluvial clay
4-5m	Red-purple clayey sand glacial till

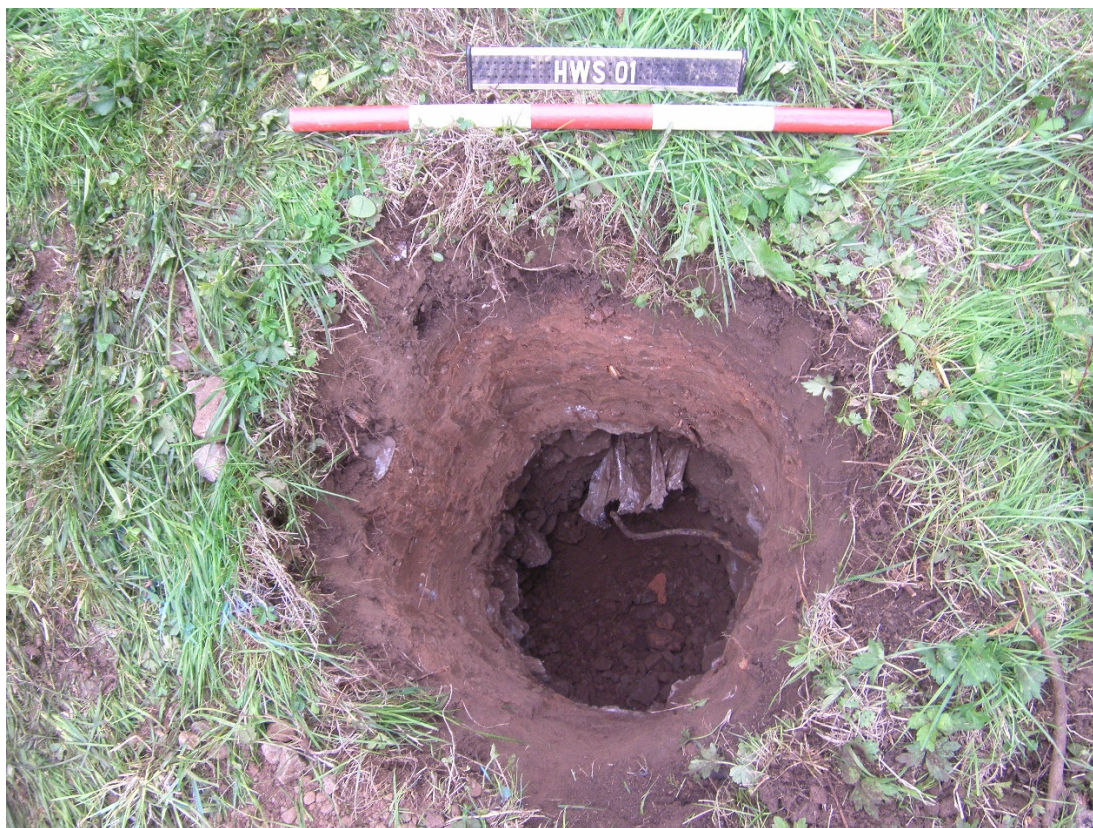
**Plate 4: WHS01**

6.1.5 HWS01 was excavated downslope from WS01 and WS02, over the existing debris screen. The pit was excavated by hand down to the top of the screen culvert, at a depth of c. 1m. The culvert was overlain by demolition debris, which in turn had been covered by redeposited colluvium identical to that seen within WS01 and WS02.

<b>Depth</b>	<b>Description</b>
0-0.2m	Turf and topsoil
0.2-0.45m	Brown-red silty sand colluvium (redeposited)
0.45-1m	Demolition rubble overlying the plate of the debris screen chamber
