**ARCHAEOLOGICAL
MONITORING
REPORT**

**HOLY TRINITY CHURCH
STARTFORTH
COUNTY DURHAM**

NAA 18/10
January 2018

HOLY TRINITY CHURCH, STARTFORTH, COUNTY DURHAM
ARCHAEOLOGICAL MONITORING REPORT

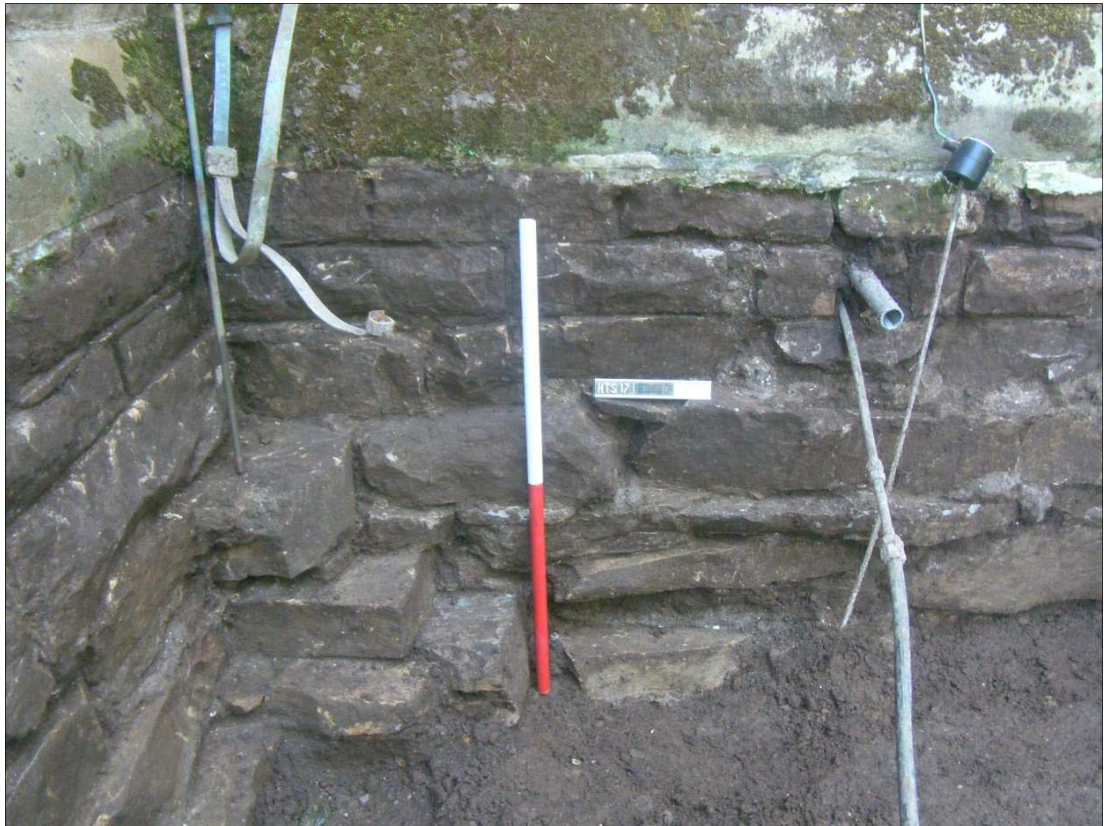
6.4 The foundations for the existing church (**003**) were examined and consisted of well-dressed rectangular stones measuring up to 0.3m long. A distinct change was noted

between the Victorian foundations and the much larger, undressed stones (004) beneath (Plate 1). It was thought that these larger stones represented part of the earlier medieval foundations for the church.

Plate 1. Church foundations overlying irregular masonry, possibly of medieval date

- 7.2 Possible evidence for the medieval church was encountered in the form of masonry that apparently pre-dated the Victorian foundations. Early Ordnance Survey (OS) mapping suggests that the 19th-century church, albeit more extensive, overlay its medieval forebear. The finds recovered from the archaeological monitoring represented a wide range of periods, from prehistoric to modern, and indicated background activity within the vicinity.

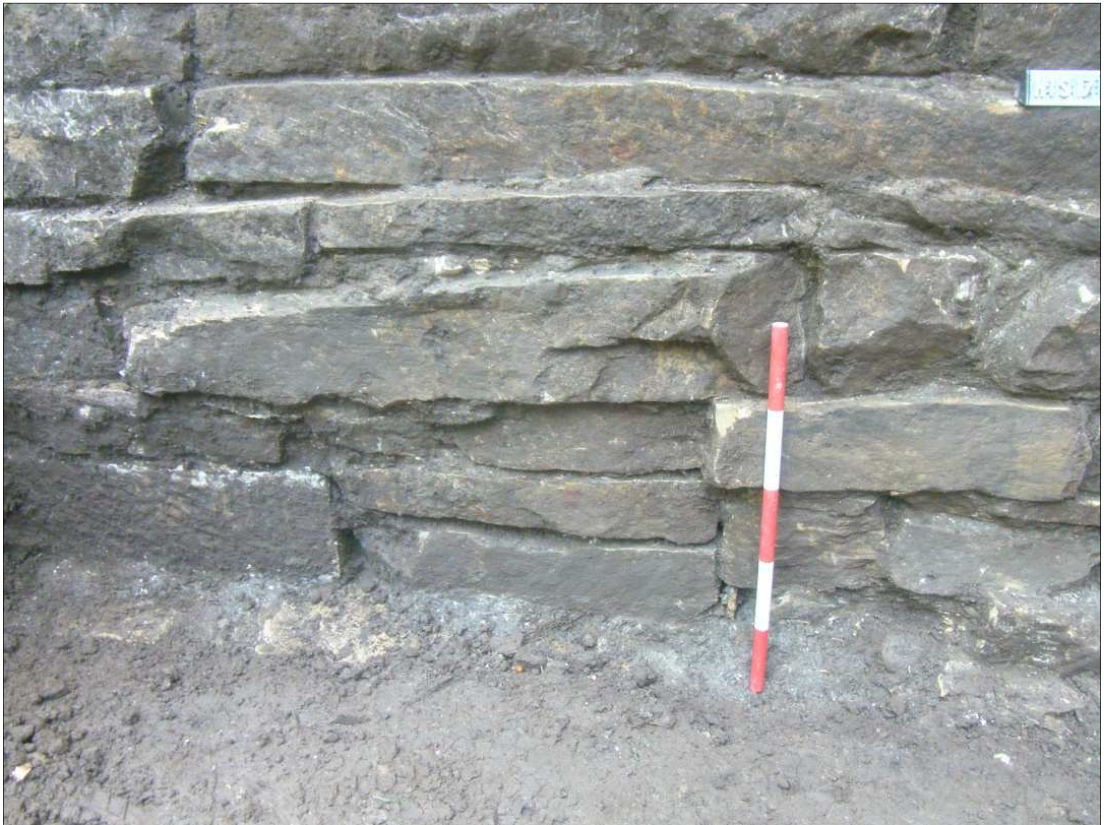
- 6.5 A possible blocked-up vent or drain was visible within the lower, undressed foundations (Plate 2). This comprised a small rectangular hole, measuring 0.4m by 0.5m with a large stone lintel across the top, which was infilled with three blocks.

Plate 2. Blocked ventilation hole within possible medieval foundations 004

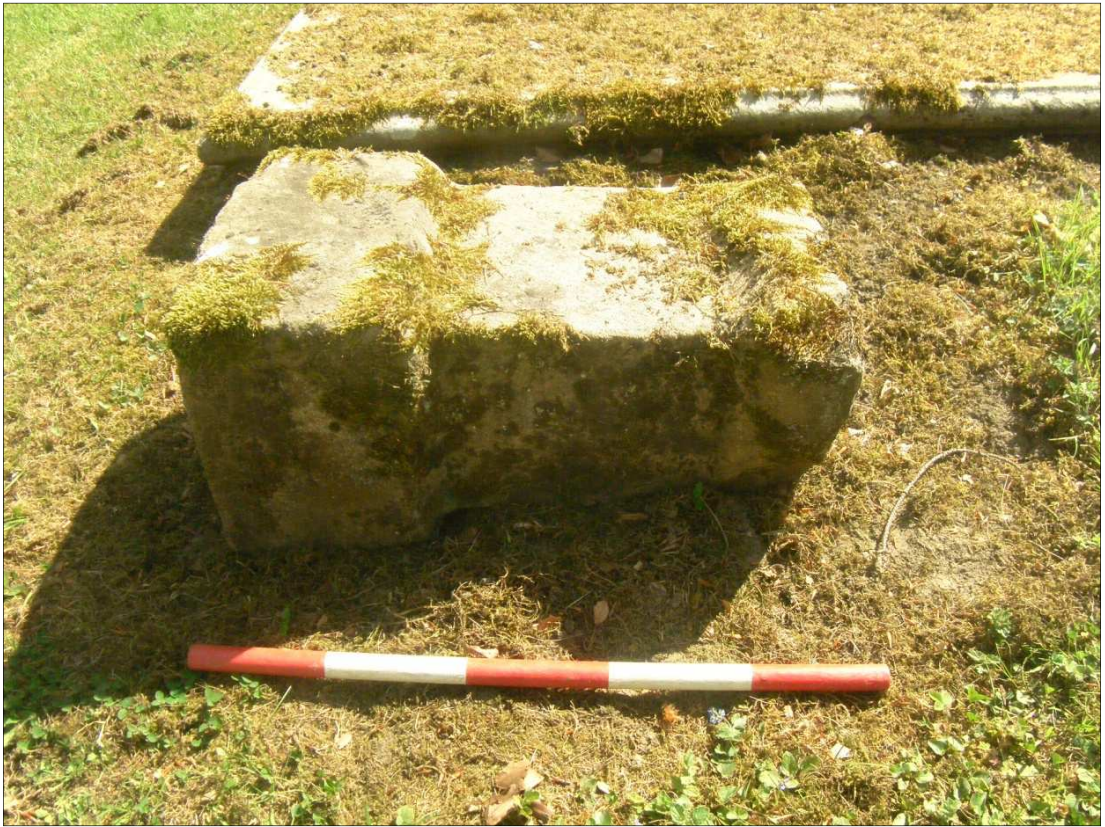
- 7.3 One enigmatic feature within the churchyard was a small stone pillar, without inscription, lying on its side, which had possibly been used as a grave marker (Plate 3). In size and shape, this was not dissimilar to a Roman altar, and it would probably warrant further investigation. The identification of a Roman settlement close to the fording point of the River Tees would be significant.

Plate 3. Possible Roman altar within graveyard

One enigmatic feature within the churchyard was a small stone pillar, without inscription, lying on its side, which had possibly been used as a grave marker. In size and shape, this was not dissimilar to a Roman altar and it would probably warrant further investigation. The identification of a Roman settlement close to the fording point of the River Tees would be significant.

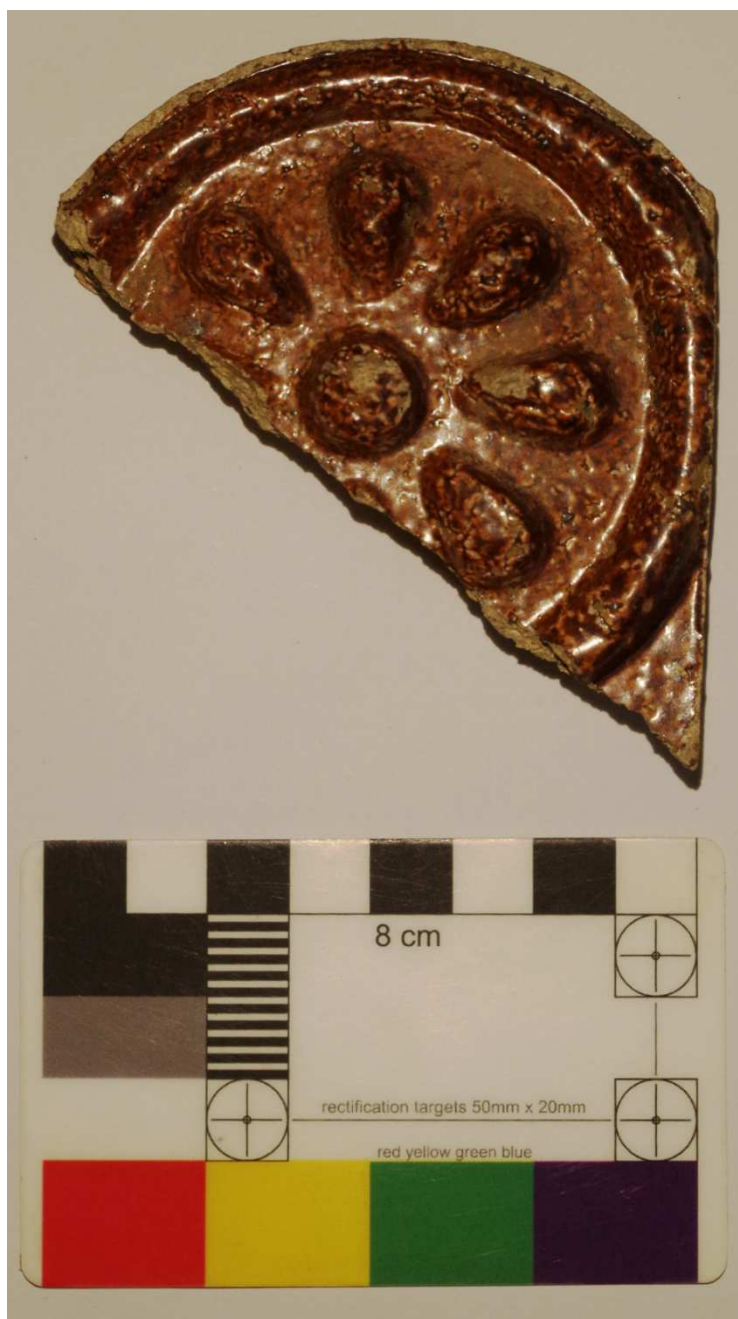
One fragment, weighing 14g, was identified as part of a modern roofing pantile. The other, 175g, is a decorative fragment of Victorian salt-glazed garden edging (Plate 4). It has one flat edge, a plain back, and is decorated on the front with a simple eight-petaled flower. Often these tiles had three lobes and this indeed appears to be the end section of a larger tile. This could have edged the path through the church grounds, or demarcated a grave.

Plate 4. Salt-glazed garden edging tile fragment

The identifiable CBM was indicative of modern activity and is generally unremarkable. It is therefore recommended that the material need not necessarily be archived with the remainder of the site.
