## GENERAL LAMBERT'S HOUSE ARCHAEOLOGICAL WATCHING BRIEF

NAA 19/68  
July 2019

Location General Lamberts House, 31 and 33 Narrowgate, Alnwick, Northumberland, NE66 1JN

**GENERAL LAMBERT'S HOUSE**  
**ARCHAEOLOGICAL WATCHING BRIEF**  
**FINAL REPORT**

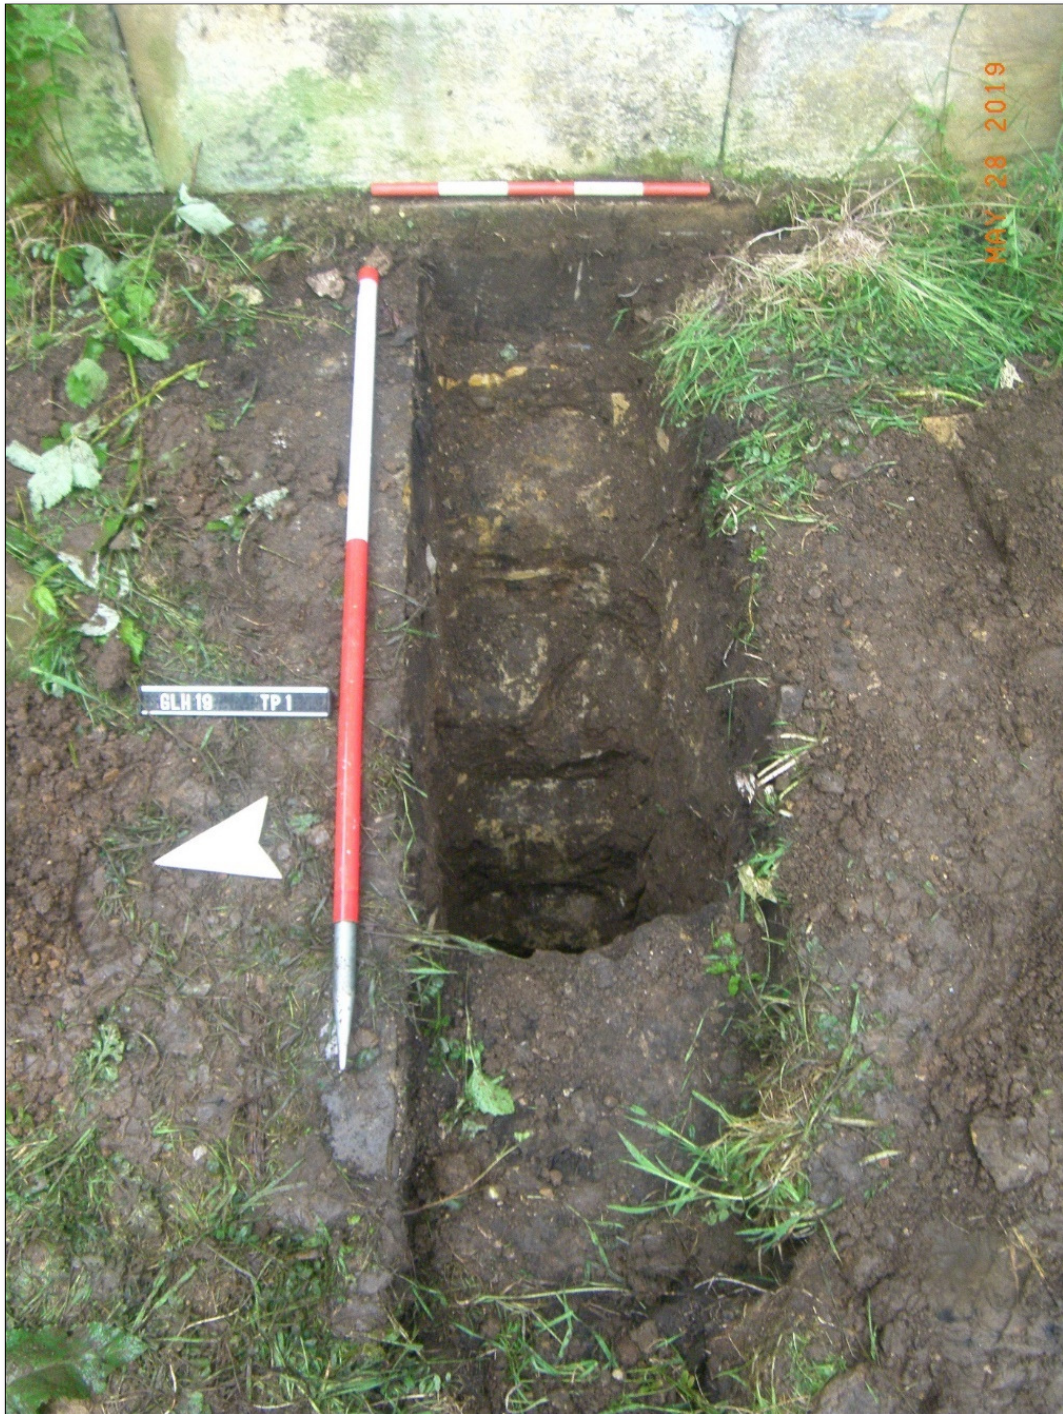
- 6.3 TP 1 was located below a ground floor window in the vestibule leading to the north staircase (Plate 1). It was aligned east–west, measured 1.10m by 0.50m, and was excavated to a maximum depth of 1.13m. The depth of the natural soil deposits was not reached within the trench. The building foundations were exposed at the eastern end, which comprised six courses of roughly dressed sandstone (05). Each course consisted of roughly shaped rectangular blocks that projected slightly forward from the course above (Plate 1). There was no indication of a cut associated with a foundation trench. A dark brown sandy deposit (02) butted up against the foundations and was overlain by a compact light brown clay deposit with stony inclusions (04). Above this was set a

roughly squared sandstone flagstone (01), which formed part of the yard surface extending to the rear of the building.

*Plate 1: Trial Pit 1, showing wall foundation 5.*

8.1 The excavation of the five trial pits along the rear wall of the building provided an opportunity to further investigate the construction of the historic property. Although excavation was limited, variation in the nature of the foundations did clearly show the different phases of build. In the two trenches position against the main house (TP 2 and 3) the foundations were flush with the rear wall of the building, while those in TP 1, which was associated with the first phase of extension, projected slightly forward from the building façade. In TP 4, at the junction of the extension and adjacent property, the foundations were again vertical to the wall. Finally, in TP 5, located against the south wall of a later extension, the foundations were quite shallow, comprising only a single course of stonework sitting on the natural sand deposits.

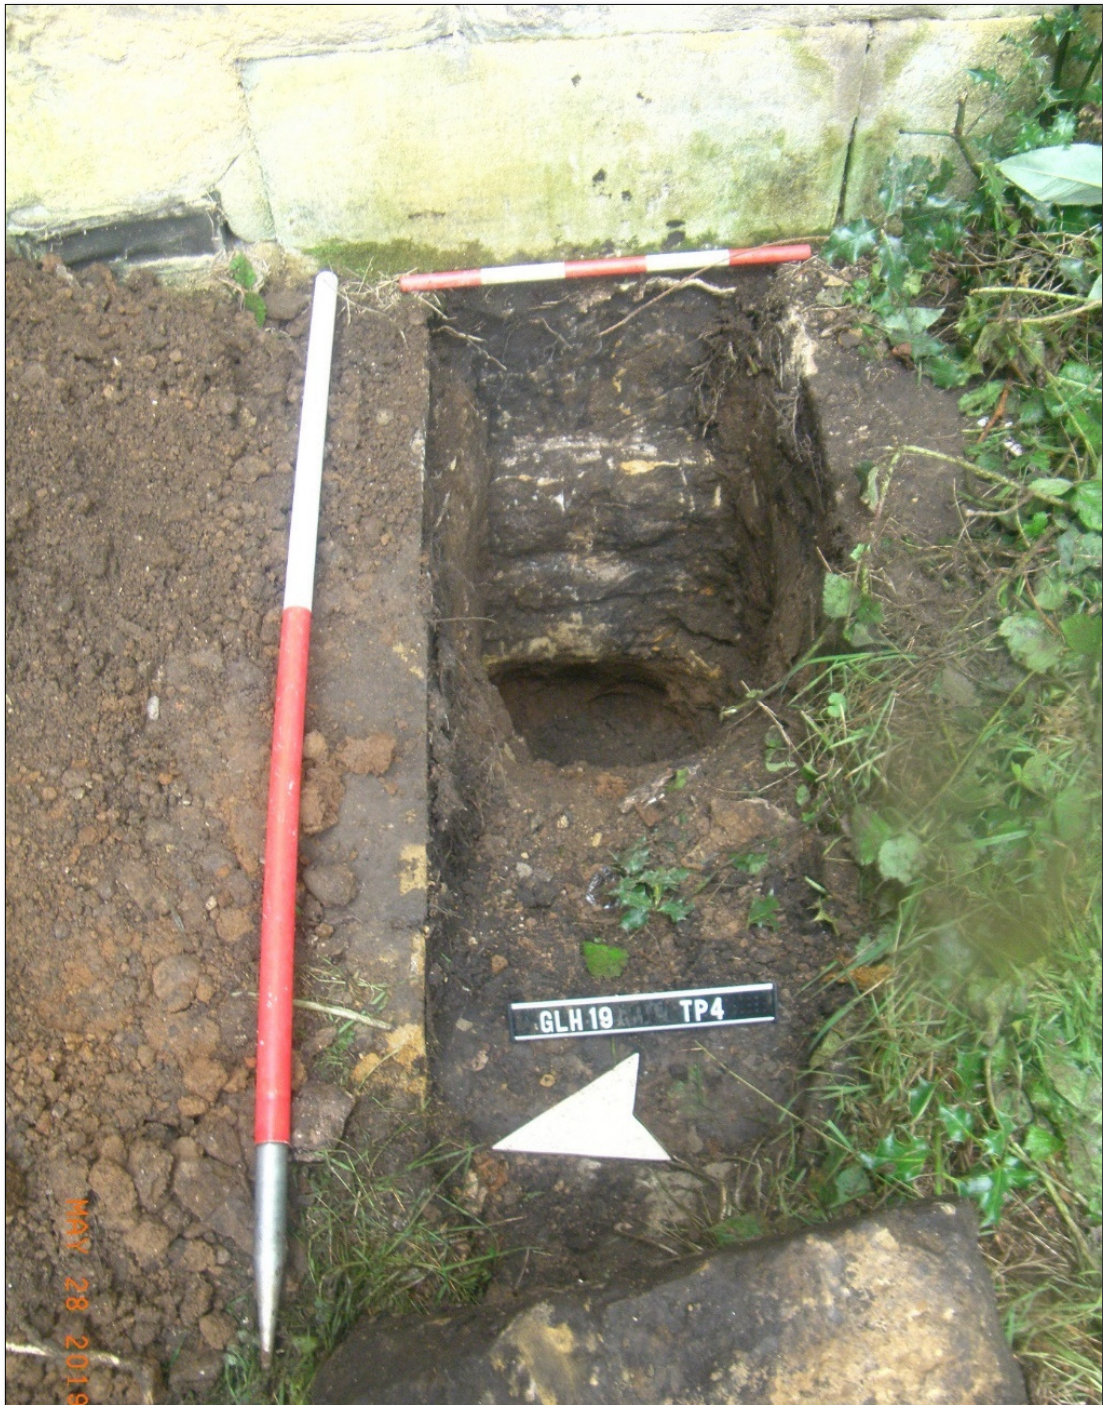
*Plate 2: Trial Pit 4, showing wall foundation 14 overlying discoloured natural sand 12.*

- 6.6 TP 4 was located at the junction of the building and neighbouring property, directly beneath a ground floor window. It measured 1.10m by 0.50m and was excavated to a maximum depth of 0.9m. The rear wall (13), was constructed of evenly set, rectangular ashlar blocks with vertical and oblique tooling. Associated with this were three courses of rough dressed sandstone foundations (14), beneath which was a level deposit (12) of mid brownish sand, identified as natural. No foundation cut was observed. Abutting the wall up to the first course of blockwork (13), was a deep layer of compact light brown clay and commonly occurring sandstone fragments (11). Covering this material and abutting the outer face of the buildings rear wall was a yard surface comprising of roughly rectangular sandstone flagstones (1).
