Studley Royal Roman Monument: Historic Building Recording for Skell Valley Project

Report Title: Studley Royal Roman Monument – Historic Building Recording

Version: v1
Issue Date: December 2022
Report Ref: 22-66

The building record was undertaken in advance of conservation and repair work. The record comprised documentary, cartographic and archive research, and a photographic and written record.

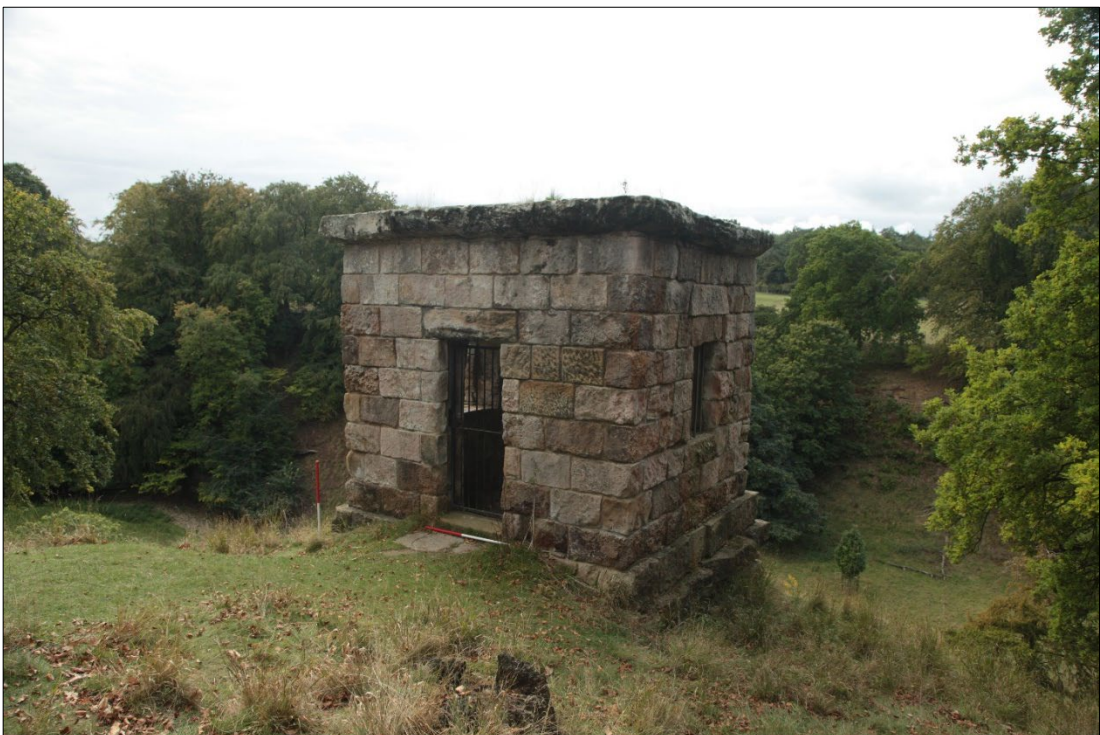
- 7.1.1 The Roman Monument consists of a single-cell, single-storey structure, which is roughly square in plan externally, and circular internally. There is a single doorway within the east-facing elevation, and windows to the south, west and north.
- 7.1.2 The north elevation of the structure is facing 20° west of true north. The structures north–south axis is aligned 340° to 160° and its east–west axis is aligned 250° to 70° . Today, there is not much difference between true north and magnetic north. Magnetic north is $0^{\circ}11'$ west of true north.

Plate 12: general view of the Roman Monument looking southwest.

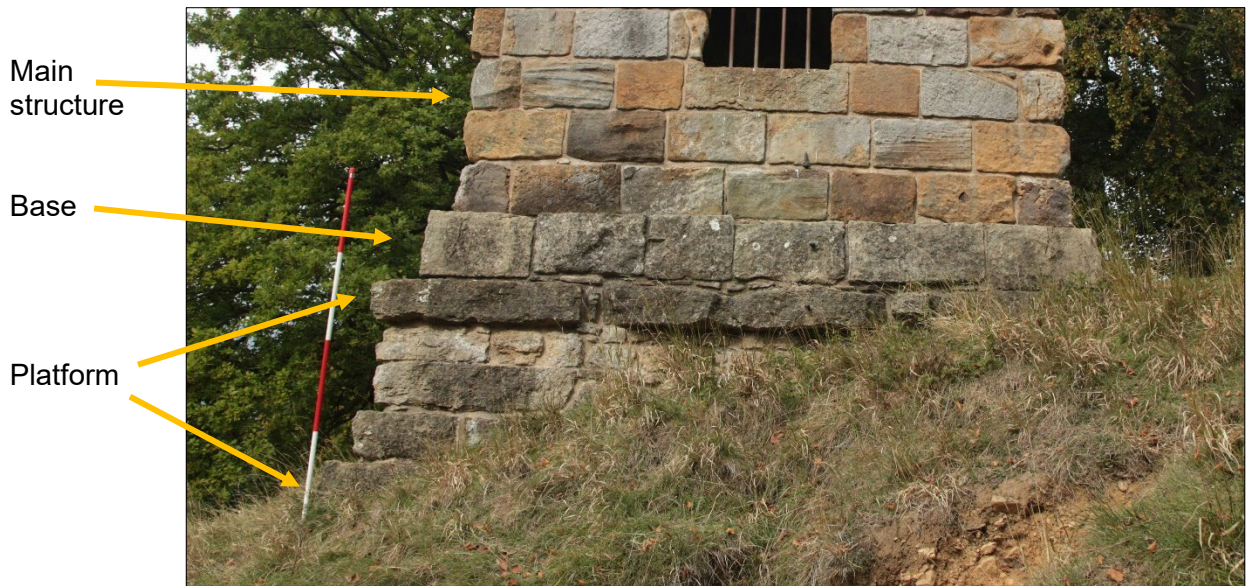
the furthest. There is evidence for repointing and infilling of gaps with smaller stones.

Plate 13: detail showing the relationship between the platform and the main structure.

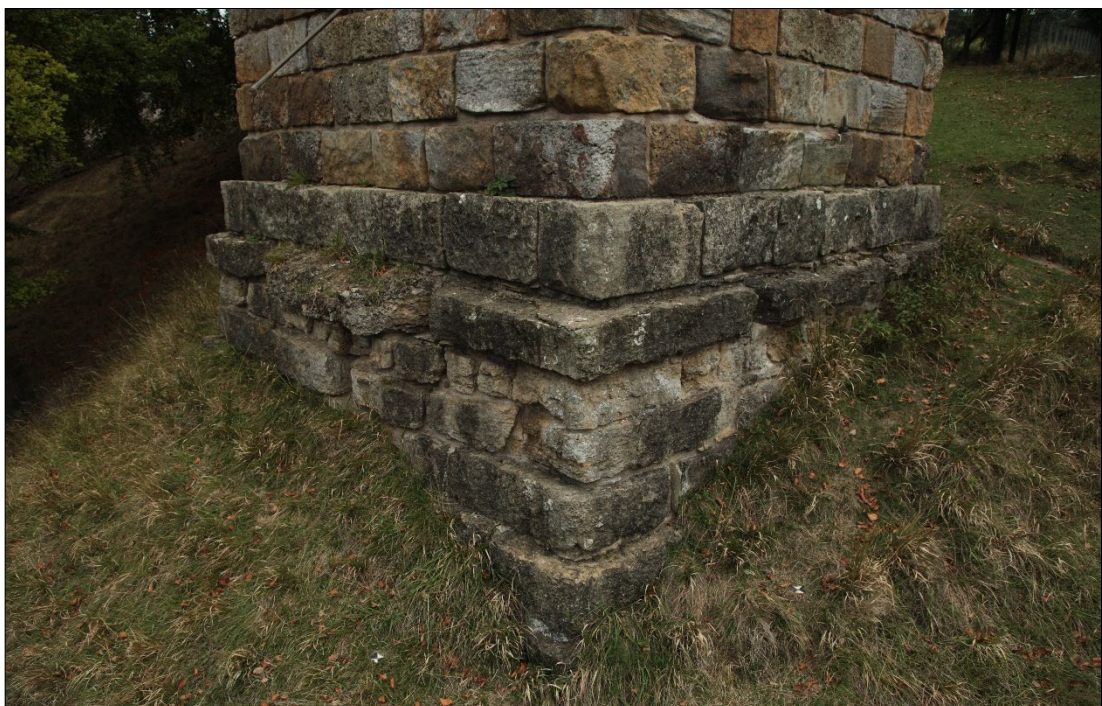
7.1.5 The footprint of the platform is larger than the footprint of the main structure. The stone used for the platform and the first course of stonework, forming the base for the main structure, is a different colour from the rest. It is greyer in colour compared to the cream, yellow and brown hues of the main walls. This could suggest that it has been constructed from limestone found in the valley.

Plate 14: detail of the platform, showing how it is built into the steep slope.

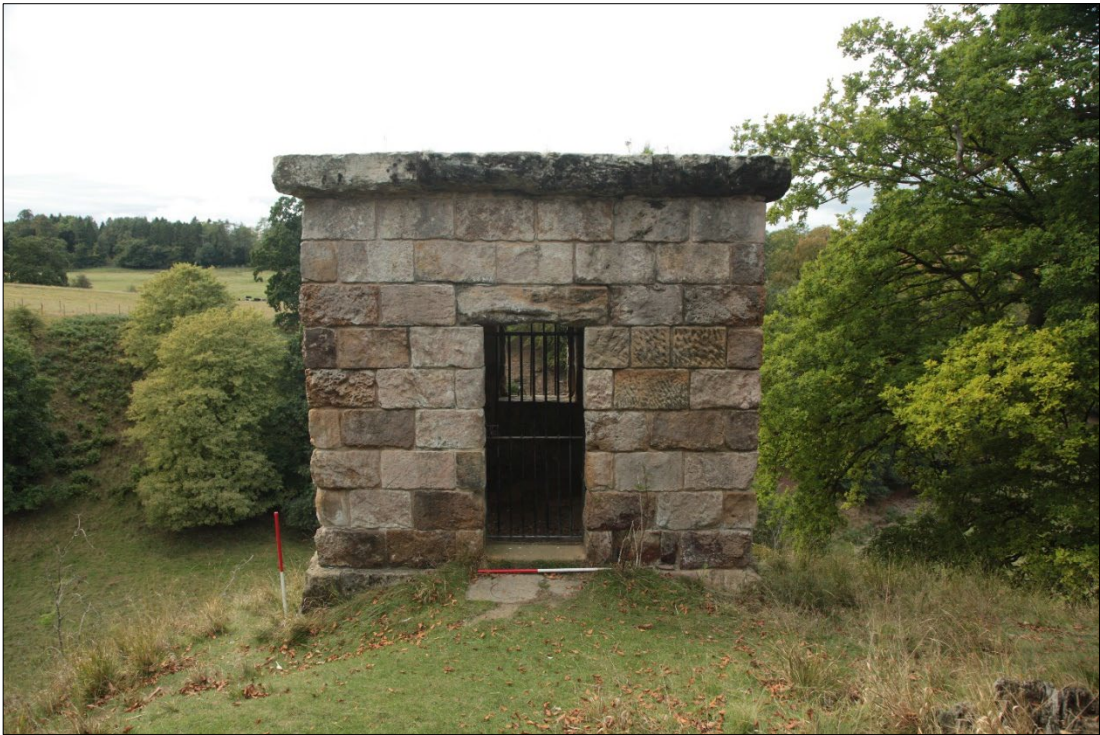
East-facing elevation with doorway

Plate 15: the east-facing elevation.

7.1.8 The elevation consists of neatly coursed sandstone blocks all approximately the same size. Overall, this produces a symmetrical effect. The notable exceptions are four blocks on the northern side of the entrance, which are yellower in colour and have distinctive tool mark patterns across their exposed faces. The three blocks are laid next to each other and are not of dimensions present elsewhere within the elevation. This could suggest that these blocks are replacements of original or earlier stones.

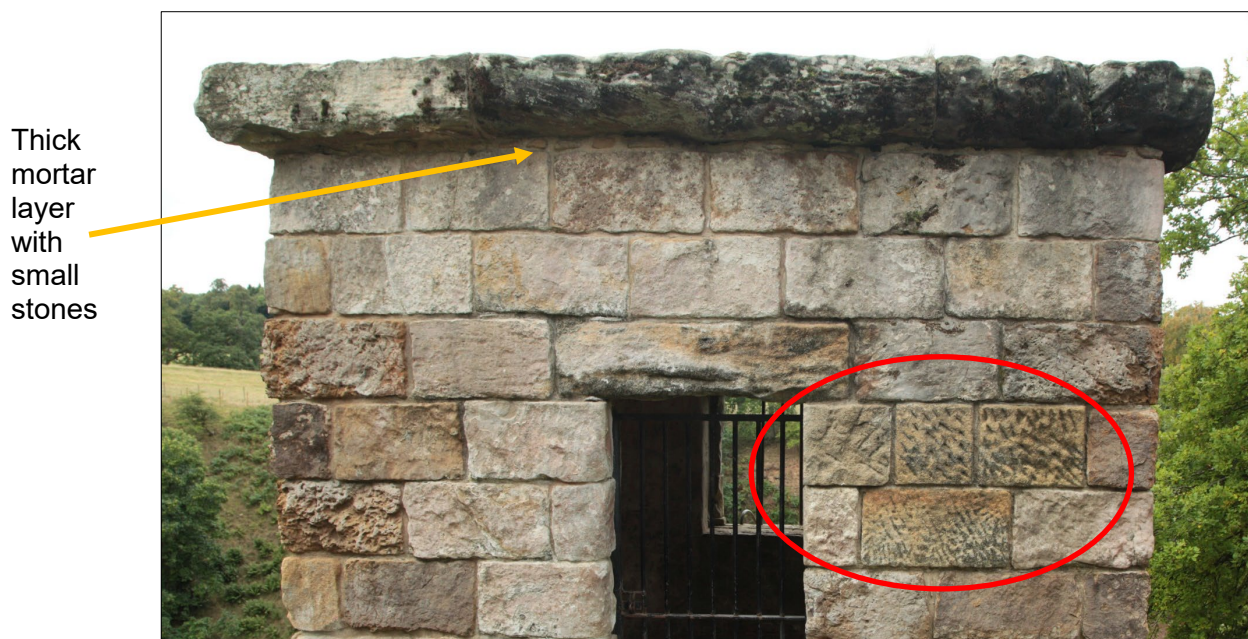
Inserting small stones can also help to strengthen a joint.

Plate 16: detail showing the inserted blocks (outlined in red) and the layer of mortar with stones.

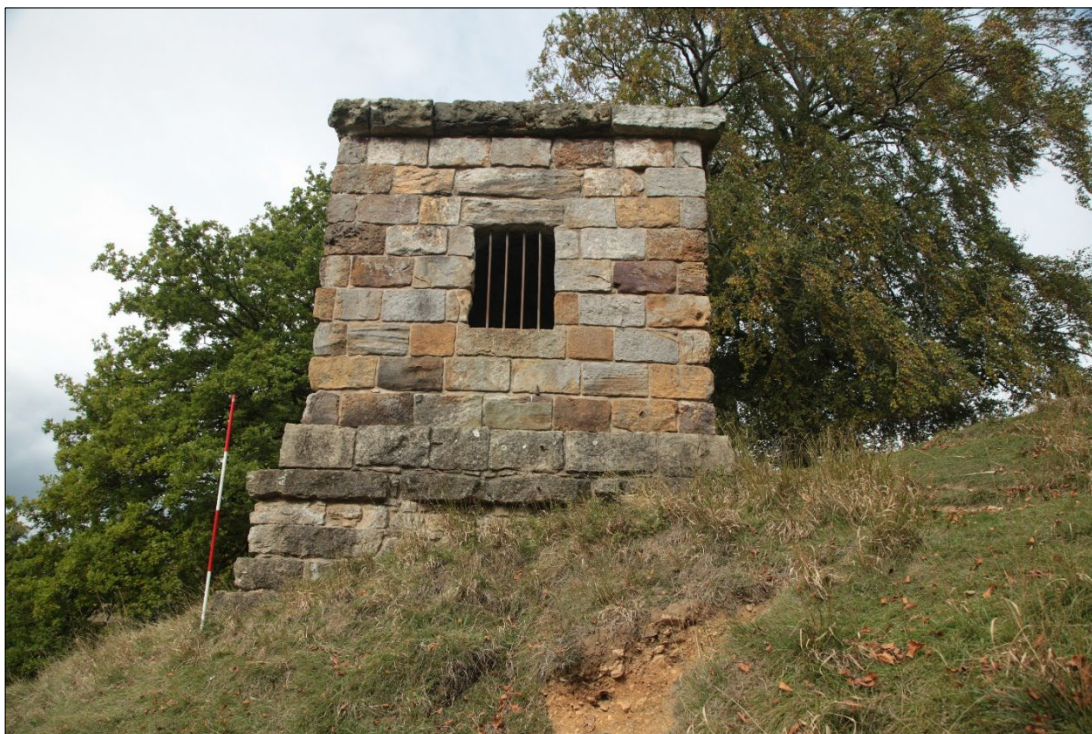
South-facing elevation

Plate 17: the south-facing elevation.

7.1.11 The elevation consists of neatly coursed sandstone blocks all approximately the same size. Overall, this produces a symmetrical effect. It is not obvious on this elevation if any of the blocks have been replaced. The blocks forming the corners appear to have suffered the most weathering.

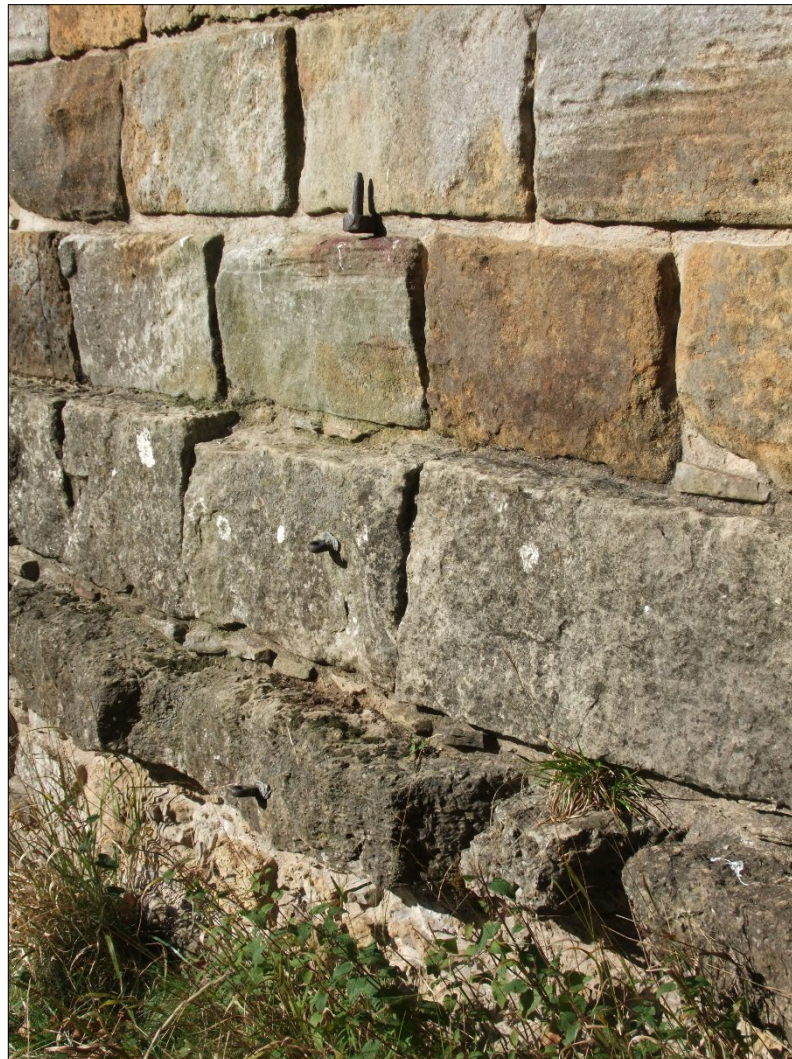
7.1.13 There are three metal attachments, approximately vertically in line with each other, which would have been previously used to secure a fence (Plate 18). These are located below the window.

Plate 18: detail showing the metal fence attachments.

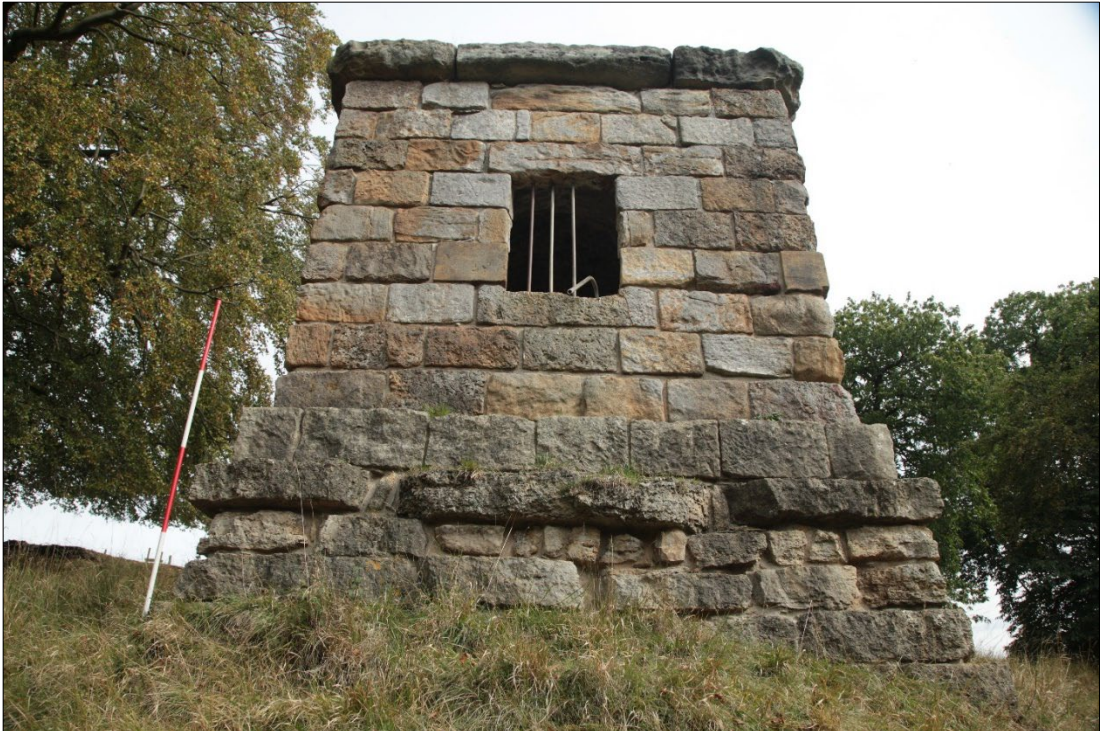
West-facing elevation

Plate 19: the west-facing elevation.

- 7.1.16 The elevation consists of neatly coursed sandstone blocks all approximately the same size. Overall, this produces a symmetrical effect.
- 7.1.17 Between the top of the platform and the bottom of the structure's base the thick layer of mortar into which small thin stones have been inserted continues. The layer of mortar and stones observed elsewhere between the top of the wall and the roof also continues on this side.

- 7.1.18 It is possible that a couple of stone blocks may have been replaced in this elevation. There are two in particular that have very crisp clean, sharp edges in comparison to other stones within the elevation. One can be seen in the southern corner and forms part of the northern edge of the window.

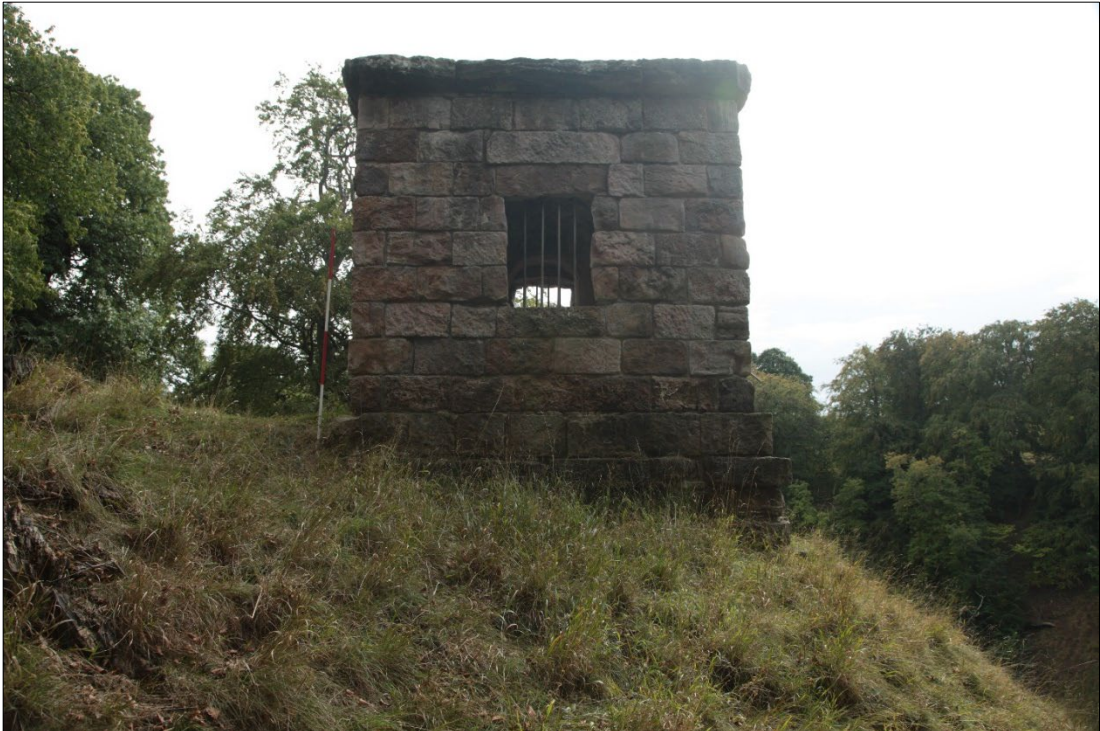
North-facing elevation

Plate 20: the north-facing elevation.

- 7.1.20 The elevation consists of neatly coursed sandstone blocks all approximately the same size. Overall, this produces a symmetrical effect. It is not obvious on this elevation if any of the blocks have been replaced. The blocks forming the corners appear to have experienced most weathering.

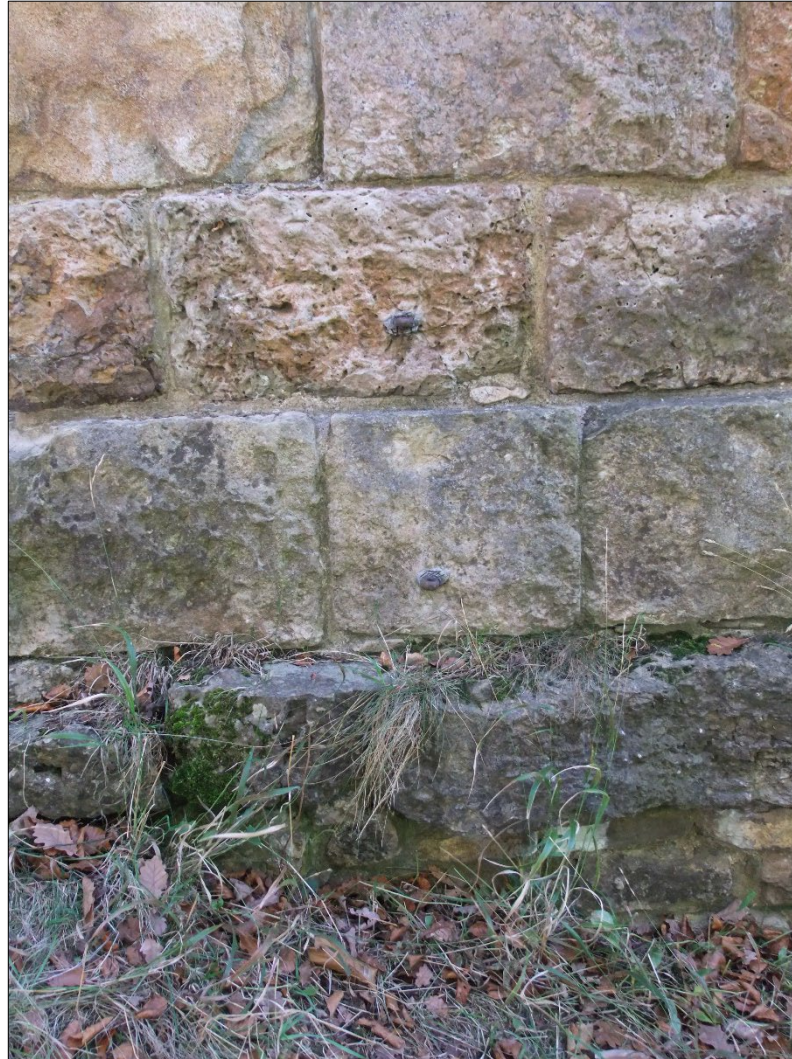
- 7.1.23 There are two metal attachments, approximately vertically in line with each other, which would have previously been used to secure a fence (Plate 21). These are located below the window.

Plate 21: detail showing the metal the metal fence attachments.

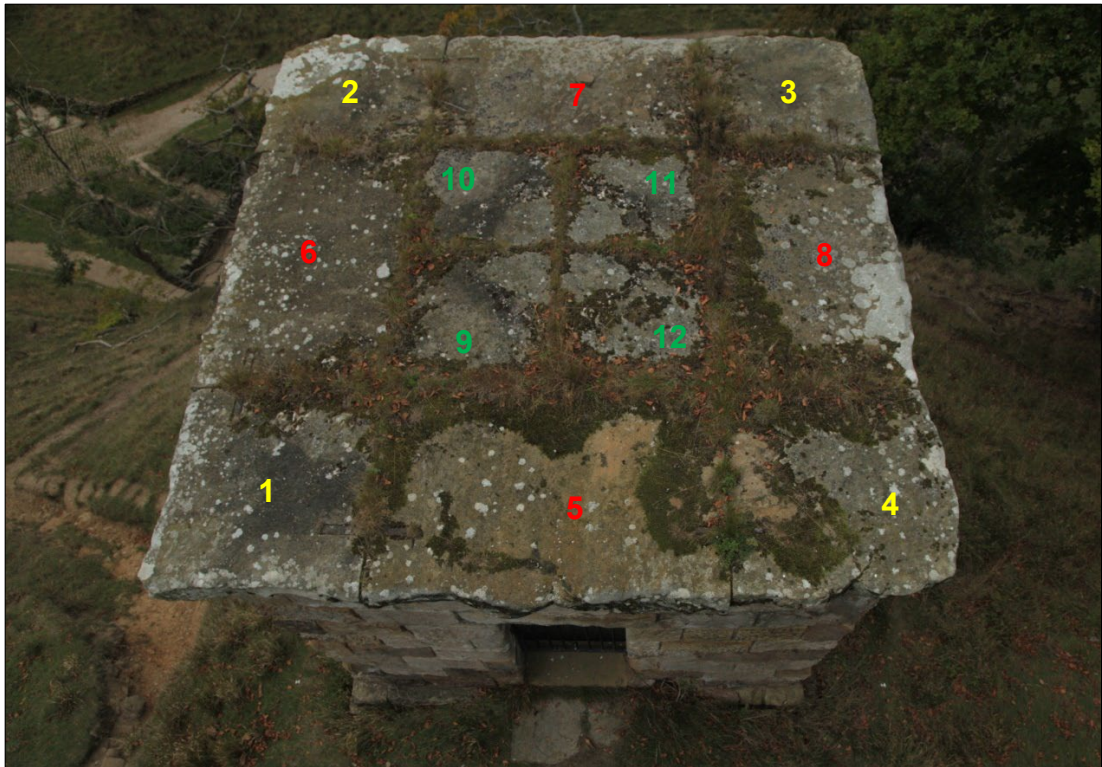
7.1.25 The centre of the roof is made up of four slightly smaller square slabs of limestone (9–12). A large dark ring of staining can be seen marking these four slabs (Plates 22 and 23). It is suggested that this marks the location of the larger central pillar. The central circle is 0.88m internally and 1.26m externally in diameter.

Plate 22: view of the roof, looking west.

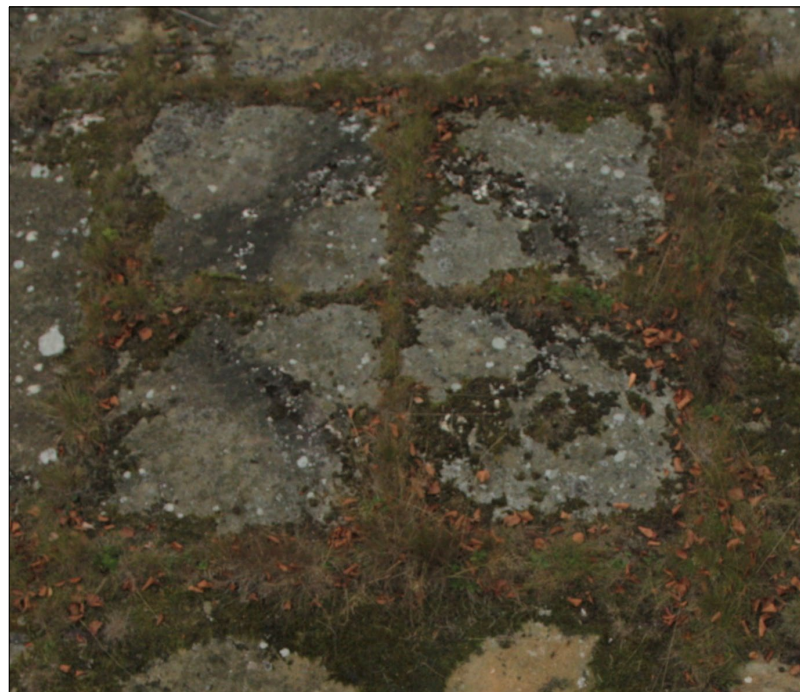
Plate 23: detail of the central circular mark.

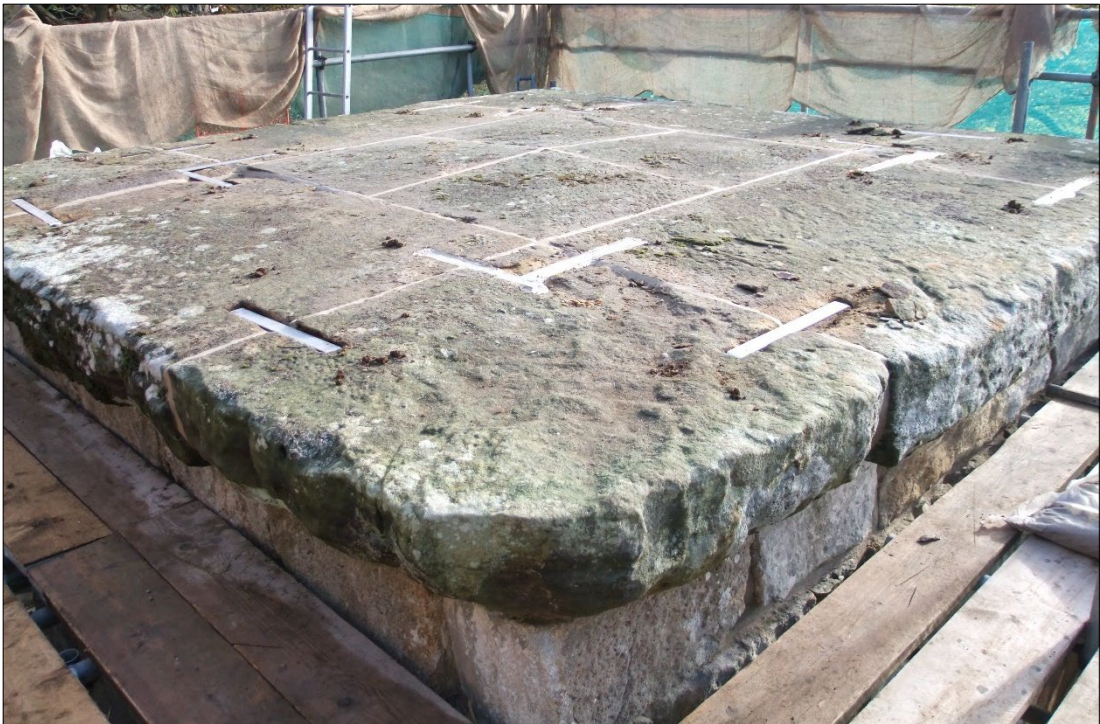
7.1.26 Scaffolding was erected after the initial site visit to facilitate conservation and repair works. This provided an opportunity to inspect the roof more closely. The roof has a gentle slope from the centre to the edges, which would have promoted water run-off. At the time of the second visit the

iron-ties had been replaced with steel ties and the moss had gently been removed (Plate 24). The circular stain in the middle of the roof was still visible.

Plate 24: view of the roof during conservation work

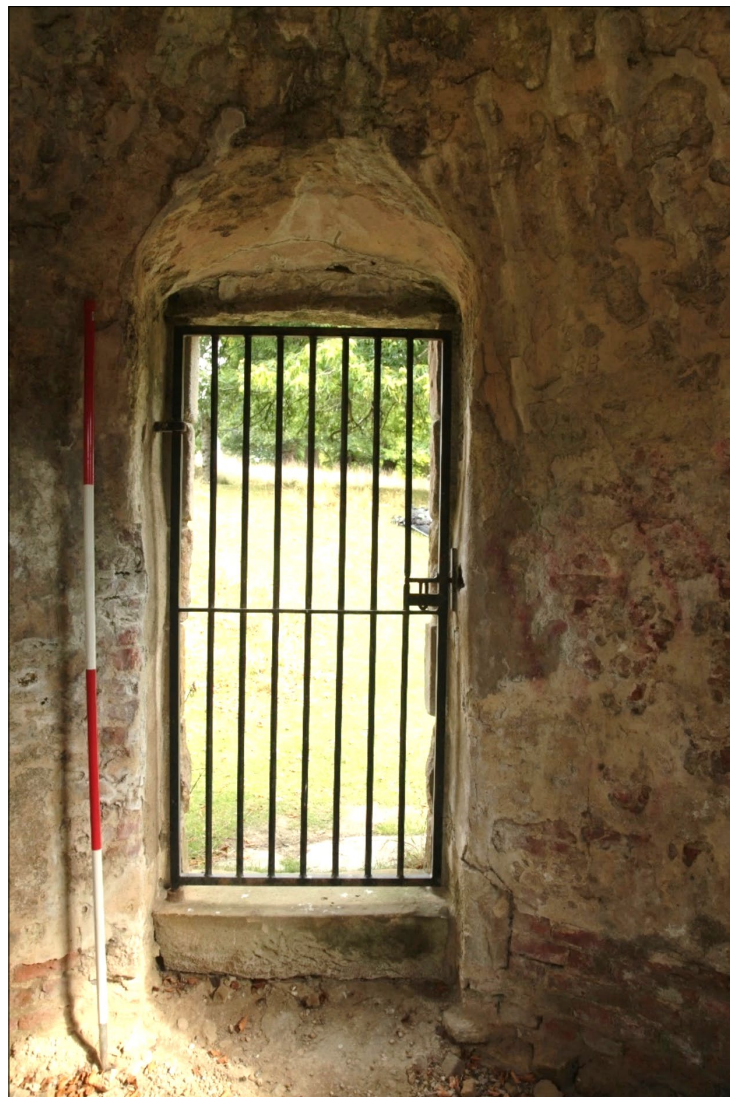
7.1.29 Behind the plain rectangular exterior, the interior doorway opening has a flattened round head above the height of the external stone lintel. Therefore, the curved nature of the entranceway opening cannot be seen from outside (Plate 25). On both sides of the doorway there is some incised graffiti. The inner edge of the entranceway is curved, rather than a sharp corner. This has been achieved by shaping the corner bricks and through the application of render.

Plate 25: view of the doorway internally showing the threshold stone and the curved entrance ceiling.

and it is possible to see the rubble foundation that the threshold stone sits on (Plate 25). The floor is made up of loosely compacted soil and small rubble incorporating broken brick and stone.

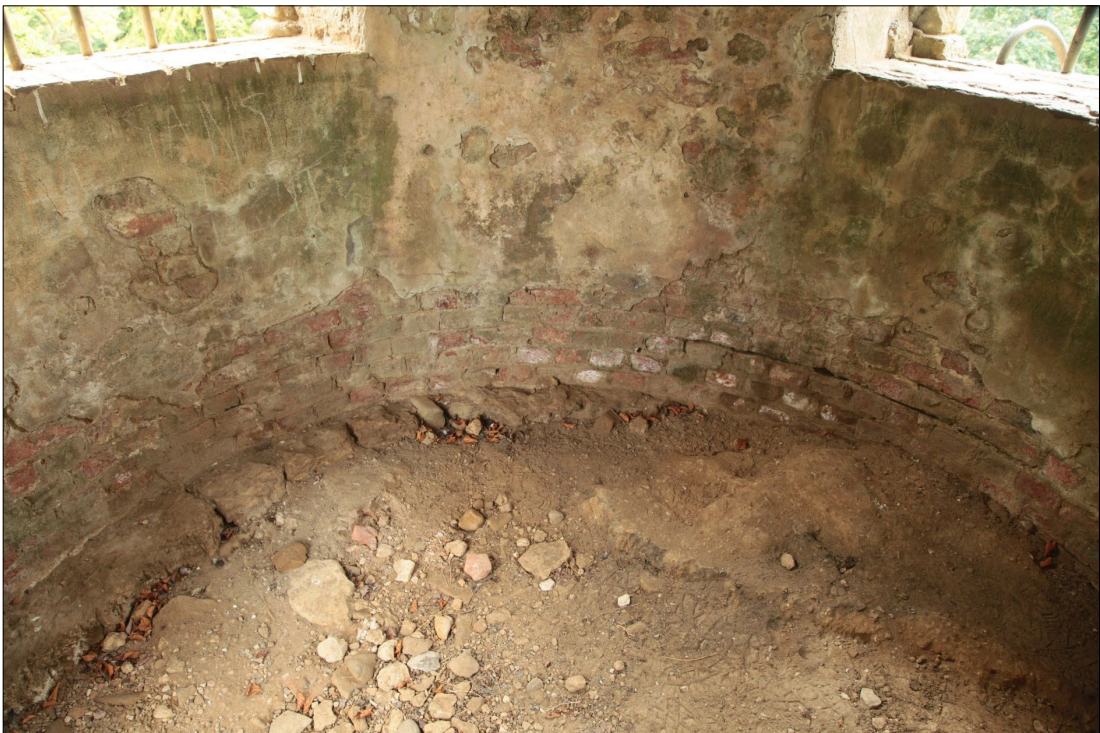
7.1.31 Surviving from the doorway round to the south-facing window and continuing up to the southern edge of the west-facing window there is a curved stone foundation, which has been exposed. This supports the internal circular brick lining. To the north-west there is a raised area of more compacted soil (Plate 26).

7.1.32 The multiple changes of level within the interior of the structure, in addition to the exposed foundation layer, suggests that the original floor level has been lost. It is also noted that the brick lining at the bottom of the walls is not covered in render, suggesting that it was not originally exposed. There are between four and five courses of exposed brick at the bottom of the walls, which suggests that the render originally began at a height close to or just above the stone threshold. There is no evidence to suggest what the original floor would have consisted of.

Plate 26: detail showing the curved stone foundation at the base of the exposed brick lining and the raised area to the right.

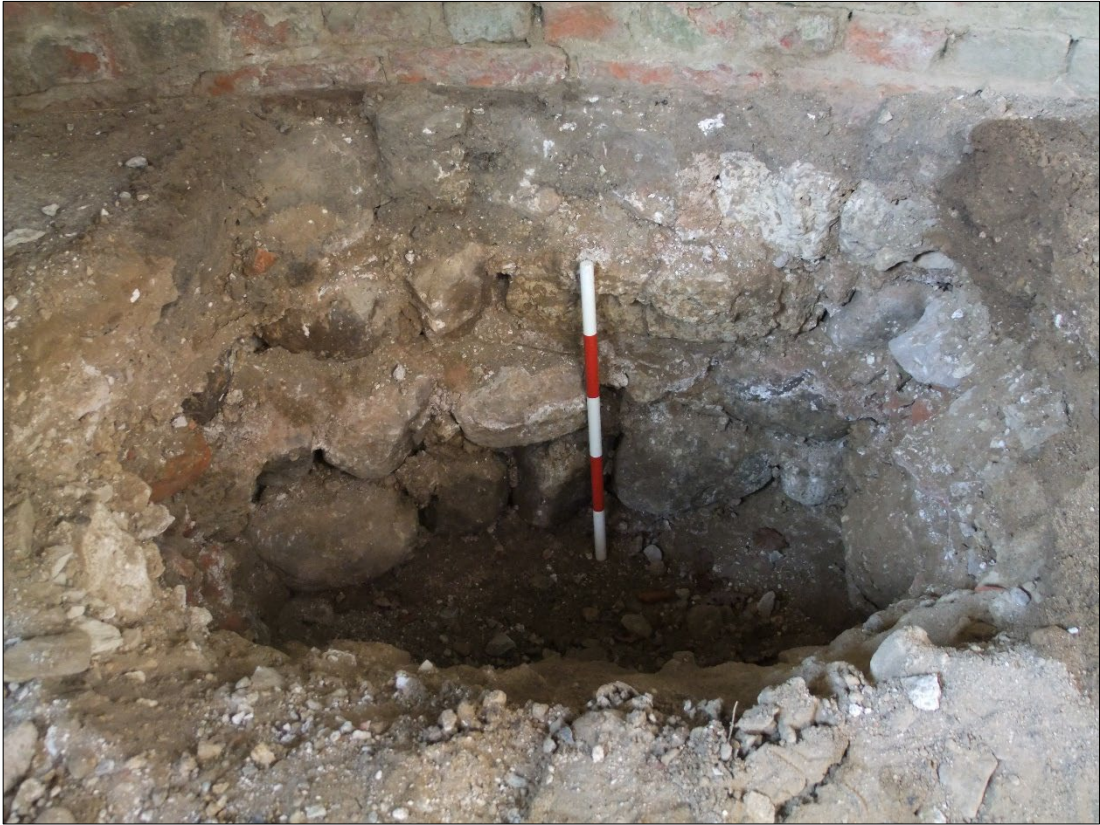
7.1.33 At the time of the second site visit, a test pit had been dug internally to investigate the extent of the building's foundations (Plate 27). The foundations were exposed to a depth of c.0.75m and it was evident that the foundations go deeper. The foundations are wider than the walls and consist of large boulders. The ground level internally has been made up of broken bricks, rubble, including burnt material, and soil.

Plate 27: detail showing the exposed foundations within the test pit.

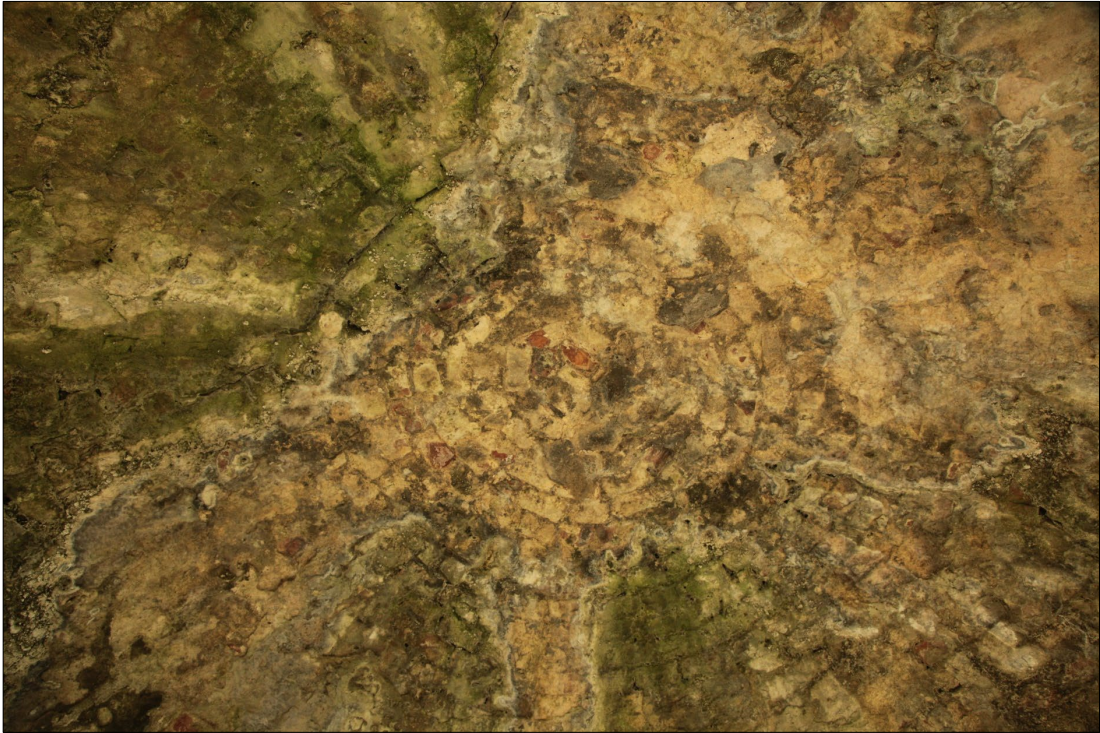
- 7.1.36 A dome can be built through the creation of a series of self-supporting horizontal rings stacked one on top of another, with each consecutive ring gradually becoming smaller in diameter until the apex is reached. Just as the keystone locks the voussoirs of an arch together, the final stone in each horizontal course of a dome locks the blocks of that course into place. Temporary framework that could be adjusted and moved may have been used during construction (Lancaster 2015, 13–14).

Plate 28: detail showing the header bond used to create the top of the dome.

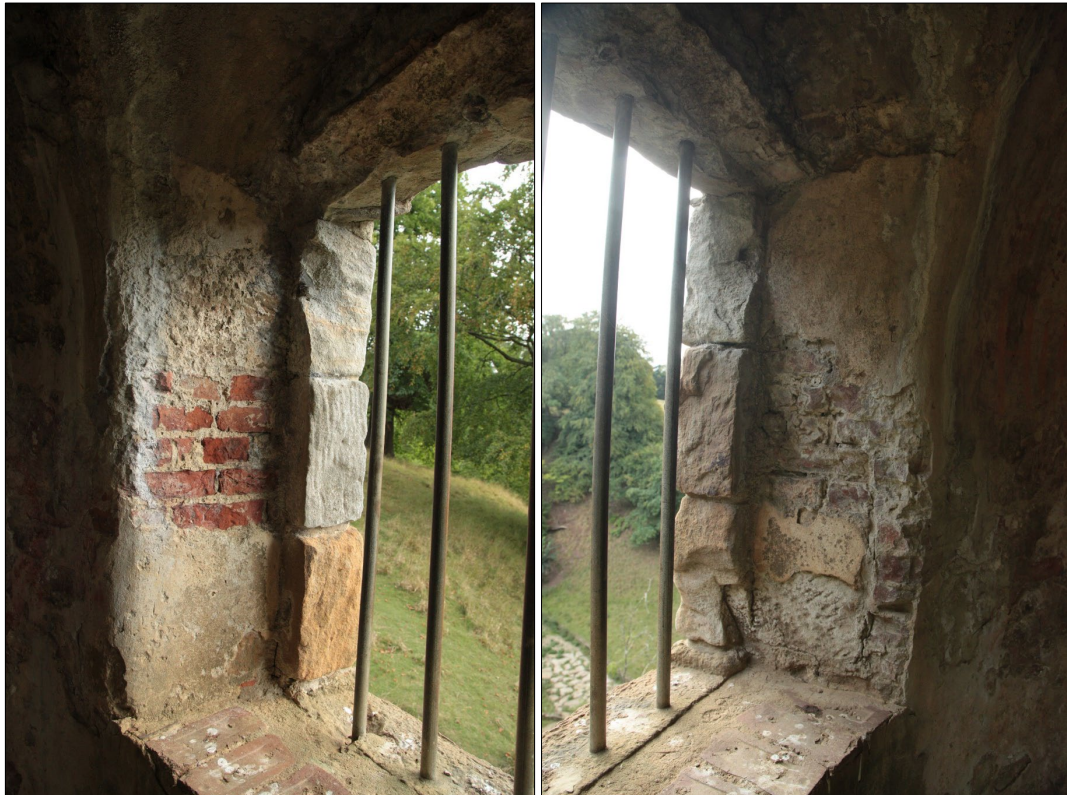
7.1.39 The south-facing window has been subject to several phases of repair. The lower third of the east side of the window recess is covered in a relatively smooth render, above this, five courses of Georgian estate bricks are exposed, which have been laid in a stretcher bond (Plate 29, left). The top third is covered in another layer of render, which is pock-marked in appearance.

Plate 29: detail showing the south-facing window recess, east side (left), and west side (right).

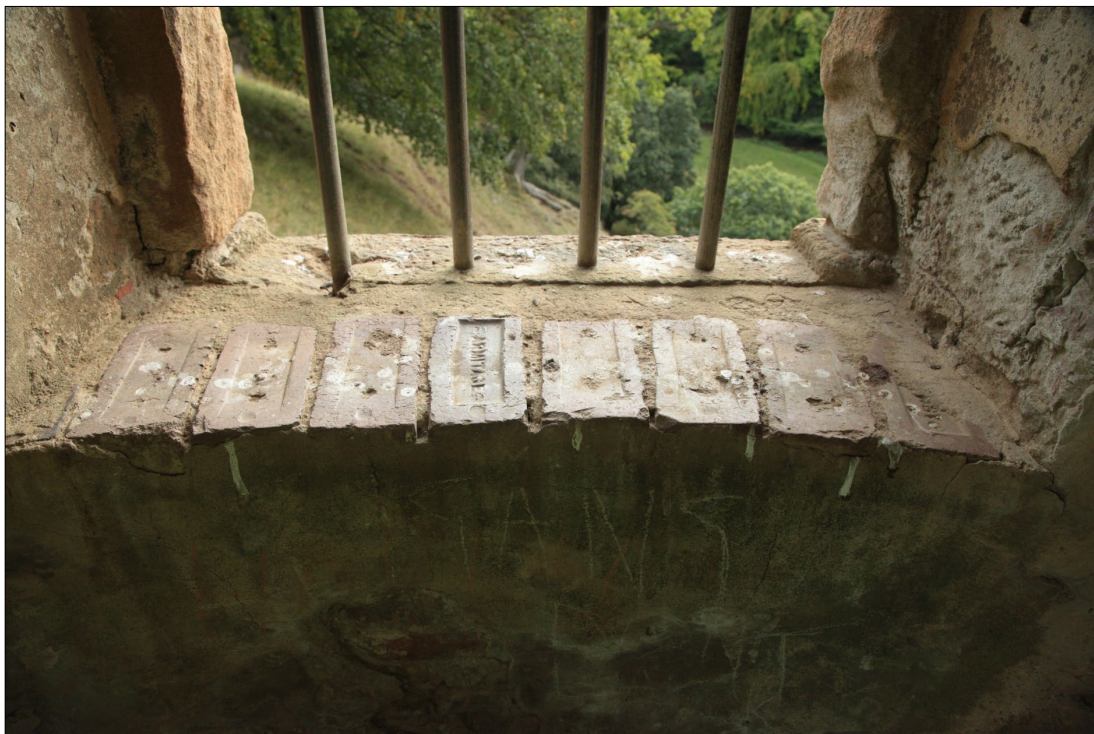
7.1.41 The windowsill has been repaired using late 19th-century–early 20th-century bricks (Plate 30). Two of them have the name ‘ARMITAGE’ stamped into their exposed surface (Plate 31). They are larger and more maroon in colour compared to the Georgian estate bricks. The Armitage bricks are all consistent in size, being 3 inches thick by 4 inches wide by 9 inches long. Between the bricks and the external stone windowsill there is some graffiti scored into the mortar. It comprises a series of letters and symbols – B S ∞ A C O ∞ .

Plate 30: detail showing the repaired south-facing windowsill.

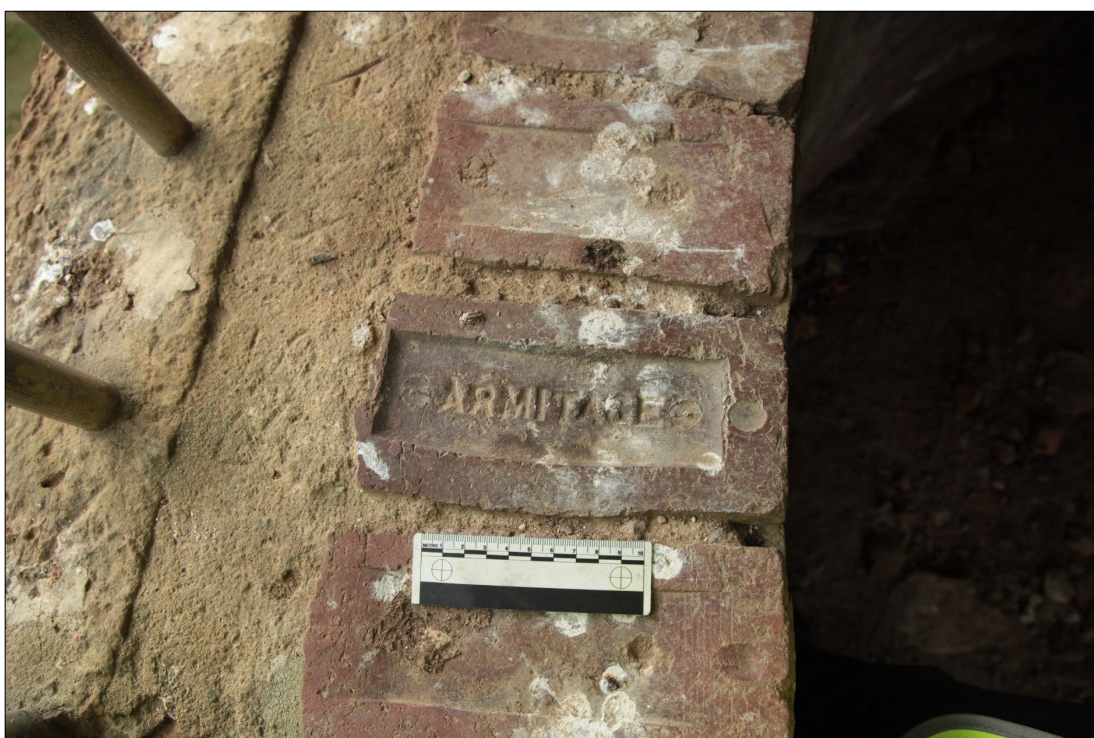
7.1.42 *George Armitage & Sons Ltd., Robin Hood, Lofthouse, Wakefield. The company started in 1824 when stonemason John Armitage joined fellow masons to work a quarry at Robin Hood. In 1864 one of his sons established the firm of George Armitage and Sons, also at Robin Hood, and expanded into brick making by exploiting the blue shale or marl which was found along with the sandstone. The Company expanded to open several brickmaking sites around the Leeds and Wakefield area including Woodlesford, Lofthouse, Morley & Swillington (Sallery, 2022).*

Plate 31: detail of a brick with the name 'ARMITAGE' stamped into it.

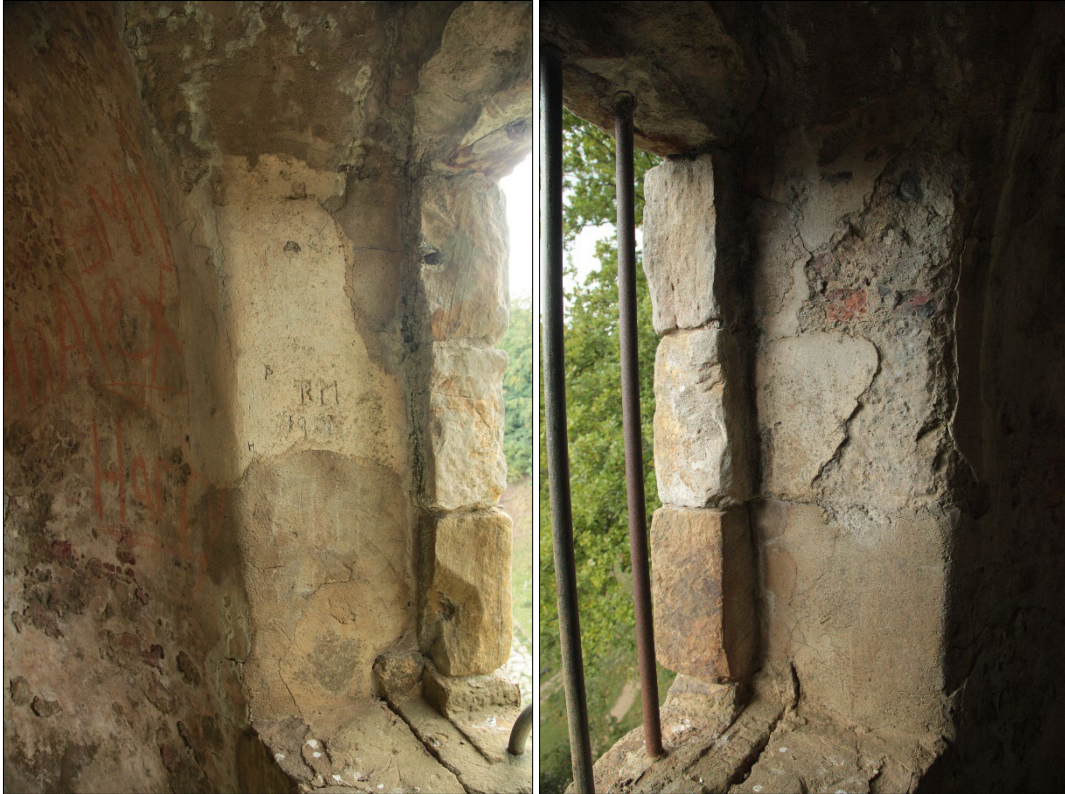
7.1.43 The west-facing window has also been subject to several phases of repair. There are three different coloured renders visible, which are cream, buff and brown in colour (Plate 32).

Plate 32: detail showing the west-facing window recess, south side (left), north side (right).

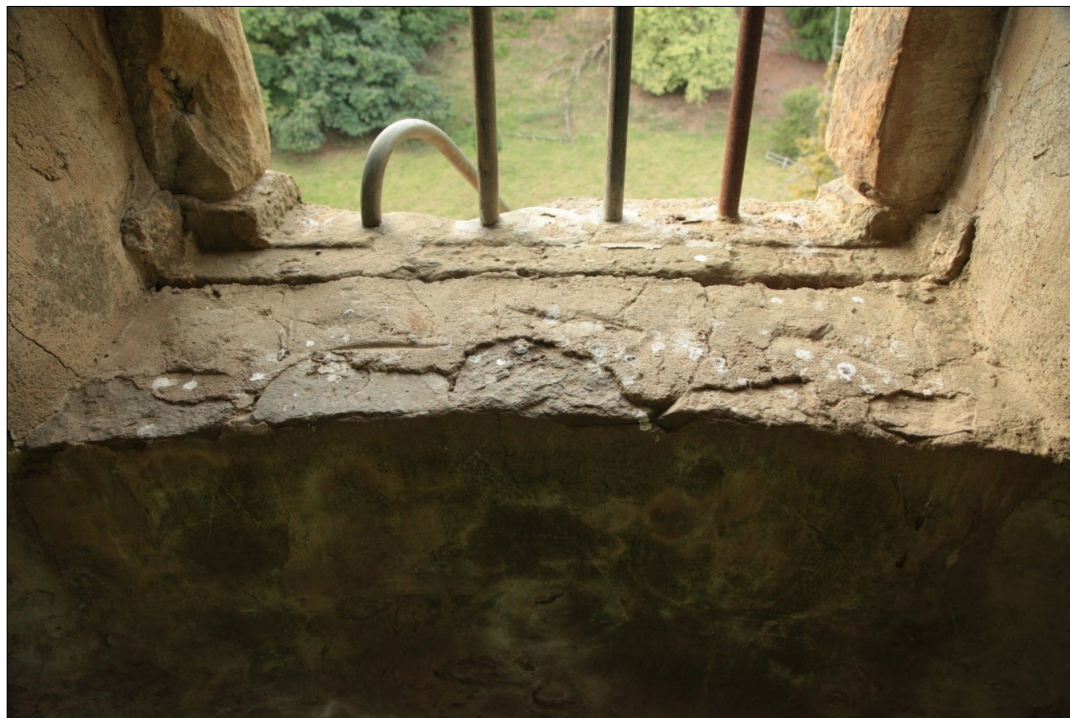
7.1.45 There are two holes in the external stones framing the window on the south side. These are mirrored on the north side. The holes may indicate the location of fixings for an internal window frame, horizontal bars or shutters, etc. The windowsill is made up of five stone blocks covered in render. The outer sill is the best preserved of the three windows, and the moulding is clearly defined (Plate 33).

Plate 33: detail showing the inner stone windowsill and the moulding of the outer moulded sill.

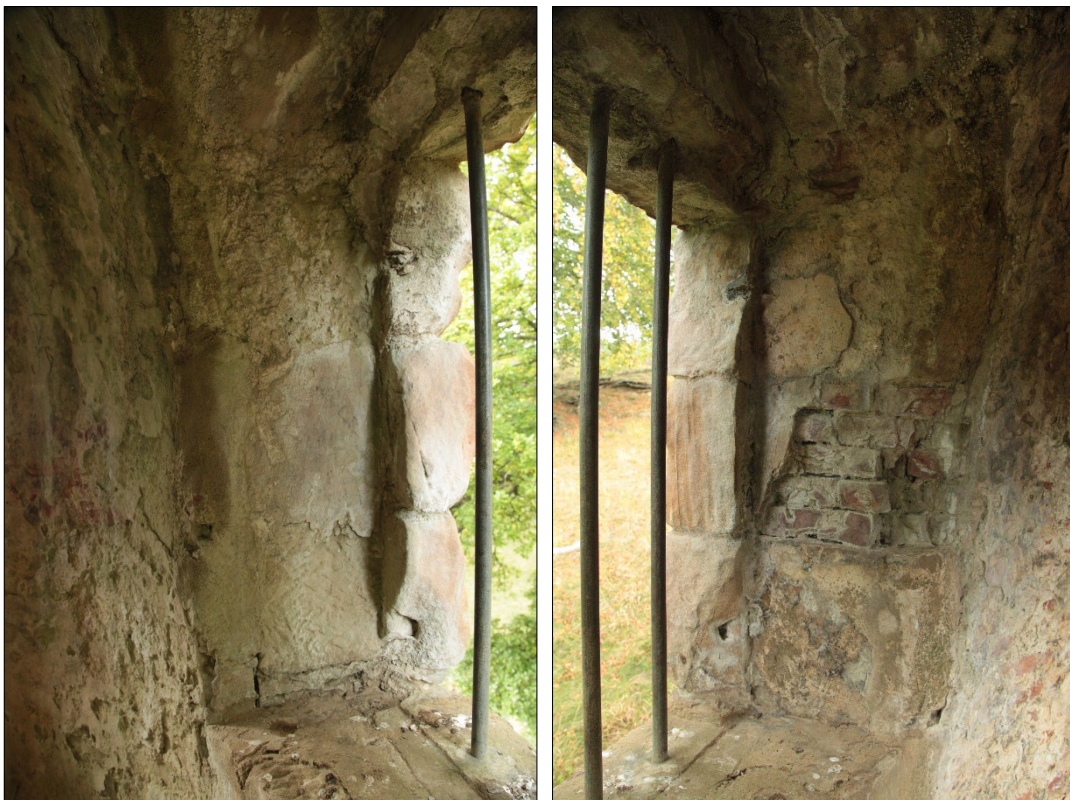
North-facing window

Plate 34: detail showing the north-facing window recess, west side (left) east side (right).

- 7.1.46 The north-facing window also shows evidence for several applications of render. The west side of the window recess is completely covered (Plate 34, left). The east side is similarly covered apart from approximately halfway up where five courses of Georgian estate bricks are exposed (Plate 34, right).
- 7.1.47 There are two holes in the external stones framing the window on the west side. These are mirrored on the east side. These holes are in a similar position to those observed in the west-facing window and may also indicate the location of fixings for an internal window frame, horizontal bars or shutters, etc.
- 7.1.48 The windowsill is made from large sandstone blocks, which have then been covered in render. Two of the blocks have been exposed (Plate 35).

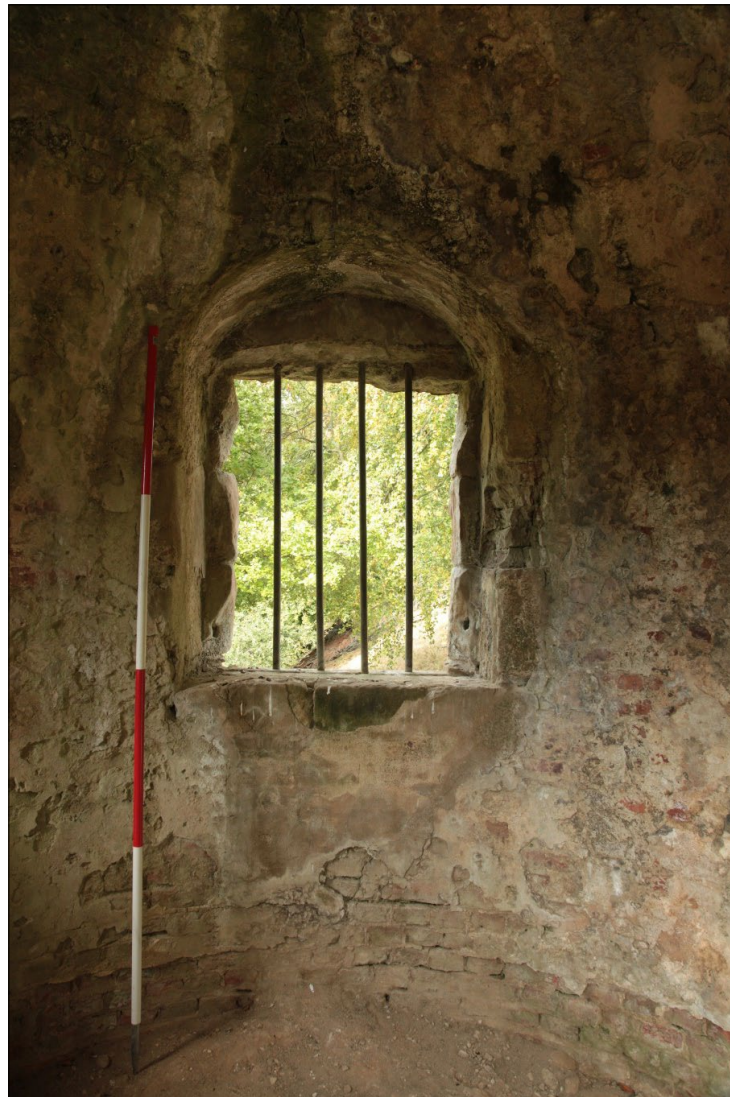
Plate 35: the north-facing window.
