Studley Royal Roman Monument: Historic Building Recording for Skell Valley Project

Report Title: Studley Royal Roman Monument – Historic Building Recording

Version: v1
Issue Date: December 2022
Report Ref: 22-66

The building record was undertaken in advance of conservation and repair work. The record comprised documentary, cartographic and archive research, and a photographic and written record.

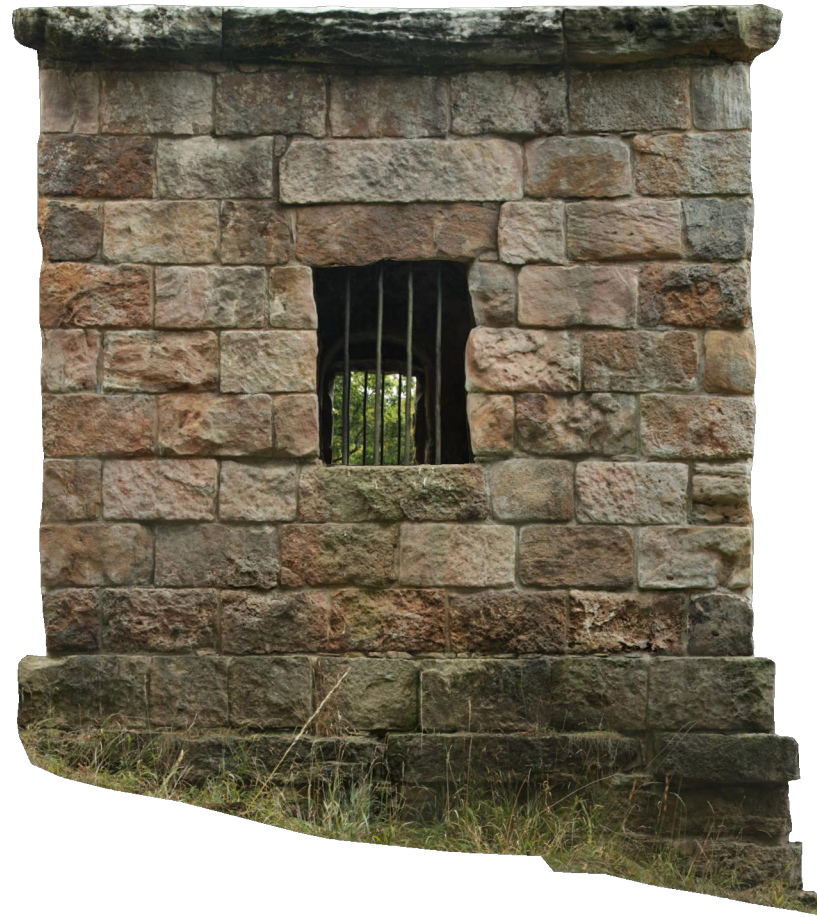
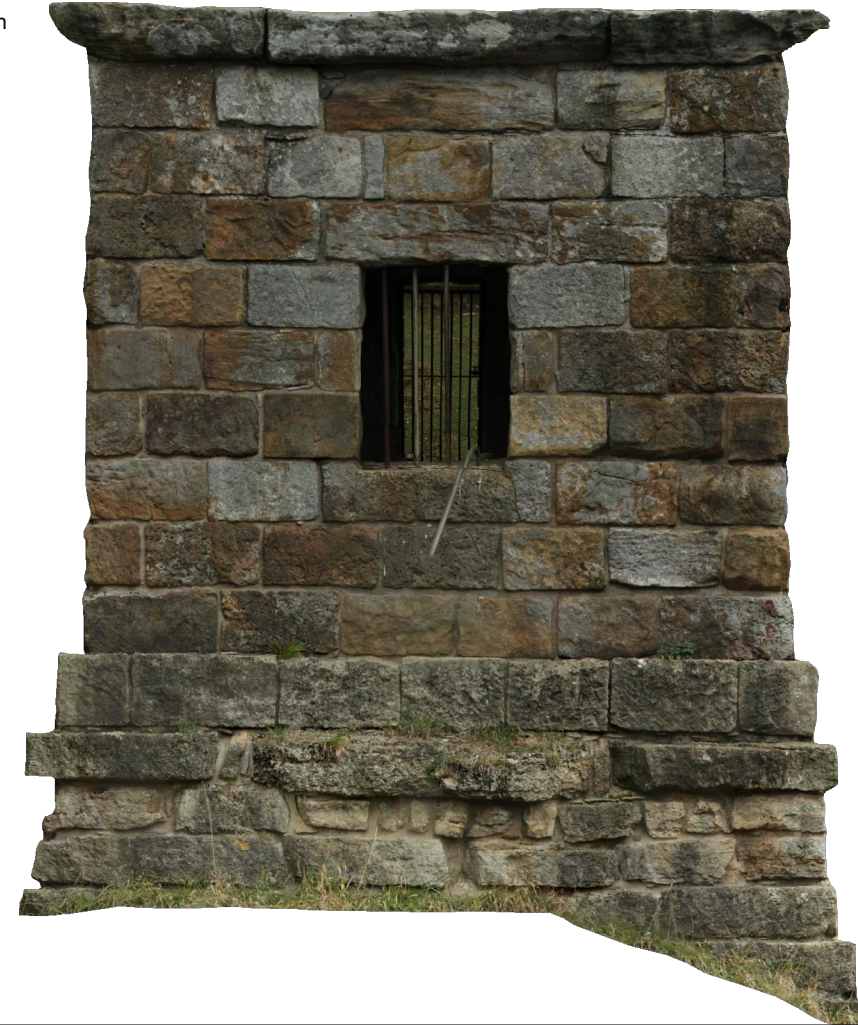
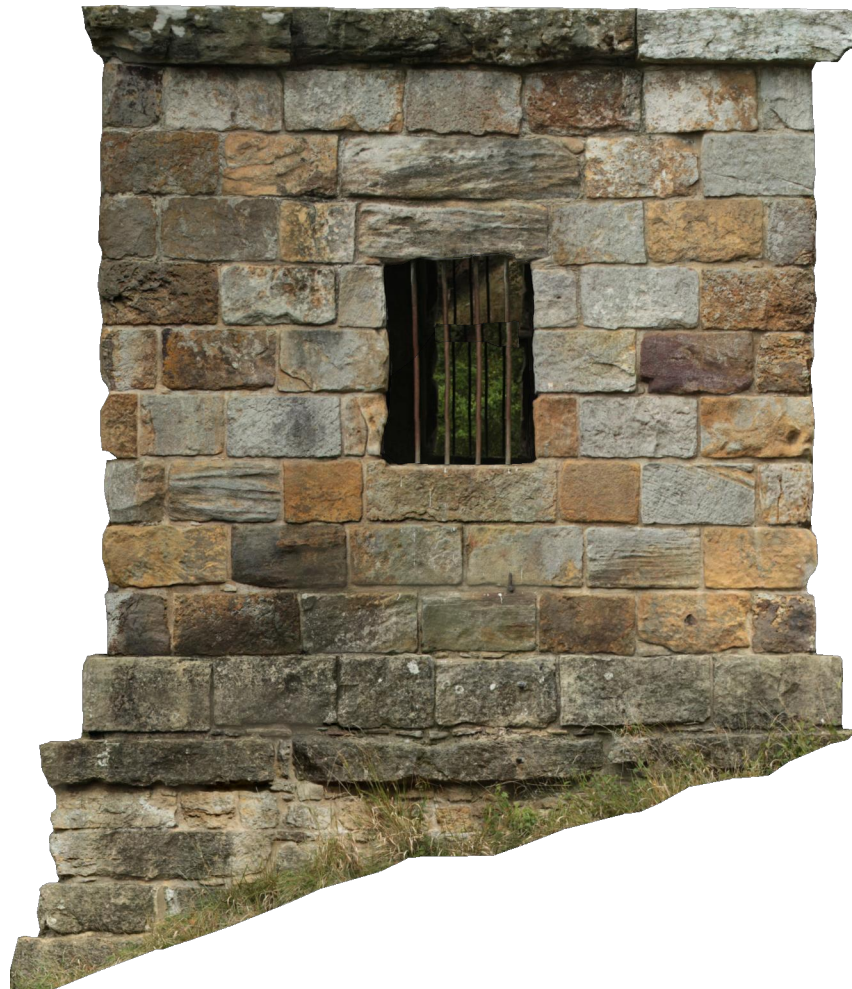
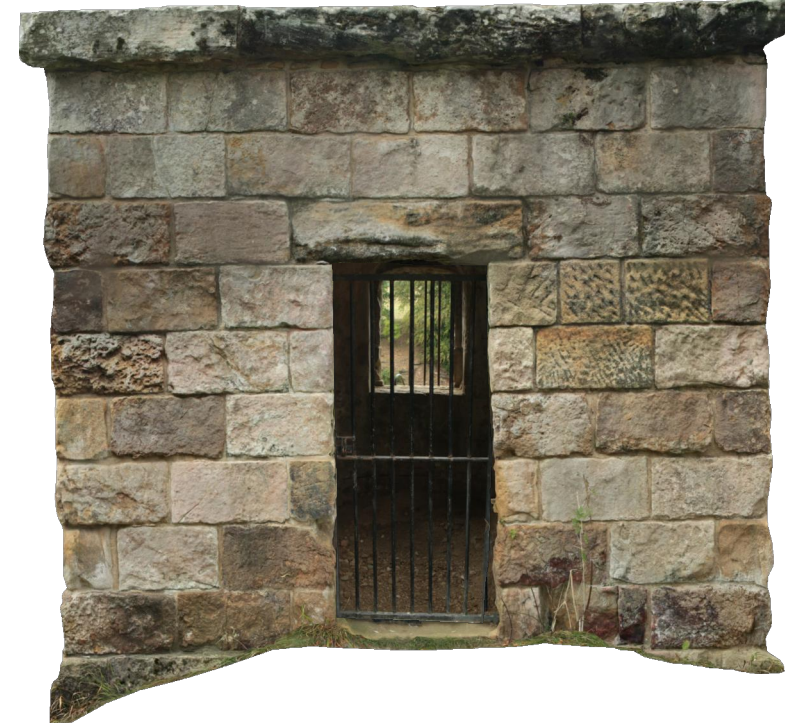
a) north facing elevation

b) west facing elevation

c) south facing elevation

d) east facing elevation

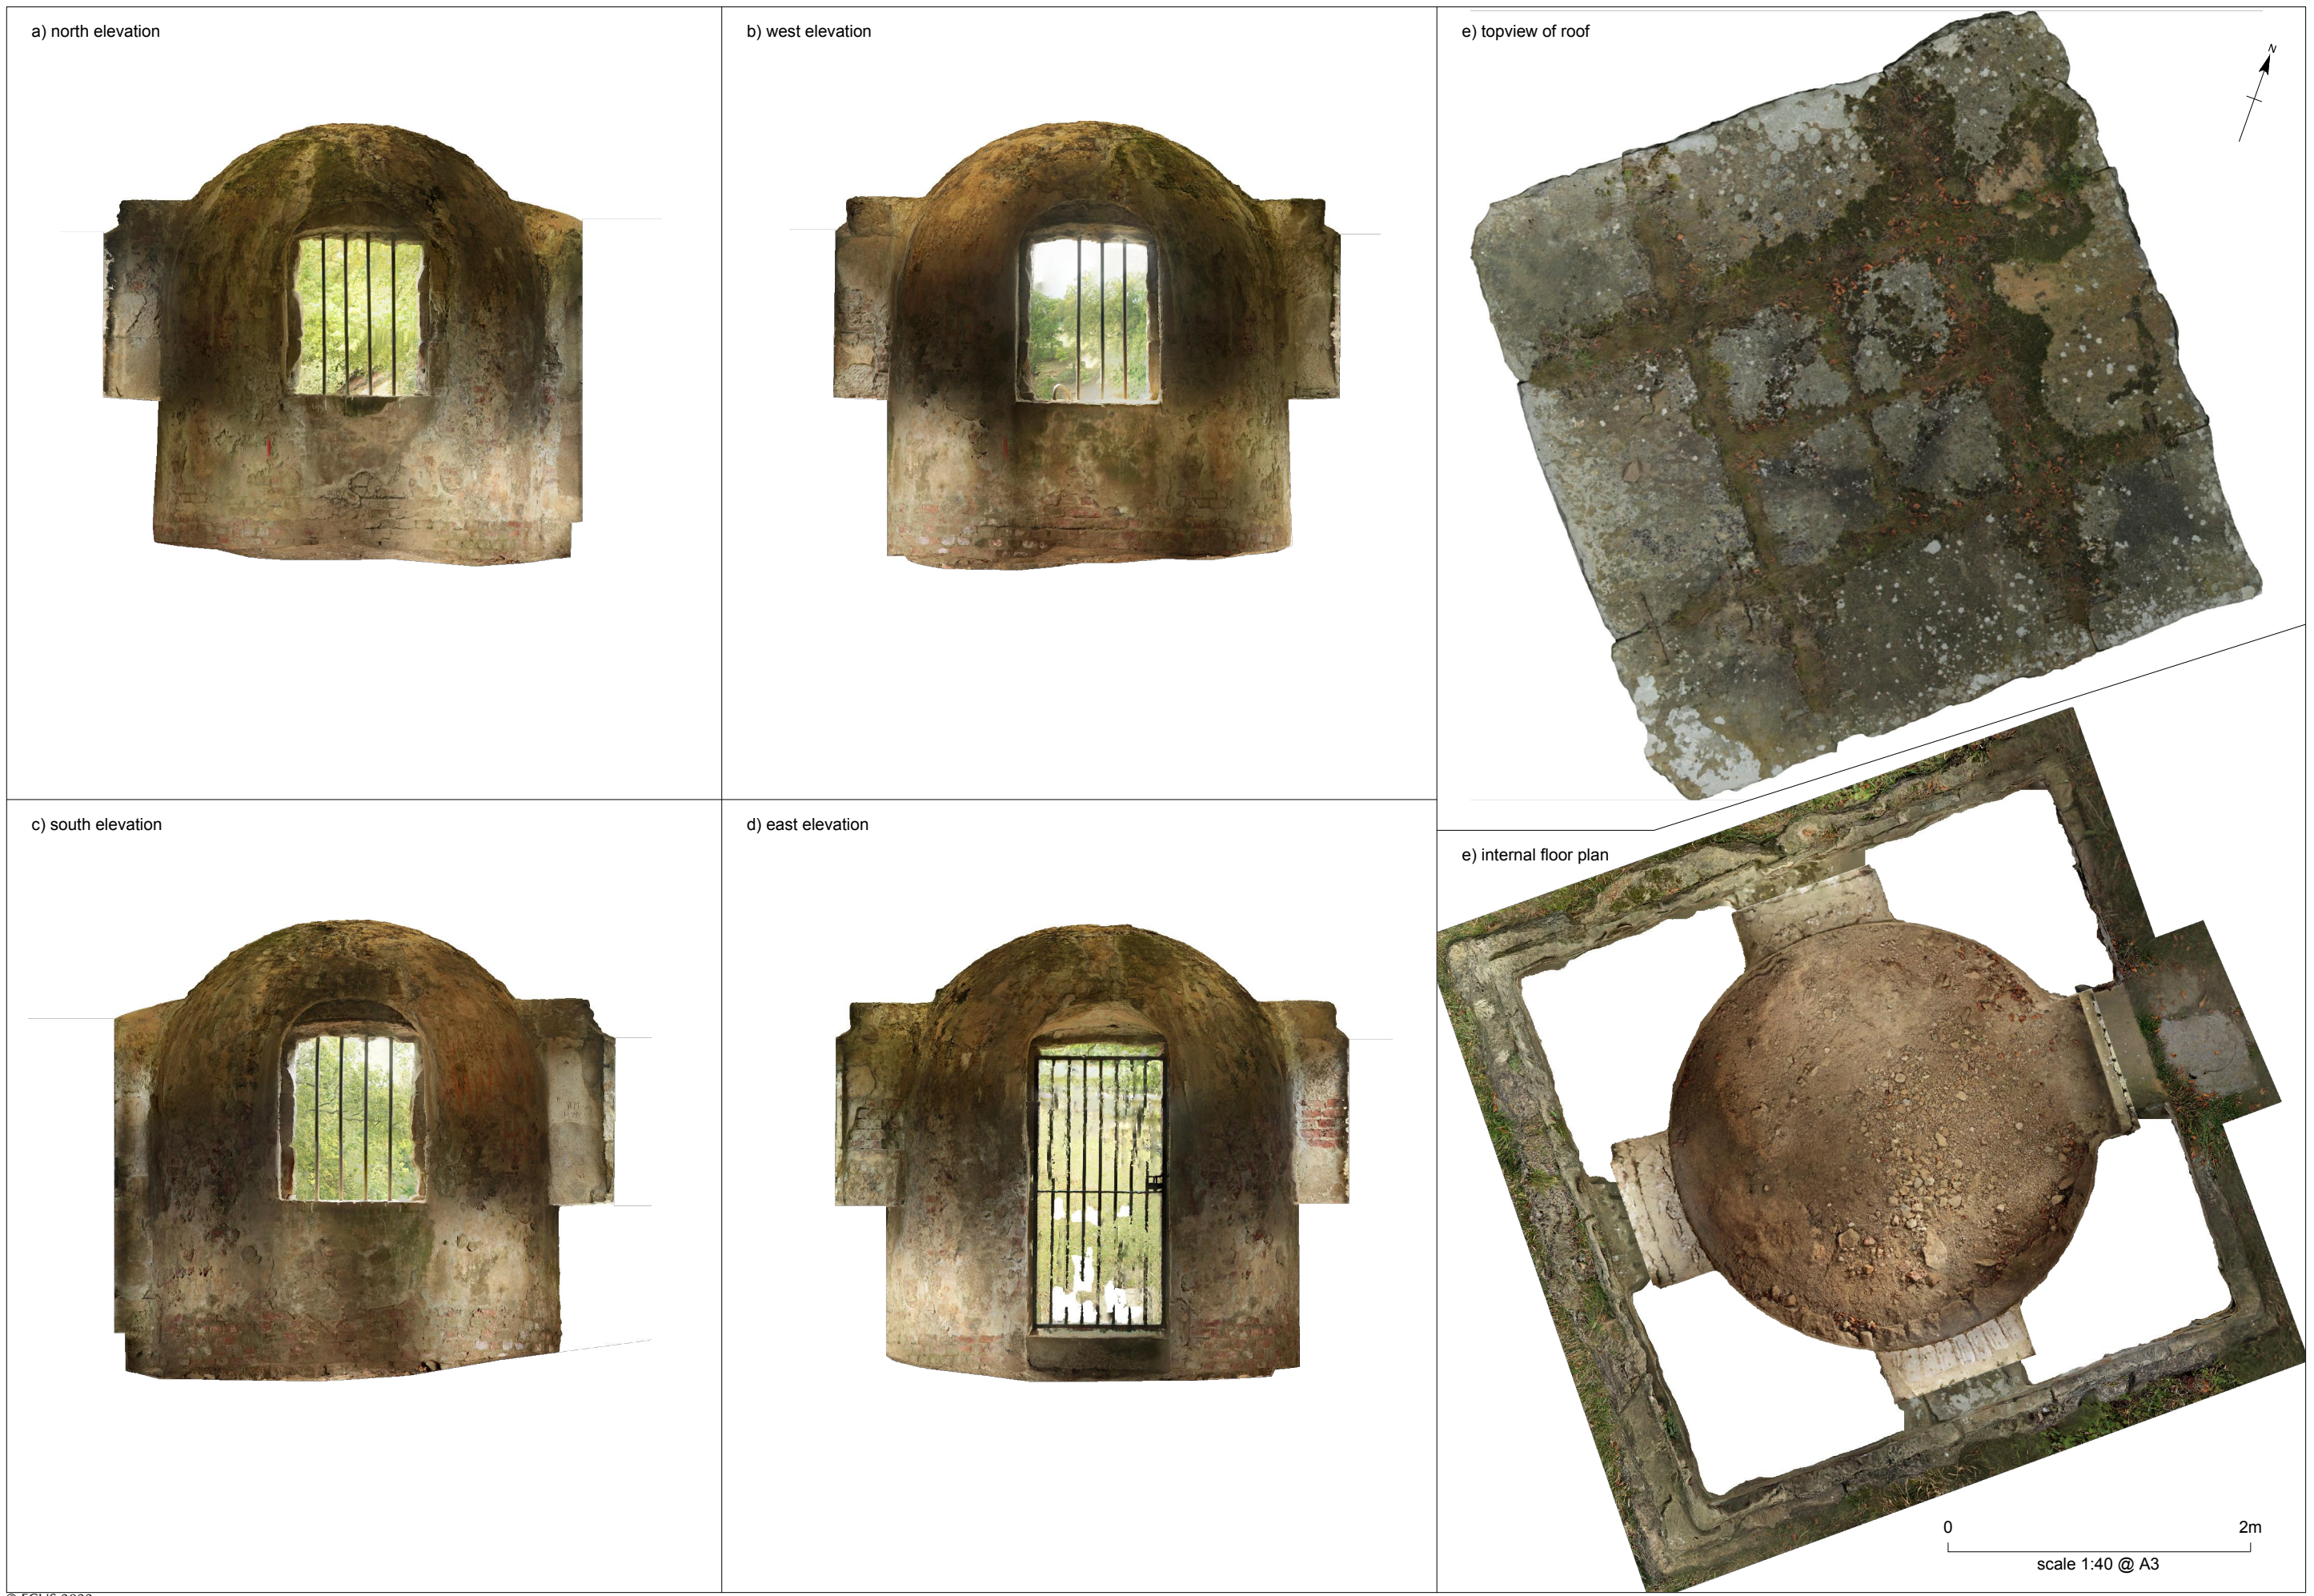
Studley Royal Roman Monument, N-Yorkshire: internal elevations, roof and internal floor

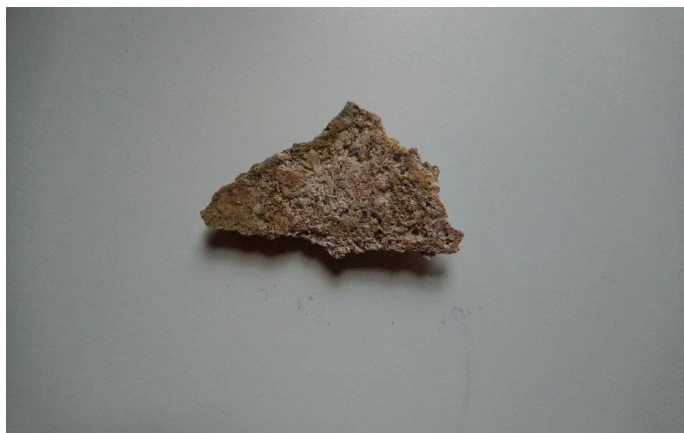
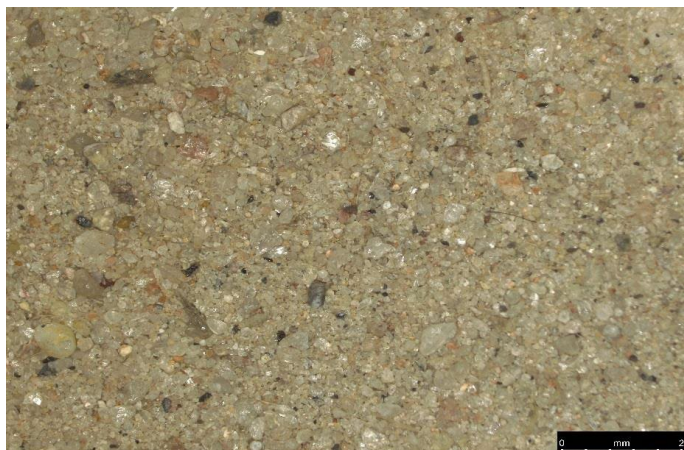
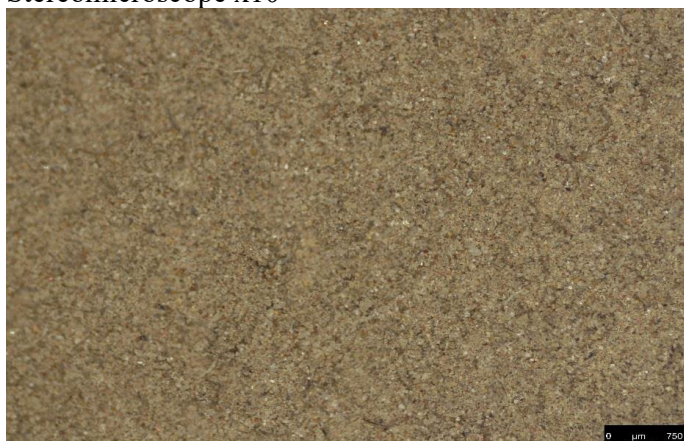
5443 Sample as tested

5443 Insolubles $>45\mu\text{m}$
Stereomicroscope x10

5443 Insolubles $<45\mu\text{m}$
Stereomicroscope x20

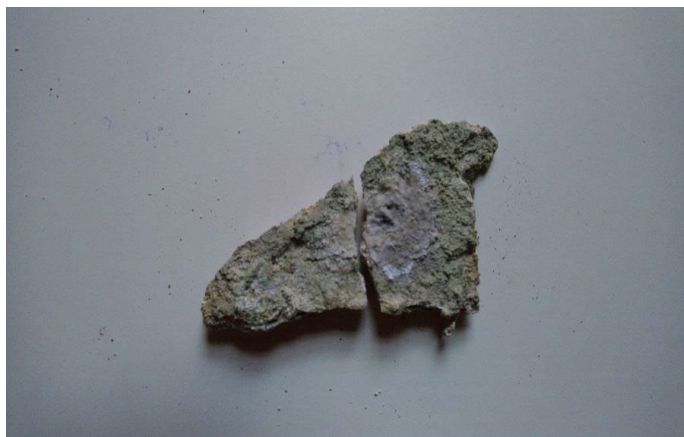
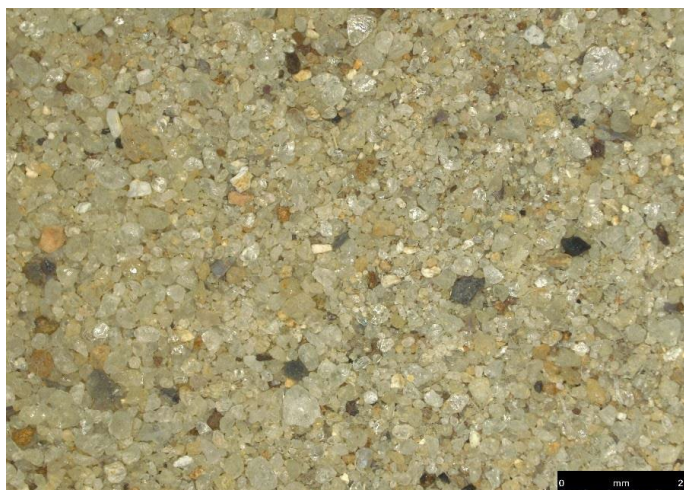
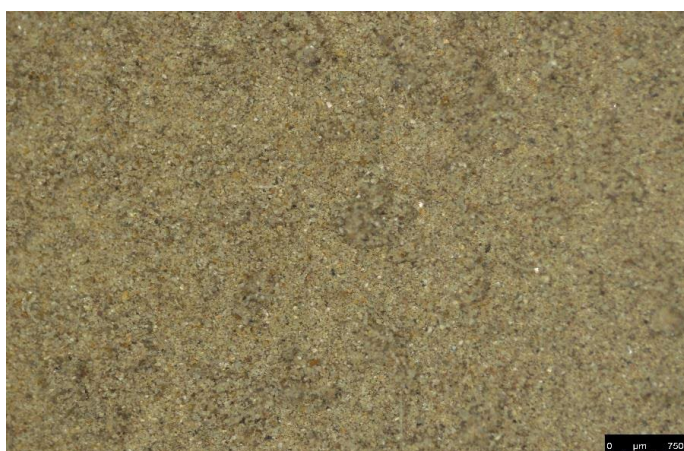
5444 sample as tested

5444 Insolubles >45µm
Stereomicroscope x10

5444 Insolubles <45µm
Stereomicroscope x20
