## ARCHAEOLOGICAL MONITORING

## REPLACEMENT GAS MAIN LINDEN WAY GATESHEAD

**Archaeological Monitoring**

**County Archaeologist's Reference Number:** MON 11589 WB

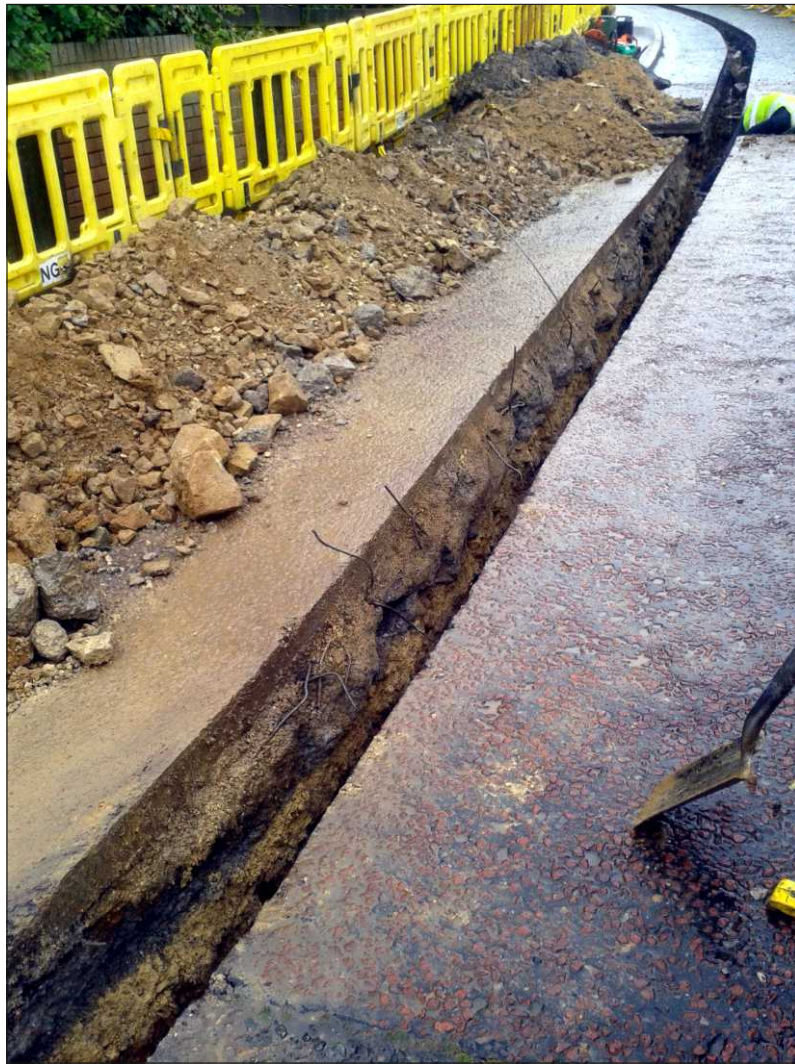
The excavation of approximately 30m of pipe-trench, on a rough north-west to south-east alignment, was monitored. The trench was located on the north-east side of the road and averaged 0.3m wide and 0.6m deep (Plate 1). The trench profile varied slightly across its length and is described below as Areas A-C (Figure 2).

*Linden Way, Gateshead: general view* Plate 1

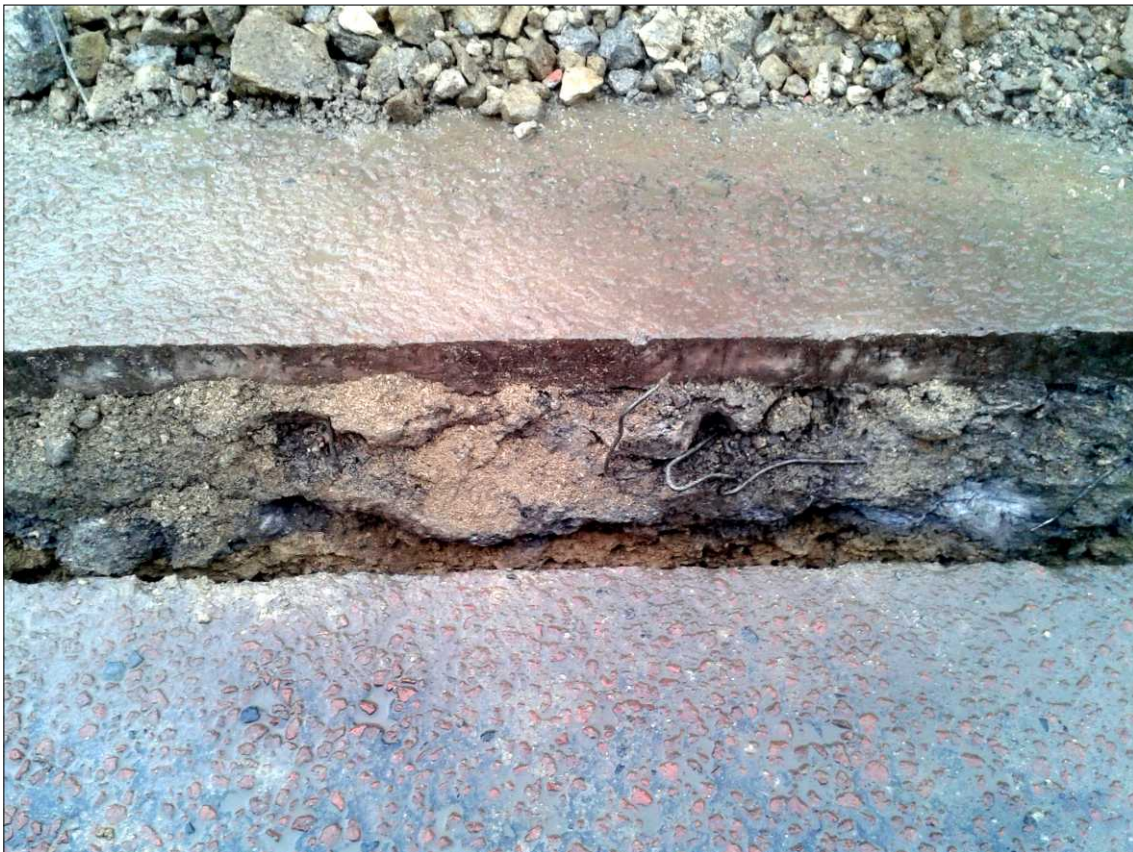
Across the line of the road (Area B), no natural deposits were visible, the entire section comprising crushed orange dolomitic sandstone overlain by a reinforced

concrete raft 0.2–0.3m thick (Plate 2), and then the modern tarmac, which had been cut by numerous service trenches.

*Linden Way, Gateshead: close up showing concrete below tarmac* Plate 2

The trenching did not reveal any remains either of the Wrekendike Roman road or its associated ditches, and no artefacts were identified. The road was a 'pinch point' for services, which were protected by 0.25m to 0.3m of concrete, so that the underlying deposits had experienced considerable previous disturbance.
