ARCHAEOLOGICAL MONITORING

REPLACEMENT GAS MAIN

679 WEST ROAD DENTON BURN TYNESIDE

Watching Brief Report

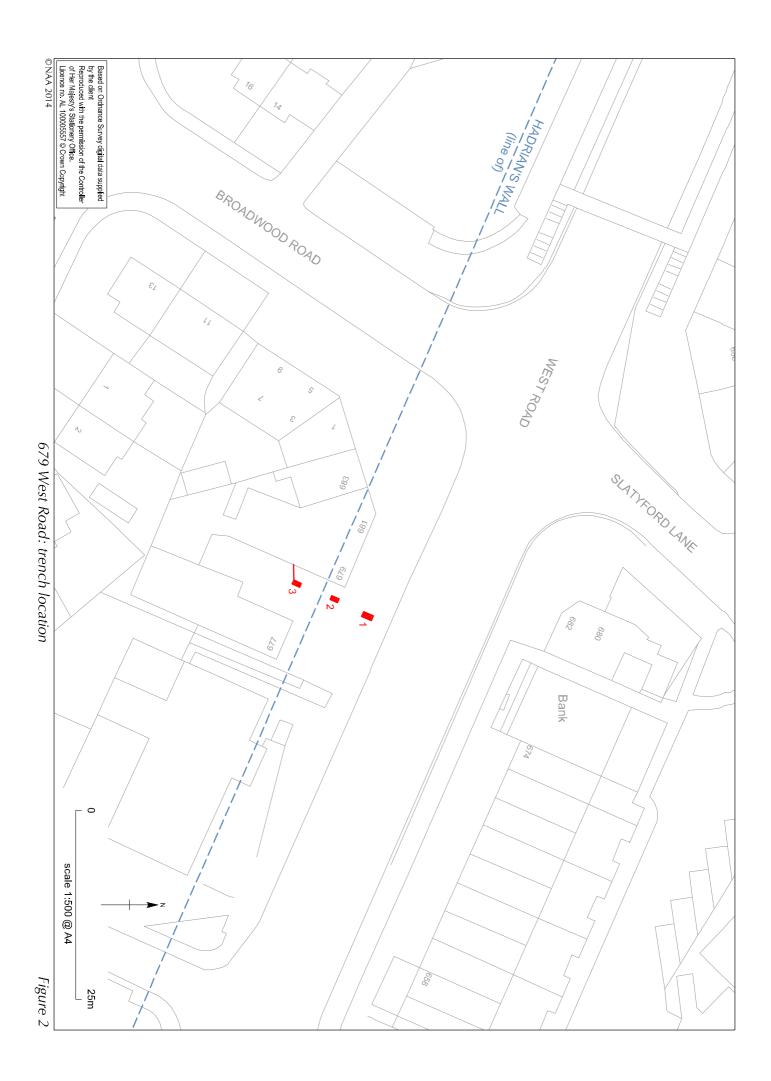
The pipe was installed using directional drilling via three hand-excavated trenches (Figure 2). Trench 1 was the point of connection with the gas main within the pavement. It measured 1.4m north to south by 0.7m east to west and was 0.7m deep. The trench was entirely within the backfill of the existing main, comprising dark ashy gravelly silt.

Trench 3 was approximately 5m to the south of Trench 2 and measured 1.1m by 0.56m by 0.54m deep, and incorporated a 0.25m wide, 0.3m deep slot connecting it to the building. Along the eastern half of the trench were the remains of an earlier concrete surface, some 0.25m below current ground level. The remainder of the trench was cut through natural orange-brown coarse clay sand.

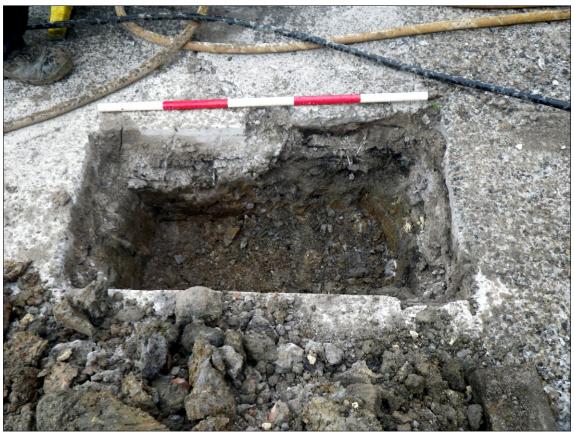
©NAA 2014 Plate 1

Some 5.5m to the south, Trench 2 (Plate 1) was excavated within the concrete pavement and measured 1.05m by 0.55m by 0.75m deep. Below the concrete was orange-brown natural clay.
