REPLACEMENT GAS MAIN

GLOUCESTER ROAD

NEWCASTLE UPON TYNE

ARCHAEOLOGICAL MONITORING

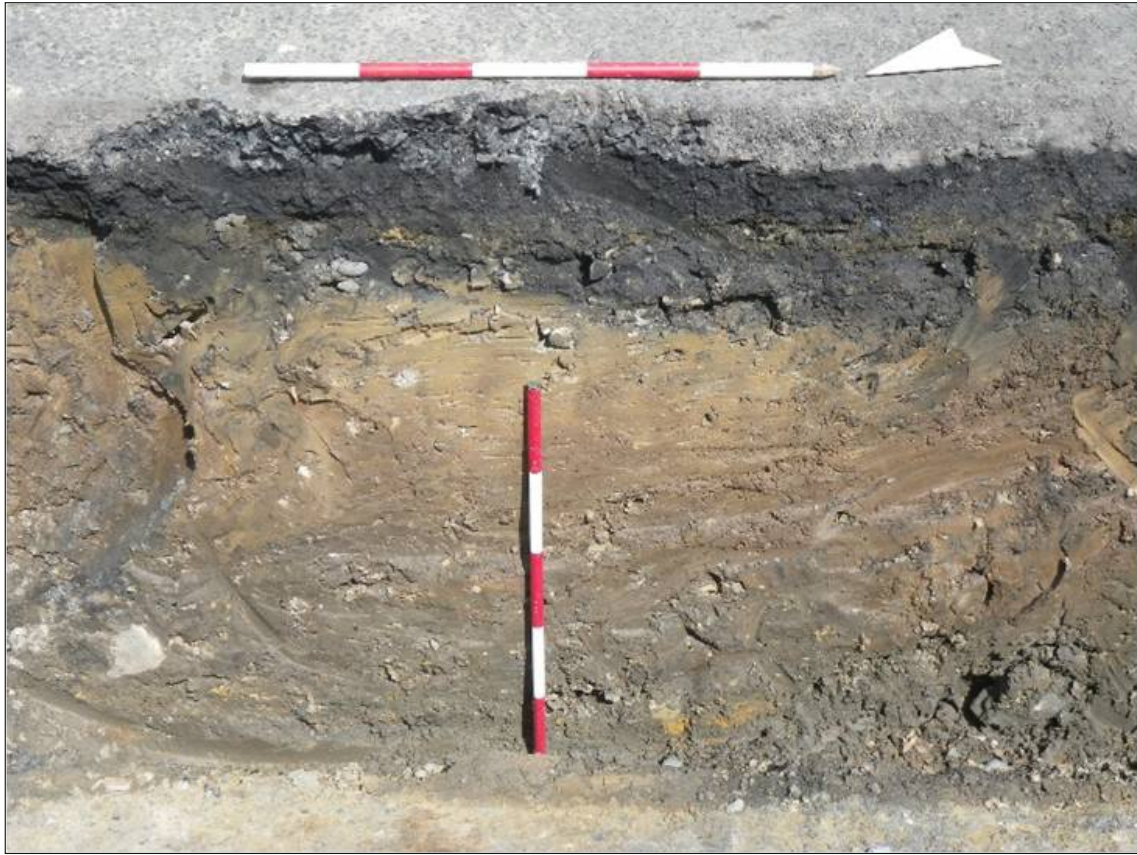
Plate 3

- 6.2 Throughout the trench two successive layers of natural boulder clay were encountered (Plate 3). The lower was located at a depth of 0.91m and was a mid/dark brown sandy, silty clay with frequent small angular stones, frequent flecks of orange and yellow mineralisation and very occasional inclusions of coal. The upper layer was a light brown sandy, silty clay with very little in the way of notable inclusions, located at a depth of 0.29m. Overlying this was up to 0.19m of loose dark grey/black modern levelling material, with tarmac of the modern road completing the profile. No archaeological features or artefacts were identified.

*Gloucester Road, Newcastle upon Tyne: north-west facing
section of the trench side*

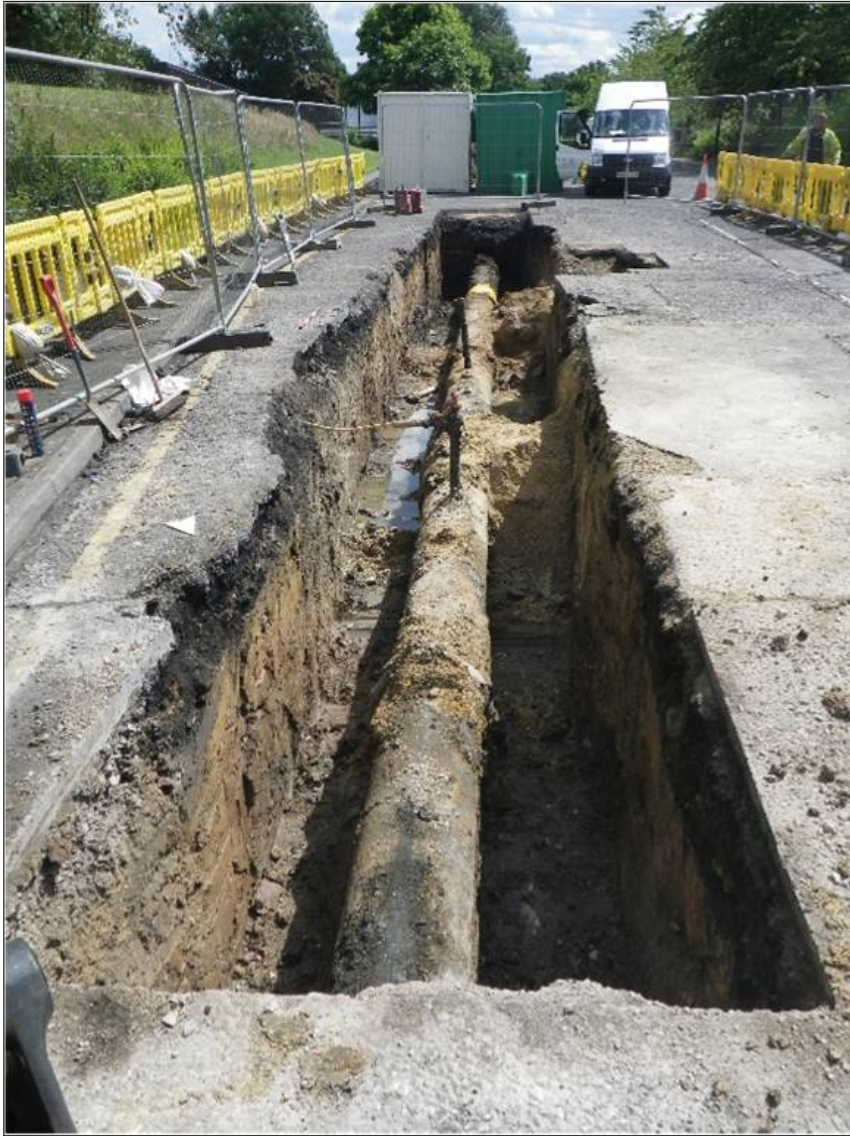
- 6.1 The area of archaeological monitoring comprised an 18.8m section of trenching along Gloucester Road, close to the predicted line of Hadrian's Wall. The trench was located on the east side of road (Plates 1 & 2) and averaged 1.9m wide and 1.62m deep and was relatively level throughout the length of the trench.

Gloucester Road, Newcastle upon Tyne: south-west facing view of the trench Plate 1

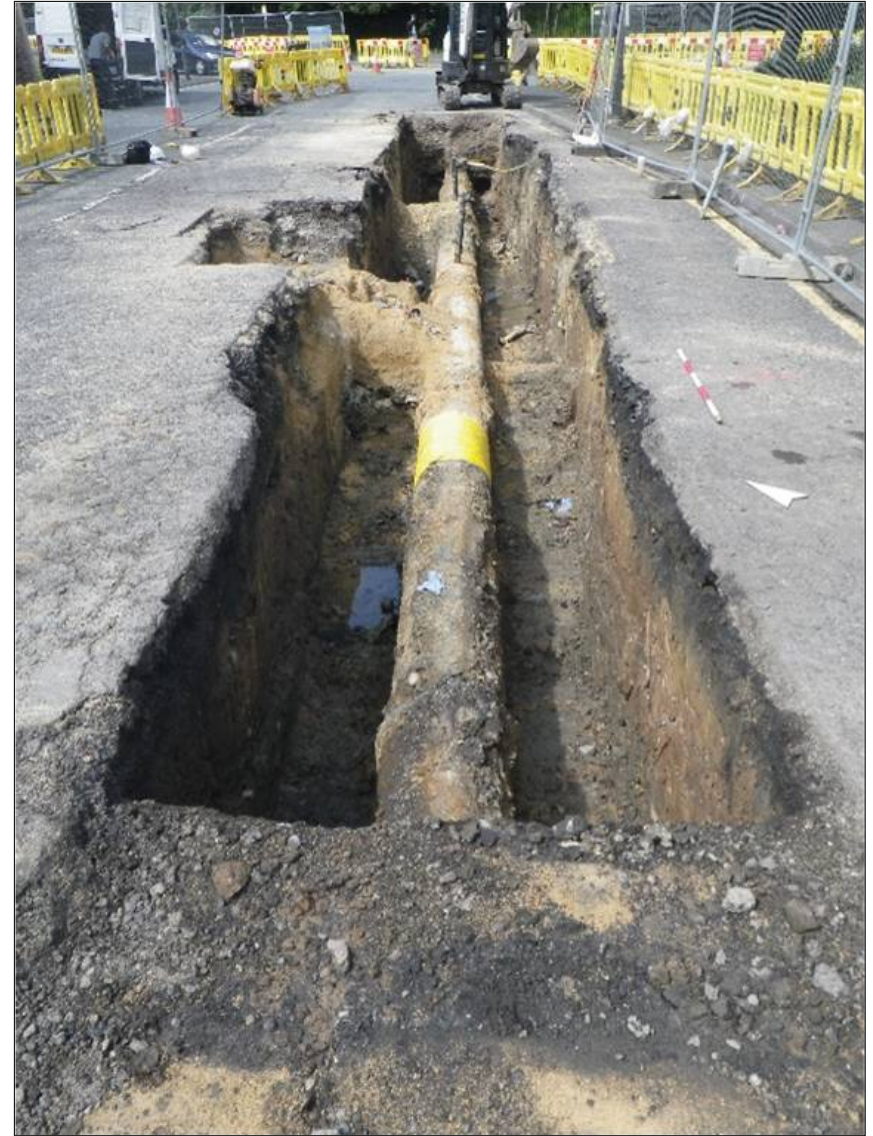
Gloucester Road, Newcastle upon Tyne: north-east facing view of the trench Plate 2
