NORTHERN ARCHAEOLOGICAL ASSOCIATES LTD

WATER MAIN RENEWAL, HUGGATE

Negative watching brief report

NAA report number: 15/134

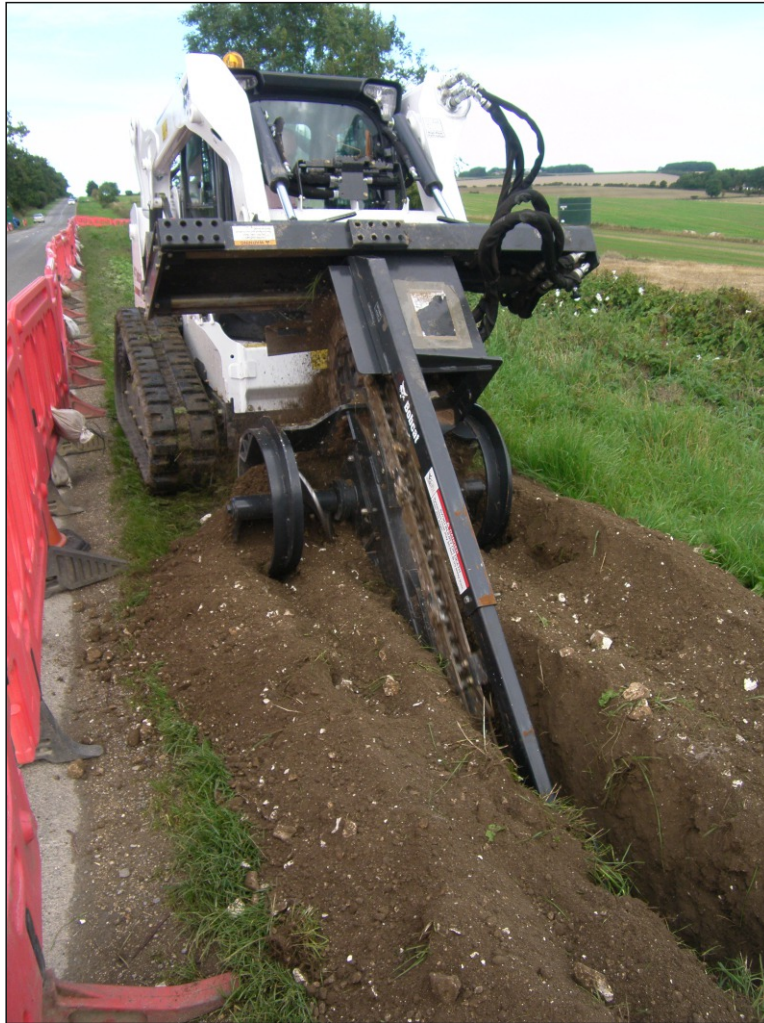
Plate 1

*Huggate: trenching machine
in action*

Excavations were undertaken partly using a trenching machine attached to a 'Bobcat' excavator (Plate 1), and partly using a mini digger, under the supervision of an archaeologist. Excavations on York Lane commenced from the road junction with Pocklington Lane. Due to the equipment utilised, the excavations were to a depth of 1.2m but a width of only 0.15m, making it extremely difficult to determine if any archaeological features existed. Not unexpectedly, none were noted. There were also no pre-modern artefacts, although deposits of modern building materials, apparently from fly-tipping, were recorded within the topsoil.

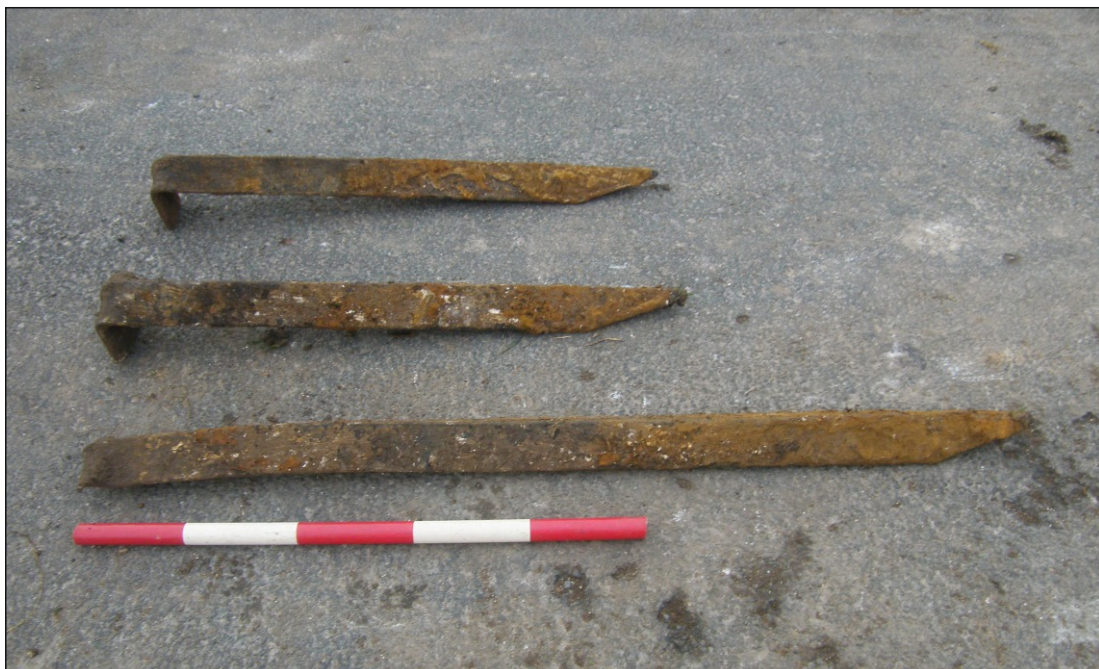
Plate 2

*Huggate: sample of spikes, possibly for
temporary runway*

The trenching along Pocklington Lane proceeded westwards, continuing onto the northern end of Cobdale Road. Once again, there were no visible archaeological deposits or features, although building demolition materials were encountered in the topsoil. There were also fragments of metal mesh and a number of angle-iron stakes (Plate 2). The stakes ranged in length from 0.6m to 0.9m. It is possible that they were associated with an experimental temporary runway which was constructed on Huggate Wold in WWII, consisting of rolls of wire mesh, which would presumably be pinned down by metal stakes. It is recorded that immediately after the trials were completed the temporary runway was removed (Halpenny 1982, 95–6). However, the stakes' location at the opposite end of the village from the airfield site might throw some doubt on this interpretation. Given this uncertainty, and the unstratified nature of the stakes, they were not retained for further study.
