CORBRIDGE ROAD BARRIER REPLACEMENT

NAA 16/113
August 2016

TEST PIT SUMMARY

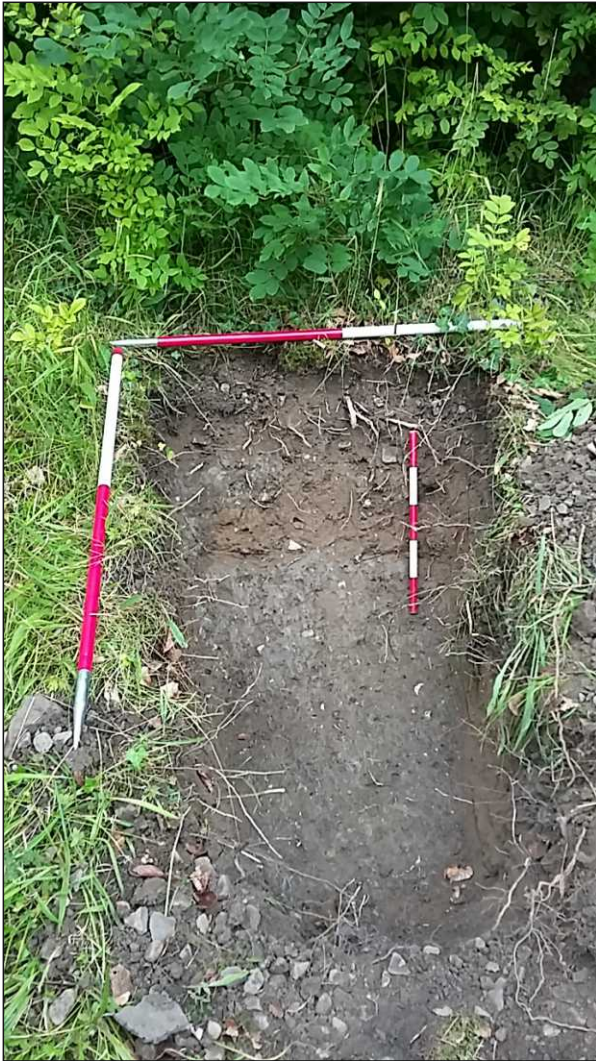
Plate 1: Test pit A

- 3.1 This pit was located next to a lamp post on the edge of the Stagshaw Road roundabout, close to the intended southern end of the road barrier. It measured 1.5m by 0.9m and was excavated to a depth of 0.7m below modern ground level (BGL).
- 3.2 Natural dark grey, stiff boulder clay was encountered at a depth of 0.5m (Plate 1), overlying which was 0.3m of mixed, light brown sandy clay with frequent stoney lenses and stone fragments. This was sealed by 0.2m of topsoil.

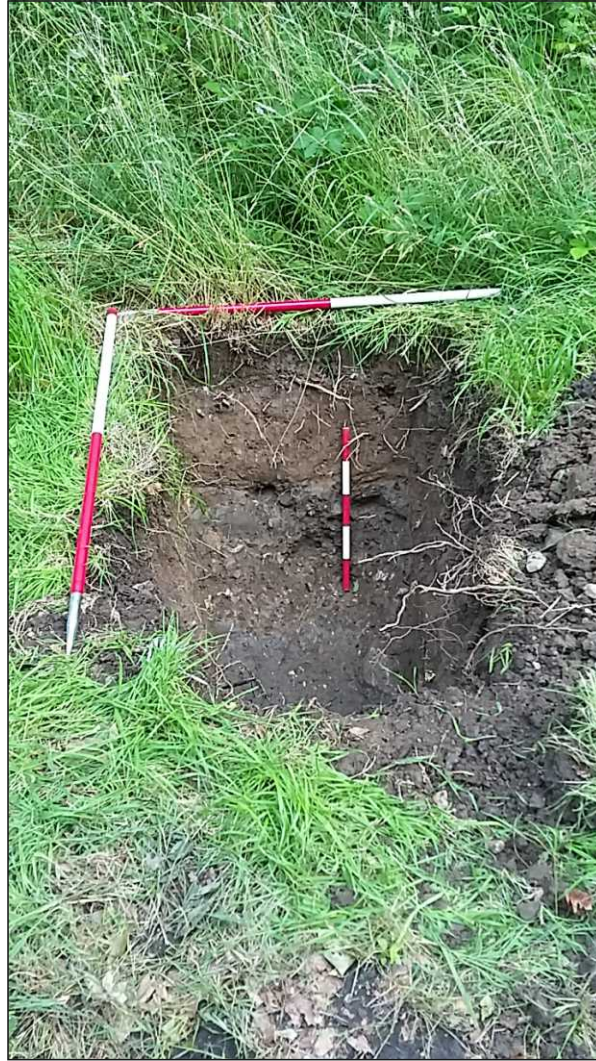
Plate 2: Test pit B

- 3.3 This pit was excavated approximately mid-way between two road signs (the Corbridge/Jedburgh junction sign and a tourist information sign) on the southern side of the slip road, approximately 65m from Test Pit A. Measuring some 1.2m by 0.9m, the pit was excavated to a depth of 0.9m BGL.
- 3.4 As with Pit A, the natural boulder clay was encountered at a depth of 0.5m BGL, and there was a subsoil of sandy clay (Plate 2). This layer produced three sherds of pottery of medieval and later date, and was sealed by 0.15m of topsoil.

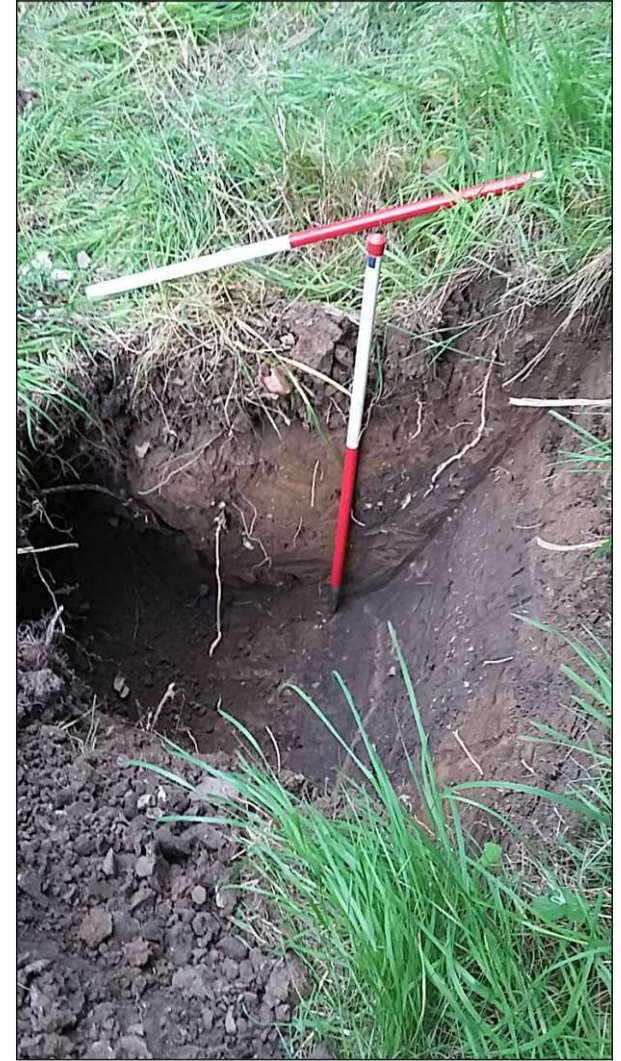
Plate 3: Test pit C

- 3.5 Test Pit C was located immediately to the north-east of the junction sign, some 30m to the north-east of Test Pit B. The pit was of the same general dimensions as Test Pit B, but was cut back into the embankment to avoid a power cable supplying the road sign. Consequently, on the up-slope side, the pit had a maximum depth of 1.3m.
- 3.6 Some 0.7m BGL there was a dark grey heavily compacted clay, overlain by 0.2m of dark grey brown clay with frequent stones and then 0.35m of mixed yellow-brown sand and clay (Plate 3). All of these deposits were disturbed by electric cables; the western side of the pit intersected a coarse aggregate filter drain, which apparently extended out to the kerb. Again there was 0.15m of topsoil.
