**ARCHAEOLOGICAL  
WATCHING BRIEF REPORT**

**REPAIRS TO A VICTORIAN  
SEWER AT BOOTHAM BAR,  
HIGH PETERGATE**

**CITY OF YORK**

NAA 07/131  
September 2007

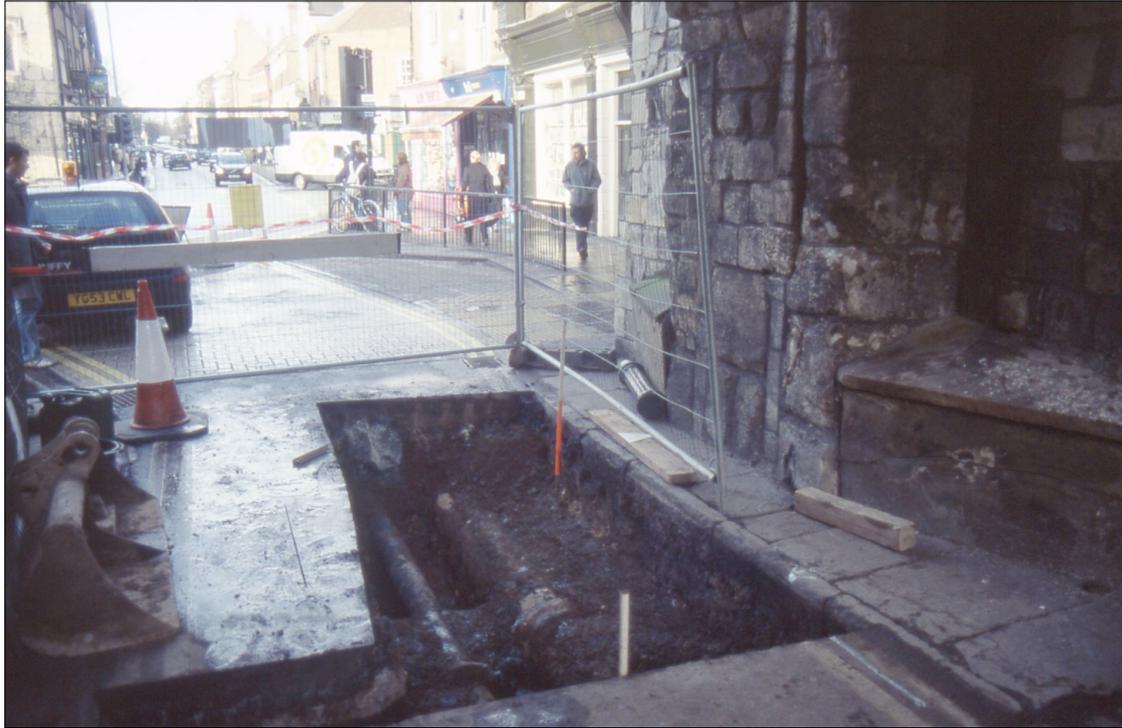
- 2.1 Bootham Bar, a gateway within the medieval city walls of York, is located at the intersection of Bootham (A19), Gillygate (A19) and High Petergate in the City of York (SE 59738 51446). The main sewer trench was located beneath Bootham Bar and extended out into High Petergate to the south-east for approximately 12m at a ground surface height of some 17m AOD (Plate 1) (Figure 2).

*Plate 1 High Petergate, York: excavations at Bootham Bar*

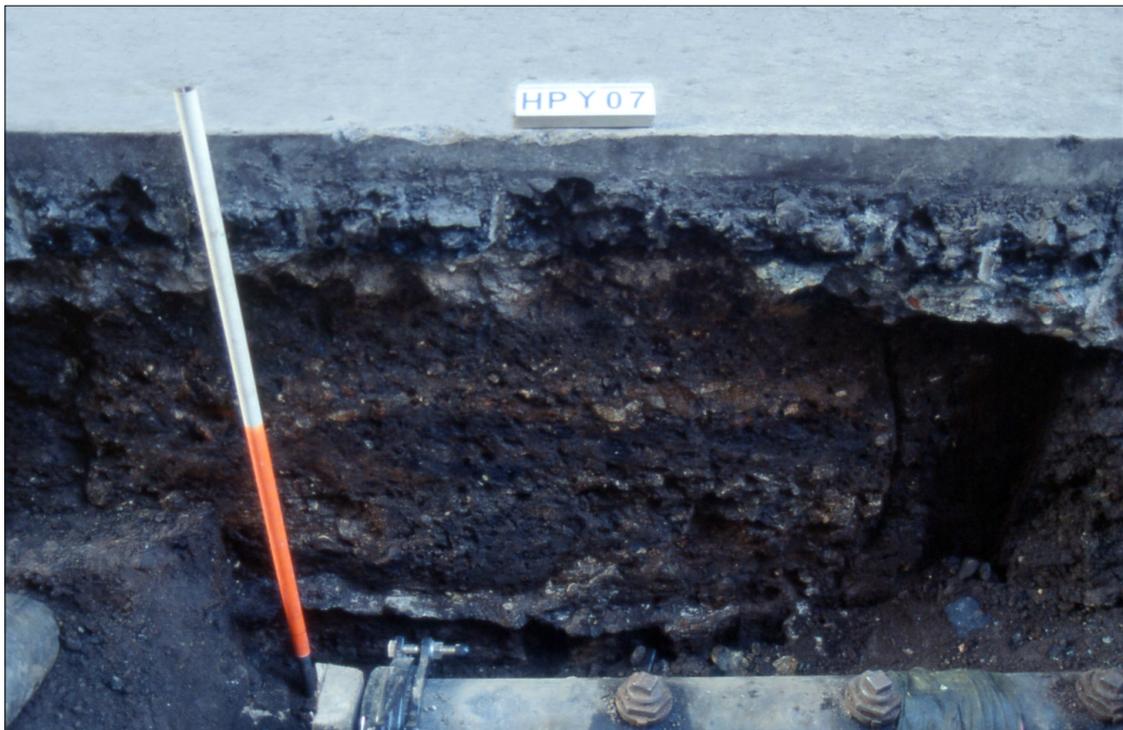
6.2 This north-east facing section of the sewer trench extended for 2.45m from north-west to south-east, and was recorded to a depth of 1.1m prior to the insertion of trench shoring (Plate 2).

*Plate 2 High Petergate, York: view of north-east of trench section 1*

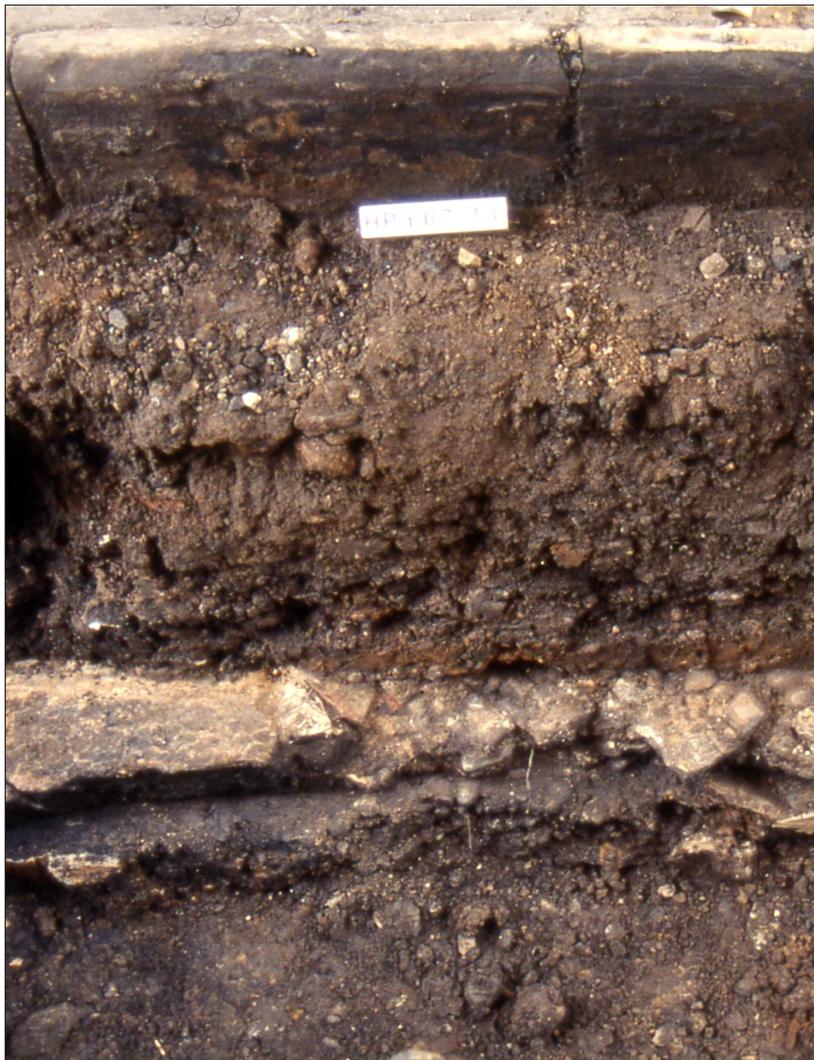
6.4 This south-west facing section of the sewer trench extended for 3.6m from north-west to south-east, and was recorded to a depth of 1.65m prior to the insertion of trench shoring (Plate 3).

*Plate 3 High Petergate, York: south-west facing section 2 with Medieval road surfaces 13 and 14 visible towards the base*

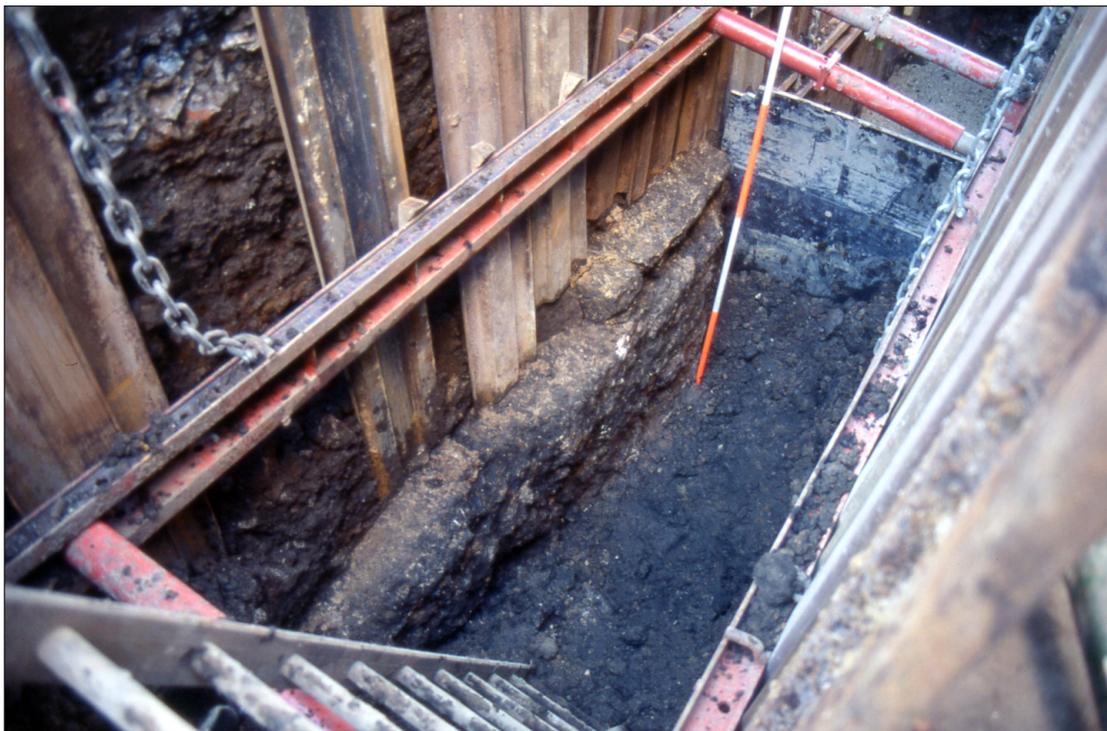
- 6.6 This north-east facing section of the sewer trench extended for some 6m from north-west to south-east, and was recorded to a depth of 3.6m (Plate 4).

- 6.7 The natural sandy clay (35) was cut by a construction trench (34) containing a wall foundation (31), the face of which was exposed within the trench. This large footing was battered slightly from the base, extended for 5.85m along the trench and stood to a height of some 1.5m. This concrete foundation was constructed from small and medium sub-angular sandstones and gritstones, up to 150mm by 100mm x 80mm in size, set within a matrix of yellow gritty mortar (Plate 5). Set upon the wall foundation was a fragmentary single course of squared sandstone blocks (30), measuring up to 1100mm by 220mm by 200mm, also set with yellow mortar. The remains of the wall (30) was overlain by a 1.5m thick deposit of sand, gravel and post-medieval and modern rubble (9), which infilled and sealed the multiplicity of services exposed throughout the trench, and was the same deposit as 29 and 5 in sections 1 and 2.

*Plate 4 High Petergate, York: oblique view of north-east face of mortared foundation of Roman gatehouse*

- 7.2 Despite the lack of datable material the construction methodology employed for the wall footing, that is a mortared rubble or concrete core set with small facing stones, was identifiably Roman and is common to many defensive Roman walls in Britain (Bidwell, 1997, 49), and particularly to the fortress walls of *Eboracum* (Ottaway, 1993, 53). It is almost certain that the foundation identified during this excavation is the same as that described by Wellbeloved (1842, 51) and recorded by Benson in 1909-10 (Benson, 1910, 41-54; RCHME, 1962, 25 and 28;), and is thus the north-east wall of the so-called 'guardroom' forming the south-western part of the *porta principalis dextra* gatehouse. The fragmentary, and slightly off-set, single course of gritstone masonry recorded during this excavation is likely to be the same material identified by Benson as being part of the 'Severan' plinth', thus dated to c. A.D. 197, upon which the later Constantinian defences were built. The evidence to support this dating is limited; however the foundation and first course of masonry identified during the excavations beneath Bootham Bar appear remarkably similar to, if a little larger than, a segment of the south-east fortress wall recorded during excavations in Parliament Street, probably built in c. A.D. 200 (Ottaway, 1996, 228; 1993, 61).

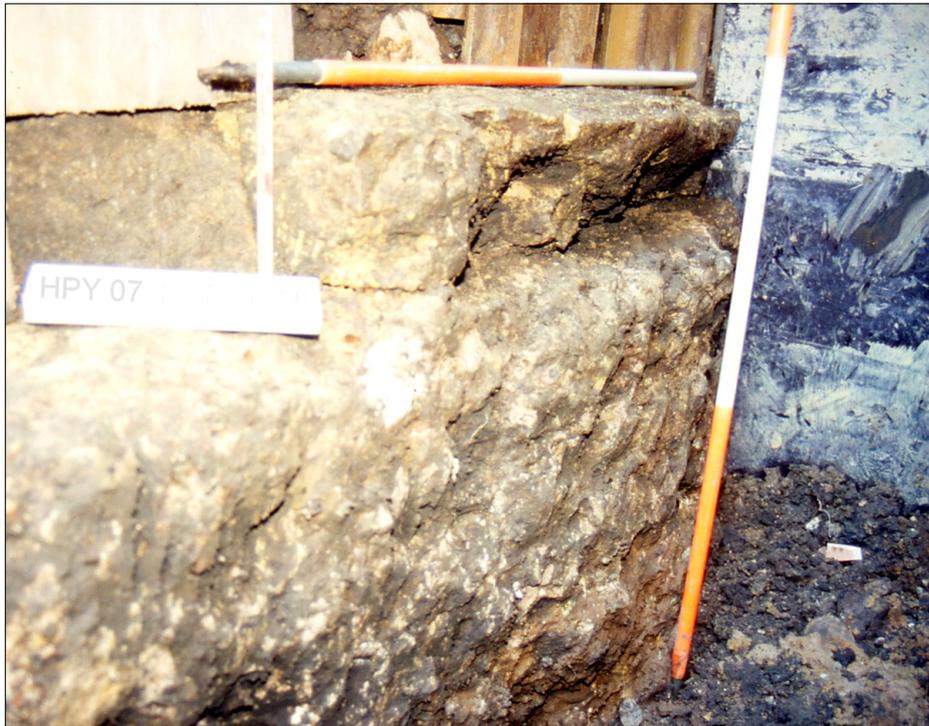
*Plate 5 High Petergate, York: detail view of mortared foundation and first course of masonry*

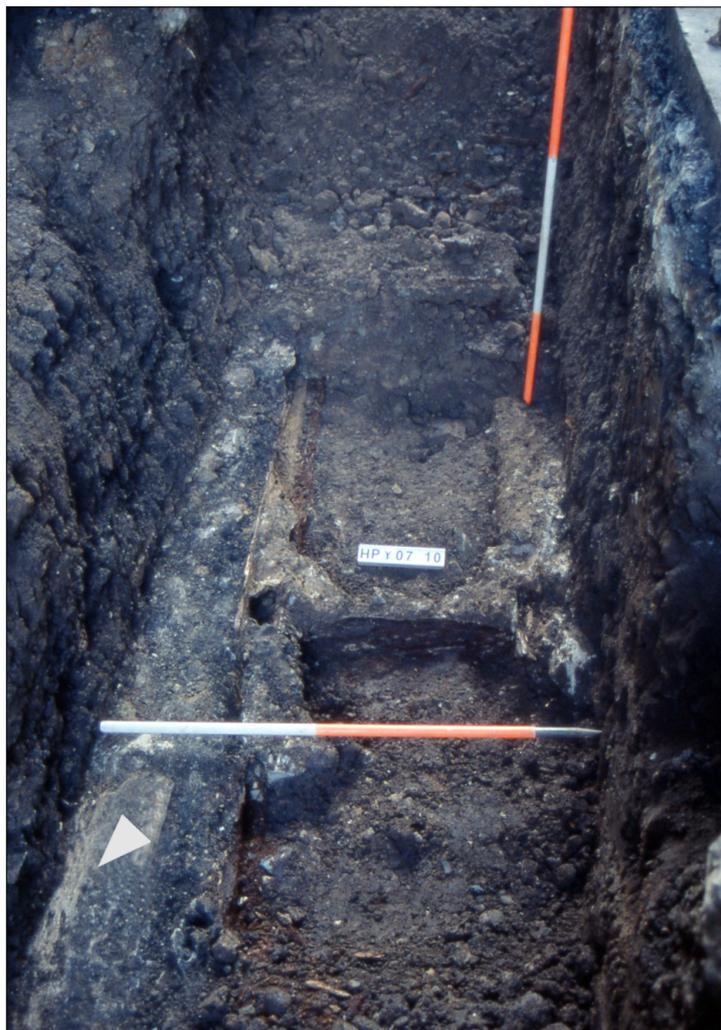
*Plate 6 High Petergate, York: Victorian sewer trench with original woden shoring. Note road surfaces 13 and 14 to the east*

- 7.8 The presence of the brick-built sewer within an open cut trench would seem to confirm the documentary evidence, which indicated that the likely construction date for the sewer would have been between 1892 and 1895, particularly given the description of Roman remains identified just to the west at St Mary's at this time. The route of the sewer shows it to pass from High Petergate to the east and directly beneath the medieval Bar, before heading out into Bootham itself to the west.
