17-19 SKELDERGATE, YORK

**ARCHAEOLOGICAL EVALUATION
AND BUILDING RECORDING**

**for
MANDALE PROPERTIES LTD**

NAA 99/65

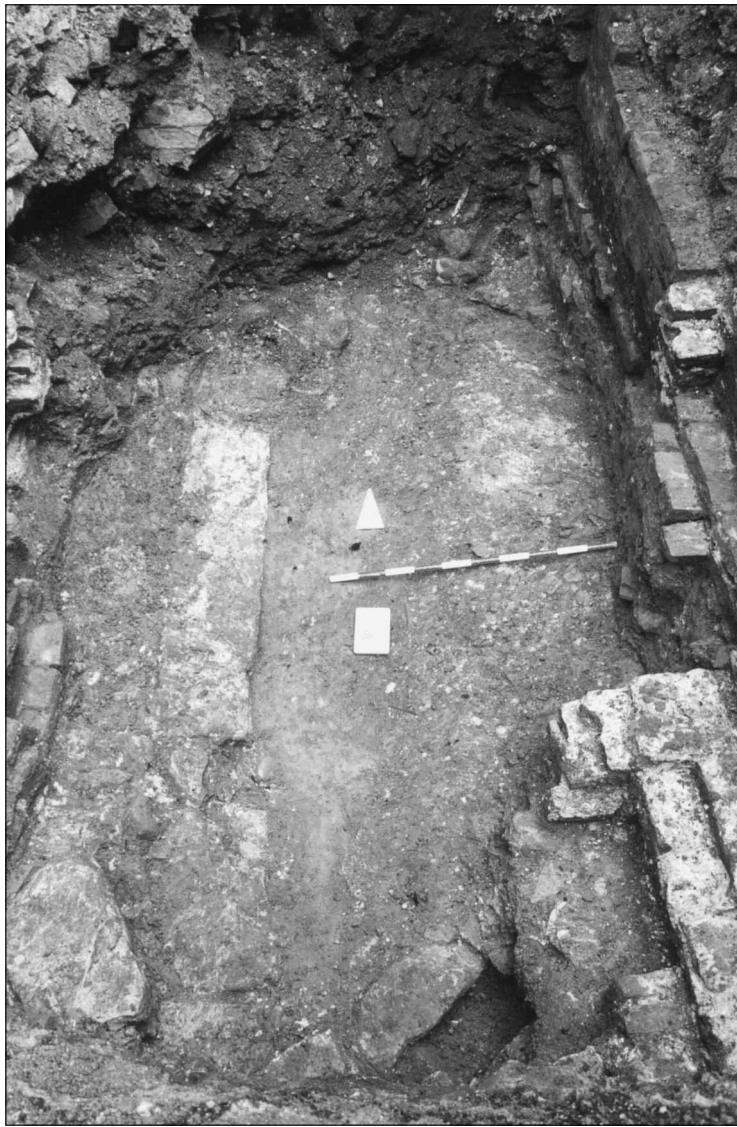
Figure 5 General view of bottom of Trench 1 (1 m scale)

- 4.2 At the base of the northern half of the trench, at a depth of 1.4 - 1.5m below the ground surface (7.56m OD) a mortar surface (118) was encountered laid onto a yellow sand (119) which contained occasional mortar flecks. A lead object possibly a fishing weight was recovered from this deposit. The mortar surface 118 contained an admixture of brown silt and a substantial element of roof tile fragments, lying flush with its surface.

- 4.3 Two stone walls (120 and 121) on a similar east-west alignment were exposed at the base of the trial trench. Wall (120) consisted of squared limestone blocks, faced on the south side only. The wall measured 0.36m wide and was exposed within the trench for 0.9m. The remains of a second wall (121) extended for 1.35m before being cut by a modern drain. The wall measured 0.3m wide was constructed from very roughly squared limestone blocks bonded with a soft white lime mortar.

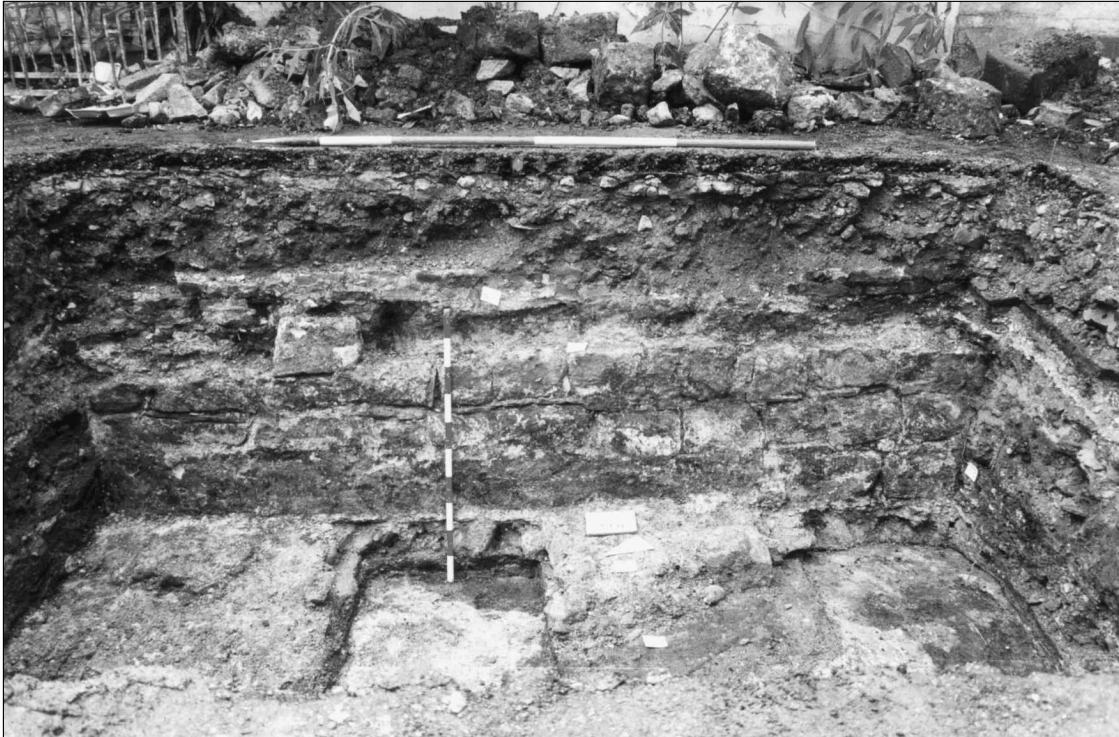
Figure 7 North-facing section in Trench 2 (1 and 2 m scales)

- 4.9 The earliest deposit encountered within the trial trench was a yellow sand (219) at a depth of 1.5m (7.64m OD) below the present ground surface. A cobbled surface (218) had been laid onto this layer. This surface was in turn overlaid by a dark grey-brown sandy silt (213), up to 0.15m thick, which contained frequent mortar flecks. This deposit had a laminated appearance and may have accumulated over some time. Deposit 213 was sealed by a thin white lime mortar surface (221) between 10 to 30mm in thickness. A further sandy silt deposit (211) very similar to 213 overlay the mortar surface. This deposit which was at its thickest (0.11m) at its northern extent thinned towards the south. It was cut by a shallow U-shaped construction trench (223) which measured up to 0.14m deep. The trench was filled with a mix of stone rubble and mortar (210) onto which a substantial east-west

aligned stone wall (206) had been constructed. Wall 206 was constructed from squared masonry blocks bonded with a hard white lime mortar. It stood three courses high, with a single masonry block representing the remains of a fourth course. The wall had been rendered with a white lime mortar, traces of which survived over much of the wall and particularly towards its base. The wall extended beyond the limit of excavation and its full length and width could not be recovered. It did, however, display a substantial batter, being wider towards the base. The upper course lay 0.67m below ground level at 8.5mOD.

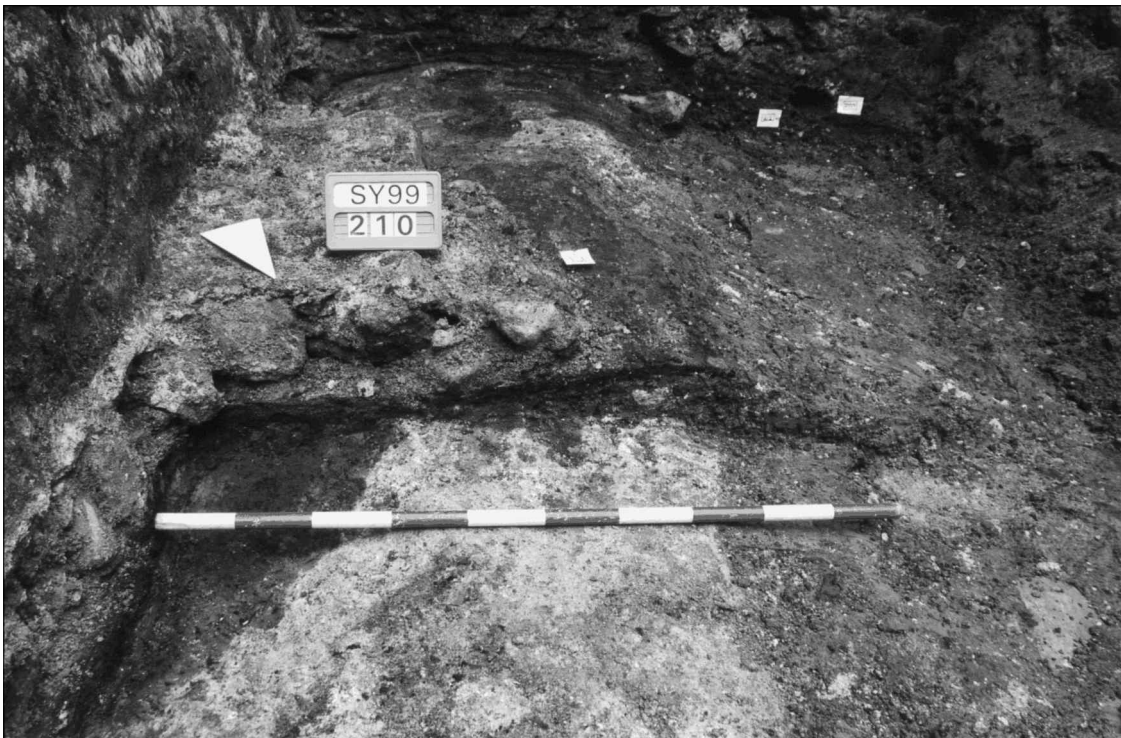
Figure 8 General view of sondages in bottom of Trench 2 (1 m scale)

- 4.10 In the central part of the trench, the southern side of an irregular cut (220), orientated east-west, was seen to cut deposit 211. The feature could not be fully excavated as it extended beyond the maximum depth of the trench (1.5m bgl). At this depth the top of a series of roughly squared stones (222) were revealed, but it was not possible to determine whether they formed part of a wall. The cut feature (220) contained three fills, the basal fill (212) a dark grey-brown silt contained a substantial quantity of stone fragments, tile fragments, mortar and charcoal. The upper two fills consisted of a medium brown sandy silt (209) and a layer of clean yellow sand (217).

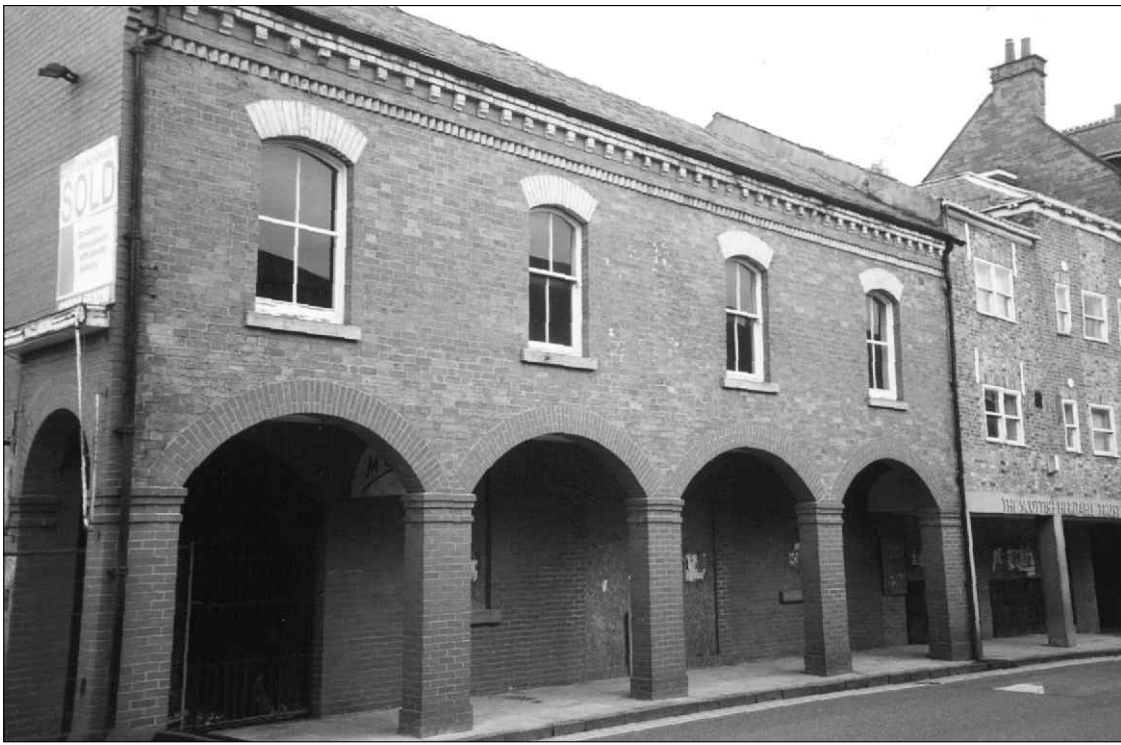
Figure 10 Elevation of 17 Skeldergate (looking east, June 1999)

- 5.5 Number 17 Skeldergate is a two storey brick building with a slate roof (Figure 10). Two single storey structures are attached to the rear, in the space between the main building and Wood's Mill. On the street frontage elevation the ground floor contains no original detail due to the rebuilding associated with the arcade, while the first floor is constructed from machine-made bricks in Flemish Bond. It is pierced by four round headed windows; the window arch comprises a segmental arch of tapered white bricks, while the sills are of sandstone. The windows are balanced sashes. Above the windows is a decorative row of dog-tooth brickwork and a dentilated cornice, both in white brick. No access was obtained to the interior of the building or to the structures to the rear.

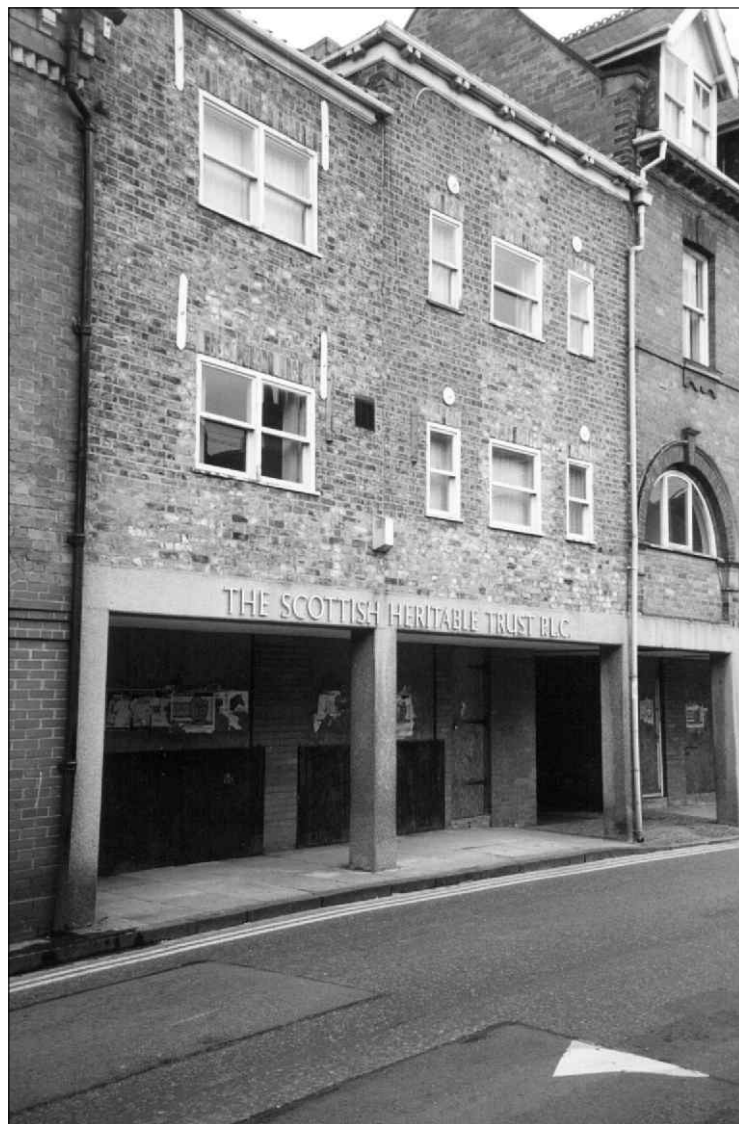
Figure 11 Elevation of 18 Skeldergate (looking east, June 1999)

- 5.4 Number 18 Skeldergate is a three storey building constructed in 18th or early 19th century handmade brick (Figure 11). On the street frontage elevation the brickwork is in Flemish Bond, while to the rear it is in English Garden Wall Bond. No original apertures or fenestration have survived, but a vertical joint on the front elevation shows that this was once two buildings. This joint coincides with a change in the height of the eaves and a change in roofing style; the southern part of the building has a higher hipped slate roof, while the northern part has a lower gabled slate roof. Two different types of metal tie plates are also visible on the front and rear elevations; straight bars with chamfered ends on the northern section and round plates on the southern part. The rear of the building is offset in plan with the southern part extending further east than the northern part. The remains of a stone cambered window head is partly visible on the southern rear elevation, but all further detail has been removed by later openings. Internally, the building had been heavily remodelled and no original internal features could be observed. There was no access to the attic.

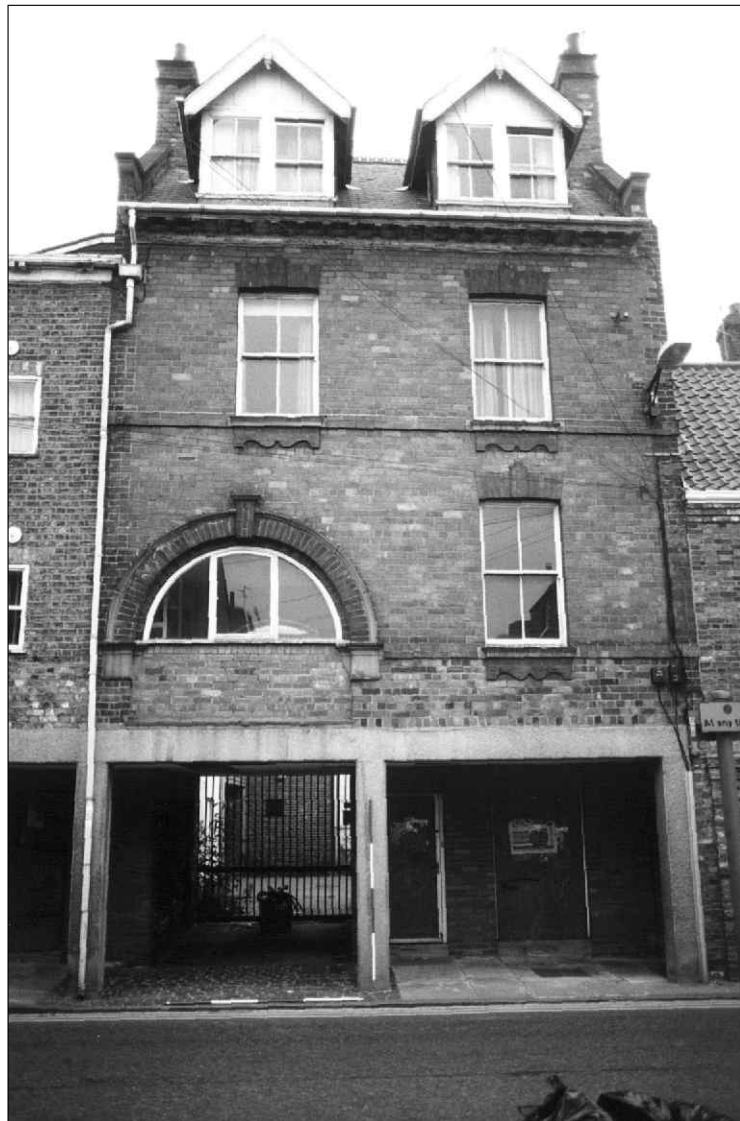
*Figure 12 Street front elevation of 19 Skeldergate
(2 x 2 m scales, looking north-east, August 1999)*

- 5.6 Number 19 Skeldergate is a three storey brick building with a gabled slate roof (Figures 12-13). There are brick chimneys on each gable and the gables are finished with coping stones and stone kneelers. The ridge tiles are decorated earthenware tiles. There are two dormer windows above the eaves on the frontage and a single dormer partly below the eaves to the rear. The front elevation has been completely altered at ground floor level due to the rebuilding associated with the arcade, but a brick arch at first floor level appears to preserve the form of the original opening: a carriage entrance from the street into the rear courtyard. The archway is partially glazed and is surmounted by a stone drip-moulding and broken by a brick 'keystone'. The windows are balanced sashes with moulded/decorated brick sills and lintels. Two brick bands coincide with the sills and false quoins are picked out in darker bricks. On the rear elevation the windows are more irregularly placed and the window heads are picked out in darker bricks. There is a scar across the lower

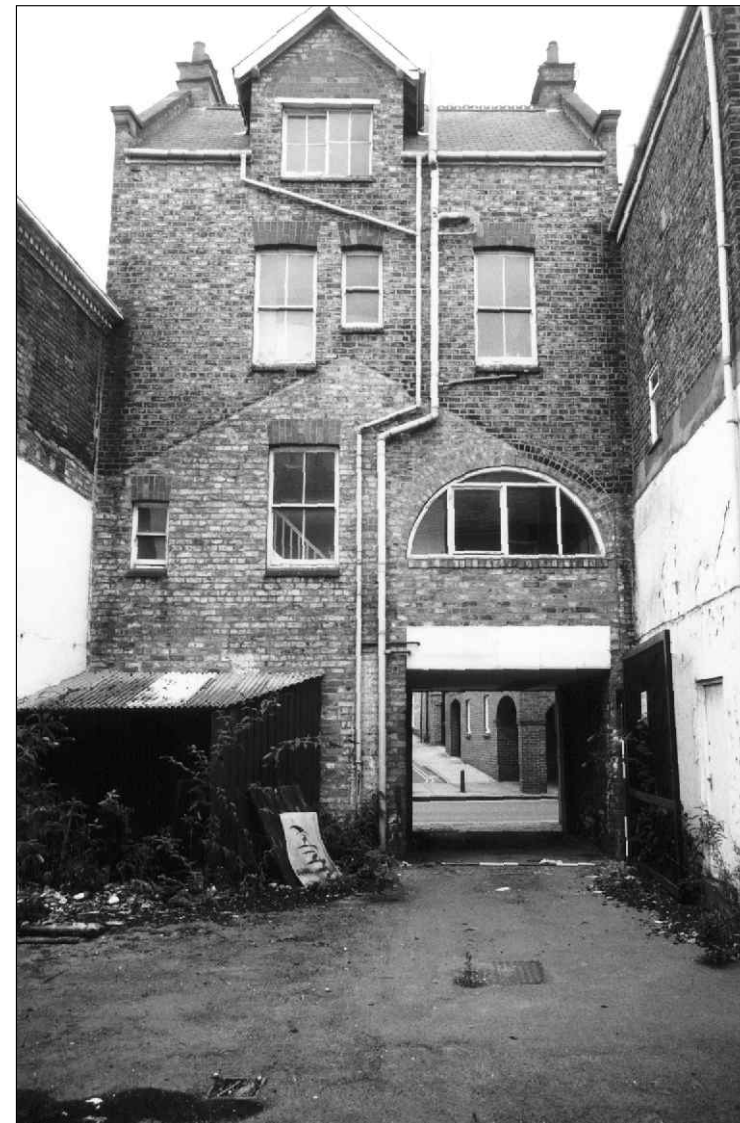
*Figure 13 Yard-facing elevation of 19 Skeldergate
(2 x 2 m scales, looking south-west, August 1999)*

part of the elevation and on the walls of the two adjacent properties which shows that the courtyard was previously enclosed by a tall single storey structure. The pitch of the roof to this structure ran at right-angles to the street. No access was obtained to the interior of the building.
