ARCHAEOLOGICAL BUILDING  
ASSESSMENT AND SURVEY

**BONGATE CROSS,  
APPLEBY-IN-WESTMORLAND,  
CUMBRIA**

Project No.: 1147  
Text: Matthew Town  
Illustrations: Dawn Knowles  
Edited by: Richard Fraser

**ARCHAEOLOGICAL BUILDING ASSESSMENT AND SURVEY**

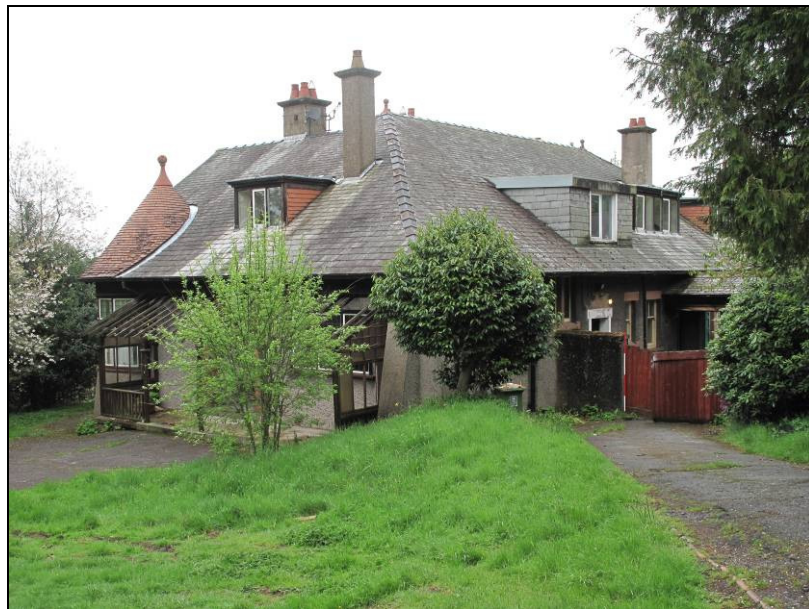
- 1.2 Bongate Cross, built in 1910, is a large house built in the late Arts and Crafts and early Modernist / Arts Nouveau styles. The exterior of the house survives largely unaltered from its construction. The interior has also been little altered, though minor alterations appear to have been made in the 1920s/1930s, and also following its conversion to flats, most probably in the 1960s. Most of its internal features survive. The building is currently being used as flats, mostly unoccupied, and is semi-derelict.

*Plate 1: Bongate Cross, from the east*

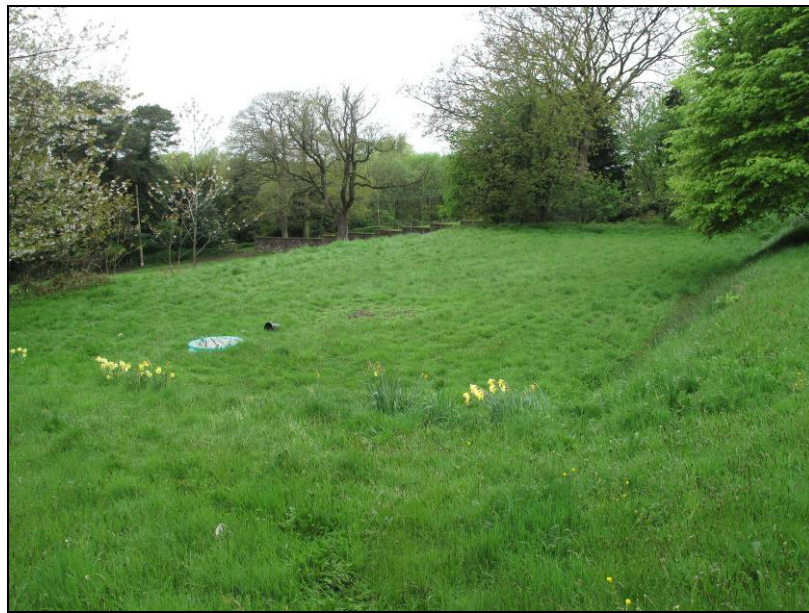
*Plate 2: tennis court to west of house, facing north*

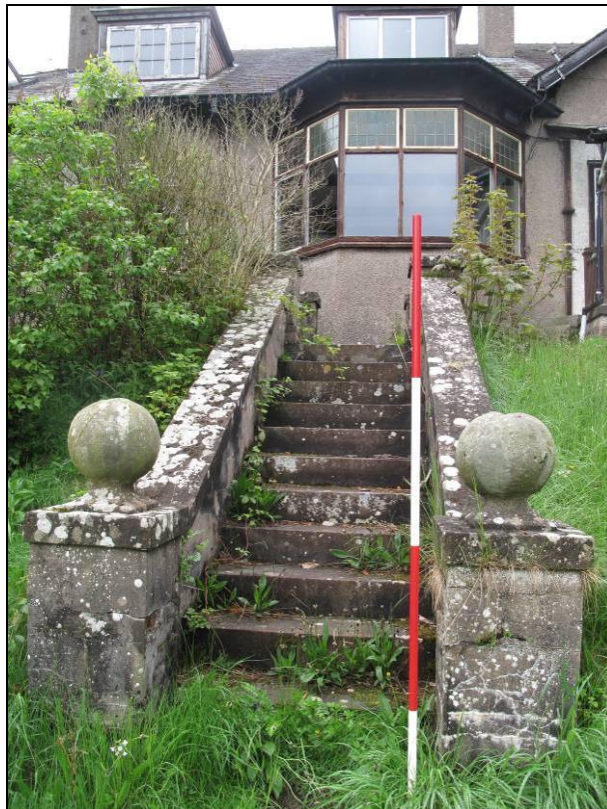
- 3.1 Bongate Cross lies about 100m north-west of Cross Croft, now located to the rear of a modern bungalow called Bongate Bank. Access to the house is from a drive off a short lane which leads to the Appleby Mortuary House. The drive leads to the front of the house, with a smaller footpath leading to the courtyard to the north-east of the house. A further drive now leads along the edge of the north-eastern boundary to a modern garage to the rear of the property. The grounds are mature and include a greenhouse against the northern boundary, and an overgrown tennis court west of the house (Plate 2). A staircase leads down from the west side of the house to the tennis court, built of brick with a cement render. Apart from the tennis court, which probably dates to the 1970s, these features are all contemporary with the house.

Plate 3: stairs leading down to the garden from the house

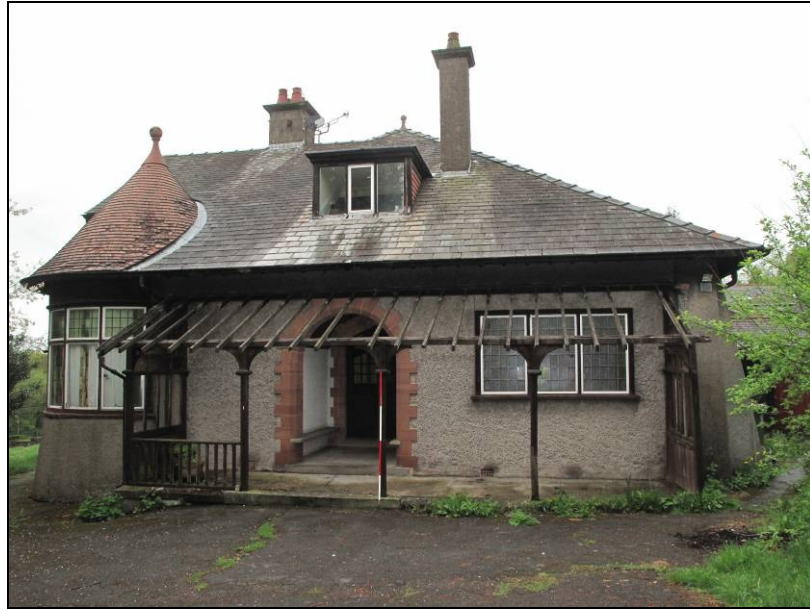
*Plate 4: south-east elevation, Bongate Cross*

- 5.3 The building was designed to be viewed from the south-west and south-east sides (Plates 4 and 5), with the result that the elevations on the north-west and north-east sides are much plainer and of a different design. The windows in both south-facing elevations deliberately vary, but retain stylistic links through their design (Plate 6). The main window utilised is a metal-framed side opening casement, set within a timber frame and divided into three by timber mullions, with each window comprising thirty rectangular leaded lights. This design is used for Rooms 1 and 10, and is varied slightly for Room 9 with the addition of three large plain lights above the standard window. At the centre of the south-western elevation is a large angled bay window, lighting Room 4, with three faces separated by timber mullions. Each face is divided into four sections by a timber frame. The lower two sections comprise metal framed side opening casement windows with a single pane of glass, whilst the upper sections comprise fifteen rectangular leaded lights, with some random coloured (blue and yellow) panes evident, though these have now faded. This style is replicated in the windows for the tower, lighting Room 2, which also includes two small timber framed windows at the base to light the cellar (Plate 6). Along both the south-eastern and south-western elevations are a series of small square ceramic vents, also very much of Arts and Crafts style, with a complex lattice design.

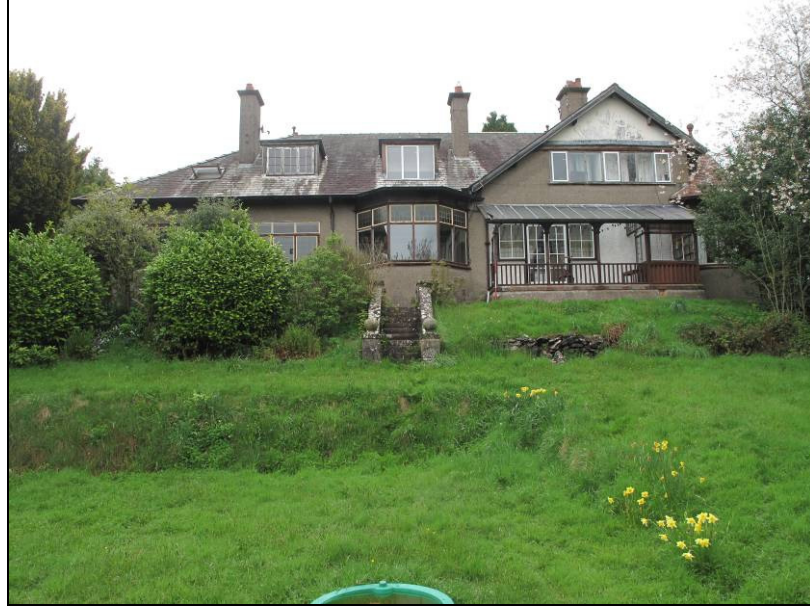
*Plate 5: south-west elevation, Bongate Cross*

- 5.2 The house appears brick-built, though the exterior is covered in roughcast which makes clear identification of this difficult. The roughcast appears to be contemporary with the construction of the house, as the outbuildings and courtyard walls are also covered in the same mix. Local red sandstone has been used for the window sills and door surrounds, particularly on the north side. The house has a hipped roof with a western gable return at the south end, and is entirely covered in welsh slate, with glazed ceramic ridge tiles. The gable end is only part covered in rough-cast with the upper portion painted, and the eaves of the gable have projecting purlins. There are five chimneys, all rendered with red ceramic pots, set within the roof-slope and projecting above the ridge line. The ridge line includes two finials or pommels at each end. At the south corner of the house is a stylised rounded tower, with a conical roof in red ceramic tiles, topped with a further finial or pommel. There are seven dormer windows lighting the upper floor. Each dormer is flat-roofed and covered with lead sheets, with the side walls covered in red ceramic tiles, mirroring the roof to the tower. The exception to this is the dormer for Room 26, which is much larger, and covered in grey slate. All the dormers have plain side-opening casement windows in timber frames, divided into three lights by timber mullions. The windows appear to have been replaced, though the windows for Room 21 may be original, and comprise side opening casement windows with six panes set in timber glazing bars, again divided into three lights by timber mullions. The rainwater goods are cast iron and appear contemporary with the house.

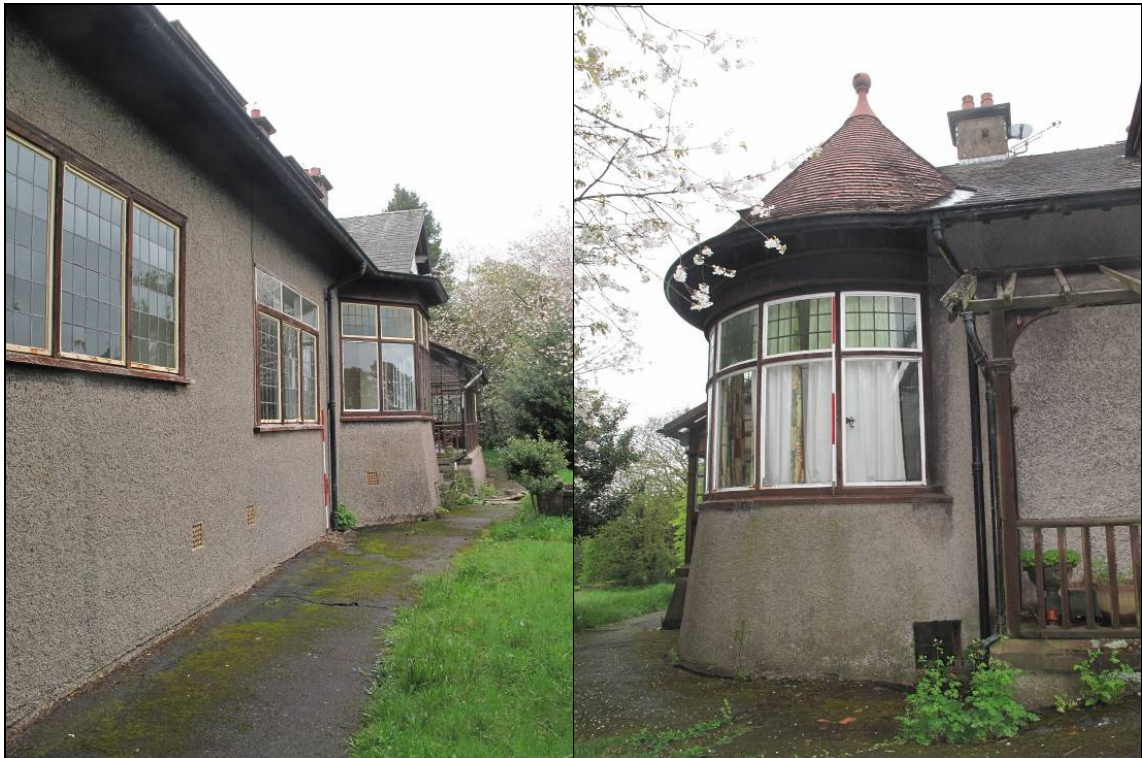
*Plate 6: windows in south-west facing elevation, facing east, and the corner tower, facing north-west. Note the small window at the base of the tower.*

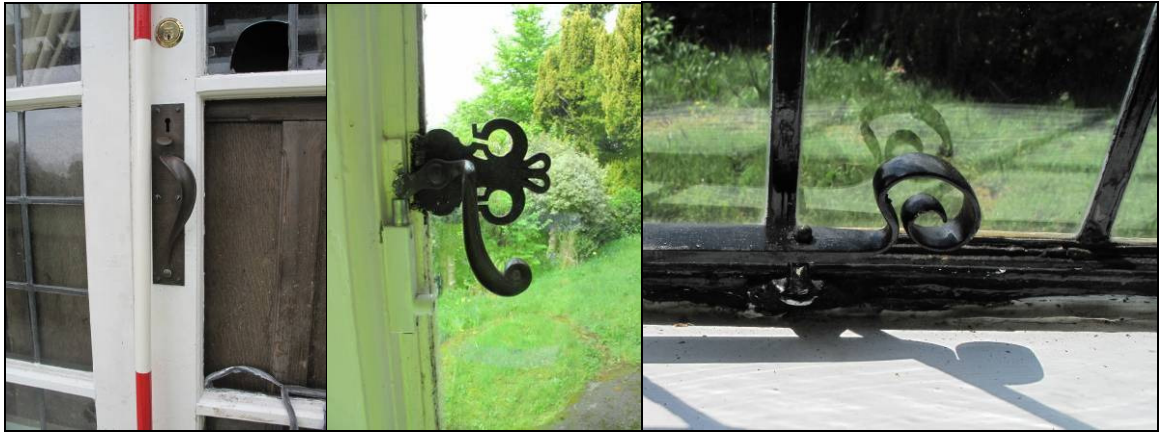
are flanked by two metal-framed windows, divided into four sections, with nine rectangular leaded lights to each section. All the windows have profiled timber sills. All the window catches for the windows in these elevations have elegant curves, very much of an Art Nouveau style, and this fluidity of design extends to the door handles of the French Windows (Plate 7) and also the main door itself (Plate 8).

Plate 7: detail of door and window catches: veranda, Room 2 and Room 9 (left to right)

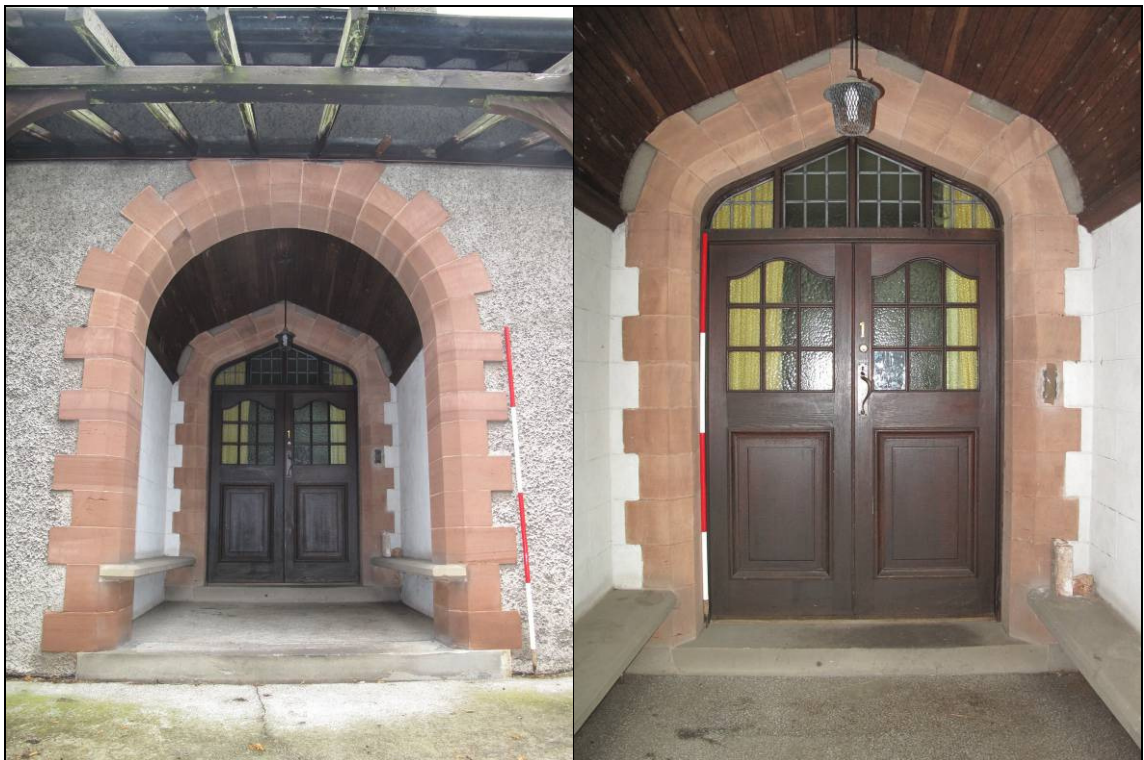
Plate 8: the porch and front door, facing north-west

- 5.5 The front door to the house lies in a porch set back from the south-east facing elevation (Plate 8). The entrance to the porch has a rounded arch and is framed by ashlar quoins of alternating length, reminiscent of a Gibbs surround, made of local red sandstone. The edges of the surround are chamfered. The detail of the porch entrance is replicated around the door, but the arch is pointed;

there is a bell push within this arch, which appears to be contemporary with the house. The side walls of the porch comprise ashlar blocks of equal size and shape, laid in equal courses to those within both arches. The walls are painted white. Set within the walls are two stone benches, which run the length of the porch from the main door, and are set into the exterior porch arch. The benches also have chamfered corners. The floor of the porch appears to be concrete with a quartz aggregate giving a marble-like finish. The ceiling is covered with birch cladding, nailed onto a support frame of ribbing which is not visible, but can be deduced from the lines of nails. There is a Bakelite light fitting over the porch. The front door is a double door, made of oak, with indented bottom panels and glazed top panels in both doors; the glazed panels have nine panes held by wooden glazing bars. The top panel has an arched detailing which mirrors the arch over the door, and the door handle is identical to that on the French Windows. The door head is divided by mullions into four sections, with nine leaded lights in the central two sections, and five in the outer sections, where the arch slopes down. The doors and porch are contemporary with the house construction.

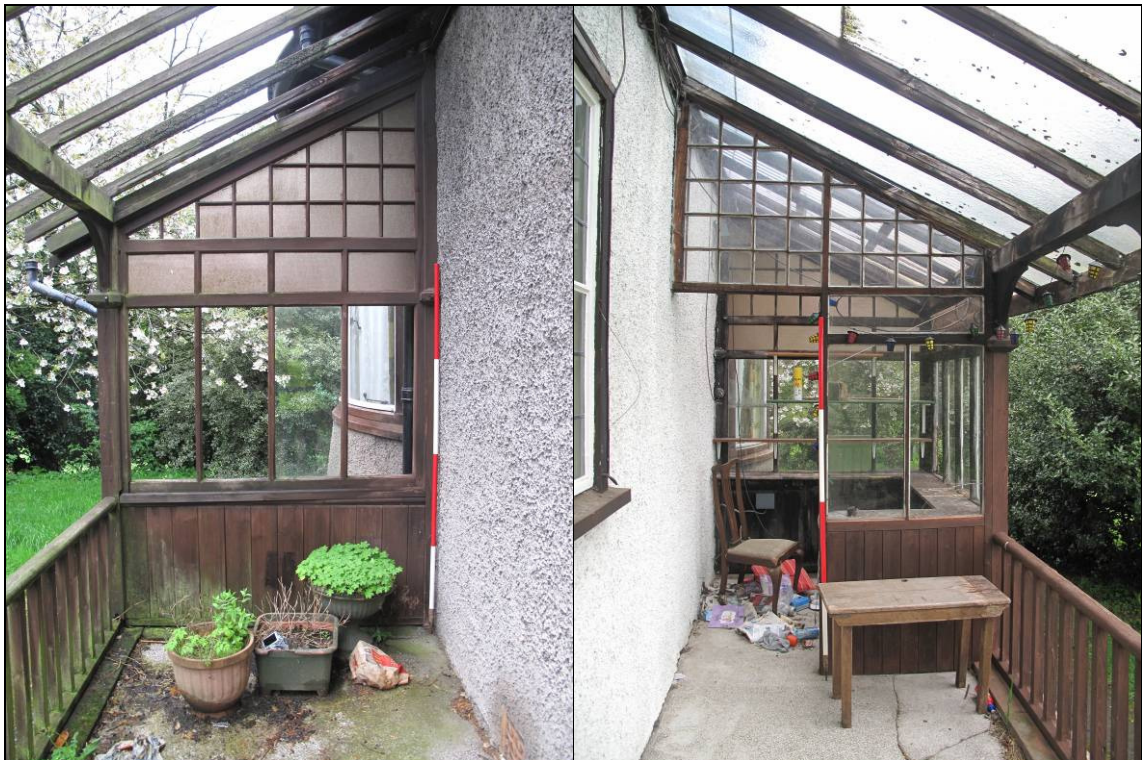
*Plate 9: western panelled section of south-east trellis (left), and potting shed in south-west trellis (right)*

- 5.6 On the south-west and south-east sides are two verandas, of similar build and also contemporary with the house, built very much in an Arts and Crafts style (Plate 9). The bases of the verandas are made of concrete with similar quartz inclusions to the porch. On the south-west side, the veranda is positioned to occupy the space between the projecting bay window and the tower, whilst on the south-east side; the veranda extends from the tower before graduating into the edge of the slope. There are steps leading down from the veranda on the south-west side. The verandas support a

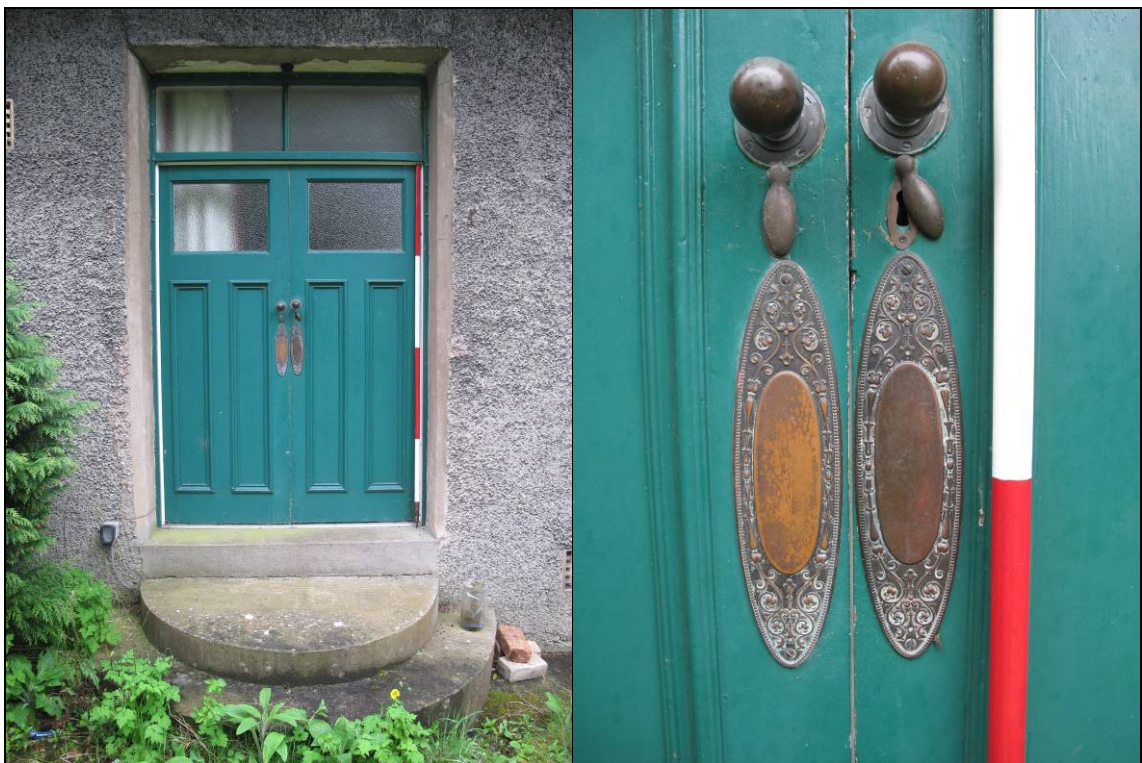
- 5.7 The north-west facing elevation, by contrast, is entirely plain, and contains no windows or decorative features, apart from a central double-door (Plate 10). This connects to the main corridor, and served as the formal back door to the property. Each door has two vertical rectangular recessed bottom panels, which mirror the doors in the interior (see below), and a glazed top panel with frosted glass. There are also two rectangular panes of glass in the fan-light. In contrast to the front door, the back door furniture is much simpler, with plain rounded brass door knobs and covered keyholes. The sole extravagance is the two ornate oval door push plates, with a delicate floral design and plain central oval, which is very much in an Arts and Crafts style. At the base of the door are two rounded door steps.

Plate 10: the back door (left), with detail of the door handles and door push plate (right)

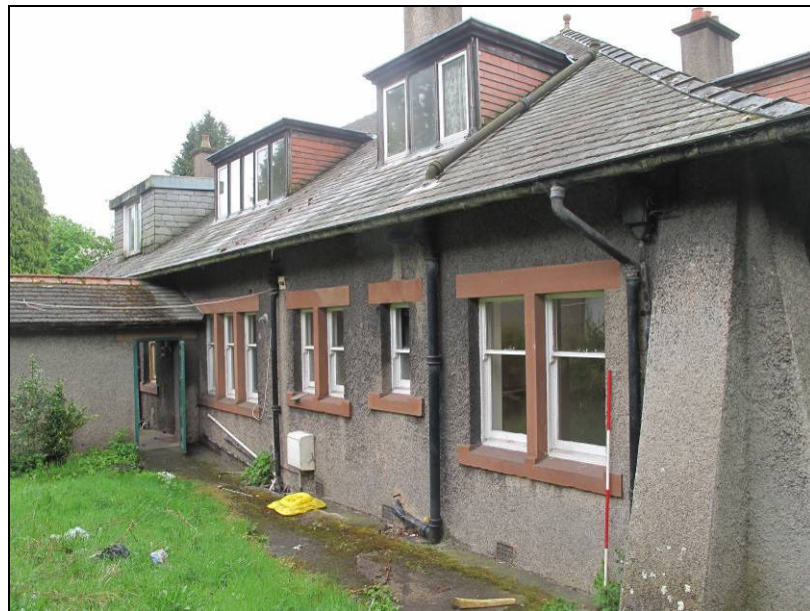
- 5.8 The north-east facing elevation is by far the most ‘functional’ and corresponds with the use of this side of the house for domestic activities by servants; it is also the side of the house which accommodates the toilets and bathrooms. There are two doors in this elevation, both within the courtyard area, and both serving as ‘tradesmen’s entrances’ for the house. The door which leads into the kitchen (Room 8) has the same vertical rectangular recessed bottom panels as the back door in the north-west elevation, with the top panel comprising six square glass panes held by timber glazing bars. The door furniture includes the wedge door handles which are visible throughout the interior (see below), and the same brass keyhole covers as are visible on the back door. In contrast, the other door in this elevation is much simpler, and is almost plank-built, though the upper half comprises vertical rectangular recessed glazed panels which echo the design elsewhere. This door leads to the hall, which leads to the back stairs.

- 5.10 The vents along the base of the elevation are all plain in comparison to those on the other elevations.

*Plate 11: the windows in the north-east facing elevation*

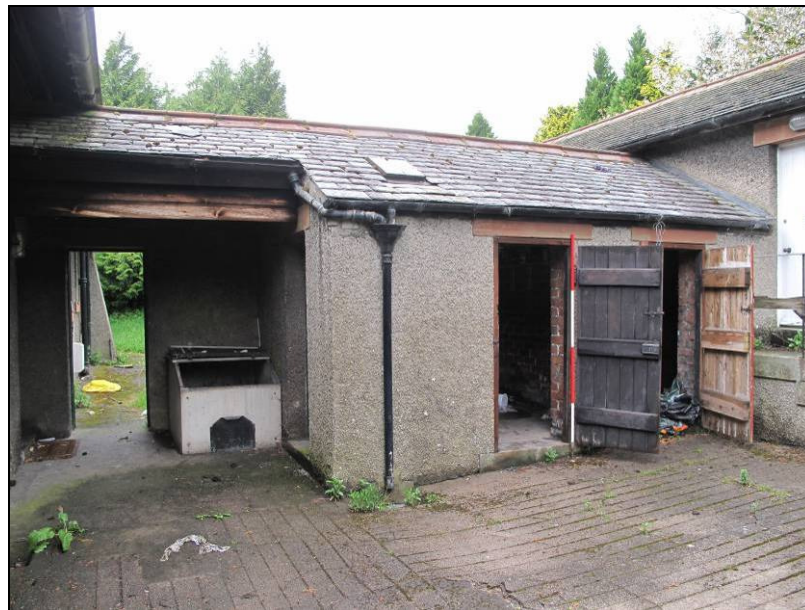
east courtyard wall, and a small door in the north-west wall, adjacent to the kitchen access; these are all plank-built. The north-west range of this complex comprises two sheds, both with plank-built doors, with cast-iron door latches and wide hinges (Plate 12). The doorways have ashlar lintels above the door, identical to those in the north-east facing elevation of the house, but the interiors are otherwise featureless, with brickwork in English Garden Wall Bond, and exposed rafters. At the south-eastern end of this range is an outdoor toilet, which has had the fittings replaced probably in the 1970s (the brackets for the original water cistern survive on the wall). The toilet has Bakelite light fittings, of 1950s date, with a pendant light fitting attached to an exposed beam. There is a single leaded skylight illuminating the toilet.

*Plate 12: north-west range of the courtyard*

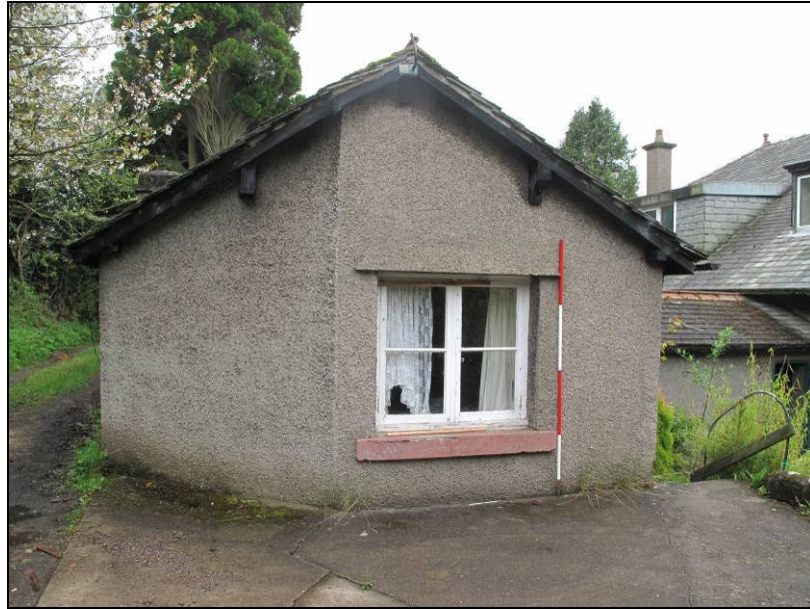
- 5.13 At the northern corner of the courtyard are stairs leading up to the access door to the house-keepers cottage. There is a further door in the south-west facing elevation, north of the courtyard, also with stairs leading up; the doors are all plank-built with brass door-knobs; the lintels are ashlar sandstone blocks, in the same style as those in the north-east elevation of the house. The doors have been sealed up due to vandalism, and therefore access was not possible. It was not possible to fully assess the interior from the windows, though the cottage appears to have three rooms. There were windows

in the north-west and north-east elevations. The north-east facing windows are identical to those in the north-east facing elevation of the house, with double lights; the north-west facing window is a timber side opening casement window with a similar surround. The northern corner of the house is angled, perhaps to facilitate vehicles turning the corner, which may imply that vehicles were parked in that area.

*Plate 13: shaped corner of the house-keepers cottage*

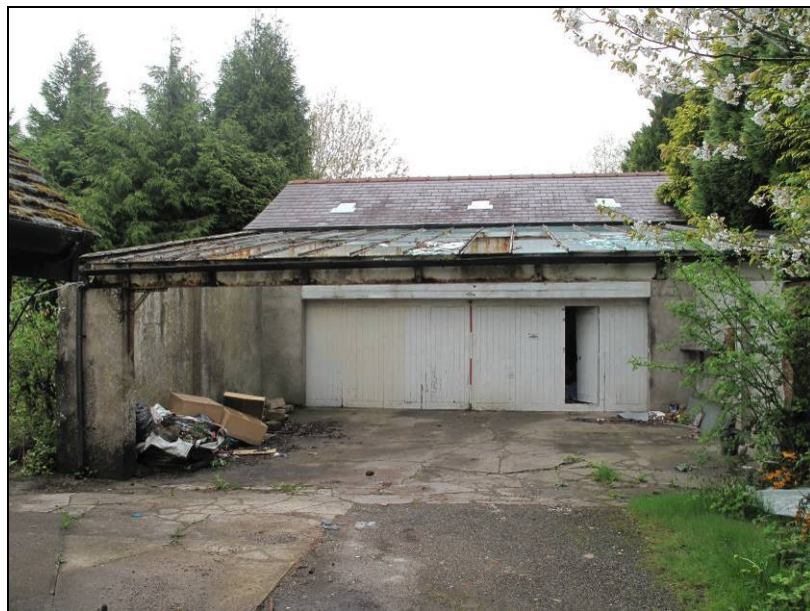
*Plate 14: modern garage*

- 5.14 North of the house-keepers cottage is the location of a modern garage, seemingly built in the late 1960s. The garage is constructed of brick with a cement render, and has wide folding plank-built garage doors. The roof is of Welsh slate, with red ceramic ridge tiles. There is a modern lean-to, to

the south-east of the building. Both brick side walls of the lean-to support an iron-I-beam, with a glazed sloping roof above. The interior of the garage is open, with exposed trusses and beams in the roof, and a row of three sky-lights along the south-east side of the roof. The garage has Bakelite electrical fittings, and markings on the wall indicate the different bays allocated to each flat.

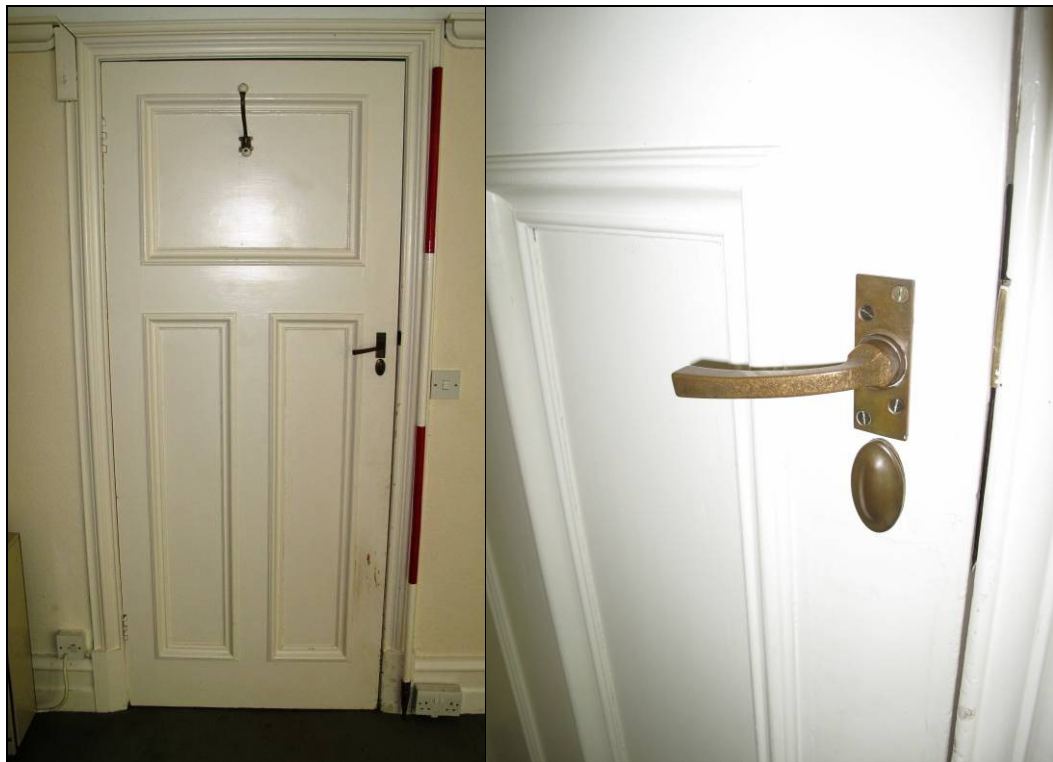
Plate 16: standard door (left) with detail of door handle (right)

which appear to survive through much of the house, but may be a later (1930s) alteration. There is isolated survival of brass door-knobs in some rooms of the house (for example, Room 14 cloakroom interior), and it is possible that these are the original Edwardian door handles which were replaced after the death of the original owner. Some of doors also include brass hooks with a dog-tooth design on the back (Room 2, Room 14), which may be original.

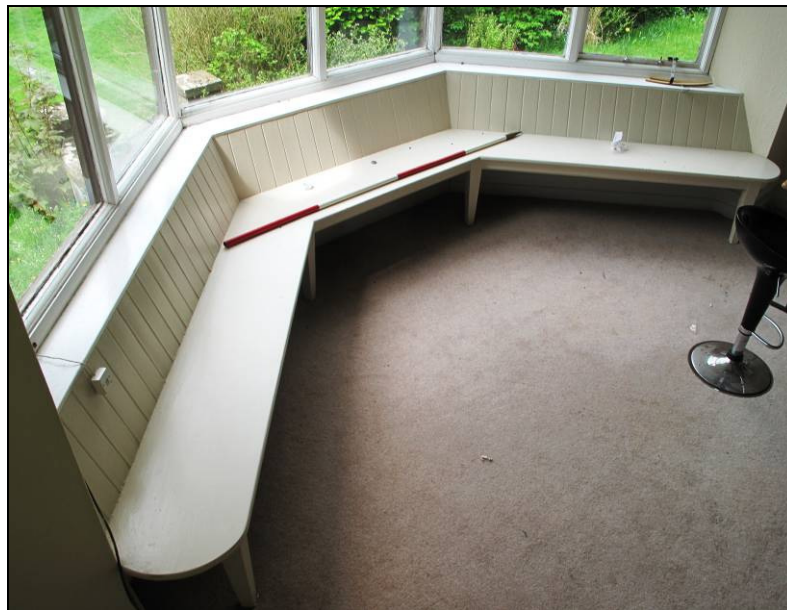
- 5.18 Rooms 1, 2, 4, 9 and 10 all include windows benches, designed to allow the occupants to sit and look out over the garden. The benches are all constructed of white painted timber sections, and are integrated into the construction of the windows, with the upper sections corresponding with the sills of the windows themselves. The backs of the seats are steep and flat, and angle sharply into the seat, which is either integrated into the wall, if the benches are straight (in the case of Rooms 1, 9 and 10), or are supported by small tapering legs, if the benches are curved or angled (Rooms 2 and 4). The use of benches is typical of Edwardian houses of Art Nouveau style, perhaps best illustrated by Charles Rennie Mackintosh's design for Hill House, Helensburgh, which includes these.

*Plate 17: bench seat, Room 4, facing west*

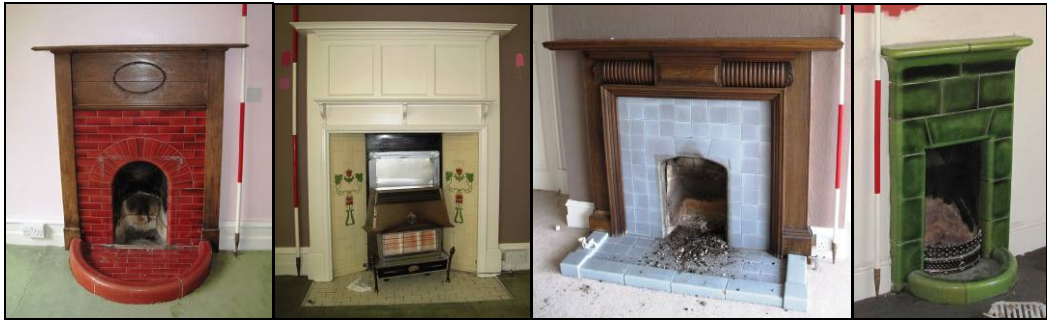
- Type 2: square backed fireplace with tiled sets in Art Nouveau style, and tiled base. High-back oak fire surround with shelf and rectangular recessed panels.
- Type 3: heavy oak mantle-piece, and tiled fireplace, with rectangular hearth with raised edging.
- Type 4: glazed tile round hearth with raised edging, with mantle-piece also made of glazed tiles.
- Type 5: modern fireplaces – mainly 1960s or 1970s. Most of these are not described but are clearly different in design, typically stone clad, or are glazed tile surrounds for gas fires.

Plate 18: Types 1, 2, 3 and 4 fireplaces (from left to right)

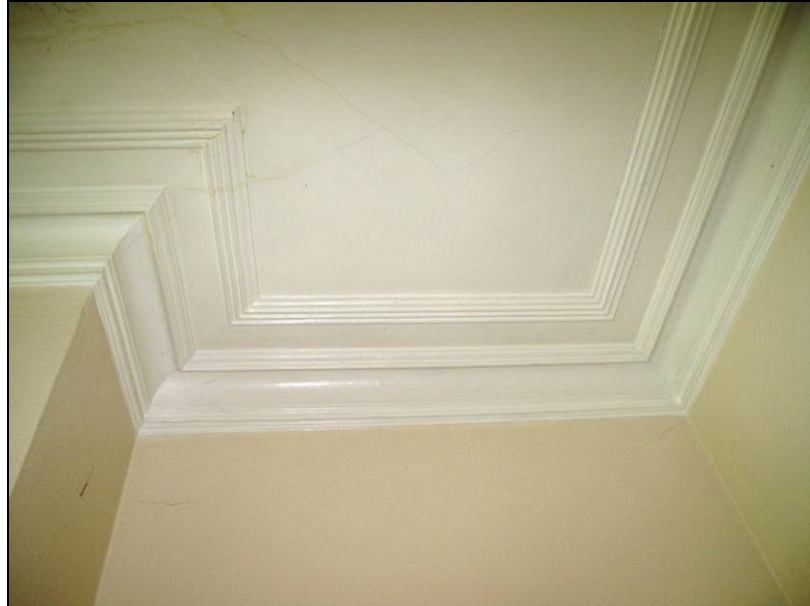
of detail along the edges and extending onto the ceiling itself. The moulding is typically Edwardian in style. None of the functional rooms (bathrooms, and kitchen, for example) or any of the upper rooms have any coving or moulded detail around the ceilings. The walls and ceiling all appear to be plastered; the walls may originally have been wall-papered.

Plate 19: detail of coving, Room 1

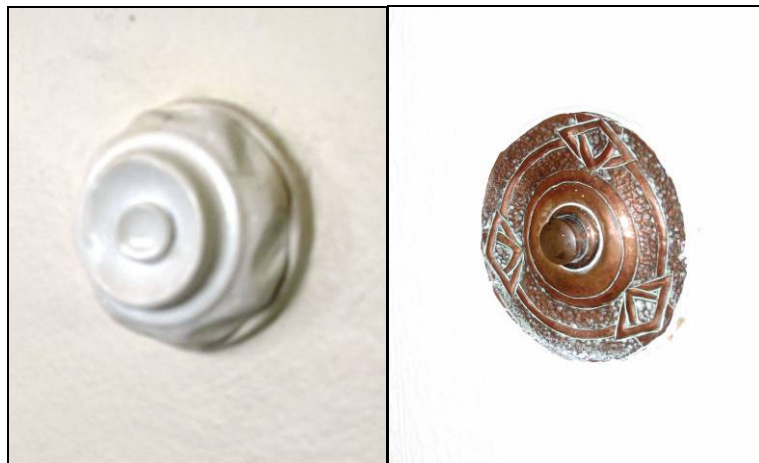
Plate 20: bell pushes (1910, left, and 1930, right)

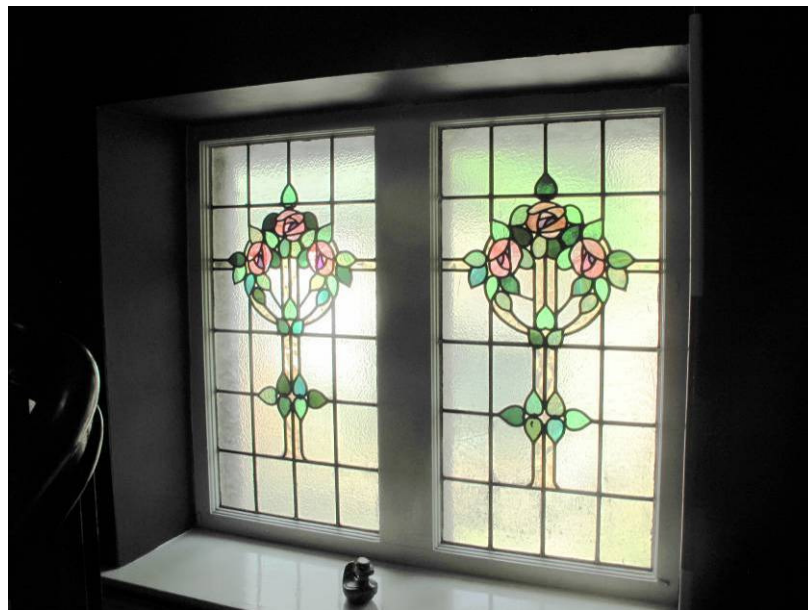
*Plate 21: stained glass window on main staircase mezzanine landing*

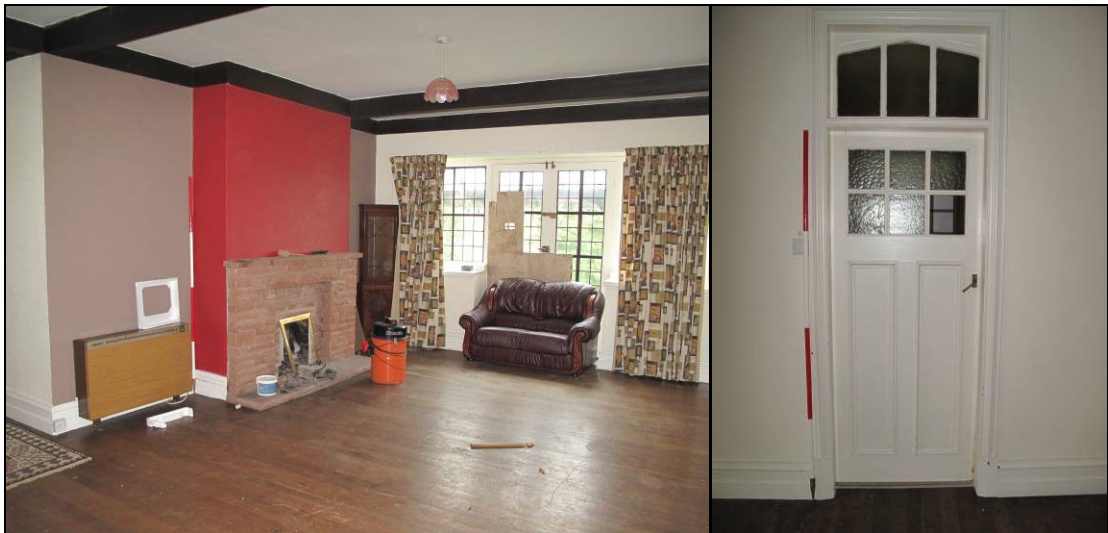
- 5.25 The hall leads to a single door opposite the front door (Plate 22), with vertical rectangular recessed bottom panels, and six glazed square lights in the top panel. The glazed door head has arched lights, which mirror the detailing in the front door. This door would originally have lead to the central corridor, but the walls in this area have been altered to create an additional room (Room 5) which utilises part of the space originally occupied by the kitchen (Room 8) and corridor. To the right of this door is a further door (standard door) with a later (modern) door handle, which leads to a small

- 5.26 The hall turns to the left and opens out into a wider annexe area, with a large fireplace on the south wall (Type 5 - the early fireplace would originally have been quite substantial). The arrangement of the hall appears not to have been a later alteration. In the west wall are the French Windows which lead to the veranda on the south-west side of the house. The layout of the room suggests this space may have served as a billiard room; the heavy wood in the design was seen as a very 'male' attribute, and billiard rooms often open out onto the garden, to avoid disturbance to other members of the household (Muthesius 1979, 222-3).

Plate 22: hall annexe (left) and detail of door to corridor (right)

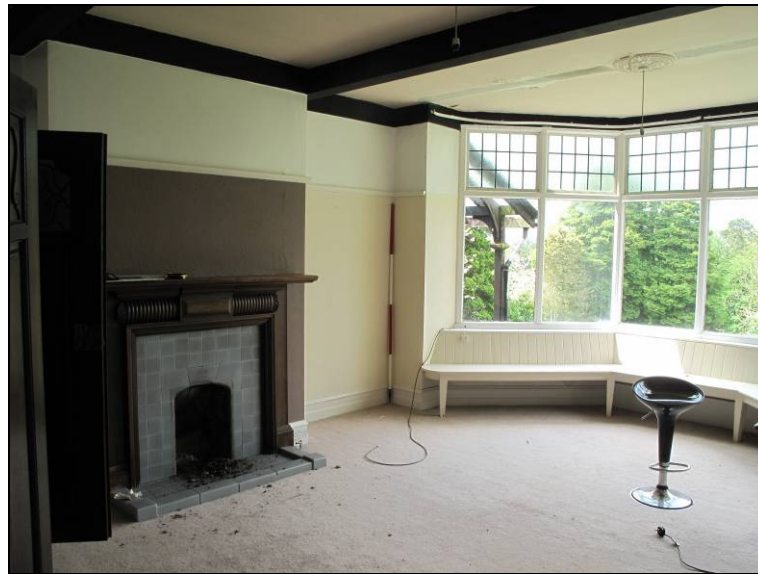
- 5.29 Room 4 is likely to be the drawing room ('White Room'). The drawing room was typically located in the south-westerly side of the house for the sunlight and views of the garden, and was a space for the residents of the house to gather and talk. The room includes a bench seat in the bay window, and is carpeted with a heavy modern carpet. The room has similar beam details to the hall (Room 3), in place of the more ornate coving elsewhere, and includes two ceiling roses, one over the centre of the room, and the second over the bay. It has a Type 3 fireplace with a mantle in dark wood (Plate 3).

*Plate 23: the drawing room, facing south*

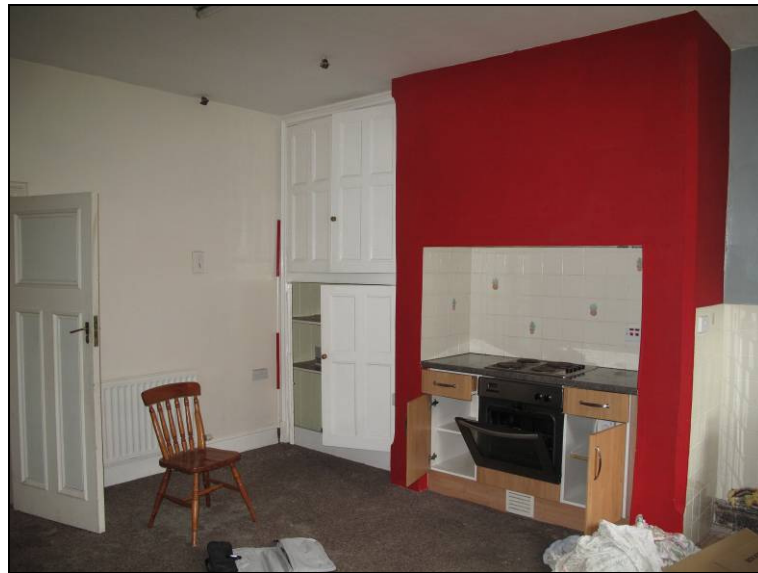
for a clothes airer, probably a post-war feature. The south-east wall appears to be a modern insertion, and originally the room would have included Room 5, to the south-east. The fireplace may originally have held an Aga, as this appears on the list in the circuit box for the house (Plate 15). There is a door to the outside courtyard from this room (Section 5.11).

Plate 24: the kitchen, facing west

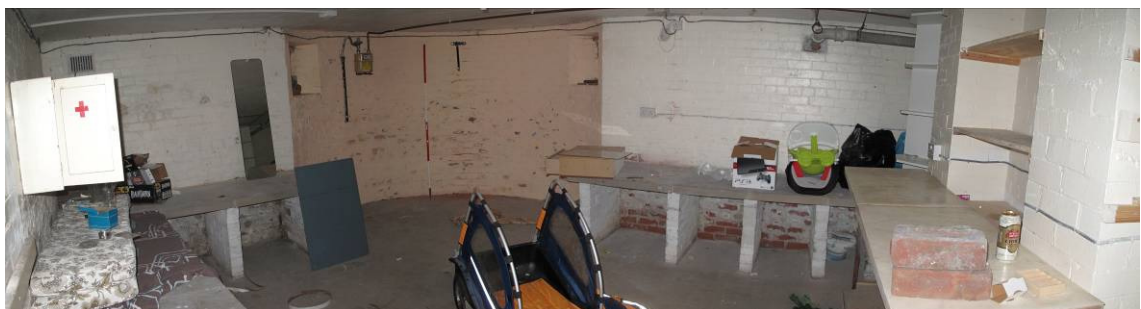
Plate 25: Room 30, cellar

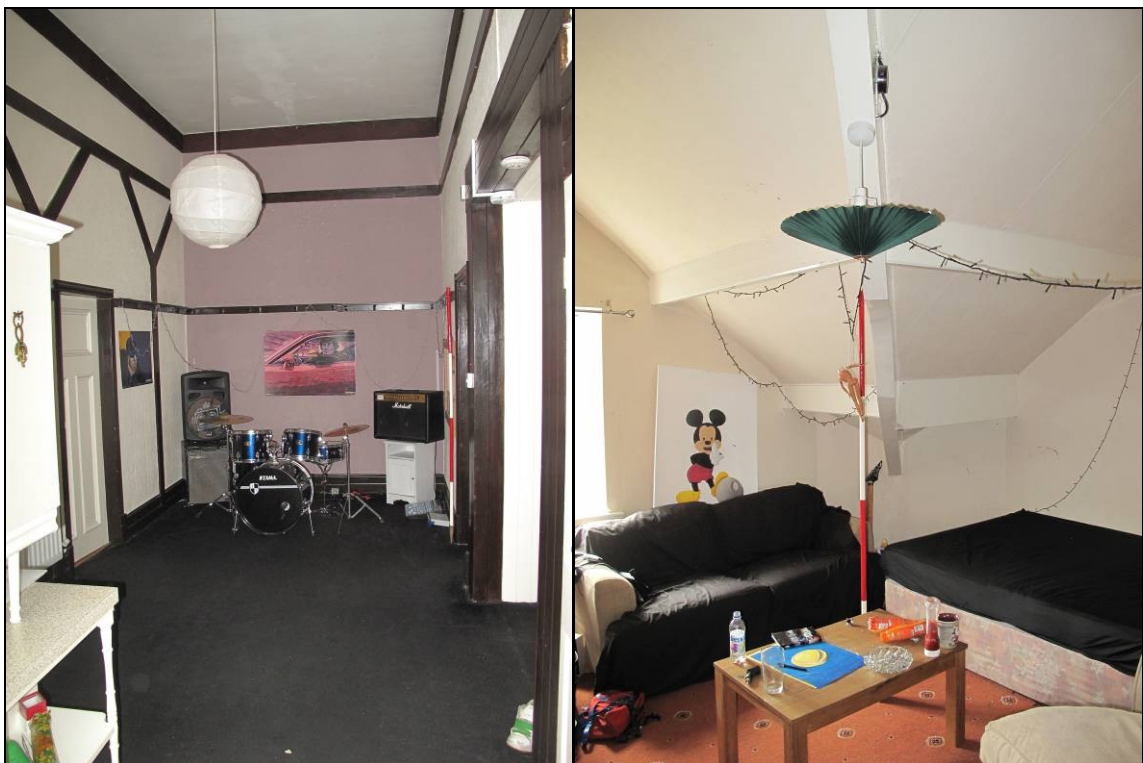
- 5.37 The two rooms facing the stair, Rooms 23 and 24, appear to be the master bedrooms, and are uniform and identical. Room 23 has a Type 1 fireplace, and standard doors with modern handles. The room is carpeted, and there are exposed beams in the corner formed by the construction of the west-facing gable (Plate 21). Room 24 echoes the arrangement of Room 23. The fireplace appears to be a modern Type 4 replacement, albeit in period style. Room 26, opposite, perhaps served as a dressing room or perhaps a bathroom, as it has no fireplace, and is wide and well-lit. Room 27, now converted to a bathroom, has exposed beams in the corner and no windows, but accessed via a standard door. This may have served as a wardrobe or store room.

*Plate 26: exposed beams on the landing (left) and in Room 23 (right)*

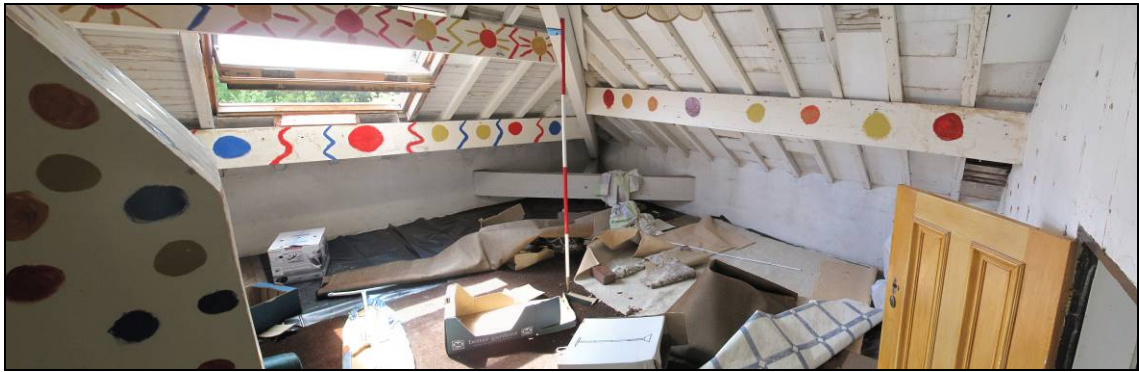
- 5.40 In the west corner of the house is Room 20, which appears to have served as a store room (Plate 27), and is accessed by a small half door. The exposed purlins, trusses and rafters of the roof are visible, and a modern skylight window has been inserted into this space. A boxed-in flue pipe is visible against the south-east wall.

*Plate 27: Room 20, facing west*

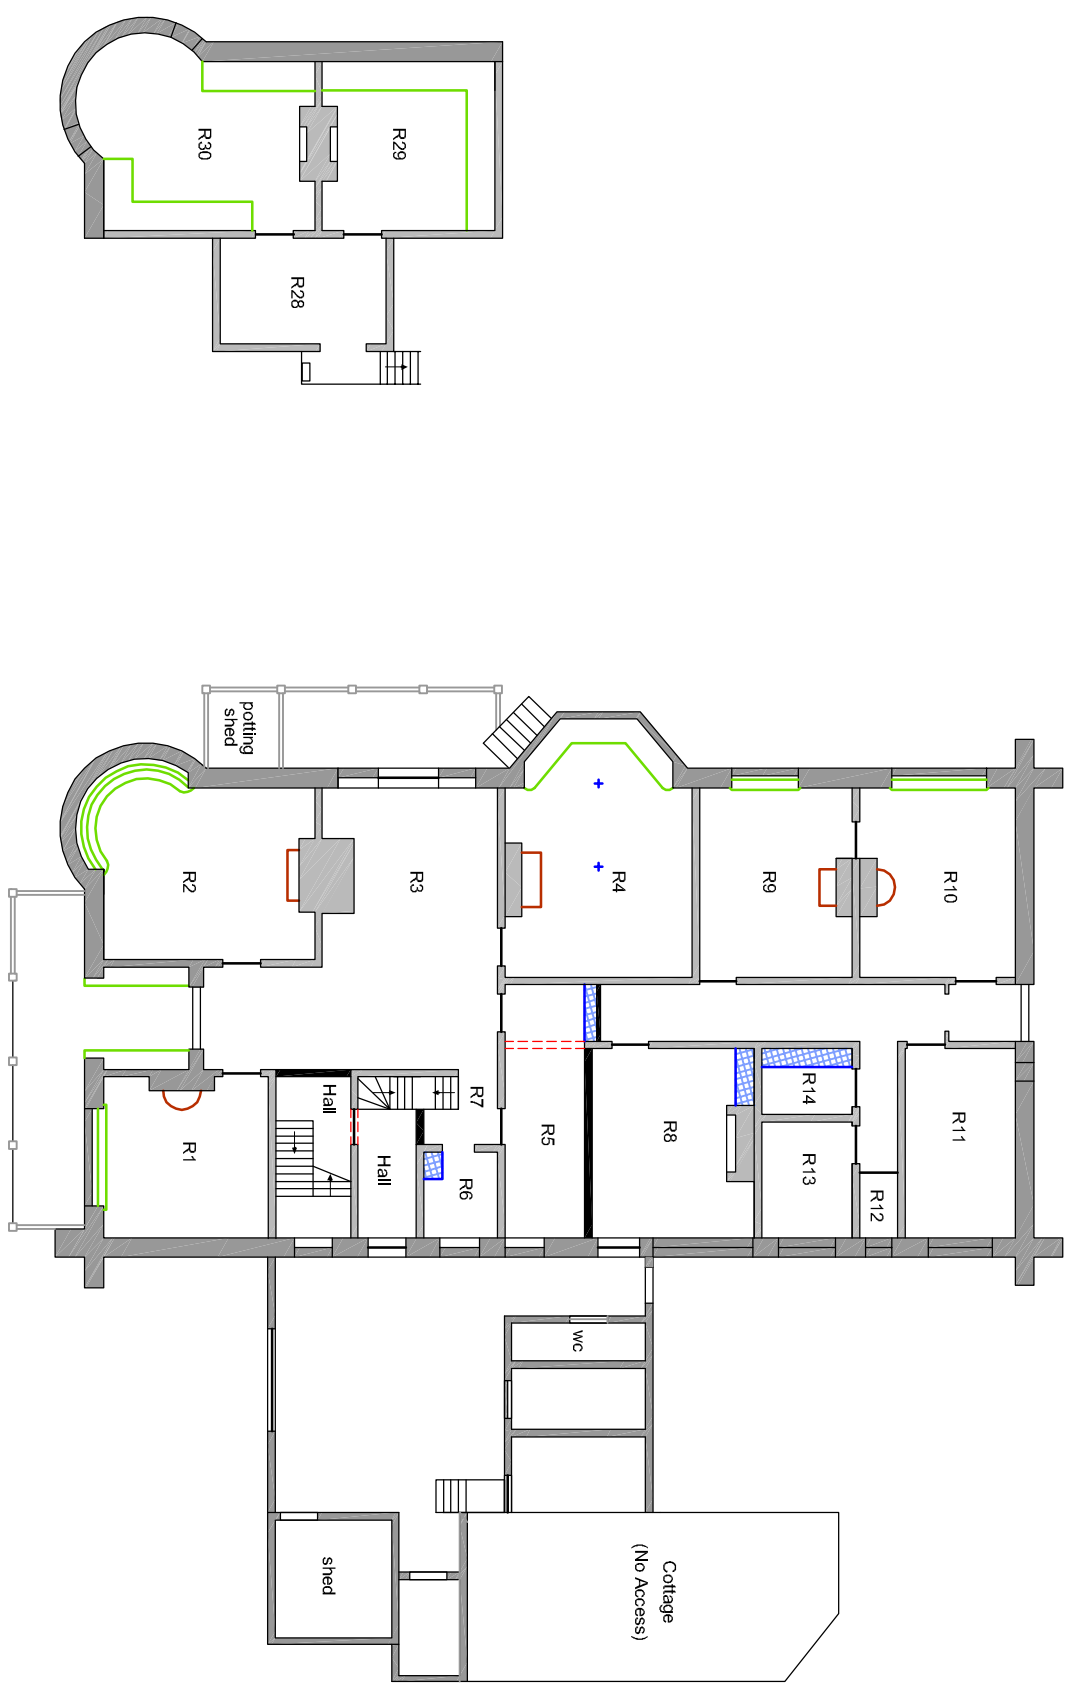
First Floor

- KEY
- bench
  - cupboard
  - blocking wall
  - former wall
  - fireplace

- 2.2 As a Level 2 survey, a detailed metric survey of the house was not required, though a measured floor plan of the interior of the house was produced as requested (Figure 6).
- 2.3 An external and internal photographic record was made of the building using a digital SLR camera at a resolution of 10 megapixels. All photographs were taken from vantage points as near parallel as possible to the elevations being recorded. The photographic record included general views of the rooms - looking from all directions - as well as detailed shot of representative examples fixtures and fittings (windows, doors etc.). A catalogue of all unedited and edited images has been submitted with this report as part of the archive. Each photograph contained a graduated photographic scale of appropriate dimensions.
