## HATFIELD COLLIERY, STAINFORTH, SOUTH YORKSHIRE

## AREA 4

## **ARCHAEOLOGICAL EVALUATION REPORT**

NAA 06/135

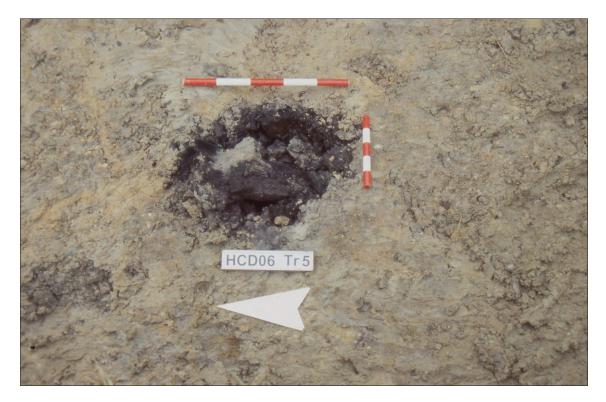
Plate 1 Remains of tree trunk preserved within matrix of alluvial deposit 501

6.6 Trench 5 was aligned north to south and measured 40m long by 2m wide. Late Devensian basal sands (502) were encountered at a maximum depth of 0.9m below ground level. These deposits were overlain by a grey brown silty clay alluvial deposit (501) up to 0.45m thick. A dark brown clayey top soil (500) up to 0.4m thick sealed all deposits. A palaeo-channel aligned south-east to north-west, cut into the late Devensian sands (502) and filled with alluvial material (202), was recorded in the south end of the trench. A scour hollow, measuring approximately 5m across, was also recorded within the trench The hollow was found to be in-filled with alluvial deposits and the remains of a short length of oak tree trunk were preserved within the matrix of the alluvium (501) (Plate 1). No archaeological features or deposits were encountered in trench 5 and no artefactual material was recovered.

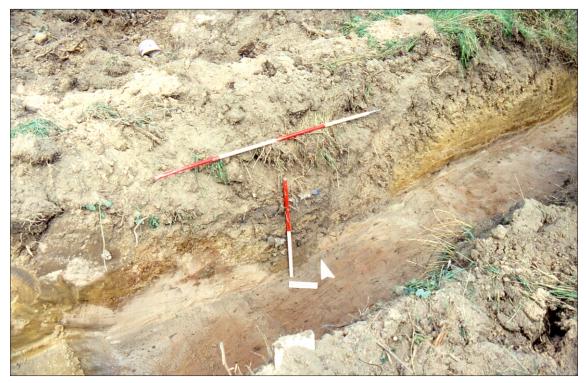
Plate 2 Bank and ditch field boundary recorded in section of trench 13

6.14 Trench 13 was aligned approximately north-east to south-west and measured 40m long by 2m wide. Late Devensian basal sands (1305) were encountered at a maximum depth of 1.05m below ground level. These deposits were overlain by a grey brown silty clay alluvial deposit (1304) up to 0.75m thick. An upstanding bank and associated ditch representing a former field boundary aligned approximately north to south, were recorded in the section of trench 13 (Fig. 3, Plate 2). This bank is depicted on both the Stainforth Enclosure Map of 1824 and the First Edition Ordnance Survey map (1854). The bank (1302) (Fig. 3, section 1), survived to a height of 0.5m and measured 3m across and the bank material was composed of a mid brown clayey silt. To the west of bank 1302 an associated ditch was recorded in

section. The ditch (1301) was aligned approximately north to south and measured 3.1m wide by 1.35m deep. The ditch appeared to have been open until relatively recently and the majority of the ditch fill (1300) comprised material tipped recently by machine and waste material resulting from fly tipping. Traces of an earlier, silty clay primary fill (1306) 0.17m thick, were evident on the western edge of the ditch cut but no dating evidence was recovered. A dark brown clayey top soil (1303) up to 0.35m thick sealed all deposits No further archaeological features or deposits were encountered in trench 13 and no artefactual material was recovered.
