**ARCHAEOLOGICAL
BUILDING SURVEY,
WALKOVER SURVEY AND
TRENCHING REPORT**

**BROUGHTON MOOR ROYAL
NAVAL ARMAMENTS DEPOT
(RNAD), GREAT BROUGHTON,
BROUGHTON, CUMBRIA**

**ARCHAEOLOGICAL BUILDING SURVEY, WALKOVER SURVEY
AND TRIAL TRENCH EVALUATION**

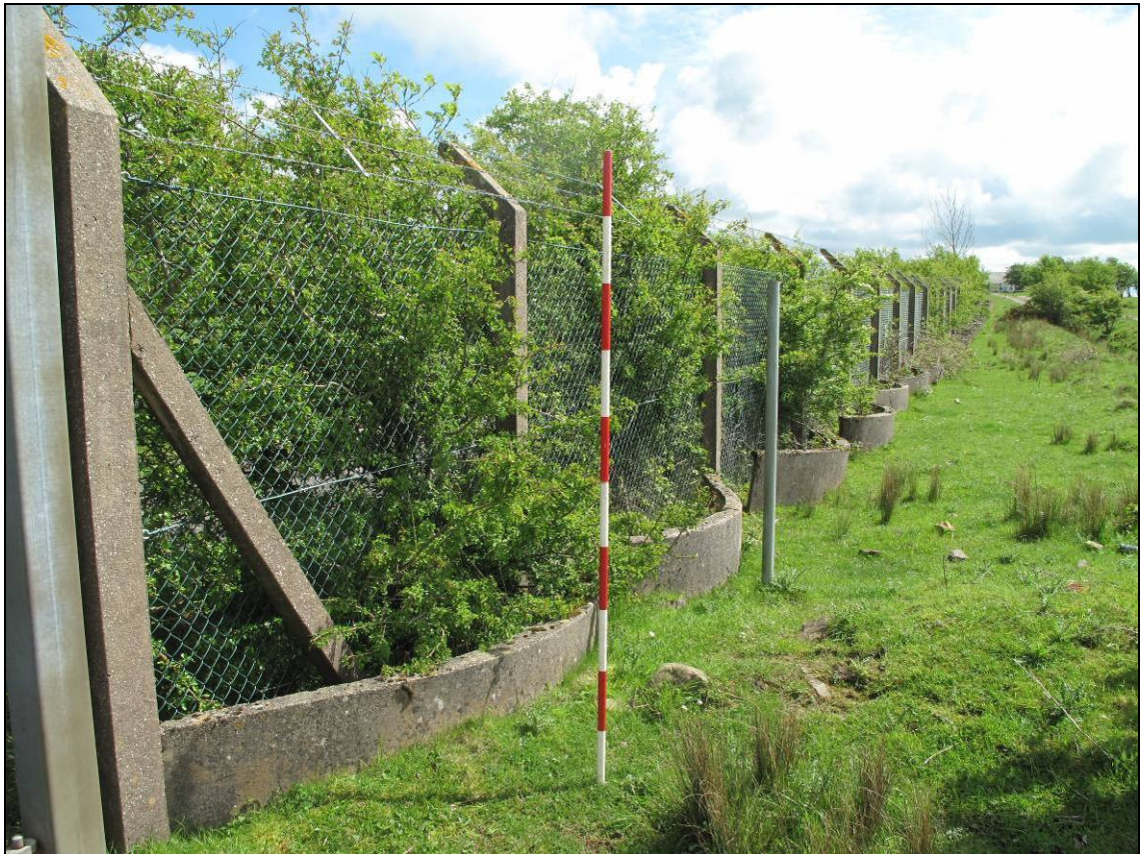
Plate 4: Perimeter fence south of Residence Gate

fence in the location of the gate, formerly known as Residence Gate, presumably to stop intruders digging under the perimeter.

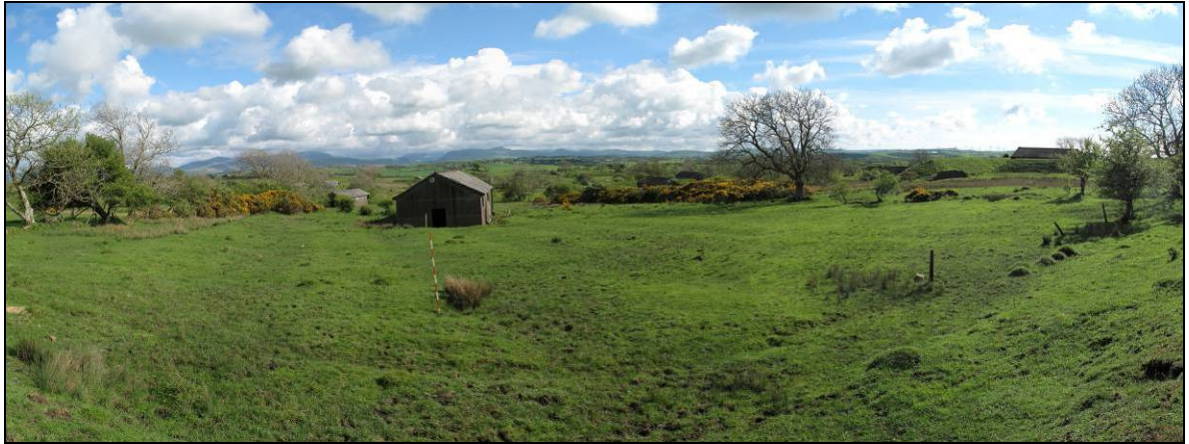
Plate 5: Ridge and furrow north of ESH 86, facing south from the railway line

- 5.3 The desk-based assessment identified that the survey area lies within a series of strip fields in the south-eastern corner of the depot, measuring 35-40 m in width, though some have been merged to form larger fields. Strip fields are narrow fields formed through the enclosure and consolidation of blocks of medieval ridge and furrow, and usually occurred from the medieval period onwards. The desk-based assessment identified that the hedges and low banks defining these fields were in fair condition, though the hedges were no longer maintained. Ridge and furrow was also identified in discrete blocks in the south-east and north-west corners of this area (Conolly 2001, 5 and Figure 2). During the walkover survey, further ridge and furrow was identified in a block within the fields to the north and south of ESH 86. The ridge and furrow comprises a broad ridge c3m in width, with a narrower furrow c2m wide, and is evidently sinuous, as is common with this type of earthwork. The ridges run north-south from the line of the Cleator and Workington Junction Railway southwards, to a point just south of the explosives storehouse, where the orientation of the ridges turns east-west.

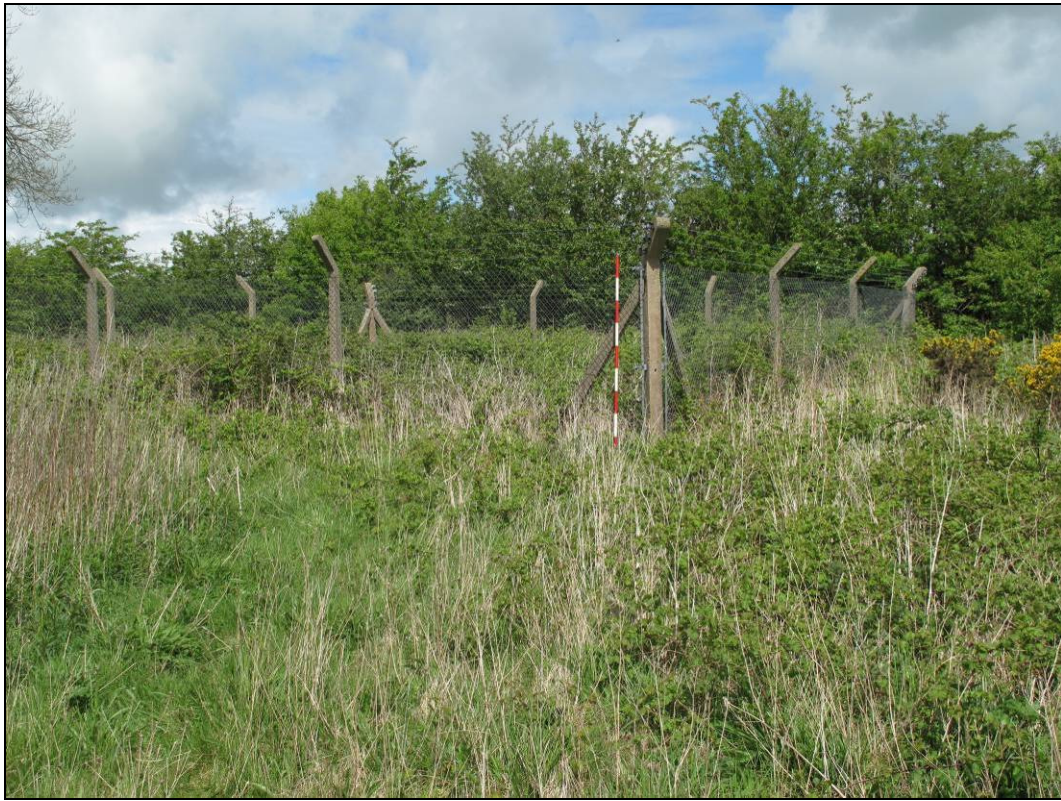
Plate 6: Fenced area within outer zone - probable location of shaft

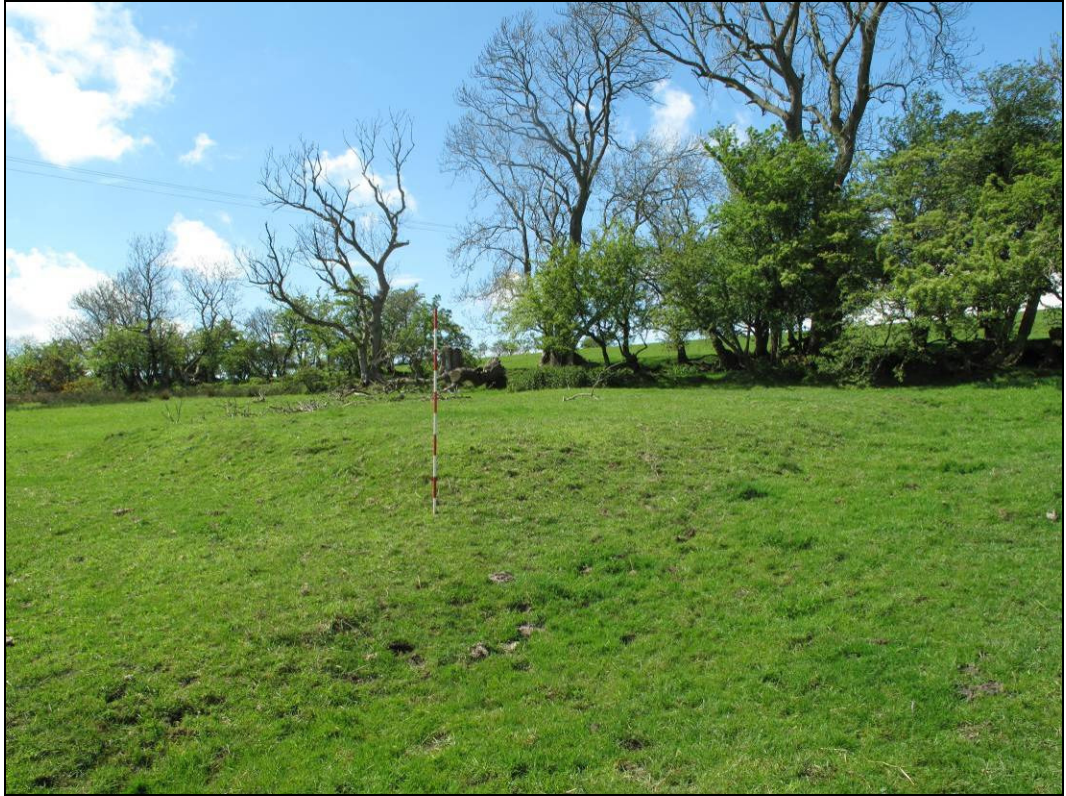
Plate 7: Building platform, facing north

- 5.5 Within the development boundary, a building platform was identified. This corresponds with a site identified during the walkover survey undertaken as part of the desk-based assessment (Site 20 - Conolly 2001, 13). The walkover identified this as a sub-rectangular platform on south-east facing slope, measuring approximately 18 by 14 m and standing to a maximum height of 0.75 m. The platform respects an adjacent track shown on the First Edition Ordnance Survey, possibly a waggonway. A further possible shaft was noted to the north-west, and outside the current development area, possibly associated with further waggonways. The building platform was examined during the trial trenching phase (Section 7).

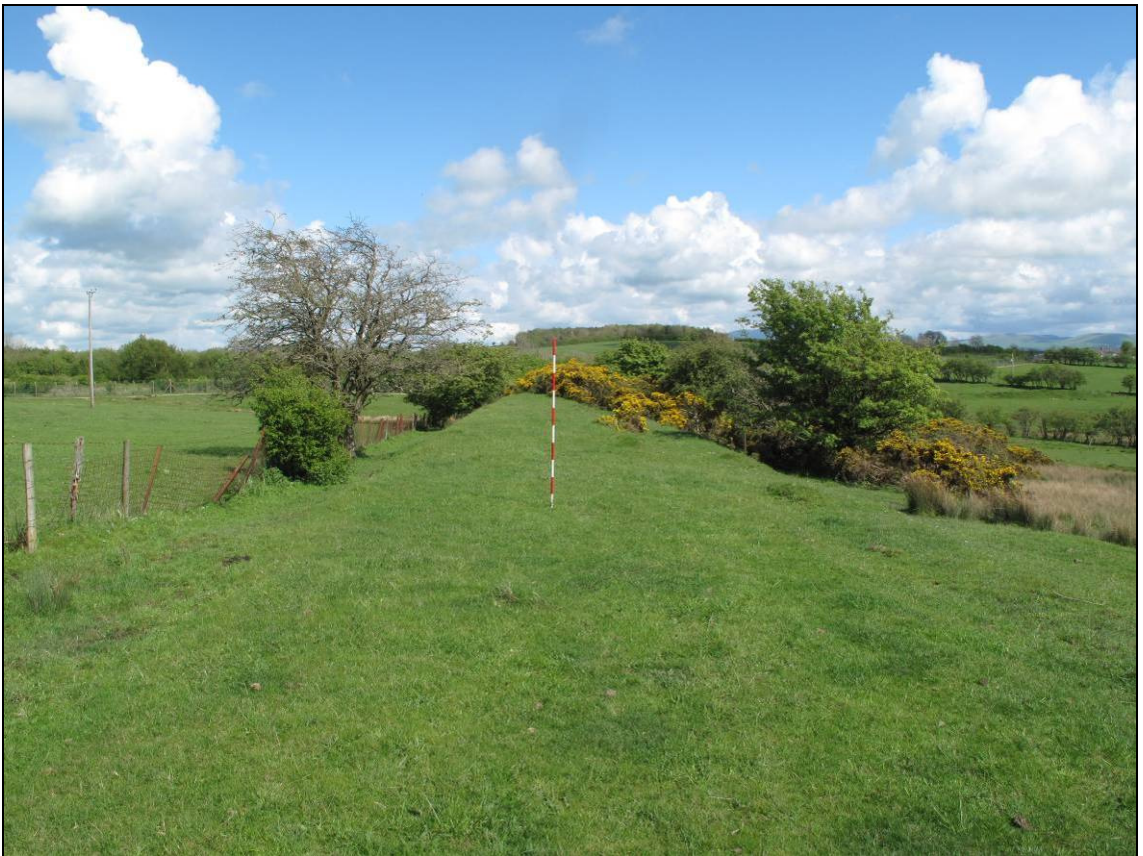
Plate 8: The Cleator and Workington Junction Railway, facing east

- 5.7 The southern edge of the development area comprises track-beds (both standard and narrow gauge) and railway embankment, originally part of the rail infrastructure, which served the site and formed part of the Cleator and Workington Junction Railway. No actual rail tracks were observed; the majority of the rails were taken up and removed from site in the early 1990s, and the track only now survives encased in concrete, at road crossing points (Capita DBS 2001, 6).

- 5.9 Examination of the bank shows it to have been built of mine spoil from coal mining, which contains large quantities of clinker, fragments of brick and other debris. Most of the embankment, however, survives as a turfed earthwork, preserving the lines of the former trackways.

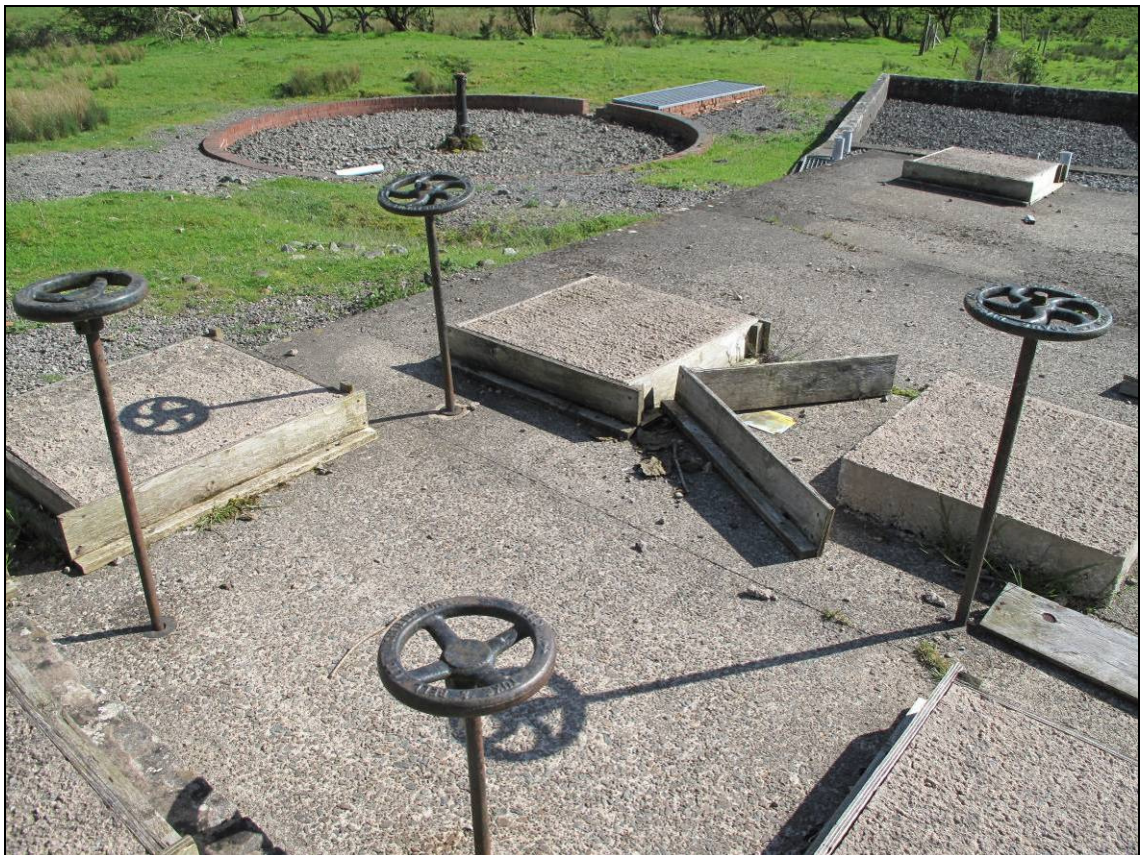
Plate 9: Sewage treatment plant, showing valve-wheels on tank

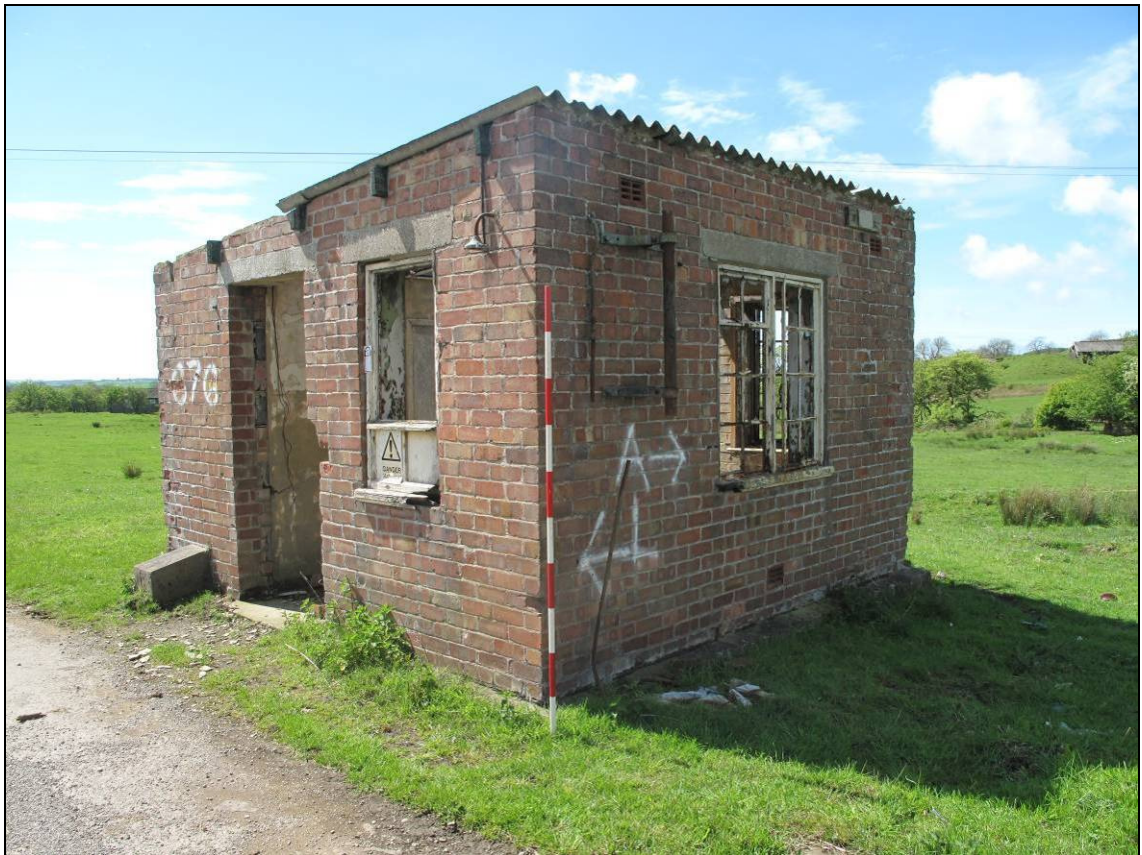
Plate 11: Building 676A, facing west

- 5.13 Building 676A is a small single room brick building, presumed to be a guardhouse for Residence Gate. The brickwork is set in stretcher-bond, with ceramic ventilators, and is built on a concrete base. The doors and windows have concrete lintels, except the rear door, which has been inserted and has a timber lintel; the windows are metal casements - no doors survive. The roof slopes south-westwards, and is covered with corrugated asbestos sheeting, which has iron fixings to hold it in place. The interior of the building is clad in fibre-board, with no fixings evident; a toilet was inserted into the south-eastern corner, separated by means of a breeze-block partition. Electricity was supplied by overhead lines to the north-eastern corner of the building.

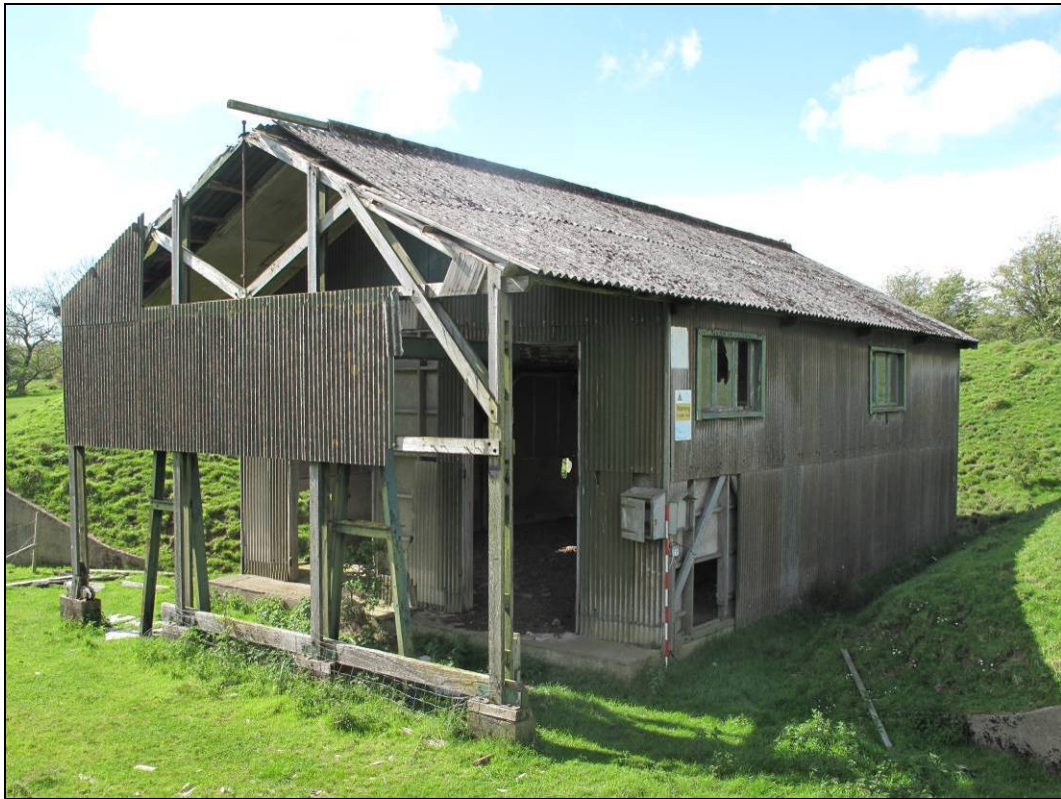
Plate 12: ESH 87, facing north. Note covers for telephone adjacent to the ranging pole.

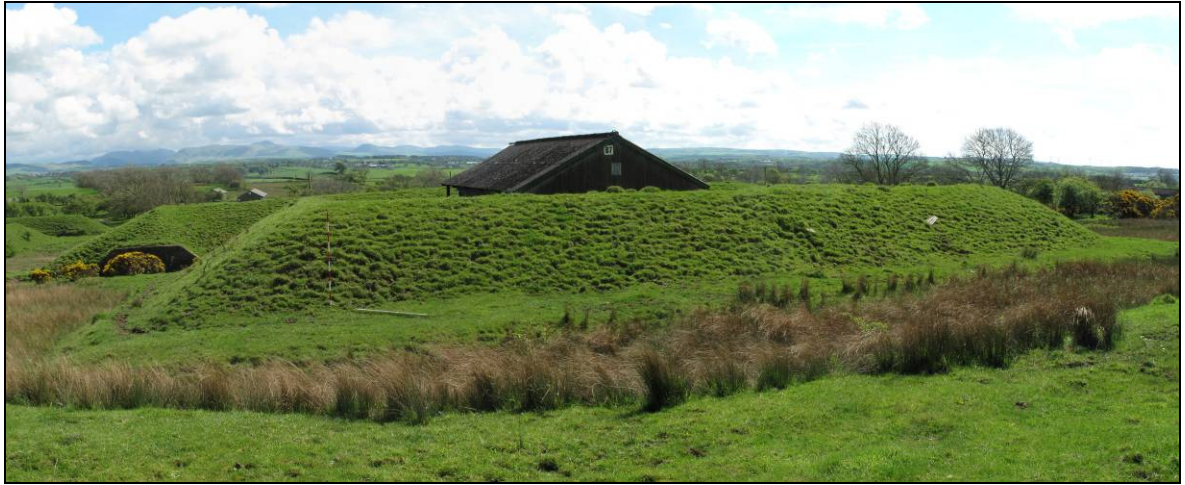
Plate 13: North bank of traverse around ESH 87, facing south; note slightly wider flattened base and boggy quarried area

the northern bank also have a slightly wider flattened base, corresponding to the original ground surface, left perhaps as an additional water-proofing measure (Plate 13). It was clear from the survey that the material forming the banks had been obtained from the machine excavation of a terrace cut into the hillside, on which the building sits, and a wider area around the position of the ESH, usually on the north side, which was a large irregular rectangular cut, now mostly quite boggy.

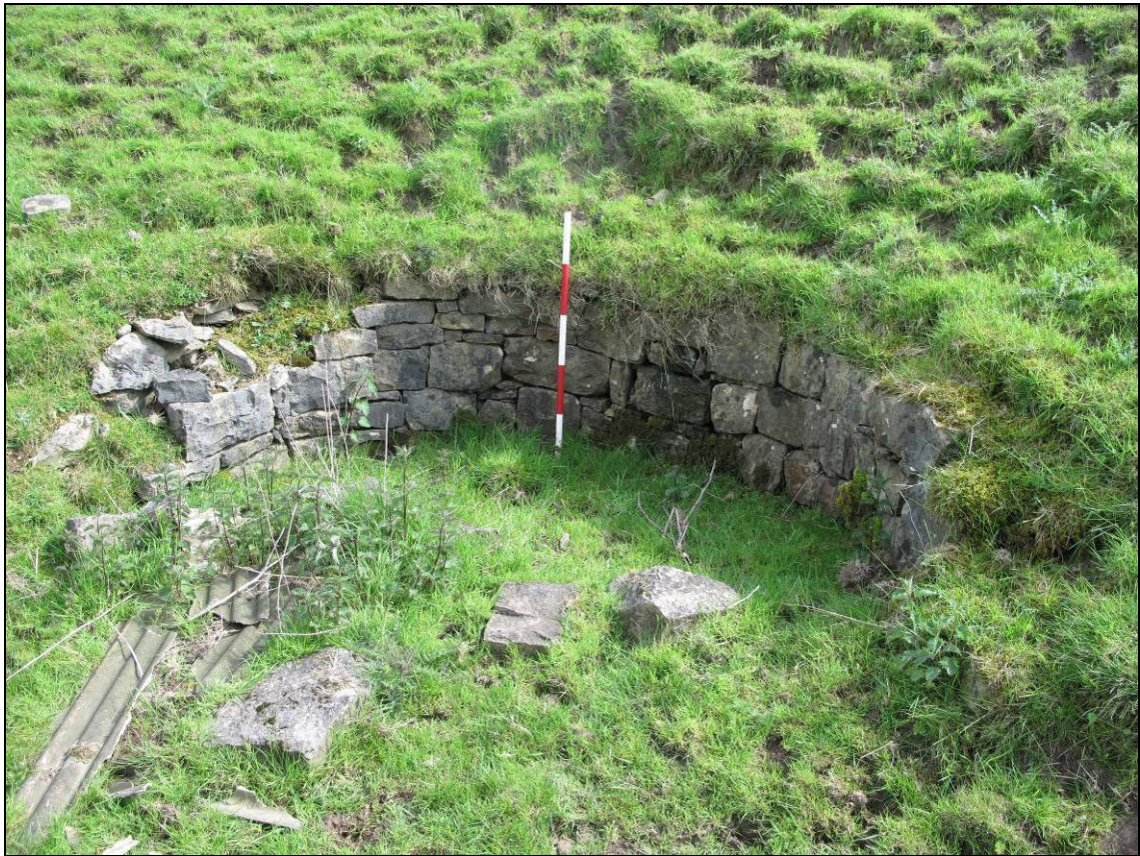
Plate 14: Semi-circular revetted recess in north side of south bund of traverse; this example, at ESH 87, is revetted with a stone wall

revetted with a random-coursed stone wall 0.8m in height (Plate 14), but this was a lone example; the other examples had no discernible revetment, suggesting they were perhaps originally revetted with timber. The function of these recesses is unknown. The western end of the southern bank of the traverse for ESH 66 also incorporates a rectangular recess, revetted with a similar stone wall. This recess houses valves for a pair of fire hydrants, connected to a gravity-fed fire main which runs north-south underneath the southern bund (Thomas 1997. 17). The pipeline continues downslope and beyond the survey area.

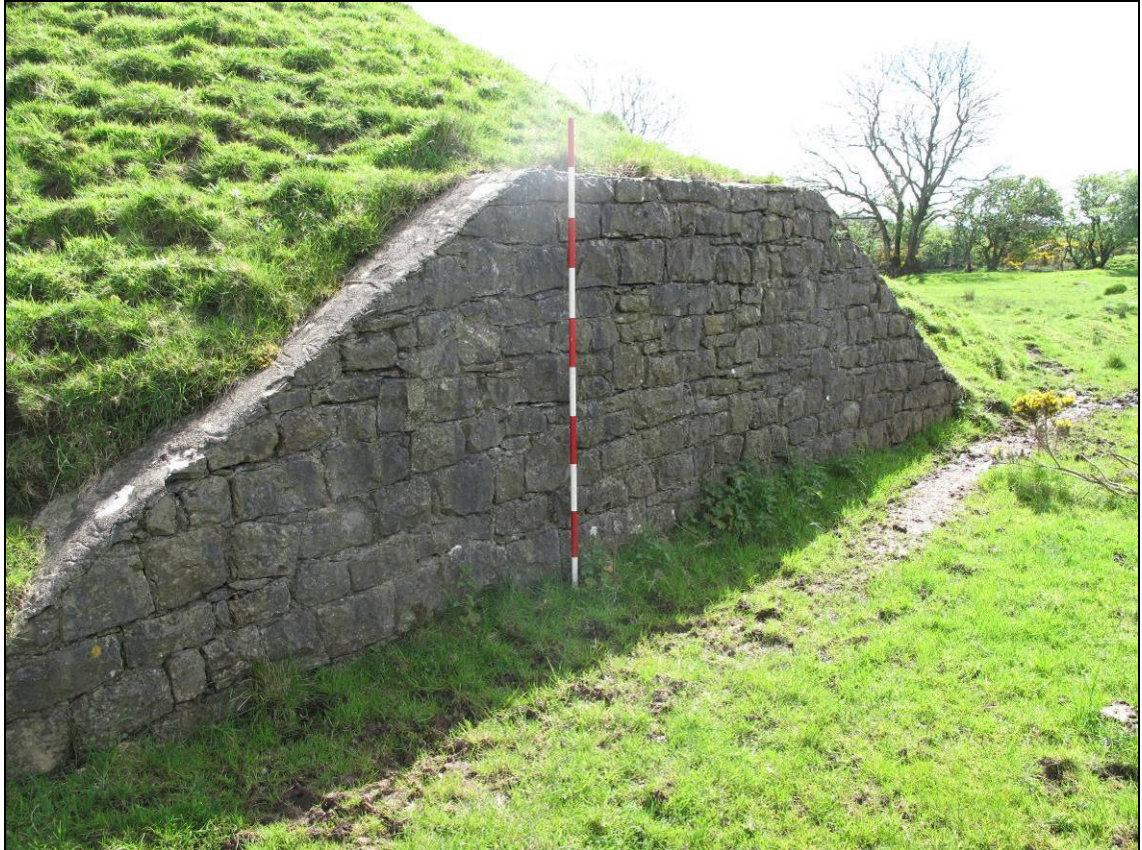
Plate 15: Stone wall, ESH 87

- 6.5 The narrow gauge track runs broadly east-west between the two banks. The north returns of the south bank are revetted by a stone wall, c.1.6m in height, and made of random coursed roughly squared blocks, with cement mortar (Plate 15). Most of these walls have been partially rendered with cement to stabilise them, and the eastern example at ESH 87 has also had ceramic drain pipes inserted along the base; in contrast, the eastern example at ESH 66 has collapsed entirely. The southern ends of the north banks are revetted by a smooth concrete wall, with shuttering impressions evident; these may be slightly later, and the original revetting may have been timber. The concrete revetments are angled, to allow the movement of narrow-gauge waggons to the sidings within the ESH. At the centre of the southern bank is a semi-circular recess, located approximately central to the bund and directly opposite the doorway of the ESH (Plate 14). The recesses measure approximately 3m in length and 1.5m in width, and whilst most have now collapsed and are infilled by bund material, they are still discernible. The example at ESH 87 was

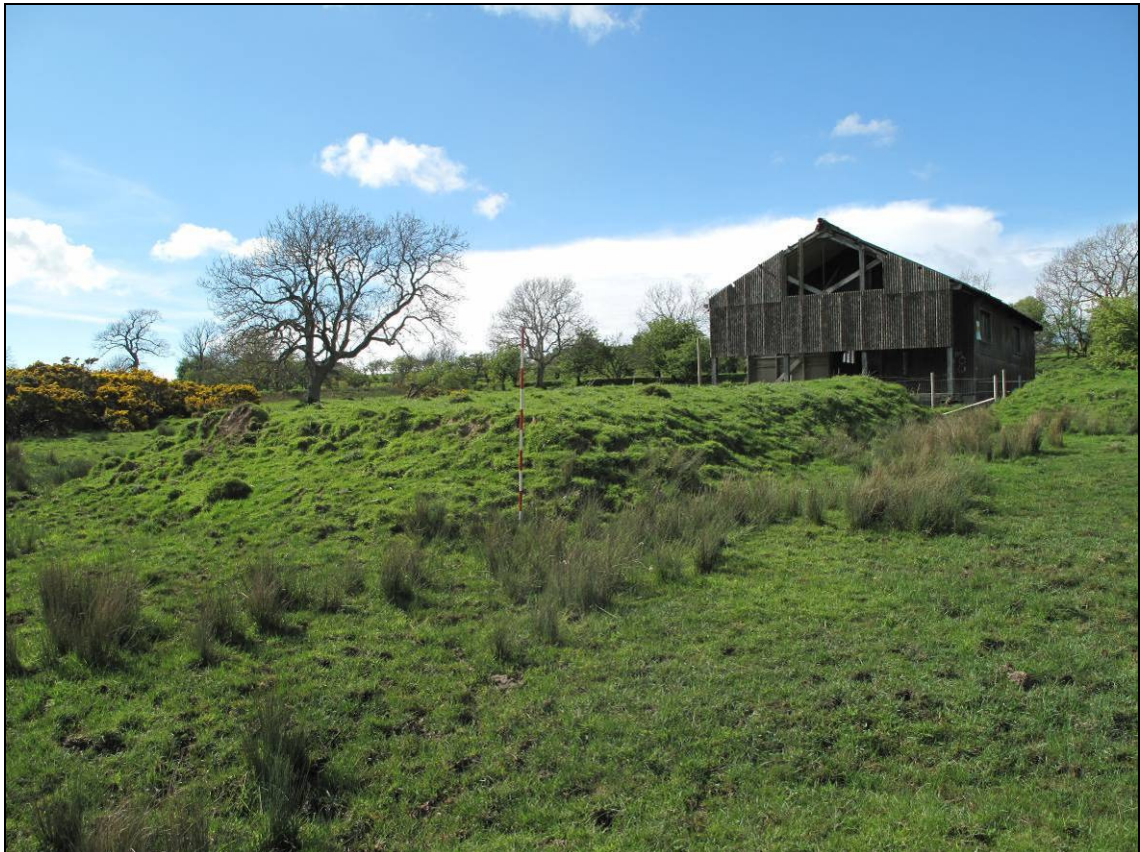
Plate 16: Rectangular spoil heap south of ESH 86, facing north

6.6 The ESH without traverses (surveyed examples ESH 65 and 86) have a large rectangular heap of spoil in front and south of the buildings, from the machining of the terraces cut into the hillslope, on which the buildings are located (Plate 16). The spoil heaps measure approximately 20m by 10m, and are 1.2m in height. They are aligned either with the south edge of the narrow-gauge waggonway, or at right-angles to it. The heaps are flat-topped, and also include the semi-circular recess on the north side, in the same way as the traverses. The un-traversed magazines also included the line of a land drain, cut c.8 from the edge of the platform, and running east-west across the slope above the magazine with a drain running down either the west or east side, and connecting to the trackside drainage. This was presumably excavated to catch the run-off from the hillslope, and to stop the magazines flooding.

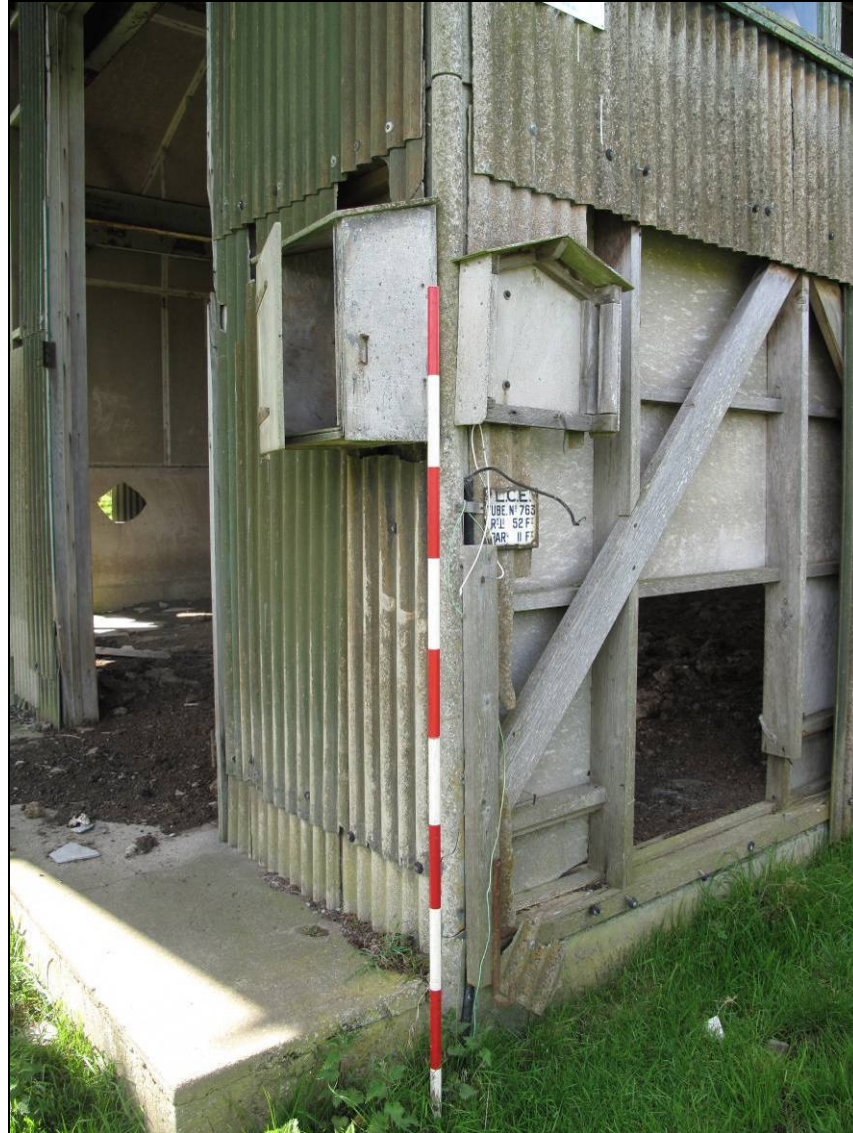
Plate 17: External telephone boxes, ESH 87; note 'L.C.E' sign and iron fixing for gates

- 6.9 At each end of the porch, L-shaped iron fixings are visible on upright posts attached to the ESH, and to the porch uprights. These appear to have originally supported gates at each end of the porch, in order to control the access of locomotives into the magazines. The magazines may have carried warning signs, indicating when a locomotive or waggon was in position and being loaded, or may have allowed magazines to be closed off, when they were empty or undergoing maintenance.

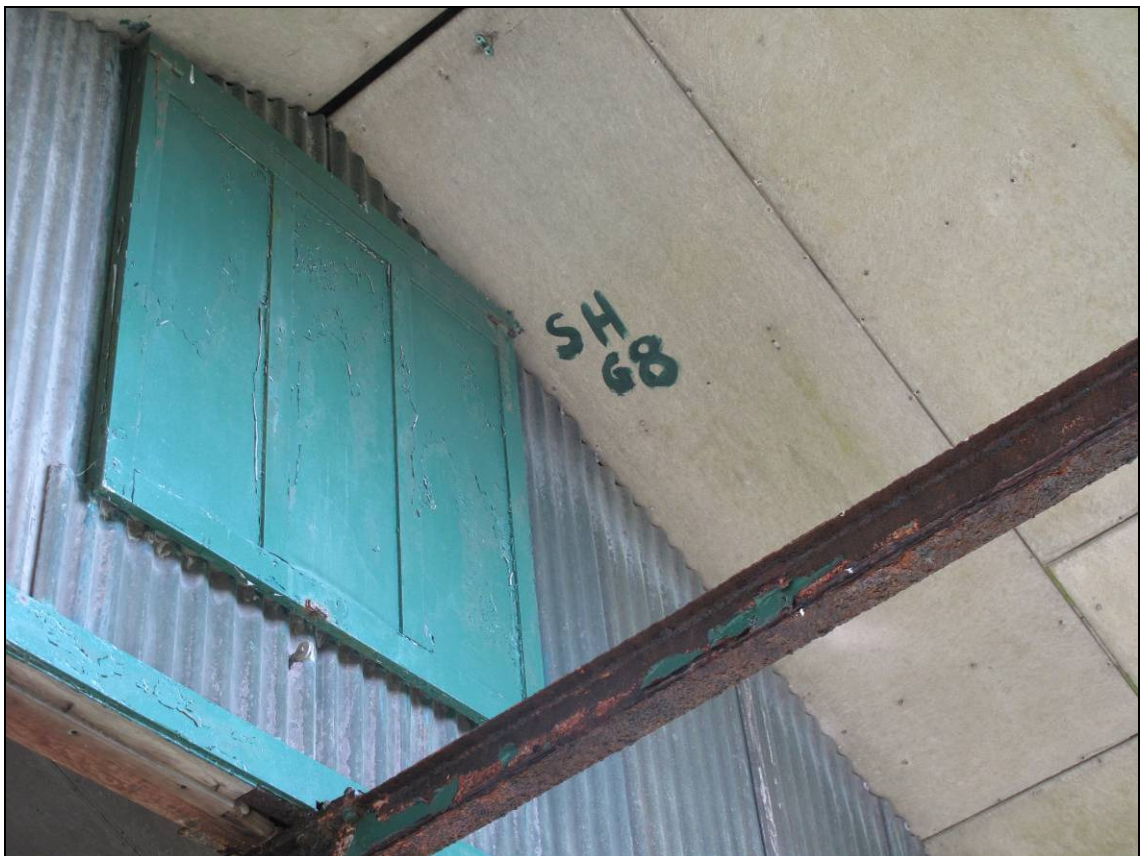
Plate 18: Exterior for shutter for ventilator, with pulley wheel below and fixings on shutter and ceiling above; note graffiti

- 6.10 Ventilation to the sheds was provided by a large ventilator above the main door, which appears to have been omitted from Roger Thomas' description (Plates 18 and 19). The ventilator, which is incorporated into the bay above the main doors, is timber framed, with eight louvered slats visible

from the interior. The exterior of the ventilator is covered by a green-painted shutter, with three recessed panels, hinged at the top. The shutter was lifted by means of a cord on a system of pulley wheels, attached to the exterior porch timberwork above and beneath the shutter, and affixed to the shutter at the base by means of an eye-bolt. The cord probably supported a counter-weight to allow the easy raising and lowering of the shutter. The shutters in ESH 66, 86 and 87 had all been repainted; the painters had added their initials and date on the ceiling of the porch ('SH 68' in ESH 66 (Plate 18); 'JS 76' in ESH 87). Sub-floor ventilation also appears to have been used in ESH 65; along the edge of the platform were two small ventilation slits covered with iron grilles, although examination of these indicated that the rear of these had been blocked with concrete. This tentatively indicates that the original floors of the magazines may have been timber, and were later replaced with concrete; no evidence of further slits was noted in other magazines, though these may have been obscured by vegetation and debris.

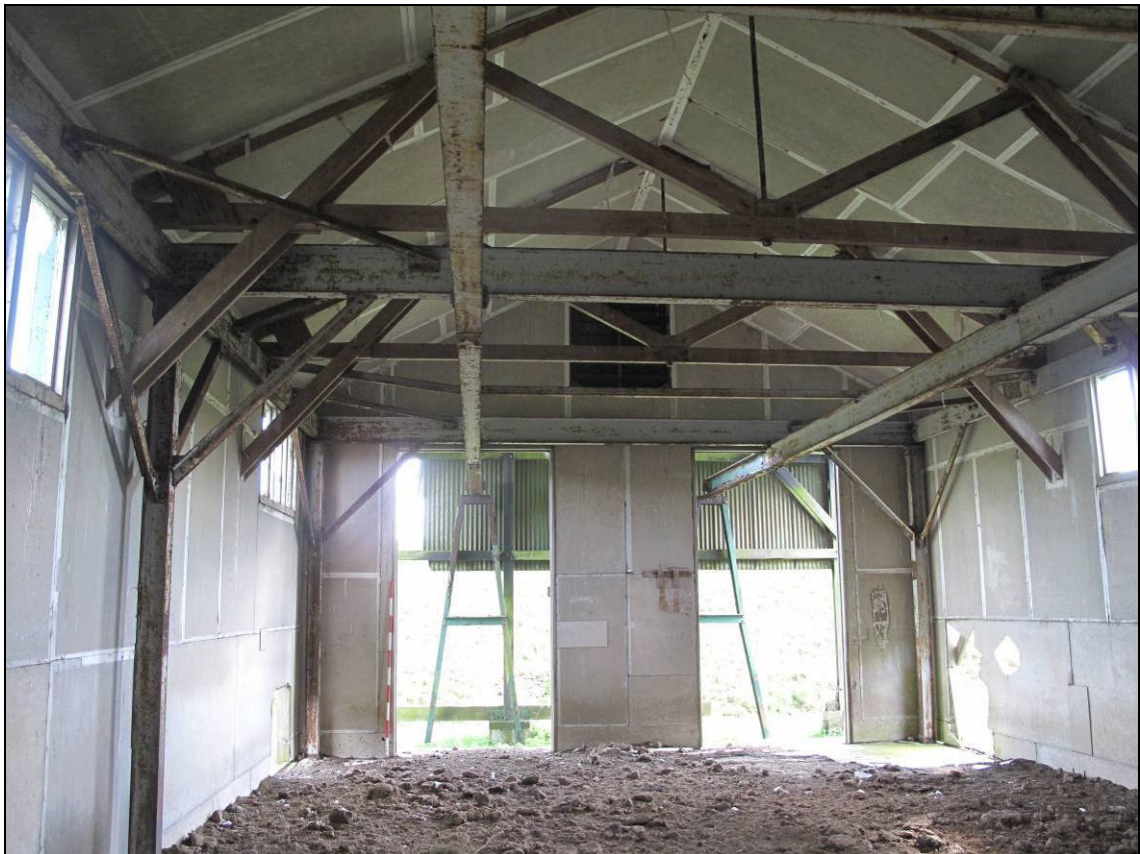
Plate 19: Double-gantry in ESH 87, facing south. Note louvered ventilator in the centre of the wall

- 6.11 The magazines with traverses all had gantries installed within their interiors, whilst those without traverses did not. This may indicate that the heavier, and perhaps more dangerous, ammunition was stored in the magazines with traverses, whilst the lighter ammunition, which could be carried manually, was held within the un-traversed examples. ESH 66 had a single gantry only, comprising an I-beam girder welded to plates bolted onto the roof trusses, which ran the length of the building

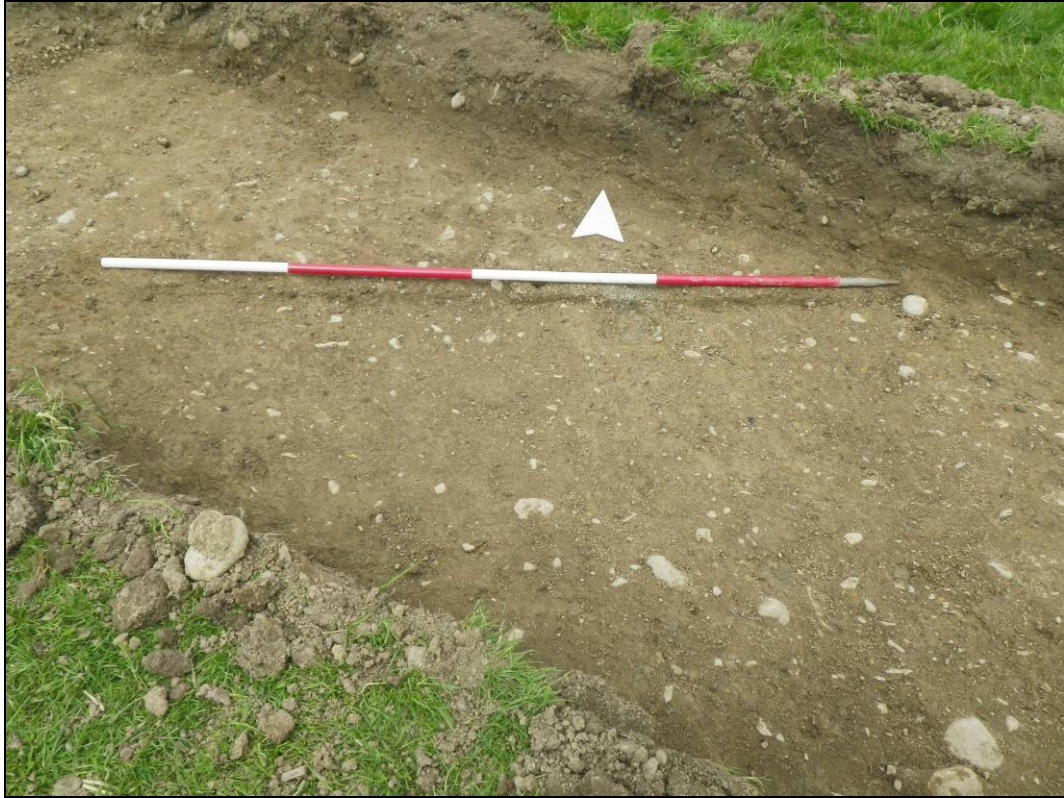
Plate 24: Furrow 403, Trench 4, facing north

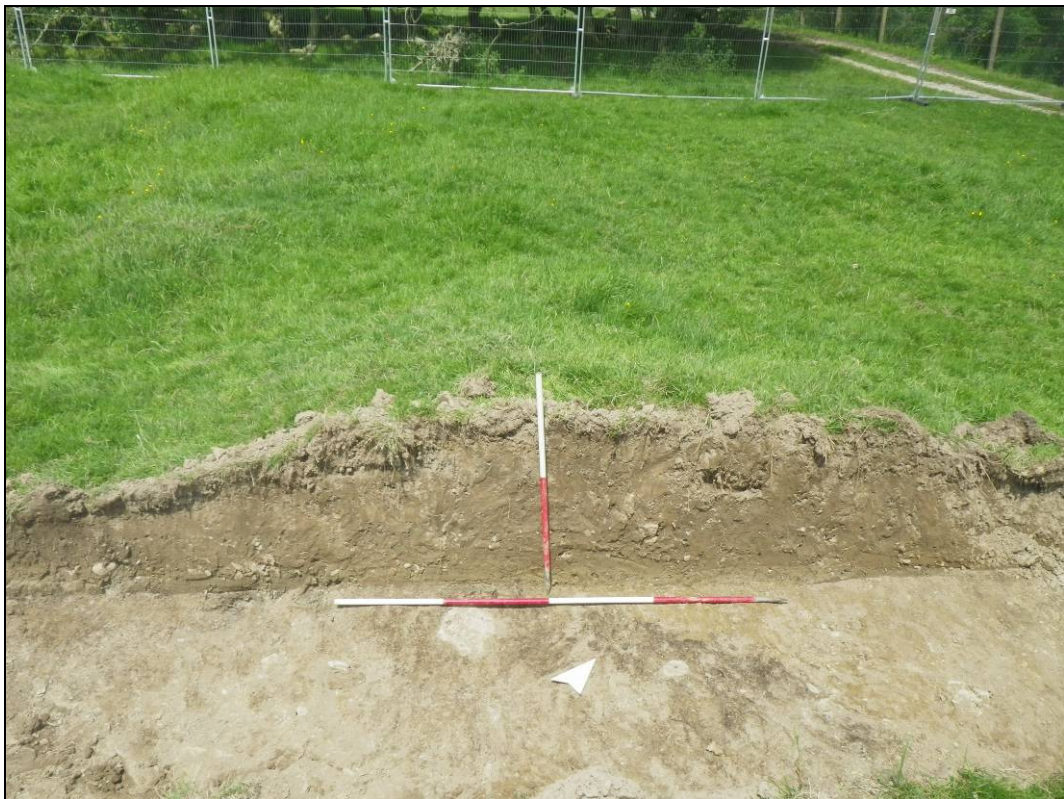
Plate 25: Earthwork mound 903, Trench 9, facing north-west

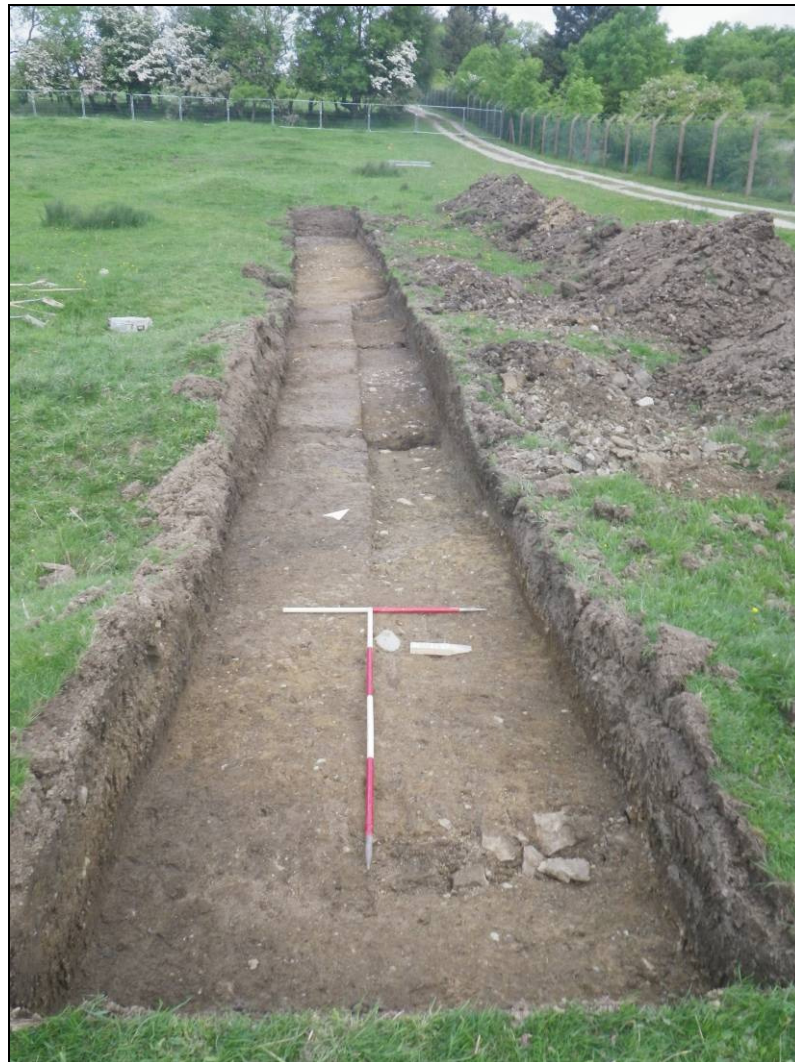
Plate 26: Hollow way 1202, Trench 12, facing west

- 7.30 The hollow-way appeared to have been backfilled, as surface 1201 and ditches 1211 and 2015 were sealed by a mixture of dark grey and yellow-brown redeposited natural clay, 0.22m thick. This layer had been truncated by a series of north-east to south-west aligned 'French' and ceramic land drains (1203 – 1206, 1210). The hollow-way was sealed by mid-grey brown, silty clay topsoil (1200), which measured at least 0.3m in thickness. The topsoil contained two sherds of glass and three sherds of 19th – 20th century pottery.

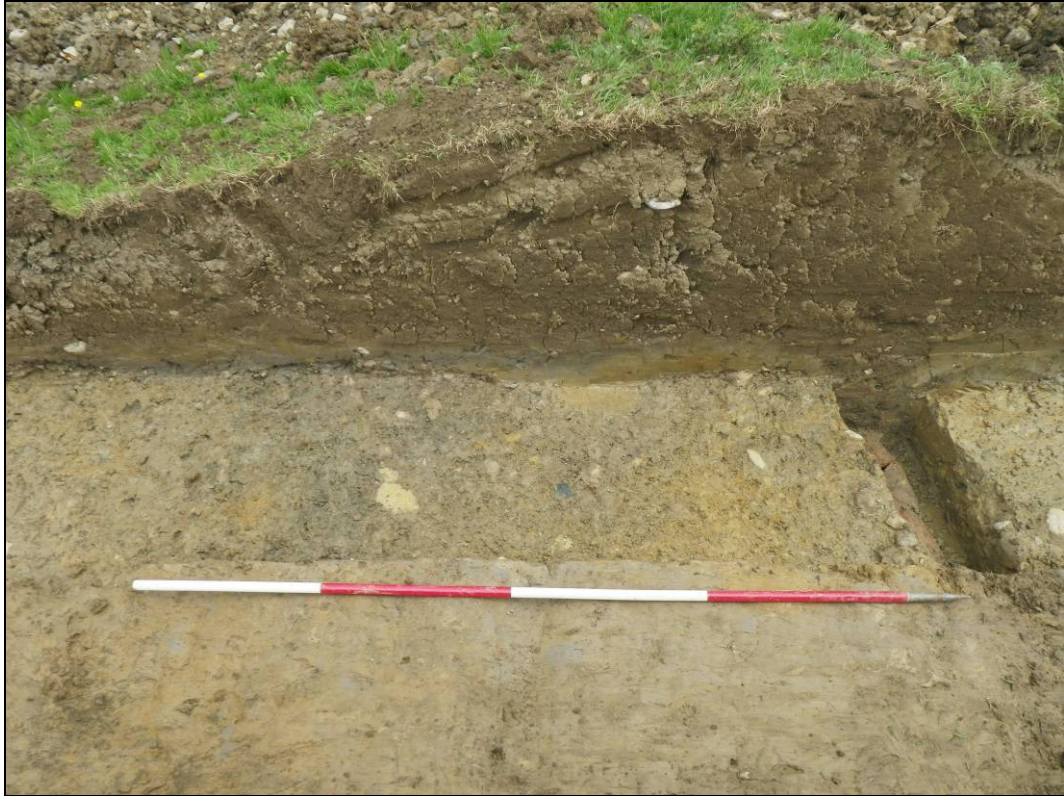
Plate 27: Surface 1212, Trench 12, facing north

- 7.28 This surface appeared to infill (1207, 1216) two ditches (1211, 1215) that had been excavated within the hollow-way on broadly parallel alignments (Figure 5, 1211: 1215 not pictured). The function of these ditches was not clear, although Ditch 1215 may have been used for drainage. Ditch 1215 measured 0.56m in width and 0.25m in depth with a V-shaped profile, whilst Ditch 1211 measured 0.83m in width and 0.19m in depth (Figure 5, Section B). Neither feature produced any finds.
- 7.29 A potential further surfacing (1201) was recorded directly atop surface (1212), and consisted of moderately well-sorted rounded stones. This was recorded as a much smaller patch of metalling, measuring only 1.4m in width and it was uncertain if this was just the worn upper part of surface 1212 (Plate 27).

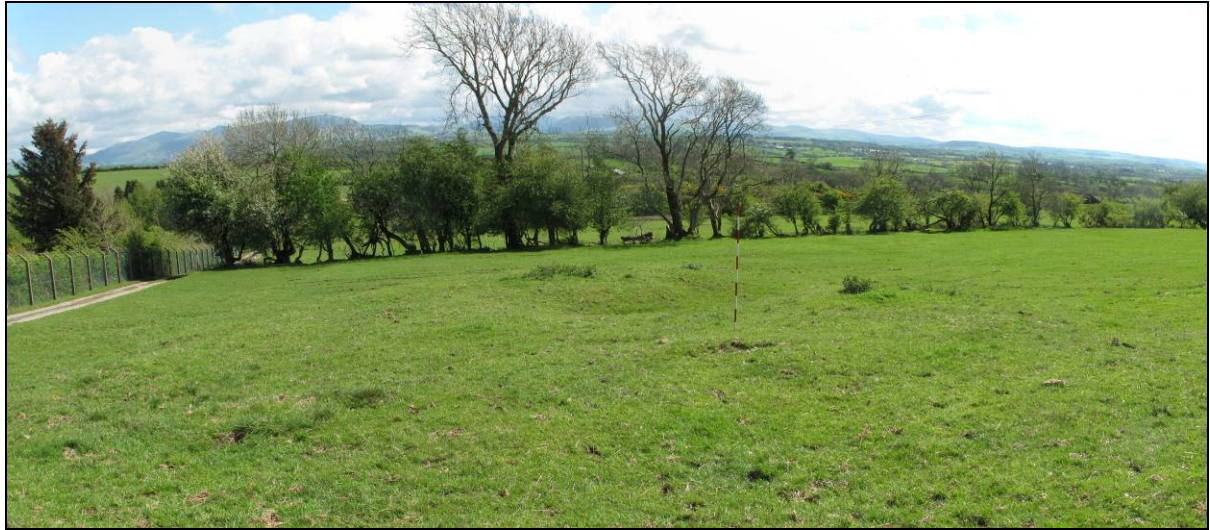
Plate 1: Potential coal shaft, facing south

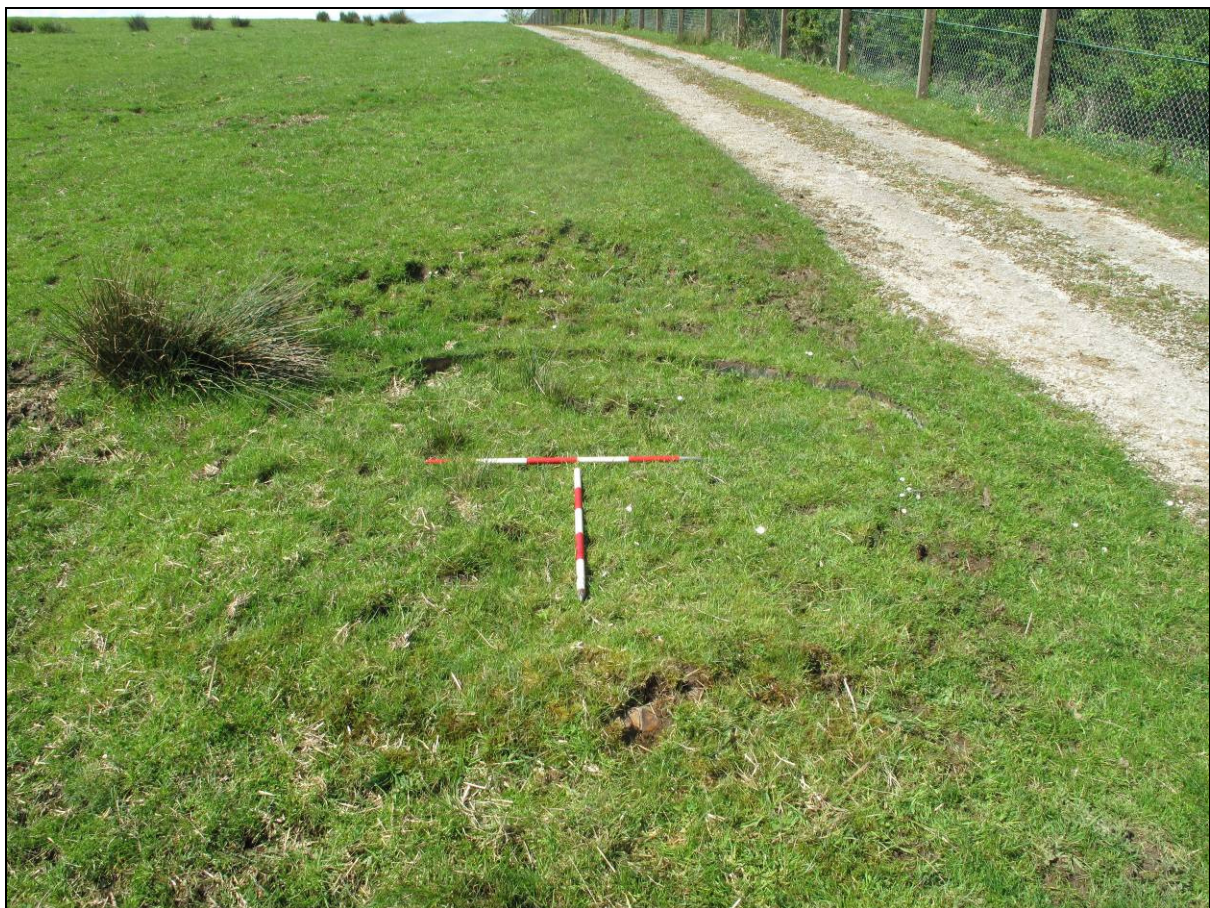
Plate 2: Circular iron structure, facing north
