**ARCHAEOLOGICAL BUILDING
RECORDING**

**BARN AT LOWSIDE FARM,
HILTON, COUNTY DURHAM**

NAA 16/116
September 2016

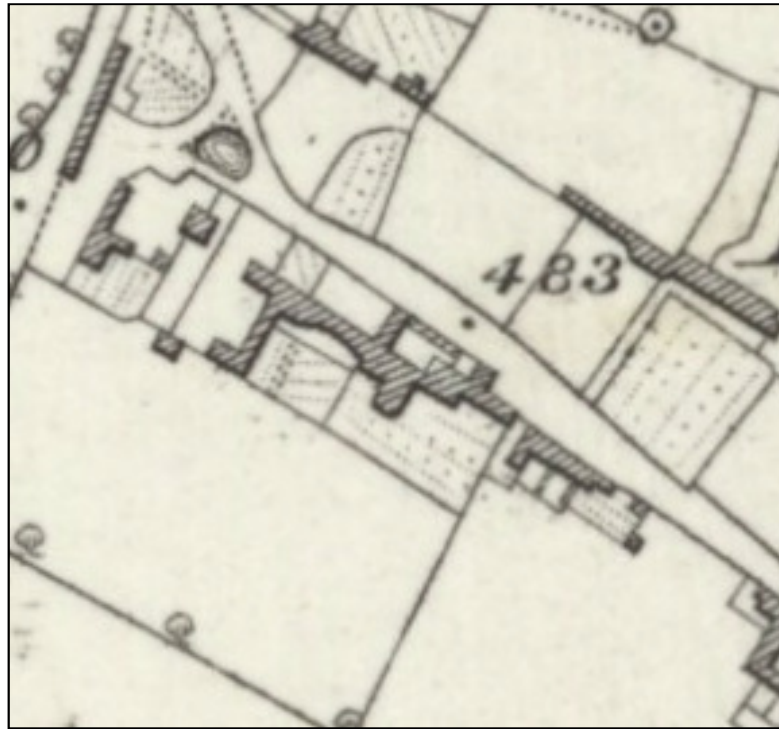
Plate 1: Lowside Farm, Hilton as shown on the First Edition Ordnance Survey map (1856)

- 4.6 The First Edition Ordnance Survey map (1856) shows Lowside Farm in a very similar layout to its form at the time of the survey (Plate 1). The Barn is, however, shown to have been a narrower structure than the buildings either side of it. This narrower section seems to have been an earlier structure predating the buildings either side of it (see below). However, by the time of the Second Edition Ordnance Survey (1896), this barn has been widened to meet the width of the buildings abutting it to the north-west and south-east (Plate 2).

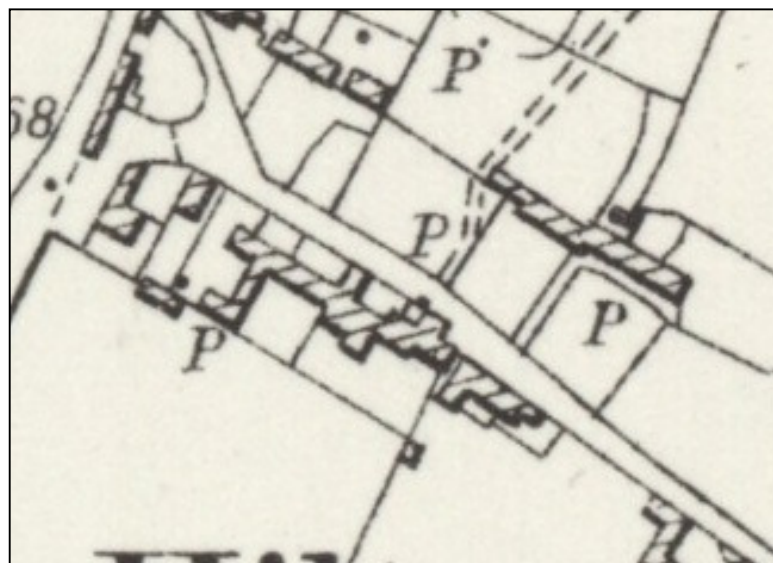
Plate 2: the site of the Barn as shown on the Second Edition Ordnance Survey map (1896)

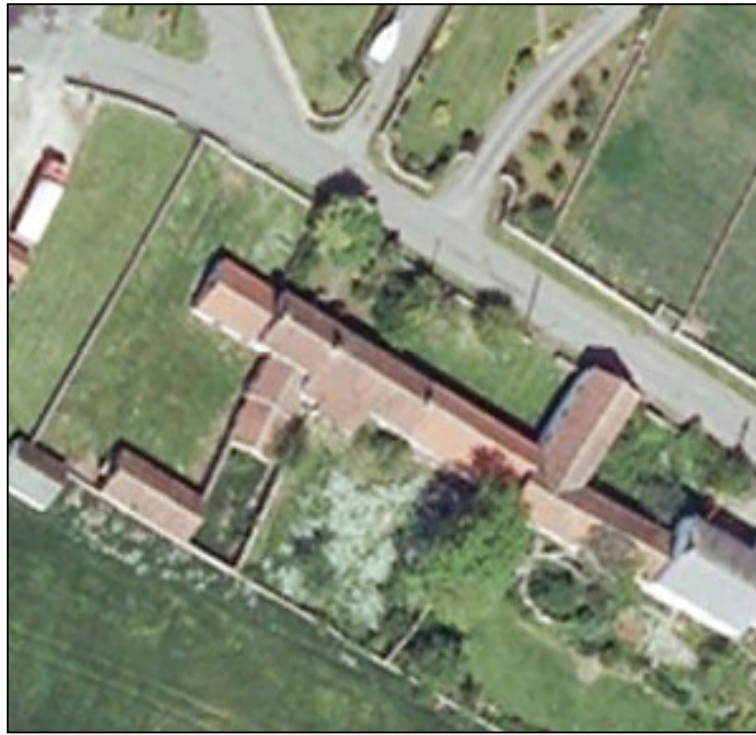
Plate 3: an aerial photograph of Lowside Farm as it was at the time of the survey (Google Earth 2016)

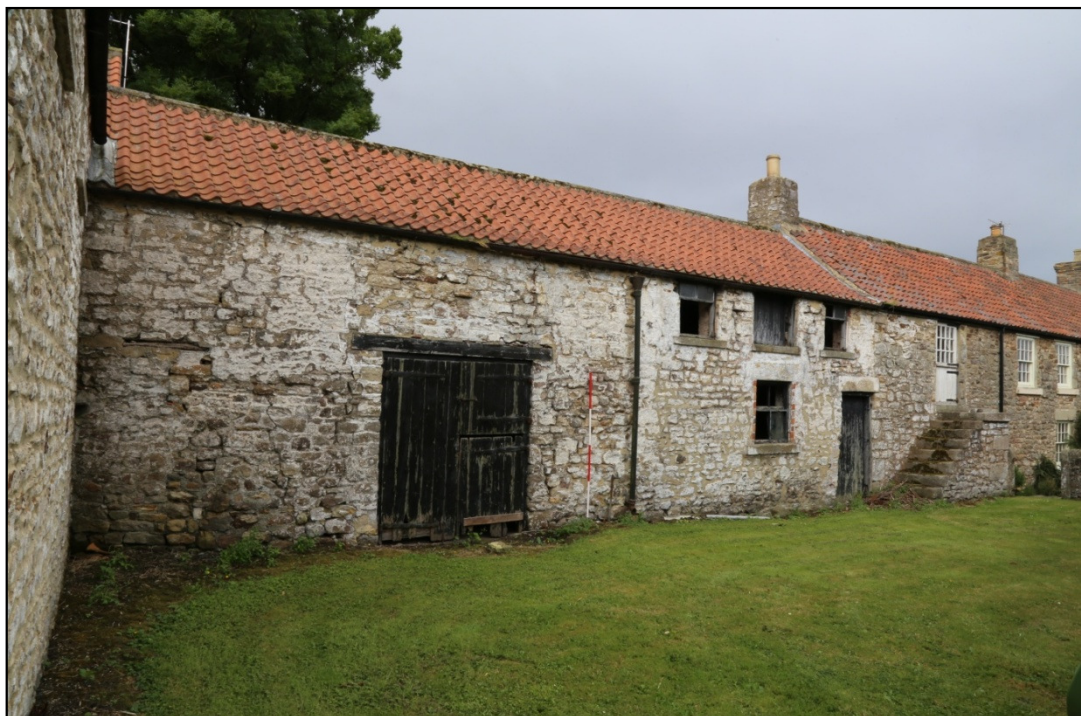
Plate 4: the north-east elevation of the Barn at Lowside Farm, showing Bay 3 (foreground), to Bay 1 (background)

- 5.8 The north-east elevation demonstrated two main phases of construction (Plate 4; Fig. 3). Bay 1 seemed to be the earliest, and was part of the farmhouse. This bay contained a loft door, accessed via a set of stone steps. South-east of this, the wall was of a different – possibly earlier – phase (Phase 1). A wall scar between the two sections was visible, with margined quoins to the north-west.

- 5.10 The middle section of the wall contained a doorway and a window opening at ground floor level (Bay 2), featuring large stone lintels and sills (Plate 4). These were probably original to this part of the building. Three first floor loft openings are of a different style, with narrower, later stone lintels indicating a later date. These openings may have been inserted into an earlier wall, or it is possible that the wall was raised to incorporate a loft; however, no horizontal wall scar was visible to support this.

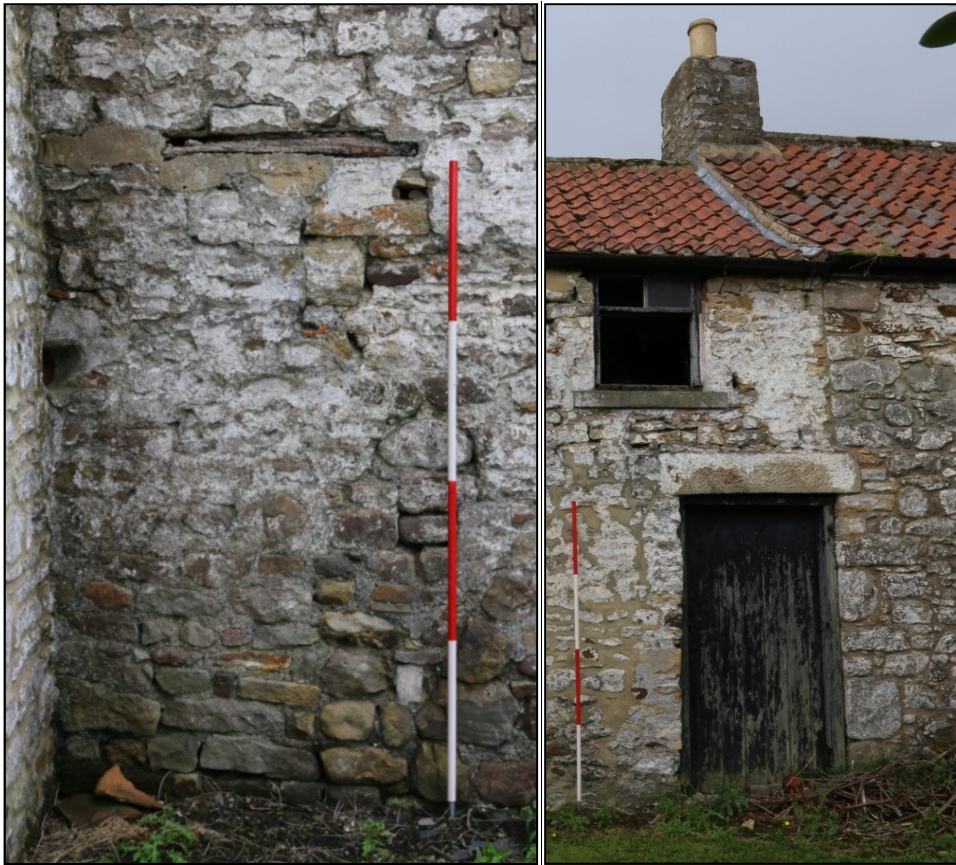
Plates 5 and 6: the blocked doorway in the southern end of the north-east elevation, and the join between Bays 1 and 2, showing the possible position of the cross-passage

- 5.11 A vertical wall join between Bays 2 and 3 indicated a third phase of construction (Fig. 3). Bay 3 seemed to have been a later wall, containing a blocked doorway in its south-western end, above which part of a timber lintel survived in situ (Plate 5). It also contained a wide doorway with a timber lintel, which may have been a later insert given the possible level of a loft internally (see below). It is possible that this was a cart door, given the width of the opening.

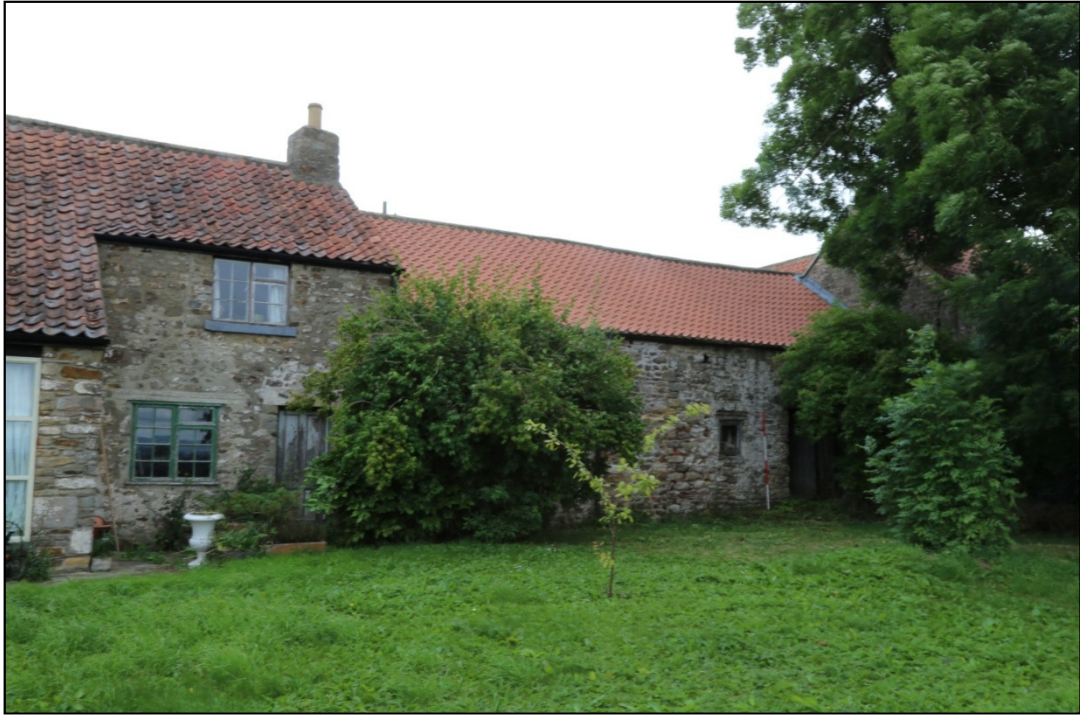
Plate 7: the south-west elevation of the Barn at Lowside Farm, showing Bay 1 (left) to Bay 3 (right)

- 5.12 The south-west elevation was similarly of at least two phases of construction (Phases 2 and 3). On this side, two vertical wall joins demonstrated this (Fig. 3). Both the corner of the farmhouse and Bay 3 featured margined quoins, perhaps suggesting that these parts were contemporary (Phase 2; Fig. 3; Plate 8).
- 5.13 Bay 1, part of the farmhouse, contained a doorway and window at ground floor level, and a window positioned centrally at first floor level (Plate 7). The door had a stone lintel and margined quoins to its right, which seemed to be original. While the first floor window had no lintel, the ground floor window had a concrete lintel, perhaps replacing a timber lintel, or indicating that it was a later insert.

- 5.14 Bay 3 contained a doorway and a small window at ground floor level. Both of these openings had timber lintels, which were probably contemporary with this part of the building. A small outbuilding had been added to this elevation just to the south-east of this doorway. This appeared to be later than this part of the building, but was also built of random-coursed rubble stone. It was in poor condition at the time of the survey.
- 5.15 The central section of wall appeared to be later, and was blind apart from a number of circular ceramic vents (Fig. 3).

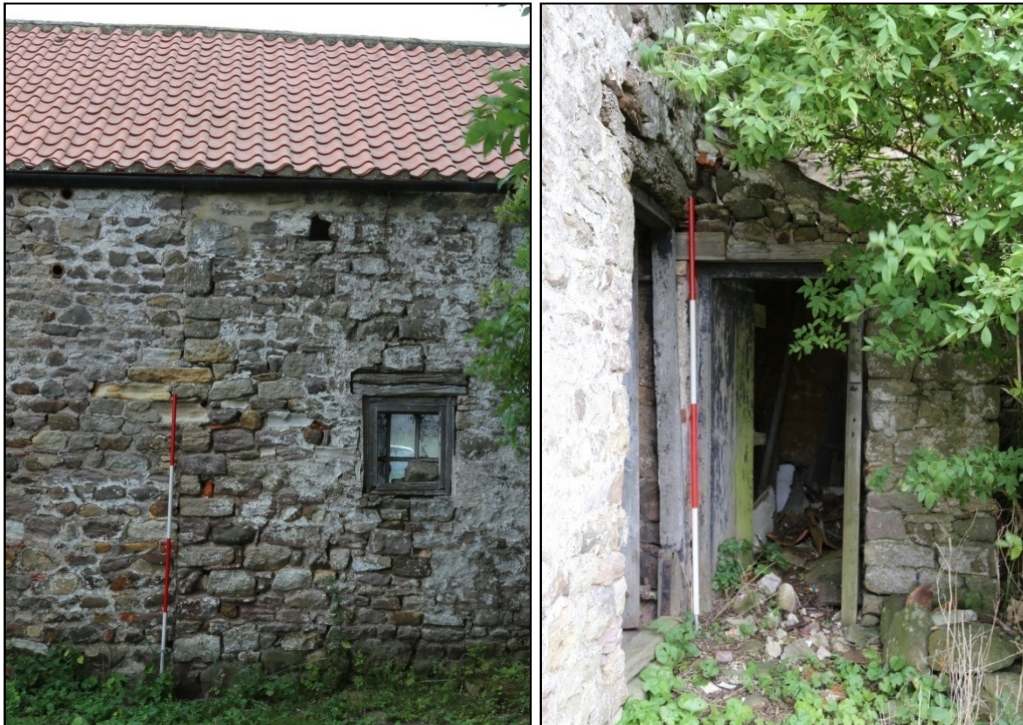
Plates 8 and 9: the vertical wall join between Bay 2 (left) and 3 (right) on the south-west elevation, and the outbuilding at the southern end of this wall

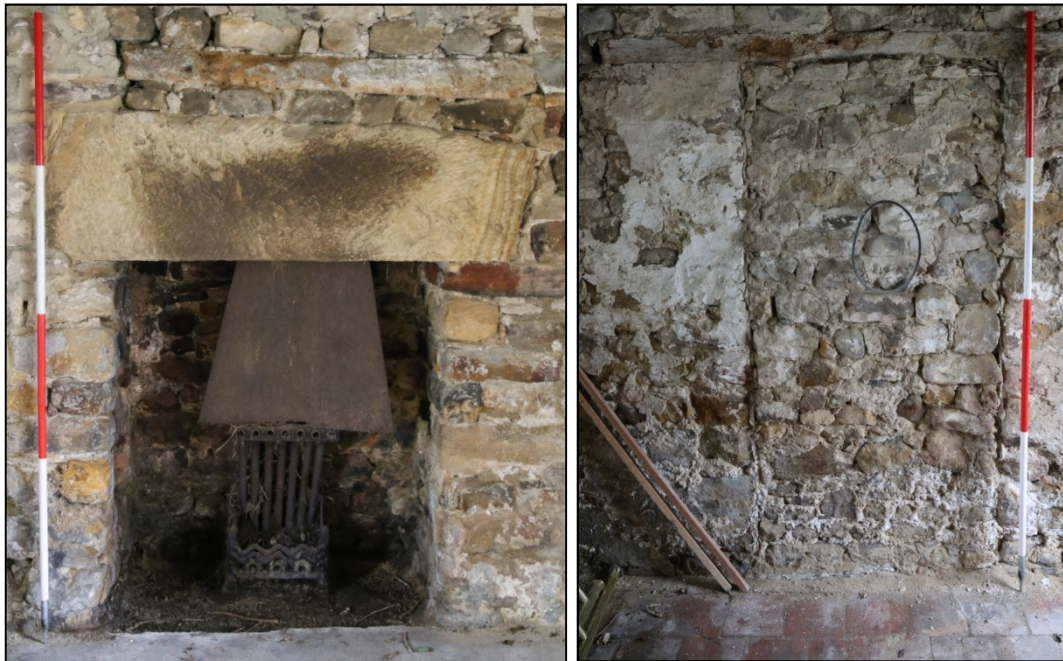
- 5.17 Bay 1 contained a number of historic features, particularly inside 1G. There was a large fireplace in the south-east wall, built in rubble stone with a large tooled stone lintel (Plate 10). A timber beam was built into the stone wall of the chimney breast above, which did not seem to have been a structural element, and may have been

evidence of alteration. At the time of the survey, the fireplace contained an iron grate. The fireplace was probably original to this part of the building and indicates that this room was historically in domestic use.

Plates 10 and 11: the fireplace in the south-eastern wall of 1G, and the blocked original doorway in the north-western wall of the same room, showing the tiled flooring in this area

- 5.19 The floor of this room was predominantly modern concrete, apart from an area of historic red quarry tile flooring to the north-west (Plate 11). A row of bricks in the floor, dividing the concrete and tiled sections, was evidence of a former modern subdivision. There is potential for further evidence of historic floor coverings beneath the modern concrete flooring.

- 5.20 Two blocked doorways in the north-west wall of the room would have led through to the farmhouse. The doorway in the centre of the wall had a warped timber lintel, and may have been original (Plate 11). Its blocking was in random-coursed rubble stone

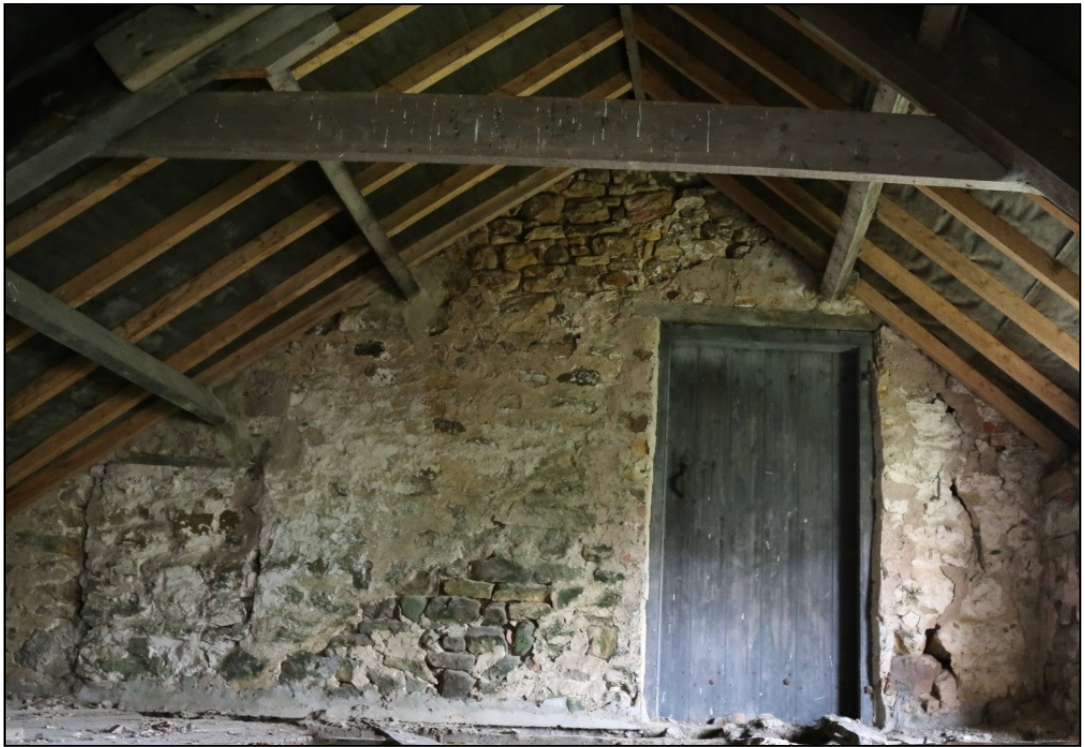
- 5.22 This part of the building contained fewer surviving historic features. It was a ground floor room with a loft above (Plates 12 and 13). The loft was formed by sawn timber floor joists, built into the external walls, demonstrating that the timbers are original to this part of the structure (Phase 2). The internal dividing walls (to the north-west and south-east) dated to the earlier phase of construction (Phase 1; Plate 12).

- 5.24 At first floor level (2F), the north-western wall contained a triangular wall scar, incorporating an early chimney, which demonstrated the outline of what seemed to be an earlier building (Phase 1) around which the building to the north-west was built (Plate 12). This earlier gable was narrower than the extant building, possibly corresponding with that shown on the First Edition Ordnance Survey (Plate 1).

Plate 12: a wall scar showing the roof pitch and chimney outline of the Phase 1 building gable in the north-west wall, truncated by a later doorway

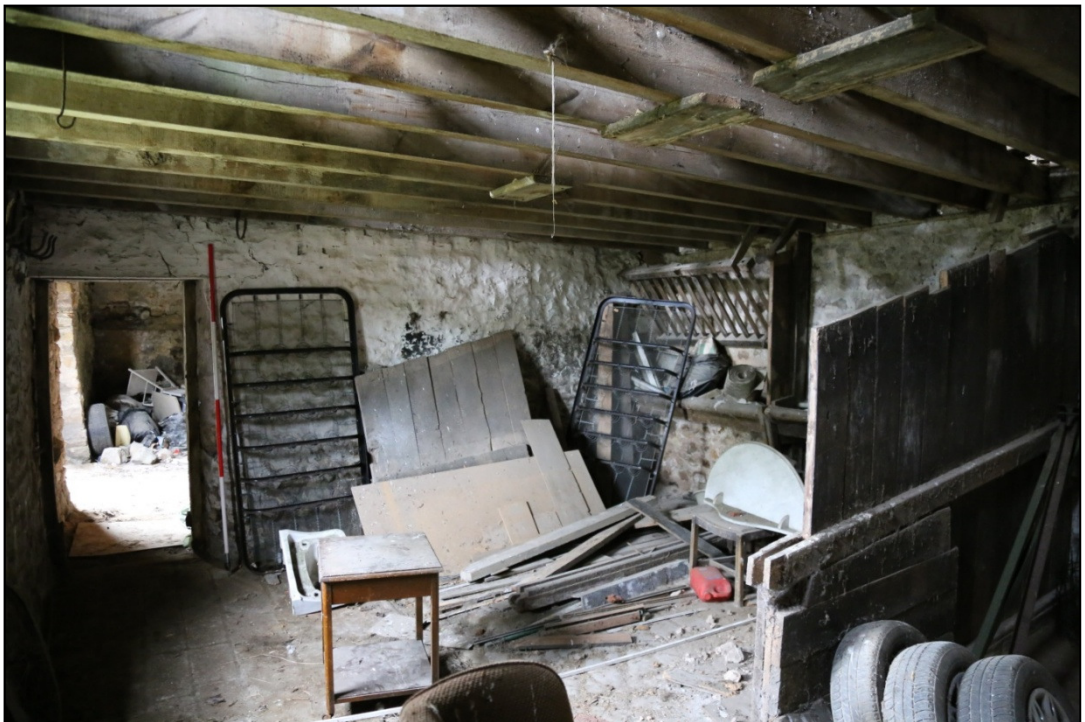
- 5.26 The northern wall of Bay 2G contained a small void, with stone surround, which was seemingly an original feature of the wall.
- 5.27 The floor was modern concrete, and it is possible that further evidence of the earliest phase of construction survives underneath this. The space also contained evidence of the recent use of the building for housing horses, including a timber stable partition and hay racks (Plate 13).

Plate 13: Bay 2G, looking south-east showing the loft joists, and later divisions which were evidence of the use of this space as stables

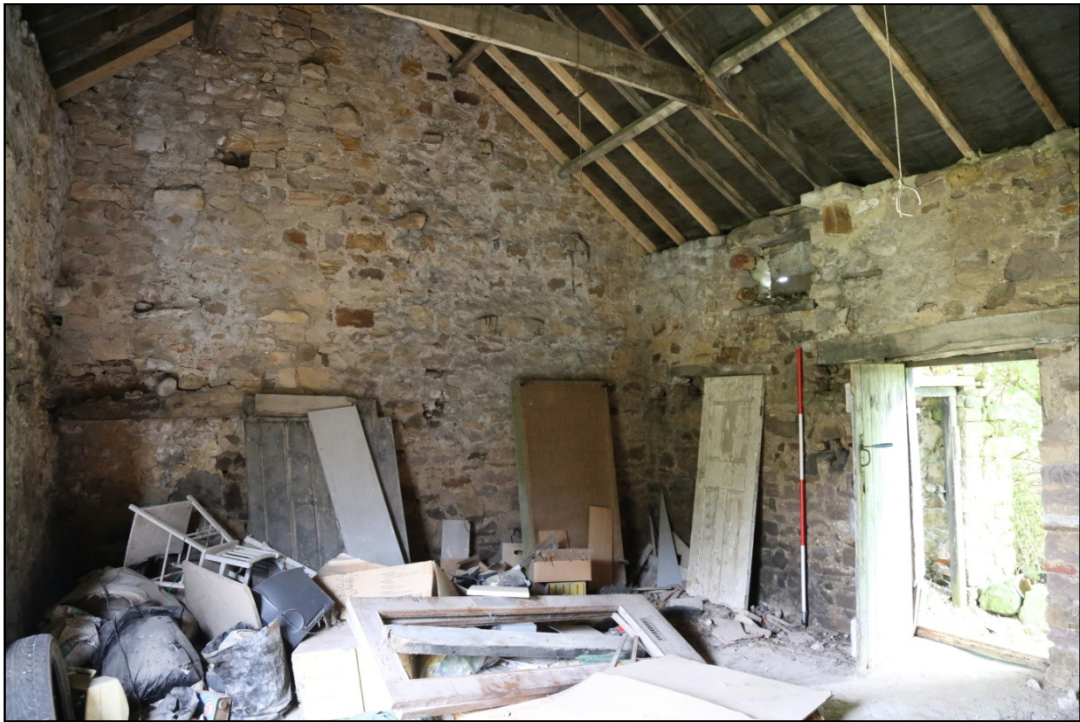
Plate 14: Bay 3, looking south, showing the loft opening on the south-eastern wall, and the door with timber lintel

- 5.29 The north and south walls of this room contained horizontal timber beams built into the wall at a height of approximately 2m, with what seemed to be former joist holes beneath (Plate 16). This may have been evidence of a former loft level in this area (Fig. 2). Supporting this contention is the opening on the south wall at loft level (Plate 16), probably a pitching loft originally. The phasing of the loft is not clear from the building fabric; the timber built into the walls was probably original, but this would have obstructed the doorway (now blocked) in the eastern corner of the room (Plate 14; seen externally, see Section 5.10).

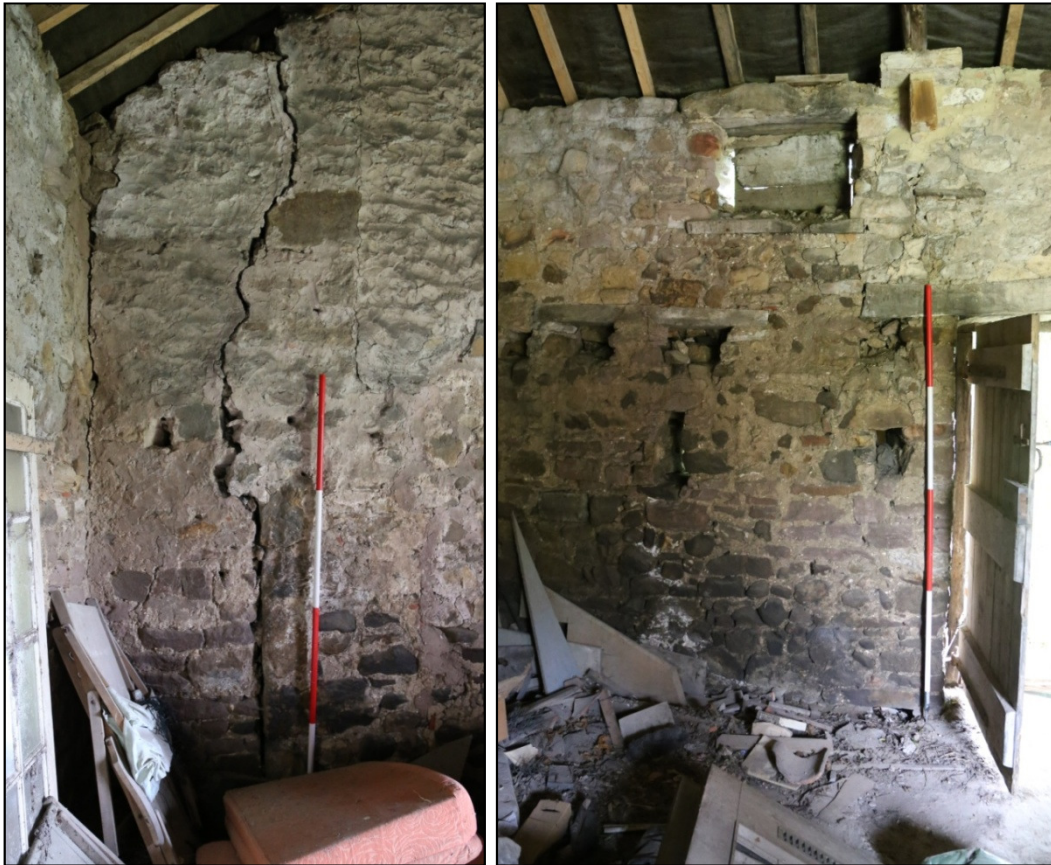
- 5.25 The internal dividing wall to the south-east (between Bays 2 and 3) contained a vertical wall scar, reflecting this narrower Phase 1 gable (Plate 15). A triangular wall scar was not visible in this wall, although it was heavily plastered, so it is possible that further evidence survives beneath this. These two internal walls were probably the earliest historic building fabric surviving within the building.

- 5.30 The south wall contained a slit vent at ground floor level, which was probably original to the building (Plate 16). At the time of the survey, this led into the outbuilding. It is likely that a slit vent would have been built into an external wall, supporting the

contention that the outbuilding was a later addition. It is rare to find a single slit vent in a farm building; there were probably multiple, with others now in-filled. This feature, along with the evidence for a loft, indicates that Bay 3 was probably used as a granary, or possibly for small-scale hand-threshing given the presence of opposing doors (although both are not wide, which might be expected in these circumstances).

Plates 15 and 16: the wall scar in the north-west wall of Bay 3, where the internal wall of the Phase 1 building was extended southward in the late 19th century, and the in-built timber and joist holes demonstrating the position of a former loft level in Bay 3
