**ARCHAEOLOGICAL  
INVESTIGATION**

**ROSEBERY COURT  
SHELTERED HOUSING**

**MONKSEATON**

Project No.: 1145  
Text: Oliver Cooper  
Illustrations: Cath Chisman

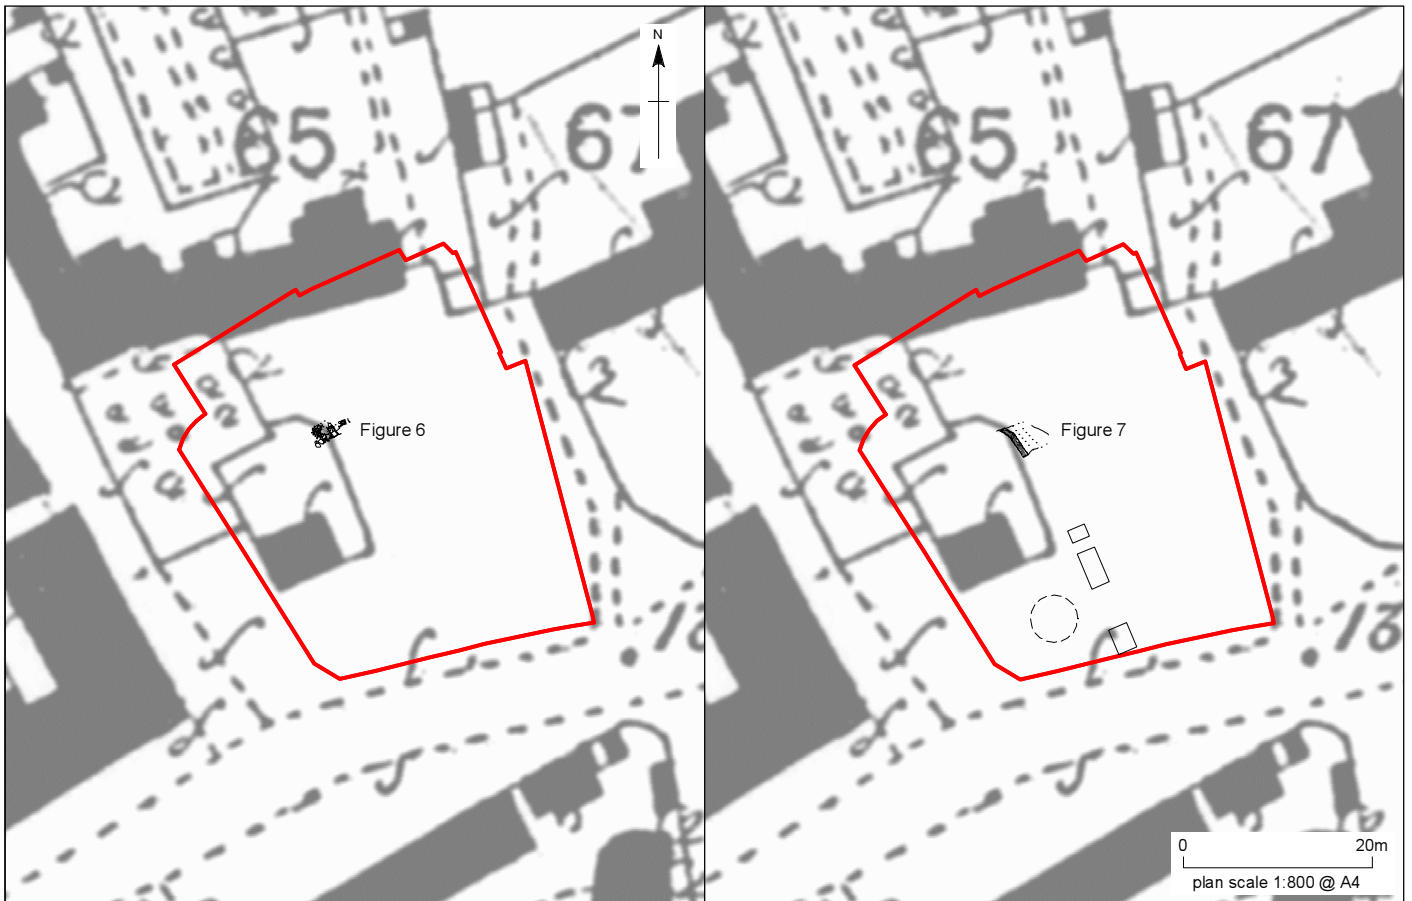
Figure 3

Rosebery Court, Monkseaton: archaeological monitoring results overlain on Ordnance Survey map, 1858

- 3.10 A small, un-named building was shown in this part of The Fold on the Ordnance Survey plan of 1858 (Fig 3). By this date, the area around The Fold had become more fully developed and formalised with lanes leading north from the main road on either side of the central open space. The lane to the west provided access to the two rows of early 19th-century terraced cottages, while that to the east provided access to the North West Farm and possibly the cottages and public house to the west. Both lanes are preserved in part within the existing road layout.

- 7.4 Following the infilling of the trough with smithing waste, a considerable depth of garden soil developed (whether gradually, or by import cannot be ascertained). By 1858 (Fig 3), a small house had been constructed on the western edge of the development site, with a rear garden enclosed by a curving boundary wall. It seems likely that feature 4 encountered during the current investigations was the footing for this wall.

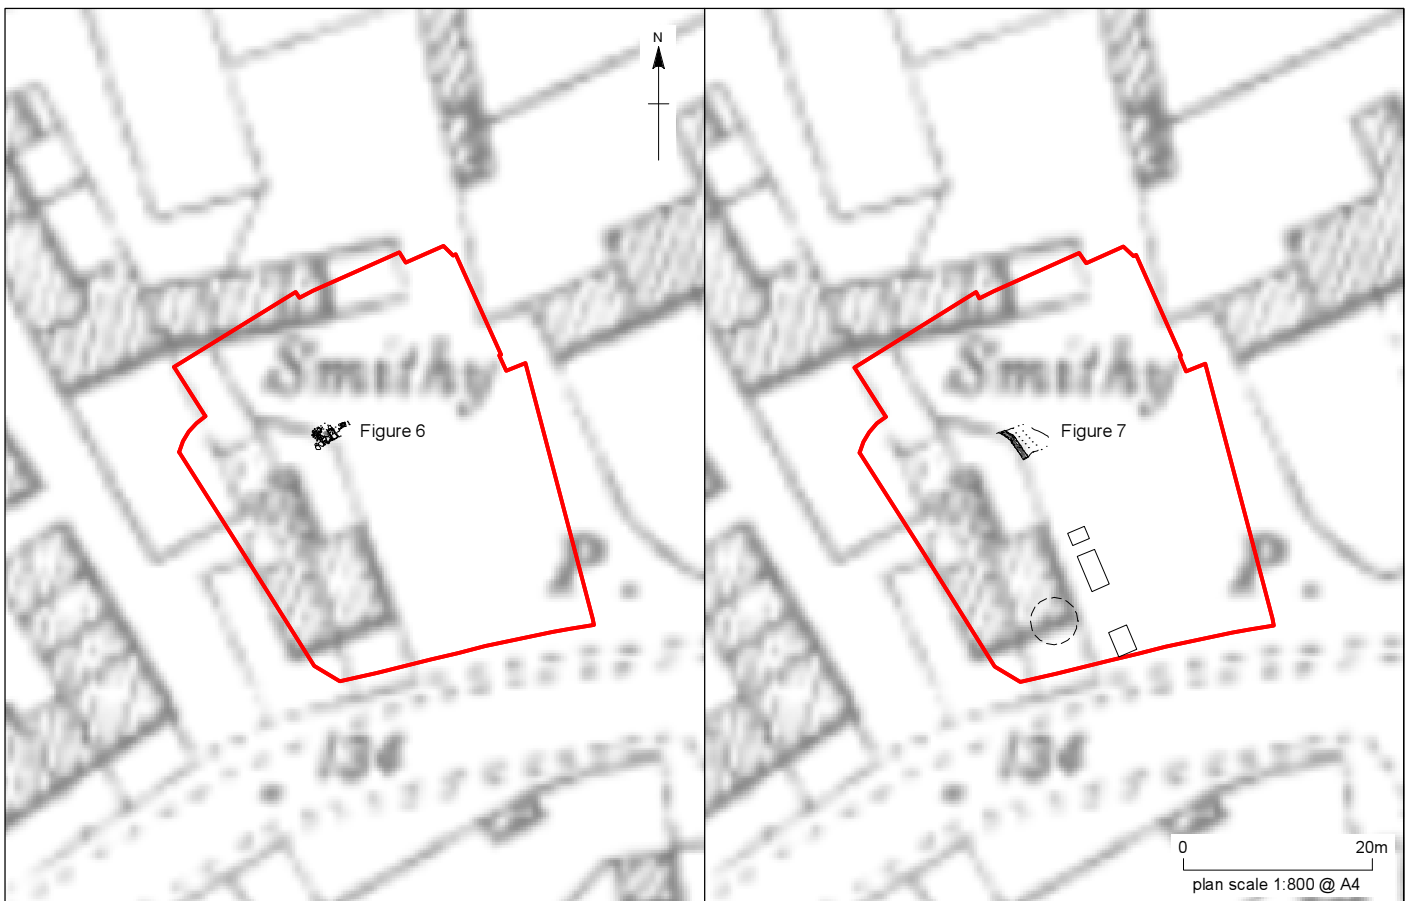
Figure 4

Rosebery Court, Monkseaton: archaeological monitoring results overlain on Ordnance Survey map, 1897

- 3.13 By 1897 (Fig 4), the small building with attached garth previously shown within the western part of the proposed development site had been replaced by two semi-detached houses called 'Murie House' and 'Jessamine House'. These were again set slightly back from the street, behind small front gardens enclosed by a low stone wall and iron railings. The 1897 map shows enclosed yards or gardens to the rear, the boundaries of which preserved elements of the boundaries of the demolished property, including the curving section of wall. To the east of these properties, there was an area of open ground.

nearest building to the site on the OS Second Edition map of 1897 (Fig 4) was labelled 'smithy'. The implication is that the smithy pre-dated the OS mapping. Pigot's directory of 1828/9 lists two blacksmiths within the village, although it does not provide addresses or other locational information (Genealogy UK, online).

- 7.5 This wall was retained as the boundary of the rear gardens of 'Murie House' and 'Jessamine House', a pair of much larger houses that replaced the smaller one prior to the 1897 map revision (Fig 4). By 1919, Roseberry Terrace had been constructed to the east of the development site, and its back lane followed the curve of the wall (Fig 5). The current investigations showed this back lane to consist of fairly regularly spaced angular sandstone blocks bedded on a layer of ash, slag and broken brick, and topped by a layer of fine crushed slag.

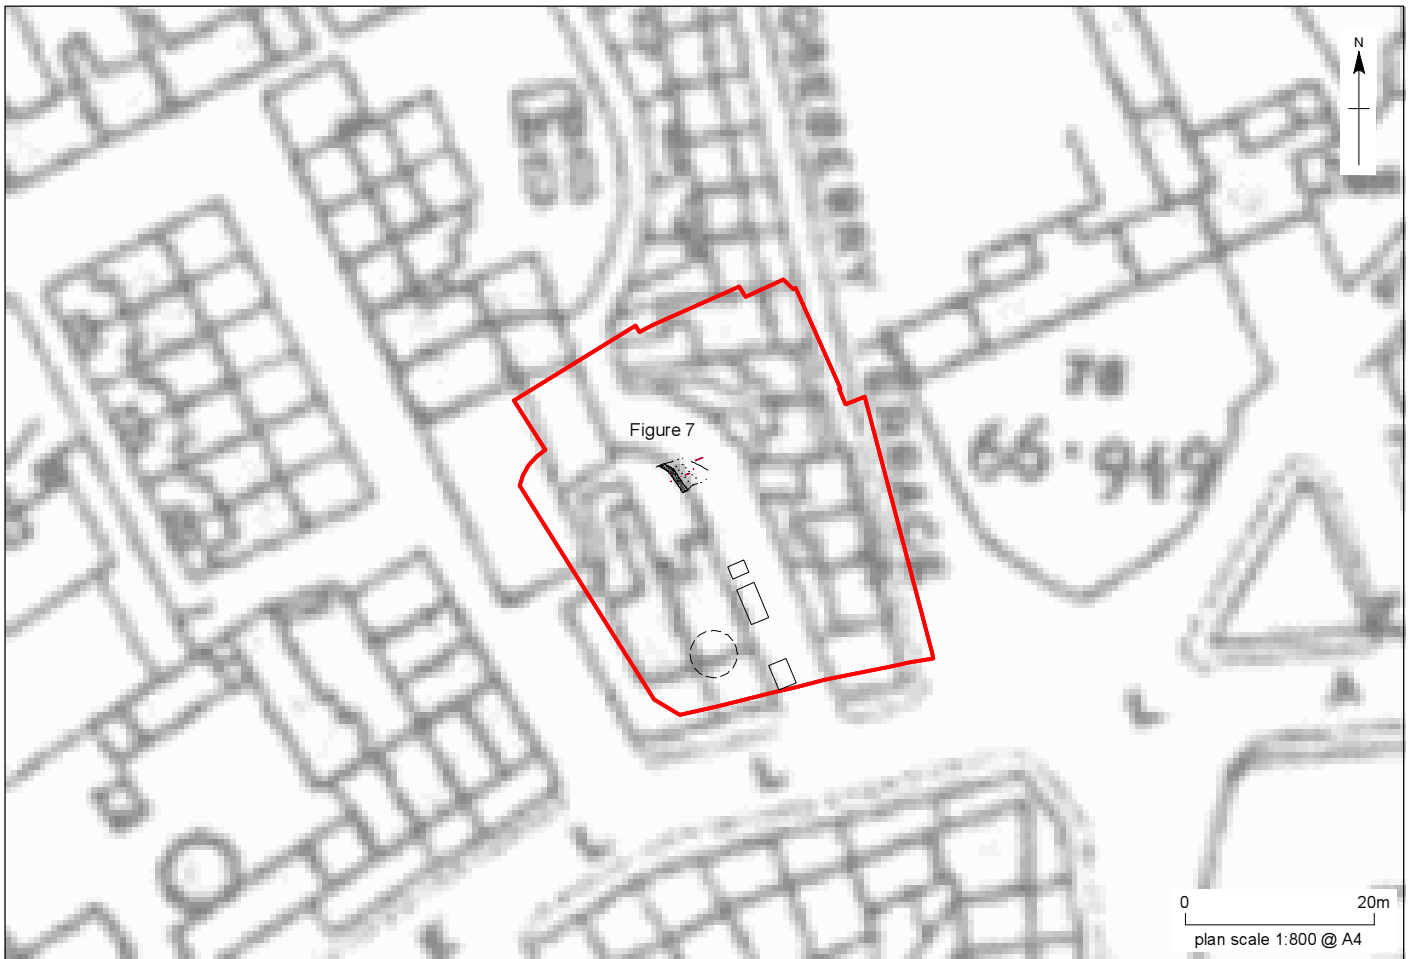
Figure 5

Rosebery Court, Monkseaton: archaeological monitoring results overlain on Ordnance Survey map, 1919

- 3.15 At some point between 1897 and 1905, the open ground within the eastern part of The Fold was developed and Roseberry Terrace, a long row of properties running at 90 degrees to the main road, was constructed. This terrace would have run north to south along the entire length of the eastern boundary of the development site. It was separated from Murie House and Jessamine House by a back lane to the rear of the terrace, sweeping round to preserve the curve of the Victorian boundary wall (Fig 5).

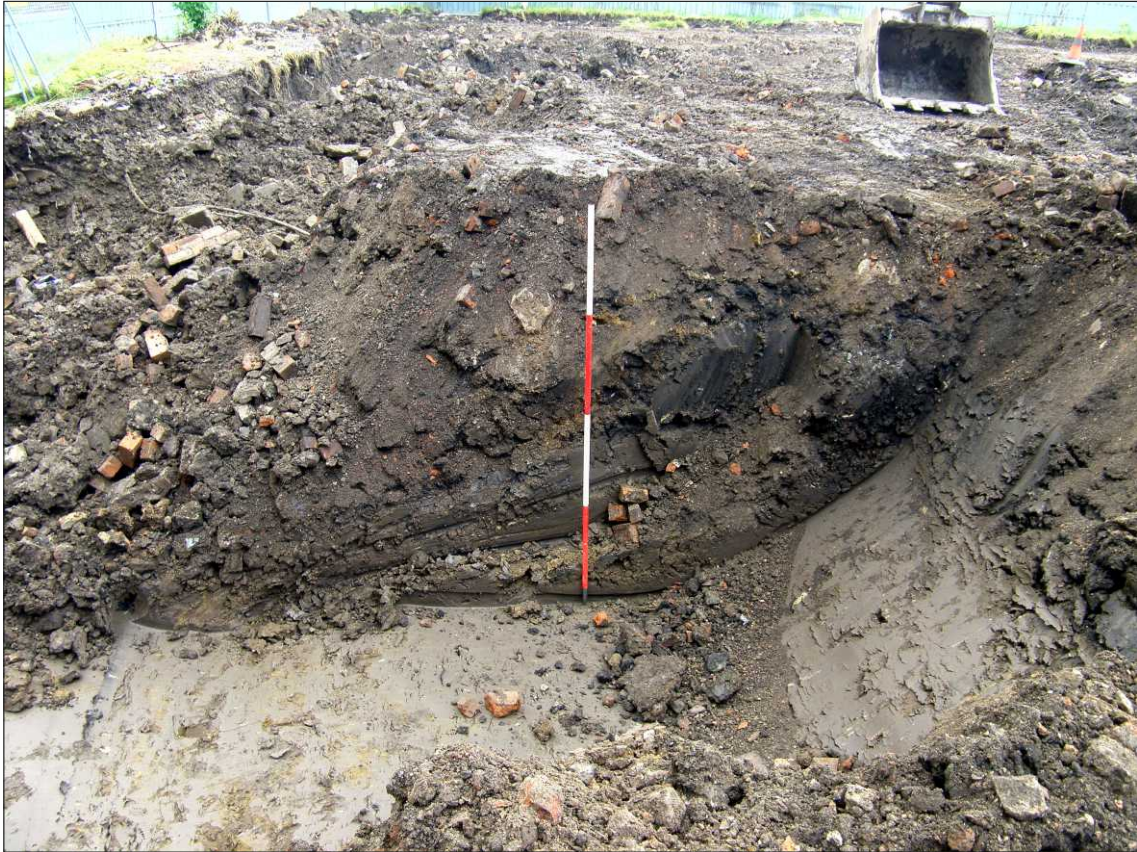
*Plate 1*

*Rosebery Court, Monkseaton: trial trench showing made ground and boulder clay*

- 6.2 The concrete slab for the original building was 0.1–0.2m deep, seated on two layers of re-used, plain machine-made bricks. Underlying this was a considerable depth of ‘made ground’ (22), representing redeposited material from the original foundation excavations (Plate 1). This was up to 1.6m deep behind the rear wall of the garages, where the slope had been infilled, rising to approximately 0.8m at the south-western end of the trench. This deposit incorporated late 19th to early 20th-century bricks, bottles and sherds of pottery, together with fragments of slate and ceramic roof tiles and rough-dressed sandstone masonry (not retained). Some of the bricks were stamped A-C, for Ashington Coal Company Ltd (Old Bricks, online). It was considered that these were derived from the demolition of Roseberry Terrace prior to the construction of the original sheltered housing. Beneath the made ground deposits was the natural boulder clay (2).

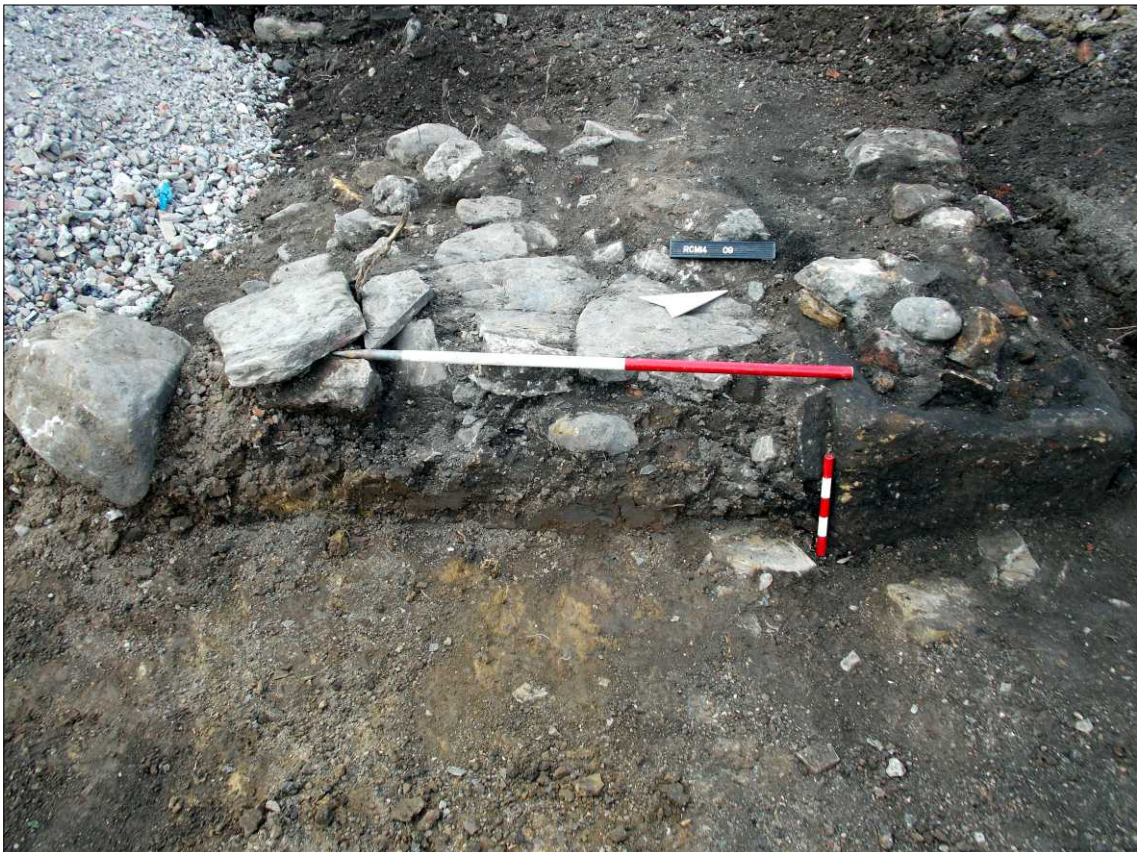
*Plate 2*

*Rosebery Court, Monkseaton: structure 9 showing filled stone trough (10) on right*

- 6.5 Throughout most of the area, the original sheltered housing had removed all soil layers down to natural clay (2). Archaeological features survived only in the areas of former garden, both in the centre of the site and at its southern edge. The earliest features were towards the north-west corner of the site, where 1m below the modern ground level, a stone trough (10) had been set into the earth (Fig 6; Plate 2). Adjacent to it was 1.3m of dry-stone, sandstone and quartzite cobble wall (15), surviving for only three courses and backed by a cobble and earth revetment (13). The wall and revetment had been capped with irregularly-shaped, flat sandstone flags (12) extending over an area approximately 1.4m square but much disturbed by later activity. The revetment incorporated large fragments of 19th-century pottery, and a clay pipe bowl of similar date was also recovered. Between wall 15 and the revetment was a 0.25m-wide gap, which may originally have been intended as a drain or for ventilation, but within which a fine silty soil (17) had accumulated,

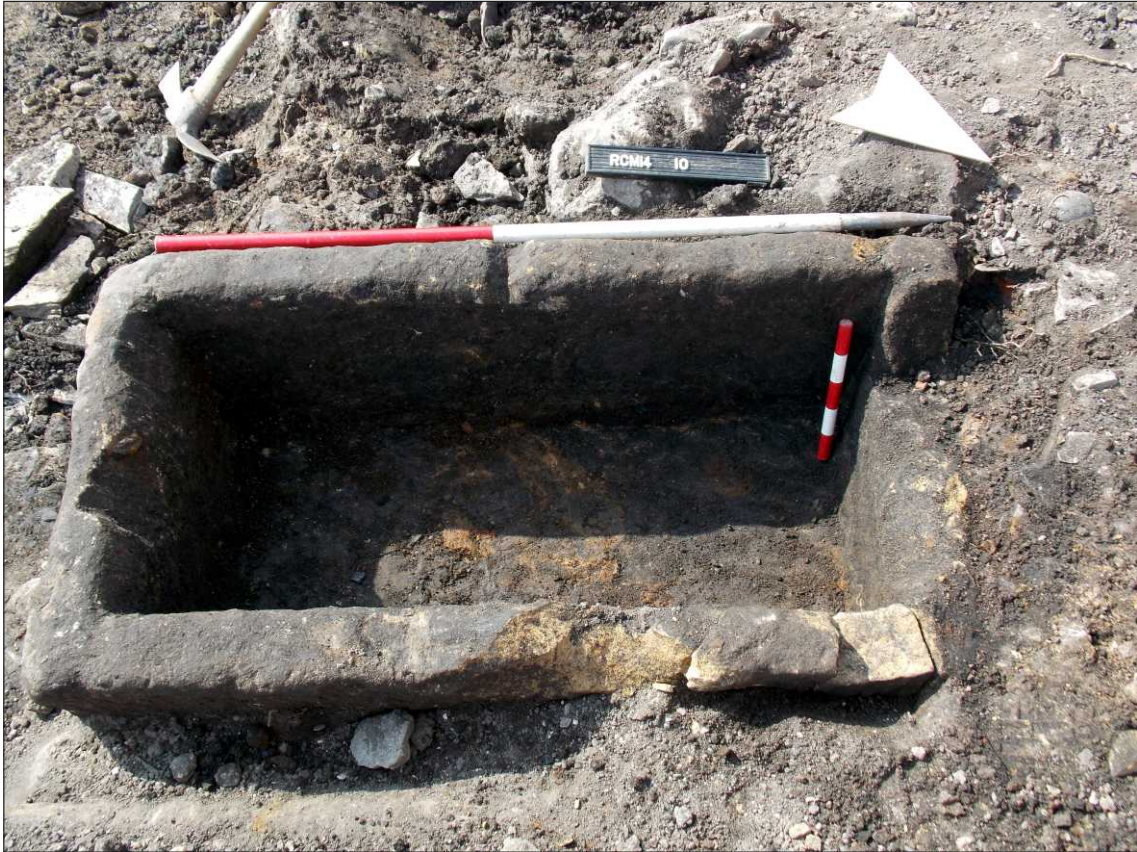
*Plate 3*

*Rosebery Court, Monkseaton: stone trough 10 emptied*

- 6.6 Trough 10, measuring 1.3m by 0.6m wide by 0.45m deep (Plate 3) had been broken at one end in antiquity but was 80% complete and retained its drain hole in one corner, and an inlet mid-way along one edge. It had been deliberately filled with waste (11; Plate 4) including large fragments of slag, together with two shoes, metal offcuts, a clay pipe and 19th-century pottery and glass. The slag included larger smithing hearth bottoms and flake and spheroidal hammerscale; *unambiguous evidence* for iron smithing to have been the major activity (Starley, Appendix C).

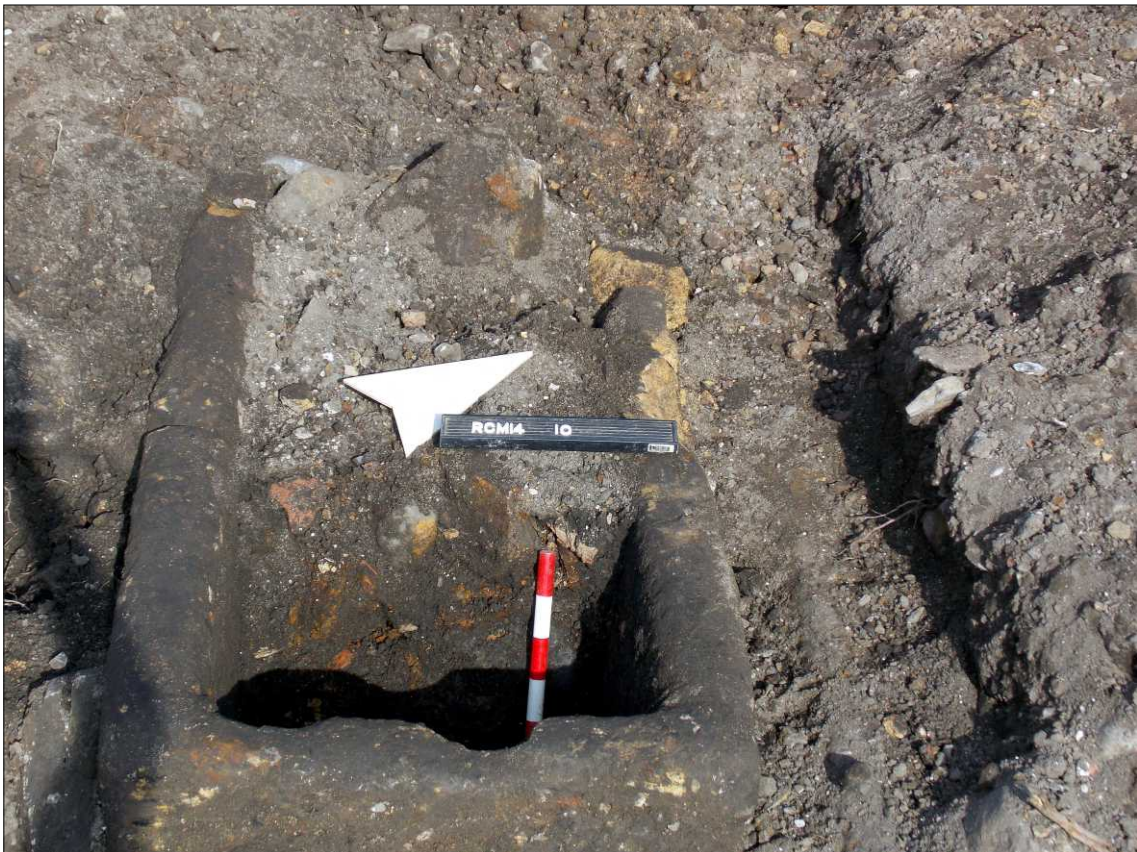
*Plate 4*

*Rosebery Court, Monkseaton: trough 10 during excavation*

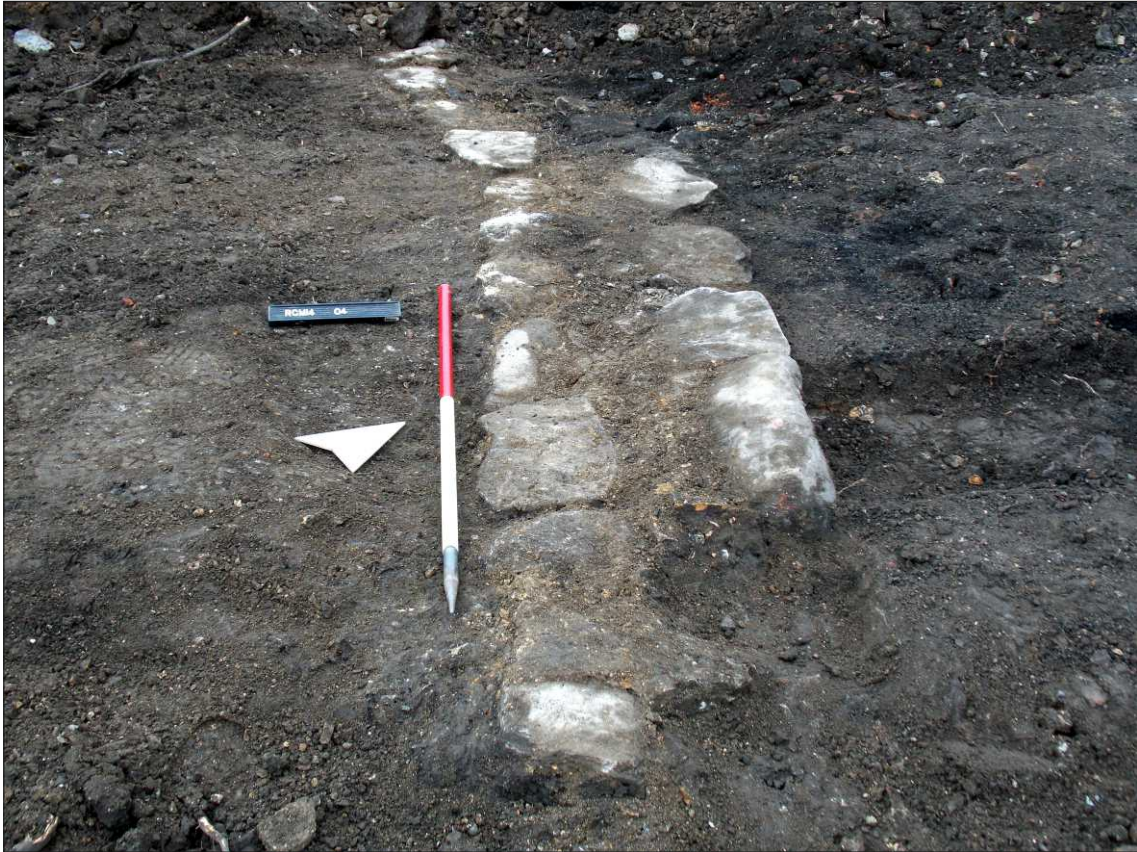
*Plate 5*

*Rosebery Court, Monkseaton: wall foundation 4*

- 6.8 Following the infilling of the trough, a layer of garden soil (8) had accumulated to a depth of up to 0.5m, although where it overlay the trough it was 0.3m deep. The foundations of a wall (4; Fig 7) were cut into this layer, levelled with occasional slabs of clay (16). The wall survived over a distance of 5m, curving from a north-easterly alignment to almost east (Plates 5 and 6), and was 0.5m wide and no more than 0.2m (one course) deep. Patches of mortar survived in places between the stones, which comprised roughly-shaped sandstone blocks and irregular river cobbles.

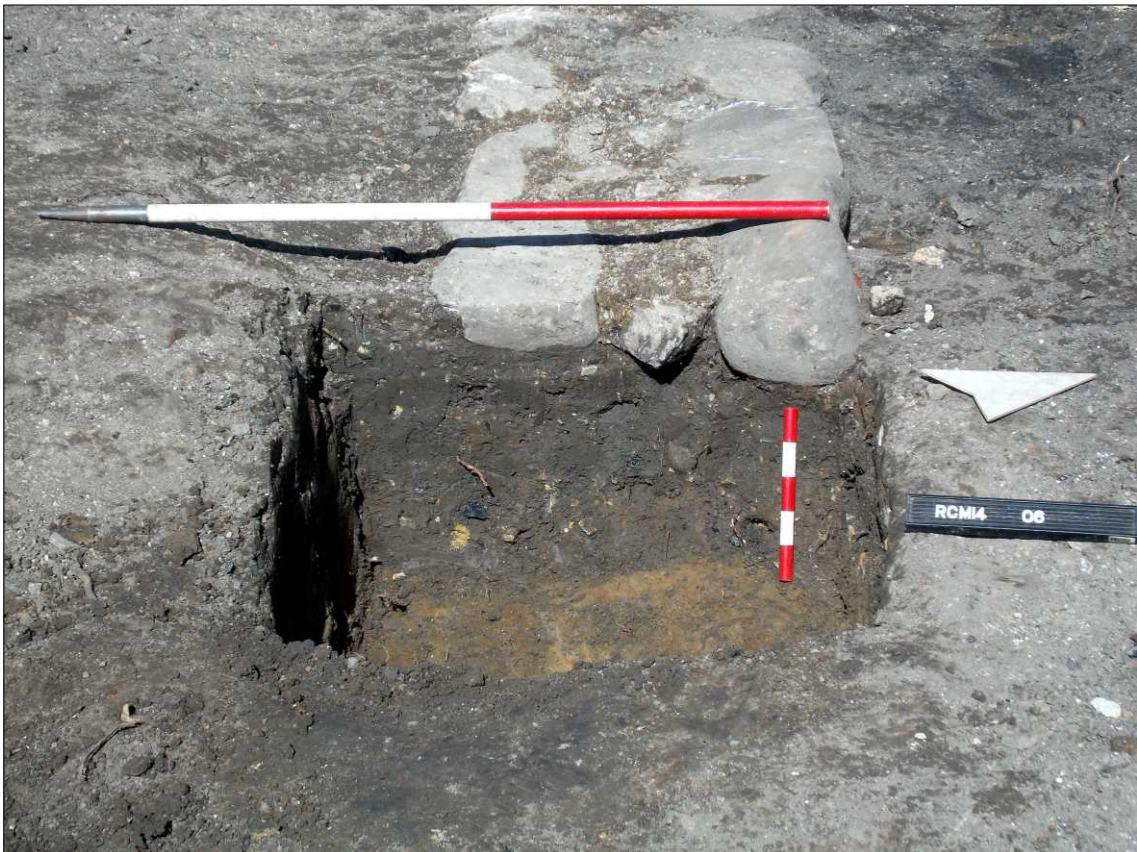
*Plate 6*

*Rosebery Court, Monkseaton: section through wall 4  
showing soil (8)*

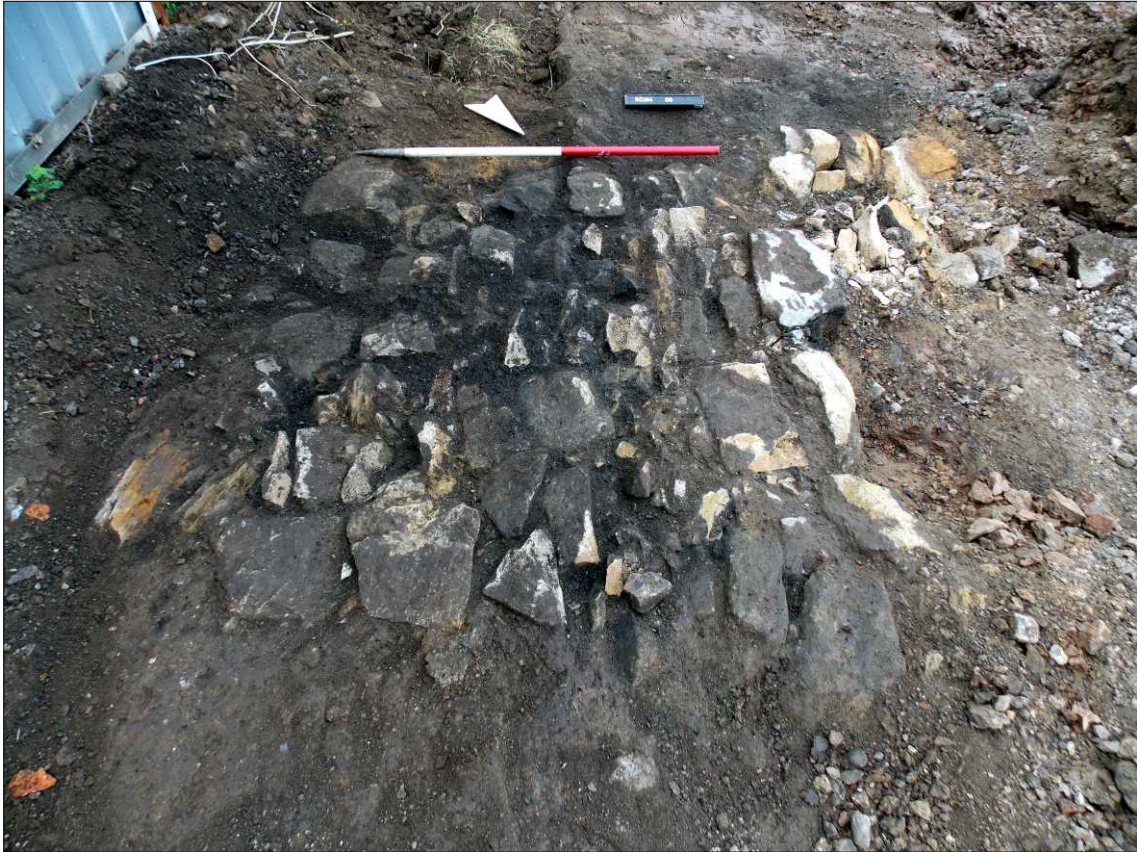
*Plate 7*

*Rosebery Court, Monkseaton: fragment of back lane (6)*

- 6.9 While to the west of the wall layer 8, extending for 8m, was covered by modern topsoil (1), to the east was a zone of dark grey gritty silt (7) with a large proportion of slag, coal and chips of ceramic building materials, plus 19th to 20th-century glass, potsherds, nails and animal bone (not retained). This deposit was the bedding for a cobbled lane (5) surviving over a distance of 3.5m north-west to south-east and a width of up to 1.5m. The remnants of this lane were encountered in three further areas (3, 6 and 20) in a band running south-eastwards across the site (Fig 2). The best preserved was at the southern end of the site, where a small patch of metalling (6) survived in the former front garden of the sheltered housing. This extended for 2.8m north-west to south-east by 2m, and comprised fairly regularly spaced angular sandstone blocks (Fig 7, Section 2; Plate 7), up to 450mm by 200mm, again bedded on a layer of ash and broken brick (19). It appears likely that fine slag was spread on top of the sandstones to provide a smooth surface.

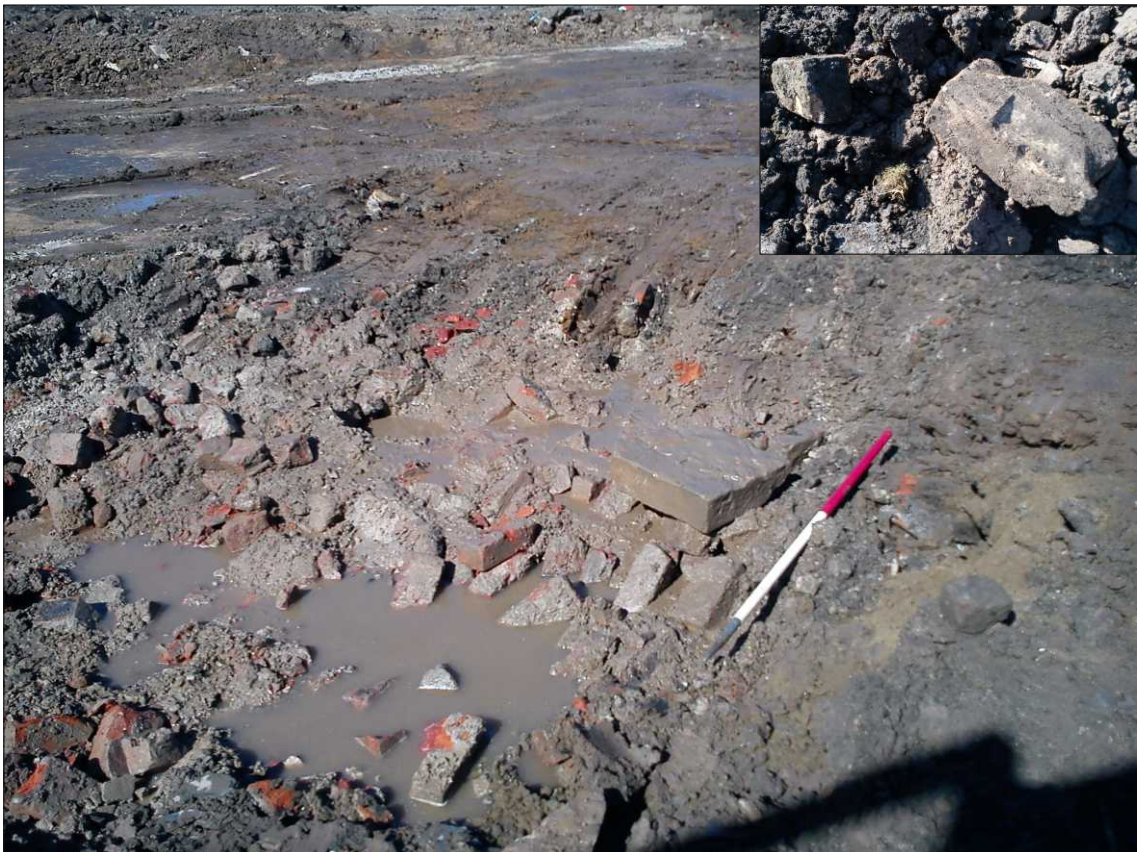
*Plate 8*

*Rosebery Court, Monkseaton: possible 1940s bomb crater (23),  
with dressed masonry (inset)*

- 6.10 The only other historic feature encountered within the main site was a roughly circular depression (23) approximately 5m across but of unknown depth (Fig 2), located at the south-western corner of the site. This had been sealed beneath the foundations of the original sheltered housing. The depression was filled with plain bricks, large sherds of window glass, pieces of wood and slate

tiles, plus fragments of dressed masonry (Plate 8). It is probable that this represents the site of the WWII bomb that destroyed the two Victorian houses.

- 7.6 In a WWII bombing raid, several buildings around The Fold were damaged or destroyed, including Jessamine House and Murie House. Pre-war photographs show these to have been constructed of brick with slate roofs and stone window cills and lintels. It therefore seems reasonable to interpret the large depression recorded during the present investigations, which was filled with bricks, large sherds of window glass, pieces of wood, slate tile fragments and dressed masonry, as either the bomb crater, or perhaps the infilled cellar of one of these houses.

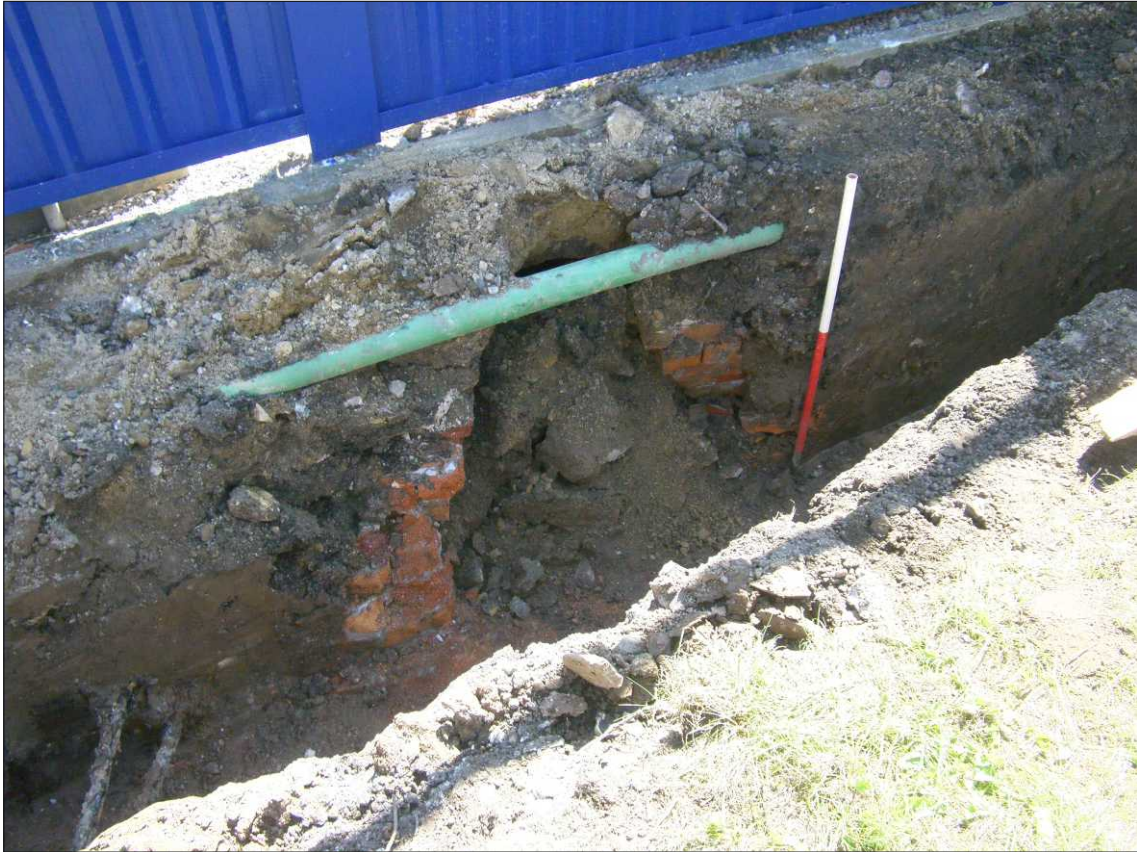
*Rosebery Court, Monkseaton: manhole in water main trench*
