CART SHED AT FORTHBURN
FARM, DENT GATE LANE,
BARNARD CASTLE, COUNTY
DURHAM

NAA 17/36
March 2017

CART SHED AT FORTHBURN FARM, LANGLEYDALE, COUNTY DURHAM

ARCHAEOLOGICAL BUILDING RECORDING

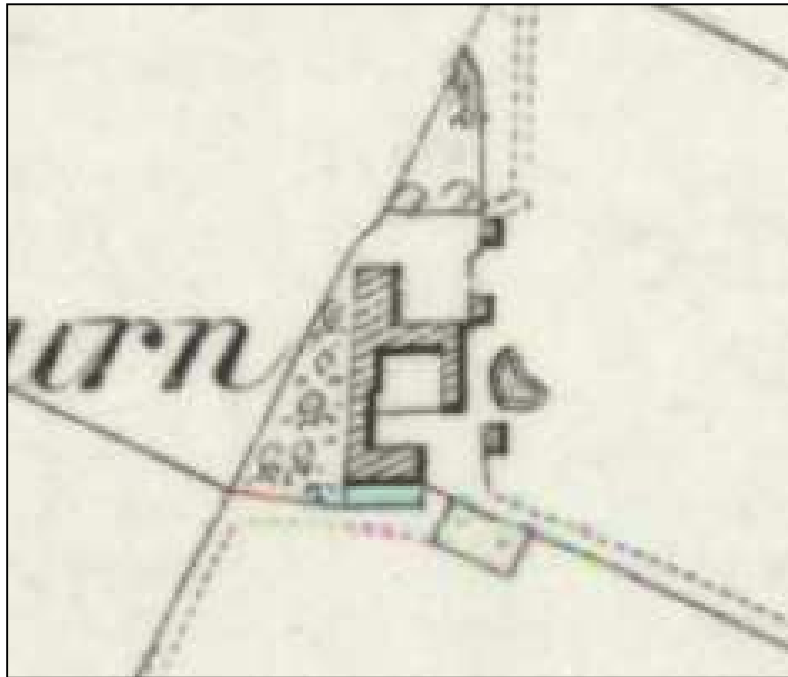
Plate 1: First Edition Ordnance Survey map, published 1859

- 4.1 Forthburn Farm was established by 1859, and is shown on the First Edition Ordnance Survey map (the earliest record available for this research), although the cart shed had not been constructed by this time (Plate 1). The farm comprised a number of conjoined buildings, positioned around a central yard. There were three small structures to the east of the main farm complex, the use of which is not known, and a small kidney-shaped pond. The main access to the farm was from the south-east, as it remains today.
- 4.2 The Second Edition Ordnance Survey map (published in 1898; Plate 2) provides the first record of the cart shed, to the east of the main farm buildings. Examples of cart sheds from this date are relatively common in the region. The rise in the number, and increasing size and sophistication of carts and field implements post-1840 were

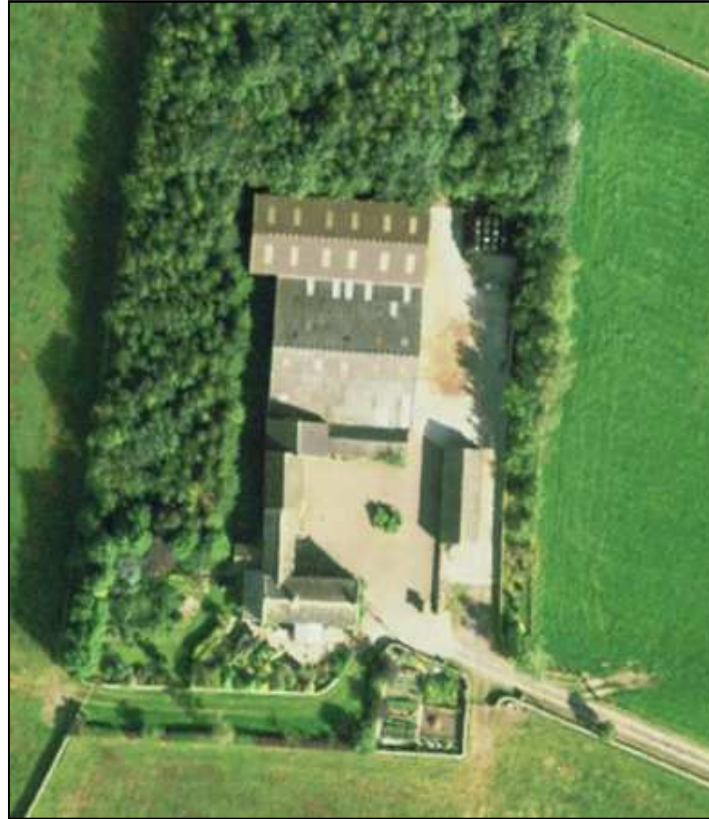
Plate 4: Modern aerial photograph of Forthburn Farm (Google Earth 2017)

- 4.8 At some point between 1960 and 1980, the owner of the site reports that the eastern building of the courtyard complex – directly west of the cart shed – was demolished. There are also two large modern farm buildings at the north end of the site, built around the same period. Apart from these changes, the farm retains much of its historical layout (Plate 4).

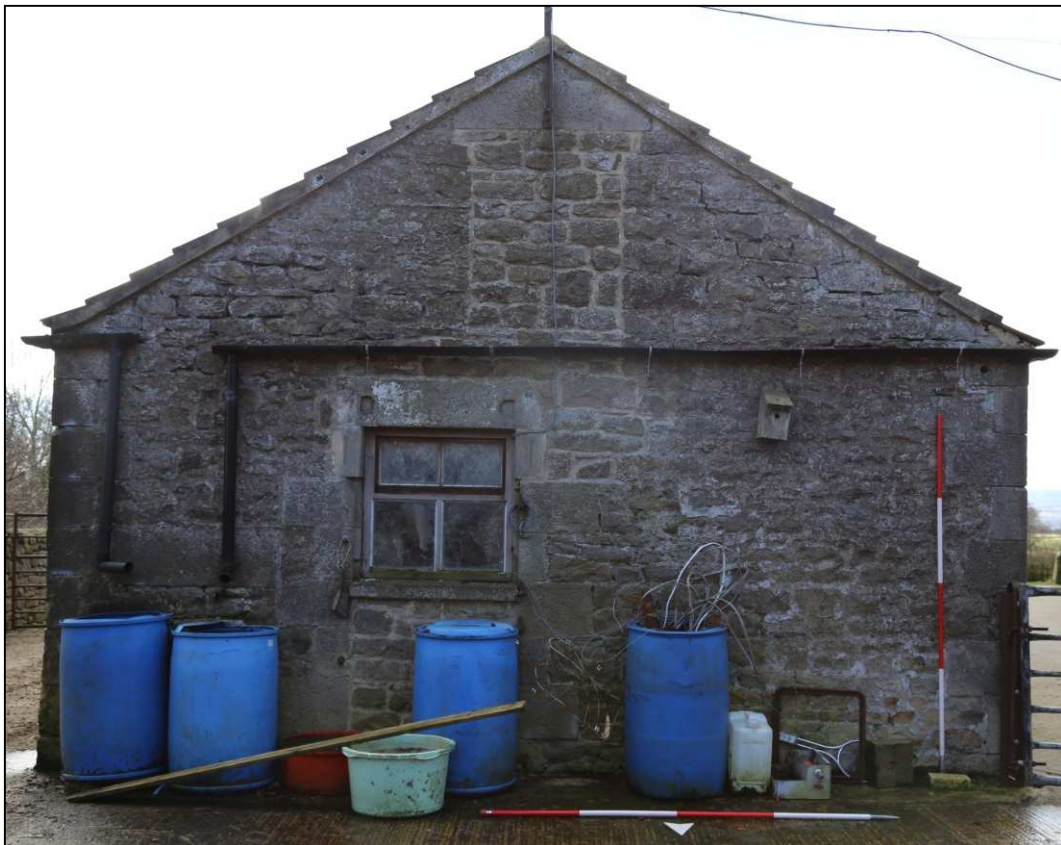
Plate 5: North elevation of the cart shed

- 5.6 The north gable faced into the main farmyard. It comprised random-coursed rubble stone, with some patches of later blocking (Figure 2; Plate 5). Dressed and margined

stone quoins formed the east and west edges of the elevation. Much of the cart shed's stone had been heavily repointed in concrete cement, which may have obscured the legibility of wall scars and other evidence.

- 5.7 The gable contained one window opening at the time of the survey. This was set into the top of what was originally a doorway with dressed and margined quoins.
- 5.8 There was a further blocked opening at loft level, containing coursed stone, which could not be accurately dated. The loft doorway had a stone lintel, which was partially truncated by the eaves; there was no clear evidence of change in roofline, indicating that this was probably originally cut to fit into the roof. However, the opening did not feature margined stone quoins, perhaps suggesting that it was a later insertion. A vague wall scar indicated the line of a former external staircase, which once provided access to the loft (removed by the current owner some years ago).

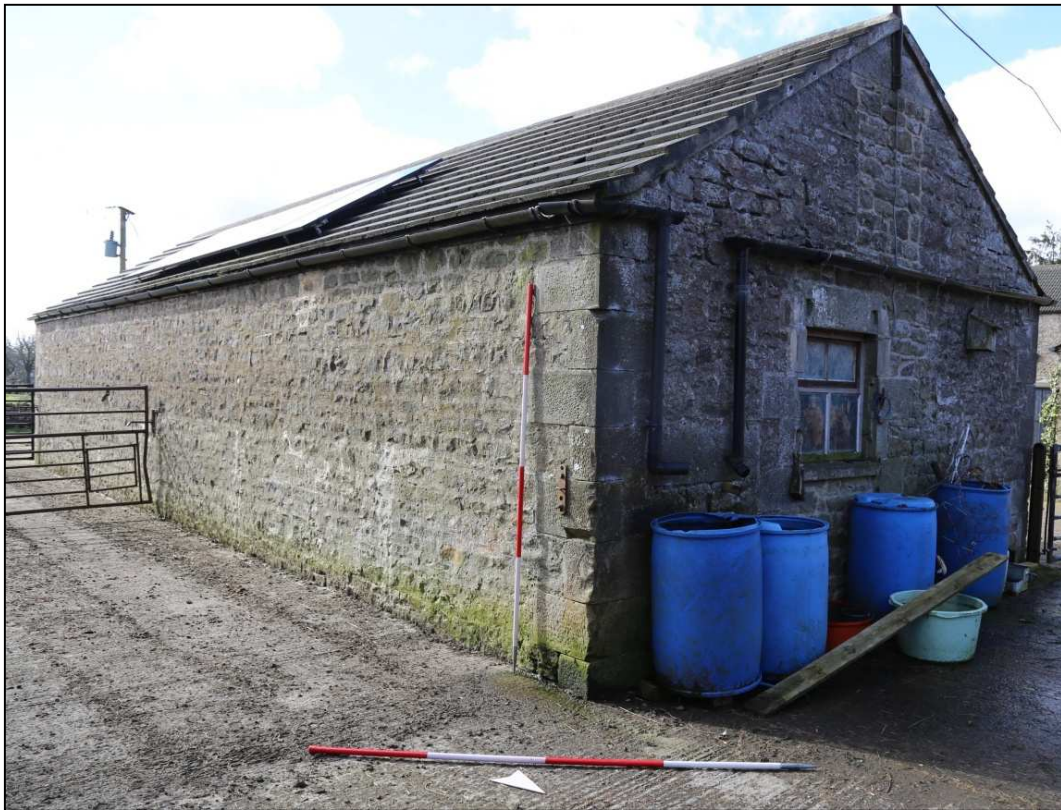
Plate 6: Oblique view of the east elevation of the cart shed, looking south-west, with the north elevation to the right

- 5.10 The east elevation of the cart shed was formed by random-coursed rubble stone and was blind, with the exception of dressed and margined stone quoins at either end and a number of inserted metal gate hinges and fastenings (Plates 6 and 7).

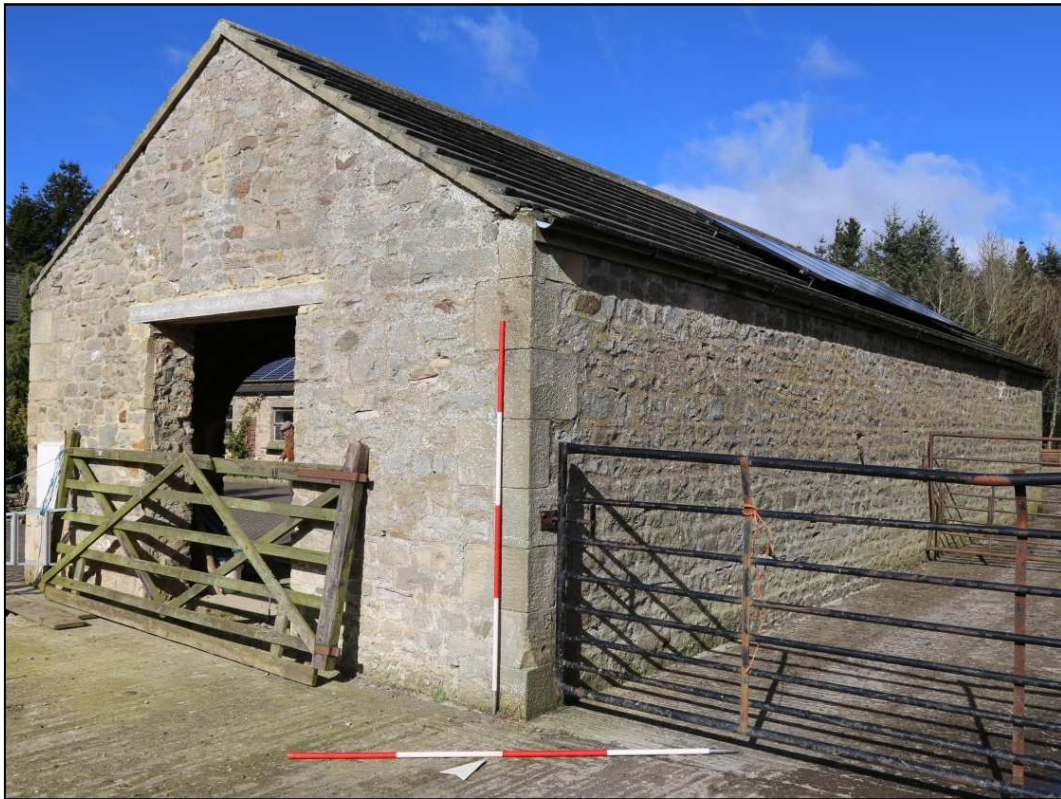
Plate 7: Oblique view of the east elevation of the cart shed, looking north-west, with the south elevation to the left

- 5.11 The south gable comprised random-coursed rubble stone, with dressed and margined stone quoins at the east and west edges (Plates 7 and 8). The western part of the elevation showed evidence of some rebuilding (Plate 10), corroborated by the current owner who reported having rebuilt the south-west corner of the building.
- 5.12 The elevation contained one large opening, positioned slightly off-centre. The opening featured a concrete lintel, which may have replaced an earlier stone lintel. However,

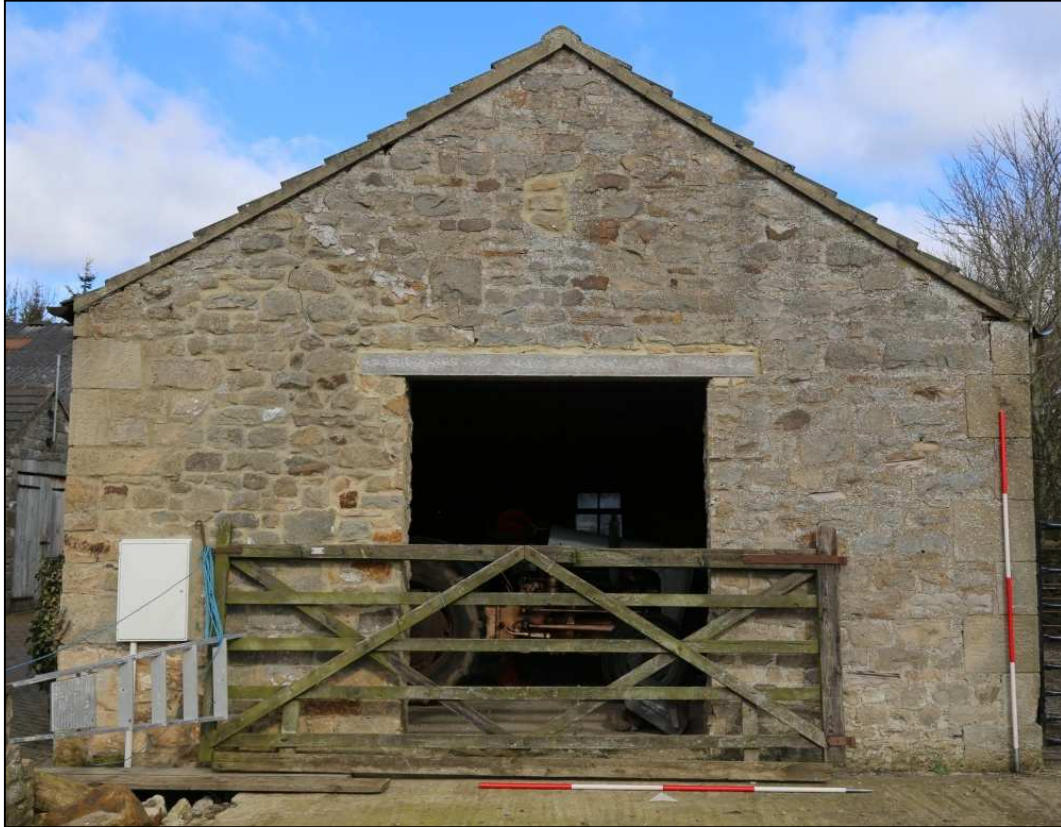
- 5.13 A very small patch of infill positioned relatively central to the wall, above the main opening, may have indicated the former position of a vent (Figure 2; Plate 8).

Plate 8: South gable of the cart shed

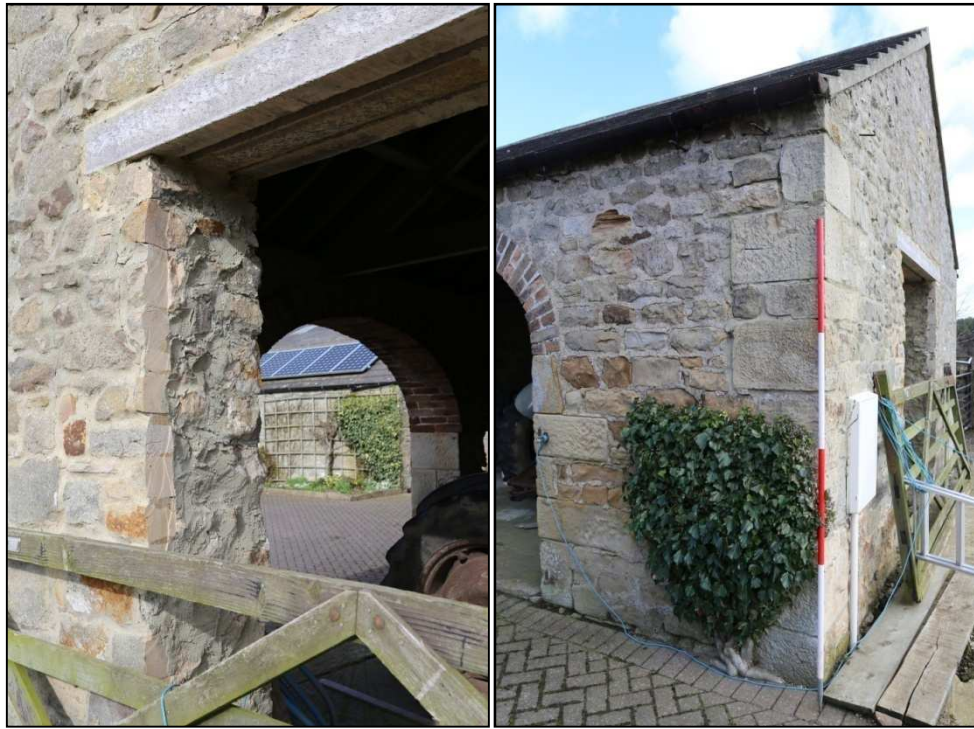
the opening was a later insertion, lacking the margined jamb characteristic of earlier openings, and exhibiting evidence of being cut into the stone walling (Plate 9).

Plates 9 and 10: Opening in the south elevation (a later insertion), and the rebuilt south-west corner of the cart shed, location of the former blacksmith's forge

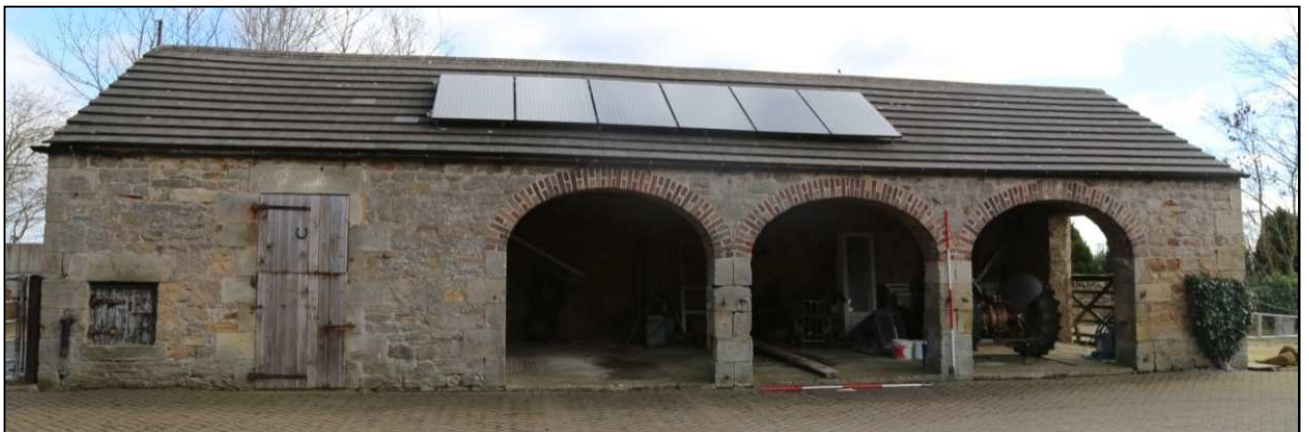
Plate 11: West elevation of the cart shed

5.16 The three arches were all of the same construction. The abutments of the outer arches were formed by margined stone quoins built into the walling. The two piers comprised large dressed stone blocks. The arch voussoirs were red bricks. The random-coursed stone walling forming the rest of the elevation continued above the arches as spandrels up to the eaves (Plate 11).

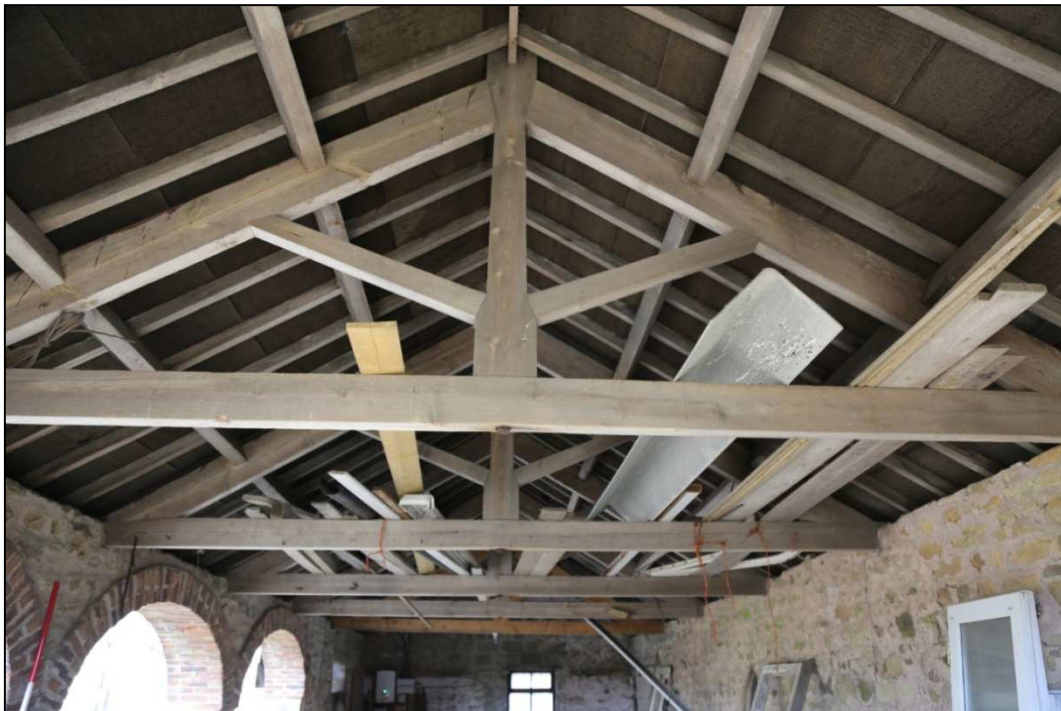
Plate 12: Modern timber roof structure, looking north

- 5.3 The roof had been entirely replaced in recent decades and comprised five sawn-timber king-post trusses and concrete tiling externally. There was no sign of reuse of earlier materials. The floor was modern concrete throughout.
- 5.4 The west elevation contained three open brick-arches supported on piers formed by large dressed-stone blocks. The openings are entirely characteristic of a cart shed, and would have been used for the passage of machinery and carts, and latterly motor vehicles.
- 5.5 The building was in use as storage at the time of the survey.

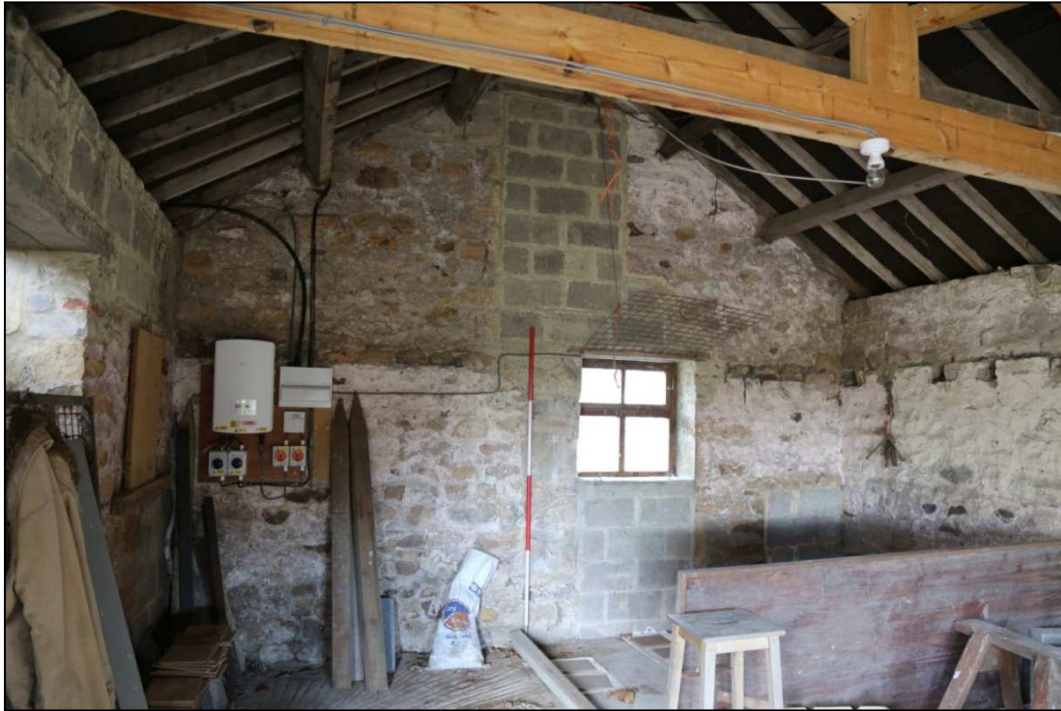
- 5.22 The north wall contained a single window, set into a former doorway (which was otherwise blocked), a blocked loft opening, and a blocked hatch (Plate 13). Internally, all blocking was in breezeblock; timber lintels survived above each opening. Parts of the north wall had remnants of lime plaster covering.

Plate 13: Internal north wall of the cart shed

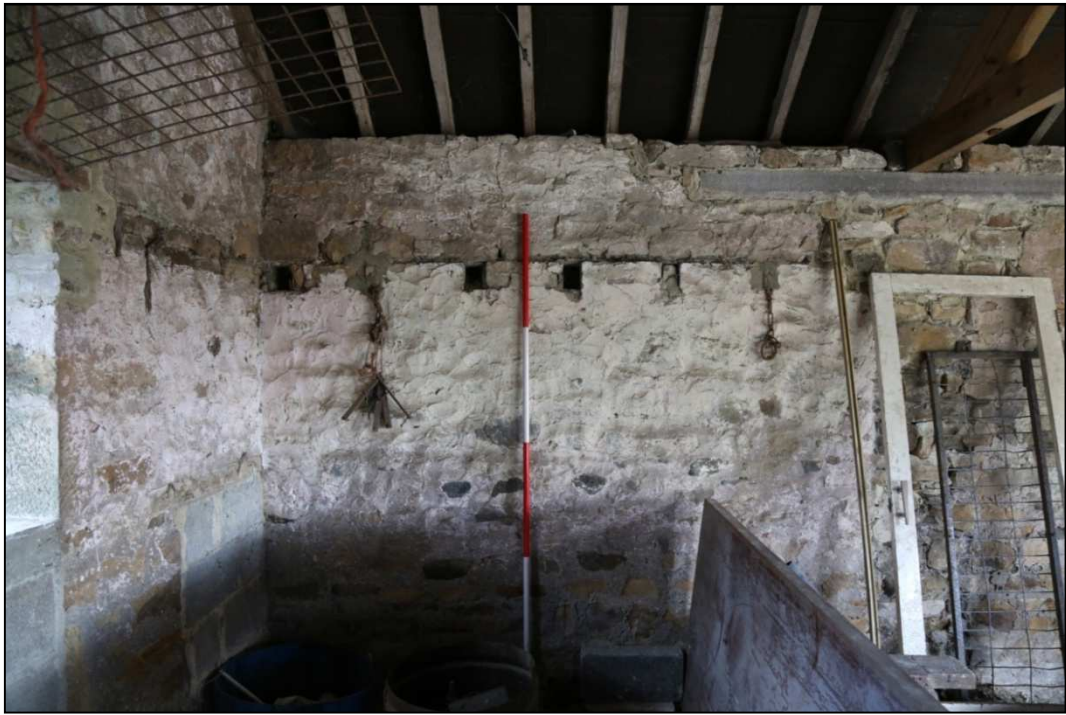
- 5.23 There was evidence of the former loft in the north-east corner, on both the north and east walls, in the form of joist holes evenly spaced at a height of just under 2m, and the blocked loft opening beneath the ridge (Plates 14 and 15).
- 5.24 To the south of the joist holes (Plate 15), there was evidence of a former subdividing wall, both as a wall scar in the east and west walls, and as a channel in the modern concrete flooring.
- 5.25 A concrete sill had been inserted in the former location of the subdividing wall, in order to redistribute the load of the truss (Plate 15). This truss appeared to be more recent than the trusses further south and had probably been replaced when the internal wall was removed.
- 5.26 The east wall was otherwise blind.

Plate 14: Evidence of a former loft in the north-east corner

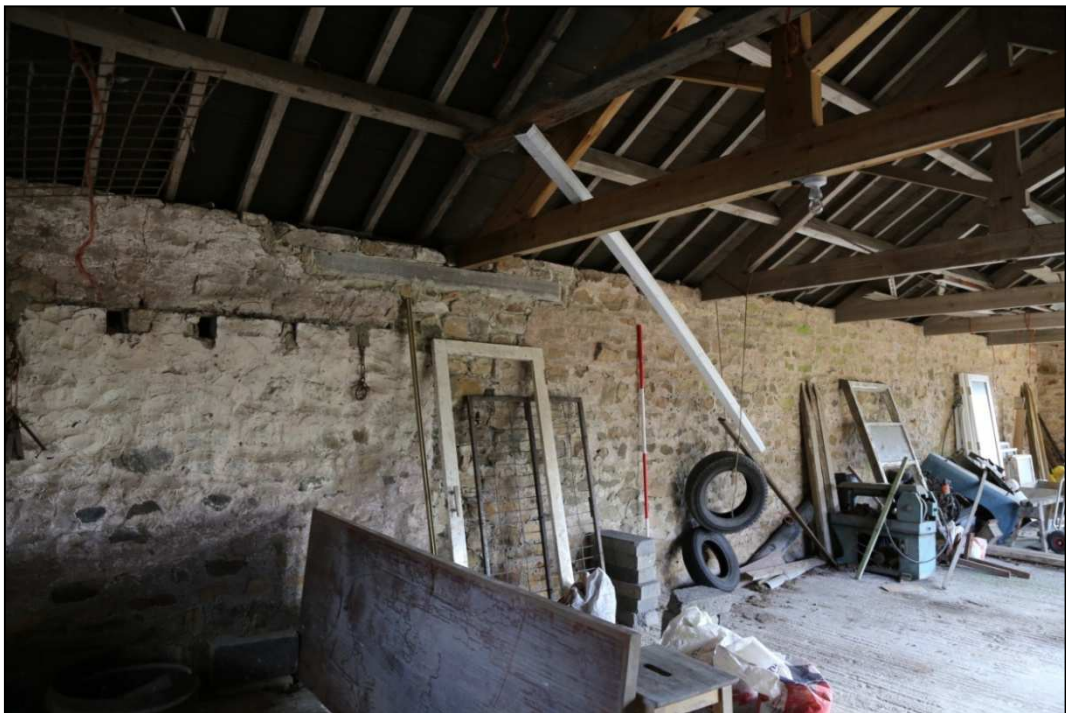
Plate 15: East wall of the cart shed, looking south-east

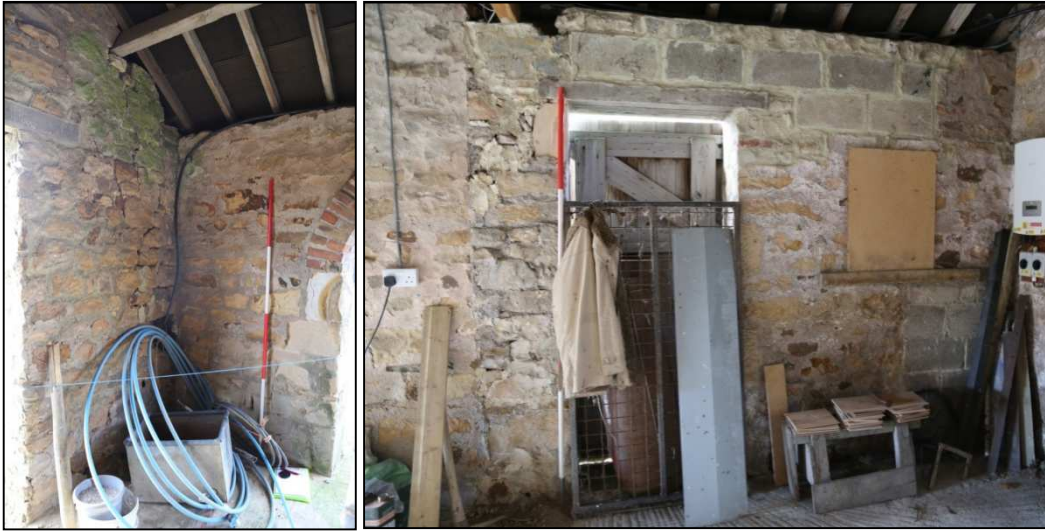
- 5.27 The south wall did not contain any particular features apart from the large opening, which was a later insertion.
- 5.28 The south-west corner showed some evidence internally of being rebuilt (Plate 16).

Plates 16 and 17: Partially rebuilt south-west corner of the cart shed, and the north end of the west wall

- 5.29 The west wall was predominantly open internally, comprising two stone piers supporting the arched openings. However, there was walling at the north and south ends of the wall (Plates 16 and 17). The opening at the south end was blind, although there was some evidence of rebuilding.
- 5.30 The walling at the north end contained a vertical wall scar indicating the position of a former subdividing wall (Plate 17). There was one functioning doorway, with a timber lintel internally, and one blocked hatch opening close to ground level at the northern end of the wall. There was further breezeblock rebuild/blocking just below the eaves, possibly filling a former loft opening or simply an area of rebuild inserted when the roof was replaced.

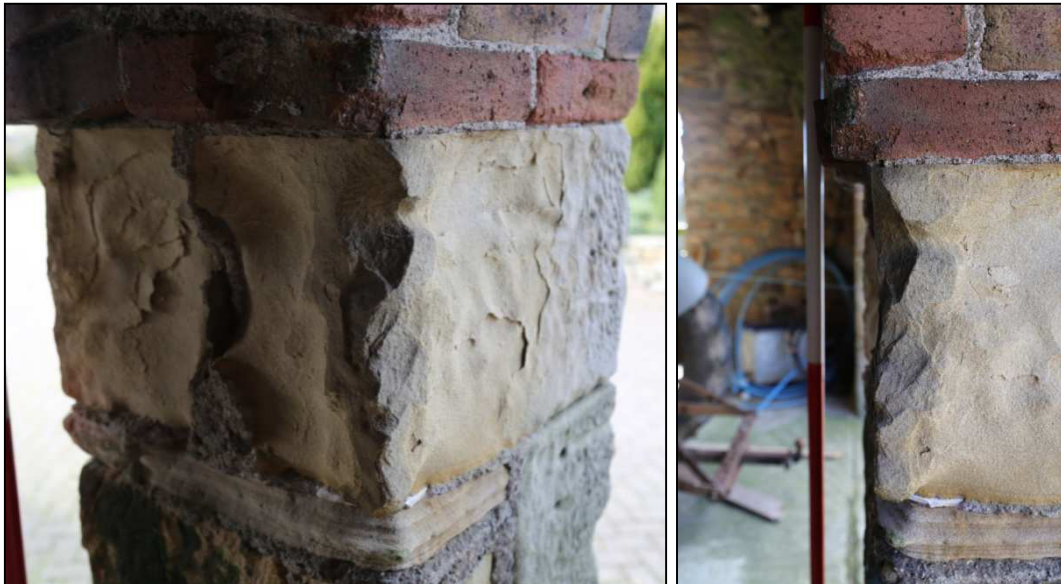
- 6.5 On each pier, the stone block forming the impost (the stone block directly below the brick arch) was severely weathered, particularly on its inner (east) face. It is possible that the impost stone on the north-most pier had been replaced at some point as a result of loss.

- 6.6 It is not entirely clear whether this weathering is recent/ongoing, or is the result of past erosive processes, which have now ceased. There was also evidence of damp at the top of the wall in the south-east corner, presumably from water ingress either through open joints in need of re-pointing or through the roof (probably before its replacement).

- 6.7 The eroded face showed evidence of efflorescence (build-up of soluble salts), lichen growth, and lamination (Plate 18). This had probably been caused by two or three contributing factors, which could be remedied to prevent further damage:

- the brick voussoirs overhung the stone below by approximately 25mm internally (Plate 19), meaning that any water absorbed by the brick would have soaked downwards through the brick, dripping onto the west face of the stone below;

- the joints in the stone piers (and between the brick voussoirs above) had been pointed with very hard, impermeable concrete cement, inhibiting the egress of water through these joints as would be normal function. As a result, water – carrying soluble salts – can only evaporate from the exposed face of the stone. As it does so, soluble salts crystallize on the surface, causing flaking; and
- given that erosion is limited to the internal (eastern) stone face, it is possible that the particular location and layout of the building has created turbulent wind flow, carrying abrasive dust, which has contributed to erosion of the surface.

Plates 18 and 19: Severe lamination of stone blocks forming the arch piers

6.8 Redevelopment of the cart shed for residential use will, in part, prevent further erosion of the piers by enclosing the interior (preventing wind damage) and ensuring that these stones are kept dry. However, it is recommended that any re-pointing is undertaken in lime mortar to enable water egress through joints, rather than through the face of the stone. To avoid further decay, care could also be taken that the stone is as dry as possible before the internal space is fully enclosed (or painted, for example) to avoid expedited evaporation and further erosion. It is suggested that any paint coverings applied directly to stone or brick be lime-based to ensure that moisture can escape effectively.
