WATCHING BRIEF REPORT

BARNEY CRAIG MINE
CARRSHIELD
NORTHUMBERLAND

NAA 17/56
November 2017

BARNEY CRAIG MINE, CARRSHIELD, NORTHUMBERLAND
ARCHAEOLOGICAL WATCHING BRIEF REPORT

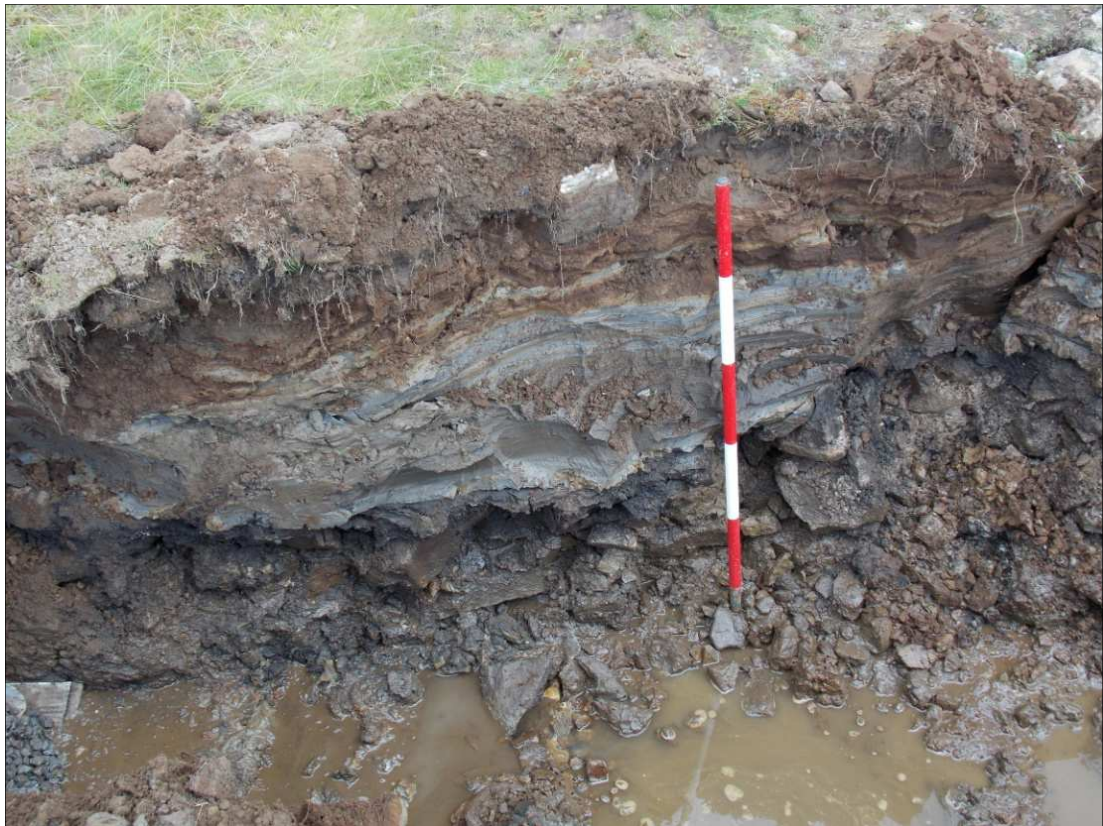
- 6.4 Approximately 30m to the south of Low Blue Row, a section of buried wall foundation was encountered 0.5m below ground surface (Figure 2; Plate 1). The foundation (**008**) consisted of a band of irregular, undressed sandstone blocks sitting on top of a reddish-yellow thick clay with traces of mortar on top of the masonry. Above the wall foundations were laminated tailings, indicating that the wall pre-dated the construction of the TMF. The tailings in this area contained occasional large stones, presumably derived from the wall foundation. One of these stones was a roughly-dressed rectangular block measuring 400mm by 300mm by 300mm. Historic Ordnance Survey (OS) mapping shows a small building in this location (Figure 3).

Plate 1. Wall foundation 008, with laminated tailings slumping into trench

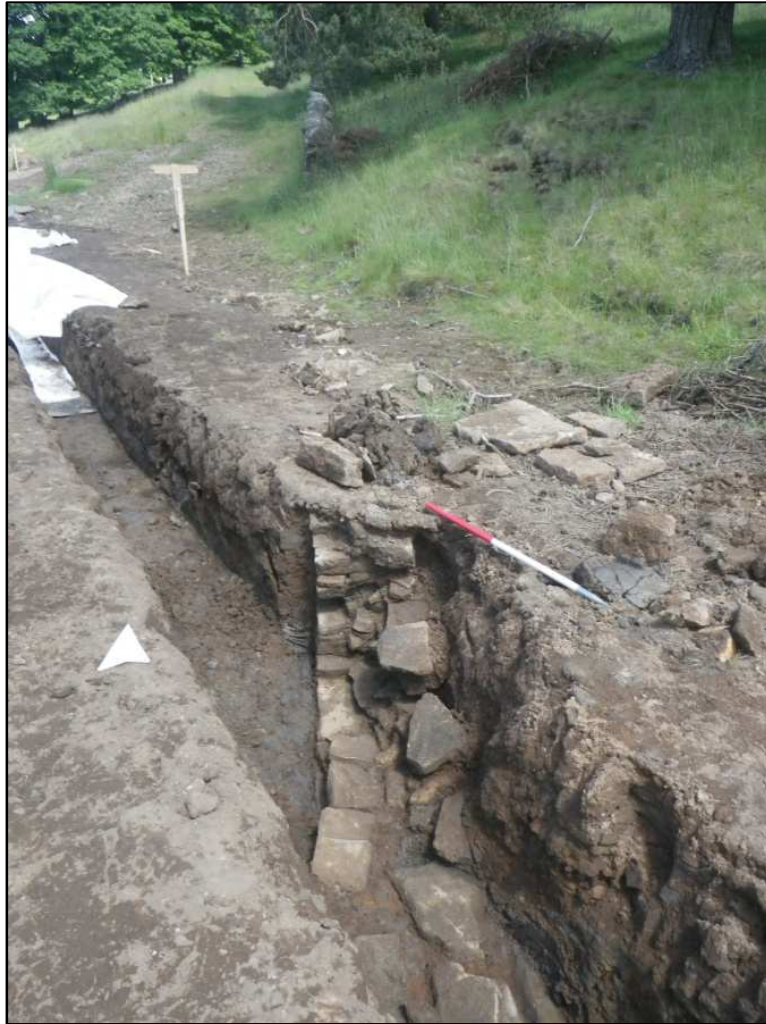
- 6.5 Some 50m to the south of wall **008**, the footing of a drystone wall (**001**), associated with a trackway leading into the mining complex, was recorded (Plate 2). The line of this wall could be seen continuing to the north-east, leading up to the main road and former mine offices. The excavated wall footing stood up to three courses high and was constructed of roughly faced, thin blocks, double faced (at 0.5m wide) with a rubble core. It was overlain by mining waste (**002**) associated with the TMF. On the southern side of the wall was a large amount of stone rubble suggesting the wall had

fallen down when it was covered by mine tailings. The wall was depicted on 19th-century OS mapping.

Plate 2. Wall footing 001 with upstanding remains visible in background

- 6.6 A deposit of heavy blue grey clay was observed on both sides of, and cut by, wall **001**. This deposit was overlain by mixed silty gravel mine waste. There was no evidence for buried topsoil between these deposits.

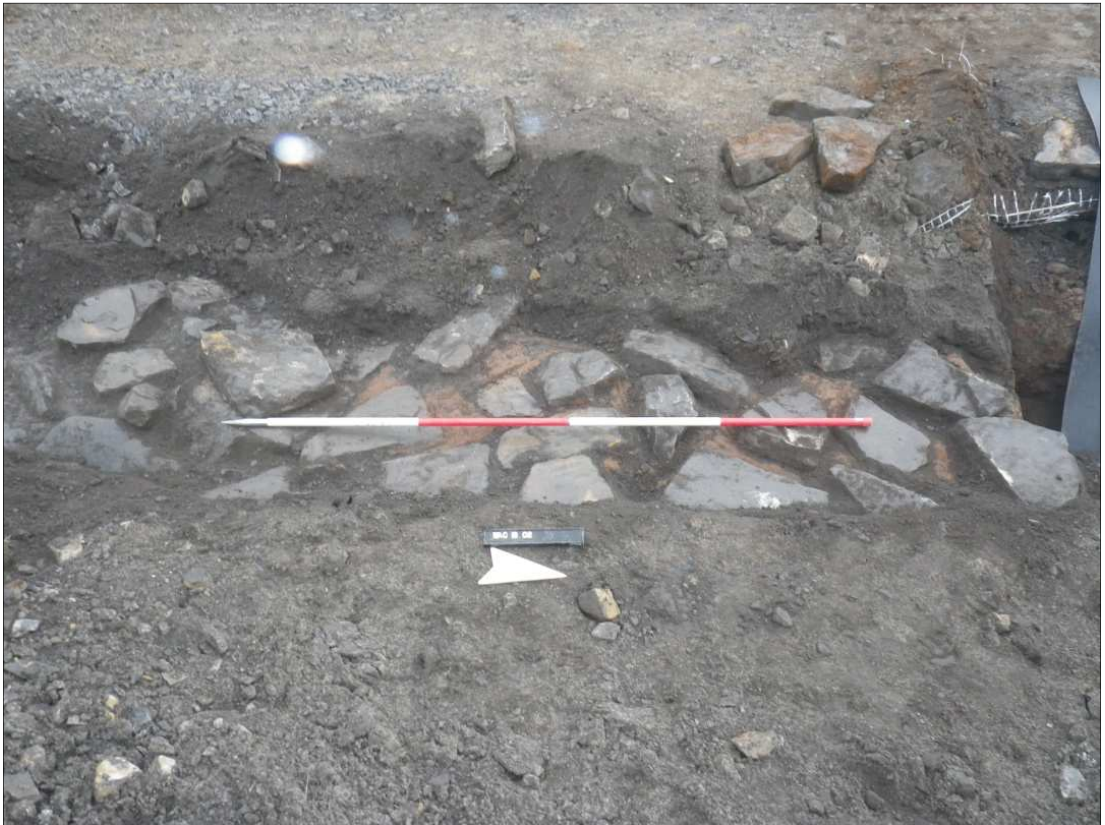
- 6.7 A rudimentary paved area or hard-standing (**002**) was recorded towards the southern end of the drainage works, adjacent to the modern trackway running between two former reservoirs. This feature consisted of angular sandstone flags (Plate 3) bedded on a shallow sandy layer over laminated mining waste. This area of the site was extremely boggy, and it was likely that the hard-standing was put down across the wet clay during the deposition of the mine tailings and was not associated with the original mining complex. Further mine waste had accumulated over the hard-standing.

Plate 3. Hard-standing 002 bedded on clean sand and overlain by mining waste

- 7.2 At the foot of a modern trackway between the two reservoirs, leading down from the upper level, was hard-standing **002**, a small area of paving bedded in a layer of sand. Mine tailings were recorded both above and below this paving, indicating that it was a temporary feature constructed part-way through the reworking of the spoil heaps. Comparison of historic mapping shows that the corner of a substantial processing building occupied this area until at least 1958. The hard-standing must post-date this structure.

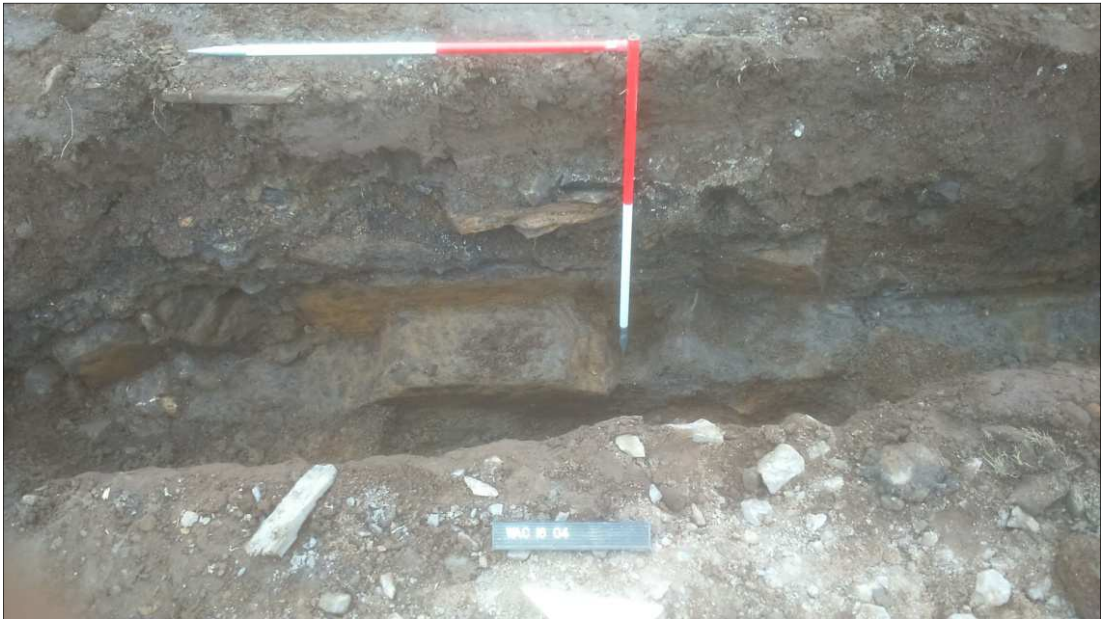
- 6.8 At the southern limit of the drainage works the possible footing of a north to south aligned wall (**004**) was identified (Plate 4) on an alignment parallel to a retaining wall for the reservoir to the east. The full width of the wall was not exposed within the trench but there were displaced stone blocks with gravel deposit **006** to the west. It was unclear as to the purpose of this wall, but it was likely to be contemporary with the reservoirs

Plate 4. Wall 004 in east side of trench

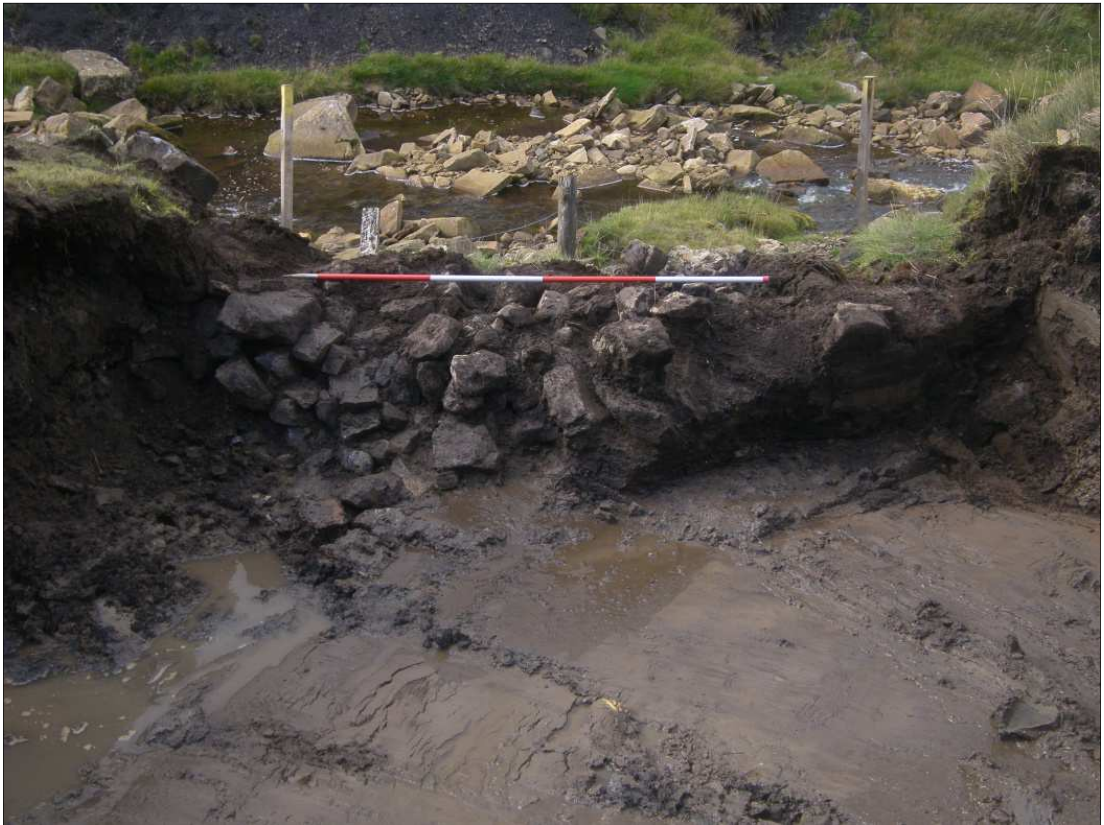
- 6.10 The location for the discharge channel had been selected where the retaining wall (**100**) was in its most ruinous condition. The wall had a rubble core (Plate 5) and was faced with roughly-dressed, sub-rectangular blocks (Plate 6).
- 6.11 Material from the inside of the retaining wall consisted of general mining waste and laminated tailings down to a depth of 1.2m.

Plate 5. Rubble core of retaining wall 100 showing tailings heap (left)

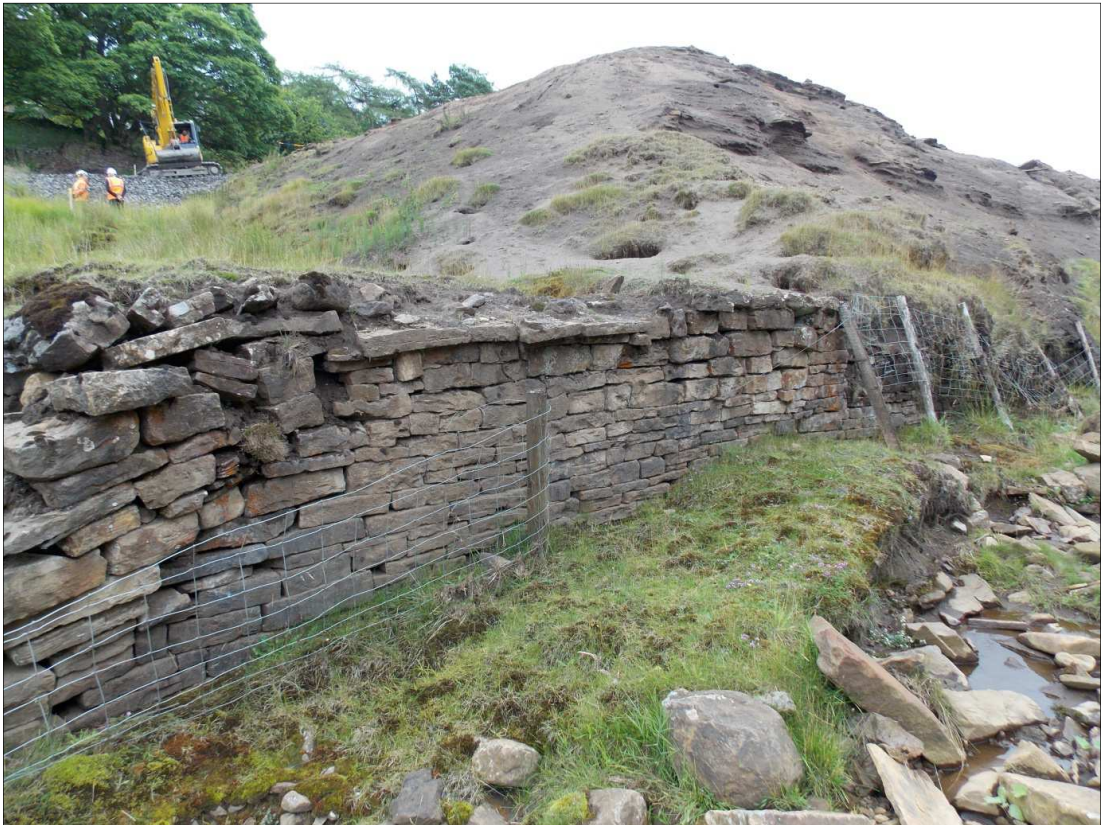
- 6.12 A change in the style of walling immediately to the south of the discharge point, with a distinctive, narrow 'string course' (Plate 6), possibly represented the location of a foot-bridge recorded on the Second Edition OS map of 1899 (Figure 3). No other elements of a bridge were encountered during machine monitoring, but it is possible that these were wooden and have not survived.

Plate 6. Outer face of river wall showing 'string course' (centre), possibly representing the location of a foot-bridge

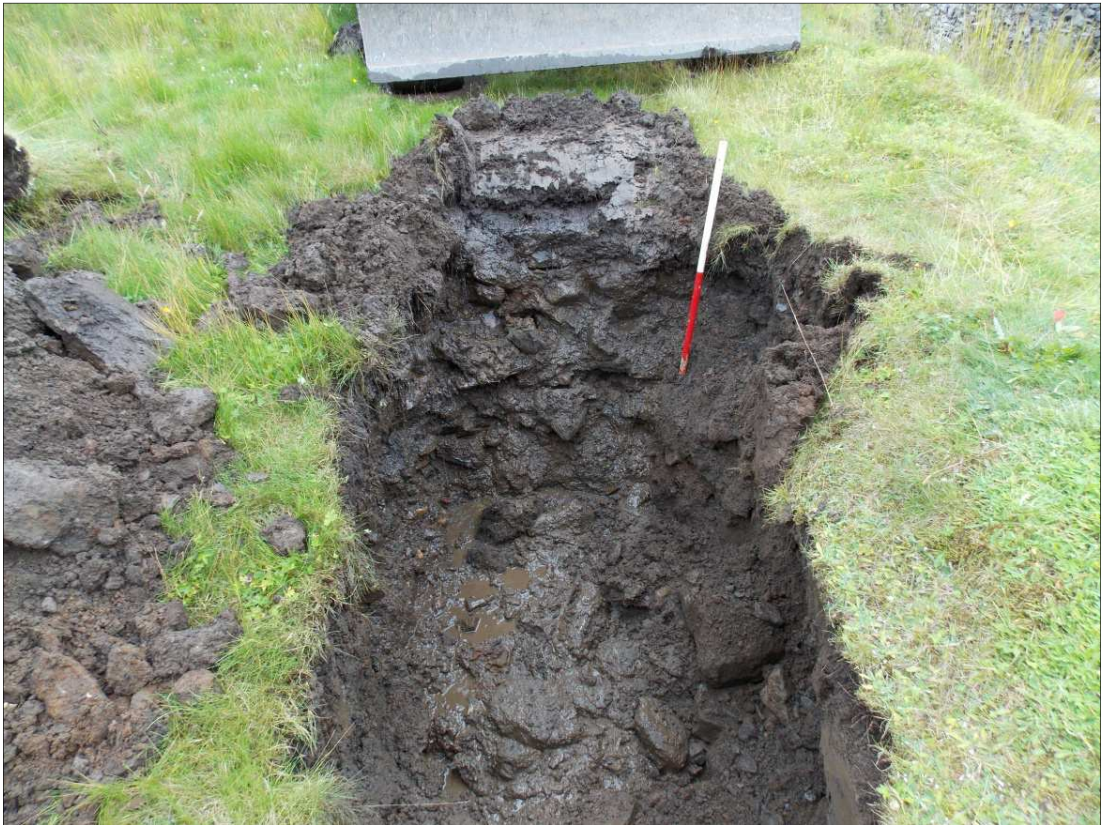
- 6.13 In order to help determine the most suitable location for the pipe outfall, a test pit was machine-excavated some 5m from the river wall, to the north of the eventual location. The pit measured 3m east-to-west by 1.2m, and was up to 1m deep. Natural horizons were not reached, the pit being entirely within 'made ground' deposits of redeposited topsoil and large boulders up to 0.8m across (Plate 7). Within this deposit were four sections of roughly-finished, 200mm diameter timber posts (Plate 8) with regularly spaced, 50mm diameter sockets, some with remains of wooden dowels still in-situ. Although most of the original ends had been broken off, two of the posts had been mortised at one end to fit together in the form of a hinge. Four such posts would have formed the main elements of a ladder stile, with the circular sockets indicating the location of the rungs. The stile was unlikely to relate to mining activity, although may have been associated with the garden plots of nearby miners' cottages; its disposal in the made ground presumably dated to the earlier 20th-century deposition of mine tailings in this area.

Plate 7: Redeposited boulders within made ground exposed by test pit

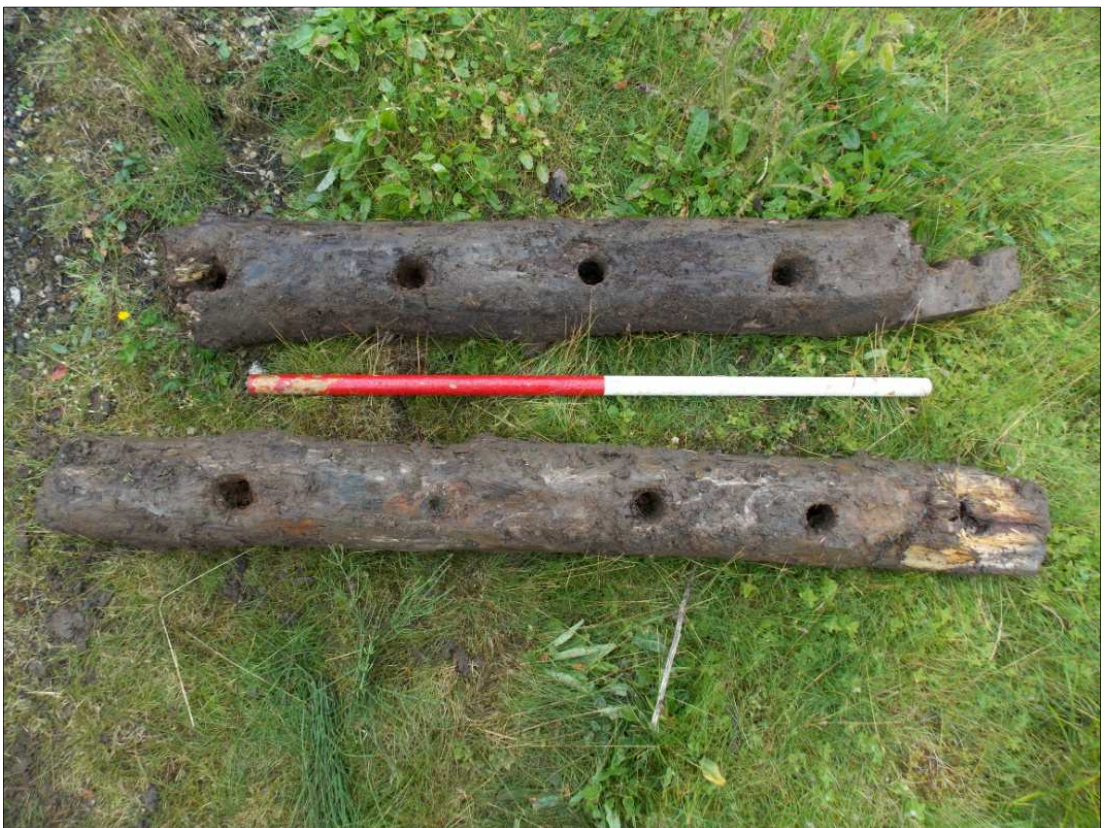
Plate 8. Fragments of wooden 'ladder stile' exposed within test pit, showing sockets for rungs and mortis joint (right)

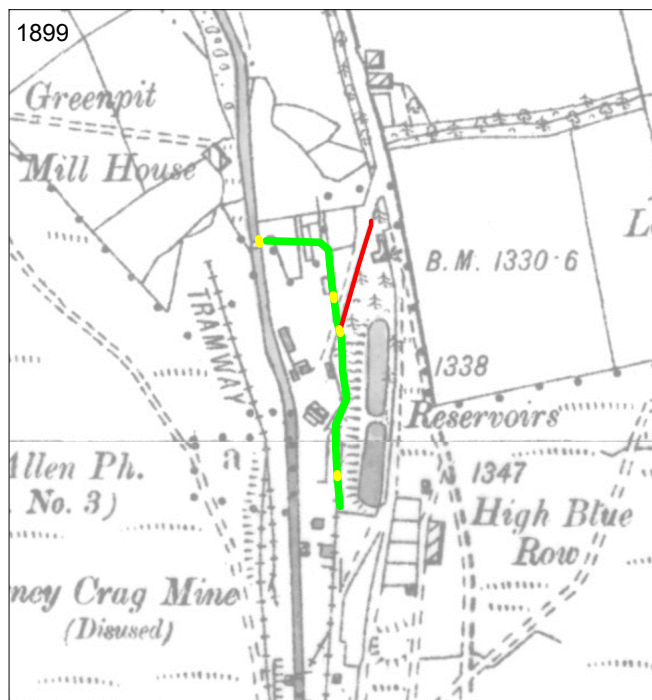
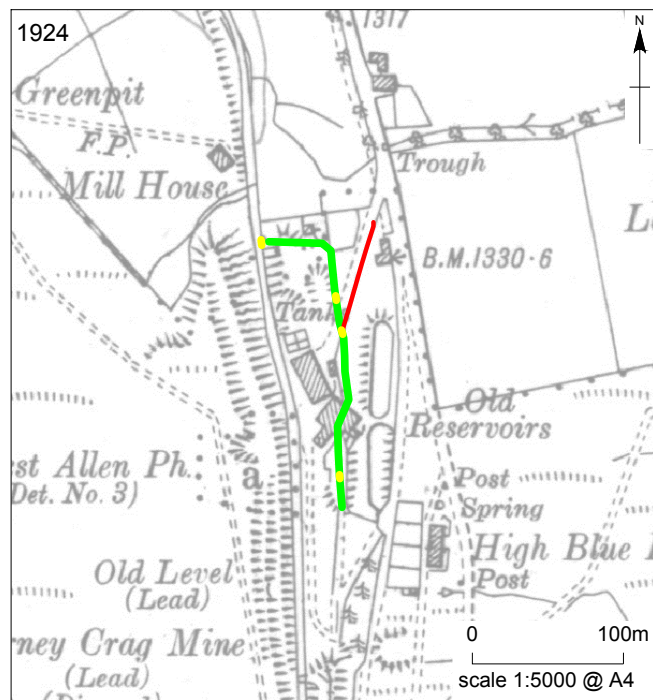
Figure 3

West Allen, Carrshield: 1864, 1899 and 1924 Ordnance Survey maps showing wall locations and High Blue Row
