ARCHAEOLOGICAL EVALUATION

ST MARY'S ISLAND,
WHITLEY BAY,
NORTH TYNESIDE

prepared for
North Tyneside Council

**ST MARY'S LIGHTHOUSE, WHITLEY BAY, NORTH TYNESIDE
ARCHAEOLOGICAL EVALUATION**

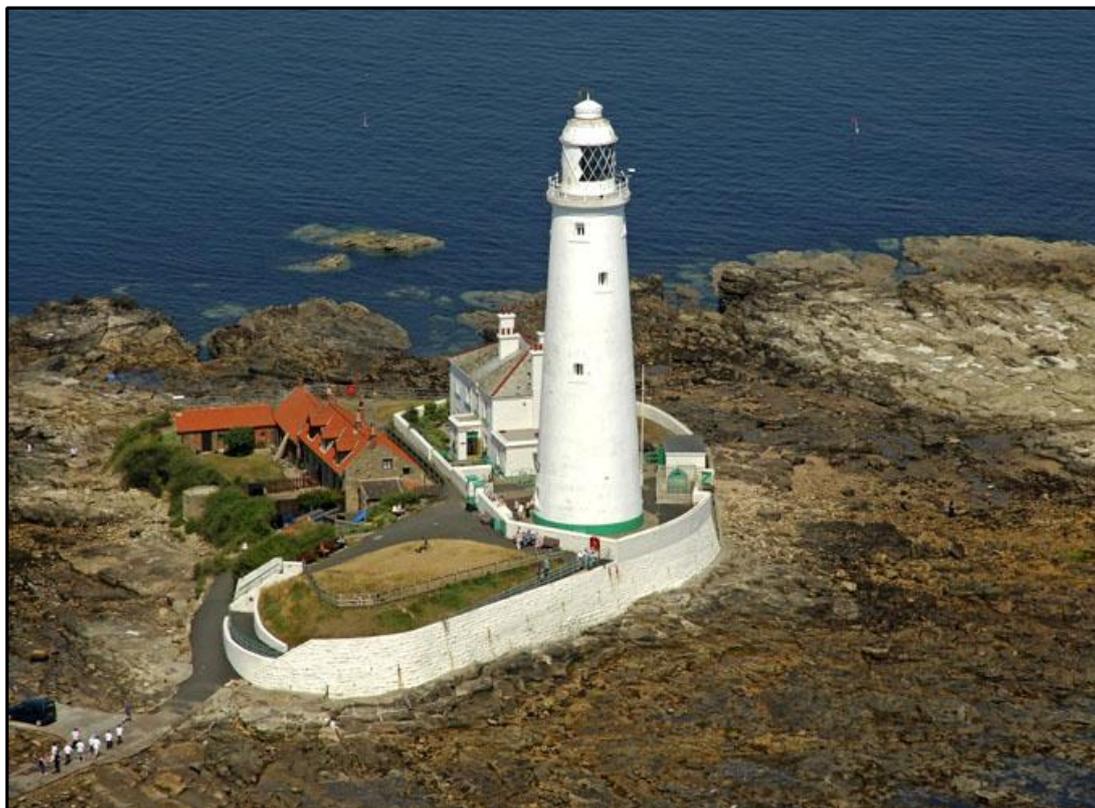
Plate 1: Aerial view of St Mary's Island, looking north-east

- 2.1 St Mary's Island is a rocky outcrop located c. 3.5km north of Whitley Bay and 20km north-east of Newcastle city centre. The island covers an area of c. 0.26ha and is cut off from the mainland at high tide. It is contained on three sides by a stone revetment wall that was constructed when the lighthouse complex was built between 1896 and 1898 (Plate 1).

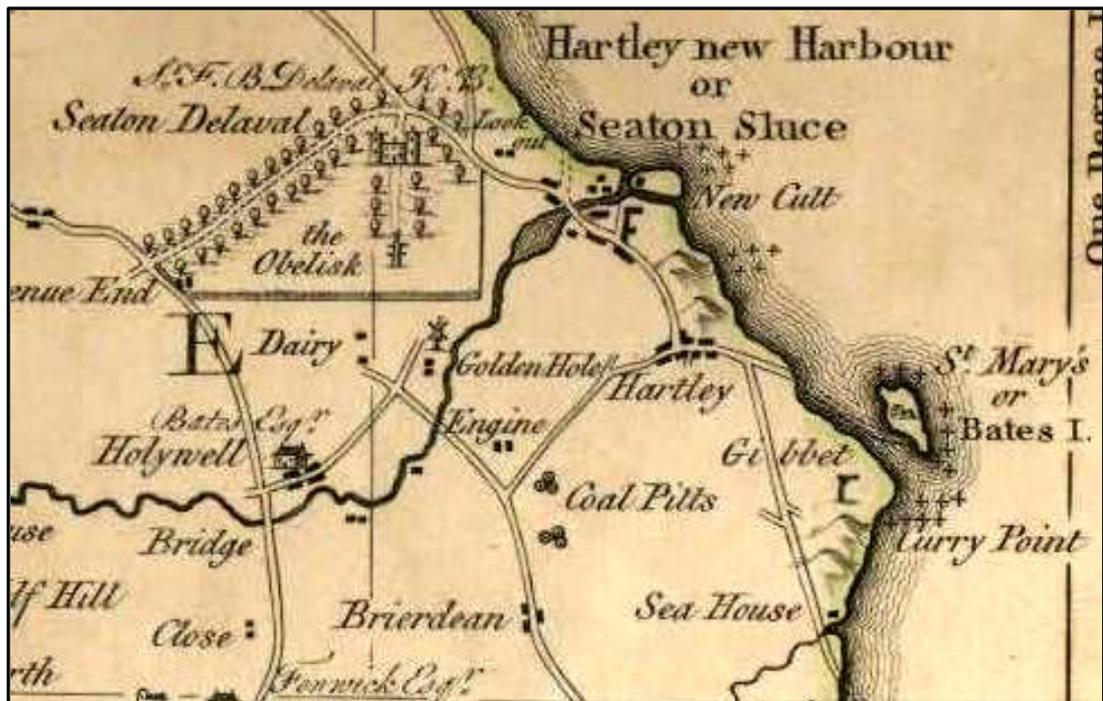
Plate 2: Armstrong's map of Northumberland, 1769, showing St Mary's Island

- 3.7 Ruins were apparently visible on the island up to the mid-19th century. Armstrong's map of Northumberland of 1769 apparently shows the symbol for a church or chapel (Plate 2) and a report by Ralph Turnbull (*Shields Daily News*, 12 November 1872) references a 90-year old resident of Hartley who reportedly remembered the removal of stones from the ruins of the chapel to build the smithy in Hartley village. Later Ordnance Survey maps, dating to 1858, 1898 and 1913, also depict St Mary's Island as the supposed site of St Mary's Chapel.

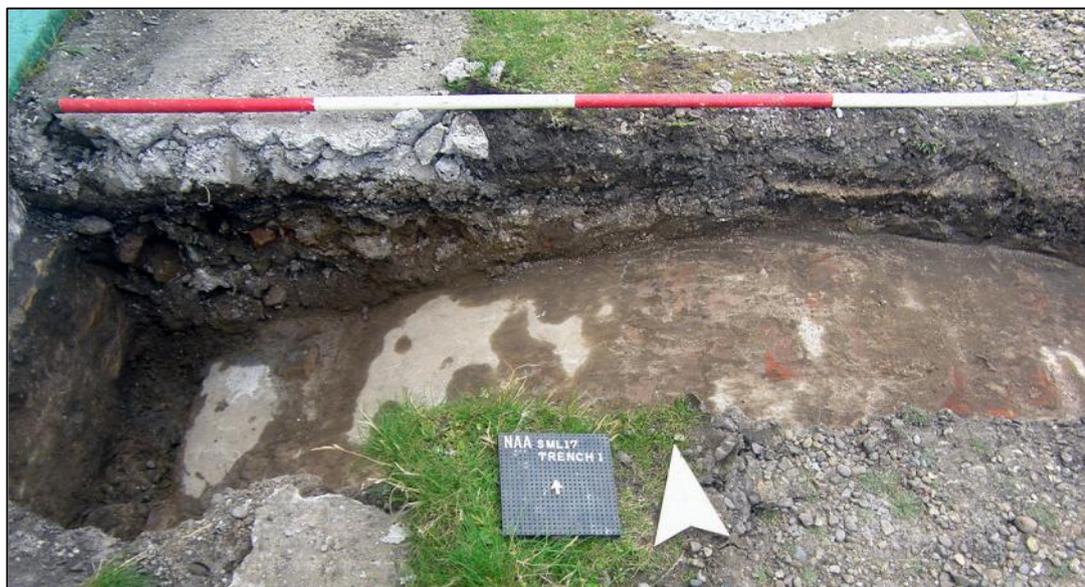
6.2 The storage tanks **30** were located at the west end of T1 230mm below the modern ground surface. Excavation exposed the brick vault, bonded with lime mortar and bordered at the east and west edges by blocks of sandstone and concrete. The tanks had been installed flush to wall foundation **31** and appeared to be orientated east-west, suggesting that the construction of the storage tanks **30** and the foundations of the lighthouse keepers' cottages **31** took place contemporaneously (Plate 4).

Plate 4: Trench 1, storage tank 30 and wall foundation of the visitor centre 31

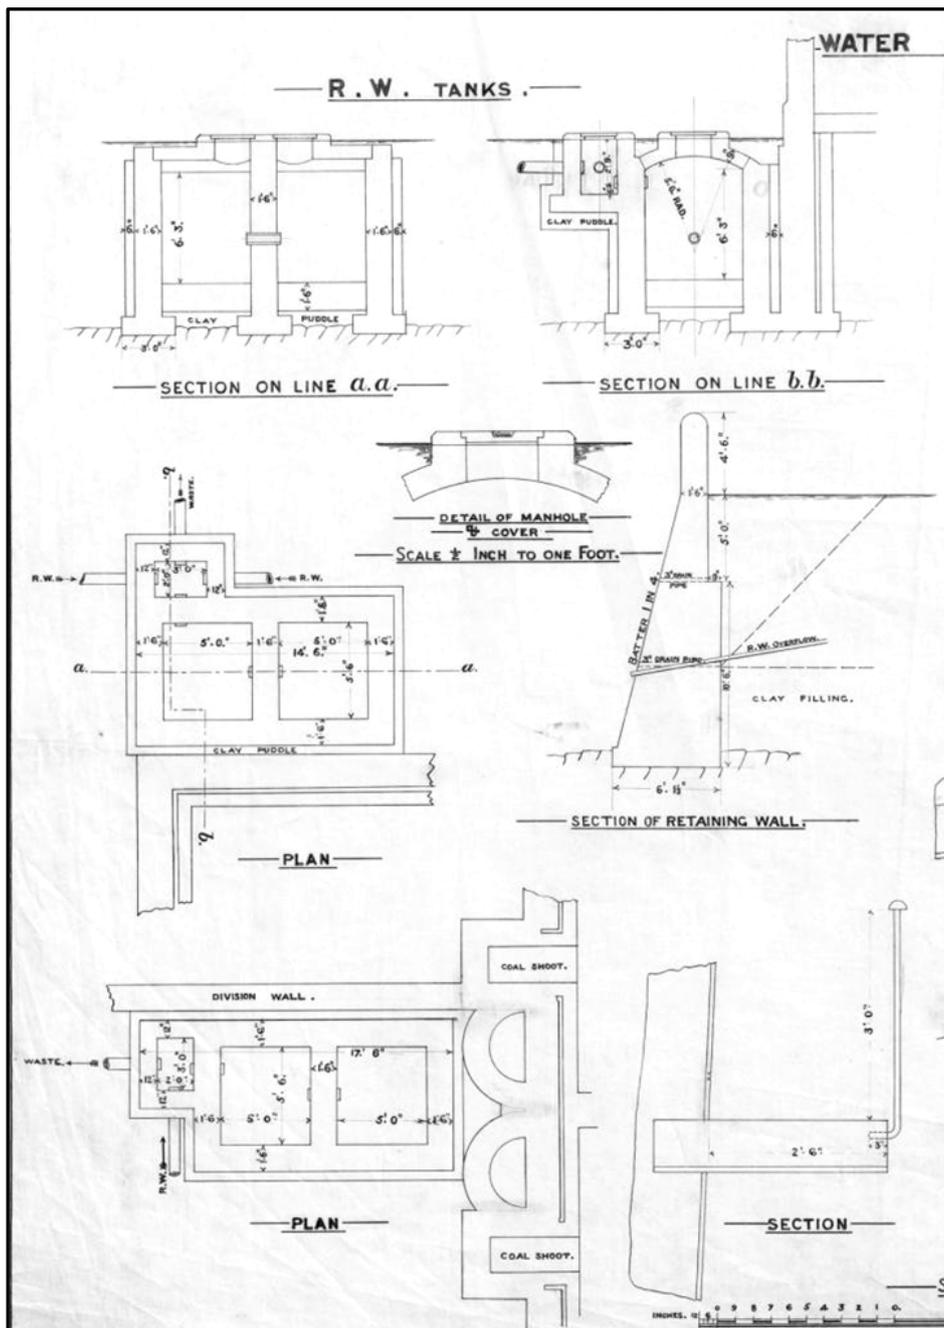
6.3 This interpretation appears to be confirmed by the original plans for the lighthouse keepers' cottages obtained from Trinity House (Plate 5). The plans show a rectangular

structure 14'6" long north-south with two internal chambers 5'0" x 5'6" and 6'3" internal height, constructed against the foundations of the lighthouse keepers' cottages. Each chamber is accessed by one of the two circular manholes still evident on the modern ground surface. Presumably, the walls of the chambers correspond to the concrete and stone elements seen on the surface in T1, with only the vaulted ceiling constructed from brick. The structure of 30 is situated within a cut lined with "clay puddle", which appears to correspond to sandy clay deposit 49 on Section 7 (Fig. 3).

Plate 5: Original plans from Trinity House showing storage tanks 30

- 6.4 A further element, though not revealed by the evaluation but explained by the original plans, is a smaller overflow chamber attached to the north-east corner of **30**. This small chamber appears to have an outlet pipe, which exits on a north–south alignment, and a waste pipe running east, presumably to an outlet in the revetment wall. It is the north–south pipe which is of interest here, apparently conforming to drain cut **25** and ceramic pipe **26** recorded in T1 running parallel to the east edge of the storage tanks **30** (Plate 5, Plate 6).

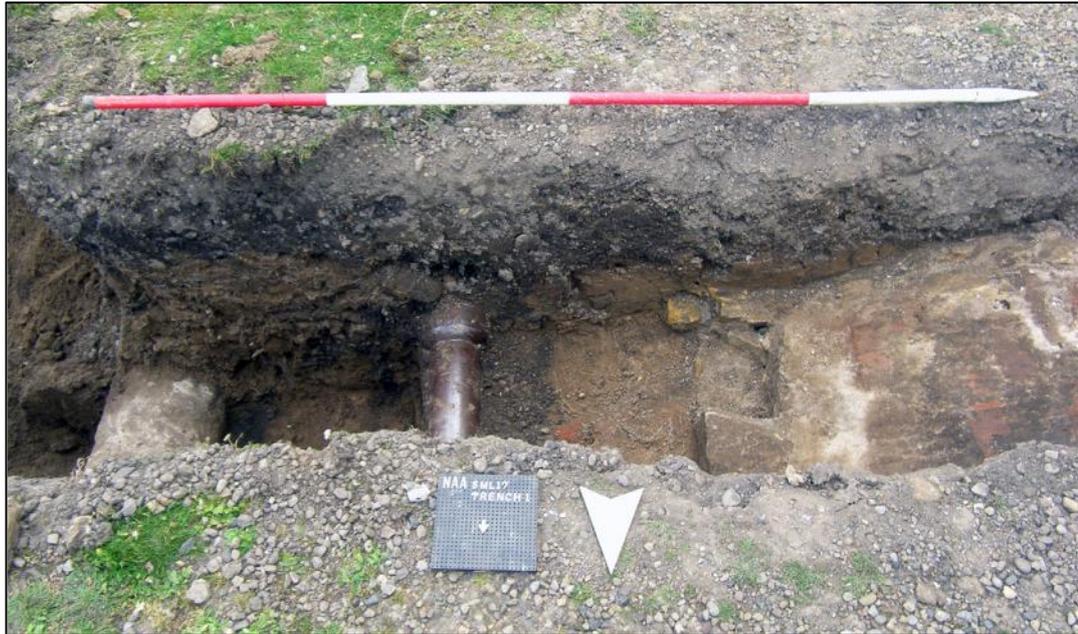
*Plate 6: Trench 1, east edge of storage tank **30**, drain cut **25** and earlier drain cut **27***

- 6.5 An earlier drain cut **27** was also seen running north–south in T1 and had been cut along its west edge by drain cut **25**. In contrast to the steep-sided profile of **25**, cut **27** was steep on the east edge with a moderate slope along the west edge. The drain was capped with concrete and recorded at a depth of 0.75m, compared with a depth of 0.55m for ceramic drain **26**. It is unclear what this earlier drain was used for, apparently relating to a phase of activity prior to the construction of the lighthouse keepers' cottages in 1899 and possibly relating to the construction of the lighthouse tower from 1896–1898.

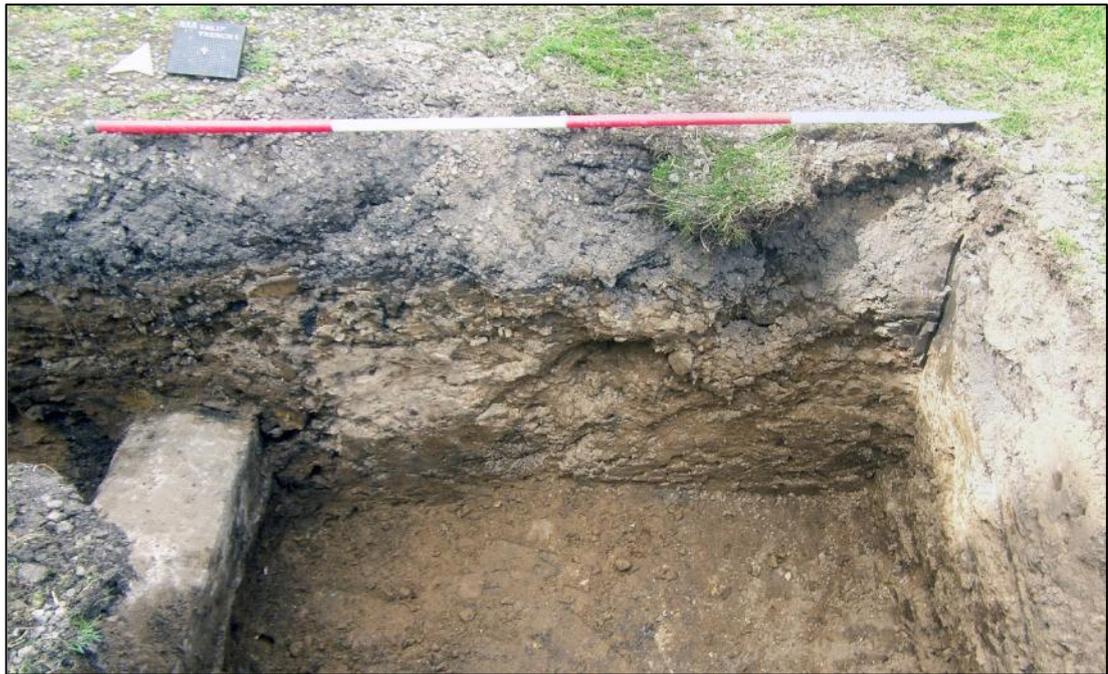
- 6.6 The eastern boxed-end of T1 was located in an area free from buried structures and services and was excavated to the maximum safe working depth of 1.2m. At the base of the trench, a layer of redeposited dark brown clay **33** was recorded, on top of which was a 0.85m-thick deposit comprising bands of sand mixed with fragments of

brick and stone rubble **32**. Mixed sand deposit **32** was cut through to the west by drain **27** and together with clay horizon **33** appears to represent the artificial make-up of the island's ground surface in the 1890s, prior to the construction of the lighthouse and its associated structures. This notion is confirmed by the original hand-drawn plans, specifically that of the revetment wall, which shows a thick layer of "clay filling" above which are further deposits to create an elevated ground surface (Plate 5, Plate 7).

Plate 7: Trench 1, clay 33 and sand 32 make-up deposits at the east end of Trench 1

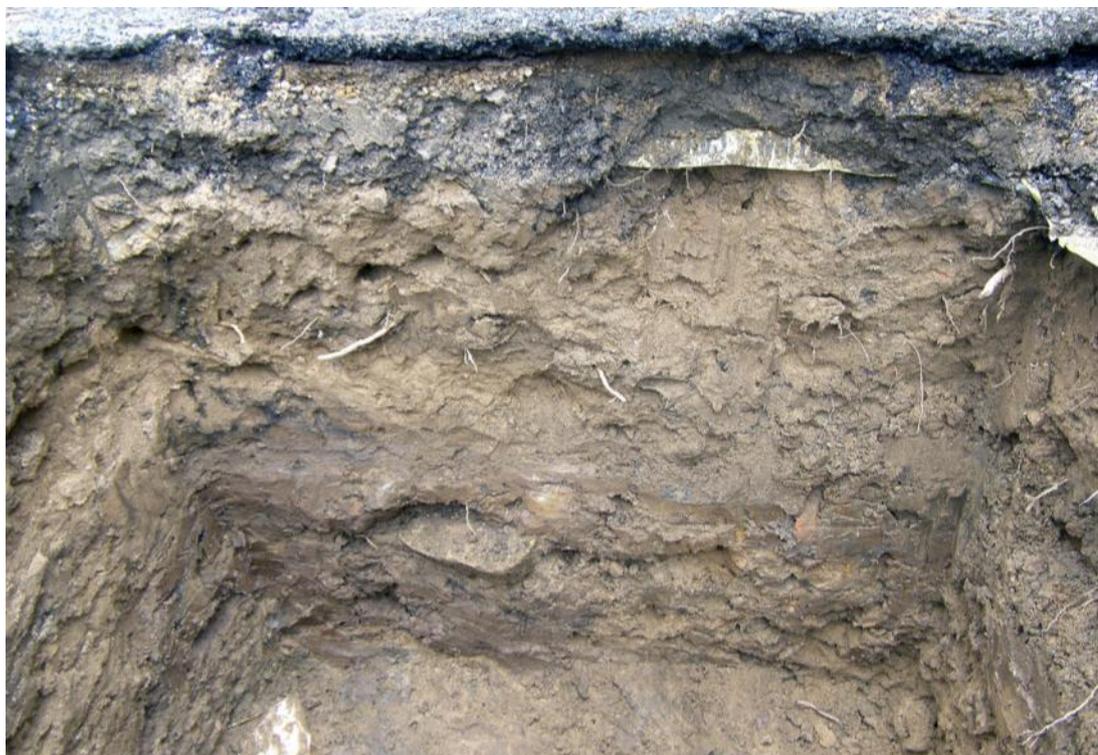
- 6.10 The trench was excavated by machine to a depth of 1.2m and, as in the east end of T1, a series of deposits relating to the artificial made-up ground surface was exposed (Plate 8). The lowest deposit **06** was a thick levelling deposit of dark pinkish-brown clay interspersed with bands of sand, its full depth unknown, but comparable to clay deposit **33** in T1. Above deposit **06** there was a further band of the same clay, **05**, which was visible across T2 and probably represents the upper level of **06** rather than a distinct deposit.

Plate 8: Trench 2, south-facing section showing sand and clay make-up deposits

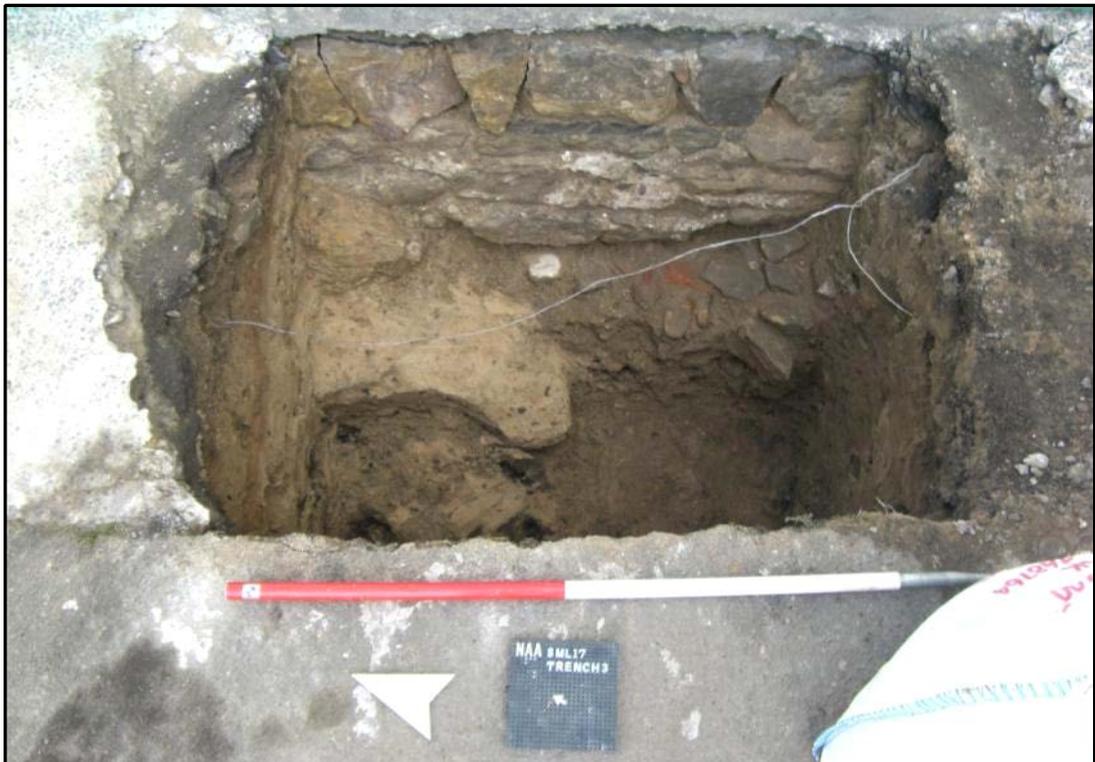
- 6.14 The trench was excavated by machine to a depth of 1.2m and exposed the foundations of the late 19th-century link building, which were then cleaned by hand. The foundations were 0.73m deep and comprised two separate phases of construction (Plate 9). The lower phase **08** consisted of three courses of flat, square, yellow sandstone slabs, laid stretcher and bonded with grey concrete mortar. The upper phase comprised a single course of roughly dressed angular yellow sandstone blocks **07**. Unlike **08** below, the sandstone blocks **07** were irregular, but had apparently been shaped to fit and required only minimal mortar bonding. A concrete sill was above **07**, and above that the link building itself. The white render of the link building masked the original Heworth sandstone of the building and it is unclear how the irregular upper course of the foundations **07** ties into the superstructure.

Plate 9: Trench 3, wall foundation 08 and upper course 07 above lighthouse construction cut 21

- 6.15 The foundations were built overlying the construction cut for the lighthouse tower **21**. The cut could be seen running east–west at the south end of T3, displaying a maximum visible width of 1.2m and a steep-sided profile (see Fig. 3). It was filled with dark brown sand with frequent brick and sandstone rubble fragments **10/22**, presumably debris from the tower construction (Plate 9).

irregular upper course to **07** (Plate 9). Furthermore, the foundations were situated within a cut, **38**, although this was probably an extension of that used in the construction of the earlier wall foundations **52** (Plate 11).

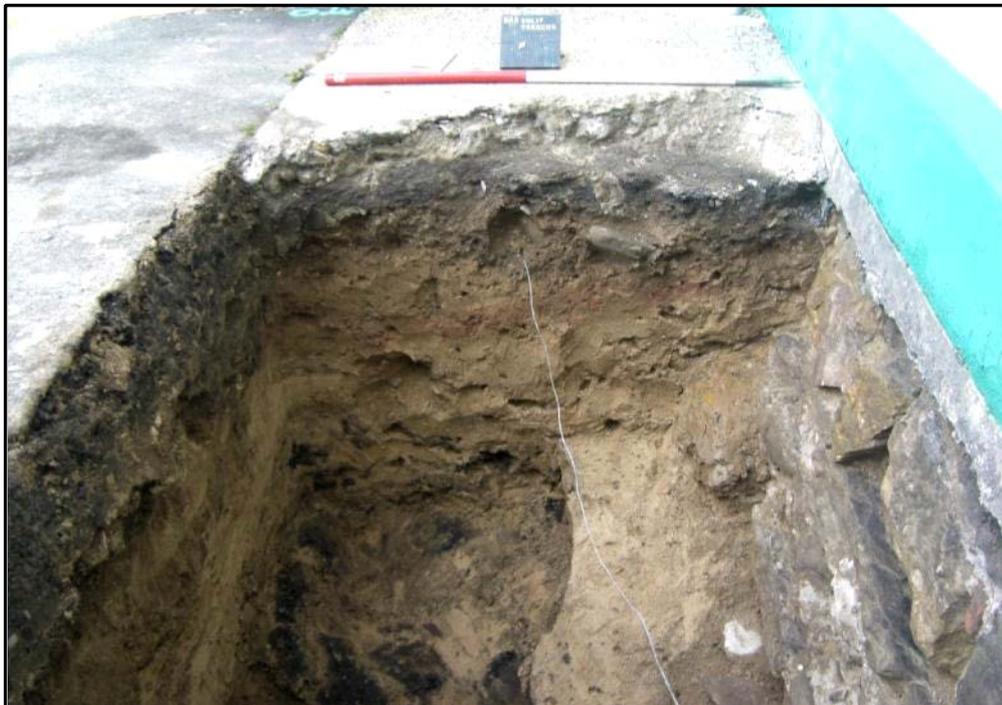
- 6.17 There was no evident construction cut relating to wall foundation **07**, **08** of the link building. It appeared that the wall was constructed on top of the deposits detailed above, before being buried by a further series of mixed sandy make-up layers **16**, **15**, **14**. It is likely that the upper greyish brown deposit of silty sand and clay **13** across T3 reflects the post-construction ground level of the late 19th–early 20th-century. A length of thin copper wire was revealed in **13**, running north–south and is thought to have been an earth wire related to the original lightning conductor on the lighthouse tower. Trench 3 was later covered by modern tarmac and concrete **18**, **19** (Plate 10).

*Plate 10: Trench 3, south-facing section showing no visible construction cut for wall foundation **07**, **08**, and a series of sandy make-up deposits*

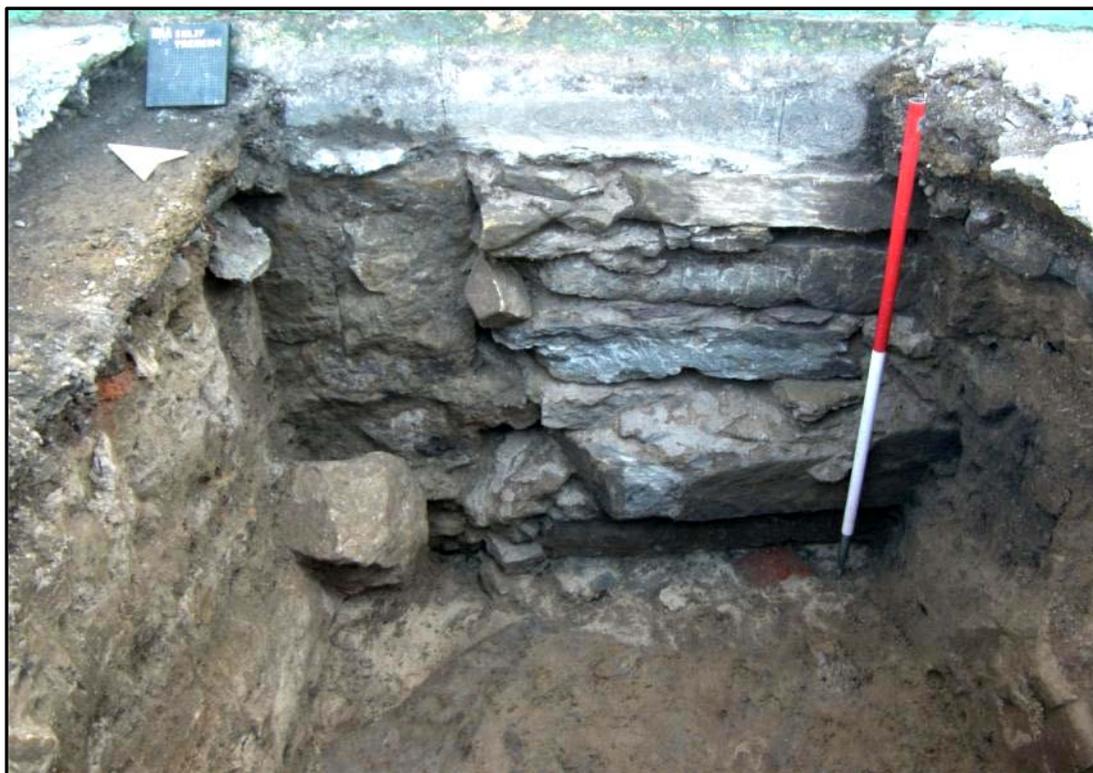
Plate 11: Trench 4, interface between wall foundations 52 and 39 and base of cut 38

- 6.20 The earlier foundations of the lighthouse keepers' cottages 52 comprised five visible courses of local sandstone. The blocks were roughly squared but uneven in size and form, resulting in uneven courses bonded with thick cement mortar.
- 6.21 In contrast, the later foundations of the link building 39 consisted of six visible courses of laminated yellow sandstone slabs, laid stretcher and forming regular courses. They were bonded with apparently the same cement mortar as 52, as had the interface between the two foundations, which had also been packed with sandstone fragments. Although consistent in form with foundation deposit 08 in T3 to the north, those seen in T4 were not only markedly deeper – in excess of 1.2m – but lacked a comparable

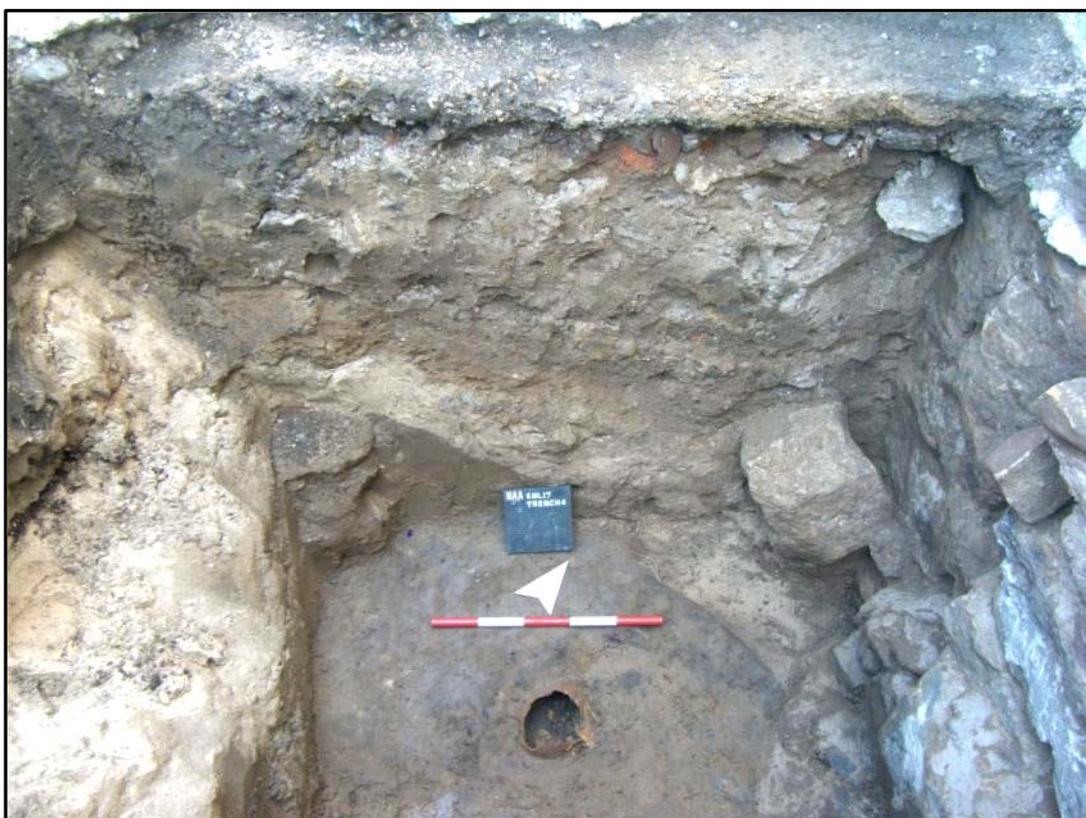
- 6.22 As noted above, T4 was the only trench in which a construction cut relating to the lighthouse keepers' cottages and link building was visible. In T1, any evidence had been obscured by storage tank **30**, whereas in T3 the wall foundations appeared to have been constructed on top of an artificial ground surface before the area was built up further. Seen clearly in the south-facing section of T4, cut **38** appeared at a depth of 0.9m in the west side of the trench following a shallow descent to the base of the trench at the east, cutting dark brown sandy clay horizon **51**. The cut was backfilled with a series of sandy deposits **37**, **40**, **41**, **42** to seal the wall foundations before the area was levelled and covered with a layer of gravel **44** (Plate 12).

*Plate 12: Trench 4, south-facing section showing construction cut **38** cutting dark sandy clay **51**, which contained grave cut **36***

- 6.23 At the base of T4 there was a dark brown sandy clay horizon **51**, which had been cut away by construction cut **38** for wall foundations **39** and **52**. Within deposit **51** and at the maximum depth of 1.2m part of an oval-shaped grave cut **36** was revealed. Orientated west–east, it was filled with mid-orange brown sand **35**, which on further

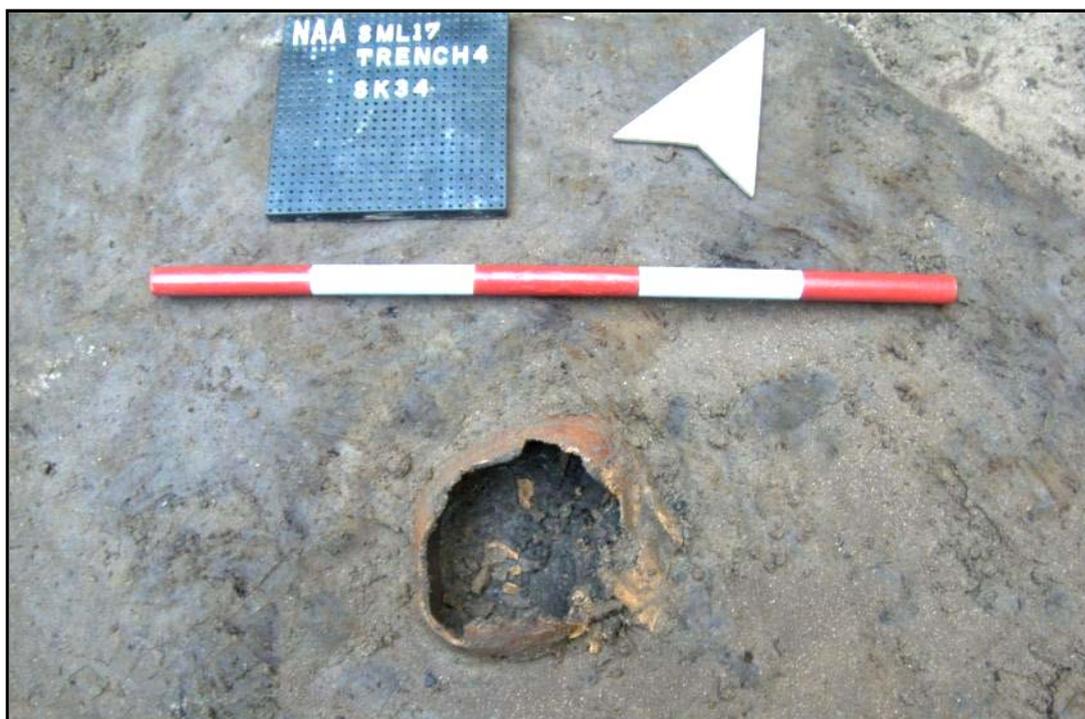
cleaning revealed a human skull **SK34** at the west end. The right parietal bone, right temporal bone, and the occipital bone at the back of the skull were exposed, but were unfortunately damaged. The visible remains demonstrated that **SK34** had been interred facing north, but due to maximum safe working depth being reached no further excavation of the burial could occur, thereby limiting the information that could be gathered from the remains (Plate 13). The orientation of the grave means that its east end has almost certainly been destroyed by construction cut **38**.

*Plate 13: Trench 4, exposed skull of burial **SK34** at west end of grave cut **36***

- 6.24 On the advice of the Tyne and Wear Archaeology Officer, **SK34** was left *in situ* until such a time when the burial can be fully excavated should the need arise. The remains were covered with wooden boards to protect them before T4 was backfilled.

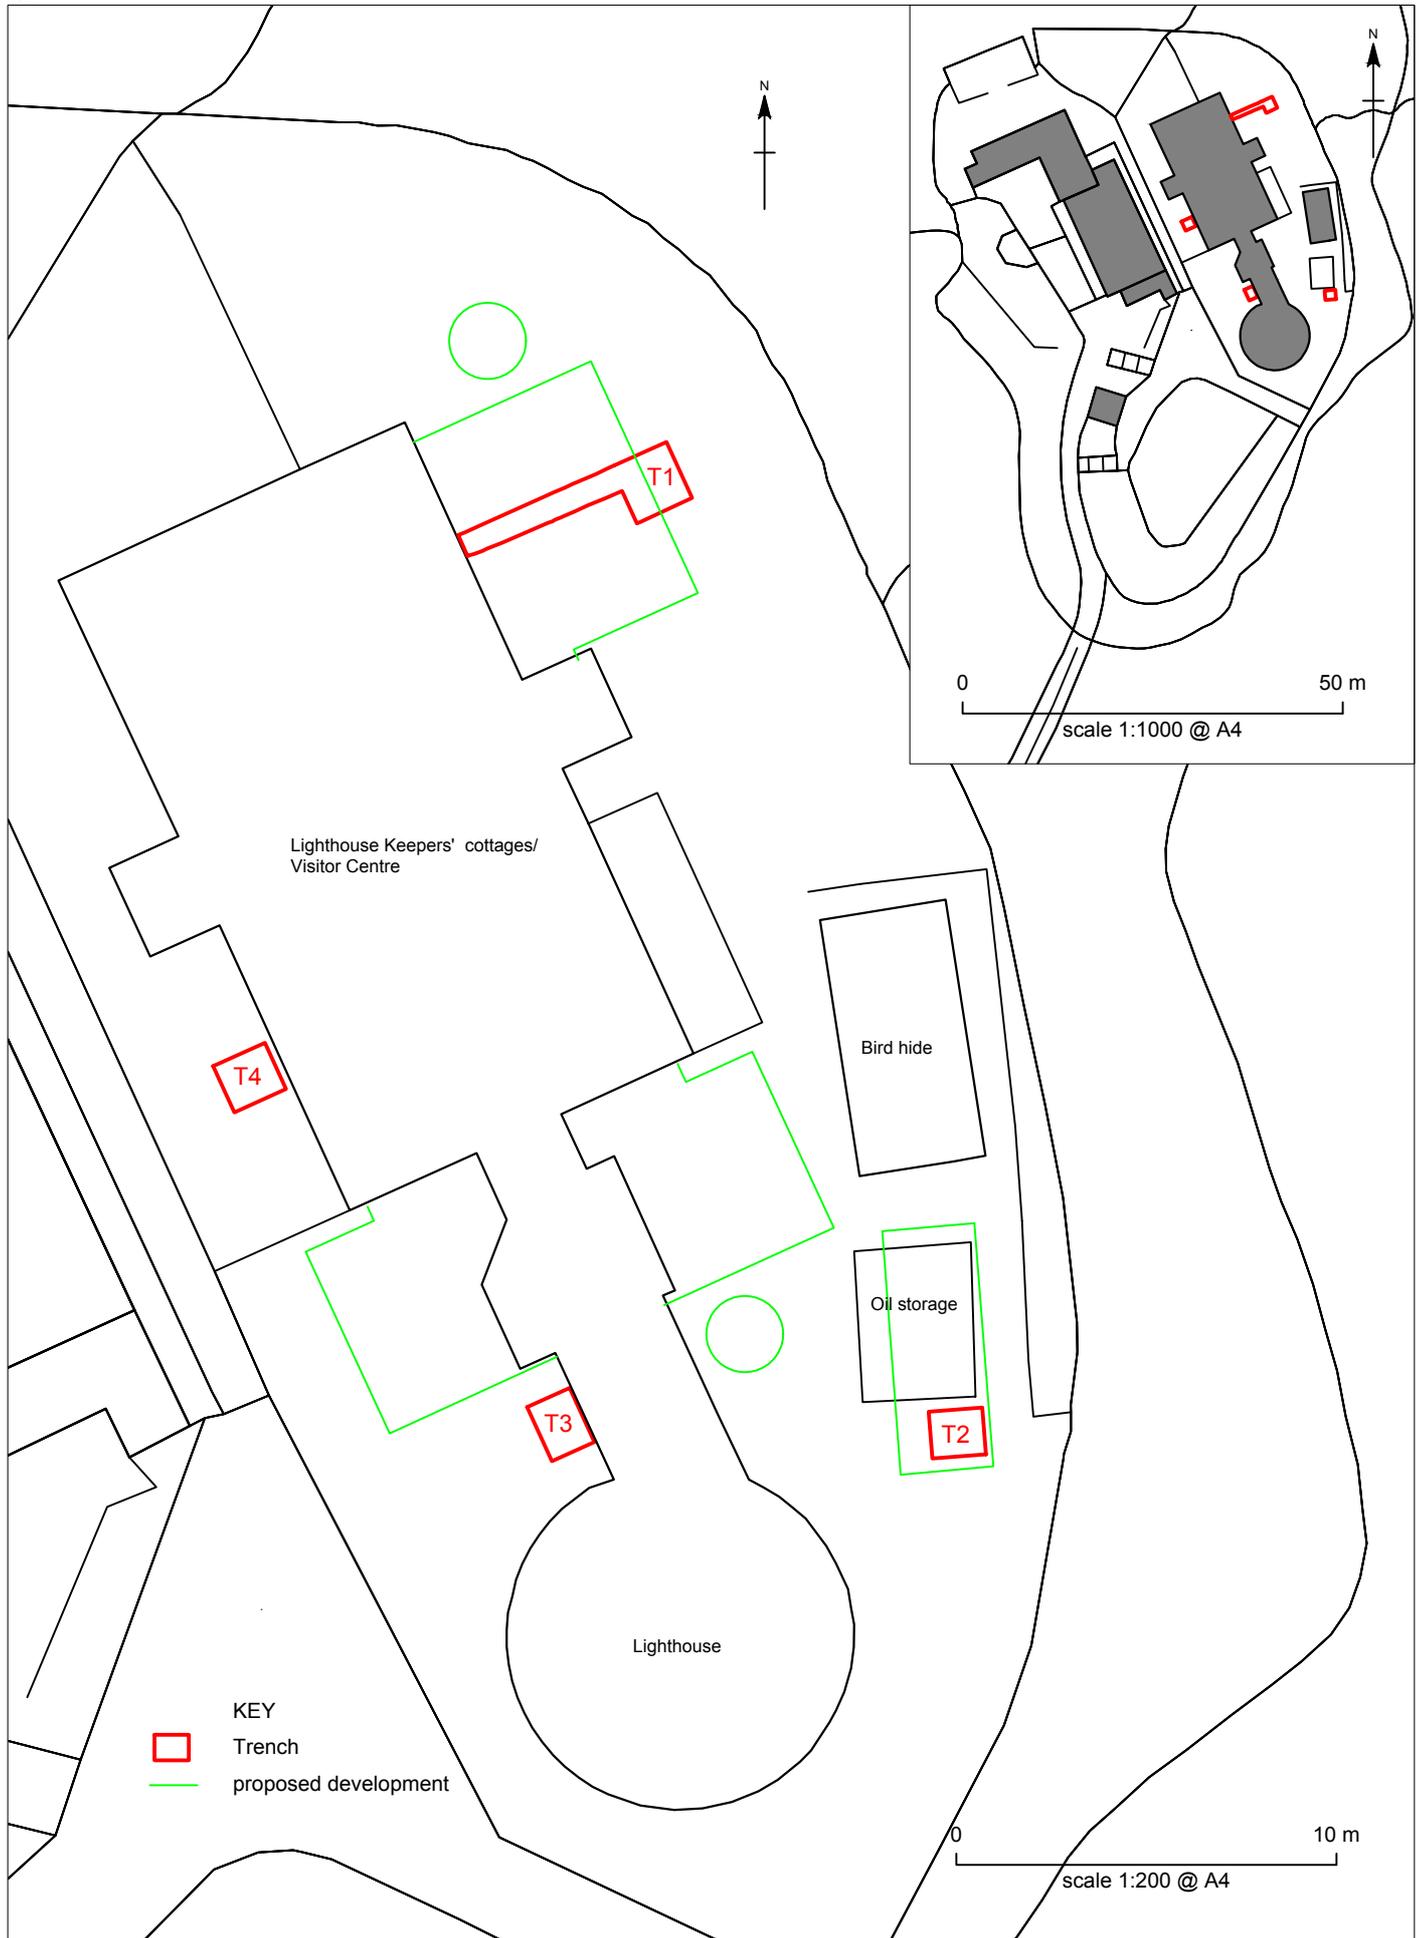
St. Mary's Island, North Tyneside: trench location and extent of proposed development Figure 2
