ARCHAEOLOGICAL EVALUATION

FUTURIST THEATRE SCARBOROUGH

Project No.: 1423
Text: Ben Turner
Illustrations: Oskar Sveinbjarnarson

FUTURIST THEATRE, SCARBOROUGH ARCHAEOLOGICAL EVALUATION REPORT

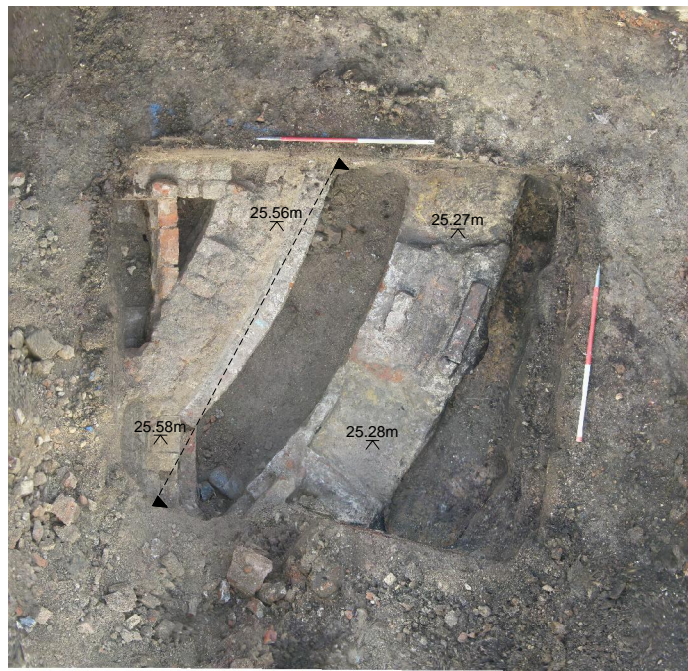
- 6.1 Trench 1 was located at the northern end of King Street car park. The earliest archaeology encountered within Trench 1 was the remains of a brick-built post-medieval bay window (Fig. 3), looking out over the bay to the east. This structure consisted of two concentric curving walls approx. 0.5m wide. Between these two walls was a narrow void, which contained a brick-lined drain and cast iron pipe. The foundations of this structure cut through natural subsoils at a depth of 1.2m below modern ground level (BGL). Natural subsoil within this trench consisted of a reddish brown slightly sandy clay.

- 6.2 A dark soil layer was recorded against the outside face of the bay window, which has been interpreted as a garden soil layer. This is consistent with historical mapping of the area, which shows an open grassy area outside of this building. A small ceramic gaming piece was recovered from this deposit, thought to be part of a Victorian children's game known as 'knucklebones' or 'fivestones'.

- 6.3 Sealing the Victorian deposits within Trench 1 was a thick layer of general demolition rubble (**100**), consisting of modern and post-medieval brick and roof tile and a wide range of pottery fragments. The earliest pottery recovered from this deposit was part of a green glazed Scarborough ware strap handle, dating to between the 13th and 14th centuries. Also recovered from demolition deposit **100** were three fragments of brick dateable to between the 15th and 17th centuries. The inclusion of much earlier

- 7.2 Trench 1 recorded the footings of a bay window, which was part of a building shown on the OS Second Edition map of 1893 as a hospital. King Street Hospital (also known as King's Cliff Hospital) was founded by Lady Louisa Sitwell in 1883 (Sitwell Society 2018), although the building in which it was housed was constructed prior to 1850. This had been demolished by c.1929.

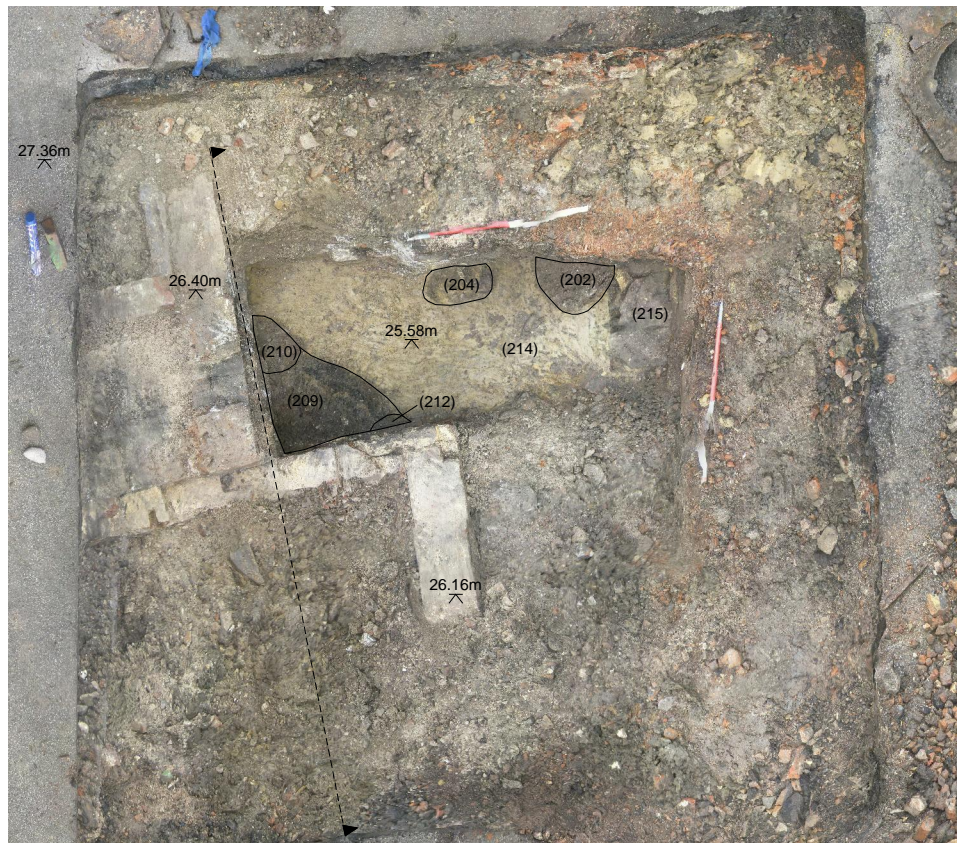
- 6.5 Trench 2 was located to the south of Trench 1, roughly in the centre of King Street car park. The earliest features encountered within Trench 2 (Fig. 4) were a series of five refuse pits and a stone paved area cut into a pale-yellow clay (**214**), which was recorded 1.73m BGL. Artefacts recovered from the fills of pits **202**, **204** and **209** included green-glazed pottery dating from the 13th to 14th centuries, fragments of animal bone, and a glazed roof tile dating from between the 13th and 16th centuries.

- 6.6 A small section of stone paving slabs (**215**) was recorded next to pit **202**. The feature consisted of three roughly-dressed slabs laid directly onto pale-yellow clay (**214**). No evidence was recovered to suggest a date for this feature. It was likely that this feature was part of a yard surface associated with the medieval pits, as they were all cut into clay deposit **214**.

- 6.7 Cutting pits **209**, **210** and **212** was the construction trench for a brick-built structure, probably Victorian in date. Sealing the Victorian structure was a general demolition layer very similar to layer **100** within Trench 1.

- 7.1 The archaeology encountered within Trench 2 dates from either the 13th or 14th centuries and probably represents an area where general household debris was disposed, potentially a back yard area. The dates of these features are consistent with the archaeology uncovered by MAP archaeology in 2007 along the northern boundary of the car park, where a wall dating to the 13th century was recorded (Stephens and Langford 2007).

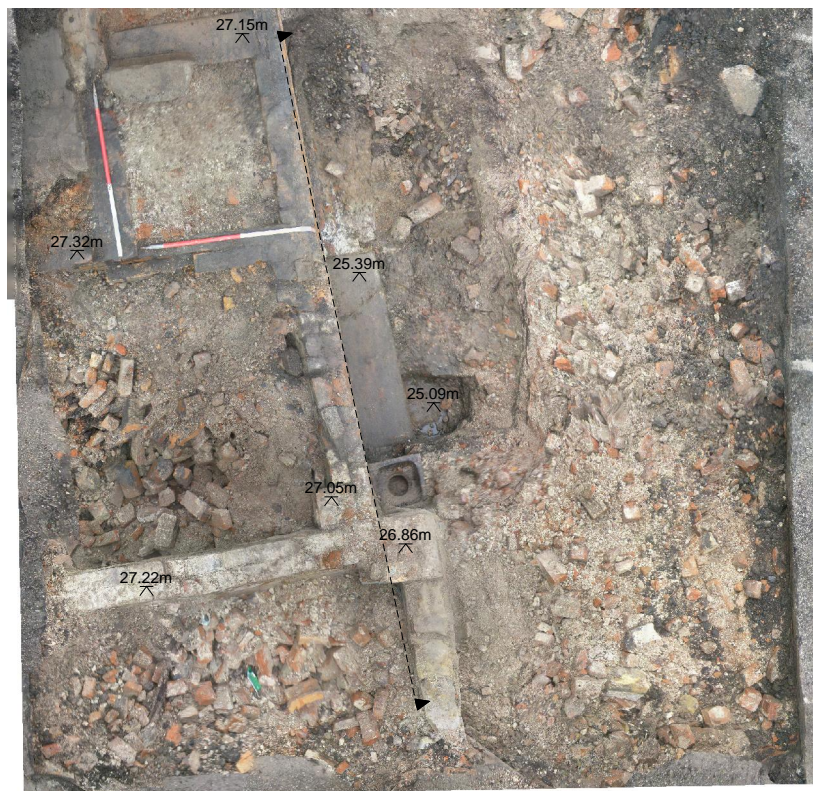
- 6.8 Trench 3 was located at the southern end of the King Street car park, to the south of Trench 2.
- 6.9 The earliest feature encountered within Trench 3 was the remains of a Victorian brick building (Fig. 5) fronting onto King Street. This building survived to a considerable depth (approximately 1.3m BGL) and was observed cutting into natural subsoil, identical to Trench 1, at a depth of 2.5m BGL.
- 6.10 Two interior cells could be seen within Trench 3, infilled by brick rubble. It was not possible to excavate these cells due to the instability of the thin interior walls. They

probably represented infilled cellars or interior rooms. A large section of the exterior of the east wall was exposed, which contained a blocked-up doorway with a doorstep at its base, likely indicating the original external ground level. The doorstep was cut into natural subsoil.

- 6.11 A general demolition layer overlay the building and was in turn sealed by tarmac.

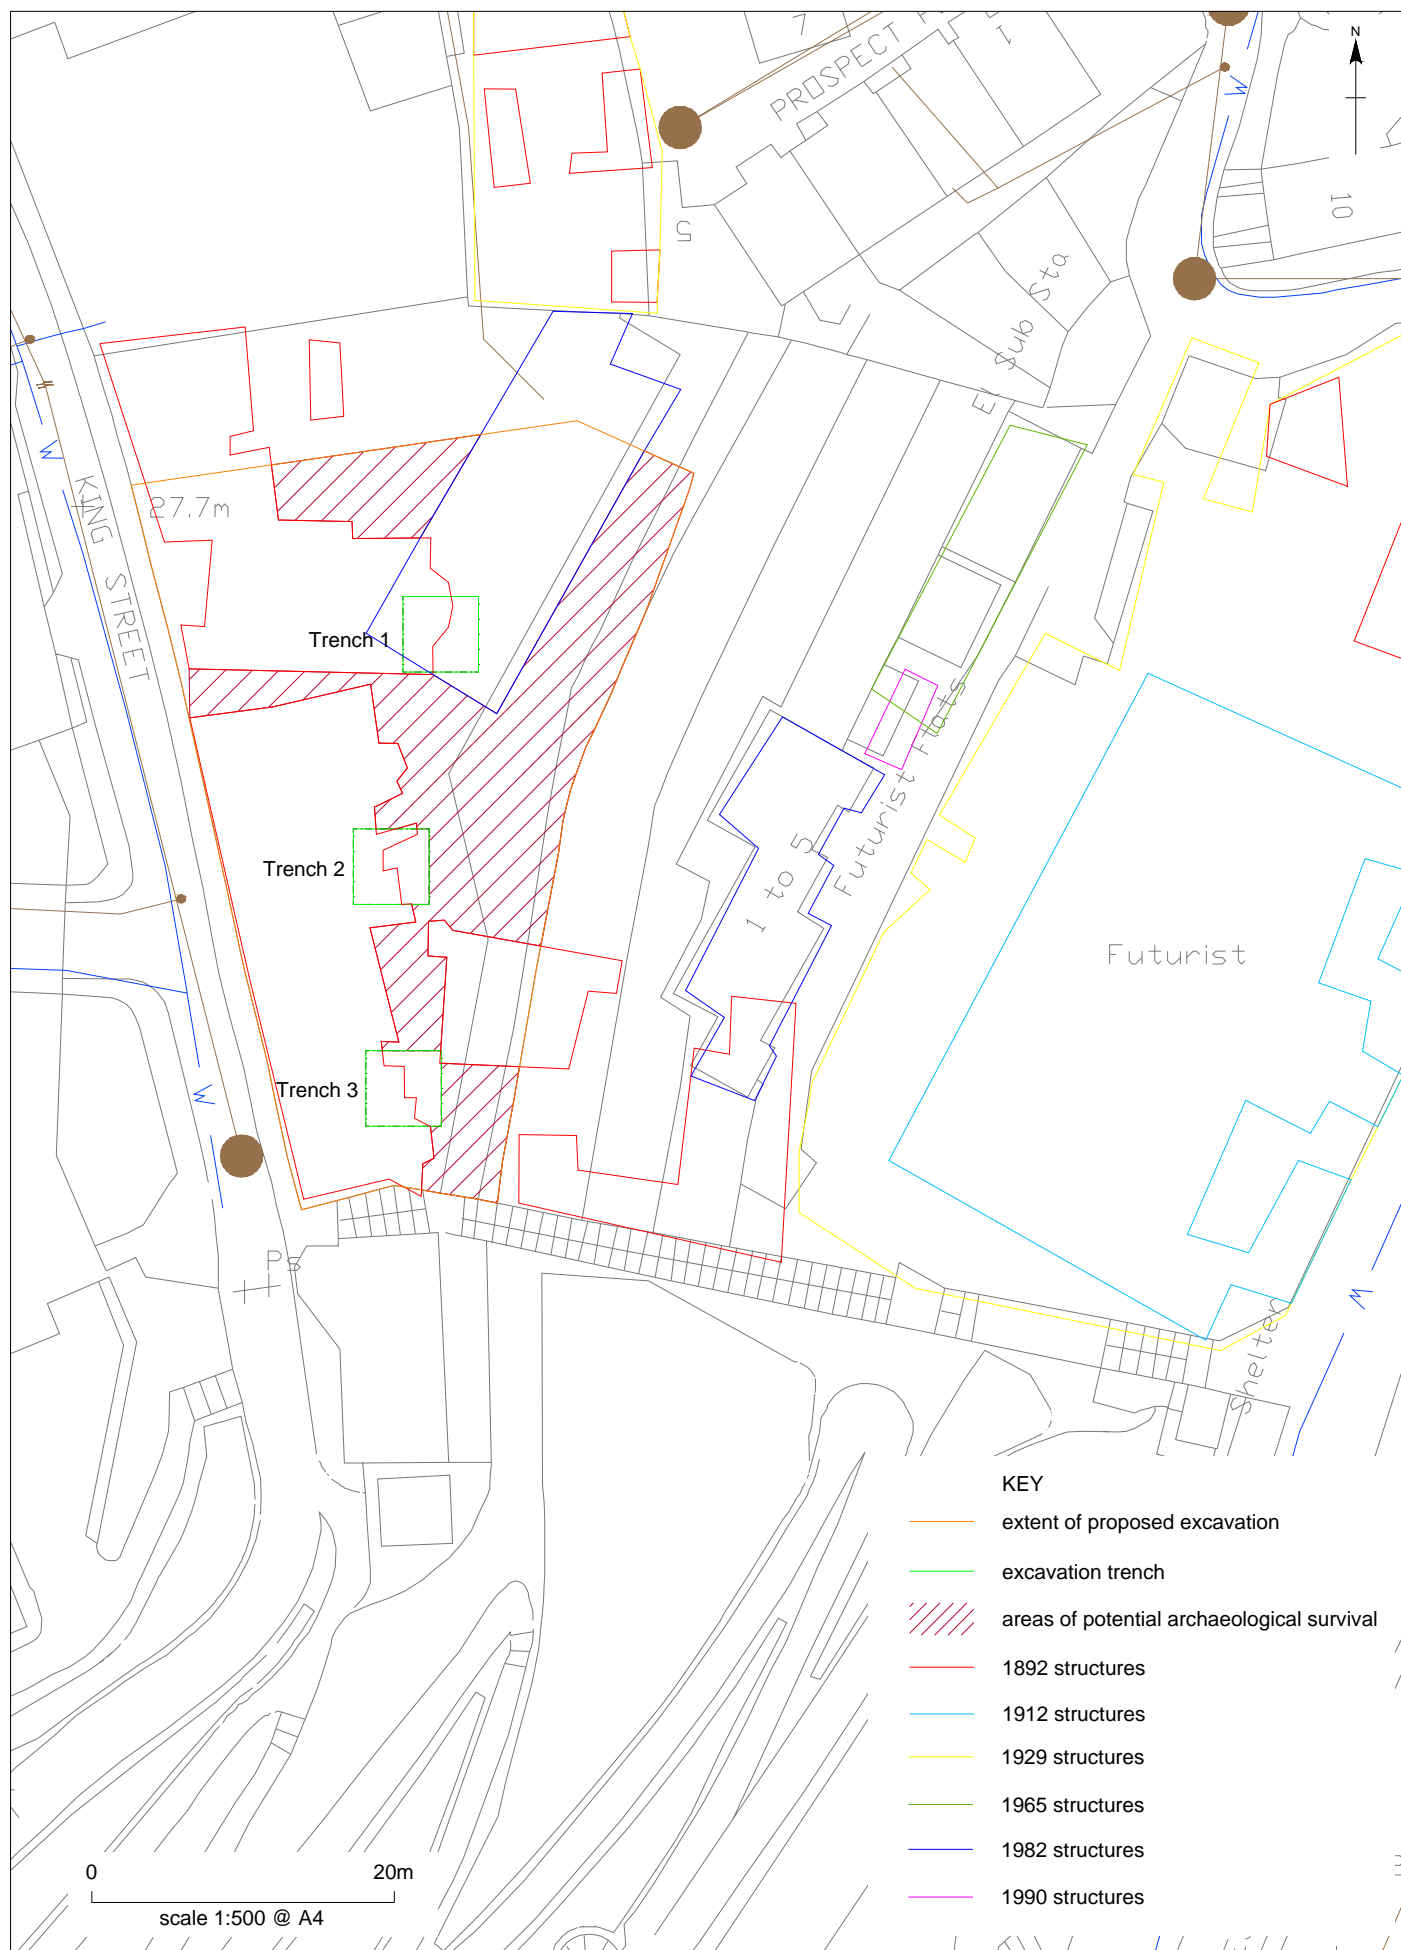
- 7.3 The trial trenching has confirmed the presence of medieval remains, which have been heavily truncated by later development of the site. It is considered unlikely that medieval remains survive beneath the foot-prints of the post-medieval buildings, but there is some potential for further medieval features or deposits to survive in between and to the east of the later buildings (Fig. 6).

- 7.4 Given the degree of previous disturbance, it is considered that archaeological monitoring of groundworks (a watching brief) should be undertaken in order to mitigate these impacts.
