ARCHAEOLOGICAL
MONITORING REPORT

**FEETHAMS RIVERSIDE
DARLINGTON
COUNTY DURHAM**

NAA 18/14
February 2018

**FEETHAMS RIVERSIDE, DARLINGTON, COUNTY DURHAM
ARCHAEOLOGICAL MONITORING REPORT**

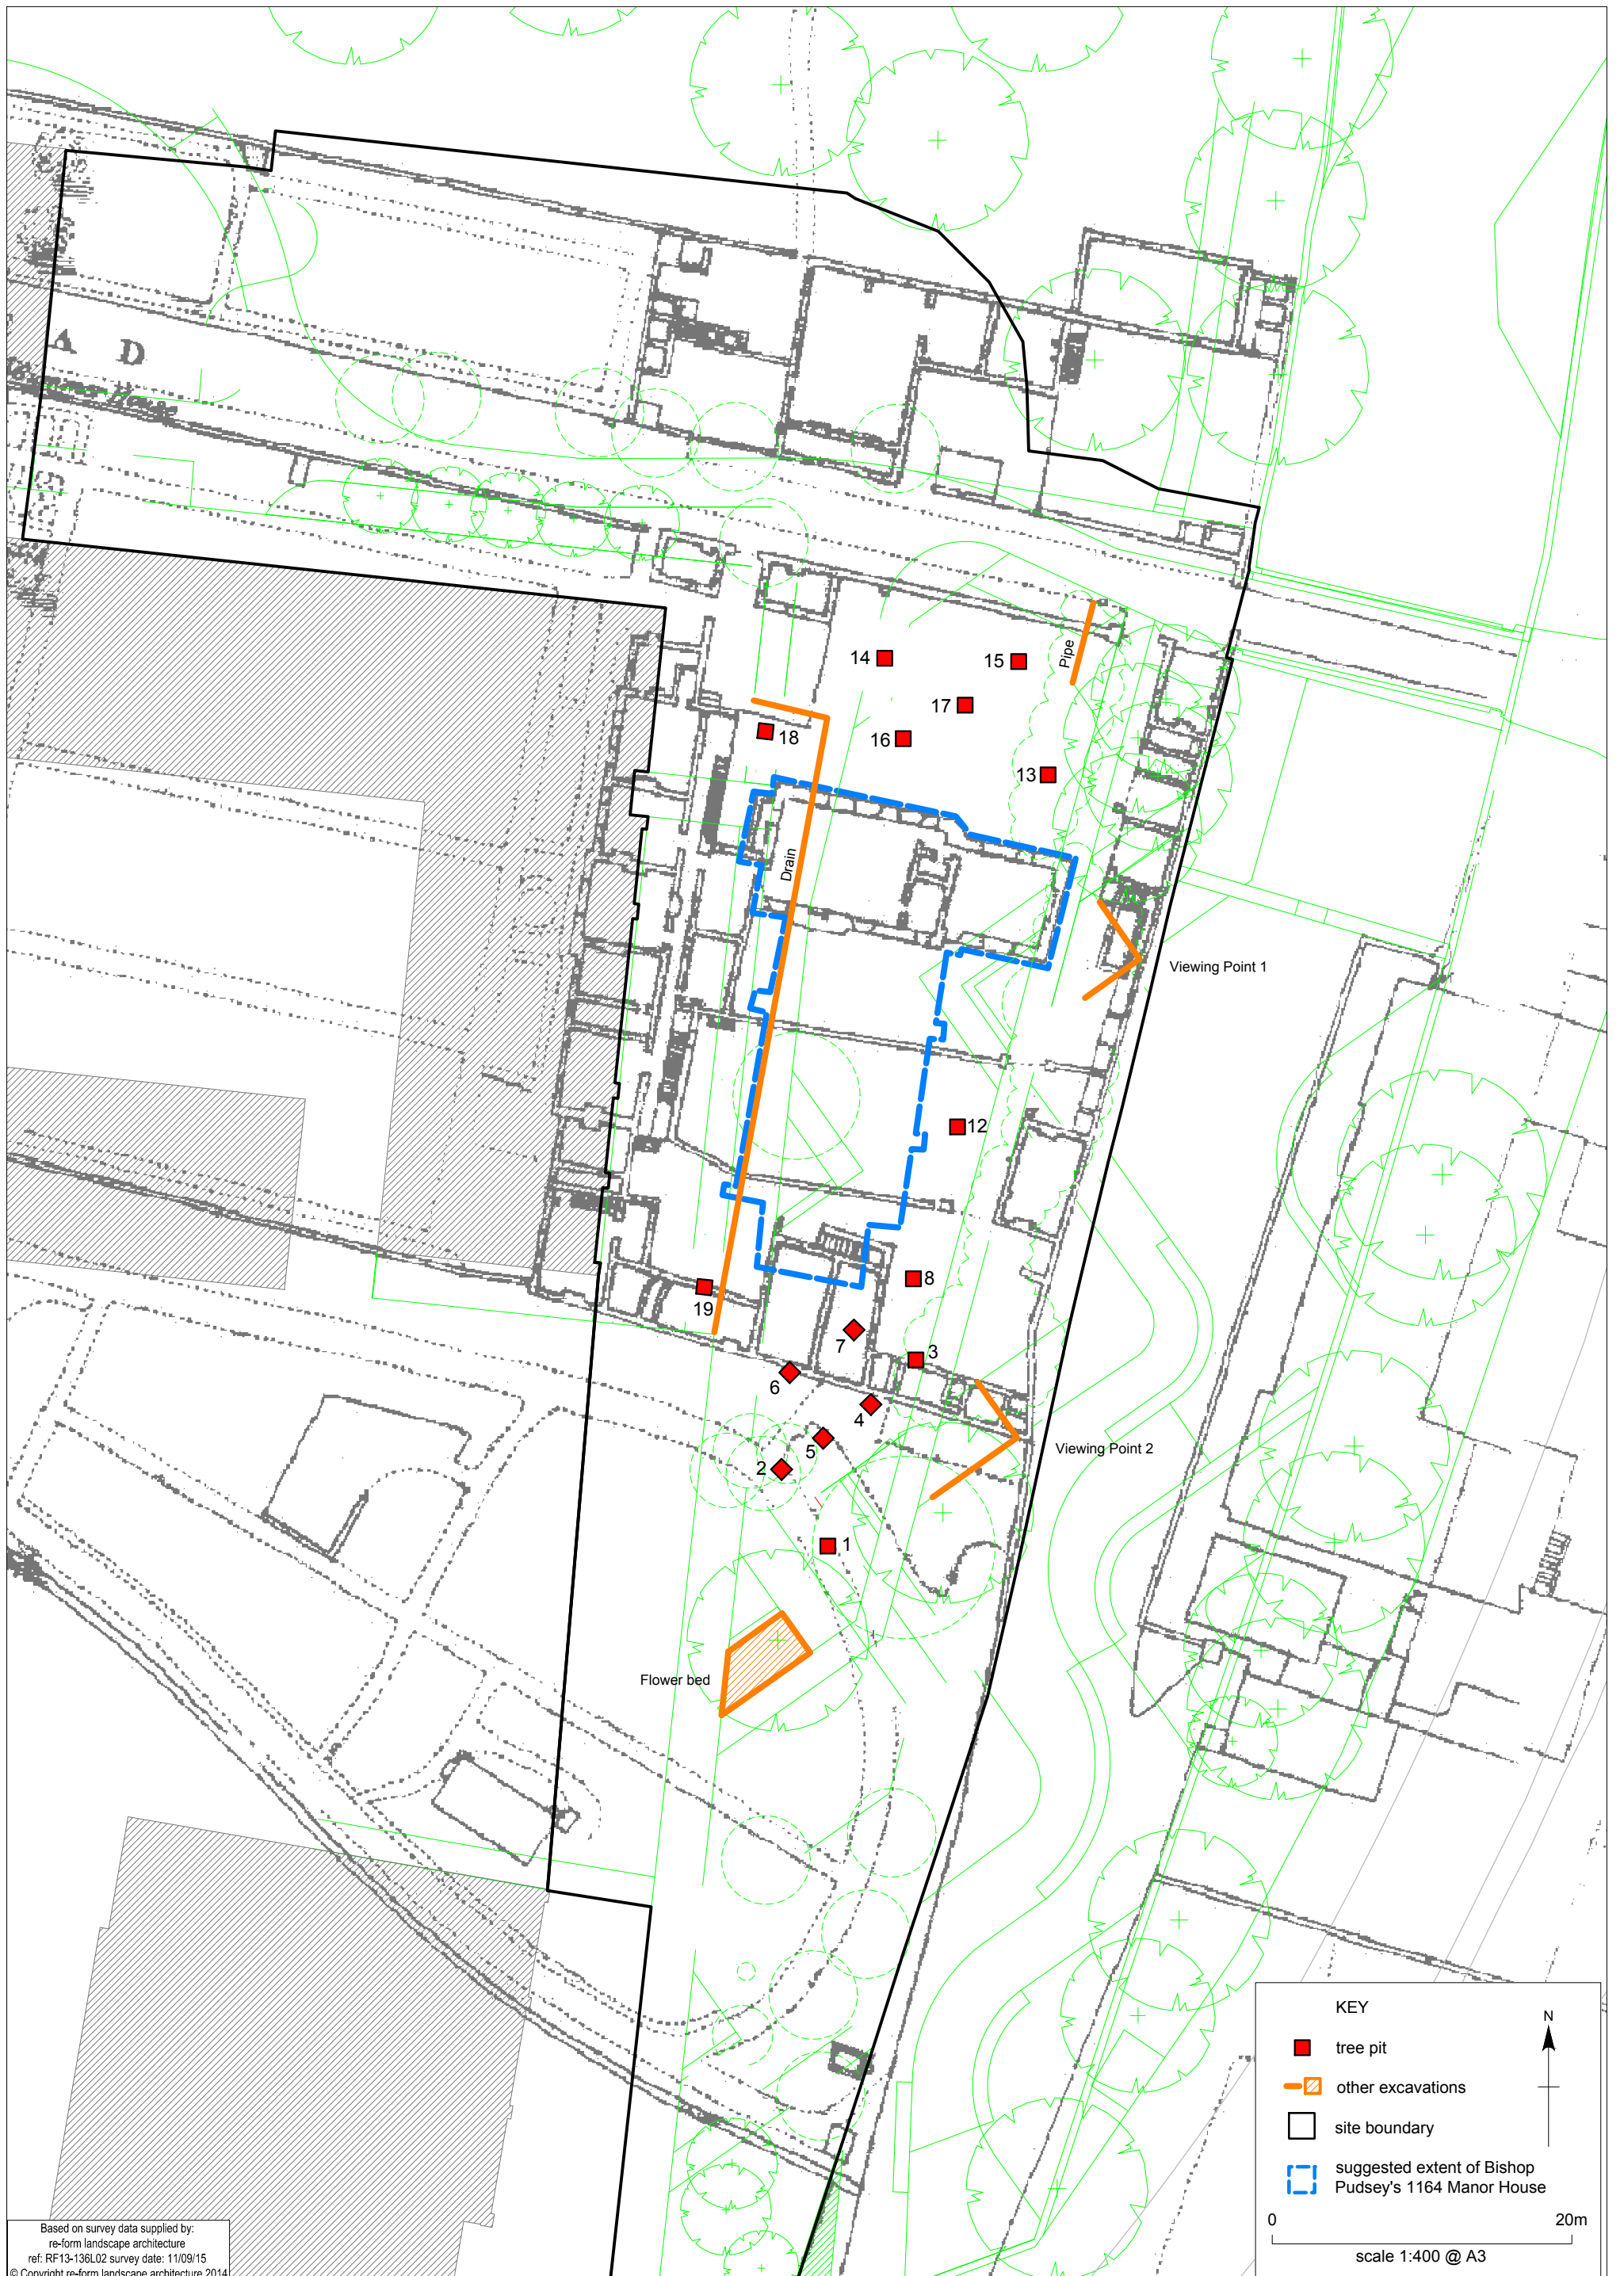
Figure 2

Feethams Riverside, Darlington: monitoring locations overlaid on 1856 Ordnance Survey map and the outline of the extent of Bishop Pudsey's 1164 Manor House

5.1 Prior to monitoring commencing, the site was cleared of the tarmac and sub-base of the car park. The ground level was then brought back up to the required height using imported hardcore and soil (Plate 1). This meant that the flower beds were mostly within newly imported soils and the cable trenches for the street lighting were within the hardcore deposit. Therefore, the monitored work consisted of the excavation of a sample of flower bed, sixteen tree pits (three of which were excavated twice), trenches for the foundations of two viewing platforms, and three drainage and water pipe trenches. The locations of the monitored work are illustrated on Figure 2.

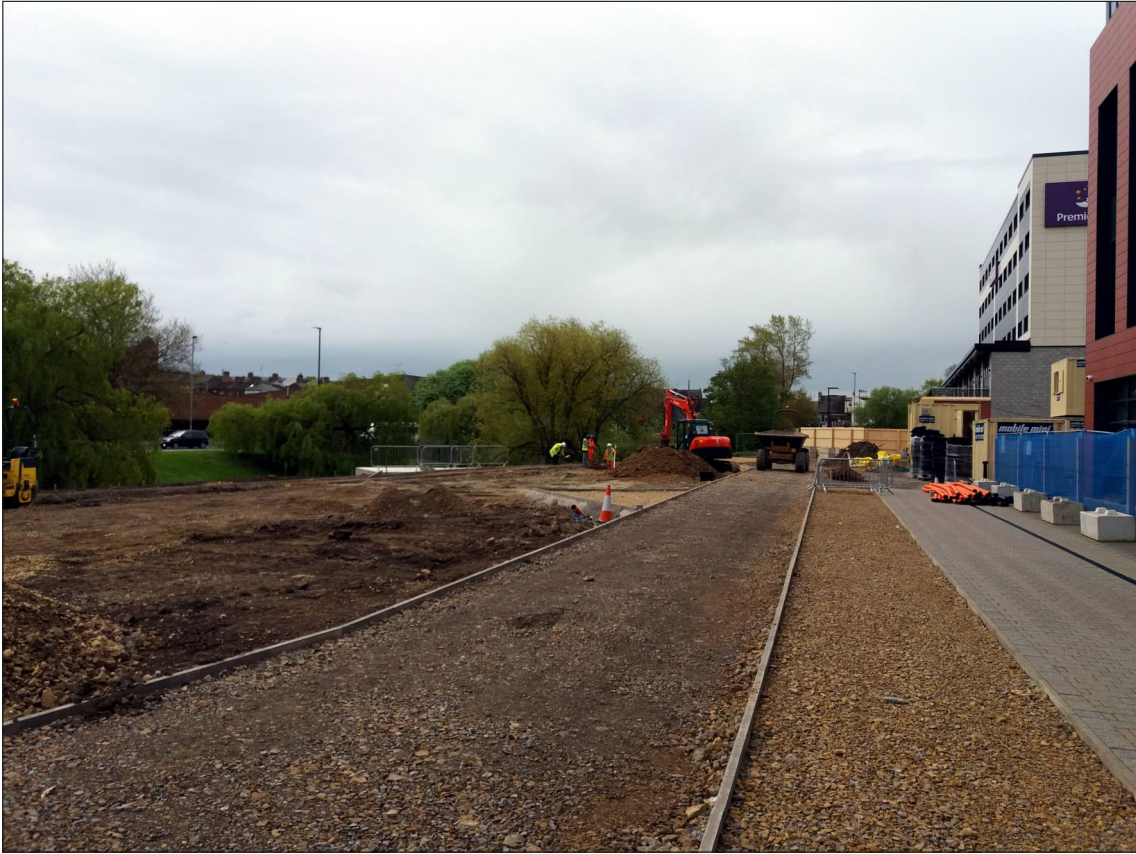
Plate 1

Feethams Riverside, Darlington: general view prior to main excavations

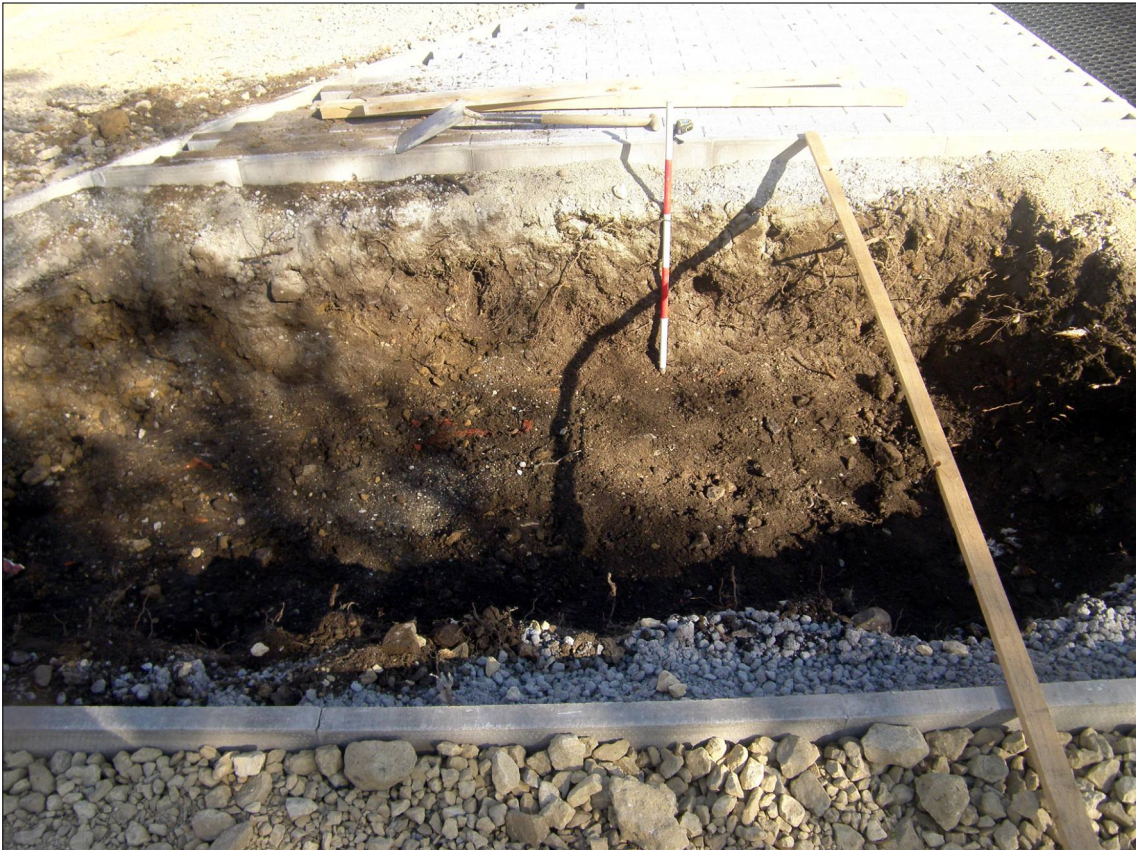
Plate 2

5.2 The flower bed measured up to 7m by 4m and was excavated to a depth of 0.6m, passing entirely through topsoil (Plate 2). Only modern finds were identified.

Feethams Riverside, Darlington: excavated flower bed

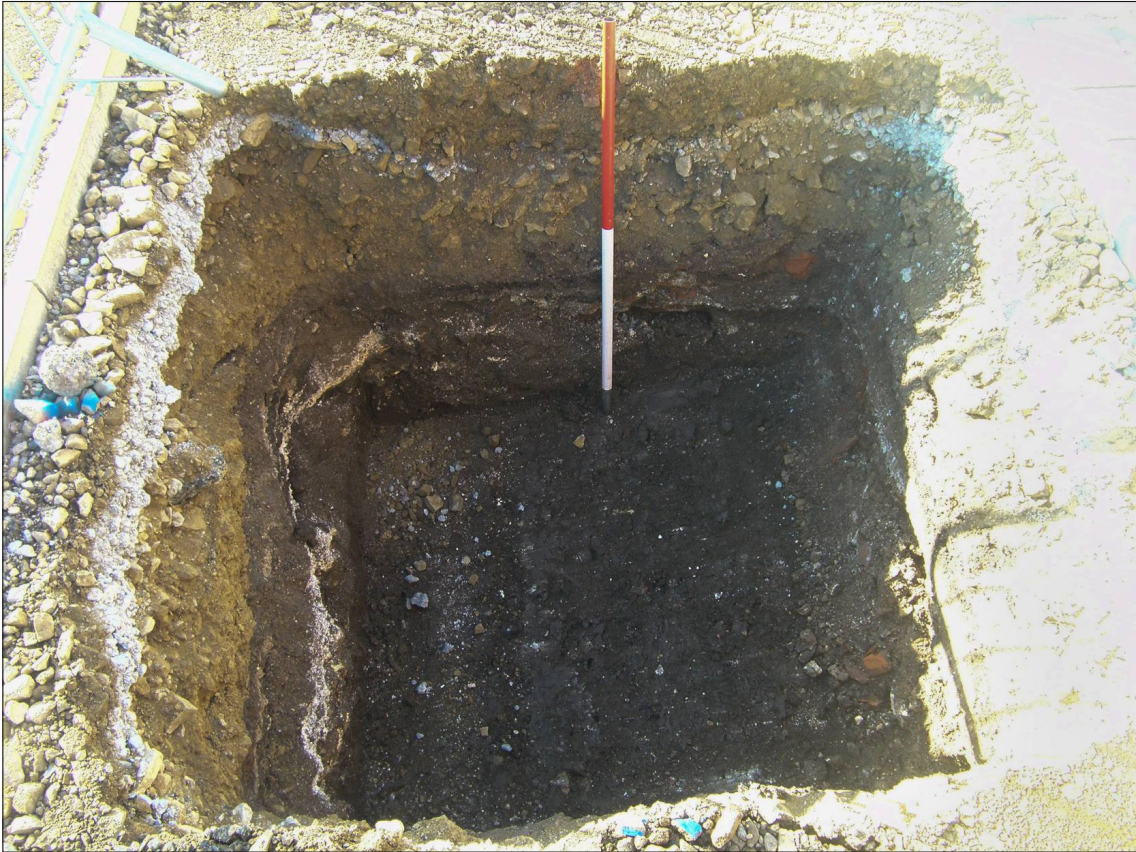
Plate 3

5.3 The tree pits in the centre of the site were aligned approximately north-east to south-west, while others were east to west. None of the pits revealed in-situ archaeological remains, with the possible exception of Tree Pit 19, which had a 50mm thick concrete surface immediately below the imported fill. This was identified only in the side of the pit (Plate 3), incorporated brick rubble, and was apparently relatively modern.

*Feethams Riverside, Darlington: Tree Pit 19 showing
concrete layer*

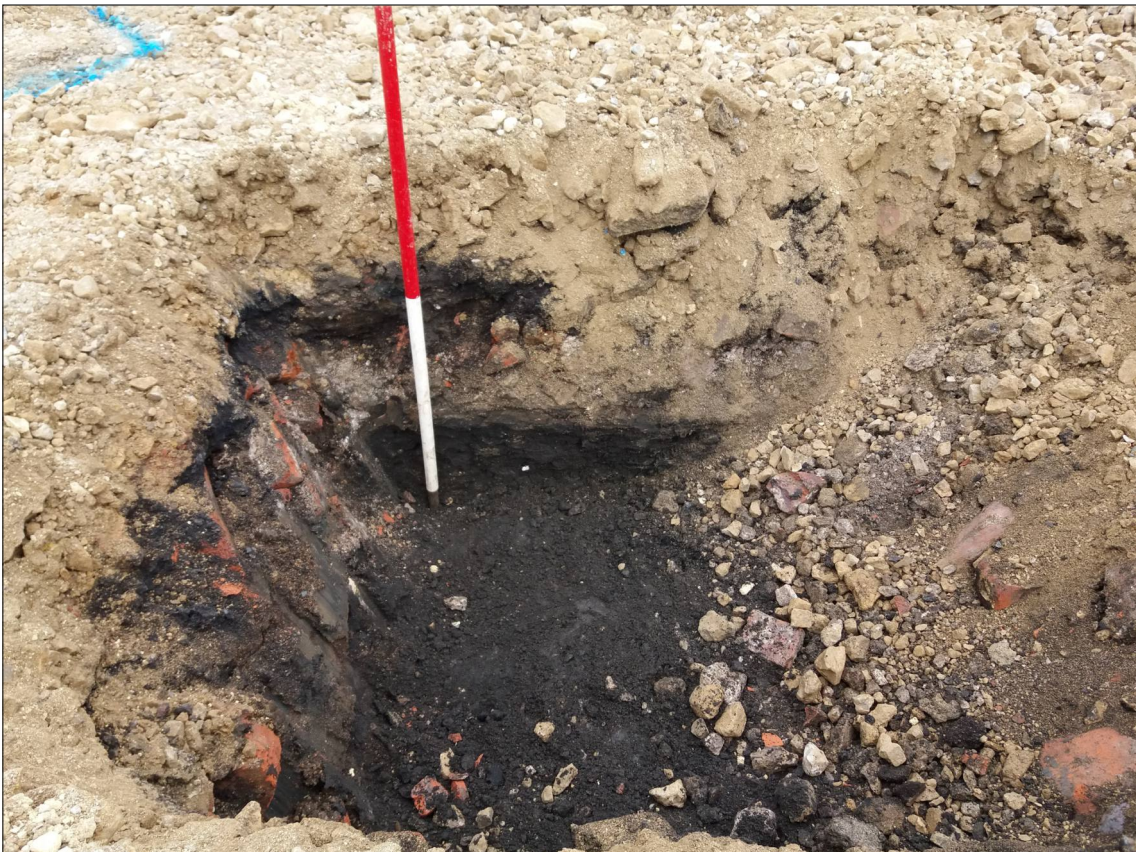
Plate 4

5.4 The majority of the pits revealed a dark, 'brown earth' buried topsoil at a depth of between 0.6m and 0.9m. There were occasional sherds of 19th-century or later pottery and glass, which were not retained. The buried soil was generally overlain by up to 0.3m of 'made ground', comprising mixed clay and soil with frequent inclusions of concrete and brick rubble, and up to 0.3m of hardcore, occasionally with remnants of the granular sub-base for the earlier car park. Within the northern side of Tree Pit 4, the made ground was almost entirely composed of brick rubble (Plate 4), probably arising from the demolition of the Victorian workhouse.

*Feethams Riverside, Darlington: brick rubble on north side
of Tree Pit 4*

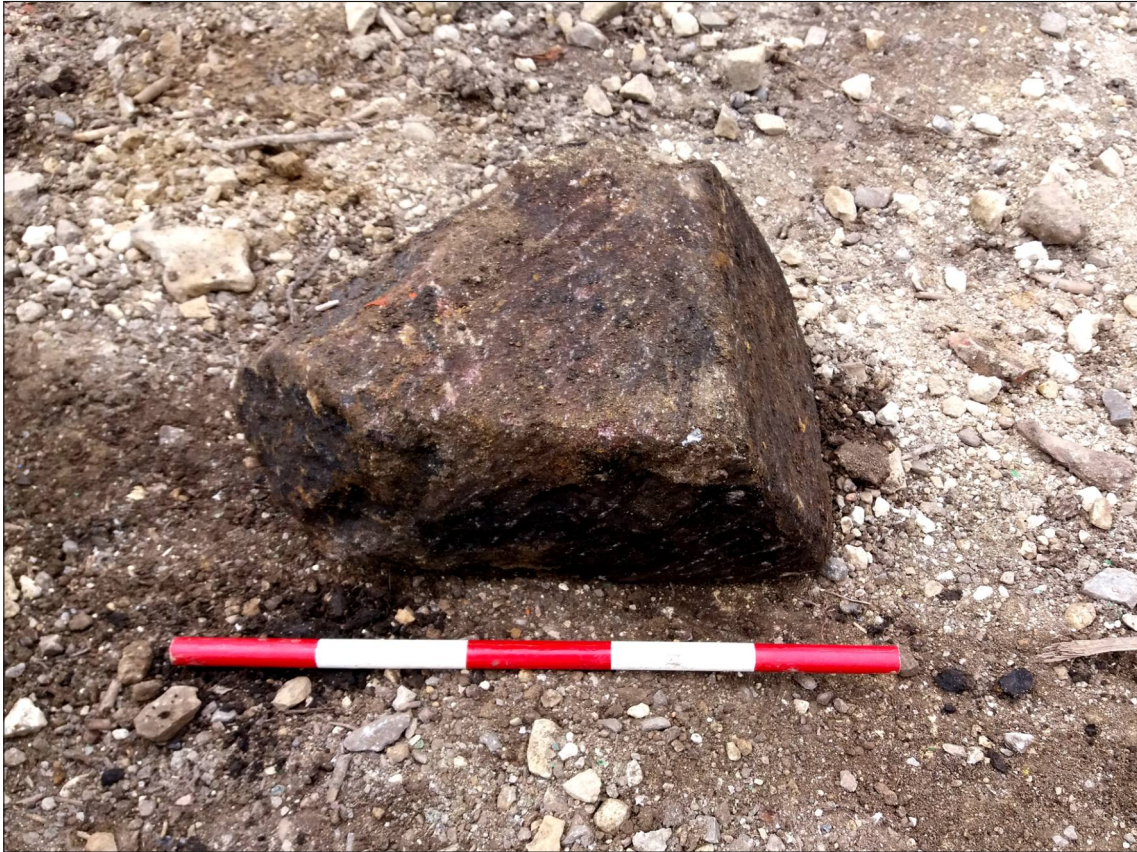
Plate 5

5.5 Tree Pit 5, immediately to the south, produced three blocks of dressed masonry, possibly derived from the Bishop's Palace. Two of these were fragments of plinths or corbels with differing angles of slope; one measured 0.28m long, 0.18m high and

0.34–0.4m deep, with an angle of c.72° (Plate 5), while the other measured 0.5m long, 0.19m high and 0.2–0.3m deep, with an angle of c.62°. The third block of masonry was approximately cuboidal, measuring 0.48m by 0.26m by 0.19m. A few other pits had occasional masonry fragments within the made ground. The larger blocks of masonry were retained by the contractor for reuse in the street furniture.

*Feethams Riverside, Darlington: fragment of plinth or corbel,
possibly from Bishop's Palace*

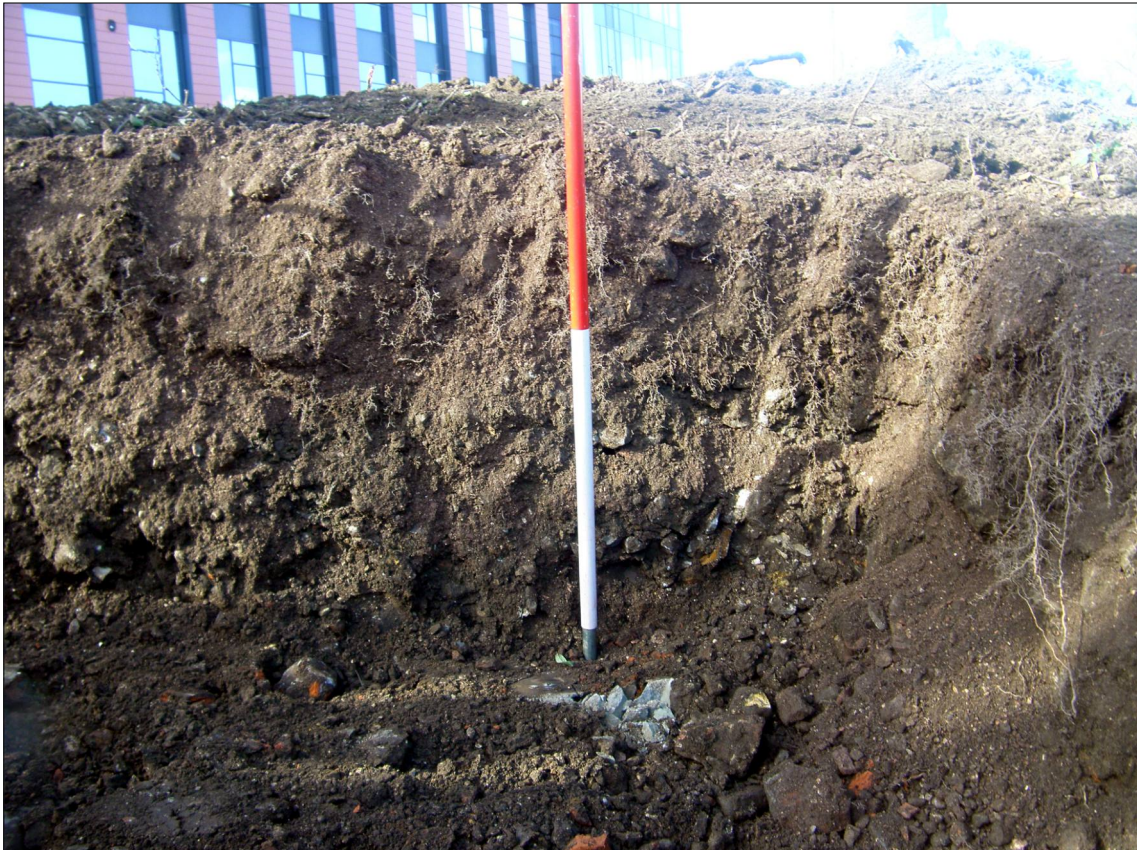
Plate 6

5.6 The trenches for the foundations of the viewing platforms were c.0.5m deep at the river edge, where they were cut through the deep topsoil of the river bank. The western (upslope) ends of the trenches were 0.8m deep (Plate 6), with up to 0.5m of made ground and 0.3m of topsoil recorded.

*Feethams Riverside, Darlington: upslope end of foundation
trench for viewing platform*

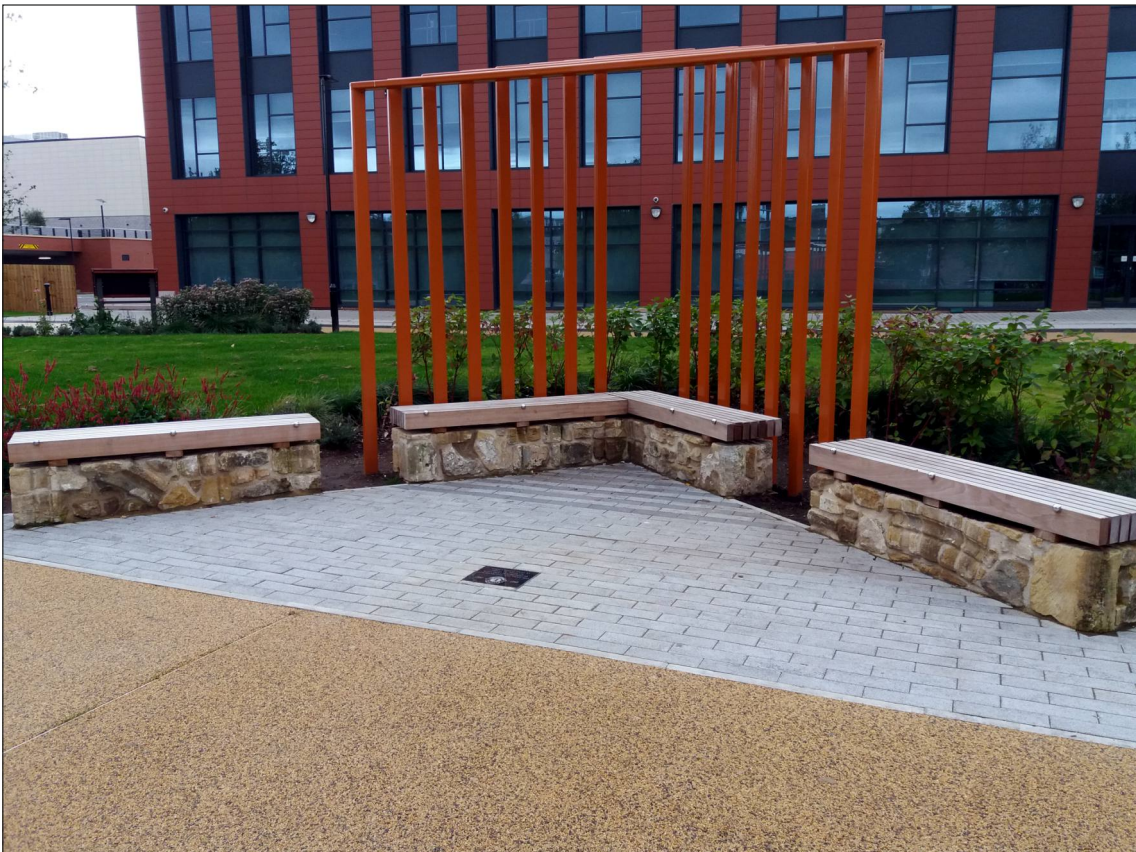
Plate 8

6.2 There were no pre-modern finds, other than the fragments of masonry, which were retained by the developer to incorporate into the street furniture (Plate 8).

Feethams Riverside, Darlington: feature seating in completed development showing reused medieval masonry
