## HISTORIC BUILDING RECORDING

COWCLOSE HOUSE,  
BARNINGHAM, COUNTY DURHAM

NAA 18/84  
September 2018

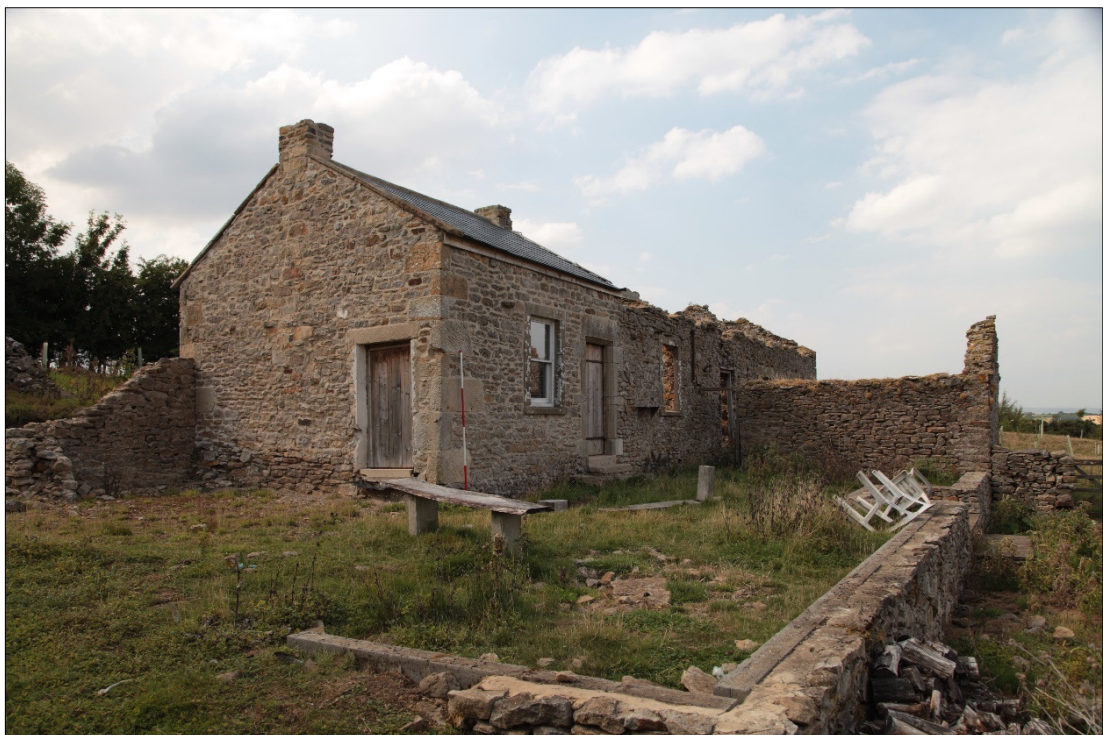
*Plate 1: view of the east elevation of Cowclose as seen from the south-east.*

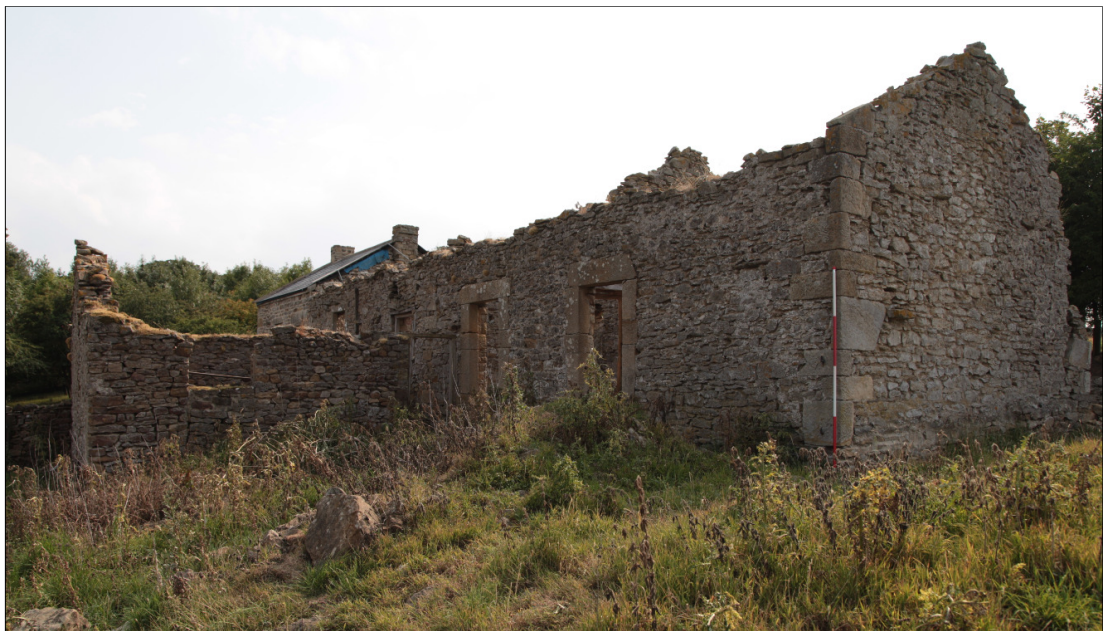
*Plate 2: general view looking south-west, with byre and barn in the foreground.*

- 5.1 The building is a traditional stone longhouse, aligned on a north–south axis with a protruding wing extending east (a later addition; Fig. 10). The lintel stone at the entrance of the building dates to 1697, although the structure has undergone considerable modification, most notably in the early 19th century with the addition of the east extension. There is little evidence to suggest that the lintel is not original to the building, although this cannot be wholly discounted, and the stone could have been reused from another structure in the vicinity.

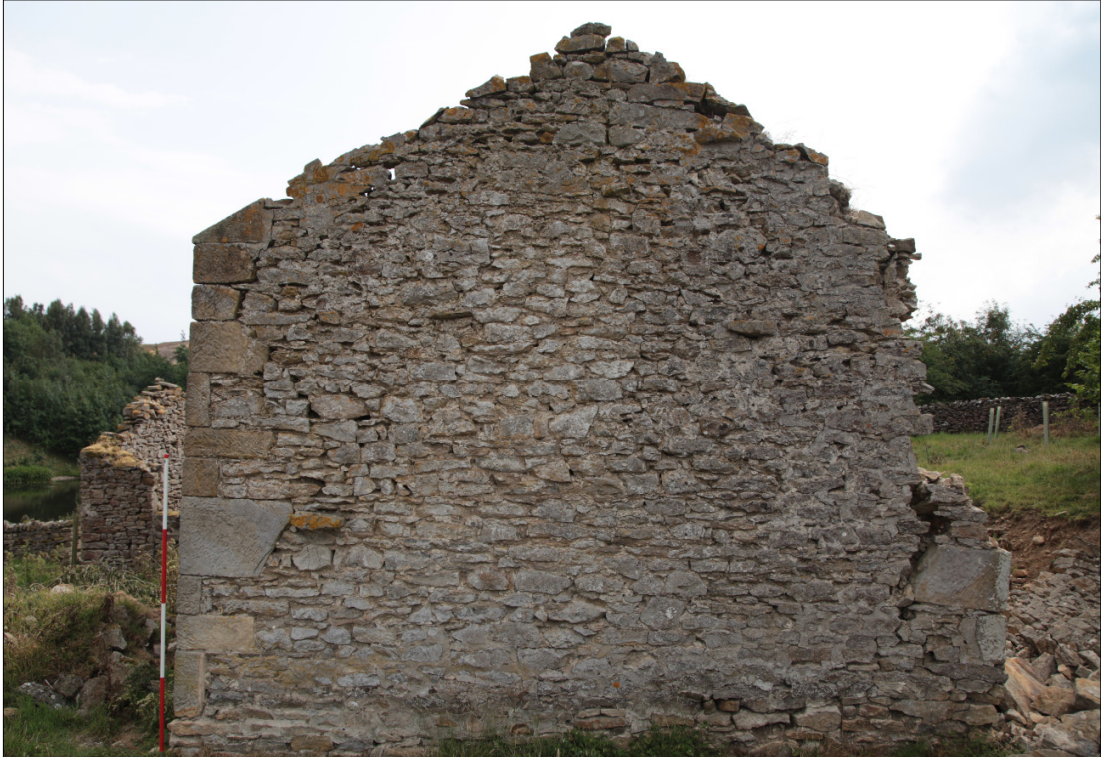
*Plate 3: north facing elevation (1100).*

- 5.3 The north gable elevation (Fig. 11; Plate 3) comprises a rubble-built wall that survives to a height of 5.00m with rough-hewn quoins (**1101**) on the eastern corner. There is evidence of quoins at the western corner (**1102**) but most of the wall has collapsed.

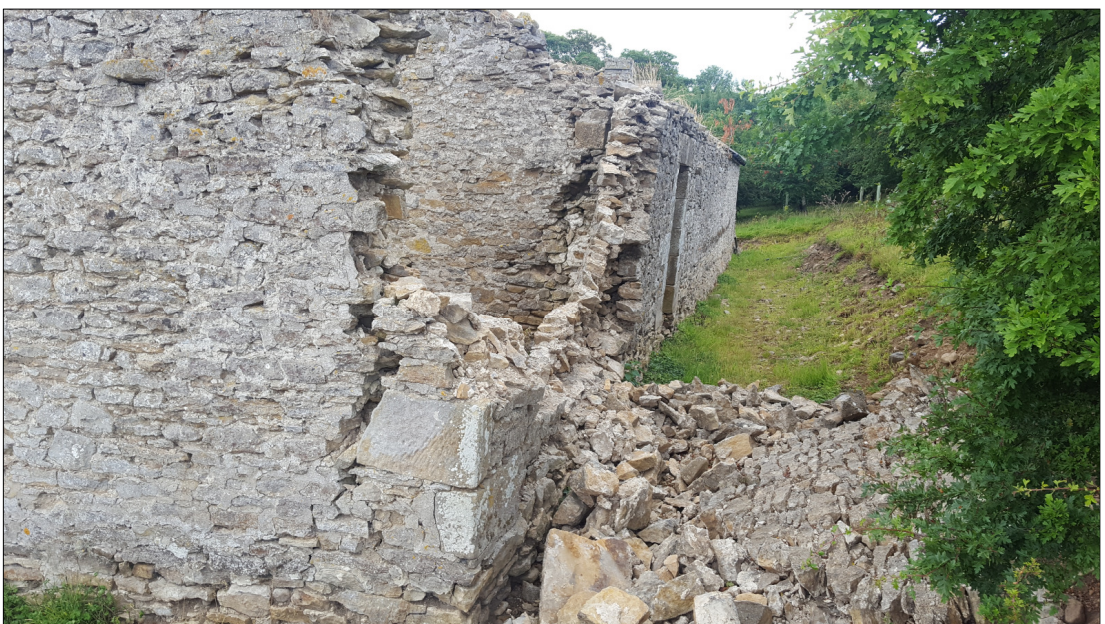
*Plate 4: oblique photograph of west facing (rear) elevation (1200).*

- 5.4 The west, rear facing elevation (Fig. 13; Plate 4) features a single door (1201) providing access into the barn (2200). The door has a stone threshold that is raised 0.50m off the ground and large dressed stone surrounds. To the north of the door is the semi-collapsed wall of the north bay (Plate 4). To the south is a ventilation slit (1202) and a square blocked opening (1203). Both the north and south corners have large stone quoins (1205) that, on the south wall, abut a short rubble-built boundary wall.

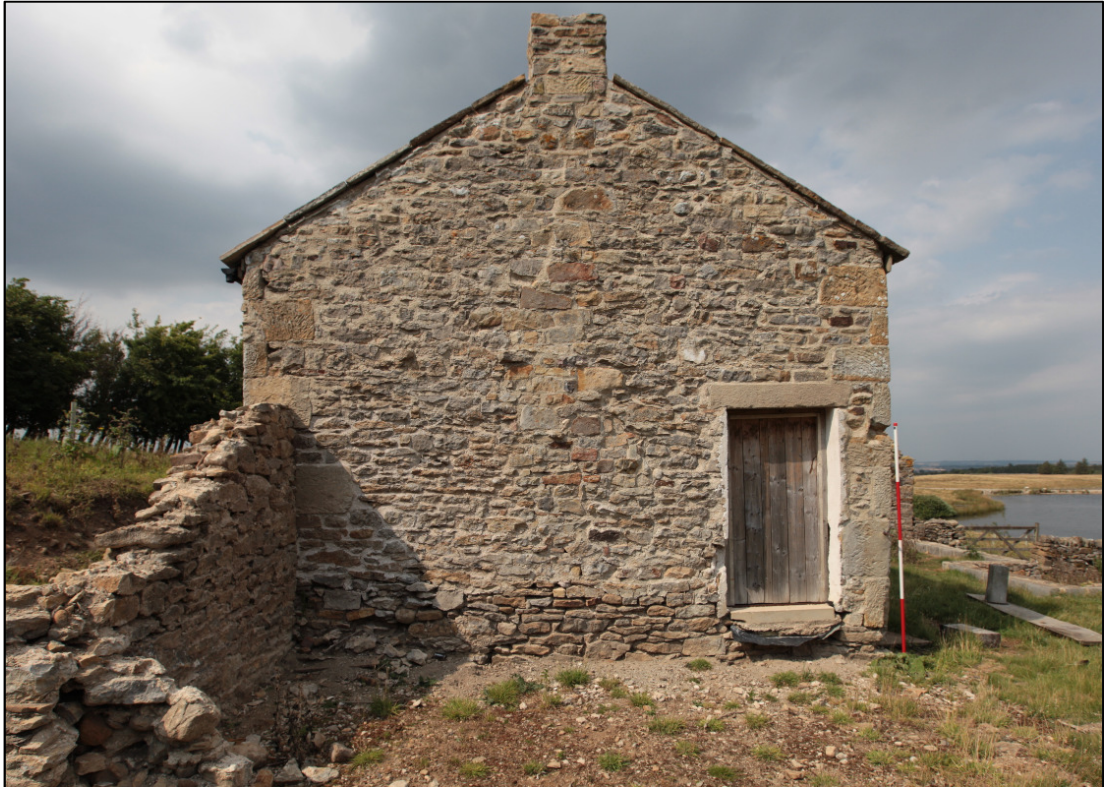
*Plate 5: south facing elevation (1300).*

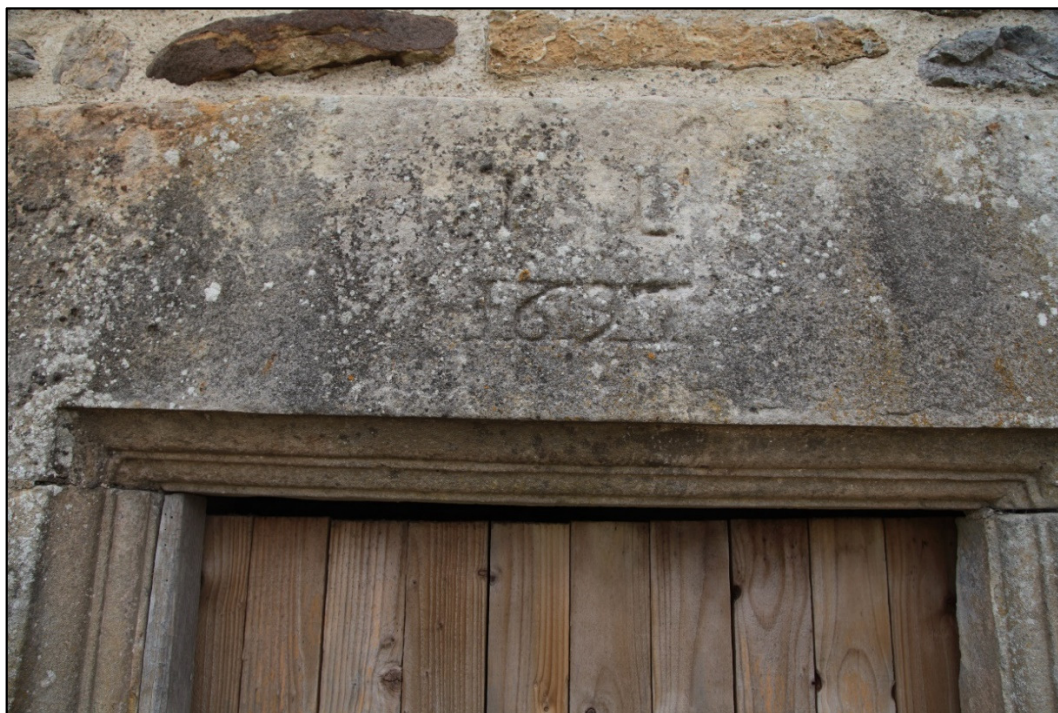
*Plate 6: lintel above the main door with the inscription 'I L 1697.'*

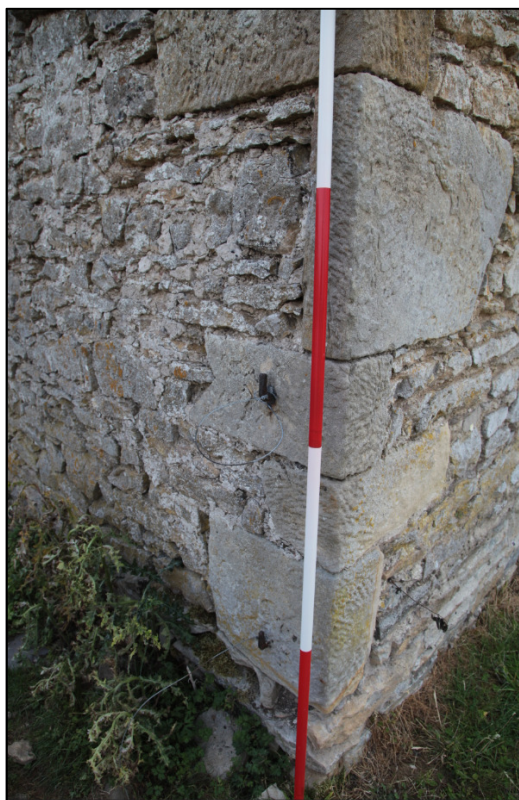
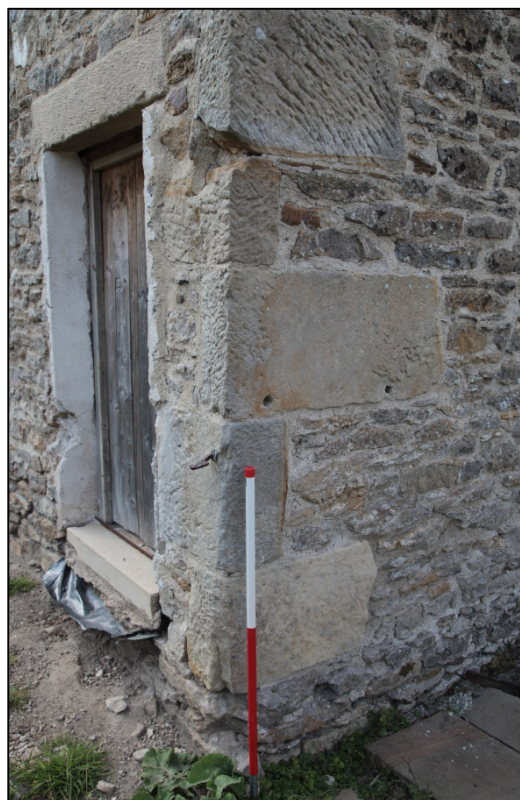
*Plates 7 and 8: setting for gatepost (1406) and square settings in quoins (1407).*

- 5.9 On the very northern edge of the elevation, set into the quoins, are two metal hinge posts (**1406**) which indicate the position of a former gate (Plate 7). Similarly, on the very southern edge of the building there are two square holes, located 0.50m apart, in one of the quoins, which is placed approximately 1.20m off the ground (**1407**) (Plate 8). These holes may be from some other gate, fence or shelf.

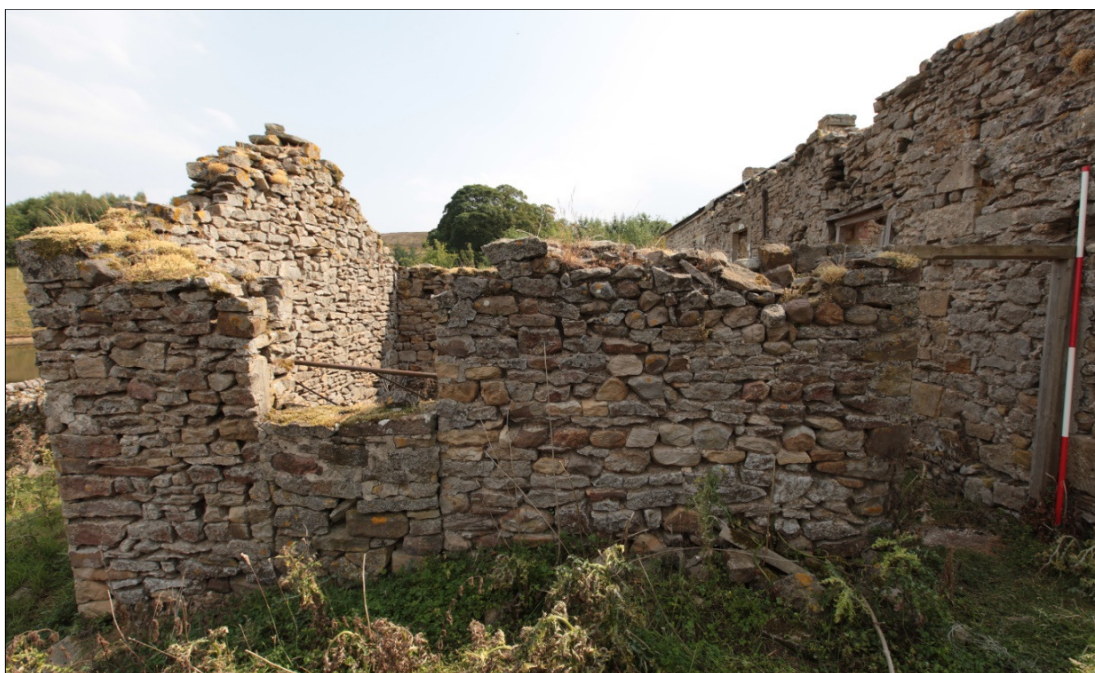
*Plate 9: north elevation of east projecting wing (2300) showing the existing door (1311) and a blocked doorway (1111), now a window.*

- 5.21 The eastern addition has lower ground levels and walls than the remainder of the building. It has only shallow foundations, further supporting the assumption that it is a later build. The room has three entrances, two doors on the north and south walls respectively (**1311** and **1111**), and one door (**2241**) into the main building. The latter door is set considerably higher than the other doors on the north and south wall yet all three have wooden frames with only the lintel tied into the wall, indicating that the structure was added later. Notably, door **2241** is the only door into the main building which has a wooden surround confirming it is a later insert (Plate 9).

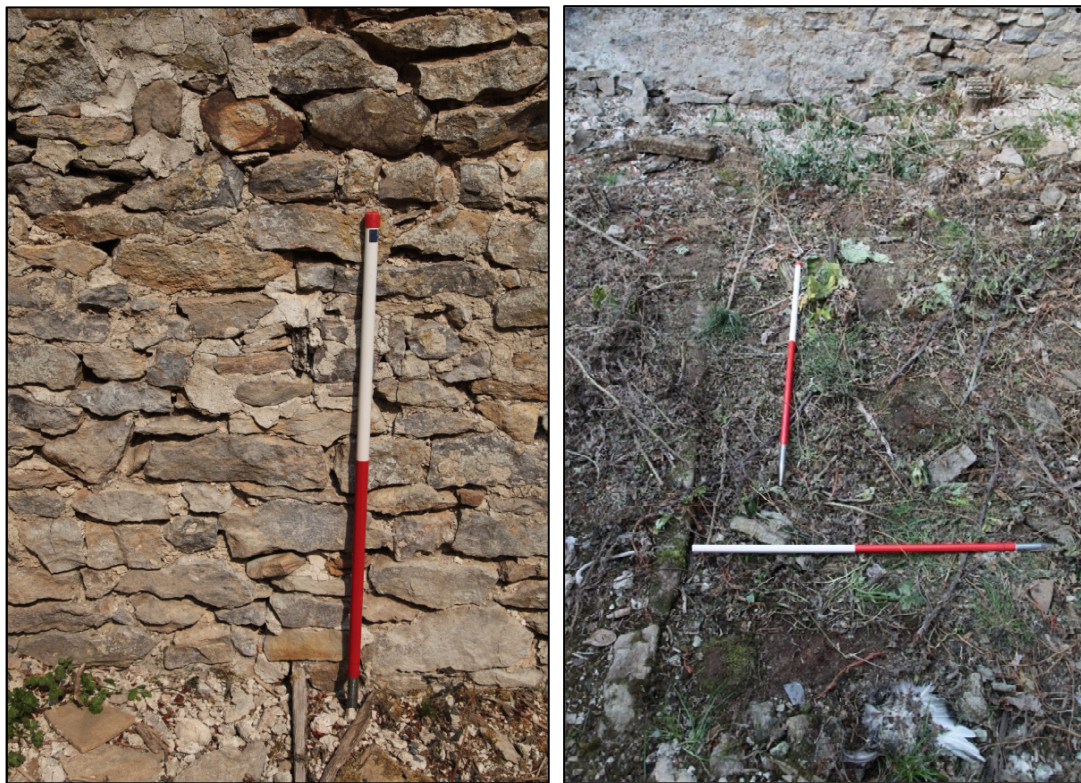
*Plates 10, 11: wooden remains of stall division (2142) and L-shaped drain (2101).*

- 5.12 The north room of the main building was used as a byre with access from the east. The eastern wall has a doorway (1405) with a chamfered, L-shaped stone door jamb and a large wooden lintel. Beside the door, to the north, there are several pieces of wood extending from the wall (2142). Located 750mm from the floor level, there are three pieces of wood approximately 1–1.25m apart, which extend from the wall. Parallel to these are floor level pieces associated with former animal stalls.

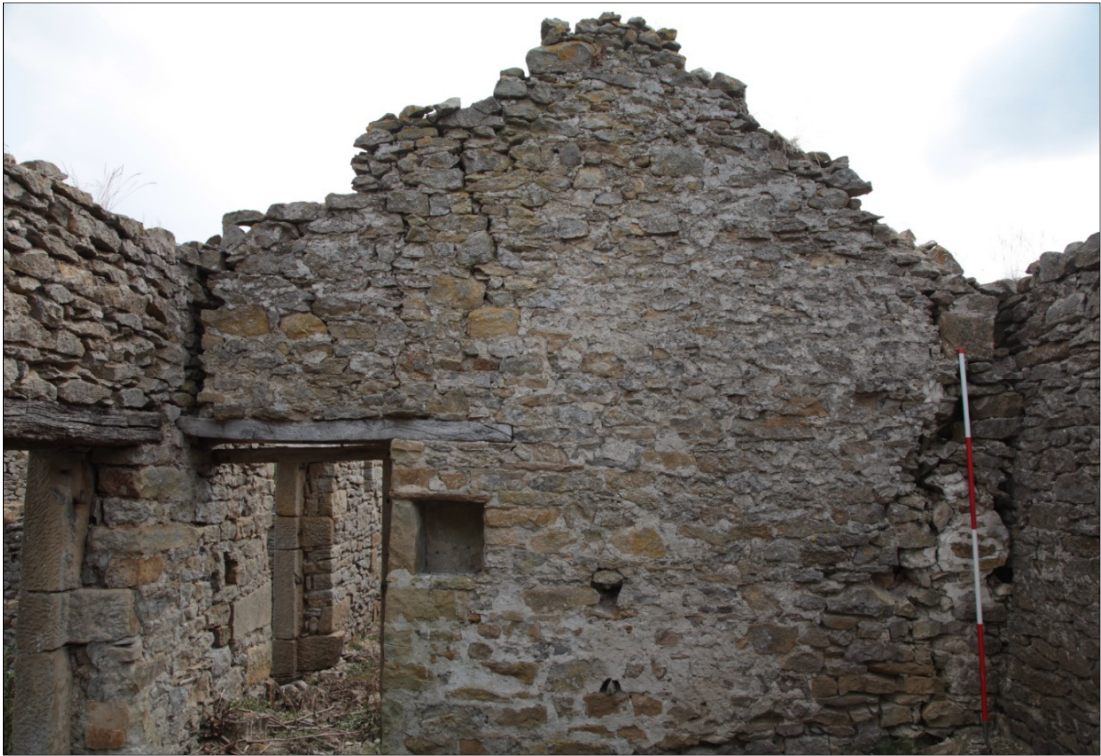
*Plate 12: south wall of byre showing door (2131) and storage niche (2132).*

- 5.14 On the south wall is a doorway (2131; Plate 12) with a wooden lintel and jambs that provides access to the barn (2200). Beside the wall is a lamp niche (2132).

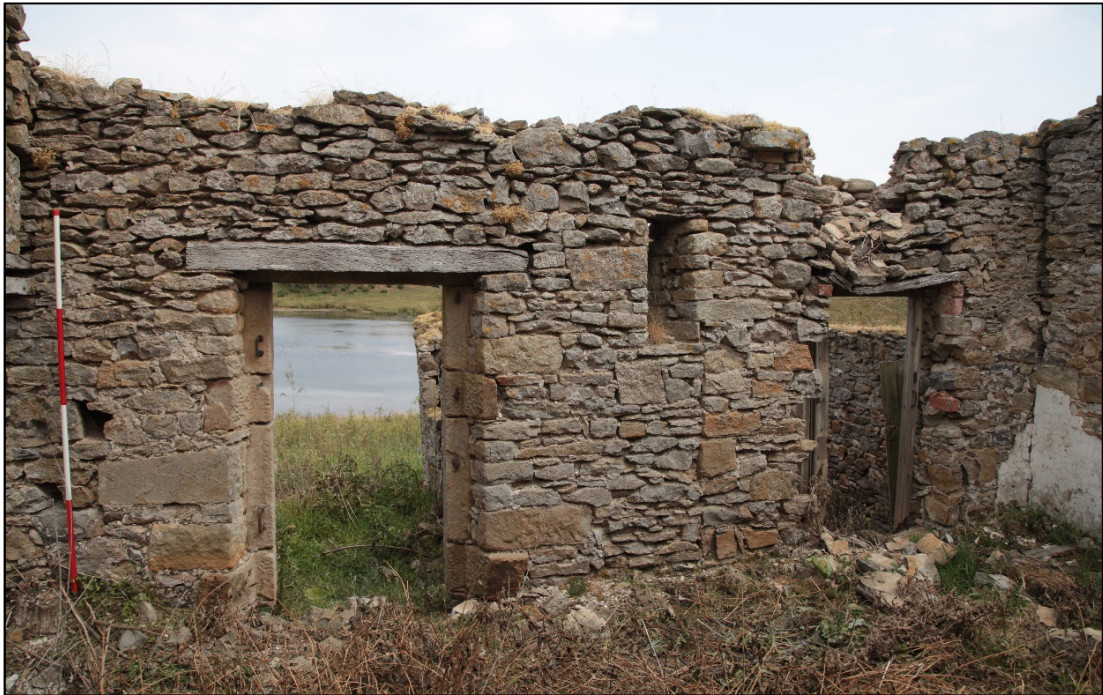
*Plate 13: east wall of north-central room showing (from right to left) the exterior door, ventilation slit, wall scar and interior door to the eastern addition.*

on the east wall, is a door frame with a wooden door jamb and lintel (**2241**). This leads into the east projecting wing (**2300**). Beside the door and the ventilation slit is a vertical scar in the wall (**2244**) that descends from the south corner of the ventilation slit to the floor. This scar is not duplicated elsewhere in the building and may indicate the position of a wall that was later demolished.

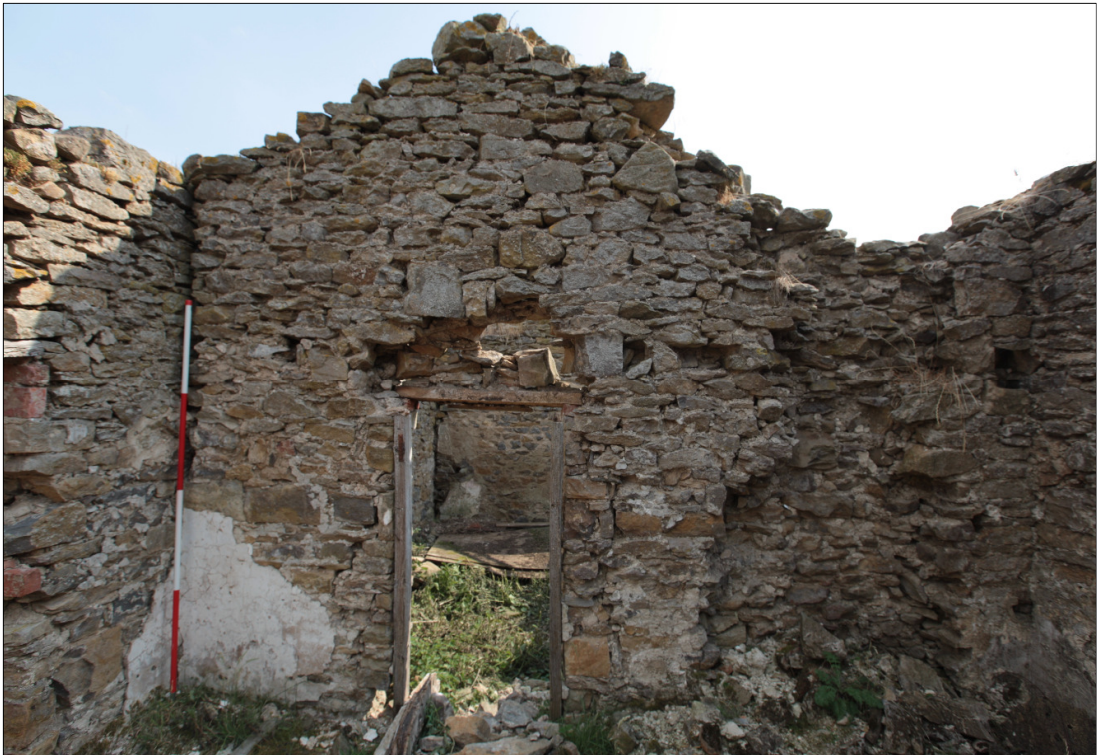
*Plate 15: south wall of the north-central room (2200) showing door (2231), remains of internal wall plaster (2233), and possible remains of a fireplace (2234); this area may have formerly been sub-divided from the barn as part of the domestic living space.*

- 5.18 Beneath the ventilation slit in the west wall were two large iron nails (**2225**), each of which were 300mm long and spaced 1.00m apart. They probably represent fittings for a shelf.
- 5.19 The south wall of the room is partially collapsed. Above the collapse and remains of a wooden doorframe (**2231**) are several putlog holes (**2232**). These are not reflected on the north wall, suggesting a floor or platform formerly extended only partially across the room. This may be indicative of a hay loft.
- 5.20 The remains of white wall plaster (**2233**) were observed on the south-east corner of the room. This possibly indicates that this part of the barn was formerly divided from the agricultural area and instead had a domestic function. It is possible that the partial collapse of the wall on the west side (**2234**) indicates a former fireplace.

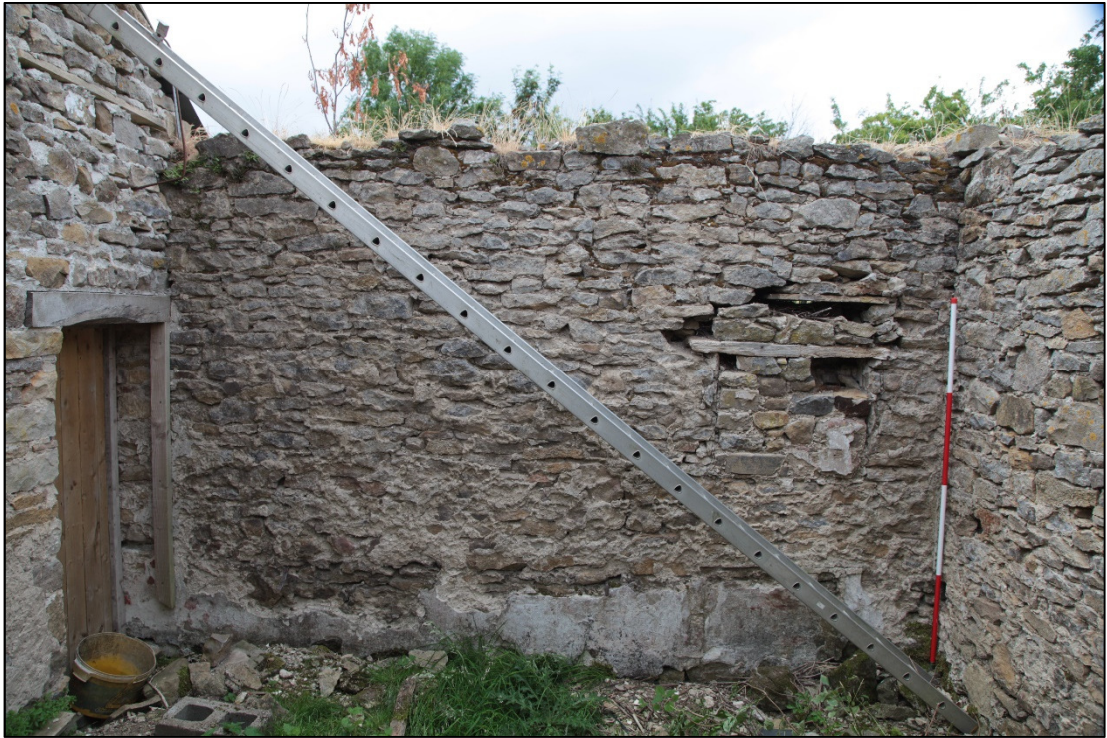
*Plate 17: west wall of the south-central room with the blocked window (2421) visible above a square scar in the plaster.*

- 5.24 The room has a window on the eastern wall (**1403**) and a blocked opening on the western wall (**2421**). The eastern window is splayed, with cut stone surrounds and set into a larger bay extending down to the floor. Below the window is a large stone, probably no longer in situ, which may have formerly been a lintel or threshold.

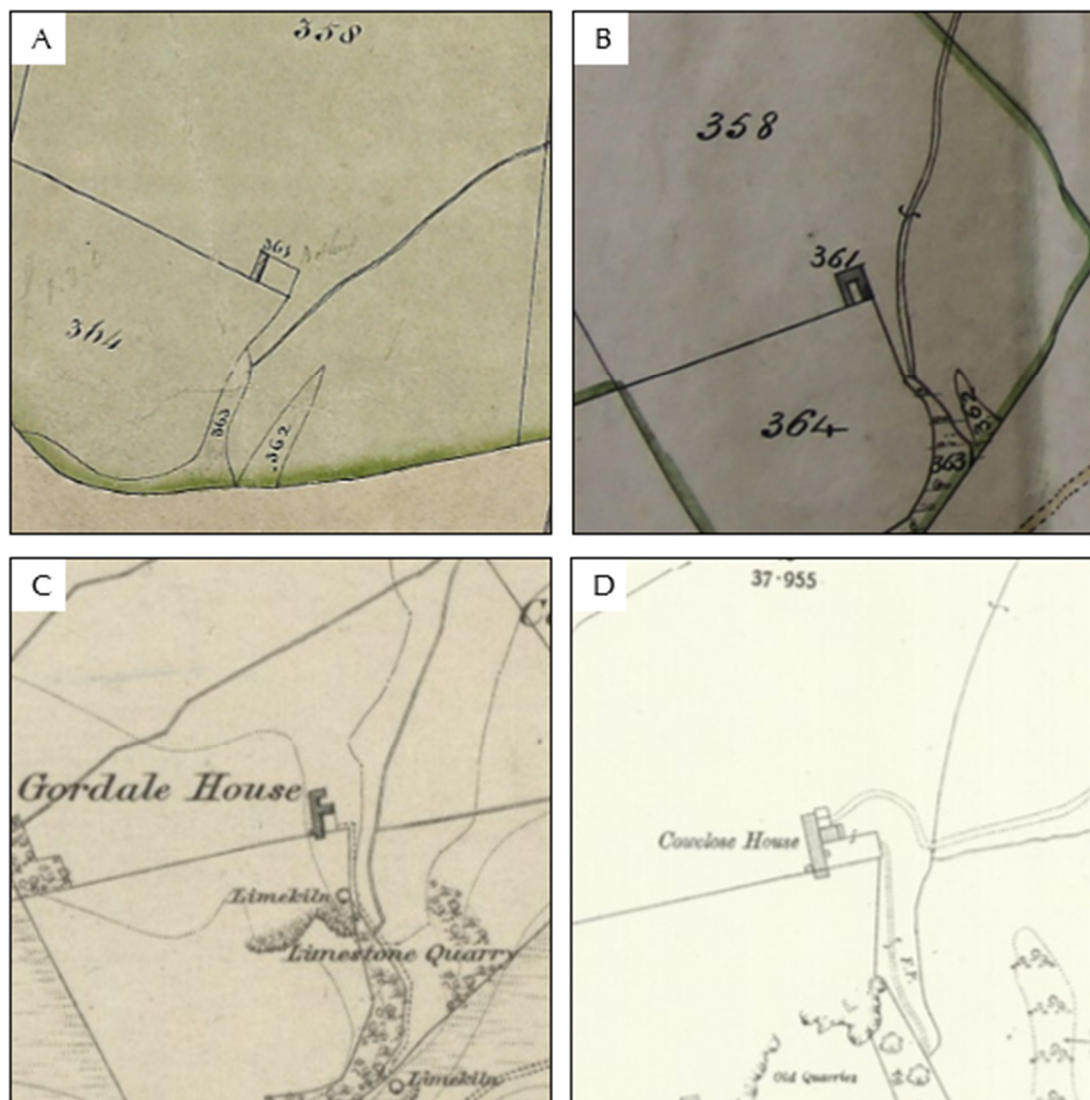
*Figure 16: compilation of historic maps. A) 1838 tithe map; B) 1854 Order of Exchange; C) 1856 First Edition OS map; D) 1914 OS map.*

- 6.17 The tithe map of 1838 (Fig. 16A) shows the structure as a simple longhouse, with no projecting buildings. Therefore, it is probable that the addition was constructed after this date, but before the First Edition OS map of 1856 (Fig. 16C), which shows two projecting structures on the east side. As evident on the 1856 map, these two additions formed a courtyard or foldyard to the east of the house.

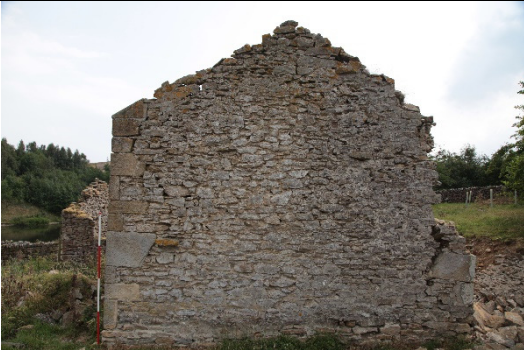
Number	Name	Description	Related Features	Date	Significance	Photo
1100	North elevation	The north elevation is of sandstone and limestone rubble-build and is gabled.	1101 – east quoins 1102 – west quoins	Late 17th century	Aesthetic – Low/Mod Evidential – Low

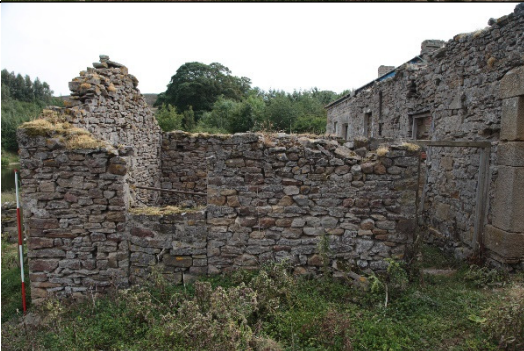
1110	North elevation of east byre	The north elevation of the east projecting byre is lower than the main body of the building and contains a door to the west and a window (once a door) to the east.	1111 – door 1112 – blocked door	18–19th addition	Has moderate historic value as evidence of the later modification of the building. Indication of changes in agricultural practice.

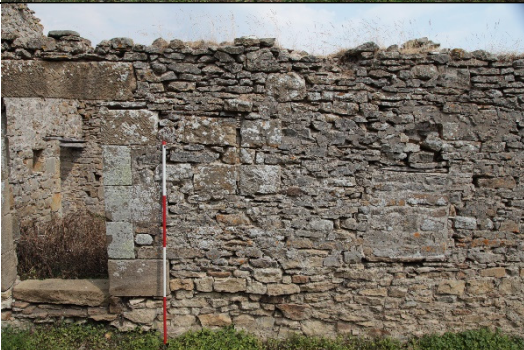
1200	West elevation	Long elevation of rubble, the northern section has partially collapsed.	1201 – door 1202 – ventilation slits 1203 – blocked muck hole 1205 – quoins 2421 – blocked window	Late 17th century with later alteration	The blocked features and wall scars provide evidence of the development of the building over time.

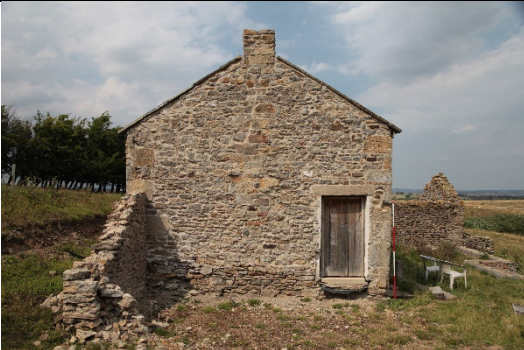
Number	Name	Description	Related Features	Date	Significance	Photo
1300	South elevation	South elevation of the main building. This part of the building has been refurbished with new pointing and a new door. A flu scar remains visible.	1301 – door 1302 – flue scar	Late 17th century with modern refurbishing	Aesthetic – Mod Evidential – Mod, includes only surviving chimney.

- 5.5 The north bay has recently been renovated, meaning that the pointing on this gable end is new (Fig. 12; Plate 5). The door (1301) seems to be a later addition, as it has a cement threshold and a machine cut lintel. A series of rectangular stones on the gable (1302) mark the location of the flue. There is also a short chimney stack above the wall head.

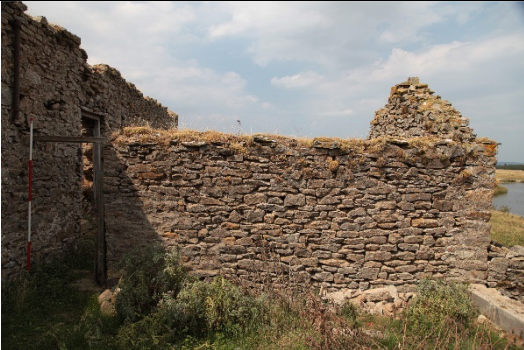
1310	South elevation of east projecting wing	The south wall of the projecting byre is lower than the main building and contains a single door.	1311 – door	18-19th addition	Aesthetic – Low Evidential – Low

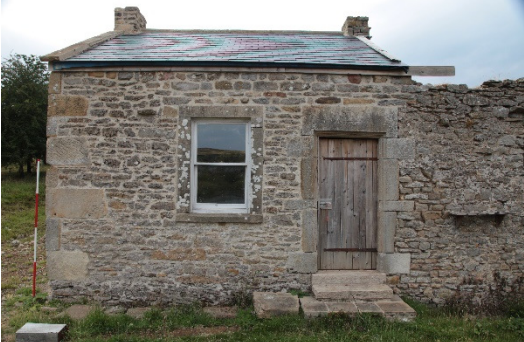
1400	East elevation	The east elevation is the front of the building with three entrance and two windows. The windows are on the south two bays on either side of the main entrance. The northern wing has	1402 – south window 1403 – north window 1404 – central door 1405 – north door 1406 – hinge posts 1407 – shelf post holes 1408 – gutter pipe	Late 17th century with later alteration	Aesthetic – High Evidential – High Historic – High

- 5.6 The east elevation (Fig. 14; Plate 1) is the front façade of the building. It features the main entrance to the south bay (1401), which forms domestic part of the building. The door features cut and dressed jambs with a dated lintel, inscribed 'I L' with the date 1697 (Plate 6). It is unknown who or what 'I L' refers to or whether the stone is in its

- 5.7 To the south of the main door is a sash window (**1402**), a recent replacement set in a machine-cut stone surround. This is replicated to the north of the door with another window (**1403**), beside which is the remainder of a metal downpipe (**1408**). The pipe is a metre long and runs down from the top of the wall.

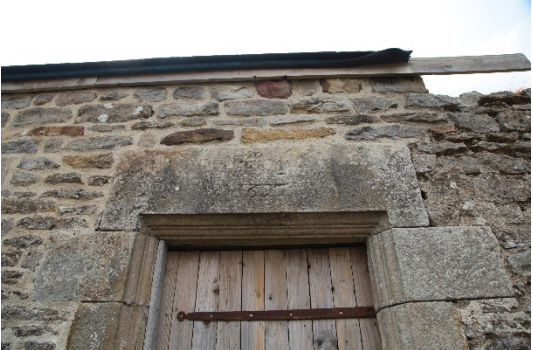
Number	Name	Description	Related Features	Date	Significance	Photo
		two large doors, each into a different room.				
1401	Main door	The main door is of stone ashlar quoins with moulding along the frame. The lintel above the door way reads 'I L 1697.' Two flag-stone steps lead up to the stone threshold. The inside of the door has modern lintel and a single niche next to the southern door jamb that is about 35x10x10cm.		Late 17th century	Aesthetic – High Evidential – High Historic – High

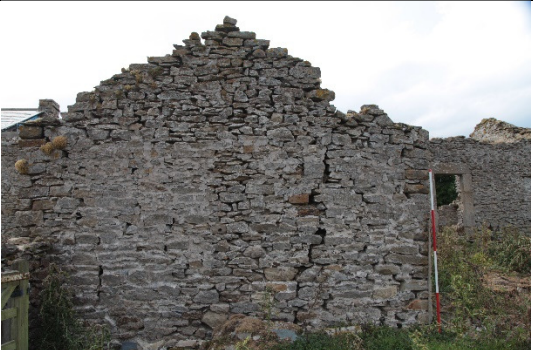
1410	East elevation of projecting east wing	East wall of the eastern addition. A single hole (2x2cm) lies in the centre of the wall; its use is unknown.		18-19th addition	Aesthetic – Low Evidential – Low

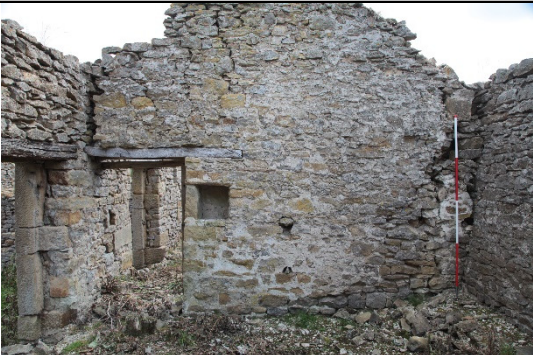
Number	Name	Description	Related Features	Date	Significance	Photo
2131	Door on south wall	Wooden lintel with a surround of larger stones on west side. On the western side of the door is a large lamp niche.	2132 – lamp niche	Late 17th century	Aesthetic – Low Evidential – Mod

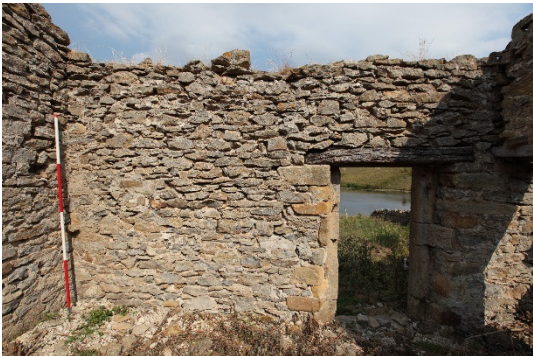
1405	Door on east wall	Chamfered door opening east with wooden lintel. Contains one hinge post and latch.		Late 17th century	Aesthetic – Moderate/High Evidential – Low/Moderate

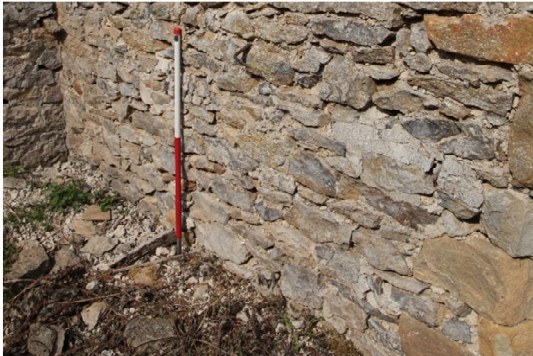
2142	Byre remains	A few remains of posts both at the base of the wall and chest height appearing at two separate places along wall. Single bent nail sticking out of wall in between two stalls. Possible byre stalls with room for two cows.		Unknown	Aesthetic – Low Evidential – Moderate/High

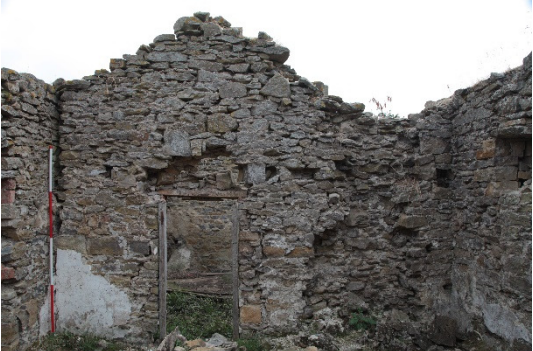
Number	Name	Description	Related Features	Date	Significance	Photo
2200	North central room	Originally of agricultural use which may have varied over time, it was accessed from both east and west.	2212 – northern niche 2222 – western niches 2244 – eastern niches	Late 17th century with later alteration	Aesthetic – Mod. Evidential – Moderate, relating to potential domestic quarters at the north end.	
2231 2241	Interior doors	Door frames of wood where the lintel is tied in to the wall, but not the frame.		Unknown	Aesthetic – Low Evidential – Low

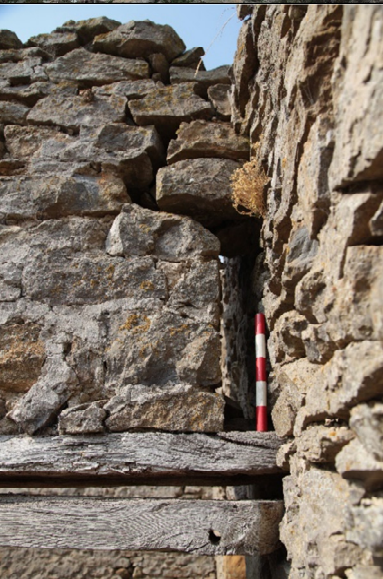
2213	Ventilation hole	A ventilation hole above lintel of door between north room and north central room running from lintel about 50cm up.		Late 17th century	Aesthetic – Low Evidential – Low

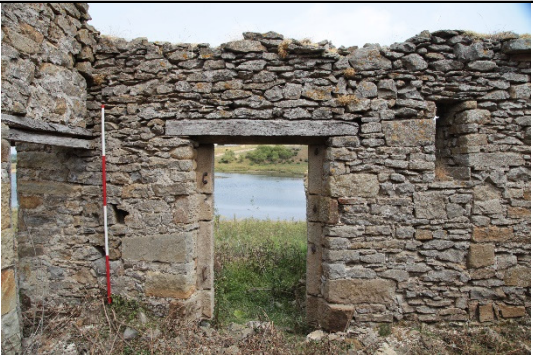
Number	Name	Description	Related Features	Date	Significance	Photo
1201 1404	Exterior doors	The doors are of large ashlar surrounds. The interiors have an L-shaped door jamb made of large ashlar surrounds. Four hinge posts on north side with three latches on south side. Wooden lintel on interior of door jamb.		Late 17th century with later alteration	Aesthetic – Mod Evidential – High

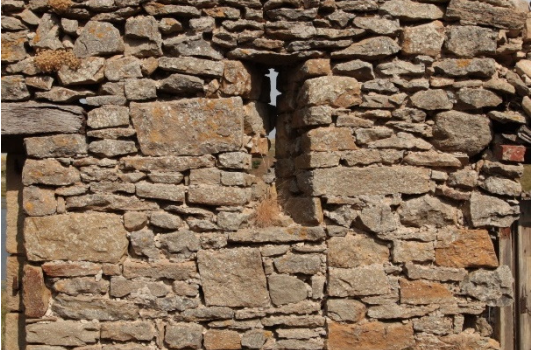
1203 2243	Ventilation slits	Narrow splayed ventilation slit in the centre of east and west about 80x40x40.		Unknown	Evidential – High Historic – High Aesthetic – Mod

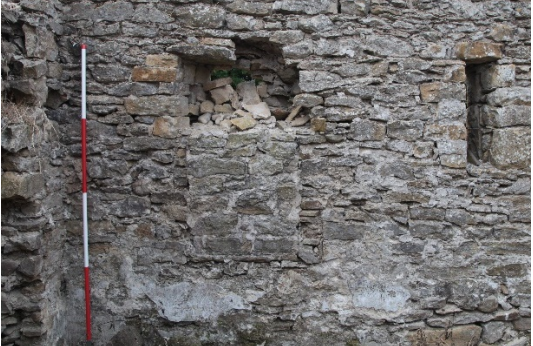
1204	Muck hole	Was blocked put part of infill has collapsed.		Unknown	Evidential – Mod

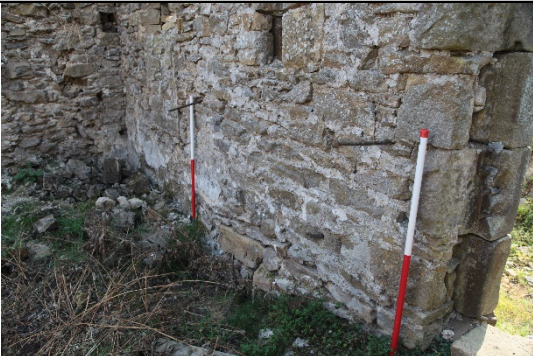
Number	Name	Description	Related Features	Date	Significance	Photo
2225	Nails	Two large nails stick out roughly 30cm from the wall beneath the ventilation slit about 1m off the floor. Probably used to hold a shelf		Unknown	Evidential – Low

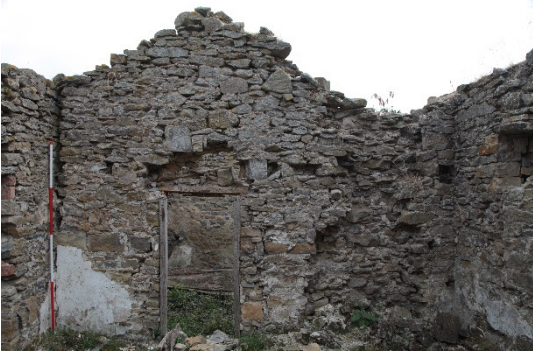
2232	Putlog holes	Visible are four small niches across the wall above the door for possible beams.		Unknown	Evidential – Mod

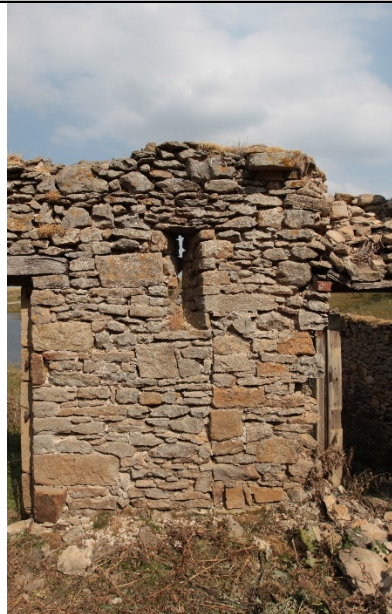
Number	Name	Description	Related Features	Date	Significance	Photo
2244	Line in wall	Visible line in the wall beneath the south corner of the ventilation slit all the way down the wall. Not replicated on the opposite wall		Unknown	Evidential – Mod

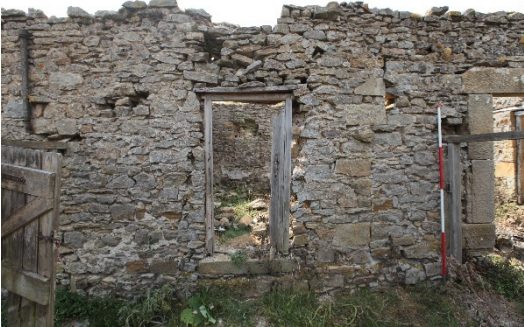
Number	Name	Description	Related Features	Date	Significance	Photo
1111 1311 2241	Doors	Doors on north, west, and south walls of addition. North and south doorframes are of wood and only lintel is tied into wall. The west door is raised about 30cm off the floor, but also consists of a wooden doorframe.		18th–19th century	Evidential – High

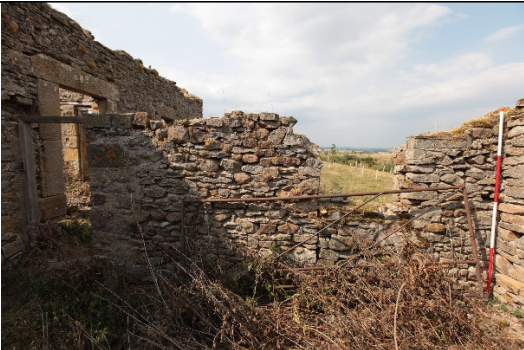
1112	Blocked door/window	U-shaped opening in the wall as top part of window is missing.		Unknown	Evidential – Mod/High

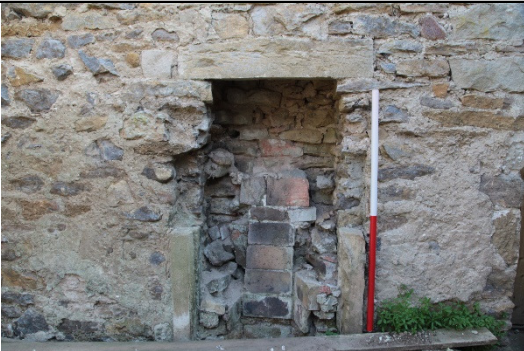
Number	Name	Description	Related Features	Date	Significance	Photo
2432	Fireplace	Small fireplace with stone lintel and side. Backed in brick, the flue is intact and has a visible scar up the wall.		19th century	Evidential – High

*Plate 16: south wall of south-central room (2400) showing fireplace (2432), flue scar (repaired) and door (2431).*

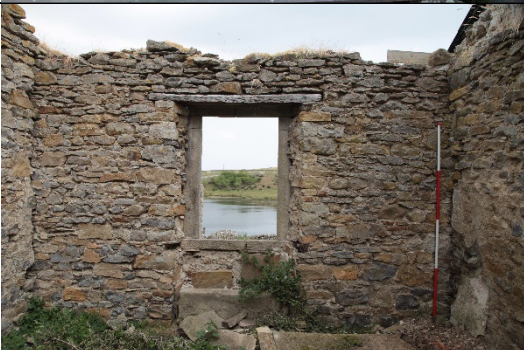
1403	South central room window	Splayed window in centre of wall with machine cut stone surround. Interior has wooden lintel. Width of window extends from window to base of wall. At base is large worked stone spanning the width of the window.		Late 17th century with subsequent alteration	Aesthetic – Mod/High Evidential – High

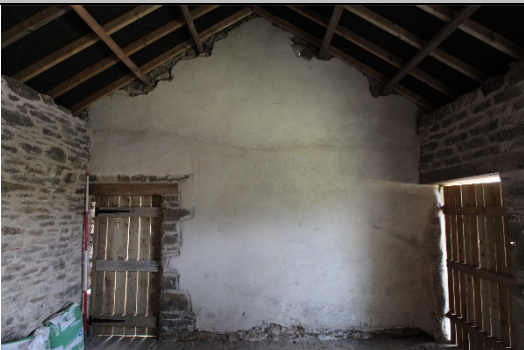
Number	Name	Description	Related Features	Date	Significance	Photo
2511 2531	Side doors	Doors have modern wooden lintel.		Modern?	Evidential – Mod

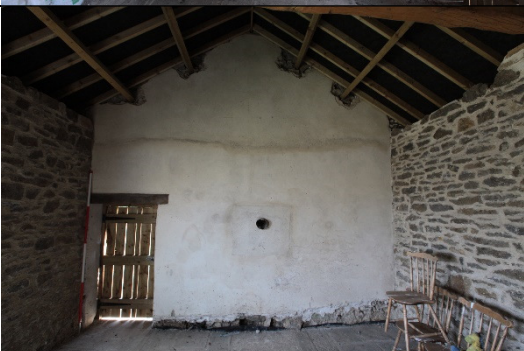
2431 1301	North and south wall scar	White plastered wall. Wall has evident line in plaster that traverses the room horizontally showing former floor.		Unknown	Evidential – Mod

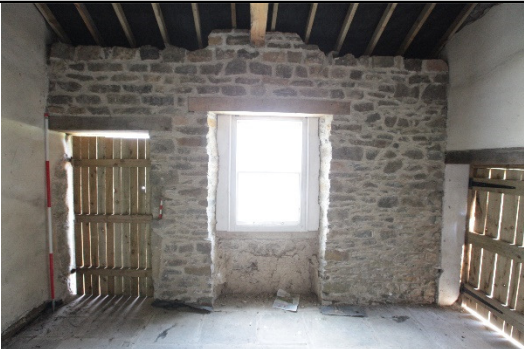
Number	Name	Description	Related Features	Date	Significance	Photo
2542	South room window	Window has modern lintel with sash window, each sash with a single pane. The window alcove descends to the floor of the room.	2441 – south central room window	Late 17th century	Evidential – High
