ARCHAEOLOGICAL  
WATCHING BRIEF

**CULVERT REPAIRS  
GARRIGILL BURN  
CUMBRIA**

NAA 19/47  
September 2019

CULVERT REPAIRS, GARRIGILL BURN, CUMBRIA  
ARCHAEOLOGICAL WATCHING BRIEF

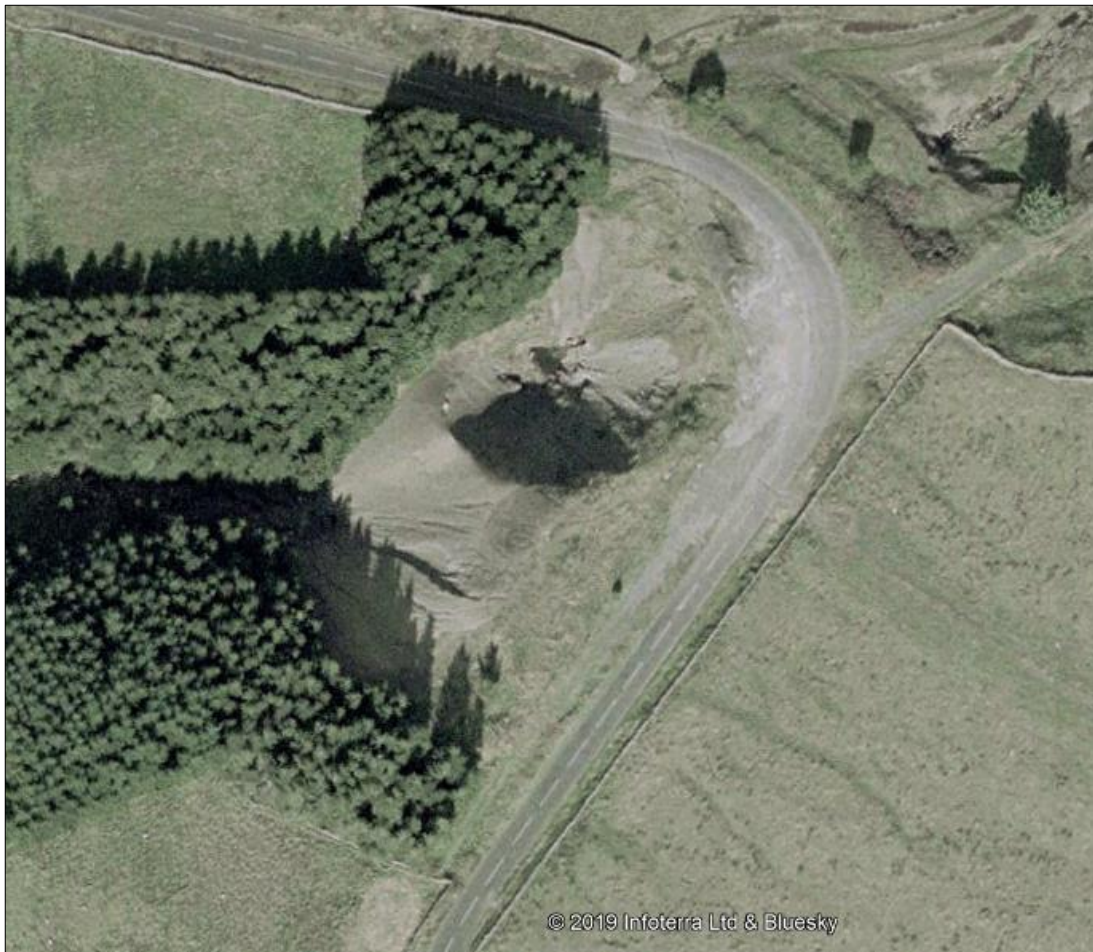
*Figure 2. Crater within spoil heap caused by broken culvert, as depicted on Google Earth © 2019 Google © 2019 Infoterra Ltd & Bluesky*

- 2.1 The monitoring work was located c. 1.3km to the north-east of the centre of the village of Garrigill, which lies c. 5.5km south-south-east of Alston, Cumbria (Fig. 1). The two sections of arch culvert lay within a spoil heap straddling Garrigill Burn, immediately adjacent to the B6277 Alston to Middleton-in-Teesdale Road (Fig. 2).

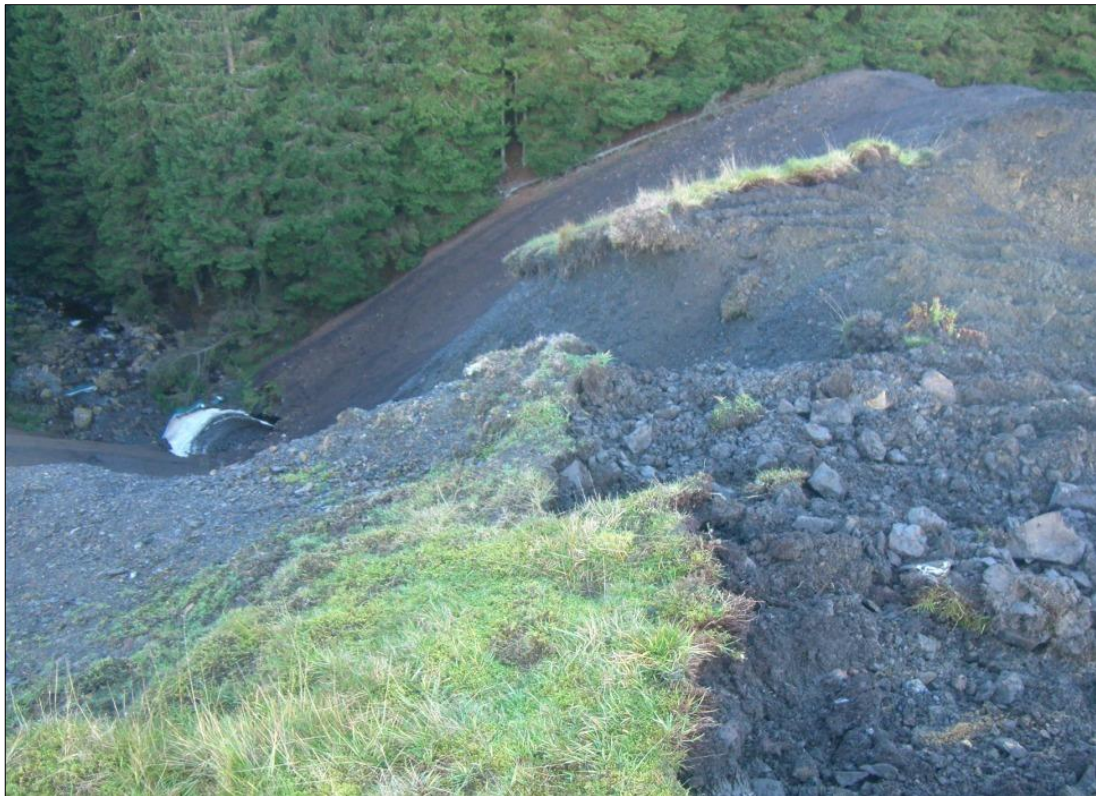
*Plate 1. View of western side of spoil heap looking towards culvert out-flow*

- 2.3 The area covered by the archaeological monitoring comprised a substantial volume of mining waste in the form of a large spoil heap (Plate 1), in part covered by rich *calaminarian* flora. The investigation area was bounded to the north and east by a section of the B6277, the main road between Alston to Middleton-in-Teesdale. To the south and west, where the spoil heap gradually filtered out into Garrigill Burn, the site was bordered by predominantly pine and spruce woodland divided by a meandering fast flowing stream.

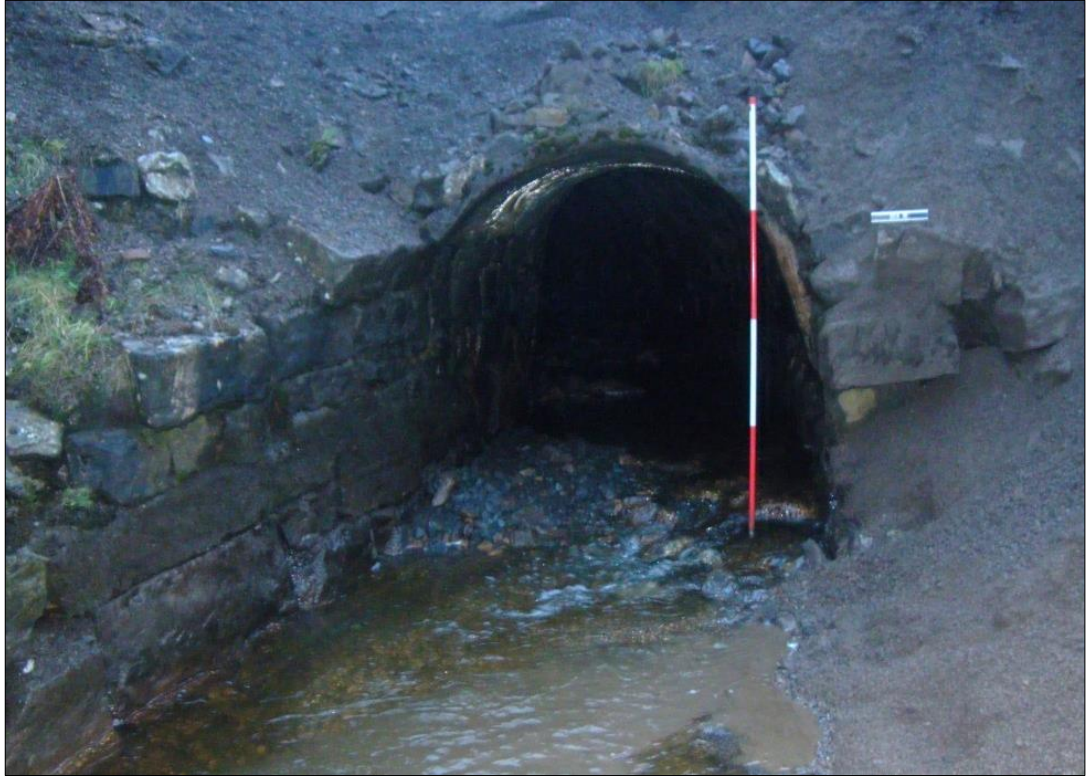
had been consolidated with concrete to reduce the possibility of collapse. The side walls of the culvert comprised up to five courses of roughly tooled rectangular blocks set on the limestone bedrock (Plate 2). Some of the blocks measured at least 1m long by 0.3m deep. It was not possible to enter the culvert to examine the arch in detail, although it could be seen to be constructed of thin slabs set on end in an arc (as seen in the surviving section of culvert to the north of the road, Plate 3).

*Plate 2. Entrance to western section of culvert looking eastwards*

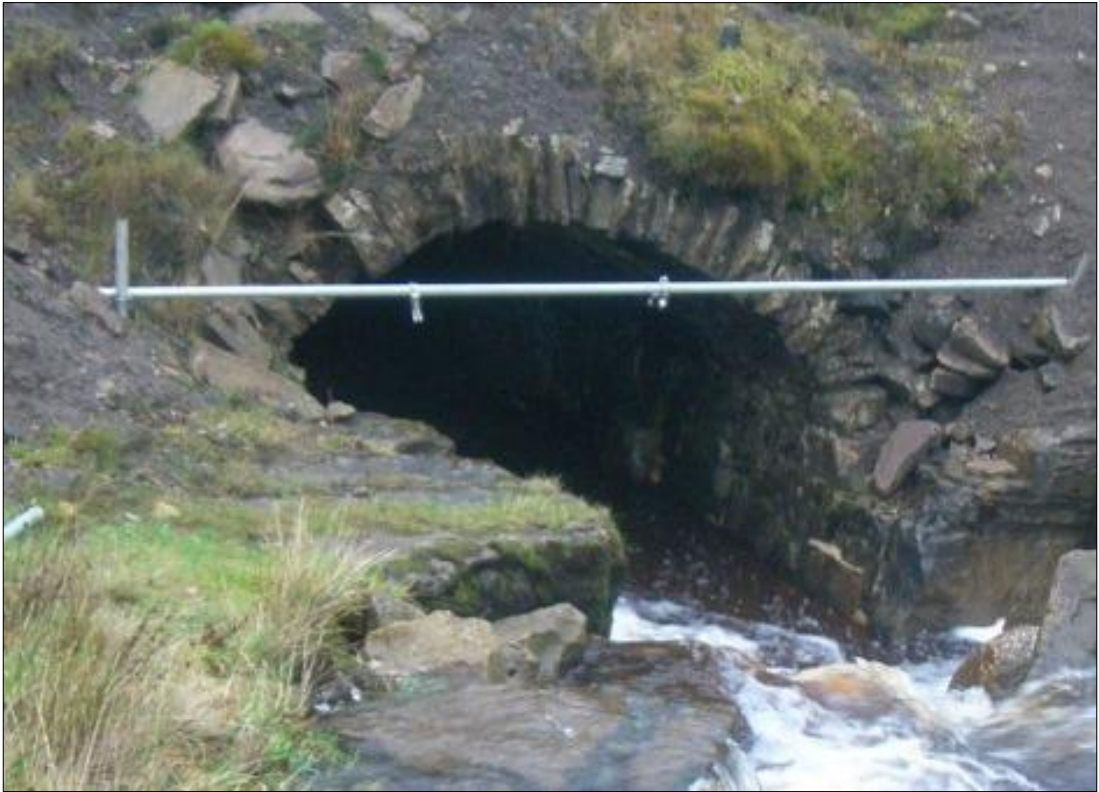
*Plate 3. Culvert arch to north of road*

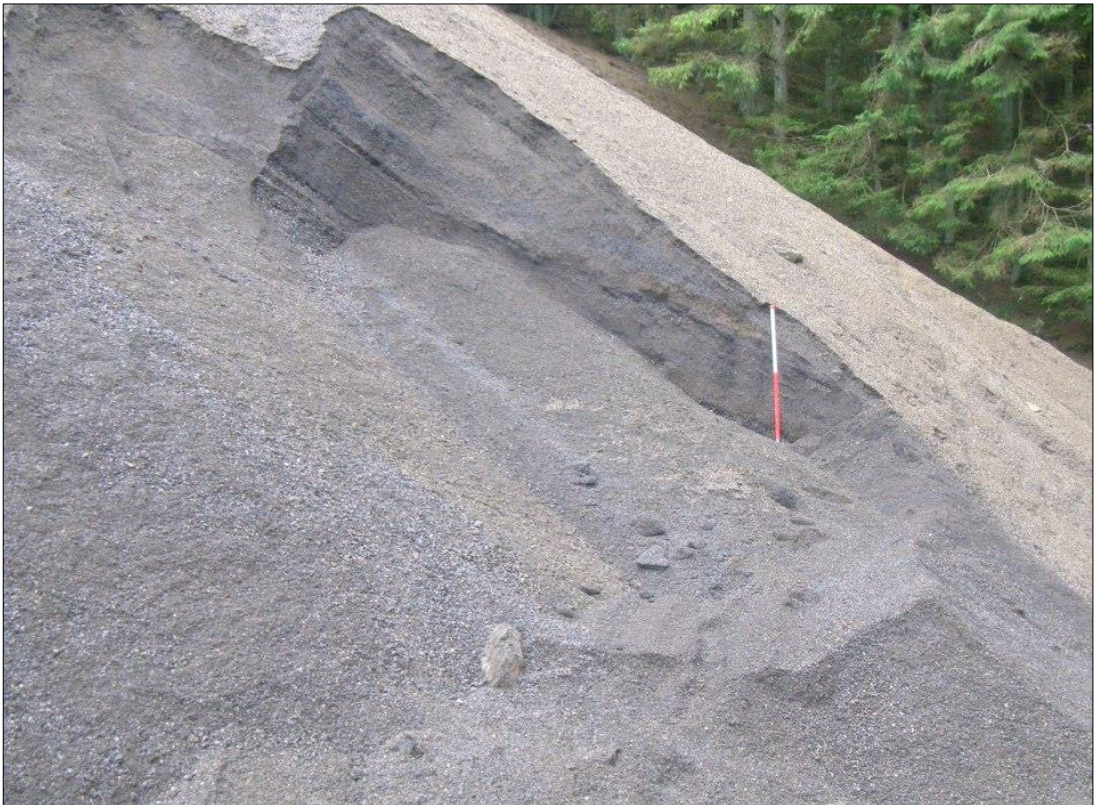
- 6.3 The access road and spoil heap profiling comprised the gradual excavation of the metal-rich spoil heap using a mechanical excavator with a toothless grading bucket wherever possible. This demonstrated that the spoil heap was formed from a series of deposits of mine waste consisting of greyish clay (2), containing large amounts of limestone and mudstone (3), overlain by fine gritty silt (1), the by-product of the washing of ore in the hotching tubs (Plate 4). Within the gritty deposit (1) were a few artefacts, the smaller of which were recovered for investigation (Appendix B), while a broken spade head and a section of rail were left on site. The recovered artefacts included a partial stoneware mineral water bottle of 19th-century date, a complete 20th-century glass beer bottle, a cast-iron guide roller and two scraps of iron bar, and the upper part of a leather shoe.

*Plate 4. North-facing section showing construction of mine spoil heap*
