BUDDLE HOUSE
ARCHAEOLOGICAL WATCHING BRIEF
REPORT

THE NORTH OF ENGLAND
LEAD MINING MUSEUM

KILLHOPE, COUNTY DURHAM

NAA 13/58
May 2013

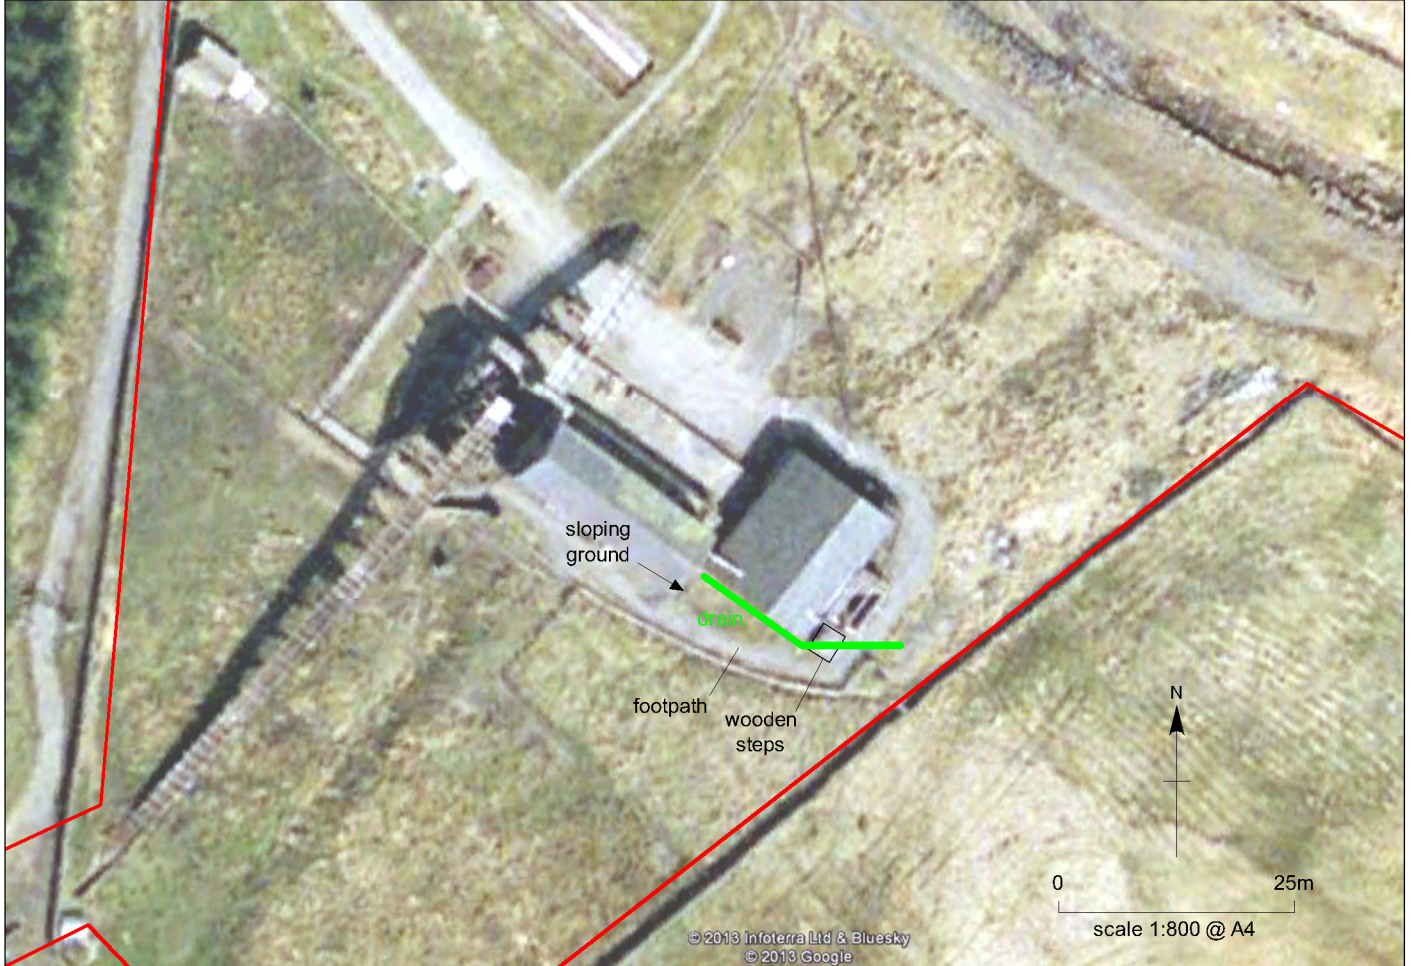
Figure 2

North of England Lead Mining Museum, Killhope: drain route in relation to Scheduled Monument

- 1.3 The drain ran the full length of the Buddle House's south-west wall, turning east and continuing beyond the standing structures, ending in a soak-away area on lower ground near the boundary of the Killhope site (Fig. 2). The excavated area measured c.28m in length, was between 0.4 and 0.8m in width, and varied in depth from 0.4m at its eastern end and 1.2m adjacent to the Buddle House.

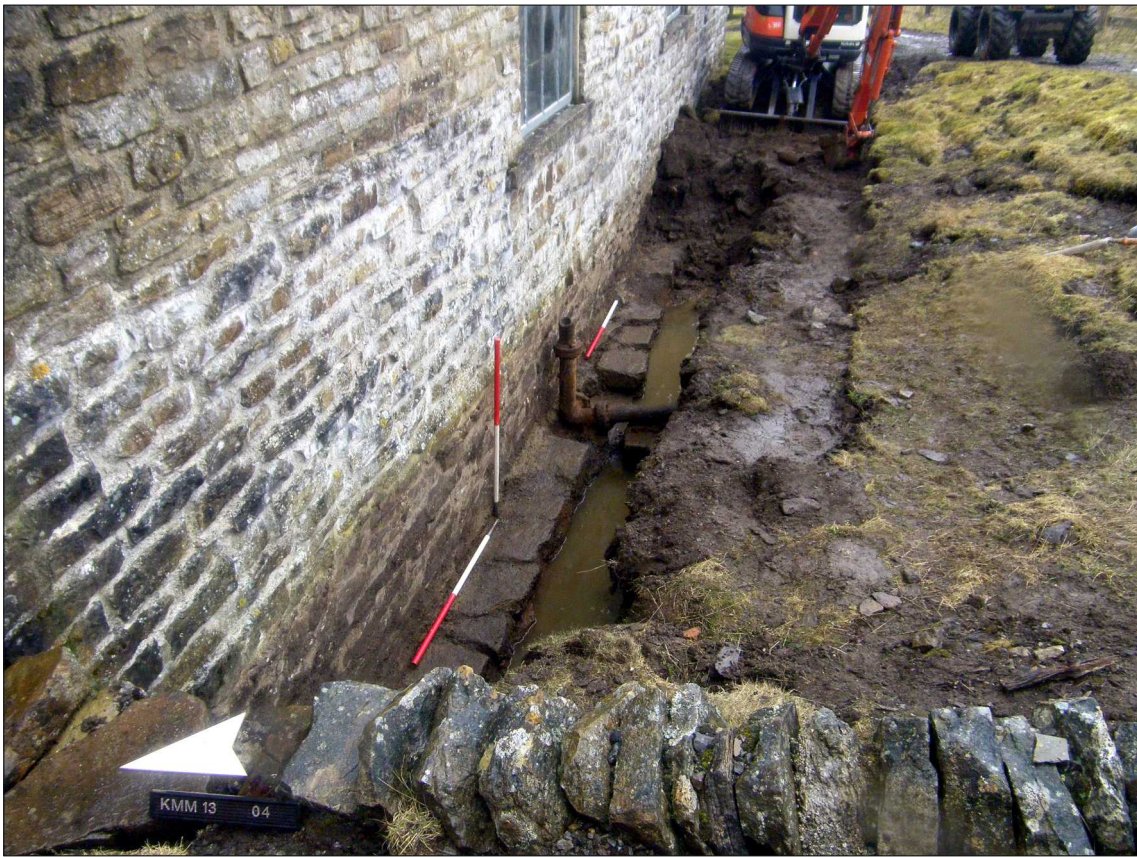
North of England Lead Mining Museum, Killhope: western part of drainage trench, showing exposed Buddle House foundations 03 and iron pipe 04 Plate 1

6.2 Foundations (03) for the building were encountered at a depth of between 0.75 and 0.9m below ground. They were constructed of roughly-coursed, unworked sandstone blocks, averaging 0.5x0.3x0.25m in size and bonded with a cream lime mortar (Fig. 3; Plates 1 and 2). The foundations projected 0.3-0.35m from the wall and lay in a vertical cut (05) into the natural clay subsoil. The presence of the foundations required the trench for the new drain to be widened to 0.8m beside the building, to allow the drain to be placed at the correct depth.

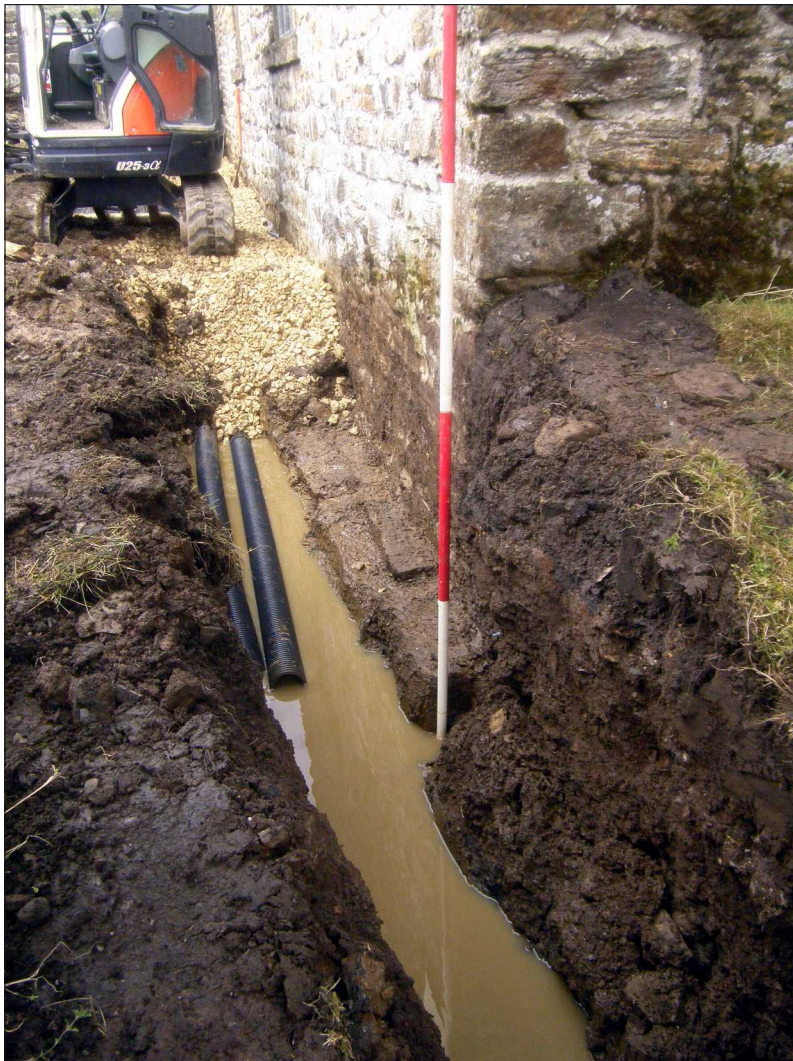
North of England Lead Mining Museum, Killhope: eastern corner of Buddle House, showing foundations 03 and installed drain beyond Plate 2

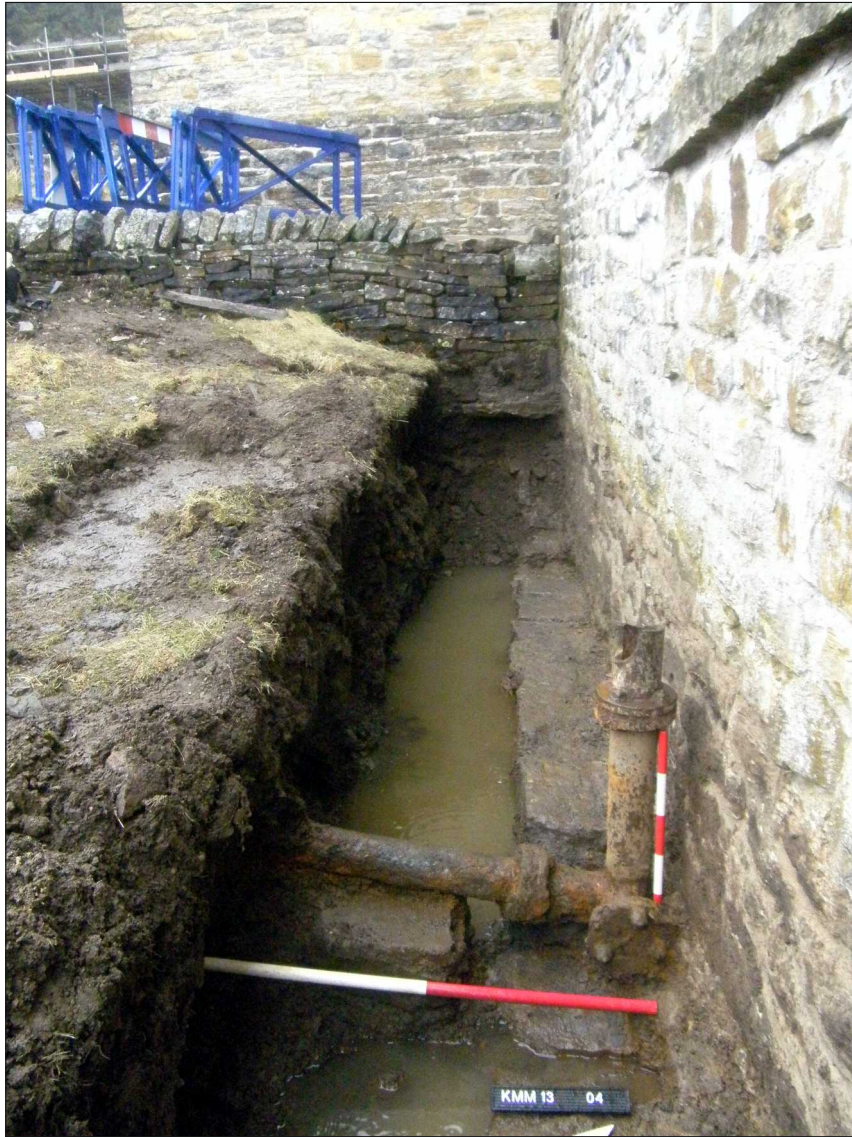
©NAA 2013 North of England Lead Mining Museum, Killhope: Plate 3
cast iron pipe 04

- 6.3 The remains of a 4" diameter cast iron waterpipe (04), was found next to the wall (Plate 3). This was positioned below one of the windows of the Buddle House, c.4.1m (13'6") along from its western corner, and would have fed water into the building, presumably from the reservoirs further up the slope. The pipe represents an alteration, as one of the slabs of the foundations appeared to have been removed for installation of the pipe (Plate 4).
- 6.4 To the east of the Buddle House, the trench for the French drain became progressively shallower, as the ground sloped away to the east and north (Plate 5). South-east of the Large Classifier, the trench averaged 0.5m deep, and cut through the same mixed layer (01) which lay directly over the clay natural subsoil.

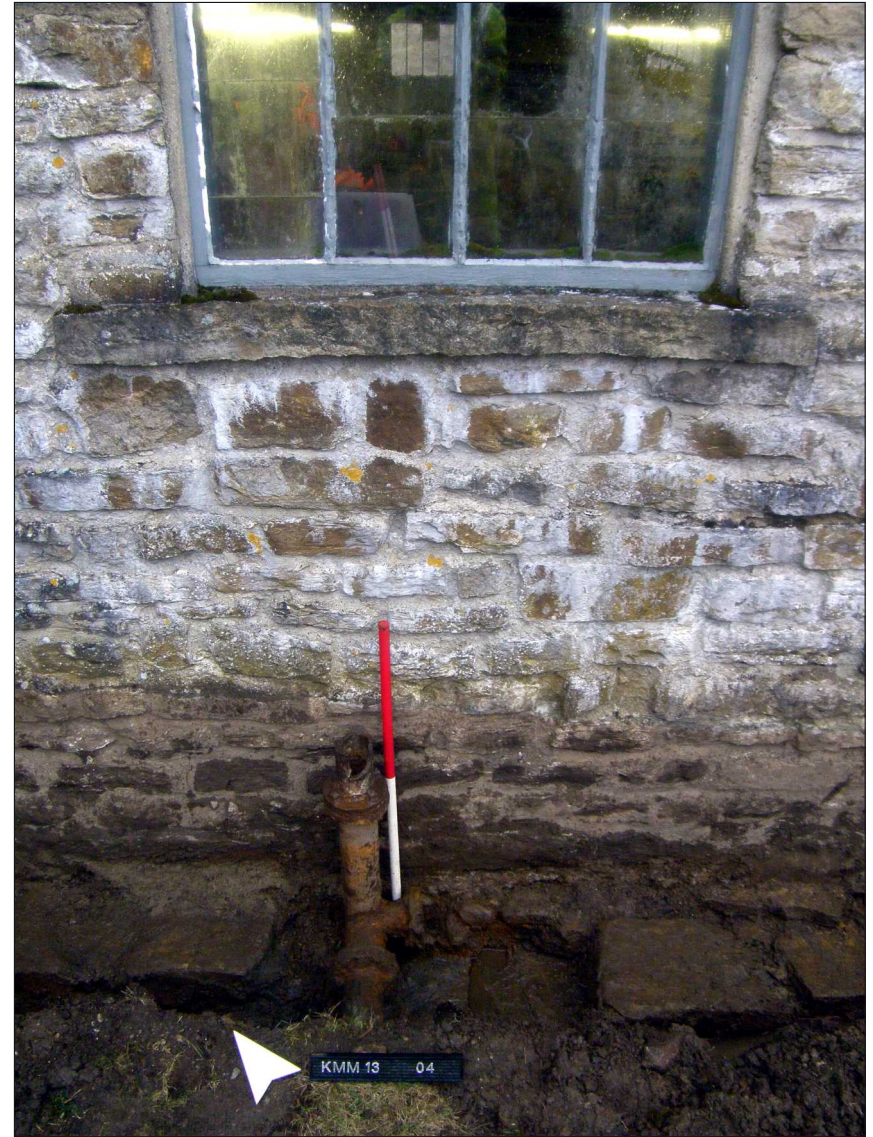
©NAA 2013 North of England Lead Mining Museum, Killhope: Plate 4
cast iron pipe 01 below Buddle House window

- 7.1 The monitoring has revealed the form of the Buddle House's foundations. They have been shown to be c.1' wider externally than the wall of the building and had been dug into the natural slope of the hill.
- 7.2 The presence of the water pipe was an unexpected discovery. Its position in front of one of the windows and the apparent removal of a foundation stone suggest it was a later addition, but its precise date cannot be established. It has been proposed that the supply of slurry into the buddles would have entered the building at the western corner of the building, and the position of the pipe near to this is likely to be related (Carlton 2013, 86).

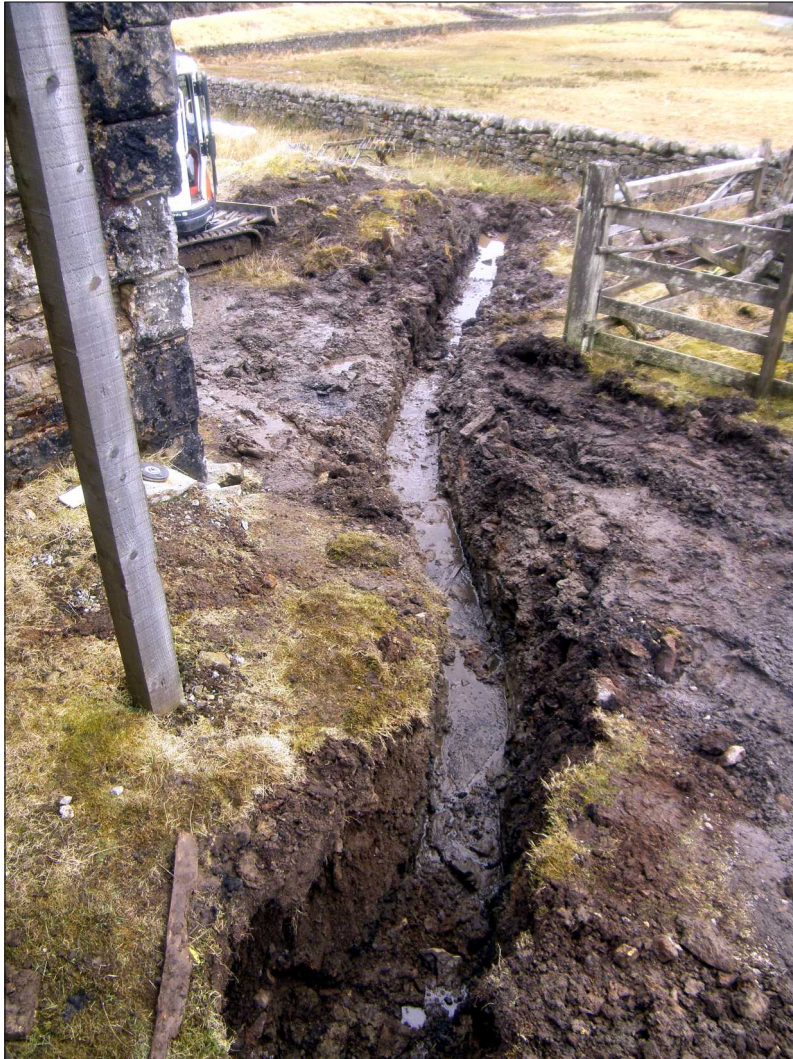
*North of England Lead Mining Museum, Killhope. Plate 5
drainage trench to south-east and east
of Large Classifier*
