**ARCHAEOLOGICAL BUILDING  
RECORDING**

**WITTON HALL FARM, WITTON  
GILBERT, COUNTY DURHAM**

prepared for  
Ryder Architects

NAA 16/112  
August 2016

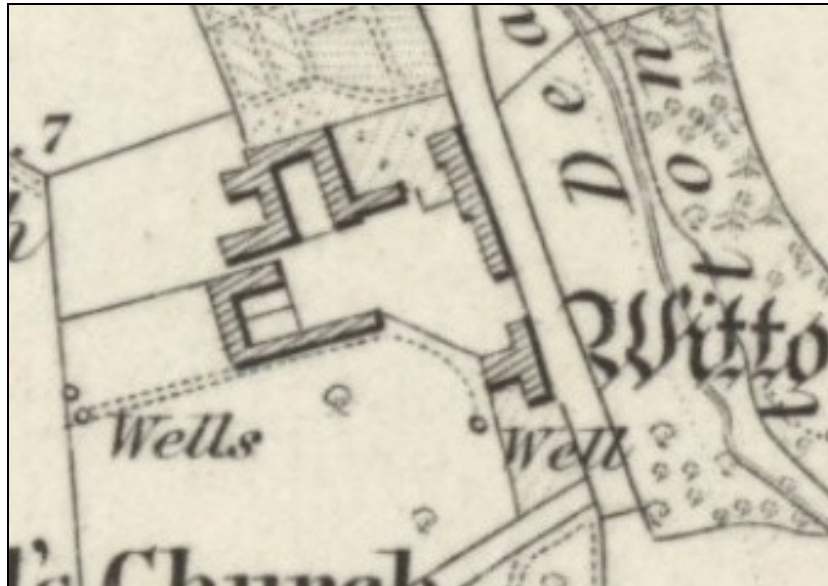
*Plate 1: Witton Hall Farm in the First Edition Ordnance Survey map of 1857*

- 4.8 Accordingly, by 1857, as shown in the First Edition Ordnance Survey map (Plate 1), this Granary appears to have been incorporated into a foldyard. This layout became common from the 1750s onwards, providing well-lit farm buildings, enclosed outdoor spaces to house loose livestock and increased manure production (Brunskill 1982). Although the Granary was the only surviving part of the foldyard at the time of the survey, evidence survived in the building fabric for the buildings shown in historic mapping to have extended from its north-east and south-west corners.

- 4.9 The Cart Shed, or a building with a similar footprint, is also shown on the First Edition Ordnance Survey of 1857, indicating that part of this building probably dates to this period or earlier. The Cart Shed seems to have been part of a longer complex extending further to the north. Relatively little is known about the history and development of this building, apart from the relatively recent rebuilding of its north and south elevations (see below).

- 5.9 The northern parts of the west elevation were original random-coursed rubble sandstone. The southern part of the wall was considerably narrower and seemed to be a later extension or rebuilt. A vertical wall scar was visible between these two parts (Fig. 5). The original part of this wall contained a large doorway, with a timber lintel and brick header relieving arch above. This opening had a tooled and margined stone jamb. South of this were two blocked doorways, both with timber lintels. These appeared to have been early, if not original, openings; the northernmost blocked door had a tooled and margined stone surround. A further partially blocked doorway, with a timber lintel, was located south of these; this appeared to have been a later insertion. It was blocked with breeze block, leaving only a small window opening at the top. At the southern end of the west elevation, within the later rebuilt section, there was a triangular wall scar delineating the former roof line of a small building. This may be the outline of the eastern gable of the building projecting west from the Granary on the First Edition Ordnance Survey map (Plate 1). Within this outline, there were three slit vents close to ground level (Plate 7).

- 5.13 At the northern end of the elevation, within the original wall, there was a triangular wall scar showing the location and form of a former small building gable. It is likely that this corresponds with the building which was shown to have extended from the northern end of the east wall, on the First Edition Ordnance Survey map (1857; Plate 1). Within this area, an iron chute passed through a hole in the wall. The chute was probably in place to carry grain from storage in the granary loft above, down into a grain bin or similar on the ground floor of the building to the east, for processing or use. There were further chutes internally which transferred grain from the loft to the ground floor (see below).

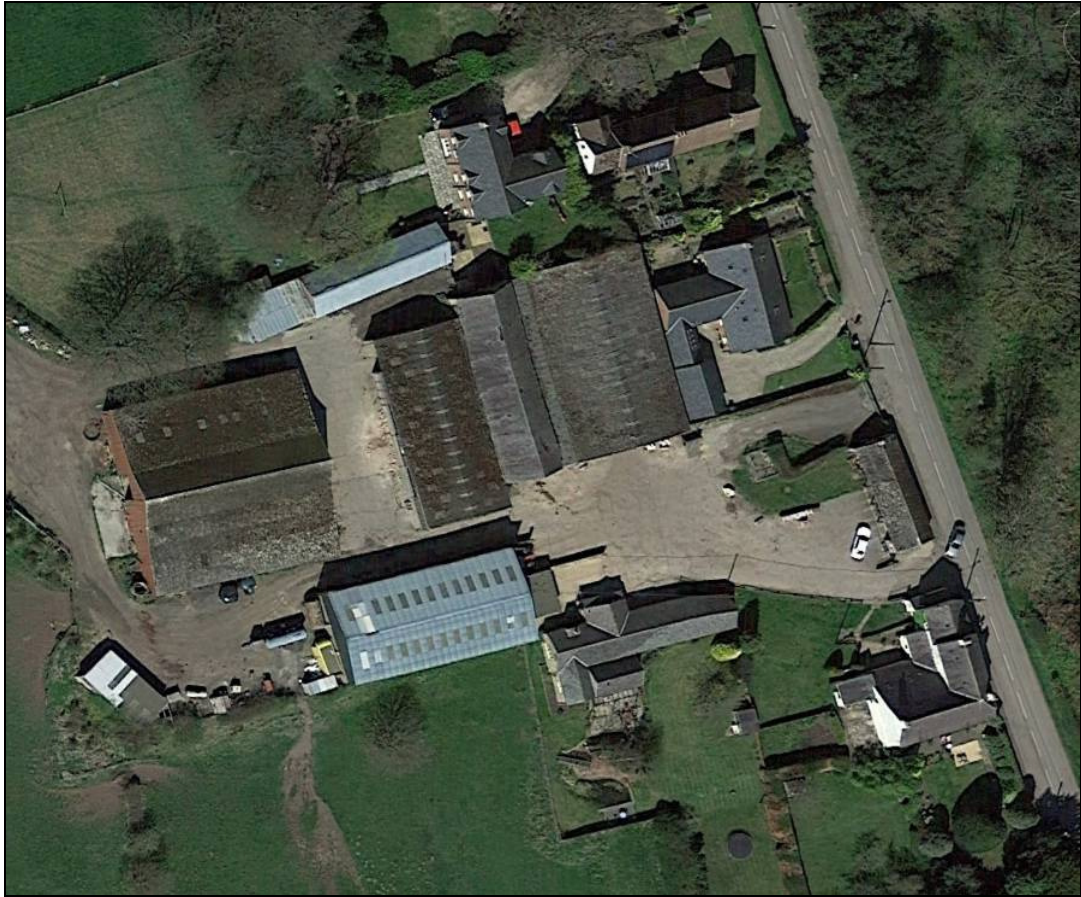
*Plate 3: an aerial photograph showing the layout of Witton Hall Farm at the time of the survey (Google Earth 2016)*

4.11 At the time of the survey, various parts of the layout shown on the First and Second Edition Ordnance Survey maps – and many elements thought to be of medieval origin – survived (Plate 3). The Granary was enclosed on the east and west sides within modern barns, but its north and south elevations remained exposed. The Cart Shed was a smaller building that that shown in historic mapping, although its southern end seemed to survive in situ, and its north and south elevations had been rebuilt.

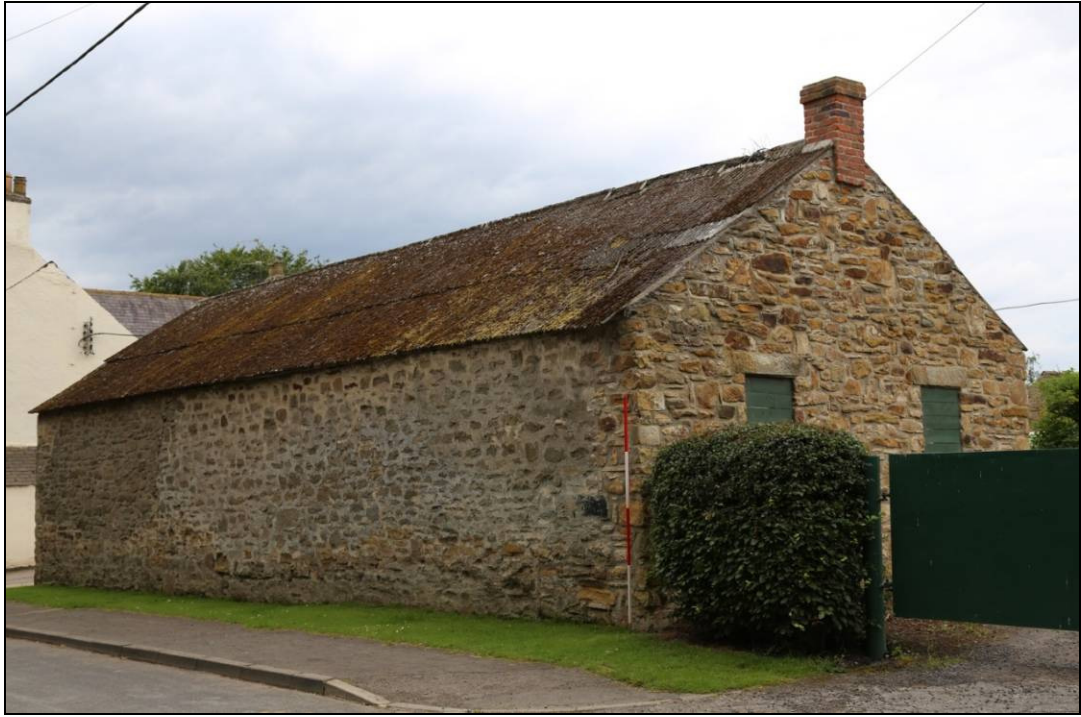
*Plate 4: the north gable and eastern elevation of the Cart Shed, showing the original random-coursed rubble stone eastern wall, in comparison to the rebuilt northern wall*

- 5.4 The southern gable had also been rebuilt, as indicated by wall scars on the east elevation (Plate 4), and later internal concrete breeze block skin (Plate 6). The elevation was blind, with the exception of a small brick dove-cote just below the ridge which, again, did not seem to be a historical feature.
- 5.5 Internally, the floor was concrete, at the southern end, and the remainder was earth. The roof was a timber king post structure, which seemed to be relatively modern. The north and south walls were concrete breeze block, and the eastern wall was original random coursed rubble stone.

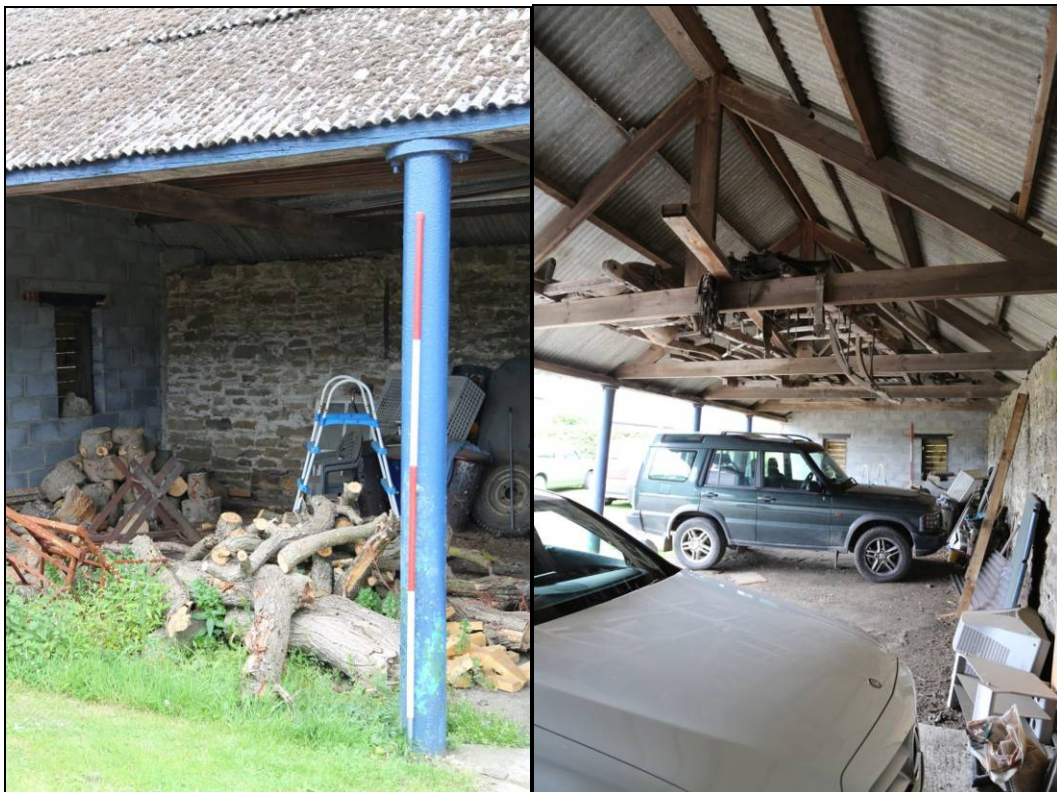
*Plates 5 and 6: one of the cast iron posts on the open, west elevation of the Cart Shed, and the interior of the Cart Shed looking north*

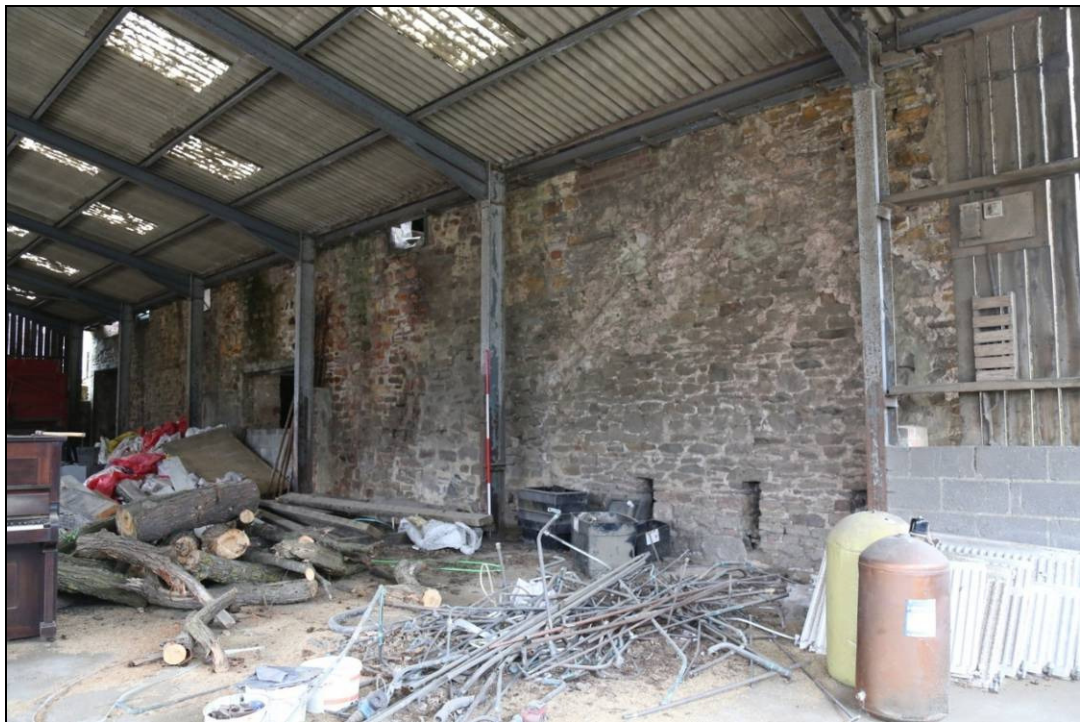
*Plate 7: an oblique photograph of the west elevation of the Granary, looking north-east, showing the later rebuild/extension part of the wall, containing wall scar of former building and three slit vents*

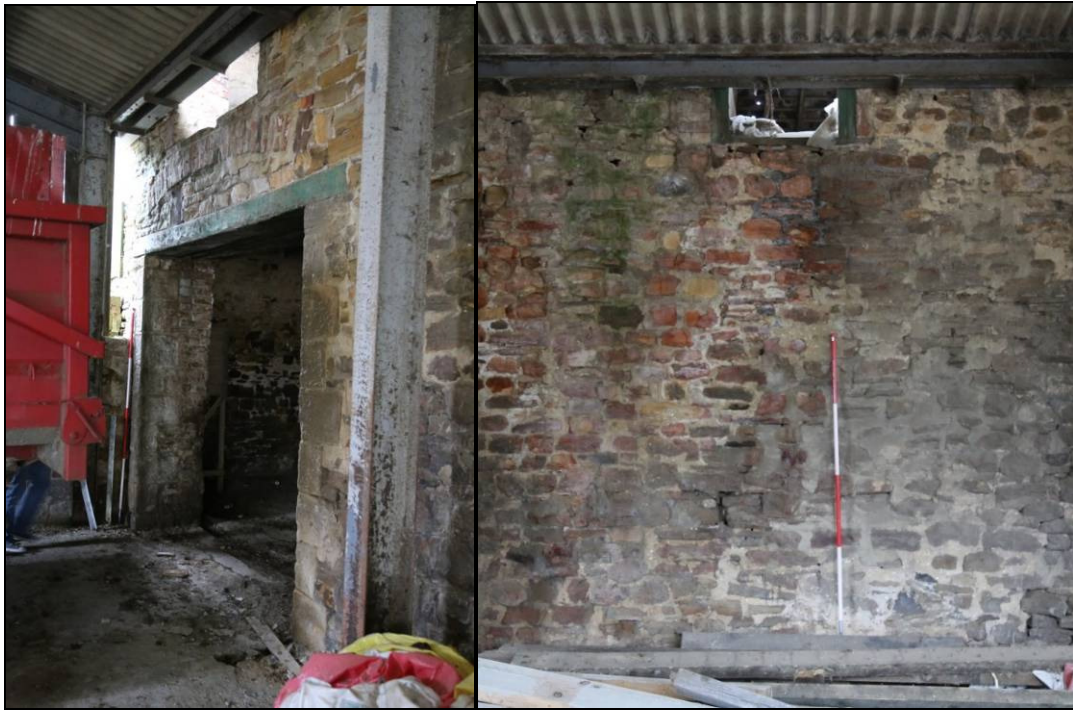
*Plates 8 and 9: the doorway with relieving arch above at the northern end of the west elevation and the vertical wall scar demonstrating the point from which the wall was extended/rebuilt at the south end*

5.10 At the northern end of the west elevation, and not enclosed within the modern shed, there was a stone staircase giving access to the loft level. It is likely that this was added when the building was raised to accommodate a loft level, probably during the 19th century.

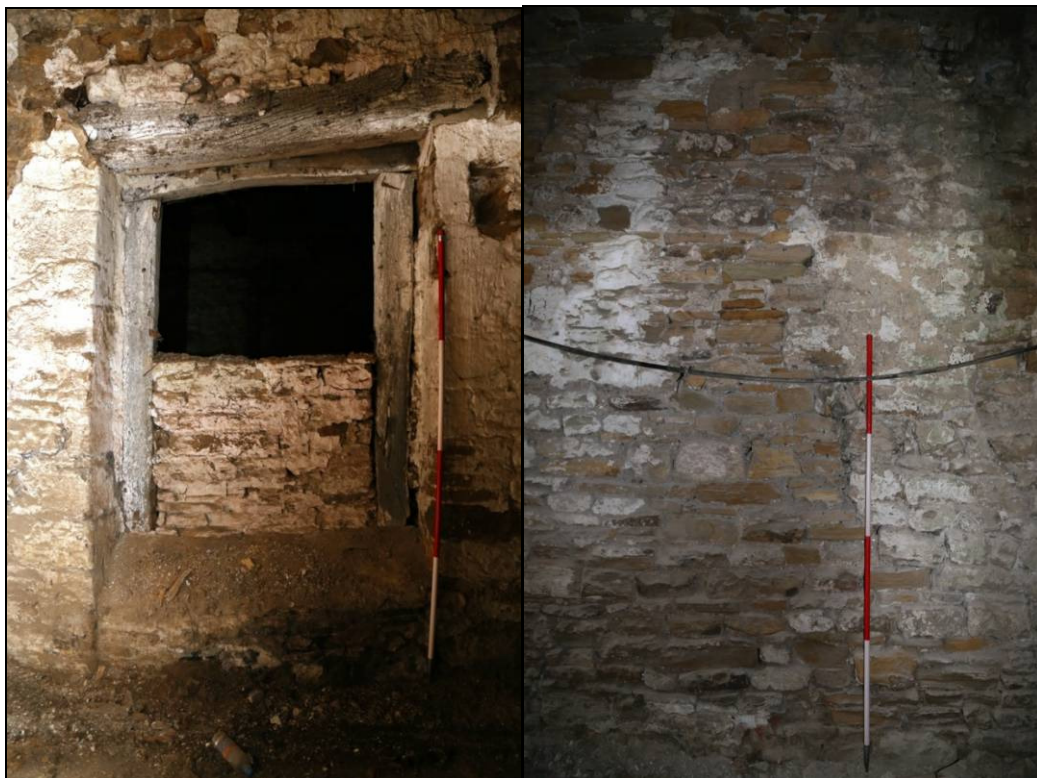
*Plates 10 and 11: an original door on the east elevation, with timber lintel and jamb, and the vertical wall scar demonstrating the point at which the wall had been rebuilt/extended at the southern end*

5.11 The east elevation similarly contained a vertical wall scar demarcating the point from which the wall was rebuilt/extended at the south end. On this wall, it seemed that there had been two phases of extension or rebuilding, demonstrated by a further vertical wall scar (Plate 11).

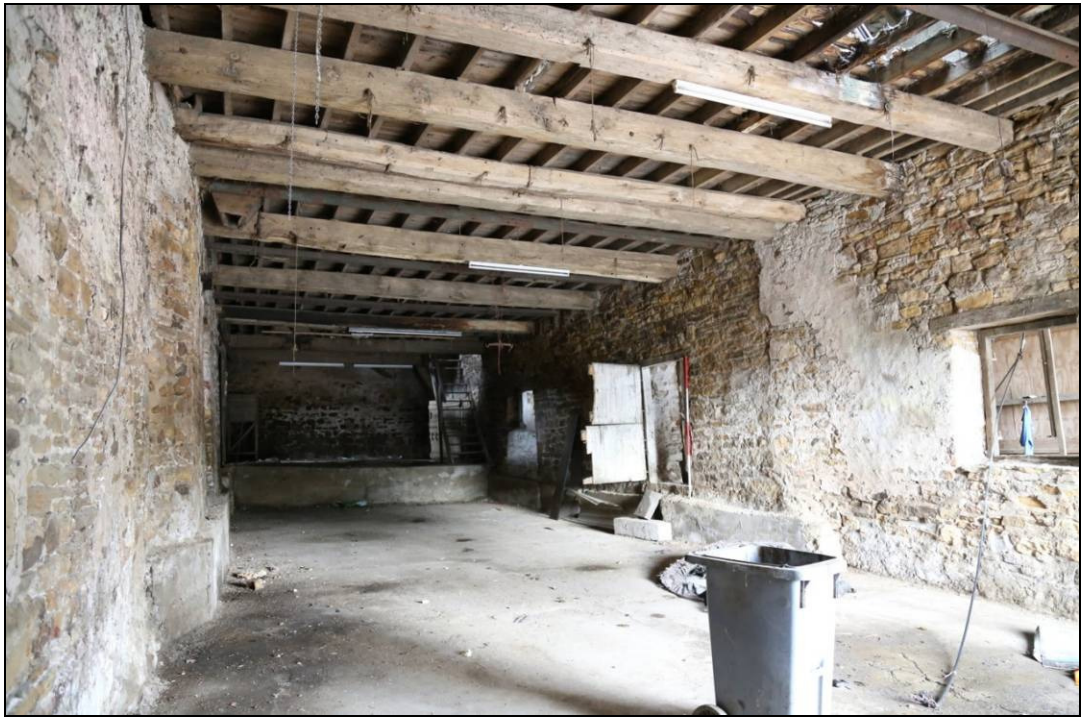
*Plate 12: the interior of the Granary looking north-east, showing the change in wall thickness towards the earlier part of the building and the paired beams supporting the loft above*

- 5.18 The loft level was supported by 13 varied beams. The central part of this featured four pairs of beams; early beams had been reinforced with later timber, presumably when the building was raised. A number of these beams were of late-medieval date and were seemingly reused tie beams from the original roof structure (see below).

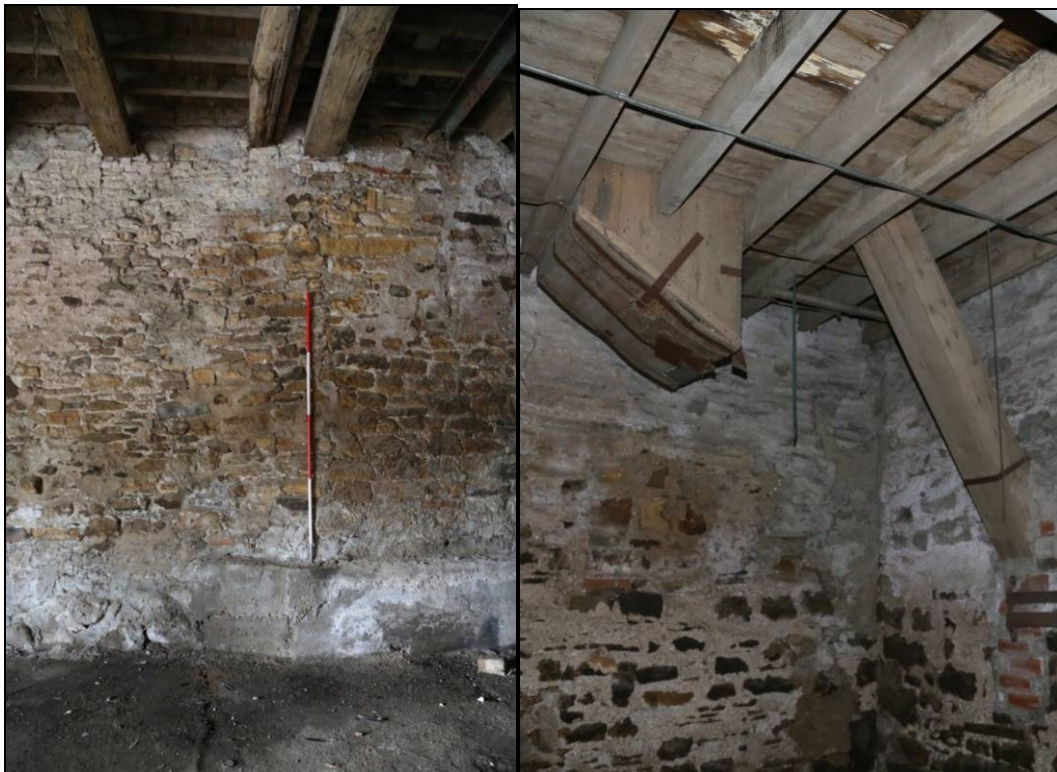
*Plates 13 and 14: the vertical scar demonstrating the point from which the wall had been extended or rebuilt, and the timber chutes at the northern end of the interior*

- 5.21 At ground floor level, there was evidence internally that the southern end of the building had been extended or rebuilt at some stage. Vertical wall scars were observed, north of which the walls were visibly thicker.
- 5.22 A number of features relating to the building's former use survived internally. A timber staircase, in very poor condition, was located at the eastern side of the interior (Figure 5). At the northern end of the interior, there were three timber chutes (Plate 14), which were evidence of former use as a granary or similar (marked onto Figure 5). One of the chutes passed through the eastern wall, on which it was visible externally.

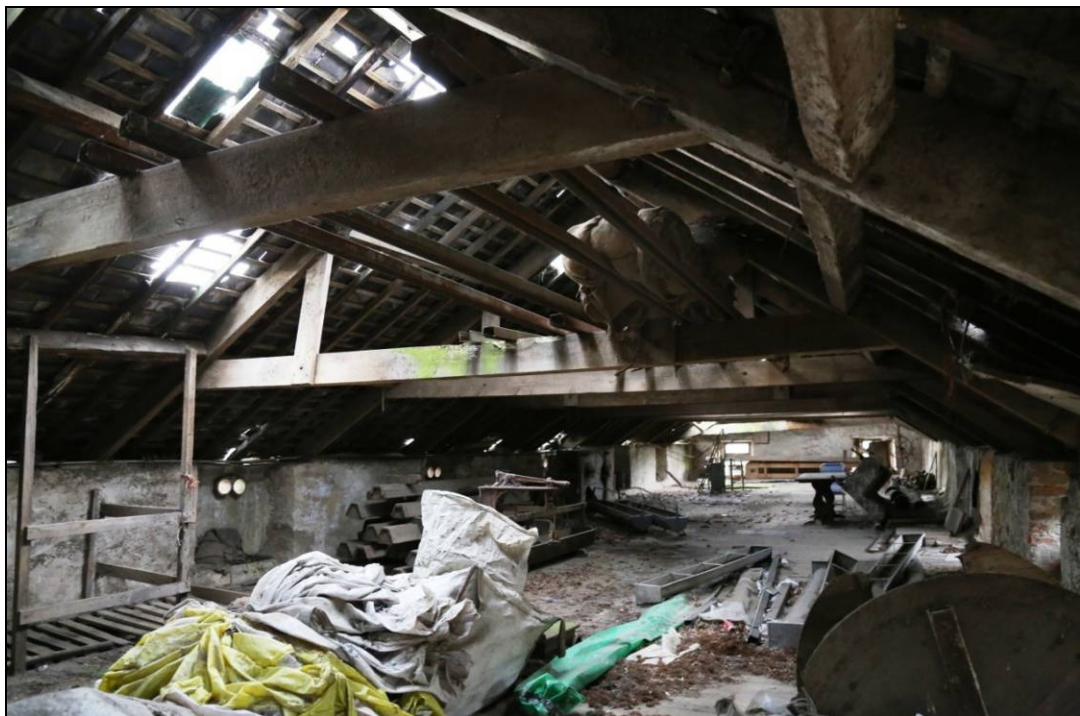
*Plate 15: the loft of the Granary, looking south-east, taken from the top of the external stone steps*

- 5.20 Access to the loft level was limited due to health and safety restrictions. However, this space was assessed from the north-west corner, which was accessible via the external stone staircase. The loft had a queen post roof structure, built from nine relatively modern machine-sawn softwood trusses.

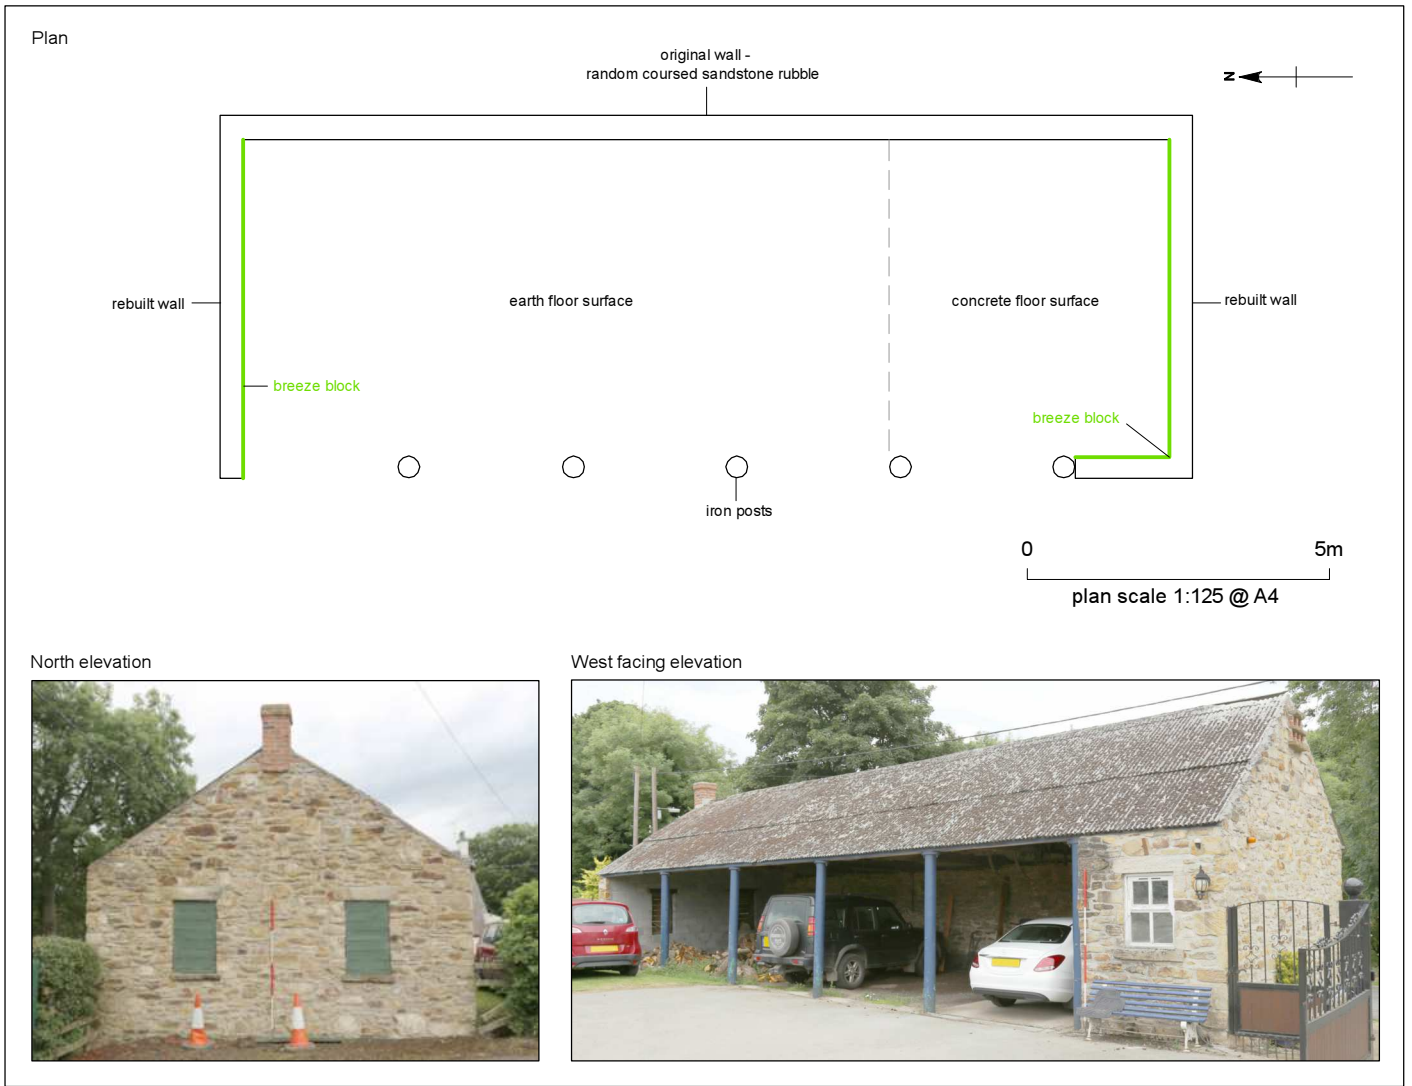
Figure 3

Witton Hall Farm, Witton Gilbert: Cart Shed, plan and elevations

- 5.1 The Cart Shed (Fig. 3) was a rectangular, open-fronted structure, orientated north to south. It was predominantly built in random-course stone, with large stone quoins at each corner. The north, east and south walls were stone externally, although it seemed that the north and south walls had been rebuilt. The roof was timber-framed, seemingly a modern replacement, clad in corrugated asbestos.
- 5.2 The western elevation, was open, with the wall plate supported on five evenly-spaced cast iron columns, with a small stretch of stone wall to the south. This part of wall contained a window, with a stone lintel and sill. The window itself was modern.
- 5.3 The north gable appeared to have been rebuilt, with an interior skin built in concrete breeze block. It contained two windows with stone lintels and sills, and a brick chimney, which may have been added when the wall was rebuilt.
