NEGATIVE WATCHING BRIEF  
REPORT

LAND AT BARK POTS TEA ROOM

CRASTER, NORTHUMBERLAND

NAA 19/69  
July 2019

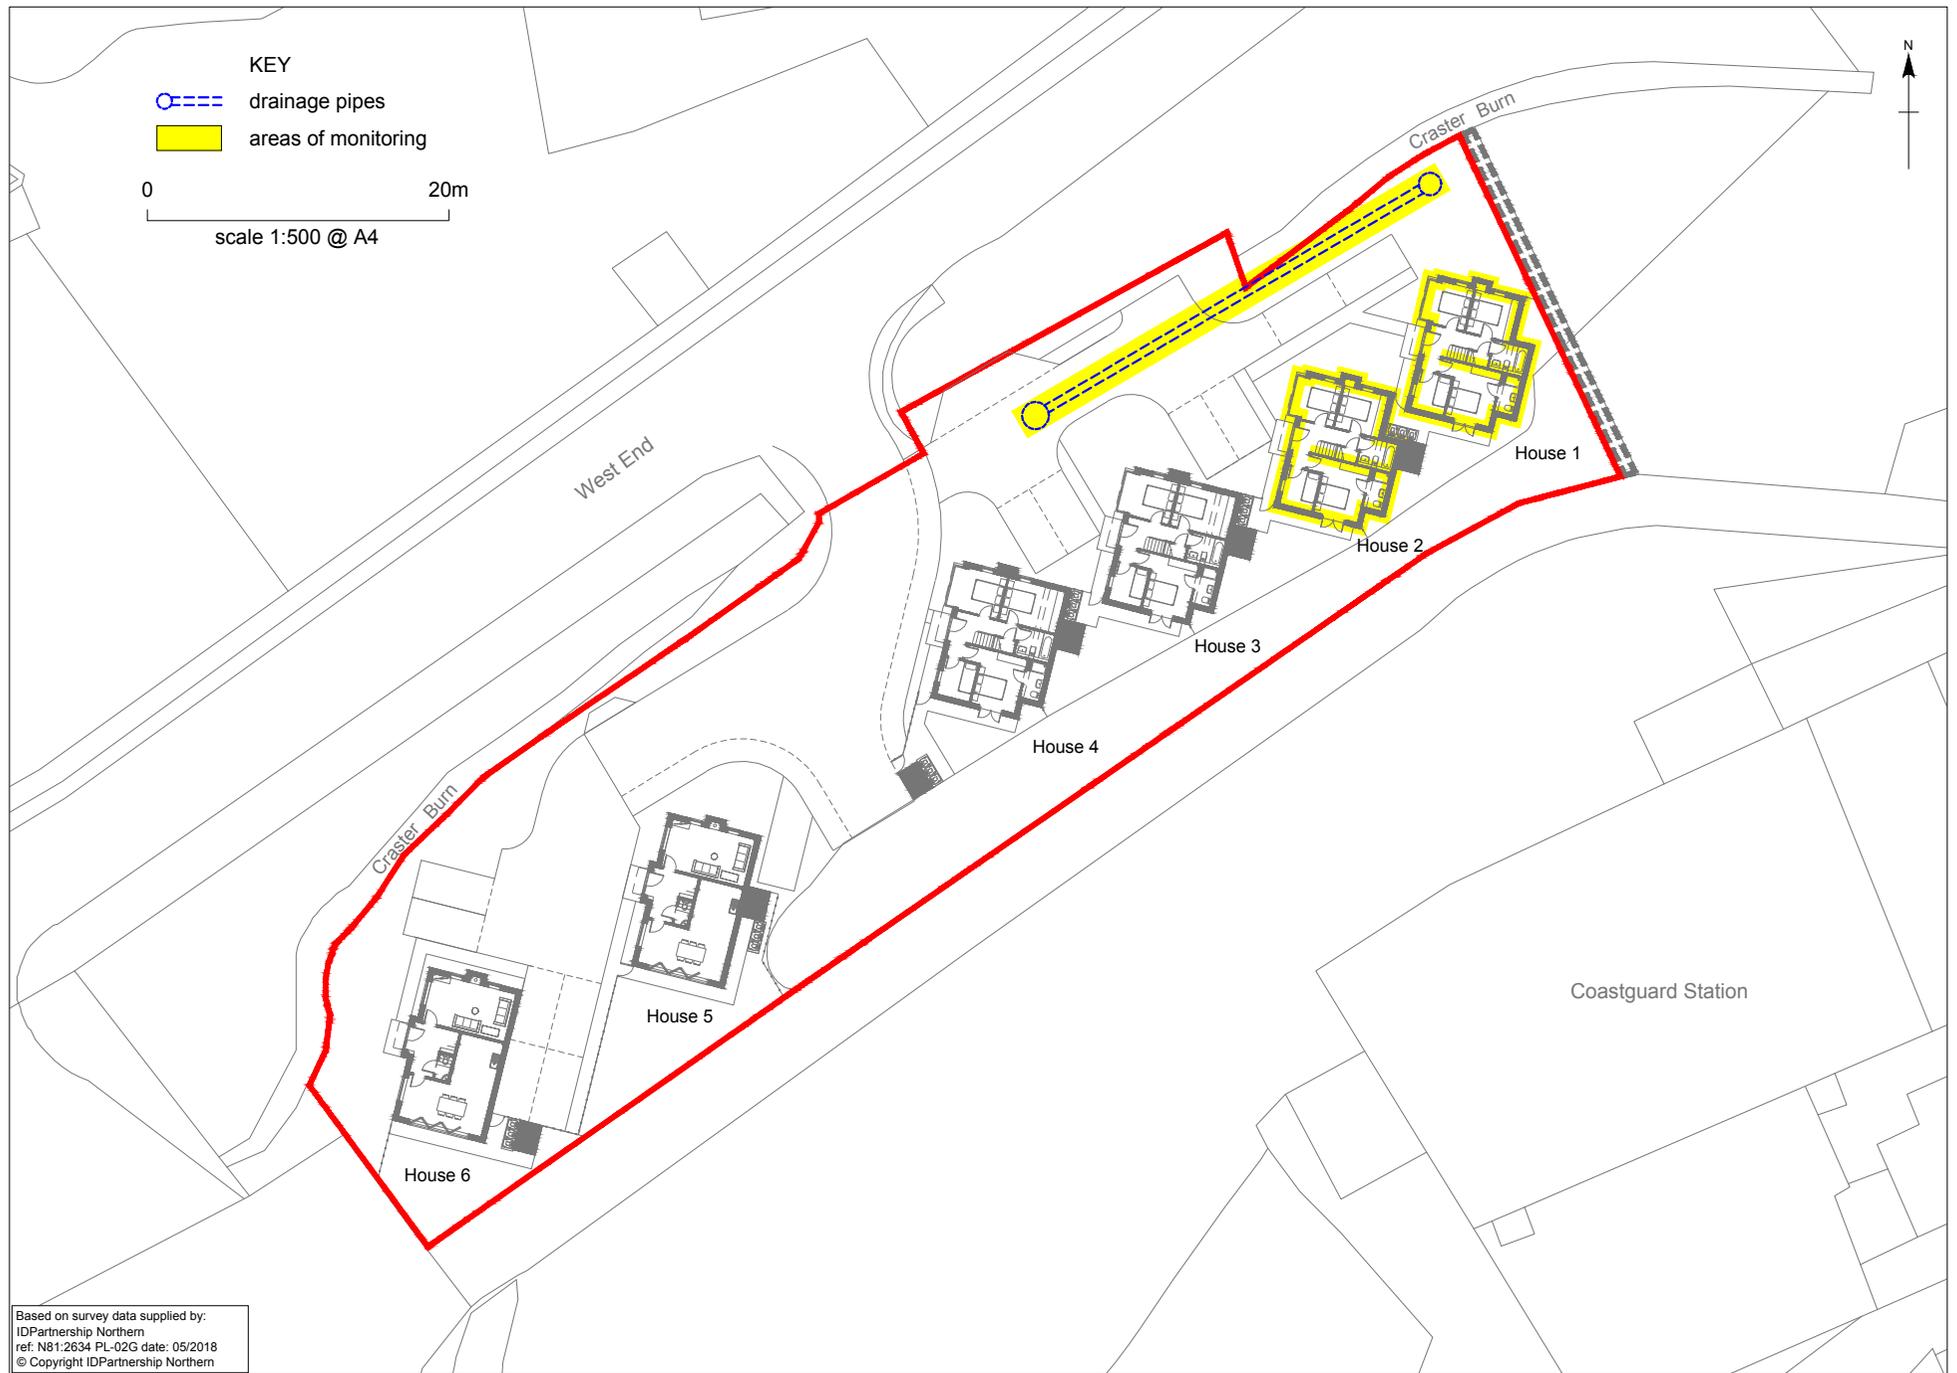
Figure 2

Land at Bark Pots Tea Room, Craster: proposed development plan showing areas of archaeological monitoring

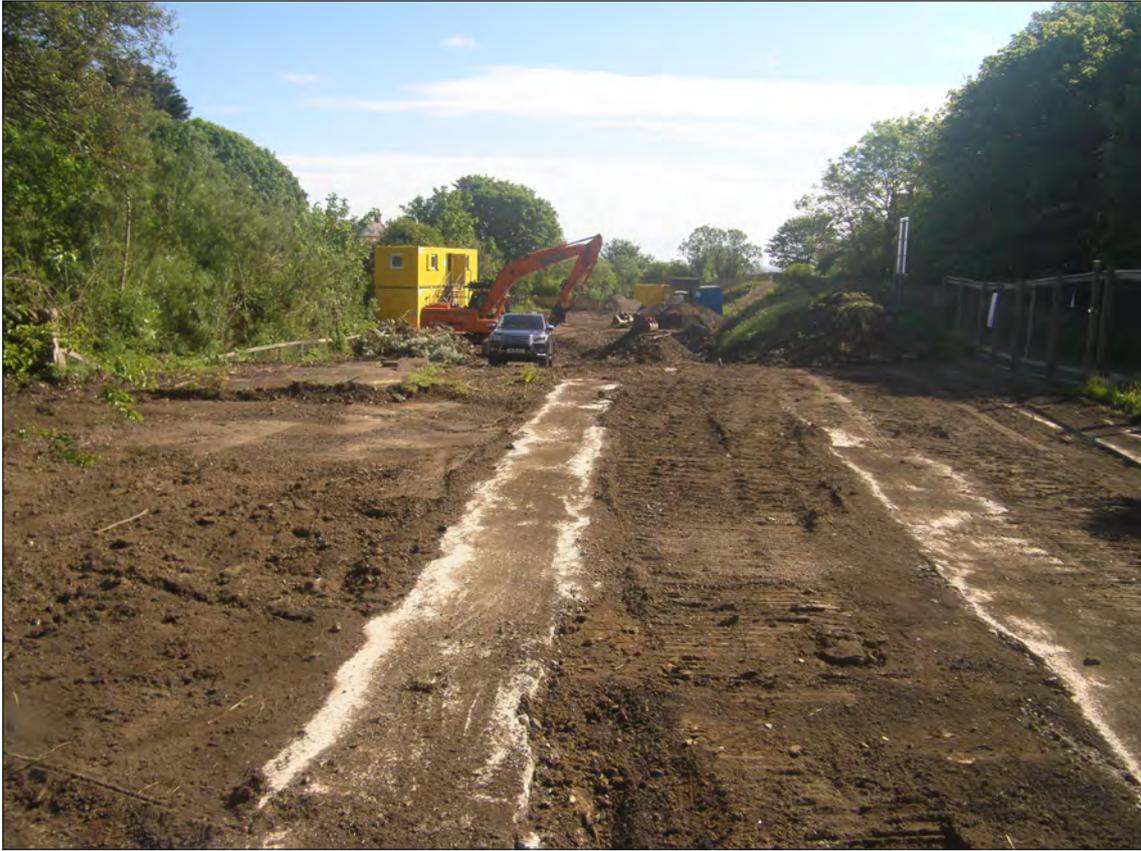
*Plate 1*

*Land at Bark Pots Tea Room, Craster: view looking east along the site with concrete building footings in foreground*

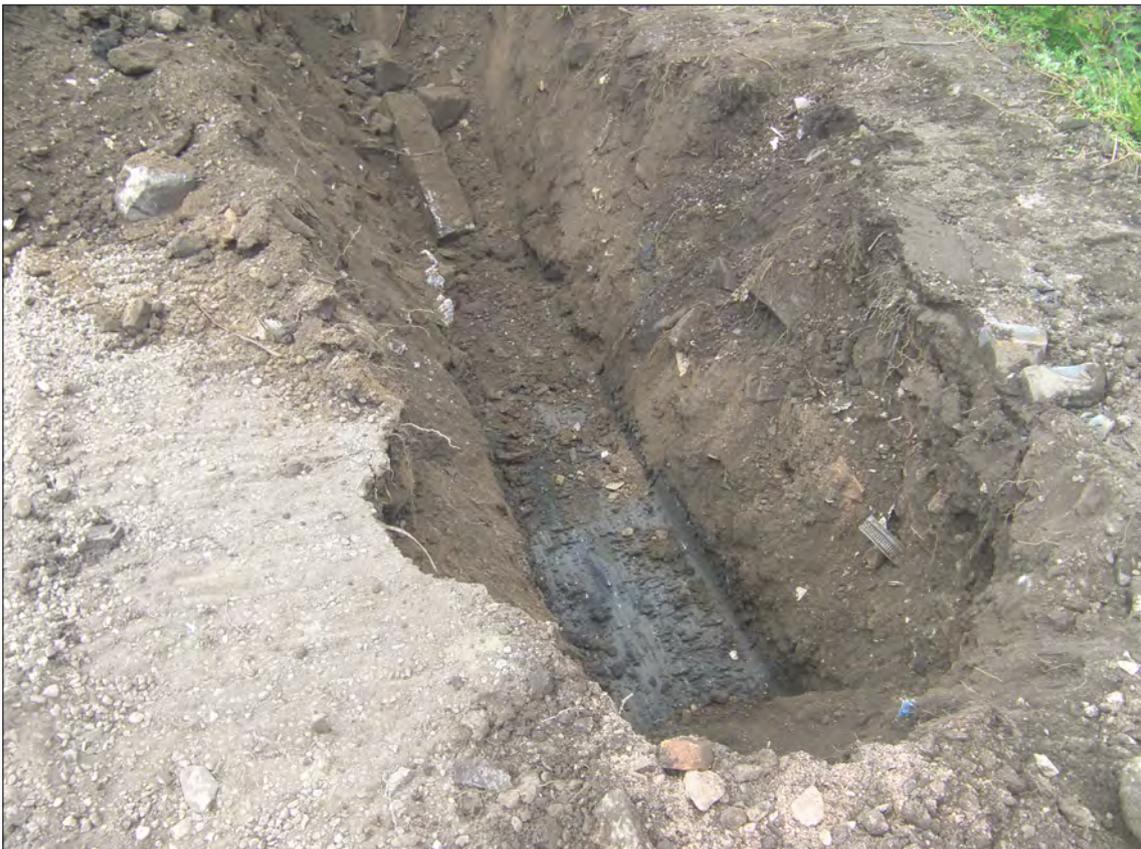
*Plate 2*

*Land at Bark Pots Tea Room, Craster: eastern end of attenuation drain trench showing modern landfill above former ground surface*

Excavation of the trench for the attenuation drain, designed to collect rainwater from the shallower drainage and feed it gradually into the Craster Burn at the north-eastern corner of the site, showed that the north-eastern part of the site had been subject to significant landfill in the later 20th century when levelled for use as a lorry depot. This landfill deposit was 1.2-1.6m thick and consisted of a variety of demolition debris and material such as orange plastic fencing and lorry mudguards (Plate 2). Due to the unstable nature of this material, the trench had to be dug down to a more solid deposit, revealing the former ground surface, which consisted of alluvial clay presumably deposited by over-bank flooding of the adjacent burn. Towards the south-western end of the trench, its line was crossed by a former dog-leg of the culvert containing the Craster Burn. At this point, the top of the north-western stone wall of the culvert and part of its silt infill were observed in the base of the trench 1.3m below the existing ground level (bgl.), although flooding of the trench prevented any further investigation (Plate 3). To the west of the culvert dog-leg, near the south-western end of the new trench, brown clay natural geology was observed at a depth of 1.8m bgl., directly overlain by dumps of crushed stone and gravel capped by a tarmac surface at 1.2m bgl.

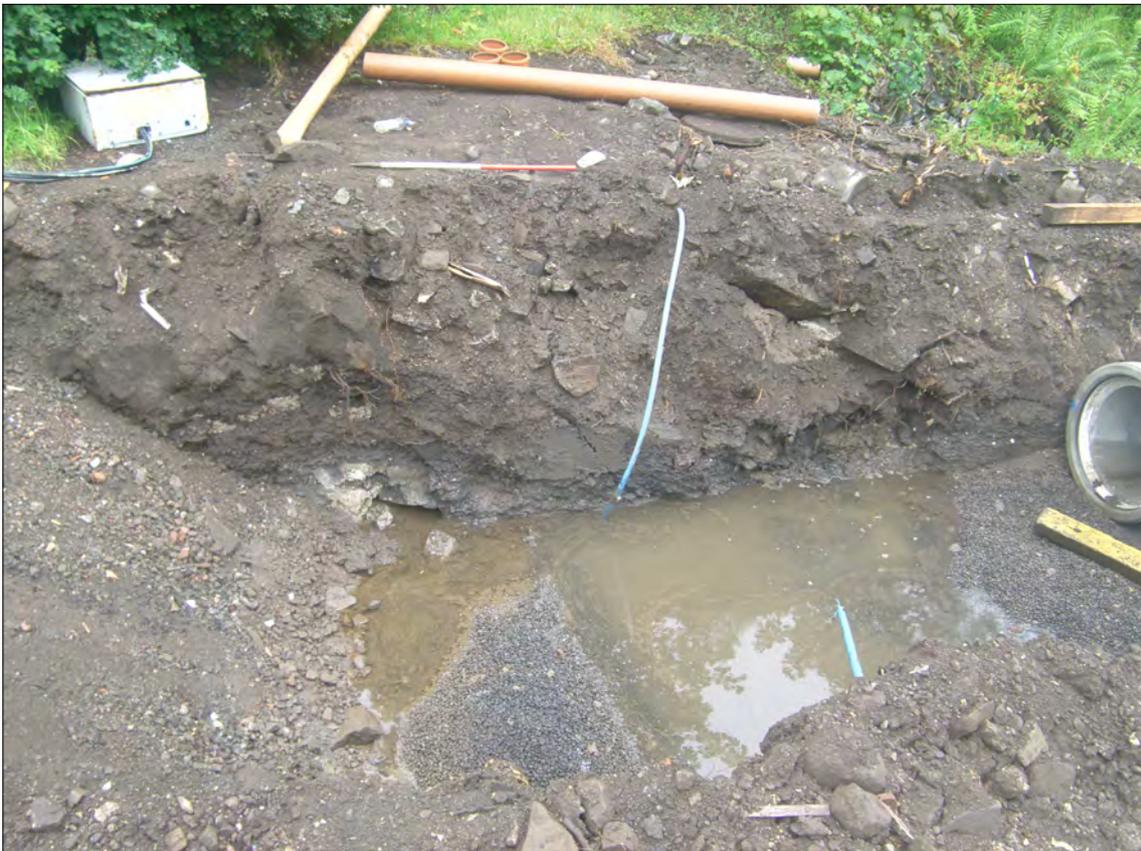
*Plate 3*

*Land at Bark Pots Tea Room, Craster: dog-leg section of stream culvert in base of attenuation drain trench, culvert wall base below left end of 1m scale*

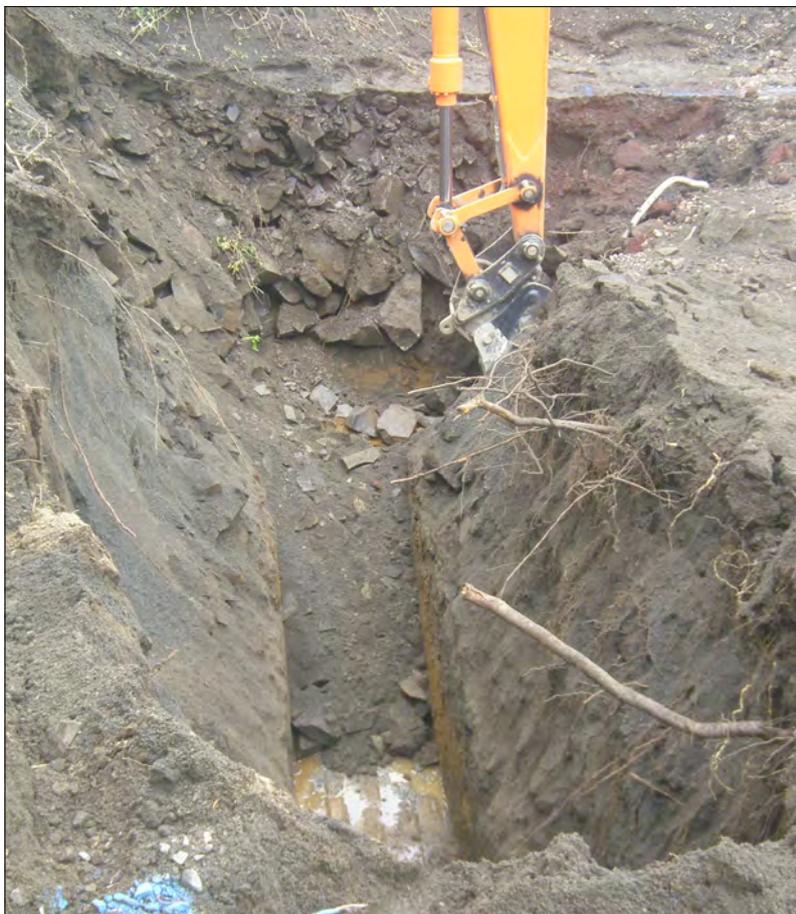
*Plate 4*

At the north-eastern end of the site, the footings for the rear of house 1 cut slightly into the slope at the back (south-eastern) of the site, showing that the trackway bordering the south-eastern side of the site had been built-out using whinstone quarry debris capped by a thick deposit of quarry finings. These unstable deposits extended to a depth of c.1.3m bgl. and extended below-ground across the southern half of house plot 1 (Plate 4). They overlay a 0.2m thick layer of yellow-

*Land at Bark Pots Tea Room, Craster: quarry debris overlying natural deposits at south corner of House Plot 1*
