NATIONAL TRUST DERWENTWATER ESTATE CUMBRIA

The National Trust

NAA 19/130 June 2020

NATIONAL TRUST DERWENTWATER ESTATE, CUMBRIA HISTORIC LANDSCAPE SURVEY AND ARCHAEOLOGICAL CONDITION ASSESSMENT

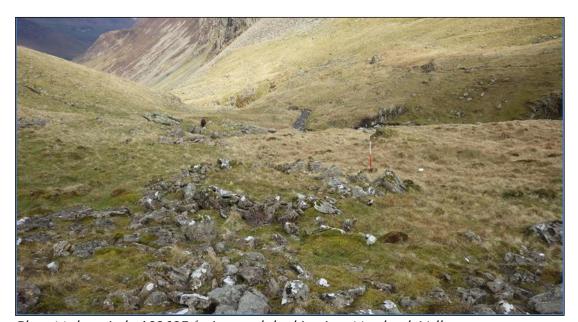
Plate 11: hut circle 182695 facing north looking into Newlands Valley.

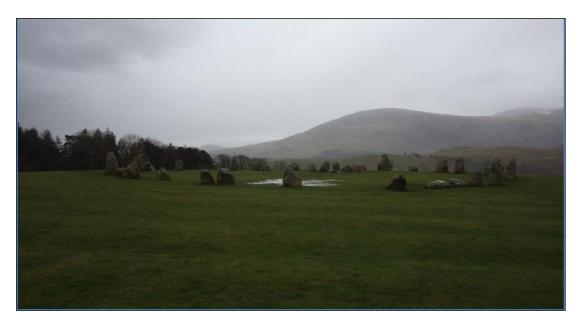
7.7 Castlerigg Stone Circle and associated bowl barrows (NHLE 1011362; **20131**) (Plate 12) are located on a plateau of the north-easterly projecting spur of Castlerigg Fell. There is also at least one surviving outlying stone, although more may have existed.

Plate 12: Castlerigg Stone Circle (NHLE 1011362; **20131**) with ridge and furrow (**182970**) in the foreground. One of the bowl-barrows is visible as a rain-filled hollow within the monument.

Castlerigg dates from the late Neolithic period (around 2500BC). The stone circle is in fact oval in shape, measuring approximately 32m north-south by 29m east-west. Thirty-eight large and three small stones now make up the stone circle, once known as 'The Carles'. The stones have been repeatedly described and mapped from the 18th century to the present day (Stukeley 1776, Otley 1830, Dymond 1881, Anderson 1915; Thom *et al.* 1980). As a result, it is thought that there were originally 40 large stones in total, meaning that two were removed at some point in the past. Based on his analysis of the post-medieval depictions of the stones, David Fraser (1986, 75-78) has concluded that the position of as many as 13 must have been adjusted at some point between 1794 and 1848.

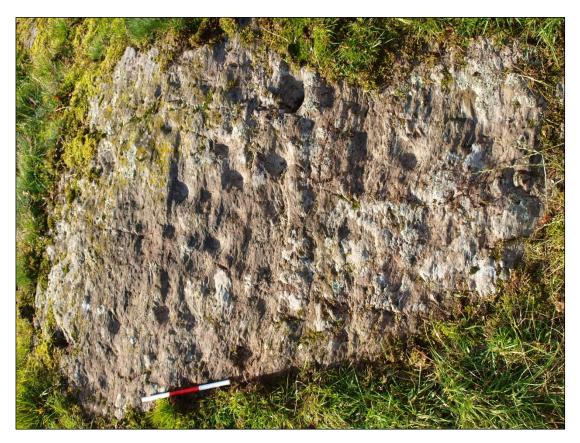
Plate 14: rock art panel (29991) showing multiple cup marks (photo: Lund 2020).

7.17 The panel was given the name 'Crabapple Rock' by the finder on account of the Crabapple trees nearby. There are two rock art panels within close proximity of each other, although they form part of the same rocky outcrop. This is a glaciated slab (Rouche Moutonnee) of the Skiddaw Slate series, which is about 50m in length, aligned north-south and located approximately 400m from Derwentwater and 135m above the

River Derwent. The first panel is covered in multiple cup marks (Plate 14). The second features bifurcated linear grooves that are V shaped in section (Plate 15). The incised lines are not a common motif, and it has therefore been suggested that they may not be prehistoric. However, there are prehistoric parallels to be found, most notably the Arrow stone in North Wales (NTSMR 29991; pers. comm. J. Lund, January 2020).

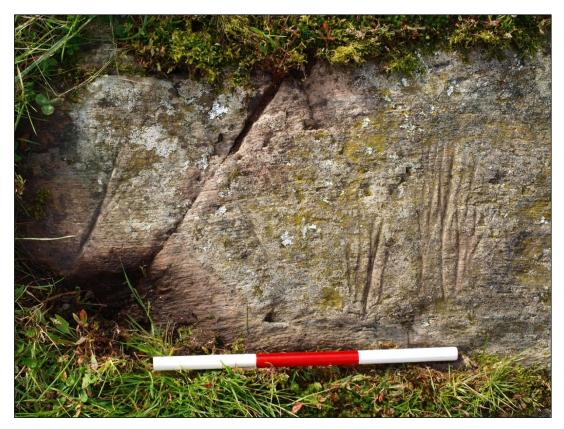
Plate 15: rock art panel (29991) showing bifurcated linear grooves (photo: Lund 2020).

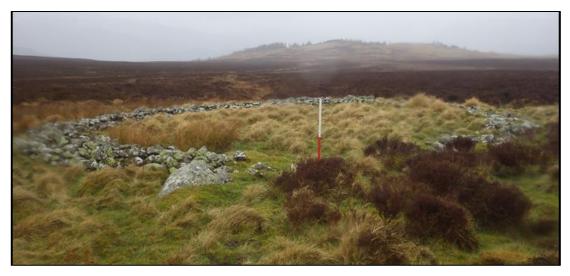
Plate 17: sheepfold (182950) with probable marker stone.

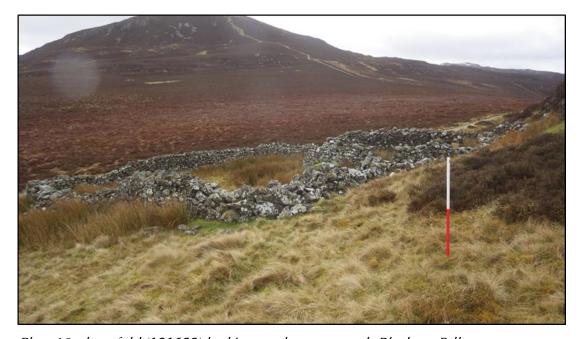
- Approximately 820m west of site **182950** was an oval sheepfold (**20138**), and south of this a square sheepfold (**181689**; Plate 18), located next to a modern walkers' track. The square structure had a small internal enclosure in the south-west corner, with a hogg hole built into the south-east face. The different forms used at these three sites may relate to topographic variation, date of construction, or simply the preference of an individual shepherd or farmer. These differences may also relate to changes in function. Simple sheepfolds offer shelter for a few yews and lambs. More complex folds, with various cells enable the penning and sorting of sheep to facilitate the processes whereby sheep are marked, ear clipped, tagged and counted. This also allows for strays to be identified and sent back to their farm.

Plate 18: sheepfold (181689) looking south-east towards Bleabury Fell.

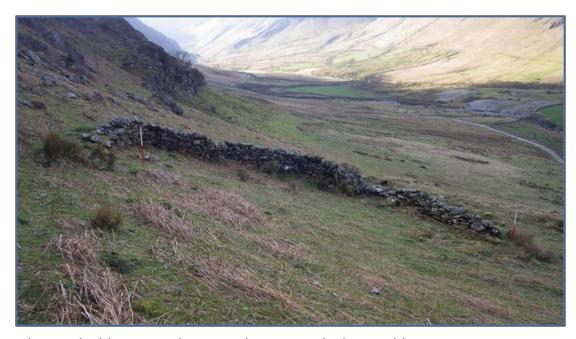
8.50 Bields can serve two purposes. Some function as simple shelter walls, whilst others are used to assist in the gathering of sheep from the common. Bields were found predominately on the west side of the survey area, across the Derwent Fells and especially in the Newlands valley, alongside Newlands Beck. Eight were recorded in total. A collection of three horseshoe-shaped bields was recorded to the west of Narrow Moor (182717), (182710) and (182705); (see Plate 19), aligned broadly north to south.

Plate 19: bield (182717) facing south-west. overlooking Goldscope Mine.

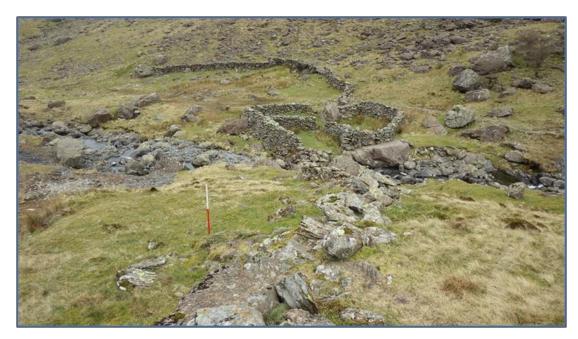
Plate 20: washfold (182673) adjacent to Long Work Mine and Newlands Beck.

319902, 521475. The feature was built into the slope adjacent to Force Crag Beck, close to Force Crag Mine. The entrance to the washfold was on the north-west corner, and an exit into the stream accommodated on the south-east face of the structure. Other examples were recorded just to the north of Castlenook Mine at NY 322807, 517133 (27612), and at Long Work Mine at NY 322875, 516290 (182673, Plate 20).

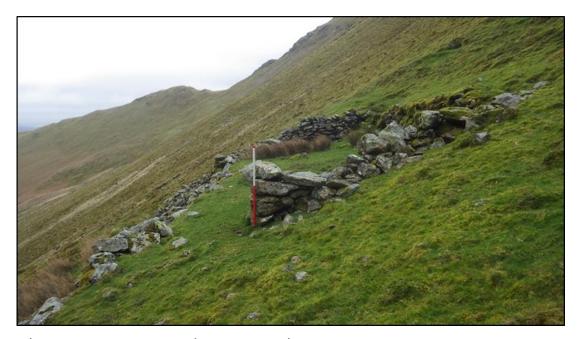
- At Robinson Crag (NY 320695,517699) a series of agricultural features was recorded (Plate 21). This appears to have been a simple shepherds hut (**182492**), which survives only as low walls standing up to 1.4m high in places. It was dug into the hillslope to create a level platform, with a single entrance on the west side. The entire north wall had collapsed downslope.
- 8.57 Adjoining the structure to the east was a section of trackway (182493) which was aligned broadly east to west. It was visible for approximately 110m, where it entered sheepfold (182496). A short distance to the east of the sheepfold was a large spread of tumbled stone (182502). This was the remains of a field enclosure, with relict walls visible. To the north-east of the enclosure was another sheepfold (182514).

Plate 21: structure 182492 facing eastwards.

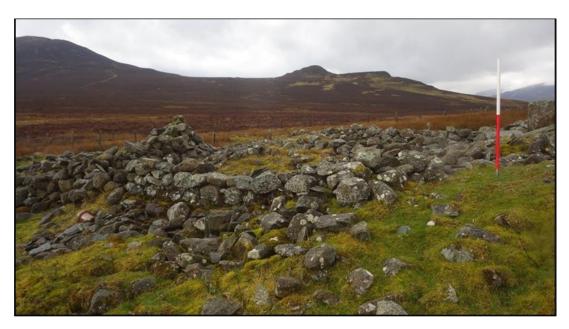
Plate 21: building (182924) looking south-west towards Bleabury Fell.

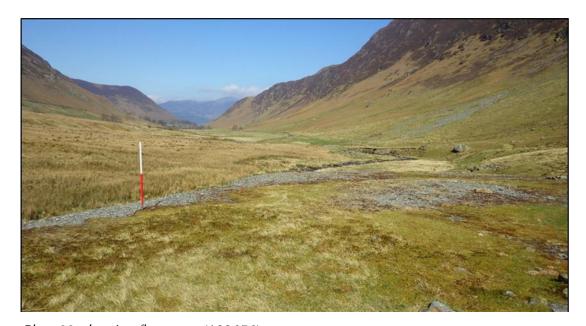
9.27 The dressing floor (**182656**; Plate 23) is located on the east bank of Newlands Beck, a short distance to the north-east of the main mining area. It consists of an artificially flattened area used for dressing ore excavated from the levels to the south.

Plate 23: dressing floor area (182656)

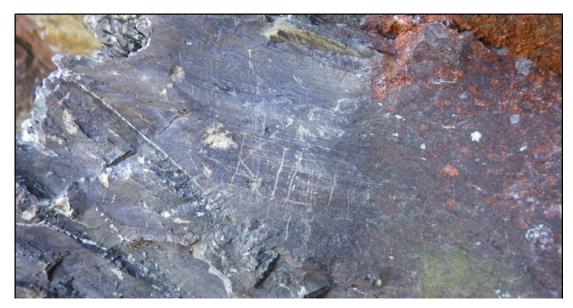
9.28 A possible trial adit or sounding (182647) was recorded to the south of the main working area (NY 322761, 516938). This comprised a rectangular opening dug into the slope to the south, with a large spoil heap located to the north. The adit did not extend far into the hillside and was likely abandoned. Numerous drill scars and holes were visible on the rock at the adit entrance. To the left was a small panel of graffiti that read 'KILROY 19..' (Plate 24). Based on the form of the lettering, the graffiti was probably contemporary with the mine, which was worked until 1918.

Plate 24: graffiti panel to the left of the trial adit entrance reads 'KILROY 19..'

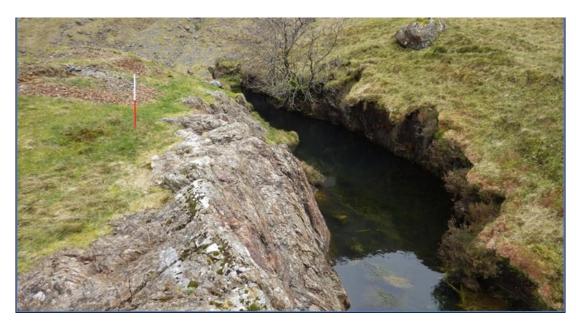
- 9.35 The Scheduled complex includes the remains of 'Long Work' (Plate 25); a 16th and 17th century open-cut stope and associated spoil heaps. It also includes prospecting trenches and pits, ore dressing floors, and the remains of a building of unknown function. These survive in a reasonable condition and, like St. Thomas Work, are considered to be nationally important as a rare example of a 16th and 17th century copper mine that has remained largely untouched since abandonment (NHLE 1019944).

Plate 25: Long Work Vein facing east

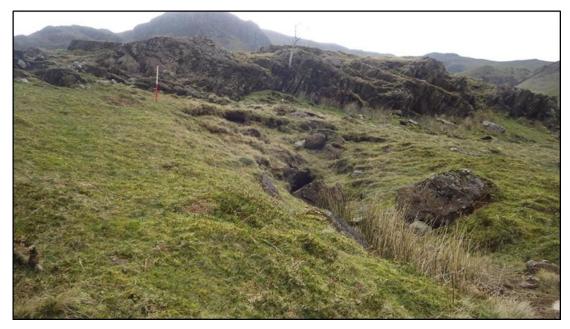
Plate 26: adit 182671 with Long Work vein in the background.

9.39 A well-preserved ventilation hole, complete with wooden props, was recorded at NY 322846, 516208 (182668). This was filled with water which has served to preserve the wooden props shoring up the sides. Directly north of this was an adit and associated spoil heap (182671). The adit was dug into the slope and associated with a large spoil heap extending from the mouth of the entrance to the north. The feature has been partially eroded by Newlands Beck. The adit entrance has collapsed, with several large boulders blocking access into the site (Plate 26).

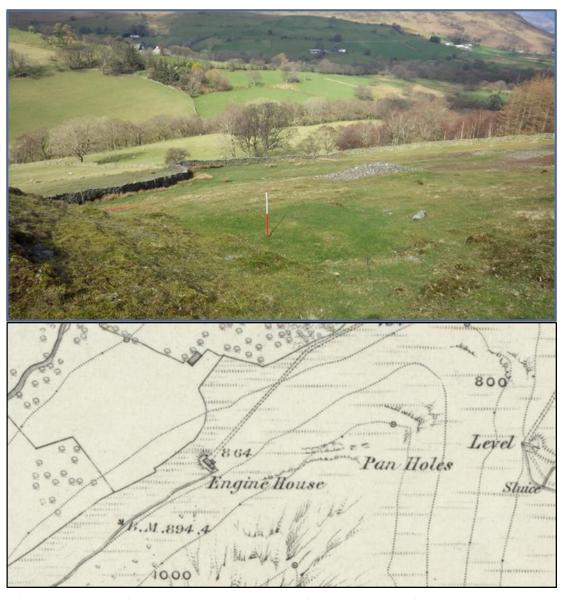
Plate 28: (Above) building platform (182604) beneath the spoil heap generated from adit (182597) (Below) 1863 OS map showing an engine house in the location of site (182604).

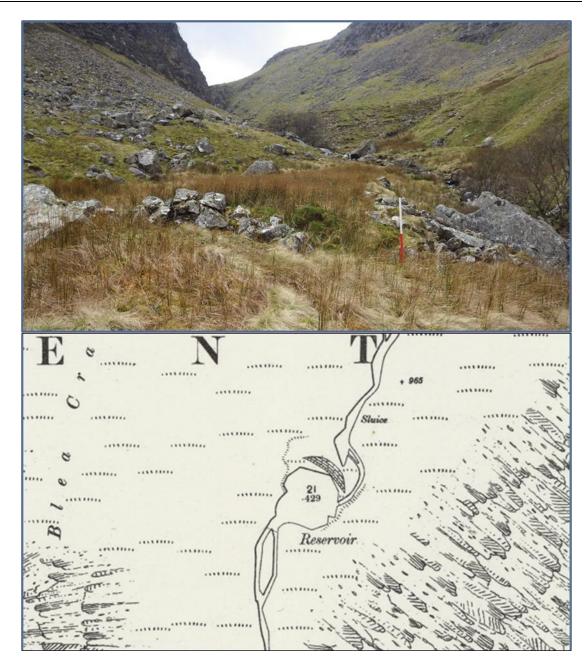
Plate 30: (Above) sluice (182540) with dam (182535) in the background. (Below) 1899 Ordnance Survey mapping showing dam (182535) and a sluice in the location of site (182540).

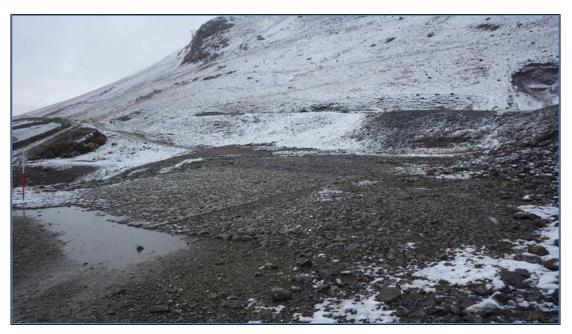
- 9.68 The site today Several features related to various mining processes were recorded across the complex. These included a well-preserved section of cobbling (part of the dressing floors) (182727; Plate 31), close to Yewthwaite Gill (NY 323932, 519426). This feature was partially restored by the National Trust and members of Cumbria Amenity Trust Mining History Society in 2006. The dressing floor is now partially covered by mining spoil on the south-east corner. Numerous small shallow drains were observed built into the cobbled surface, and potential wall footings were also seen.

- 9.69 Upslope of the cobbled surface were the footings of a long rectangular building (182731). The structure contained numerous internal walls, which appeared to separate the building into three rooms. It was rubble built and, unfortunately, many of the stones had been removed to create walkers' cairns (182729) along the path through the site.

Plate 31: cobbled surface 182727. Building 182731 is visible on the slope above the cobbled surface.

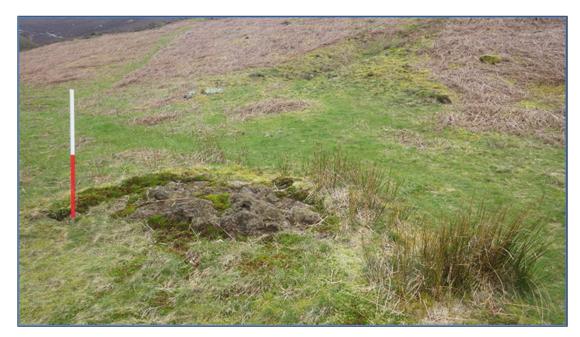
- 9.82 To the south-east of this smelter (182613/23006), reached by a track (182617) branching off track 182629 were the foundations of a large rectangular building (182615). Piles of stone and a slag-like material were visible within the building interior. Similar material was found built-up against the outer face of the south-eastern wall, which lies adjacent to the gill. A long, narrow rectangular trench (182620) recorded on this side of the building may be the remains of a waterwheel pit used to drive machinery. There was a gravel spoil heap to the south (182616).

Plate 32: site 23006. Semi-circular buried stone structure containing slag-like material. Adit 182612 visible at the top of the image. Trackway 182629 cuts through both features.

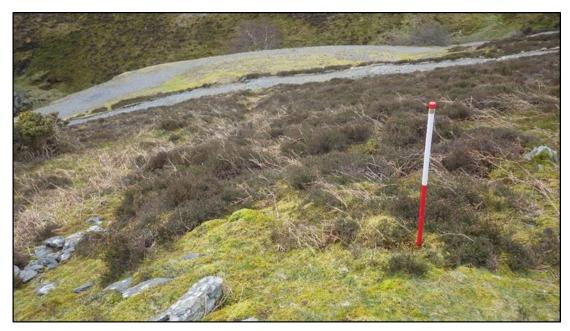
internal baffle walls were visible, but these may remain buried beneath the rubble. At the northern end of the flue, after 37m, were the remains of a rectangular stone chimney base (Plate 33). Immediately adjacent to the west is a large stone lined hole; this is a second chimney (Tyler 2005, 186; NTSMR 23008, 26445). The line of the flue was crossed by a north-west to south-east aligned trackway at approximately (NY 322841 521211).

Plate 33: image taken from the remains of the chimney looking south down the line of the flue into the smelt mill building.

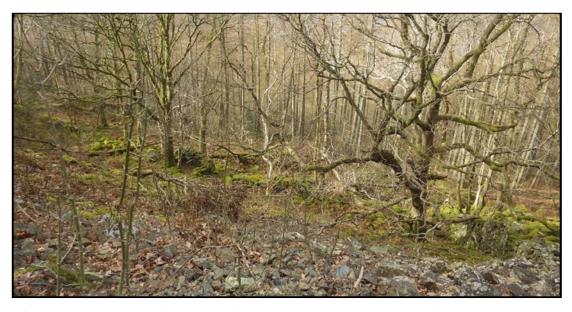
- 10.22 To the south of the wall **180057** (Plate 36) were the remains of a large rectangular structure (**182888**) built on a very steep sloping section of land. This is not depicted on historic OS maps of the area. Only two walls survived, and much of the site was covered by fallen stone, either from the structure itself or the adjacent cliff face. A further building (**180037**) was located to the north-west of **180057**, close to the B5289 which cuts through the wood.

Plate 36: enclosure wall (180057) showing structures (182884) and (182887).

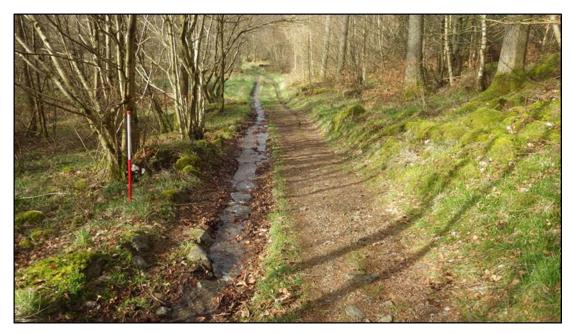
- 10.30 Further enclosures were recorded to the east of site 182904. Enclosure 182907 was located approximately 30m to the south-east and is depicted on 1898 OS map. The enclosure was broadly rectangular in shape and aligned north-east to south-west. It was cut by a north-west to south-east aligned trackway (182908; Plate 38) and seemed to align with a second trackway (182909). No internal features were visible to indicate function, but these were probably part of the woodland pasture, enclosed to prevent grazing animals straying into woodland areas.

Plate 38: trackway (182908) cutting through enclosure (182907).

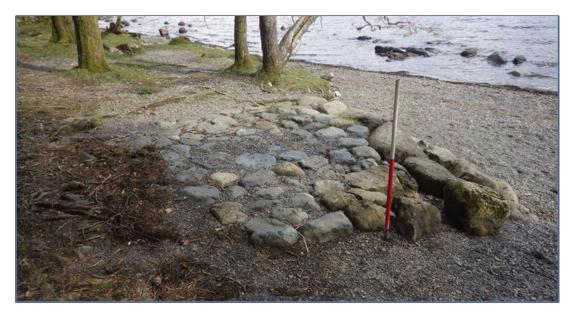
- 12.27 Several jetties were recorded along the eastern shoreline of Brandelhow Park. Although these are likely modern features, they may incorporate the remains of earlier structures. The best evidence for this was the foundations for a small square hut recorded at NY 325178,519769 (182799), close to High Brandelhow Landing (Plate 40).

Plate 40: building foundations (182799) close to High Brandelhow Landing.

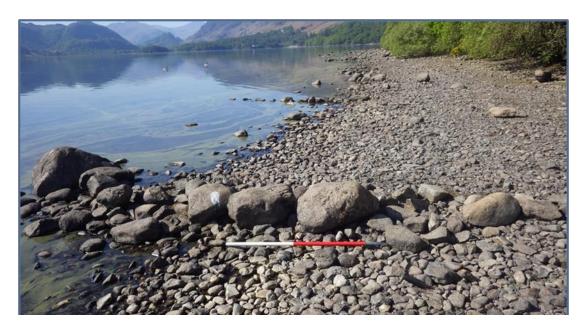
- 13.64 A number of stone jetties and groynes were recorded along the shoreline (Plate 41). The groynes comprised linear piles of stone deposited along the shoreline to prevent bank erosion. At the time of the survey some of these could be seen extending for over 2m into the Lake and likely extend further. The date of these is not known. In addition to

Plate 41: jetty (182987) with a second jetty (182986) in the background.

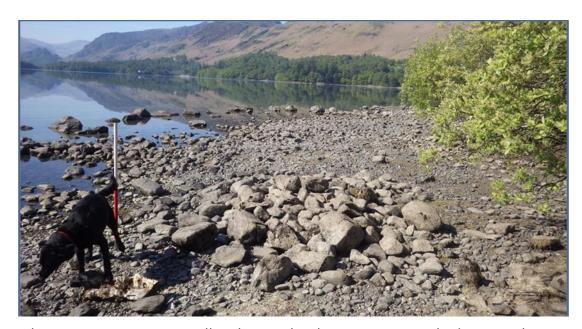
On the south side of the island was a D-shaped arrangement of stones which extended into the Lake (182984; Plate 42). It was unclear if the feature was two stone jetties or part of a more elaborate mooring. On the shoreline next to the site were several deliberate piles of stone (182985) which may have been stockpiles for creating further jetties around the island.

Plate 42: site (182984) partially submerged with site (182985) in the foreground.

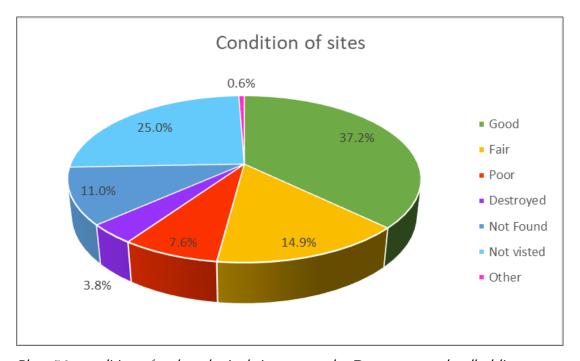
15.1 In total, 820 sites were recorded as part of the survey. Of these, 521 sites were visited, and their condition assessed. This included the sites identified as part of the desk-based assessment process and new sites discovered as part of the survey. There were 90 sites visited but not found, 31 sites destroyed and a further 210 sites that were not visited for the reasons stated in the introduction. The results of the assessment are illustrated on figures 30 to 43.

Plate 56: condition of archaeological sites across the Derwentwater landholding.

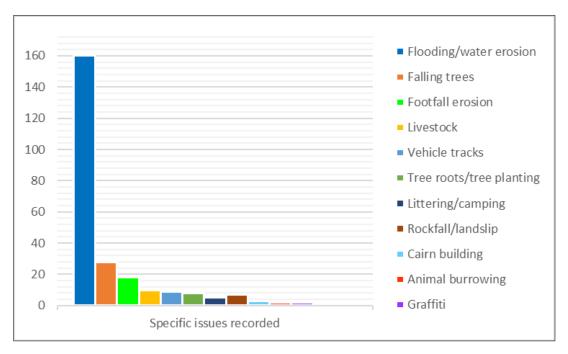
Plate 57: specific issues recorded at sites across the Derwentwater landholding.

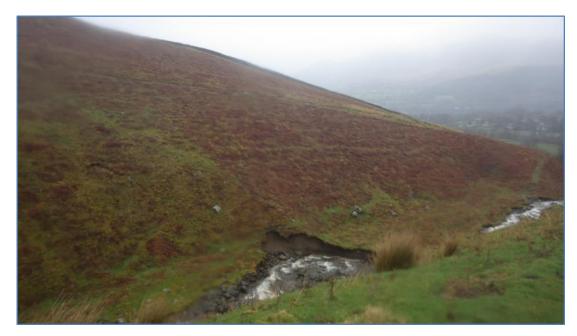
sites were observed during a period of sustained rainfall over several days and were severely inundated.

Plate 59: water erosion damage from Brockle Beck looking north into site 182934.

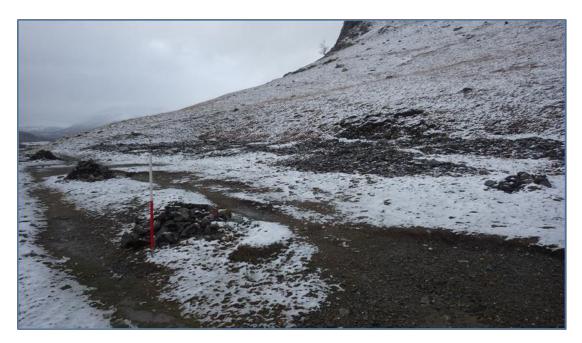
15.18 Numerous walkers' cairns were observed. The majority of these were relatively modern, founded perhaps in the last 30 to 40 years, and were particularly common on summit approaches and along the main tourist walking routes. Most were of no immediate risk to the archaeology but in a small number of cases stonework was taken from nearby archaeological features to be used in construction. The most extreme example of this was at Yewthwaite Mines to the south-east of Little Town where eight large walkers' cairns that line the main walking route through the complex have been constructed from stonework taken from building 182731 (Plate 60). This has undoubtedly had an adverse effect on the stability of the structure.

Plate 60: alignment of walkers' cairns parallel with structure 182731.

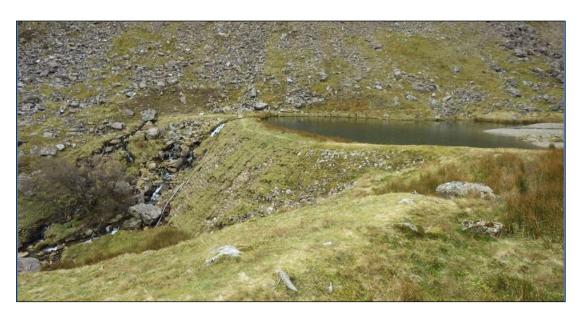
the archaeology and contaminating the water course.

Plate 63: dam 182535 showing the spillway.

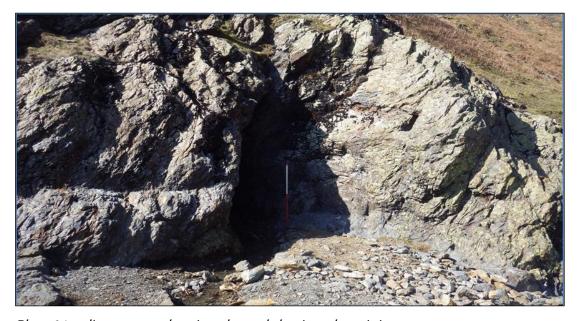
Plate 64: adit entrance showing channel dug into the mining waste.

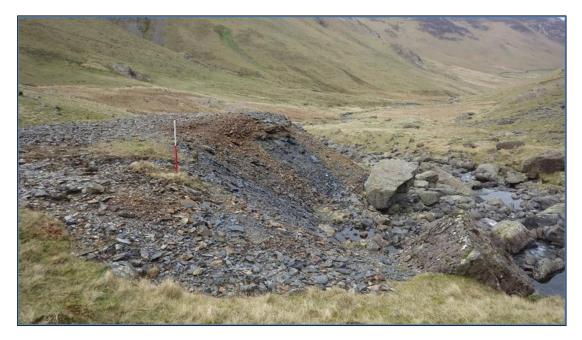
15.51 Site **182671**, although outside the boundary of the scheduled Long Work Mine, is under significant threat from water erosion from Newlands Beck (Plate 65). A section of the spoil heap at the entrance to the adit (measuring approximately 95m²) has already washed into the beck. This may have an impact on any buried mining remains beneath the spoil and will have deposited a large quantity of mining waste into the watercourse. The site will be vulnerable to further flooding, particularly during periods of heavy

sustained rainfall.

Plate 65: washed-out section of mining waste at the entrance to adit 182671. Newlands Beck is to the right.

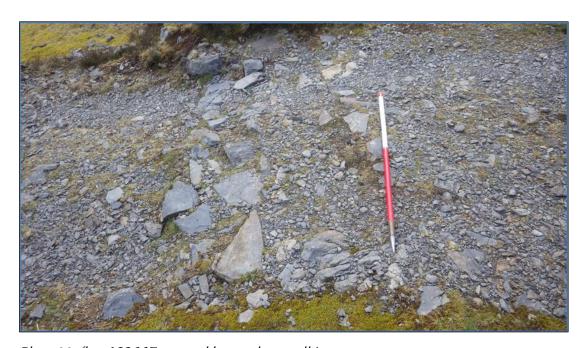
15.56 The length of the flue means that diverting the walking route would not be a viable option. In addition, there is an extensive network of trackways associated with the mine. A number of these run closely parallel to the gill, especially those around adit **26649**, and are vulnerable to erosion from the beck.

Plate 66: flue 182667 crossed by modern walking route.
