HISTORIC BUILDING  
RECORDING

STABLE AND CART SHED ASSOCIATED  
WITH FORMER PROVINCIAL  
LAUNDRIES COMPLEX,  
PROVIDENCE ROW,  
DURHAM CITY

prepared for  
Kier Construction

NAA 19/02  
January 2019

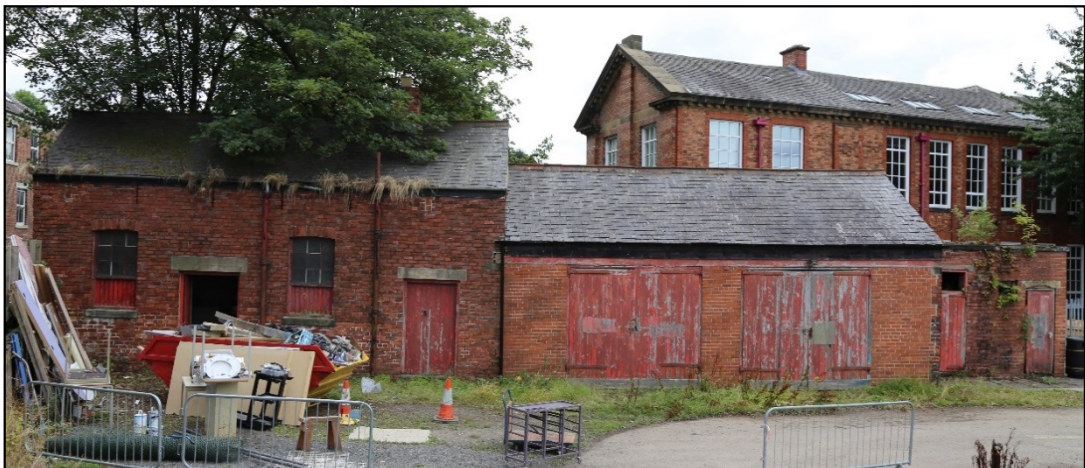
*Plate 2: front elevation of the stable and cart shed associated with the former industrial laundry.*

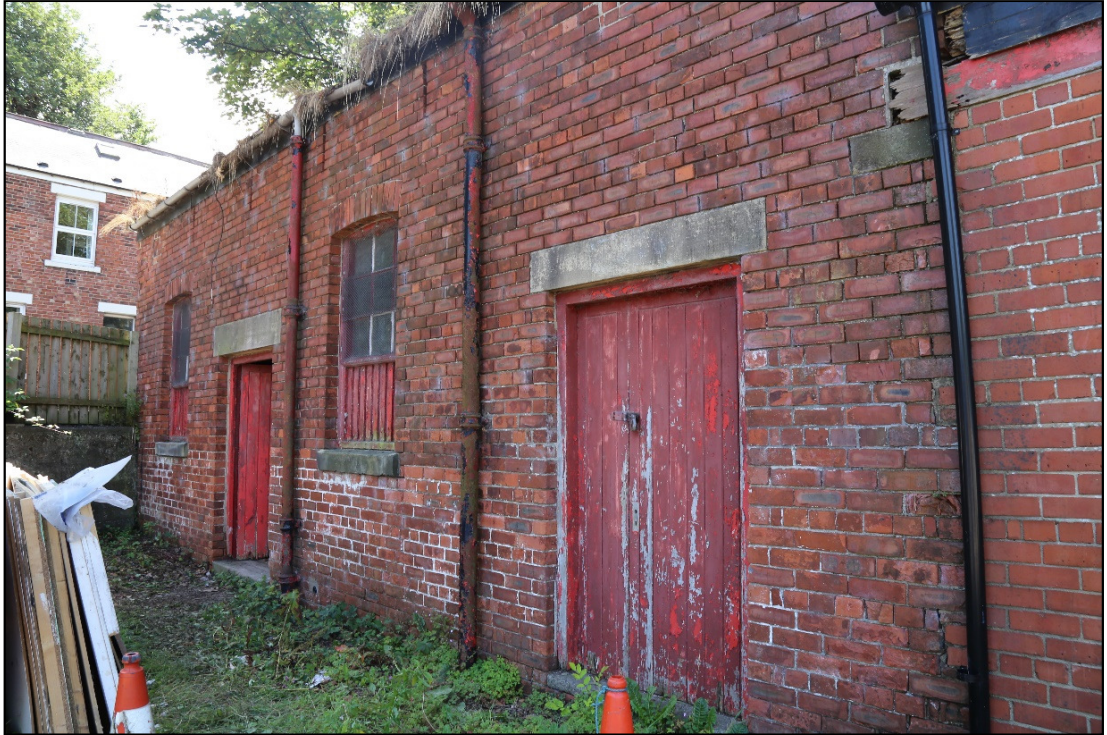
- 5.4 The north elevation of the stable is of brick in English Garden Wall Bond (Plate 2; Fig. 12). The main door into the stable (1111) is an asymmetrical double door with the western panel slightly wider than the east. On either side of this door are windows (1113) with segmental arched headers. Each window has nine panes above a wooden louvre and stone sill. To the west is another double door, also asymmetrical, that is now blocked on the inside (1112). Both doors have stone lintels.
- 5.5 Below the eave-line are four ventilation slits (1114), which are placed 1.50m apart. On either side of these slits are two blocked owl holes, which initially look like blocked ventilation slits, but are much larger on the interior. The roof is grey Welsh slate, with a single chimney.

*Plate 2: oblique view of the north elevation of the stable block, showing both doors (1111 and 1112), the windows (1113), and the ventilation slits (1114).*

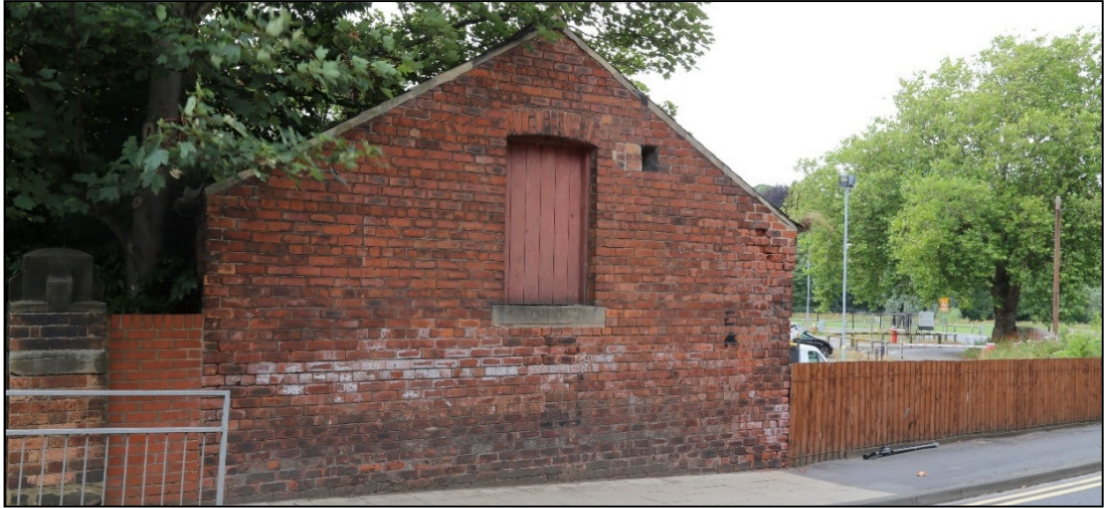
- 5.7 The east, gable elevation (Plate 3; Fig. 14) faced onto Providence Row and features a central loading door (**1131**) with a segmental arched brick header and a stone sill, beside which is an open owl hole (**1132**). The current road level is considerably higher than the original ground surface.

*Plate 3: east elevation of the stable with the loading door (1131) and owl hole (1132).*

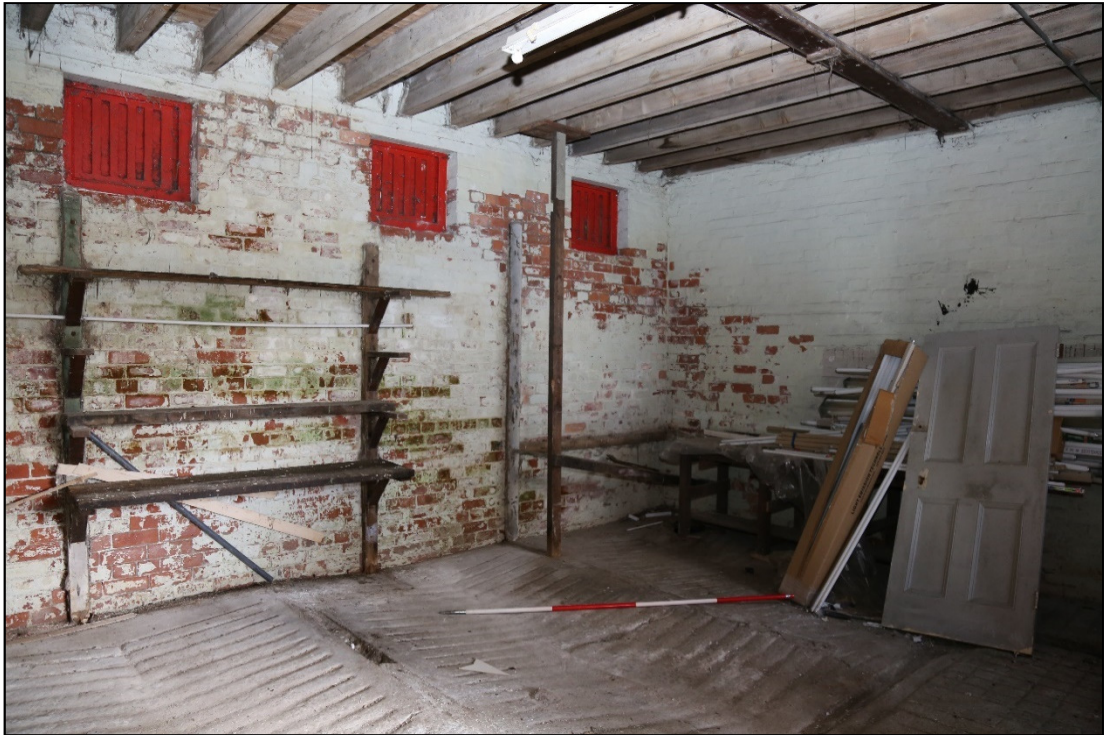
*Plate 4: view of corner of the stables looking west. Visible are the louvre windows (1214), stall grooves (1211), drainage channel (1212) and feeding trough remains (1215).*

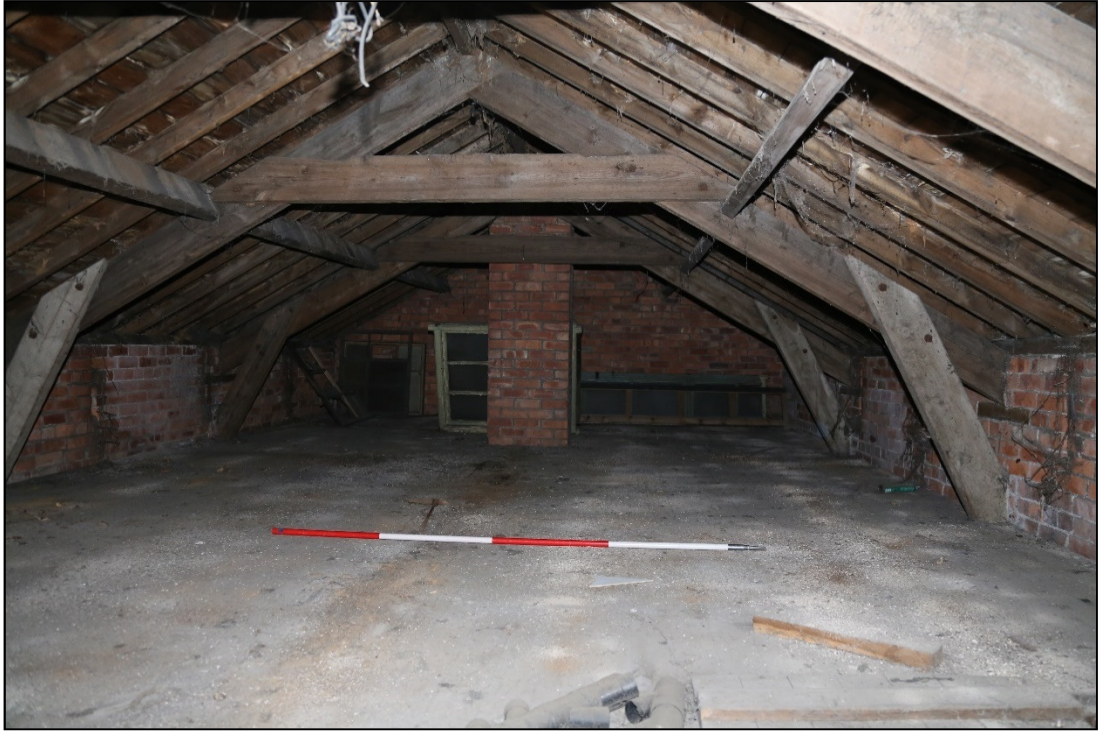
*Plate 5: view of the hayloft looking south-west, with the chimney stack (1224) at the rear*

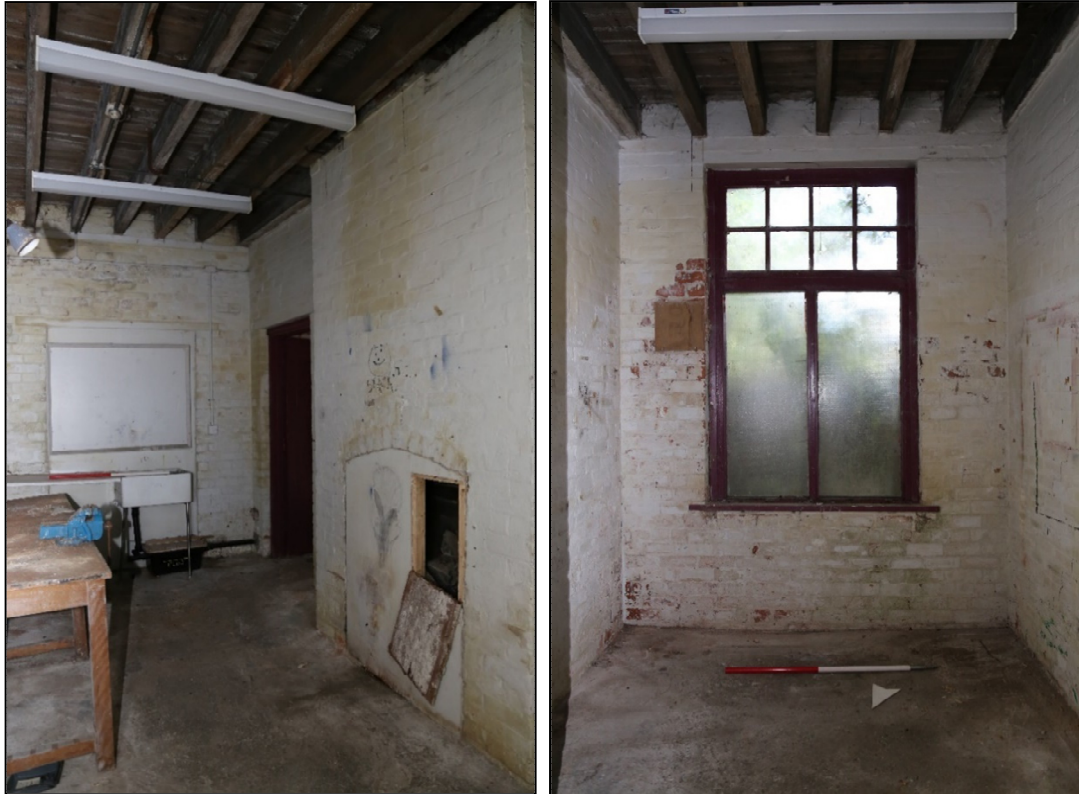
*Plate 6 and 7: (left) view of the harness room looking north with the blocked door (1112) and fireplace (1231); (right) window (1232) on the south wall of the tack room and feed store.*

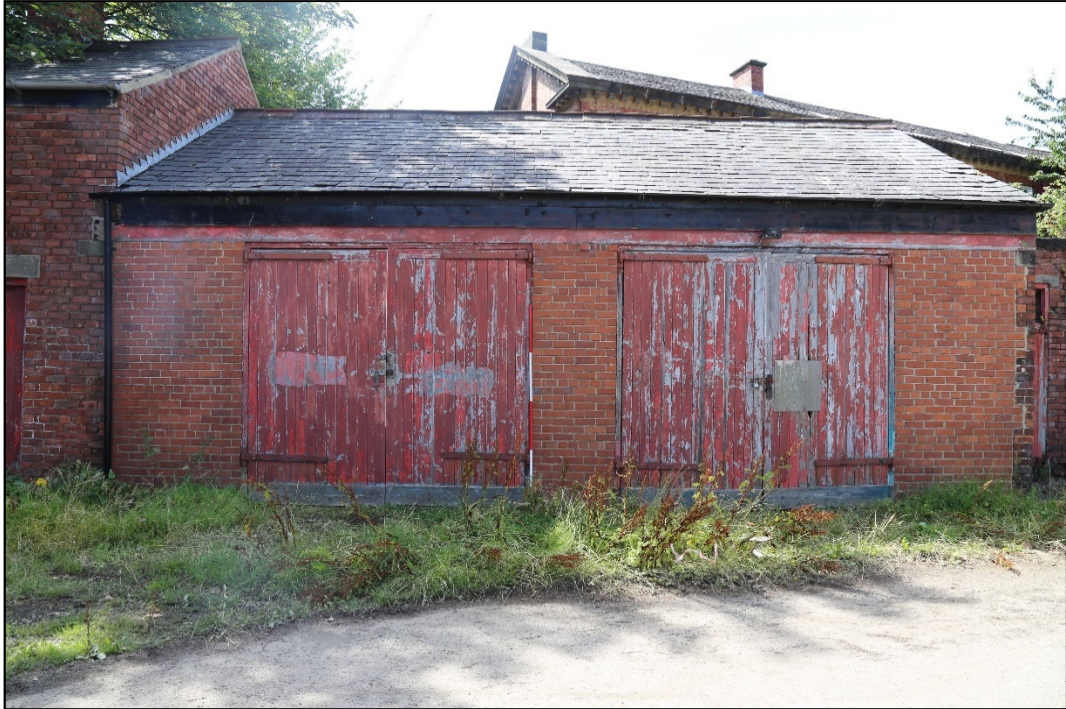
- 5.15 The north elevation (Plate 8; Fig. 12) of the cart shed is composed of modern brick set in common bond, which is clearly later than that used in the adjoining stable. However, there is a vertical line of older bricks at each end of the building, indicating that the original structure was probably open to the front, as would be anticipated of a cart or van shed. Later, when the building was converted for use as a garage, the brick infill and two large double doors (2111) were added. This probably took place when motorised van delivery replaced the laundry cart around the mid-20th century.

*Plate 8: view of the northern elevation of the cart shed showing the two double 'garage' doors (2111).*

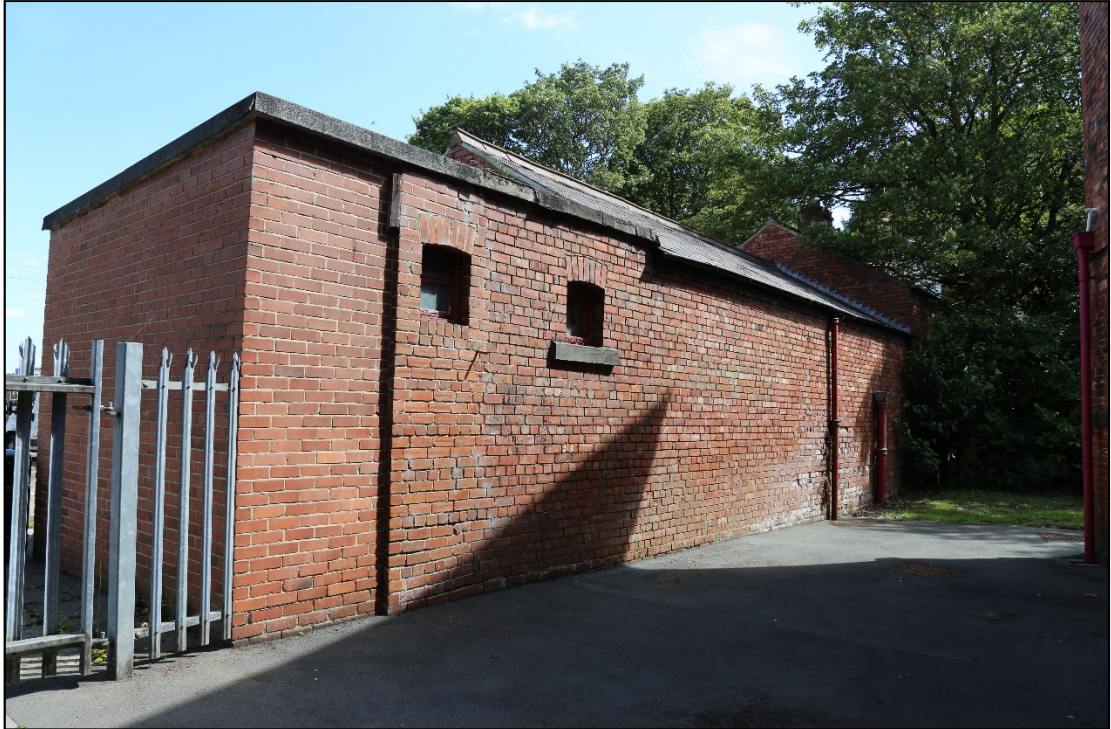
*Plate 9: oblique view of the south elevation of the cart shed (2120) and outbuilding (3130).*

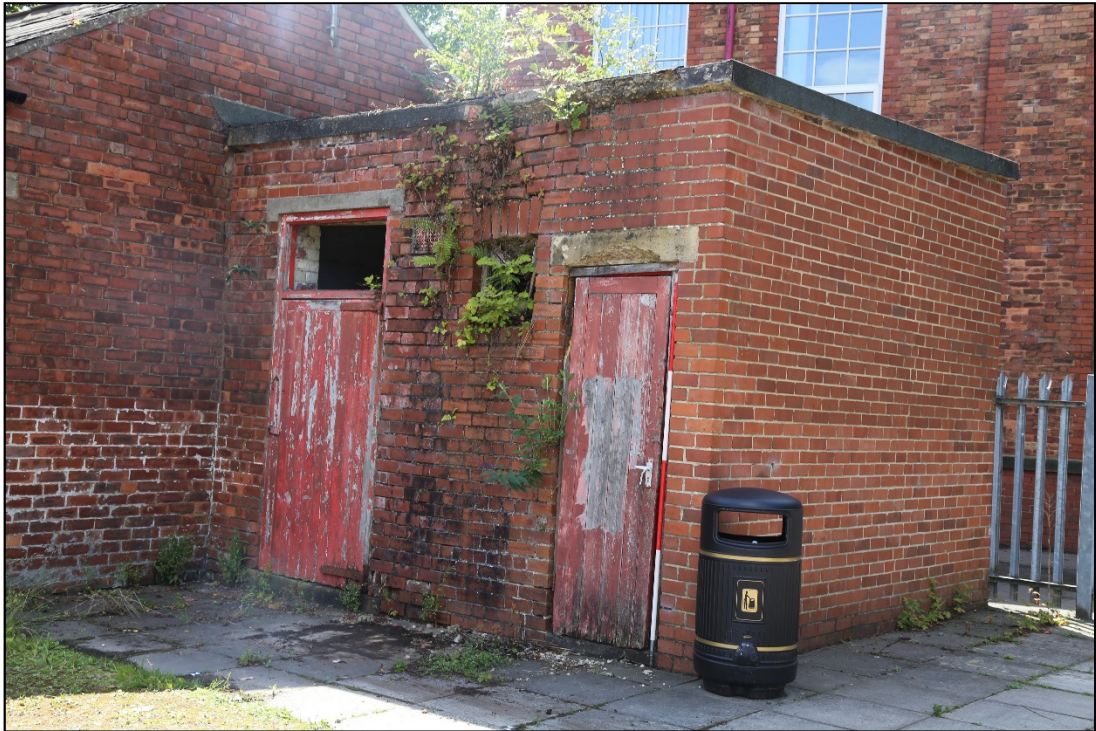
- 5.19 The north elevation of the outbuilding features two doors (3111 and 3112) of unequal size, a small window (3113), and a vent grill (3114) (Plate 10; Fig. 12). The east door (3111) is larger, with an incised concrete lintel over a large square light. The variation in the brickwork above the lintel would suggest it was a later repair or addition. The west door (3112) is thinner and slightly shorter than the east. It also features a stone lintel, although this is broader than that on 3111. Situated between the two doors is a small square window (3113) with a segmental arched brick header and a wooden frame. Set just north of this is a small, ornate vent grill (3114). The brick work is in English Garden Wall bond. The west wall is clearly a later addition, and was almost certainly

*Plate 10: view of the outbuilding looking south onto both doors (3111 and 3112) and the small window (3113). The vent (3114) is barely visible behind some foliage.*

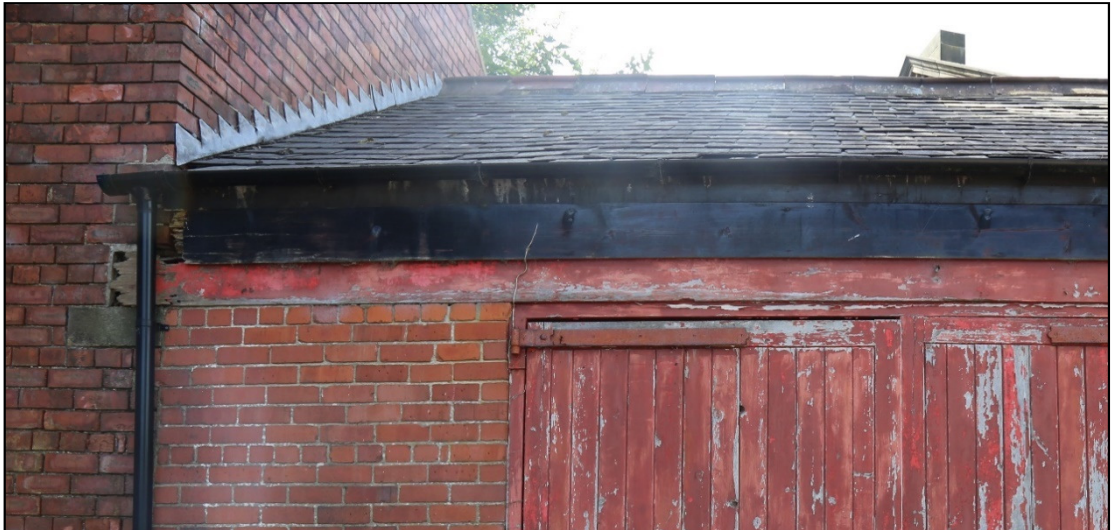
6.4 It is uncertain when the open frontage was replaced but this was probably in the 1930s–50s when the horse drawn laundry vans were replaced with motorised transport and the shed was converted for use as a garage. The 1969 plan, which was produced soon after the purchase of the site by the Durham Girls' Secondary School, shows the cart shed with a set of sliding doors to the front. Subsequent to this, the present brick elevation was added, and the two large double doors erected.

*Plate 11: upper east corner of the cart shed where the beam is tied into the stable wall.*

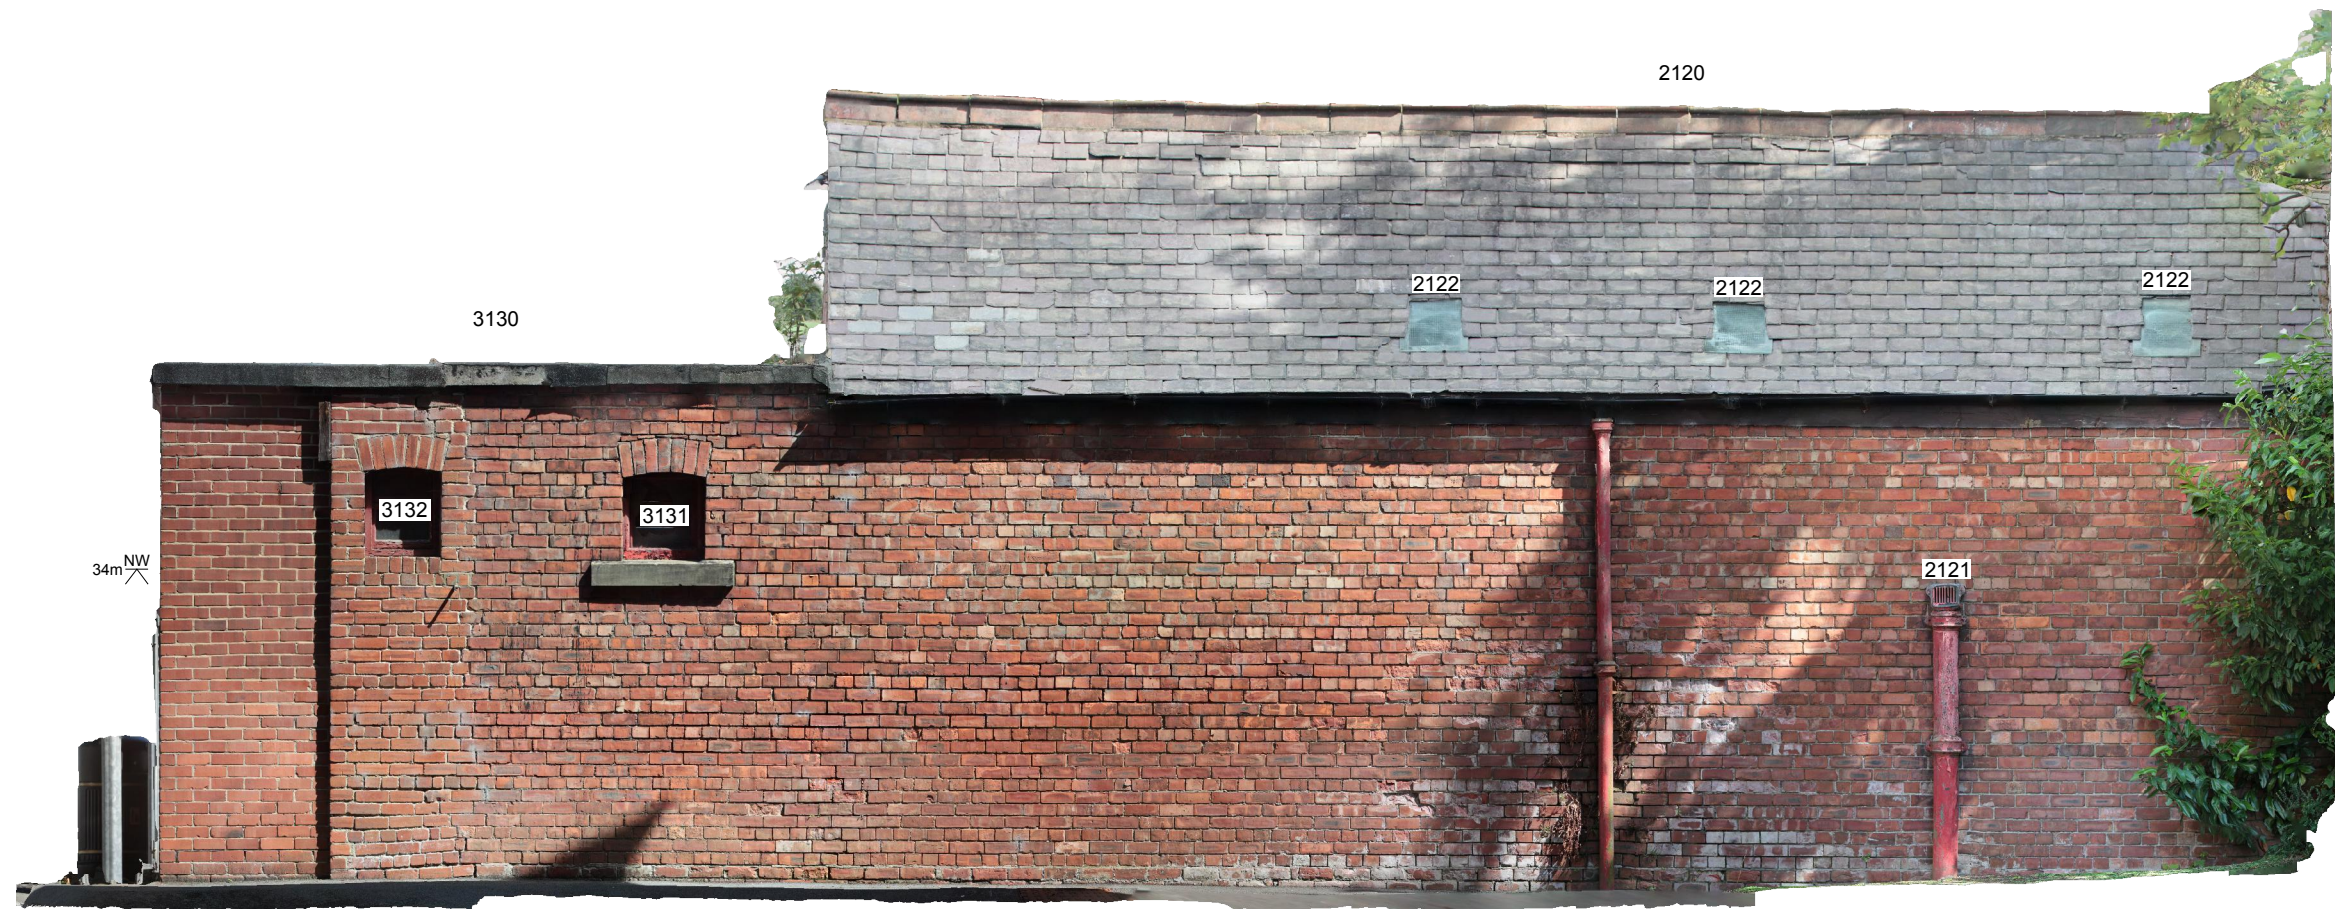
South elevation

building obscured

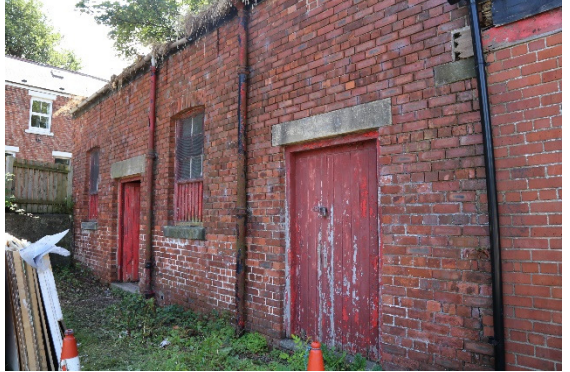
1110	North elevation	The north elevation is the front of the building, looking out onto the car park. It is built in English Garden Wall bond and consists of two doors, two windows, and ventilation slits at the upper storey.	1111 door 1112 door 1113 window 1114 vents 1115 owl holes	1901	Moderate	See above

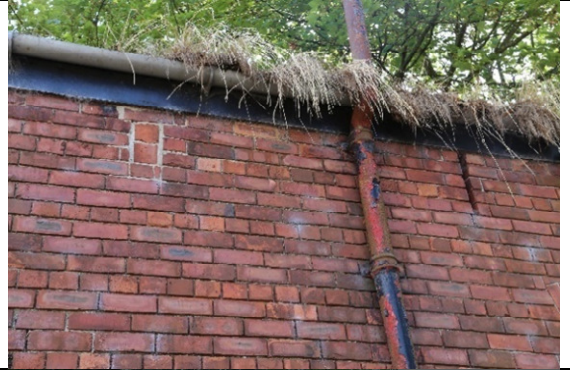
1130	East elevation	The east elevation looks onto Providence Row. It is of brick in English Garden Wall Bond and includes a large loading door with a rounded brick header and a stone sill. To the north of the door is a single owl hole measuring about 300 x 300mm	1131 loading door 1132 owl hole	1901	Moderate-High

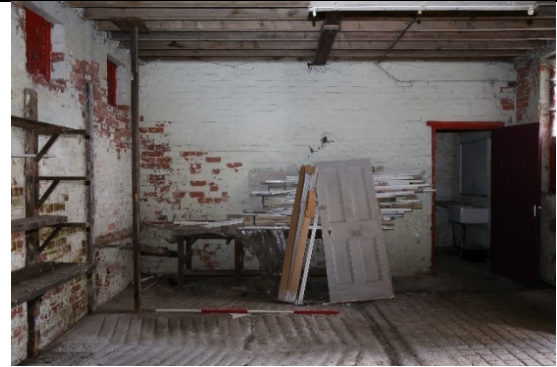
1211	Floor grooves	On the floor of the room are four sets of V-shaped 'herringbone' grooves extending out from the east wall to provide grip for the horses. These grooves clearly denote the location of the four stalls.		1901	Moderate-High

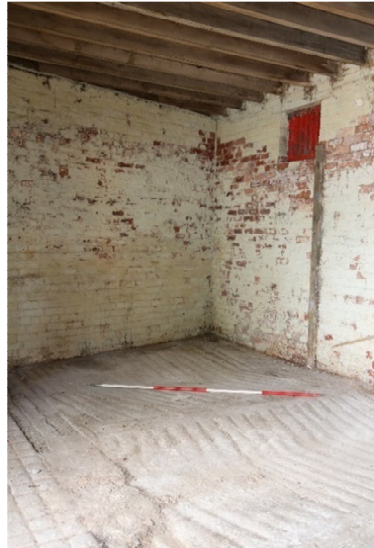
Context	Name	Description	Related Features	Date	Evidential Value	Photo
1212	Drain	Along the centre of the room is a drain that empties below the western window of the north elevation. The drain is about 30cm wide and runs the whole length of the room.		1901	Moderate

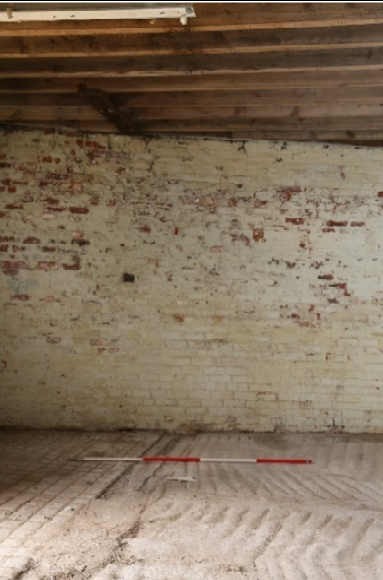
Context	Name	Description	Related Features	Date	Evidential Value	Photo
1213	Side groove	Beside the drain is a narrow groove about 75cm long and 10cm wide that has been plugged. Its use is unknown.		1901 but later blocked	Low-Moderate

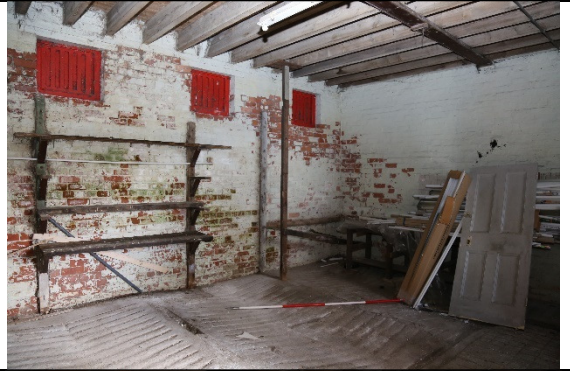
1220	Hayloft	Accessed from the stairs (1216) in the north corner of the stable, the hay loft is a low space between the stables and the roof. On the east wall is the loading door with a simple wooden lintel and adjacent owl hole.	1221 vents 1131 loading door 1132 owl hole 1223 trusses 1224 stack	1901 with subsequent blocking of owl holes.	Moderate-High

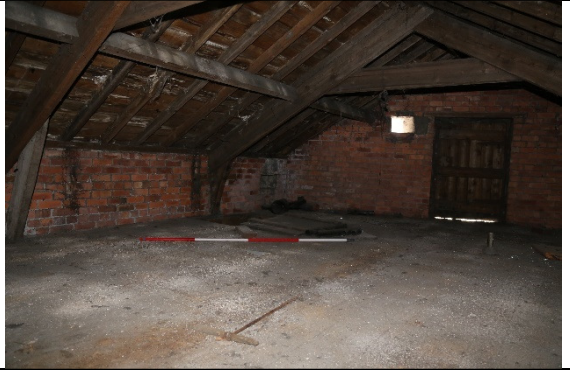
1223	Trusses	The room has three common A-frame trusses with collar and side braces projecting from the principal rafter to the wall plate.		1901	Moderate

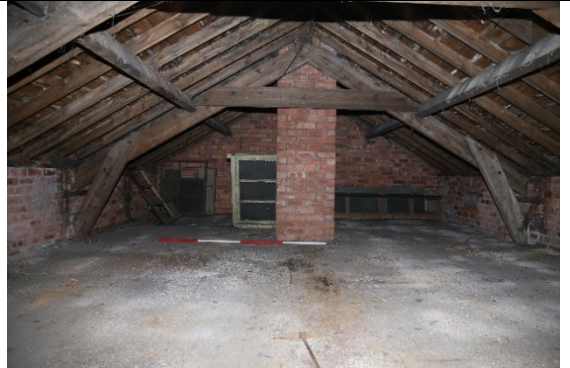
Context	Name	Description	Related Features	Date	Evidential Value	Photo
1224	Chimney stack	Cutting through the hayloft on the western side of the room is a large chimney extending up from the tack room below.		1901	Low

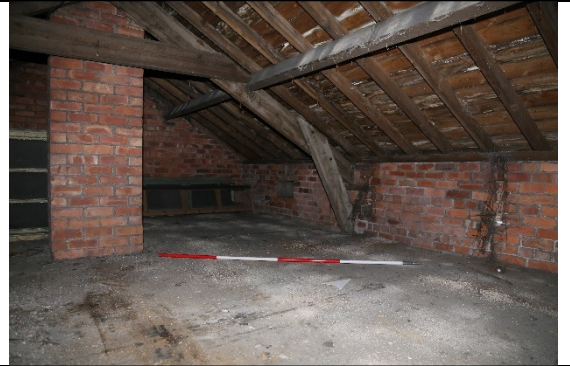
1230	Tack room	The tack room is small and narrow and includes a central fireplace on the east wall, a large window on the south wall, and blocked door (1112) in the north elevation.	1112 blocked door 1231 fireplace	1901	Low-Moderate

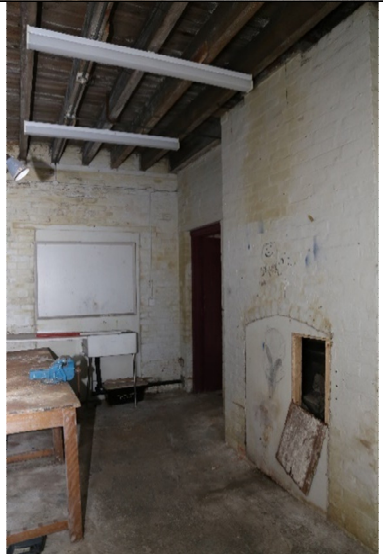
Context	Name	Description	Related Features	Date	Evidential Value	Photo
1231	Fireplace	The fireplace is mostly blocked save for a square panel that has been removed. The fireplace of brick with a segmental arch brick header set into a wide stack.		1901 but later blocked	Low-Moderate

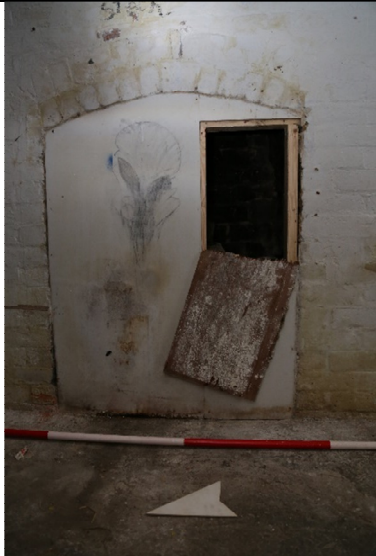
1232	Window	The window has three lights, an upper light with eight panes across the width of the window above two vertical single-paned lights.		1901	Low

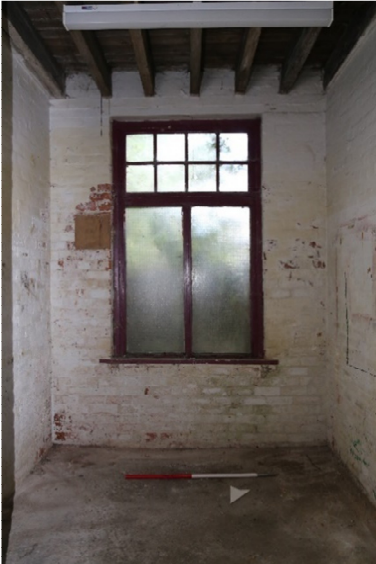
Context	Name	Description	Related Features	Date	Evidential Value	Photo
2000	Cart shed	The cart shed is a simple building with two large doors and three skylights. It now serves as storage room but may have once been a student common room, there are brightly coloured murals on the walls. The roof is supported by two large king-post trusses.	2201 roof trusses 2110 north elev. 2120 south elev. 2130 west elev.	1901	Low

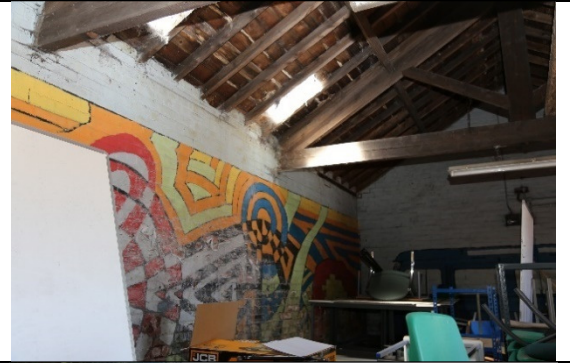
2110	North elevation	The north elevation is of brick in common bond with two large, wooden garage double doors (2111) with wooden lintels. A large support beam spans the length of the elevation.	2111 garage doors	1901 with subsequent alteration	Low-Moderate

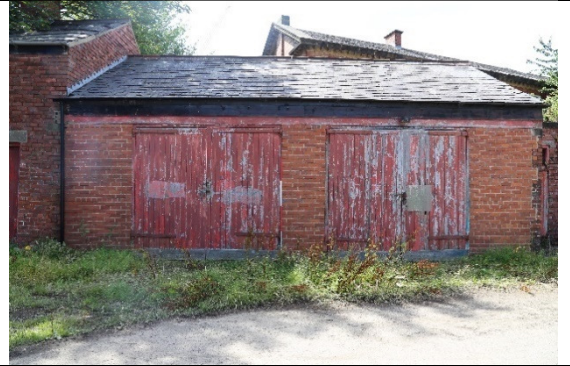
2120	South elevation	The south elevation is of brick, in English Garden Wall bond with three skylights on the roof. A large pipe rises about 2m off the ground.	2122 roof lights 2121 pipe	1901	Low

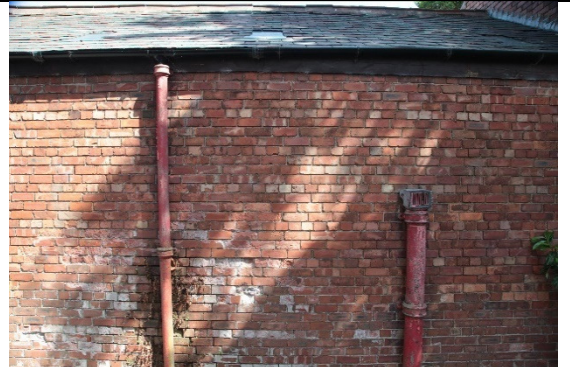
Context	Name	Description	Related Features	Date	Evidential Value	Photo
2130	West elevation	The west elevation is partially covered by the outbuilding. The remaining elevation is of brick in Flemish stretcher bond.		1901	Low

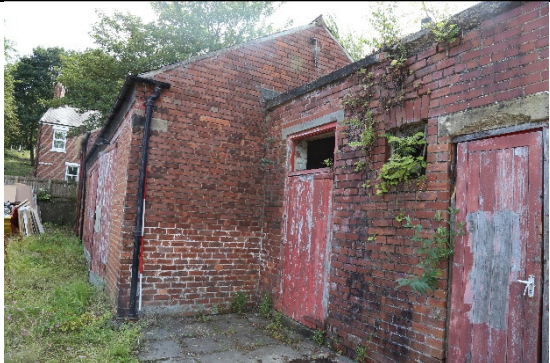
3000	Outbuilding	The outbuilding is a small building that now serves as a lavatory. The interior was not surveyed.	3110 north elev. 3111 east elev.	1901 with subsequent alterations	Low

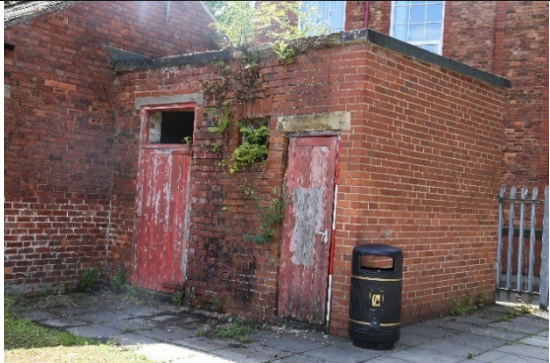
3110	North elevation	The north elevation features two doors, a small window and a ventilation grill. The roof of the building is slightly sloped downward to the north. The elevation is of brick in mostly English Garden Wall bond with some variation to the west.		1901 with two phases of alteration visible	Low-Moderate

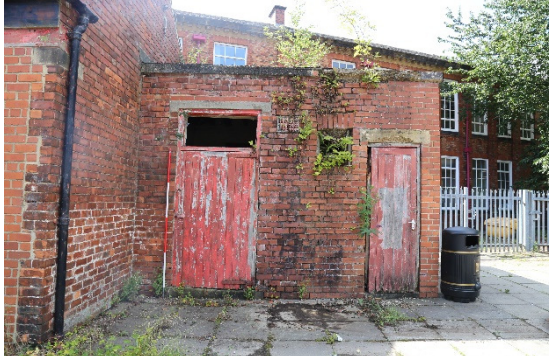
Context	Name	Description	Related Features	Date	Evidential Value	Photo
3111	East door	The east door is wider than the west door with a large square light above its frame. The light is cut in a stone lintel above which has been added some new brick. The door has a concrete threshold.		1901 with later repairs visible	Low

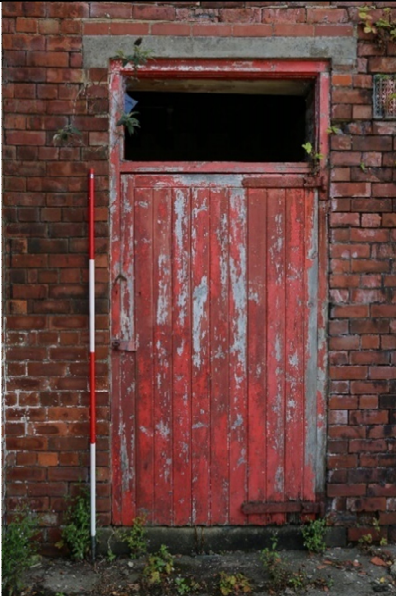
Context	Name	Description	Related Features	Date	Evidential Value	Photo
3112	West door	The west door is narrower than the east and is in a wooden frame with a stone lintel and threshold. The brick work around it is newer.		1901 visible later repair	Low

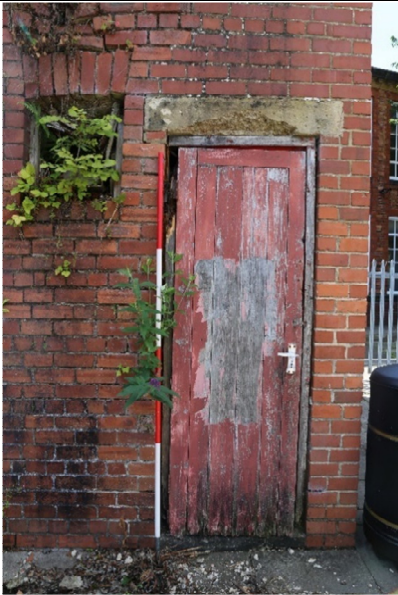
Context	Name	Description	Related Features	Date	Evidential Value	Photo
3113	Window	Small and square, the window has a brick header that used to be round but has slumped considerably. The frame of the window is wooden.		1901	Low

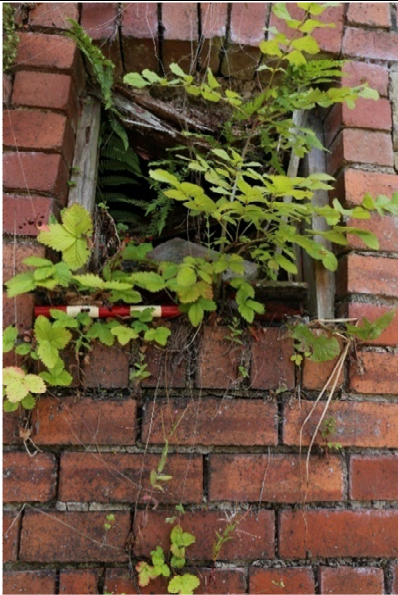
3114	Vent grill	A small ornate vent grill placed between the window and eastern door.		1901	Low

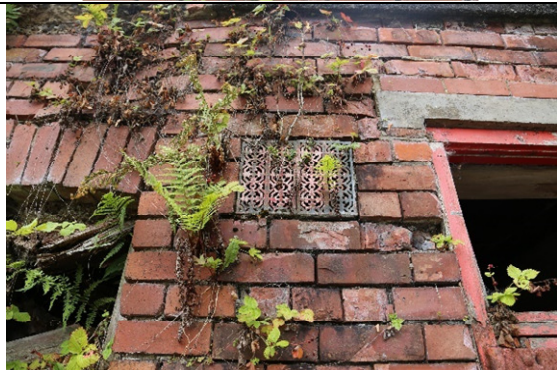
Context	Name	Description	Related Features	Date	Evidential Value	Photo
3120	West elevation	The west elevation is of modern brick in stretcher bond with some headers creating a faint scar on the south part of the wall.		1901 Extensively rebuilt post 1969	Low-Moderate

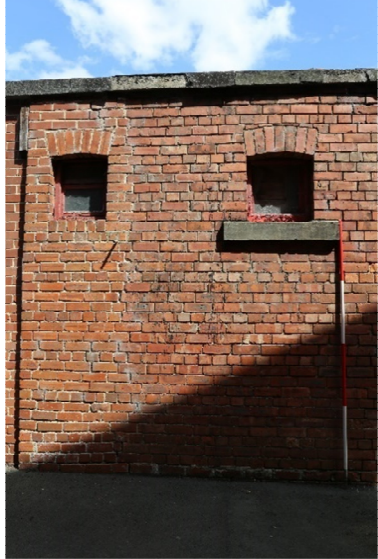
3131 3132	Windows	Both windows are of brick with wooden frames. The east window (3131) has a stone sill. The west window (3132) is a later addition in the same style.		1901 with later additions	Low	See above
