LANE HEAD FARM SOUTH CAPITOL PARK, BARNSELEY, SOUTH YORKSHIRE

BUILDINGS SURVEY AND WATCHING BRIEF

NAA 06/41

July 2006

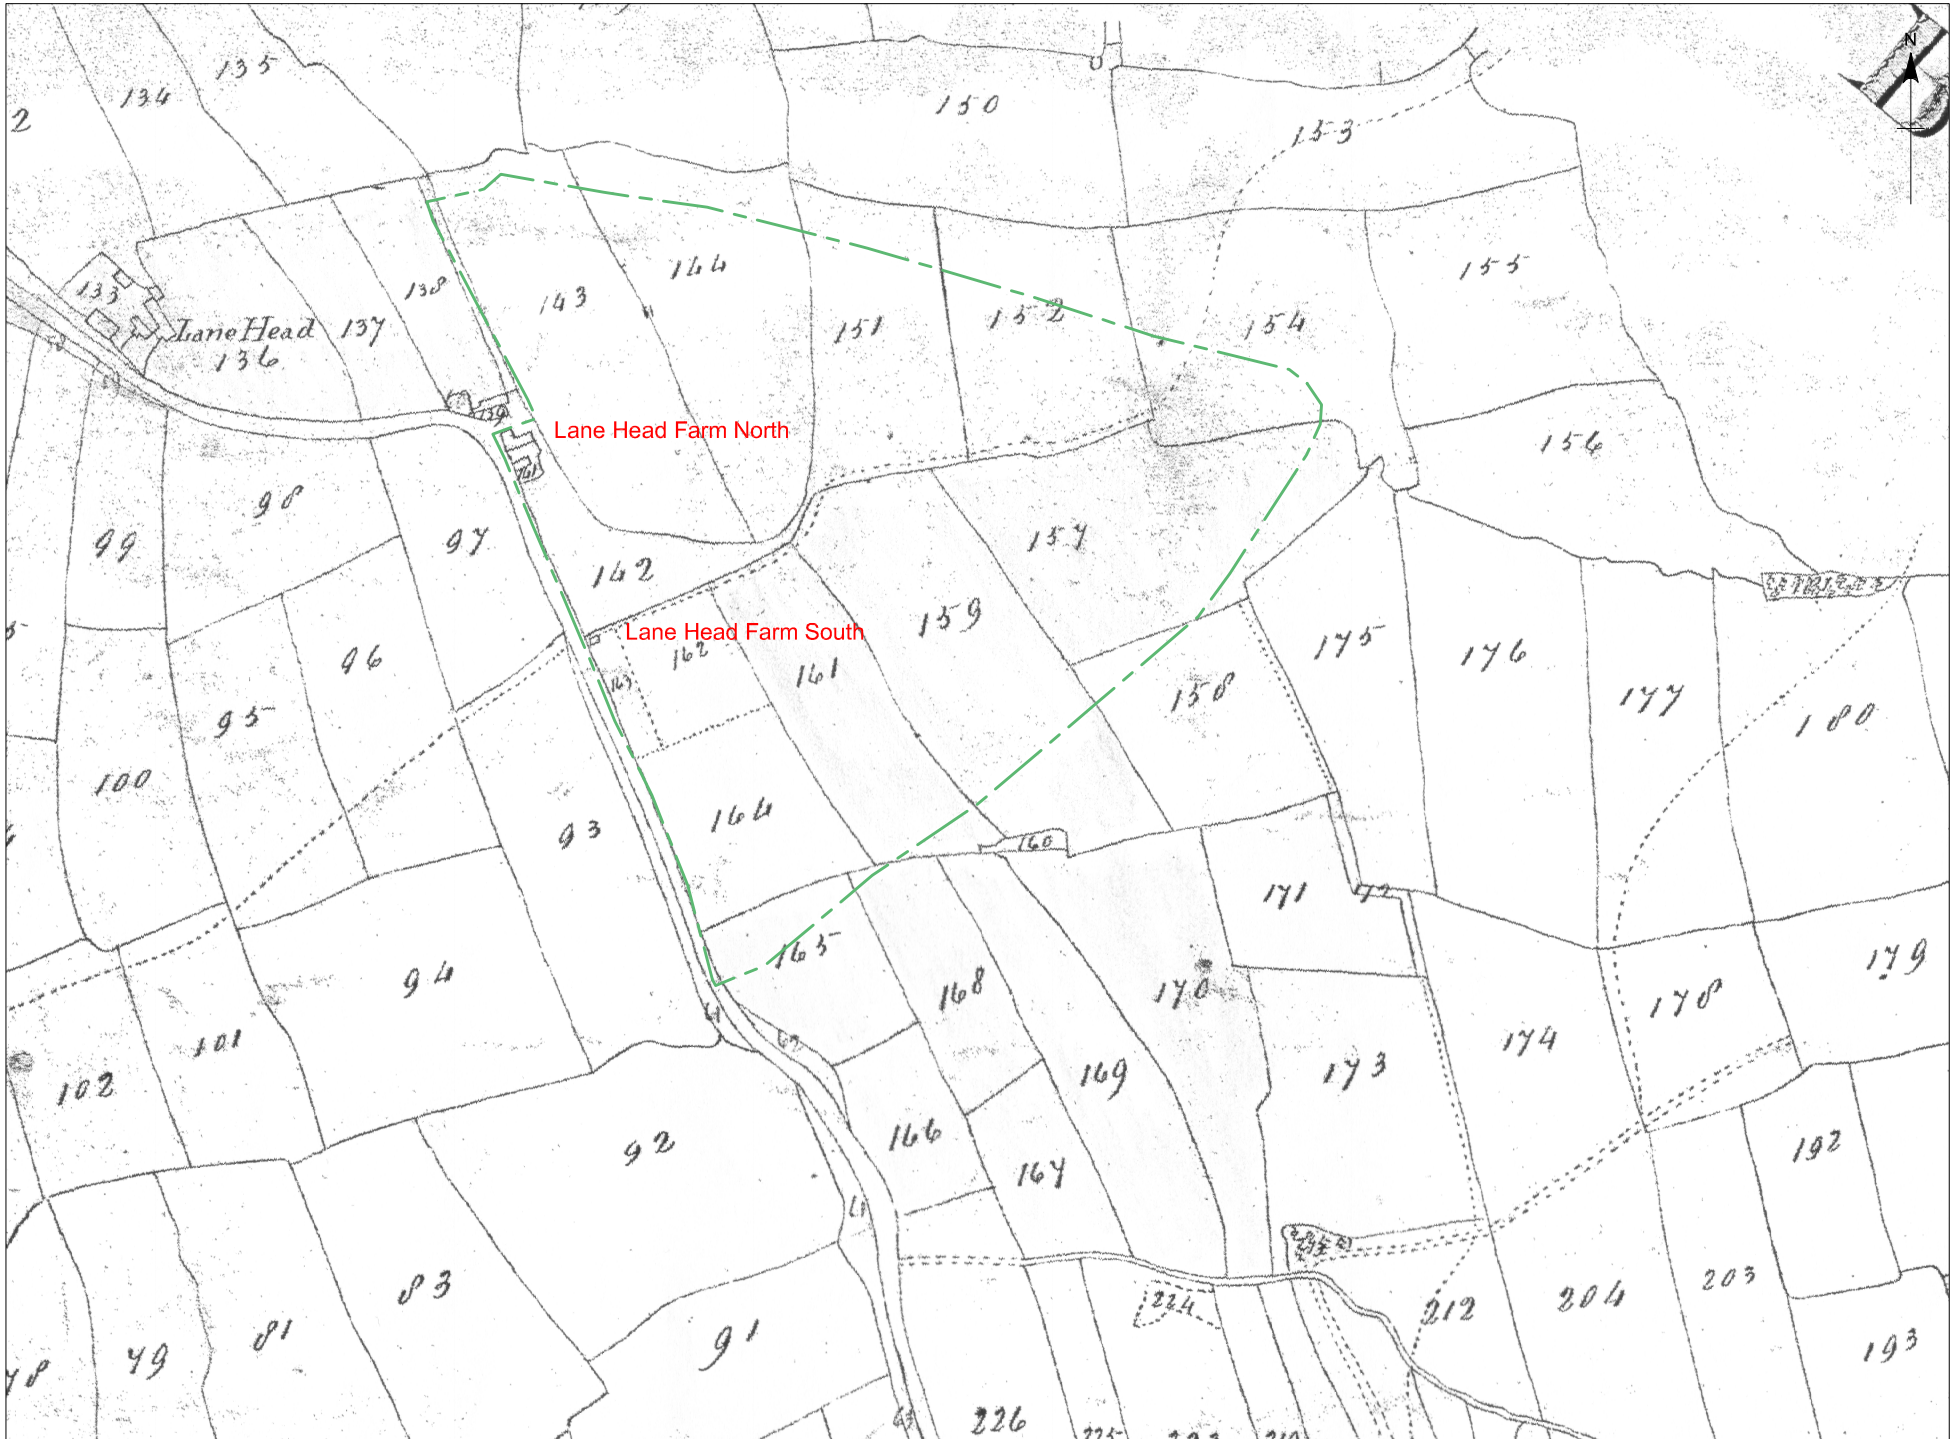
Figure 4 Lane Head Farm South, Capitol Park, Barnsley: 1806 Valuation plan

- 4.7 The earliest detailed cartographic material for the area is a Plan of the Township (Figure 4) dated to 1806 by an associated valuation document (SCRO *SpS. Add 3* and *Sp.St 60702-1*). With the exception of a small number of additional field boundaries and the new Barnsley to Dodworth Road (now marked by the A628), the layout shown in the 1806 plan is virtually identical to the later 1847 Tithe Plan (Figure 5).

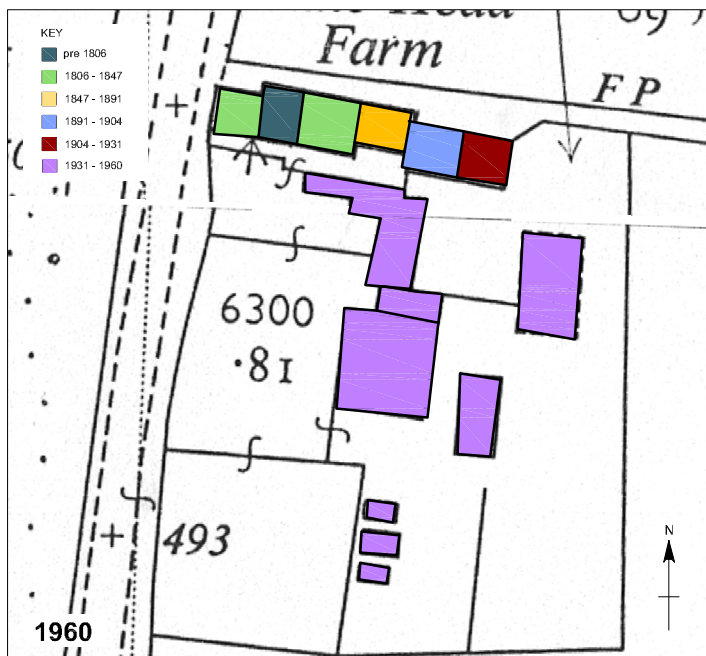
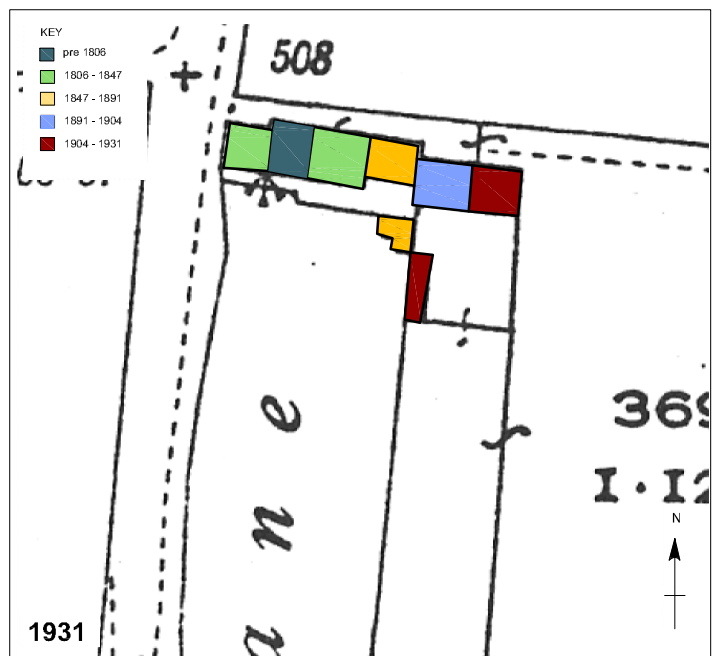
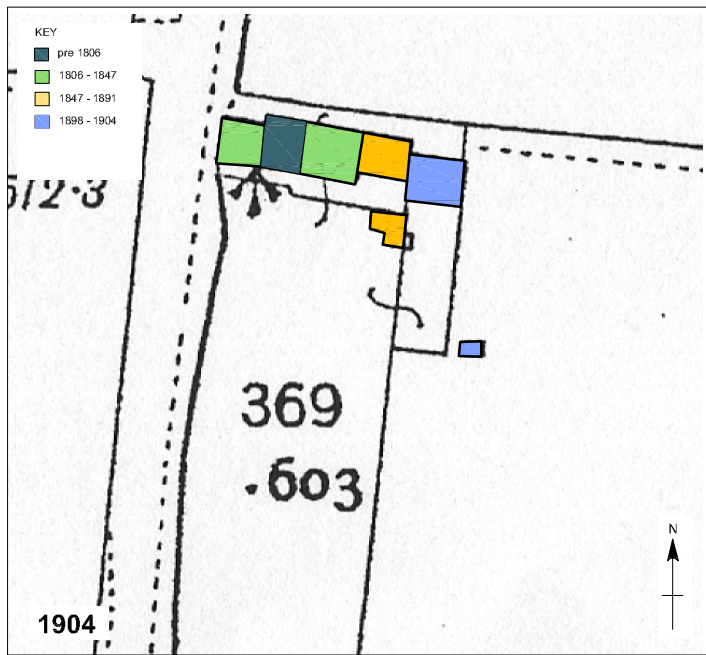
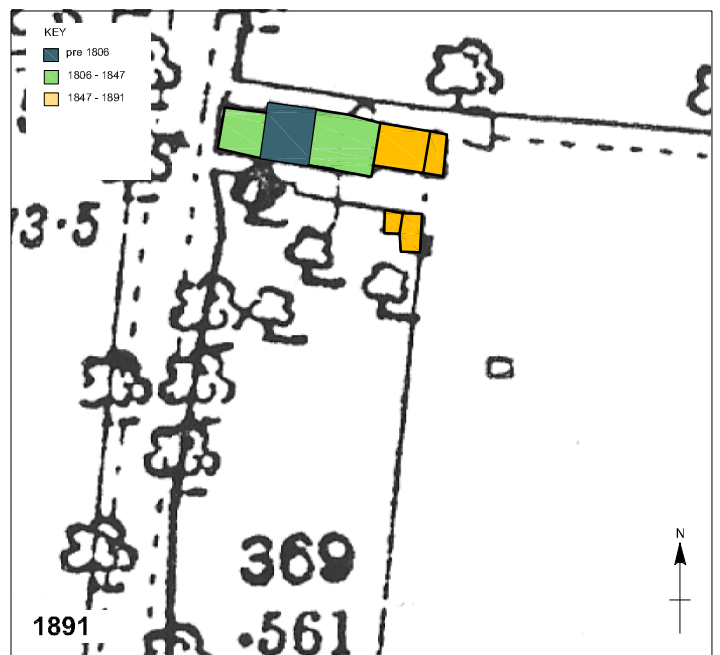
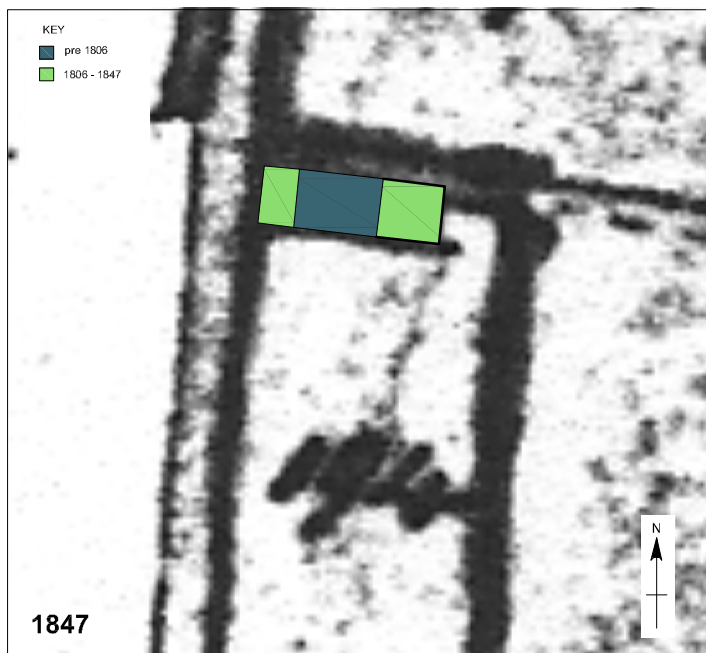
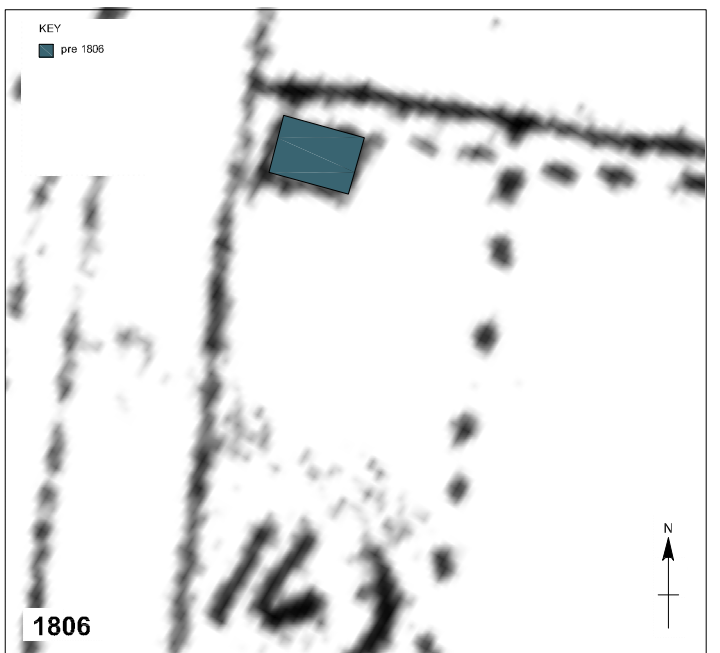
Figure 5 Lane Head Farm South, Capitol Park, Barnsley: development of property based on map regression

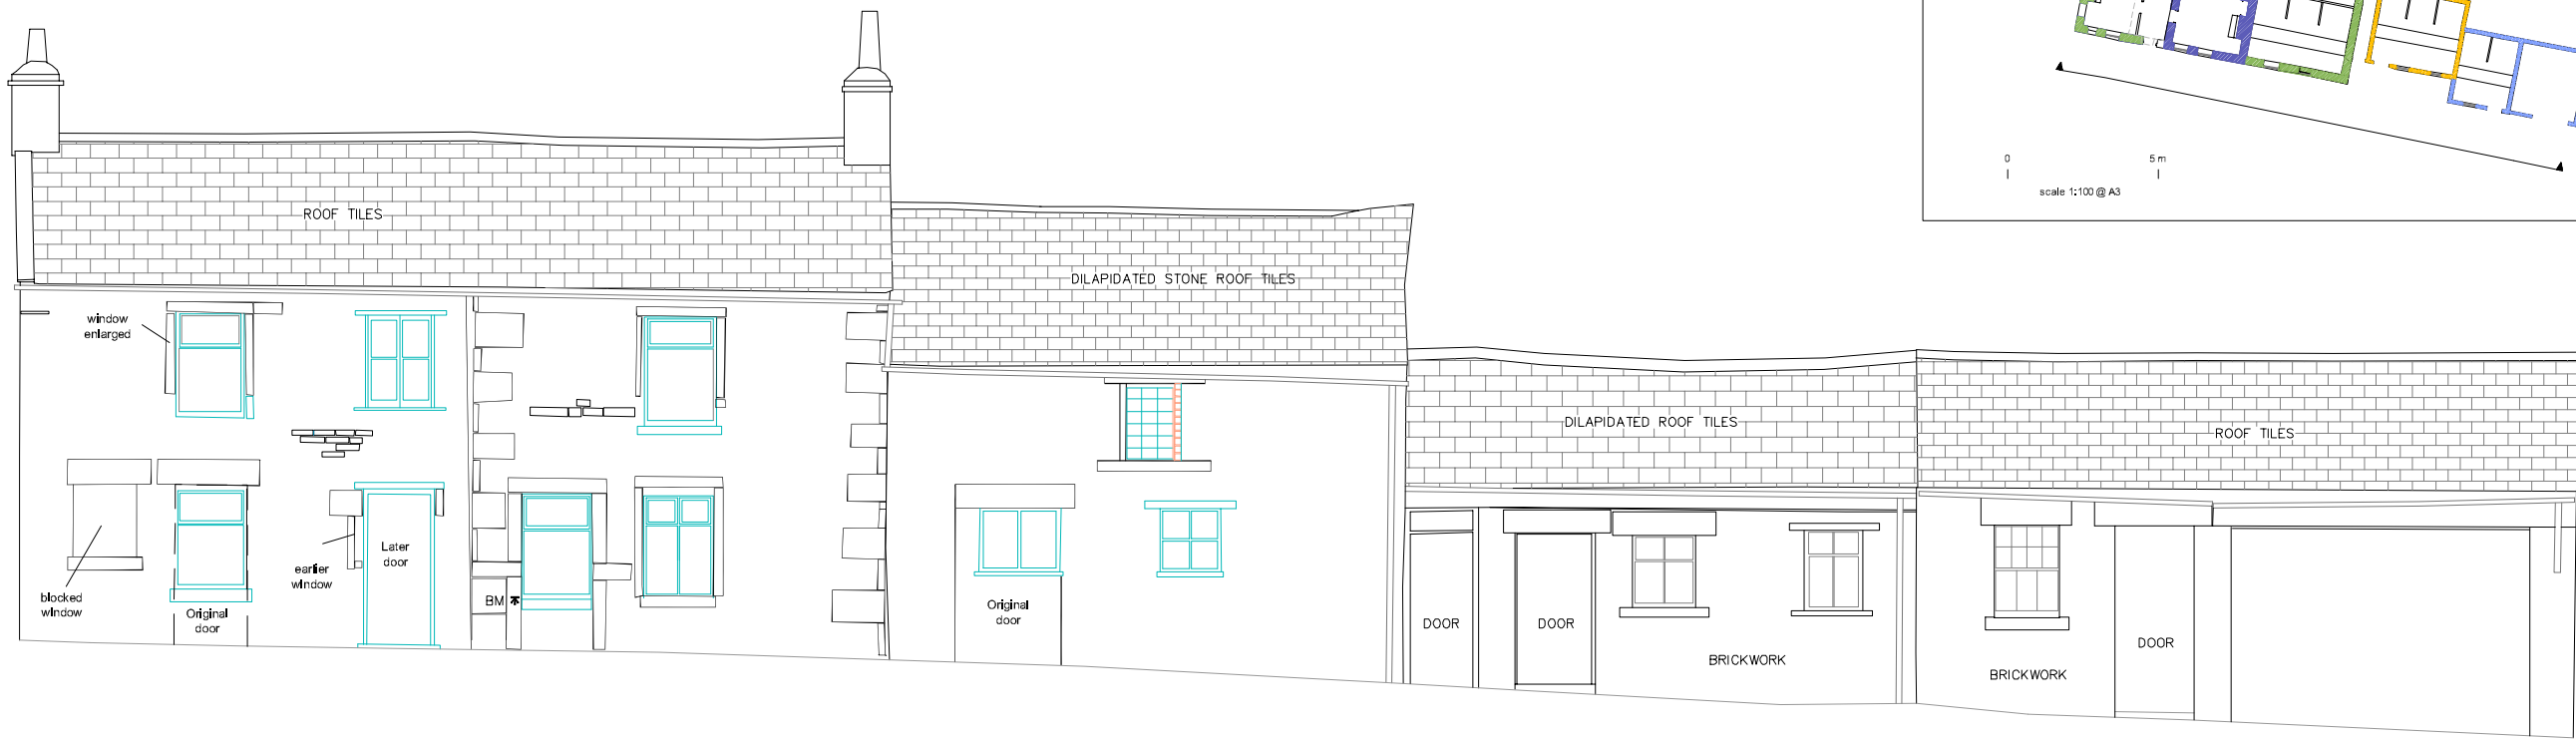
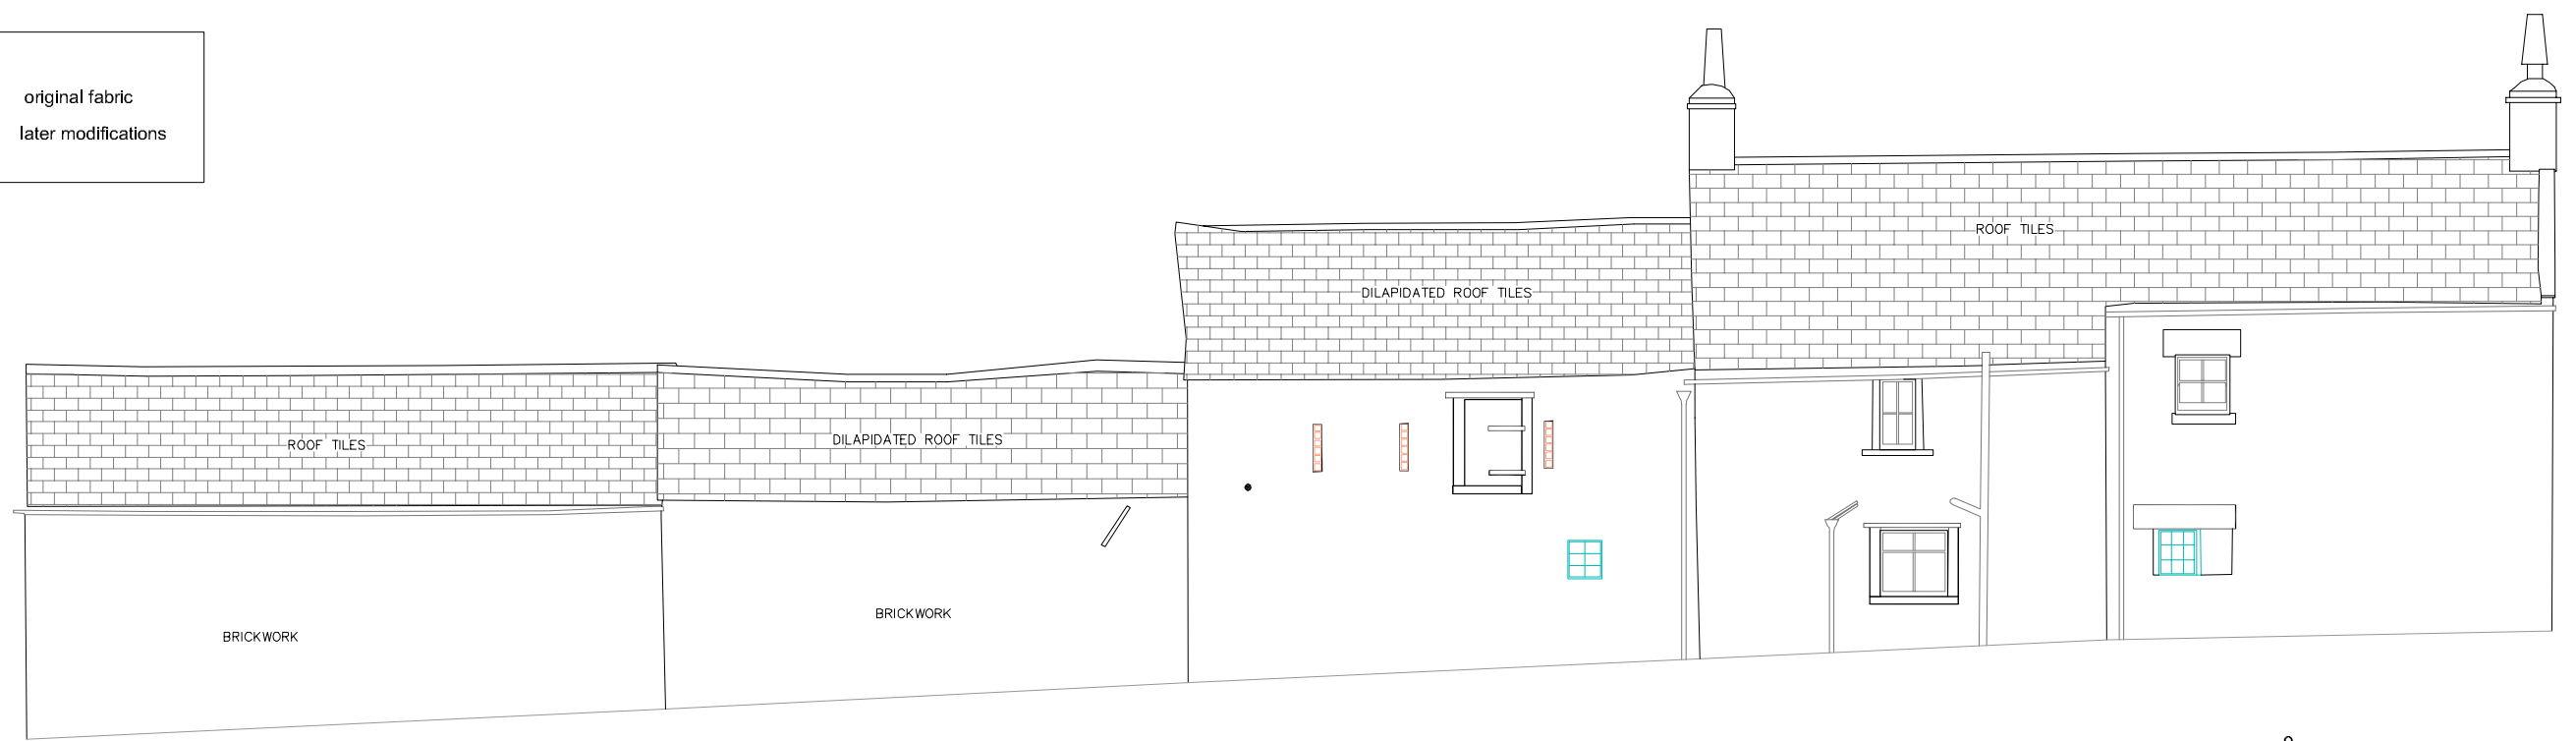
Figure 6 Lane Head Farm South, Capitol Park, Barnsley: long elevations

SOUTH FACING ELEVATION

NORTH FACING ELEVATION

- 5.5 The building was entered from the south through a single doorway which was later partially blocked to form one of the ground floor windows (Plate 3). The south elevation originally featured two windows, one on the ground floor, and one on the first floor; both of which were subsequently lengthened. On the ground floor the window was set just east of the door and measured 0.90m wide by 1.30 high (Plate 3). The original sill was later replaced extending the length of the window by 15cm. The upper storey window, again on the east side of the elevation, measured 0.90m wide by 1.00m high, but had been extended to a height of 1.45m, presumably when the current sash windows were added in the early 20th century (Figure 6).

- 5.16 The first floor was lit by a single window located immediately above the earlier door. This originally measured 1.10m by 0.90m but was subsequently extended to accommodate a later sash. The second window on the first floor (Figure 6) was a later insertion to light the stairs and upper landing. This may have replaced an earlier, smaller window in this location although no evidence of this survived.

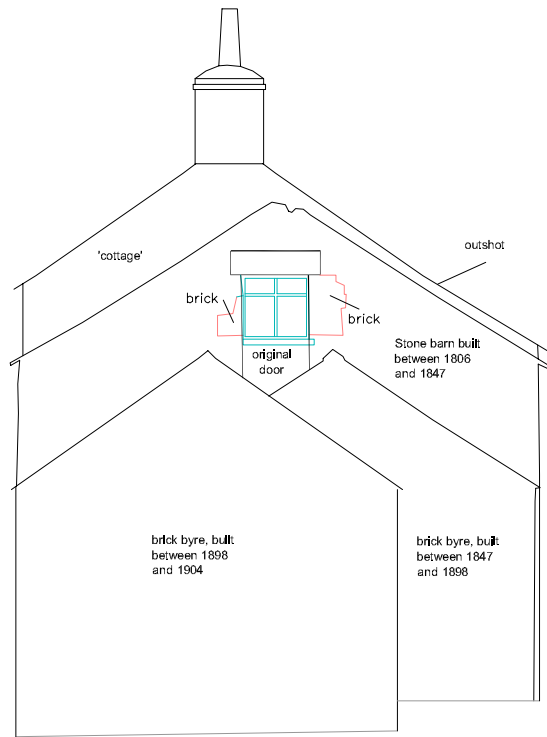
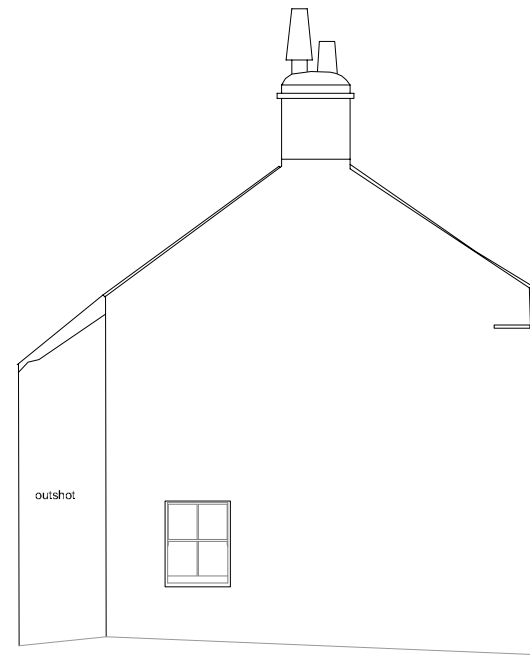
Figure 7 Lane Head Farm South, Capitol Park, Barnsley: short elevations

EAST FACING ELEVATION

WEST FACING ELEVATION

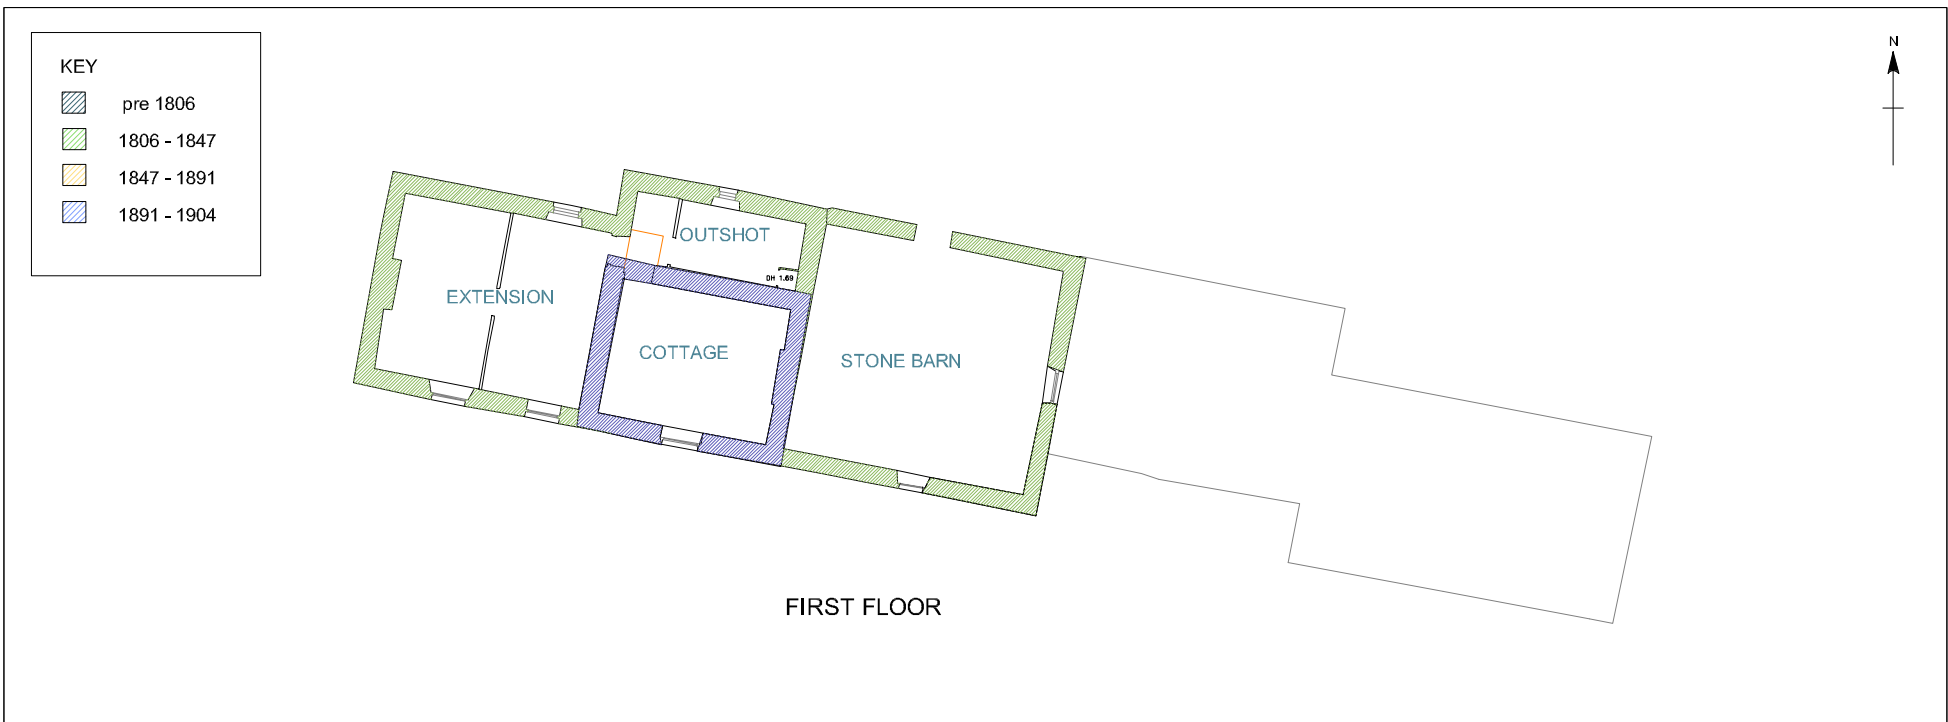
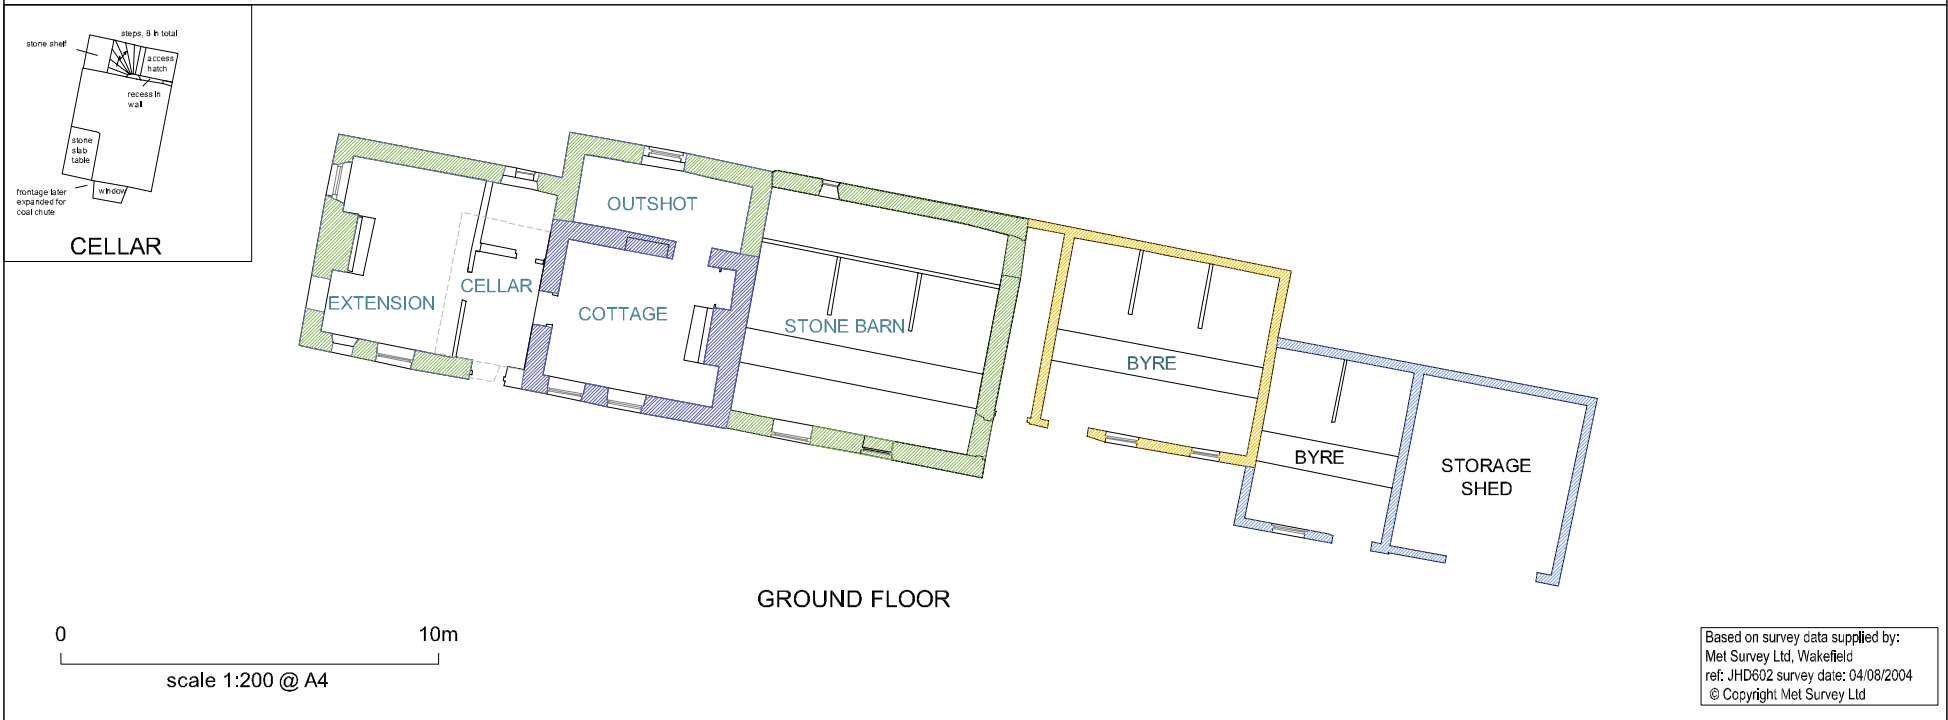
Figure 8 Lane Head Farm South, Capitol Park, Barnsley: phased plan of linear range

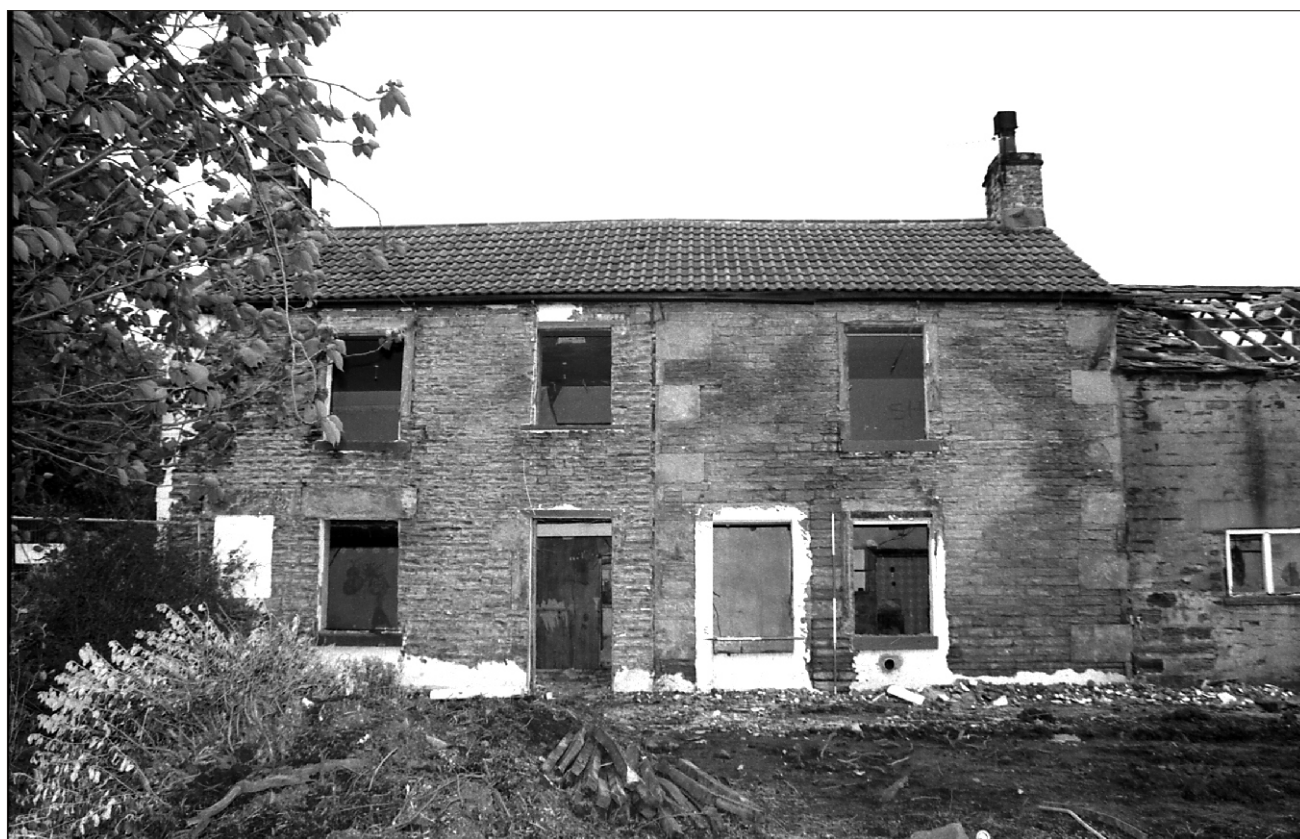
Plate 2 Lane Head Farm South, Capitol Park, Barnsley: main farmhouse after render removed clearly showing 'cottage' and western extension

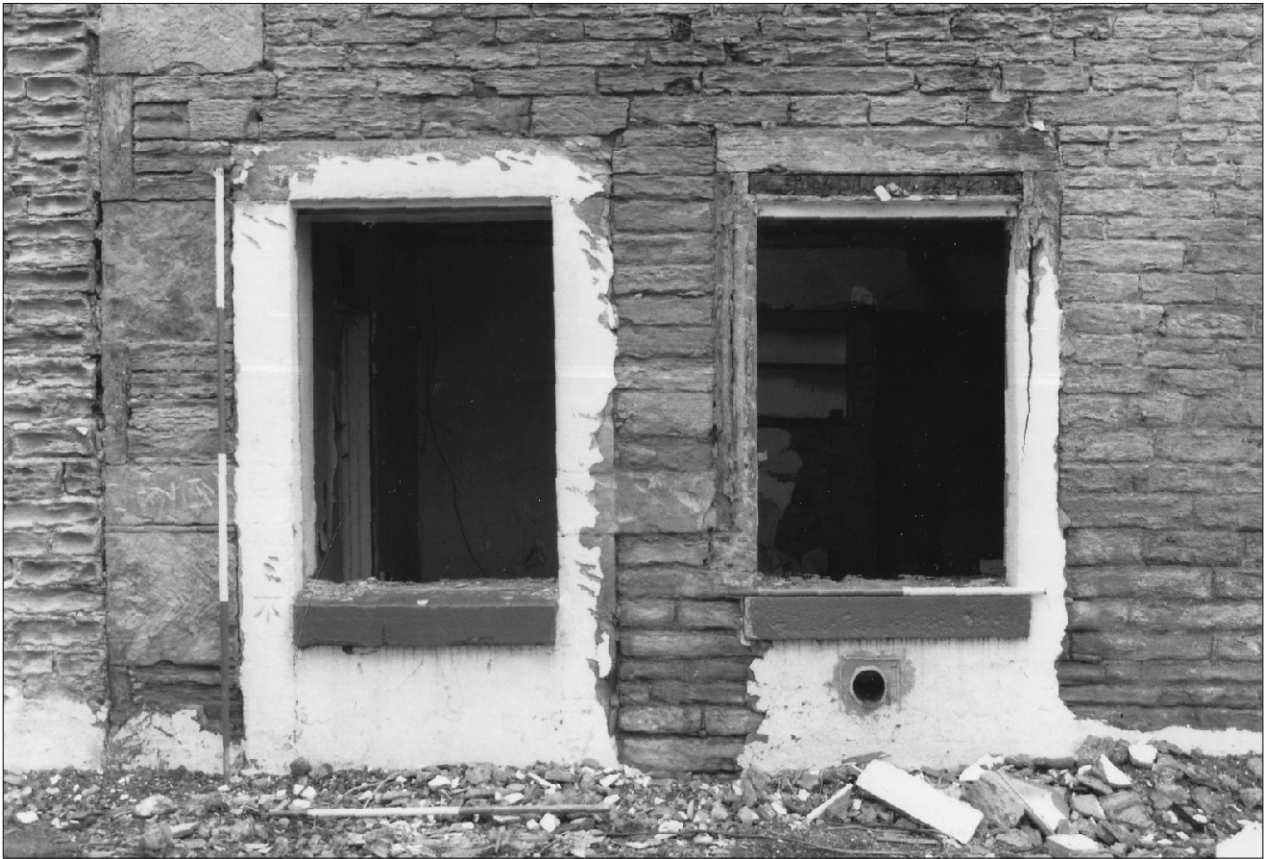
Plate 3 Lane Head Farm South, Capitol Park, Barnsley: original door into the 'cottage' (blocked) and adjacent window

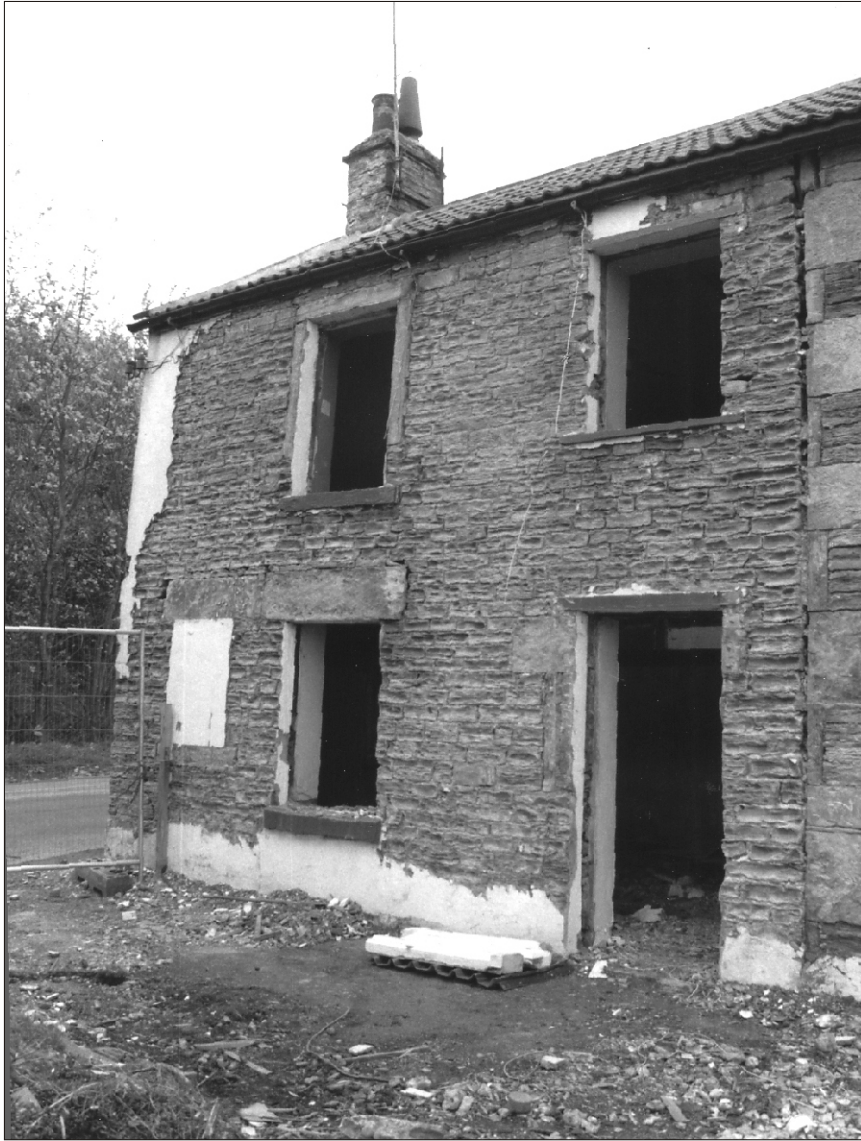
Plate 9 Lane Head Farm South, Capitol Park, Barnsley: south facing elevation of western extension with edge of the 'cottage' in foreground (looking northwest)

- 5.13 The farmhouse extension to the west of the ‘cottage’ was constructed of poorer quality sandstone, cut in small rectangular blocks and evenly coursed (Plate 9). The windows and doors were set with narrow stone jambs and massive lintels and the roof had been replaced relatively recently with grey pantiles. The extension clearly butts up against the quoin stones of the ‘cottage’ (Plate 2) and cartographic evidence indicates that the building probably dates to the first half of the 19th century, between 1806 and 1847. The rear outshot to the north of the ‘cottage’ was also built as part of the same phase of expansion.

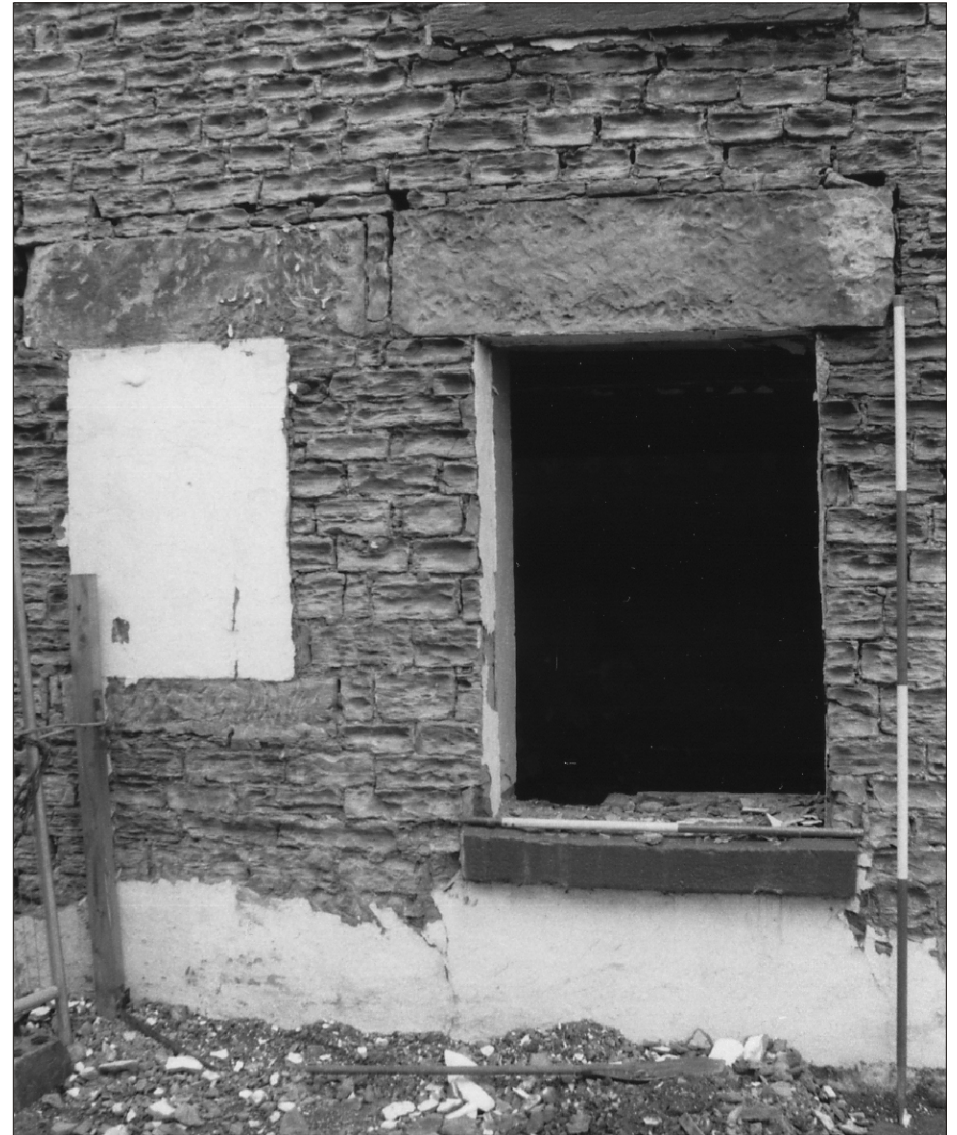
Plate 10 Lane Head Farm South, Capitol Park, Barnsley: doorway into western extension (blocked) and window (blocked)

- 5.21 Four windows, three of which were subsequently blocked, would have originally lit the ground floor room; two each on the south and west sides of the building. One of the windows on the west gable end was later removed and blocked. Both windows on the south side were later blocked, the west one becoming a cupboard (Plate 15), the east one being replaced by the later farmhouse door (Plate 11). At this stage the doorway to the western extension was also partially blocked becoming the only window on the south side (Plate 10).

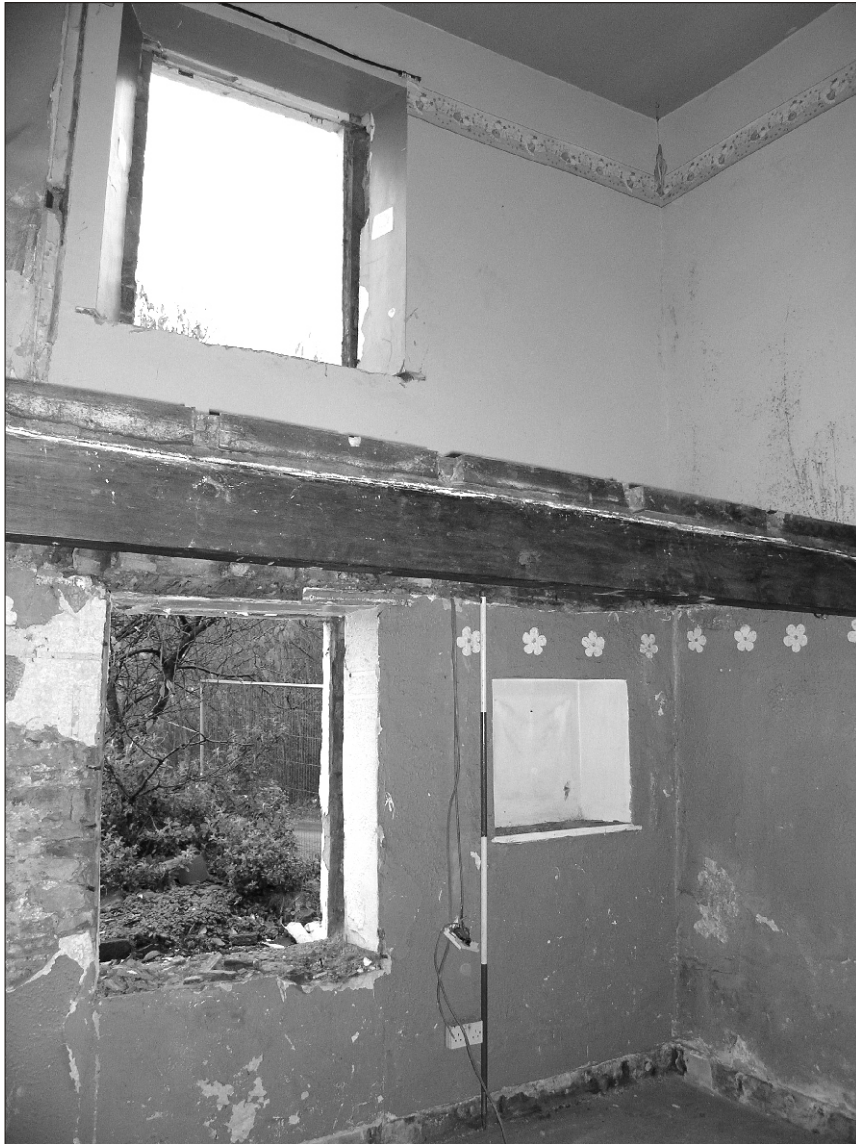
Plate 15 Lane Head Farm South, Capitol Park, Barnsley: ground floor room in western extension, looking southwest. Western window has been blocked to form a cupboard and the former doorway partially blocked to form a window

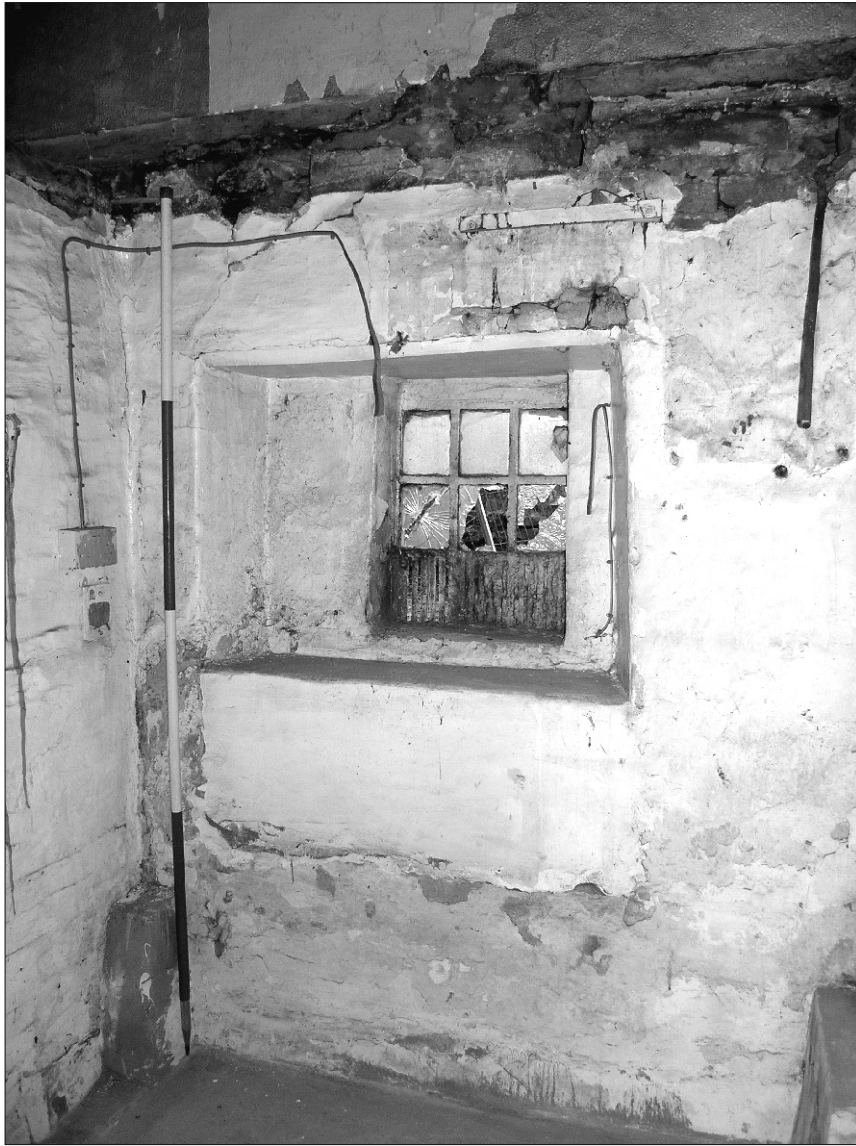
Plate 17 Lane Head Farm South, Capitol Park, Barnsley: north facing window in scullery (partially blocked)

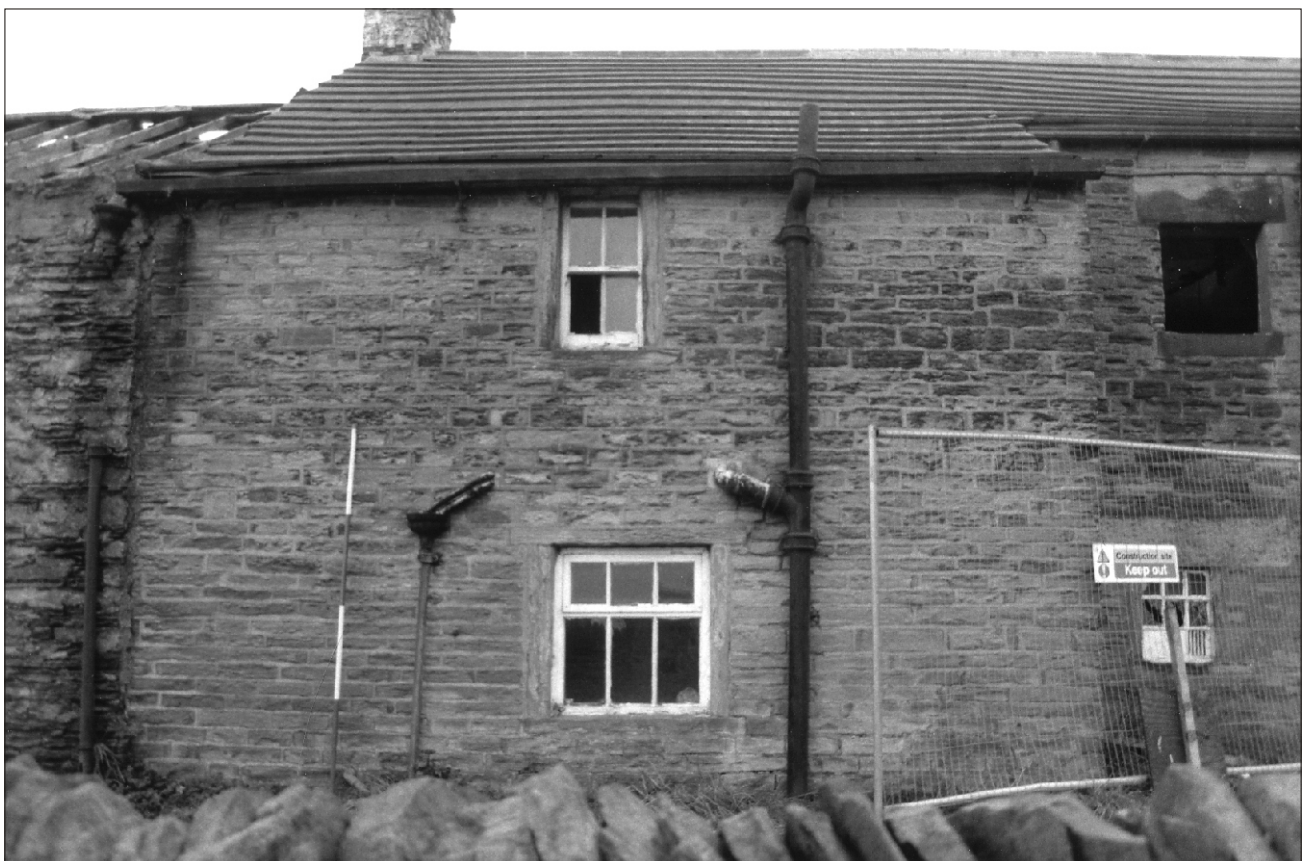
Plate 22 Lane Head Farm South, Capitol Park, Barnsley: north facing elevation of outshot

- 5.29 The two-storey outshot on the north side of the ‘cottage’ was probably constructed at the same time as the western extension and built of the same rectangular sandstone blocks which were much narrower and longer in length than those found in the ‘cottage’ (Plate 22). The building protruded 1.20m beyond the rear of the western extension (Plate 13) and extended the entire east to west length of the ‘cottage’, abutted by the stone barn on the east side.

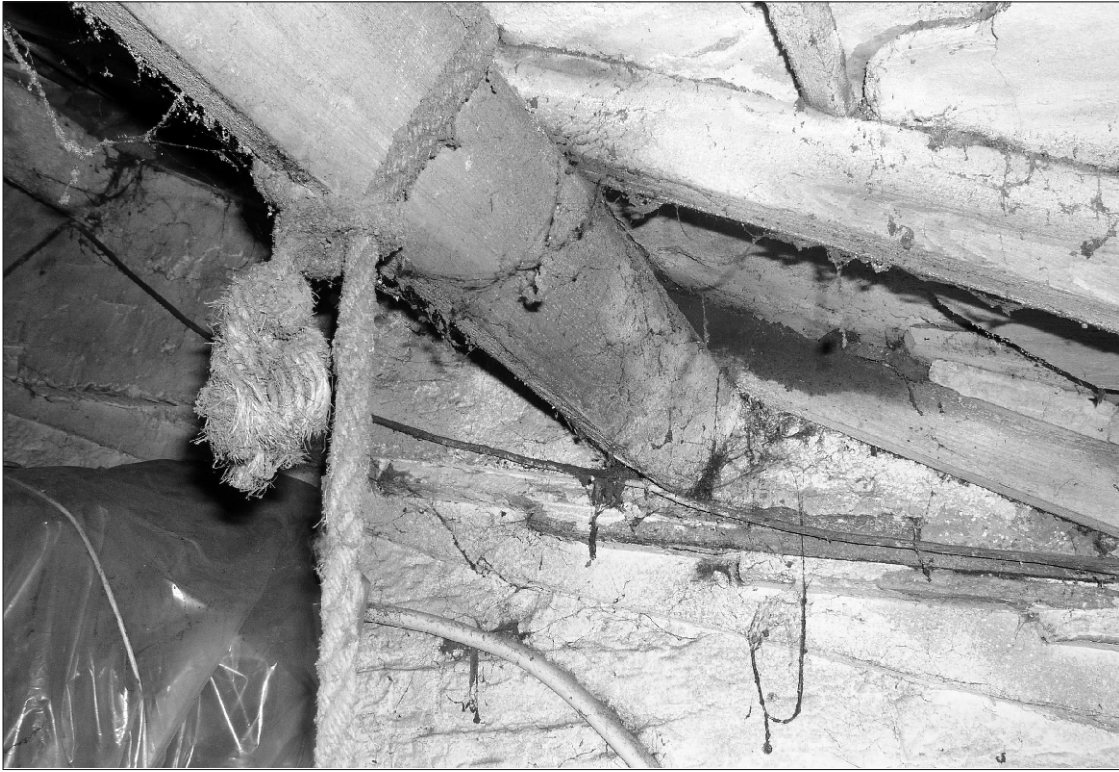
Plate 23 Lane Head Farm South, Capitol Park, Barnsley: earlier roof line visible in eastern gable of 'cottage'/outshot below later barn roof.

- 5.28 The roof was common rafter built and constructed of sawn cut timbers, a large number of which had been replaced. Evidence from the earlier roofline on the east gable would suggest that the building had originally been covered in stone slabs; these had been recently replaced with modern grey pantiles.
