NEGATIVE WATCHING BRIEF REPORT

RYECROFT ROAD HAINWORTH WEST YORKSHIRE

prepared for Morrisons Utilities Service on behalf of Yorkshire Water

> NAA 20-100 November 2020

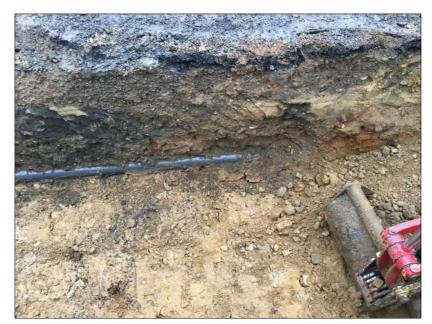
Plate 1: sample section of road trench showing depth of disturbance

Excavation of a trench 2m wide by 1.2m deep along Ryecroft Road, crossing the projected line

of a Roman road at right angles, revealed that the area had been disturbed by the construction

of the modern road and various modern utilities trenches (Plate 1). At the southern end of the

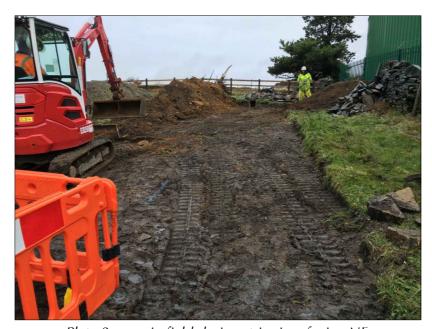
Plate 2: area in field during stripping, facing NE

brown silty sand topsoil was stripped over an area of 15m x 5m to a depth of 0.20m (Plate 2).

This revealed undisturbed natural sandstone and sand. Subsequent monitoring of 24m of 0.07m

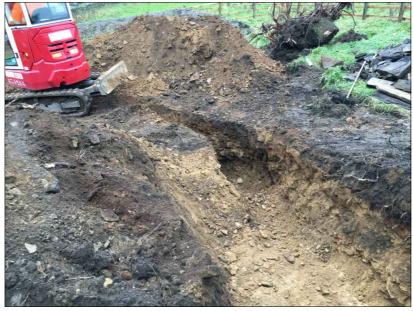
Plate 3: pipe trench in field showing topsoil over natural Ryecroft Road, Hainworth, West Yorkshire: plates

wide by 1.2m-deep pipe trench across this area also recorded only undisturbed natural geology

(Plate 3), with no archaeological features or artefacts identified.
