ARCHAEOLOGICAL WATCHING  
BRIEF

PLOT 2, STATION PLACE  
MERCHANT PARK  
NEWTON AYCLIFFE  
CO DURHAM

prepared for  
Merchant Anglo (Amazon Park)  
Property Holdings Ltd

NAA 21/70  
August 2021

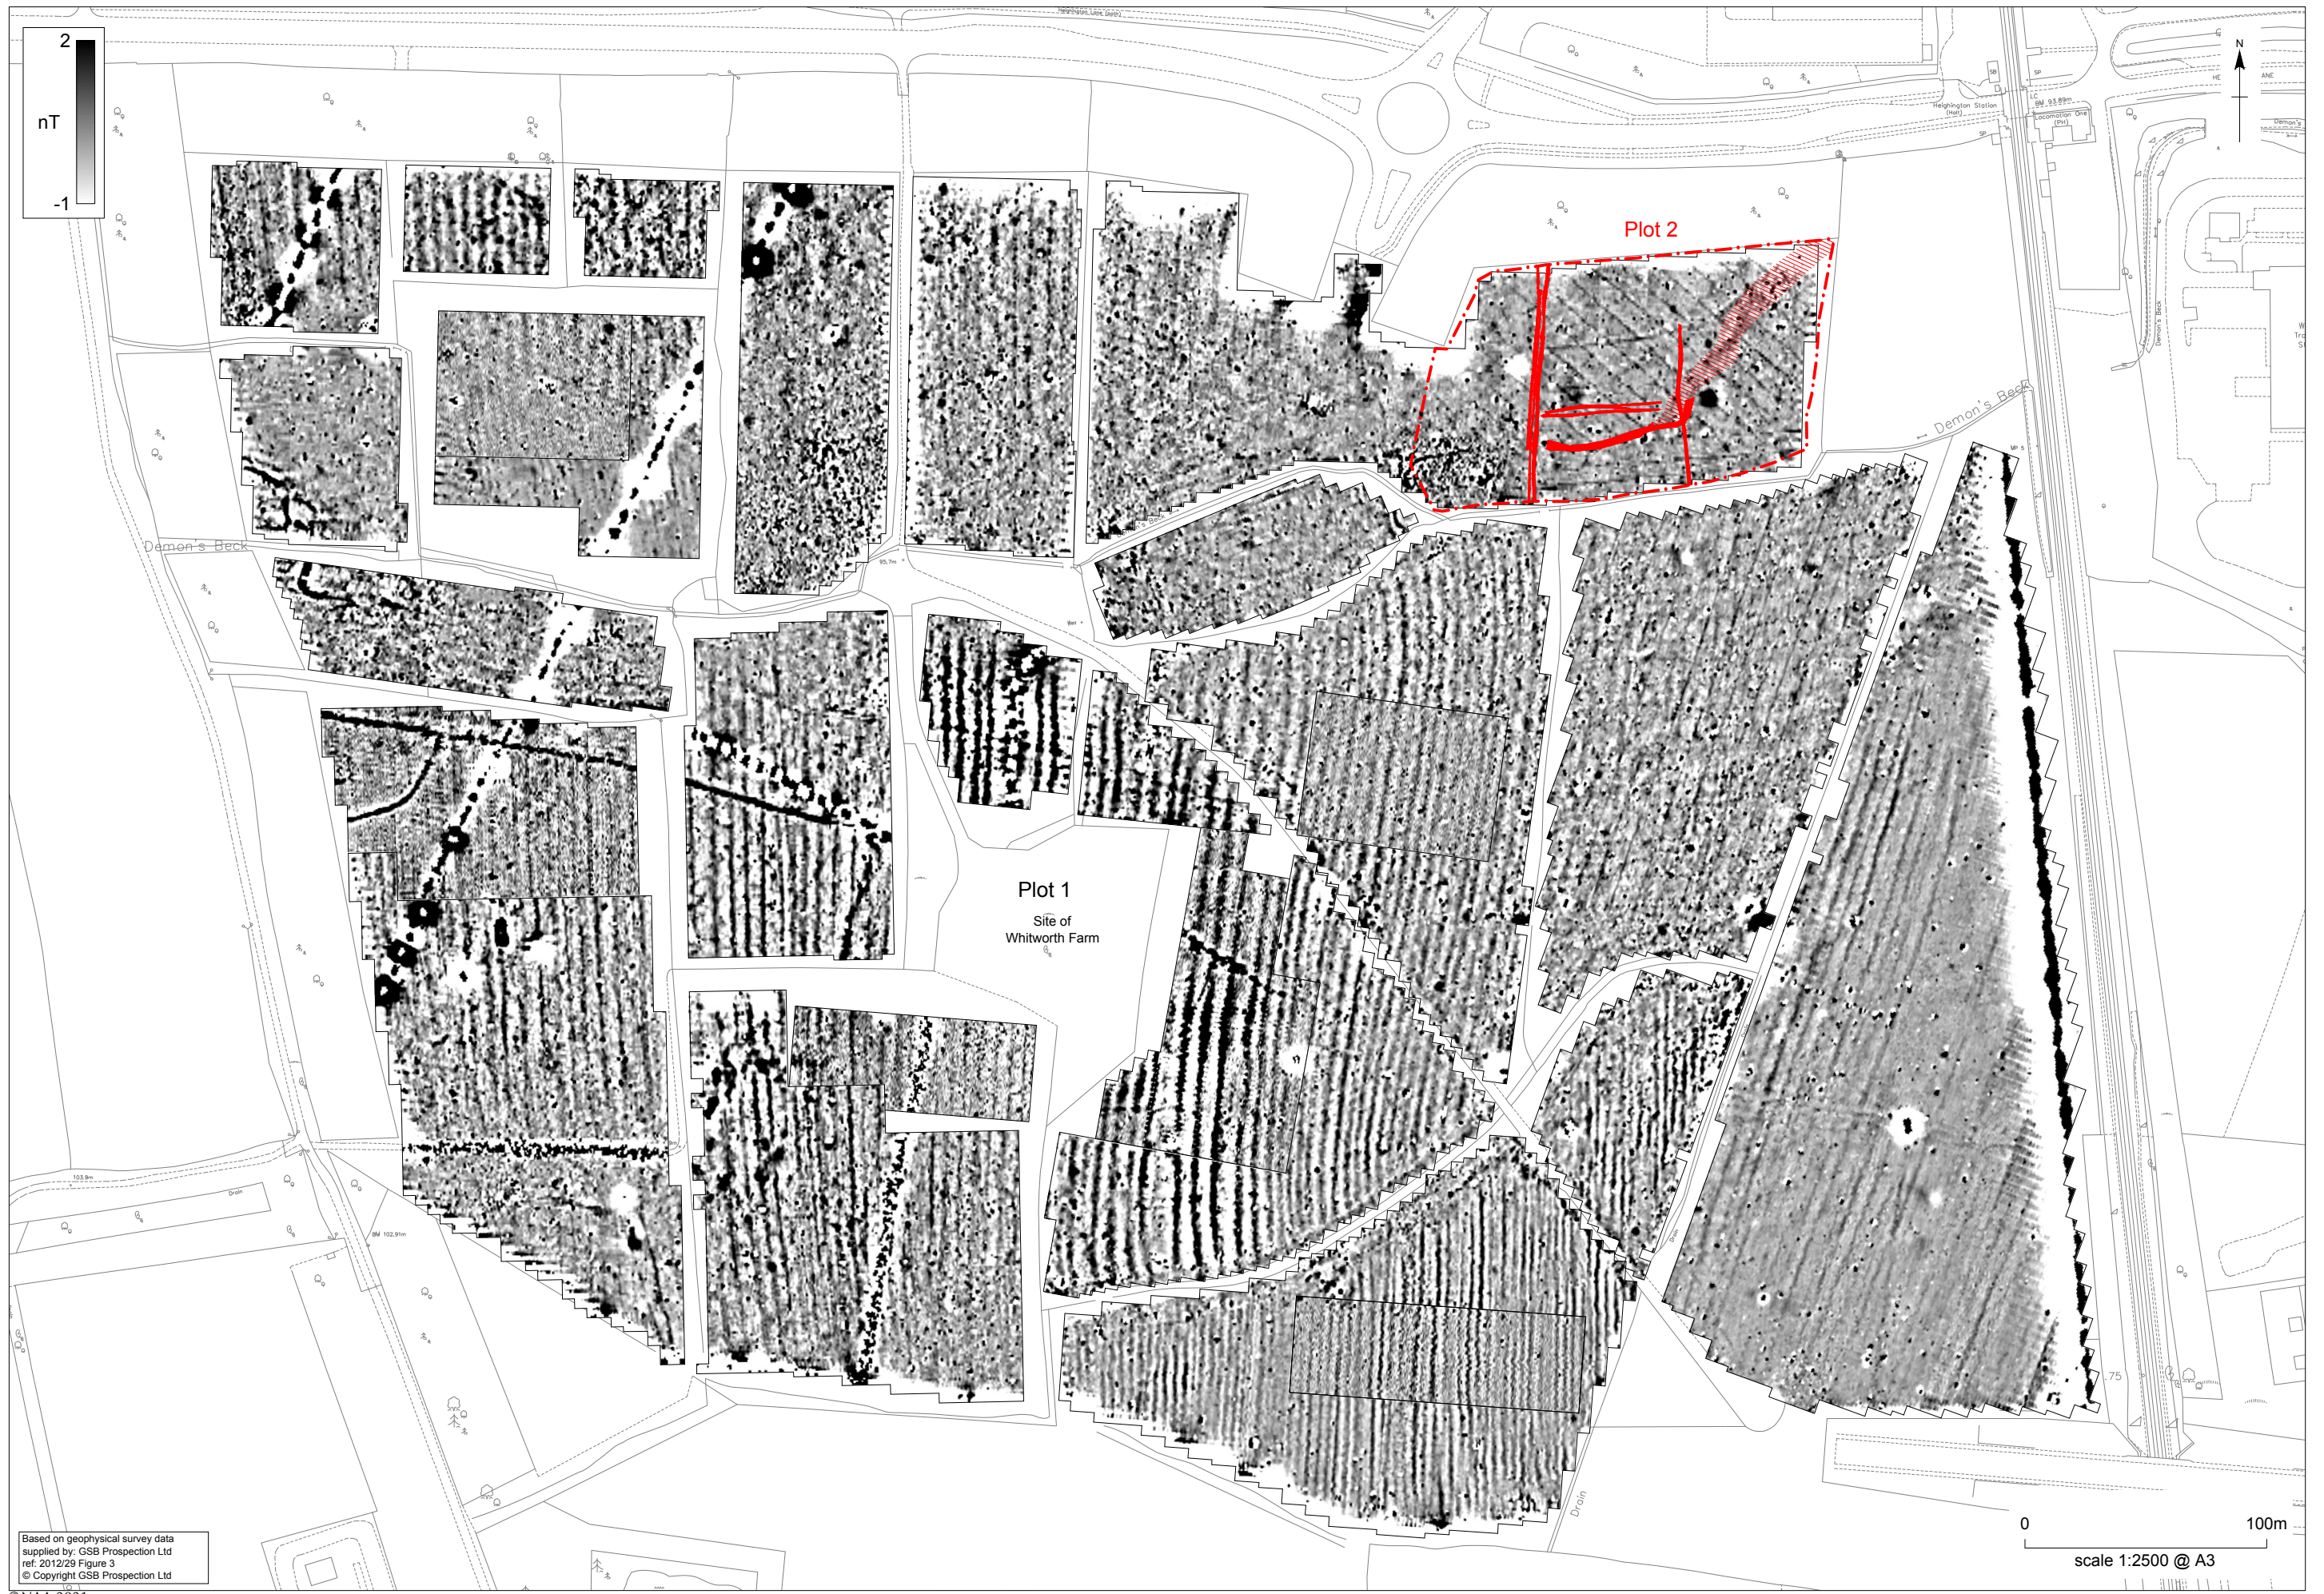
Figure 3

Merchant Place, Plot 2: recorded features (red) overlain on geophysical survey results for the whole area

- 3.5 The geophysical survey showed that during the medieval period the whole of Plot 1 had been under arable cultivation, represented by ridge-and-furrow ploughing (Fig. 3); however, this was not observed in Plot 2. Where plough furrows were examined during the 2013 excavation, they produced an assemblage of 12th- to 14th-century pottery (Churchill 2014).

- 6.6 The stripped area was crossed near its western side by north–south ditch **4**. This was recorded over a length of 73m, but continued to south beyond the site, and its line can be seen on the geophysical survey extending to the beck (Fig. 3). To the north it terminated within the stripped area (Fig. 4). The ditch was typically 1.1m wide and 0.5m deep with steep, slightly convex sides and a rounded base (Plate 2; Fig. 5 Section 1). Where investigated it had either two or three distinct fills consisting of mid-grey or blue-grey slightly silty clay (**7/13/16**), mottled reddish brown and grey silty clay (**6/12/15**) and an upper fill of mid-brownish grey silty clay (**5/14**). None of the excavated segments contained any dateable finds.

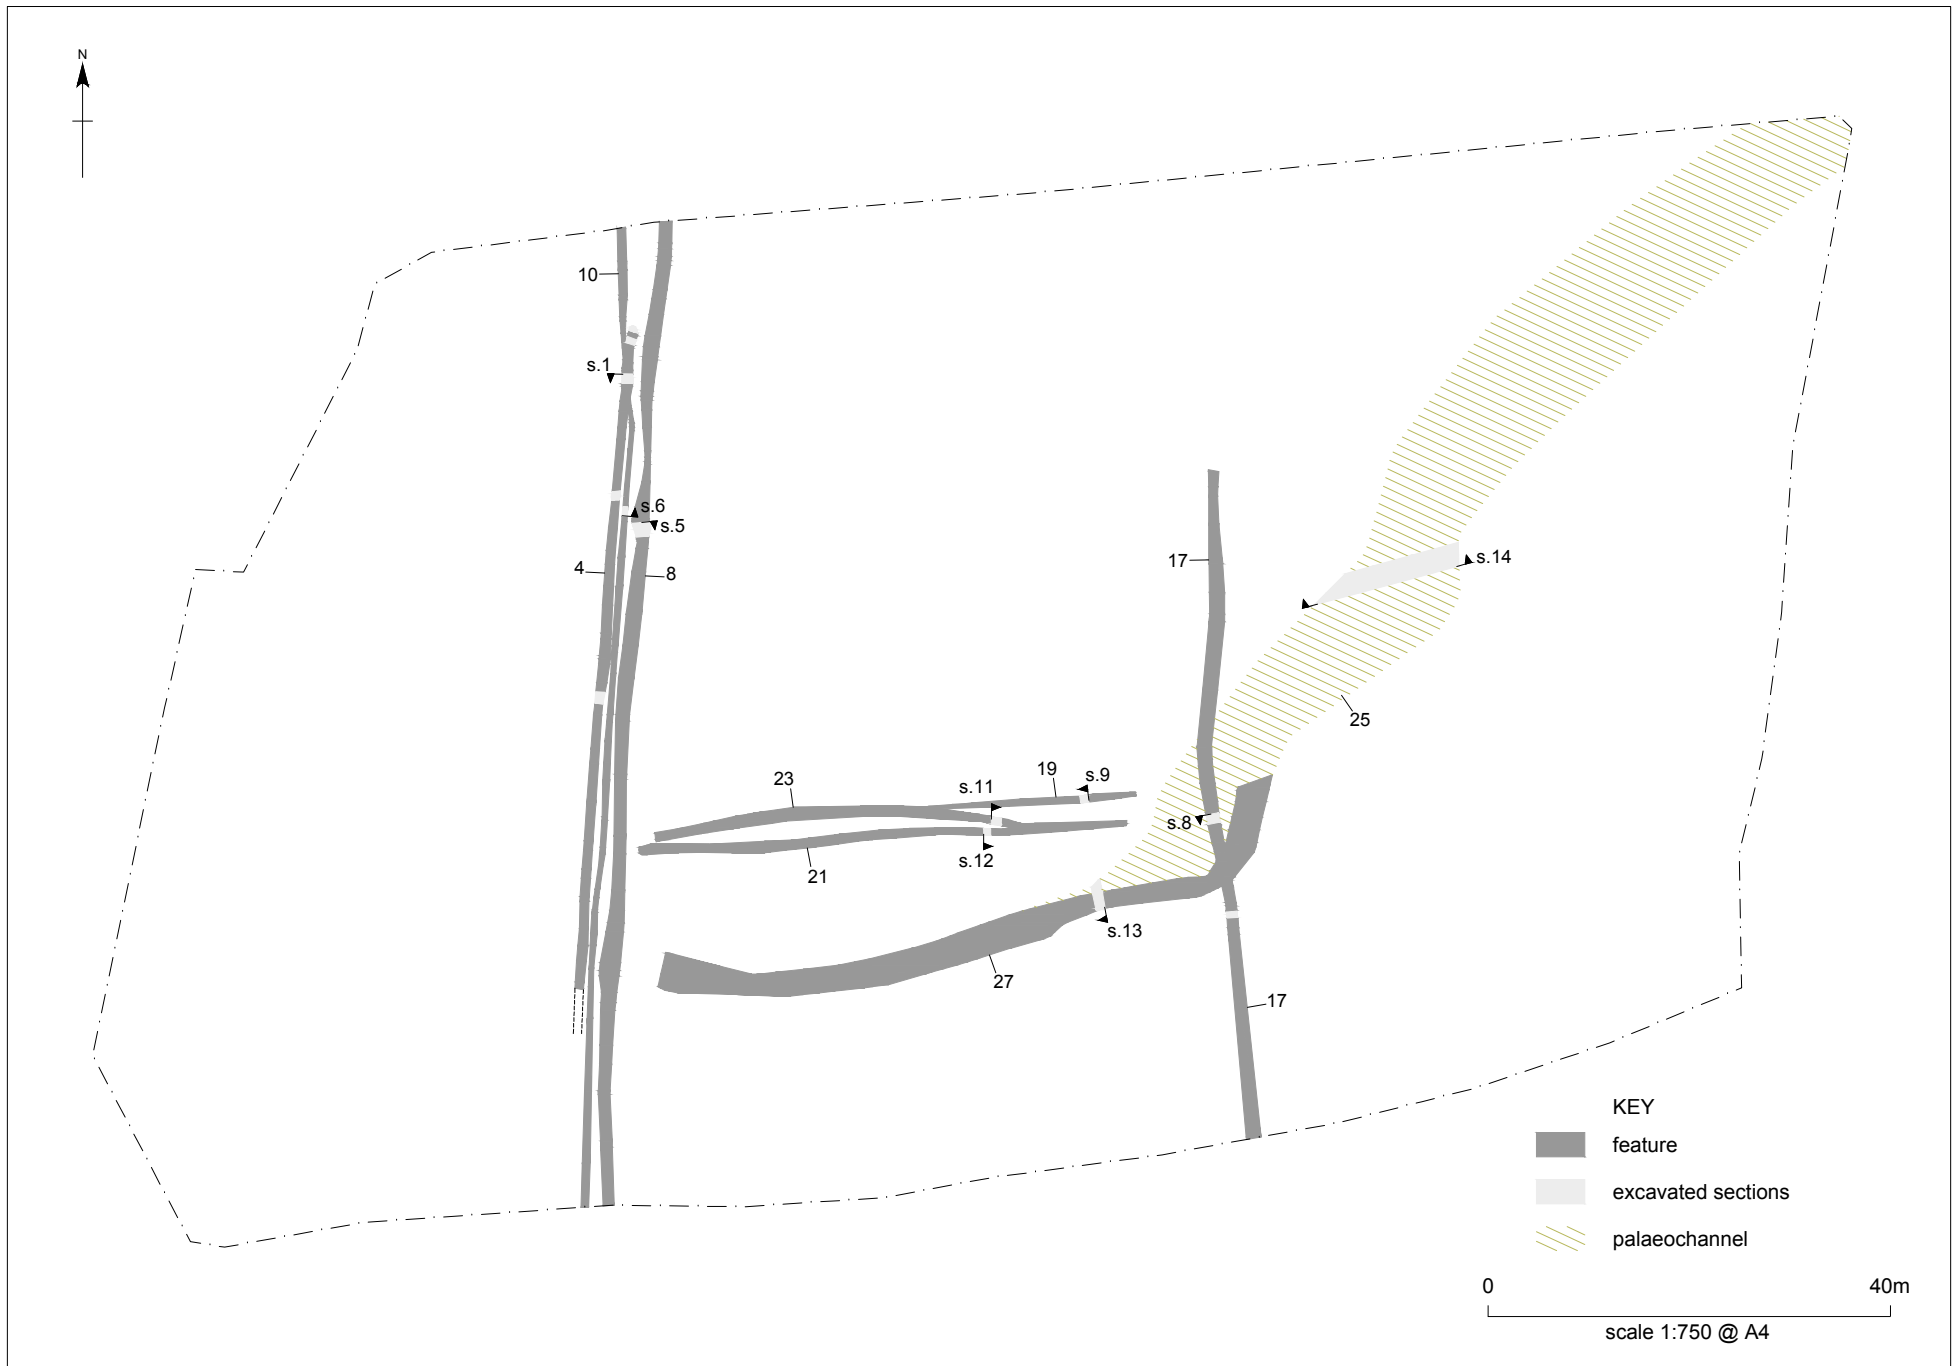
Figure 4: plan of recorded features.

- 6.1 The investigated area was a slightly irregular rectangle measuring up to *c.*180m from east to west, and up to *c.*100m from north to south (Fig. 4). It was covered by mid-brownish grey sandy clayey silt topsoil (1), which was up to 0.3m thick. Below this was a layer up to 0.15m thick of light to mid-brown sandy clayey silt subsoil (2). These deposits were removed by machine to reveal natural mid-yellowish brown or grey boulder clay (3) containing occasional small pockets of sandy clay or gravel.
- 6.2 The possible ditch recorded by the geophysical survey was not identified following soil-stripping.
- 6.3 The earliest feature recorded cutting the boulder clay was natural palaeochannel 25, which presumably represented a former course of Demon's Beck. It crossed the eastern part of the stripped area running from north-east to south-west over an observed length

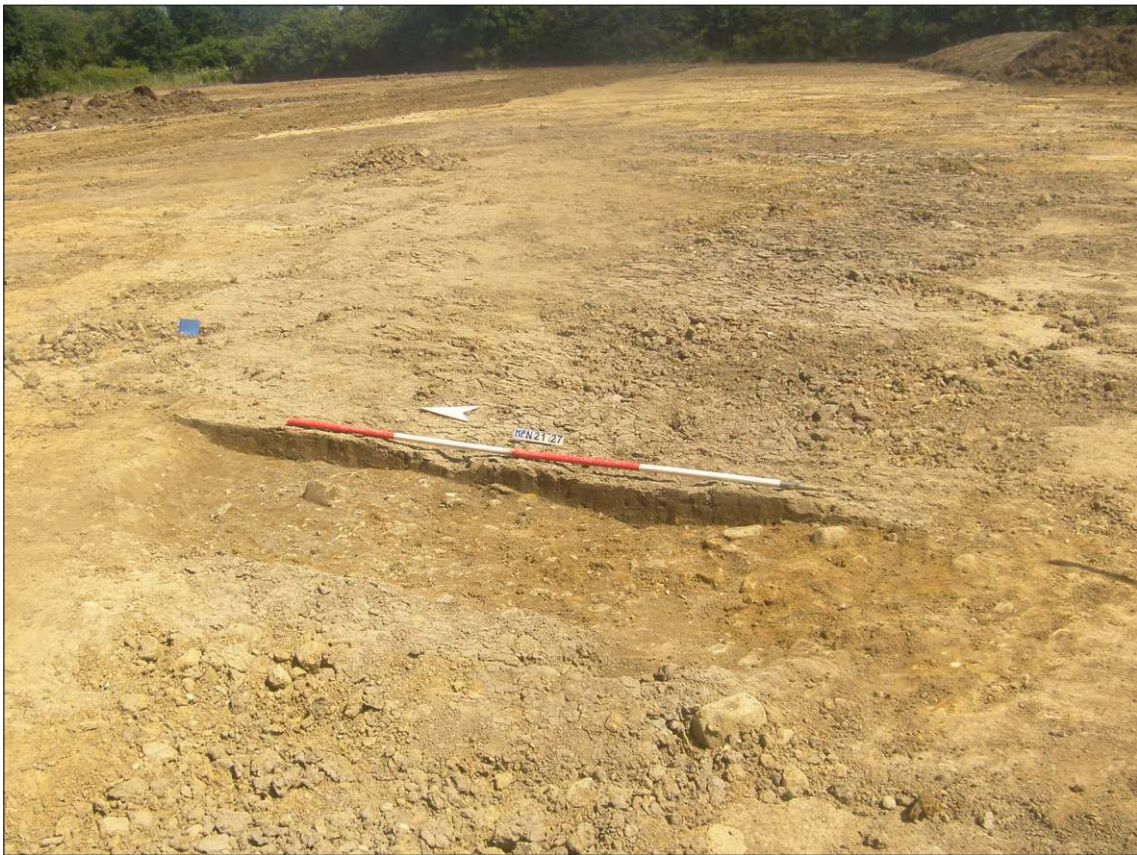
*Plate 1*

*Merchant Place Plot 2, Newton Aycliffe: west-facing section  
across palaeochannel 25 (left) and feature 27 (right),  
facing north-east, scale 2m*

- 6.4 The palaeochannel had been cut by feature **27** (Plate 1; Fig. 5 Section 13). To the west this petered out before reaching boundary **4**, although on the geophysical survey its alignment may have been continued westwards beyond the investigated area as was potentially indicated by an anomaly running in a relatively straight line for c.50m before curving to the south-west and intersecting the modern beck. Within the stripped area, at its eastern end feature **27** turned to the north-east to follow the south-eastern edge of the palaeochannel for a short distance. Where investigated, feature **27** was 2.45m wide but only 0.13m deep, and filled with mid-greyish brown, slightly silty, slightly sandy clay (**28**). No finds were recovered from this feature and it remained undated, although it was cut by boundary **17**.

- 6.5 Feature **27** probably represented a final iteration of the palaeochannel which had been truncated to the north-east, and the character of the fill supported this. However, if the feature recorded by the geophysical survey to the west of the stripped area was a continuation of **27**, its straightness raised the possibility that the excavated feature was anthropogenic. If so, it was unlikely to have been designed for drainage since the beck flows from west to east meaning that at times of high-water feature **27** would have served to introduce water into the area of palaeochannel **25** rather than to drain it. Alternatively, feature **27** could have been created as a boundary of some sort, but without further investigation in the area to the west of the stripped area its origin and function must remain uncertain.

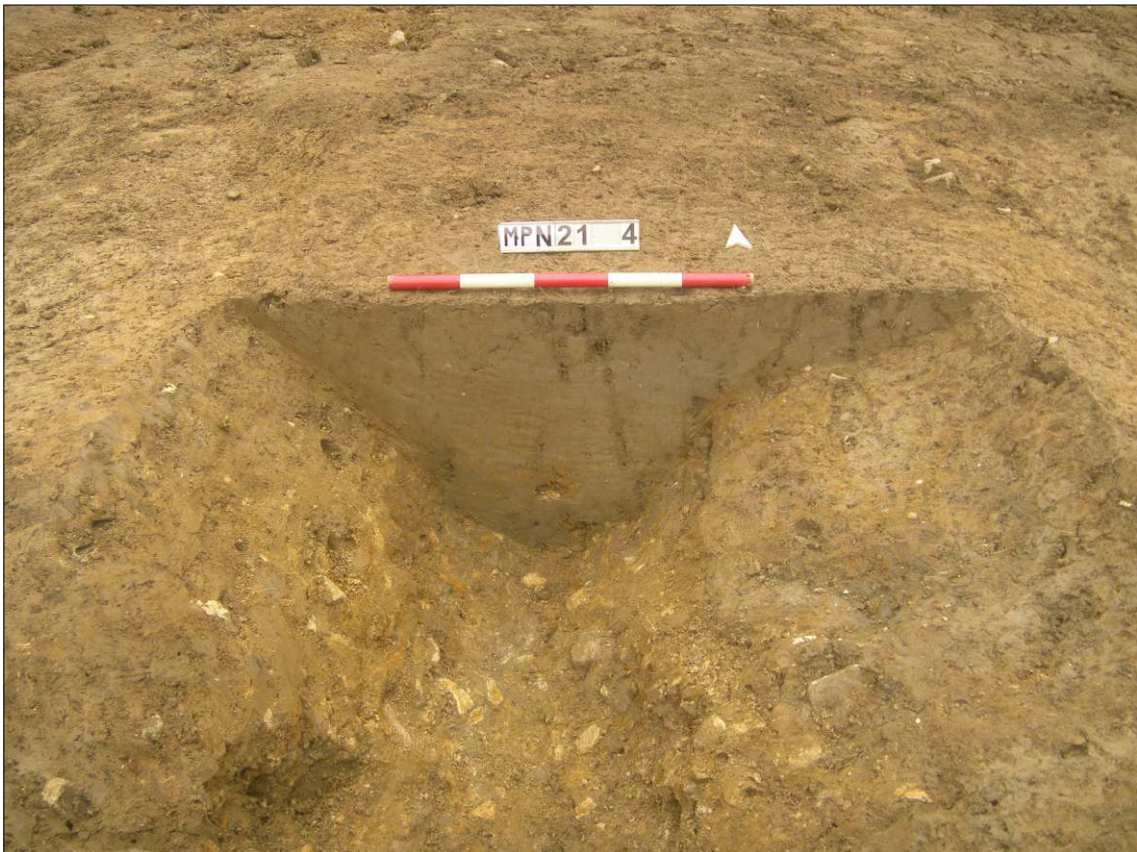
*Plate 2*

*Merchant Place Plot 2, Newton Aycliffe: Ditch 4,  
south facing section, scale 0.5m*

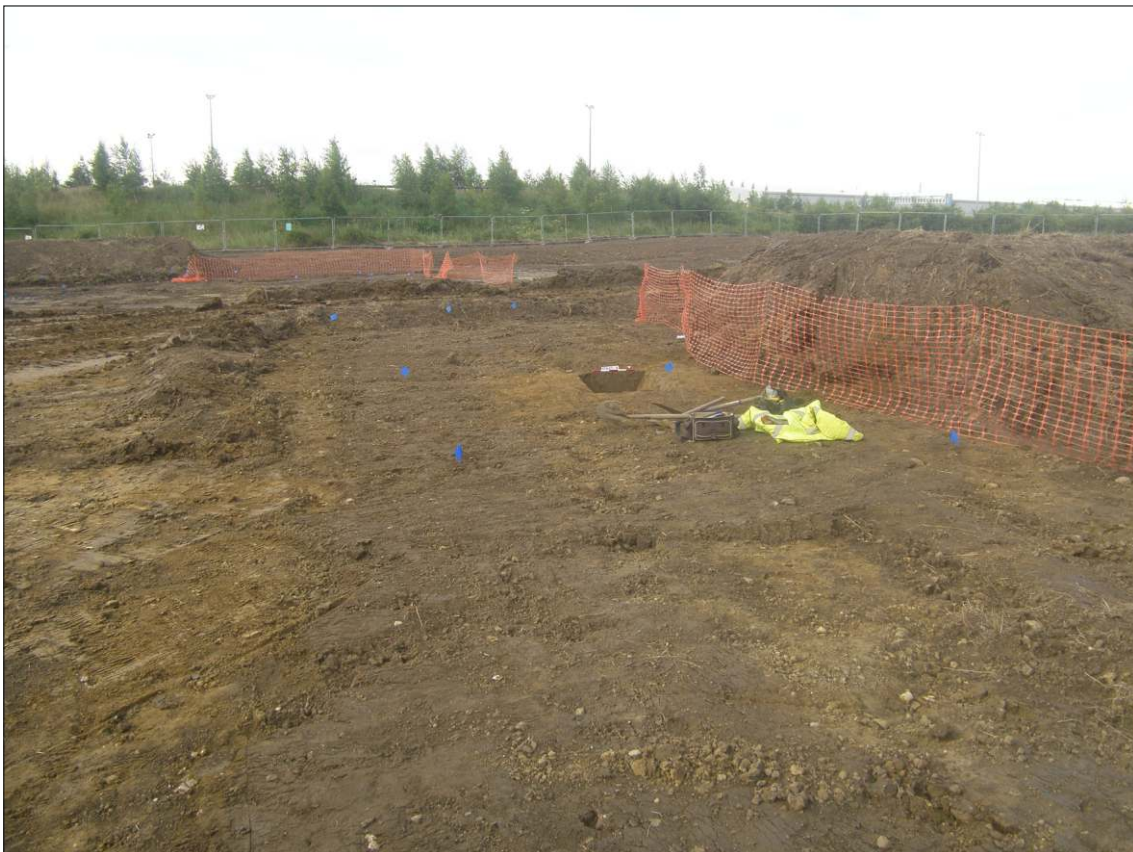
*Plate 3*

*Merchant Place Plot 2, Newton Aycliffe: Ditch 4 (right) and features 8 and 10 (left), facing south*

- 6.7 Adjacent to ditch **4** were two much shallower linear features **8** and **10** (Plate 3). The shallow depth of these features prompted their interpretation as plough furrows, although given the absence of similar features nearby it is possible that they were shallower re-cuts of boundary **4**. Feature **10** certainly post-dated the infilling of ditch **4** since to the north it cut across its line (Fig. 4 and Fig. 5, Section 1). Feature **10** was observed running from north to south across the full width of the stripped area (c.100m). It was c.0.6m wide but only 0.09m deep (Fig. 5, Section 6) and filled with mid-brownish grey silty clay (**11**). Immediately to the east, Feature **8** also crossed the full width of the stripped area from north to south. Where investigated it was 1.7m wide and 0.18m deep (Fig. 5, Section 5) and had a similar fill (**9**), which contained post-medieval pottery, post-medieval ceramic building material fragments and a piece of slag (not retained).

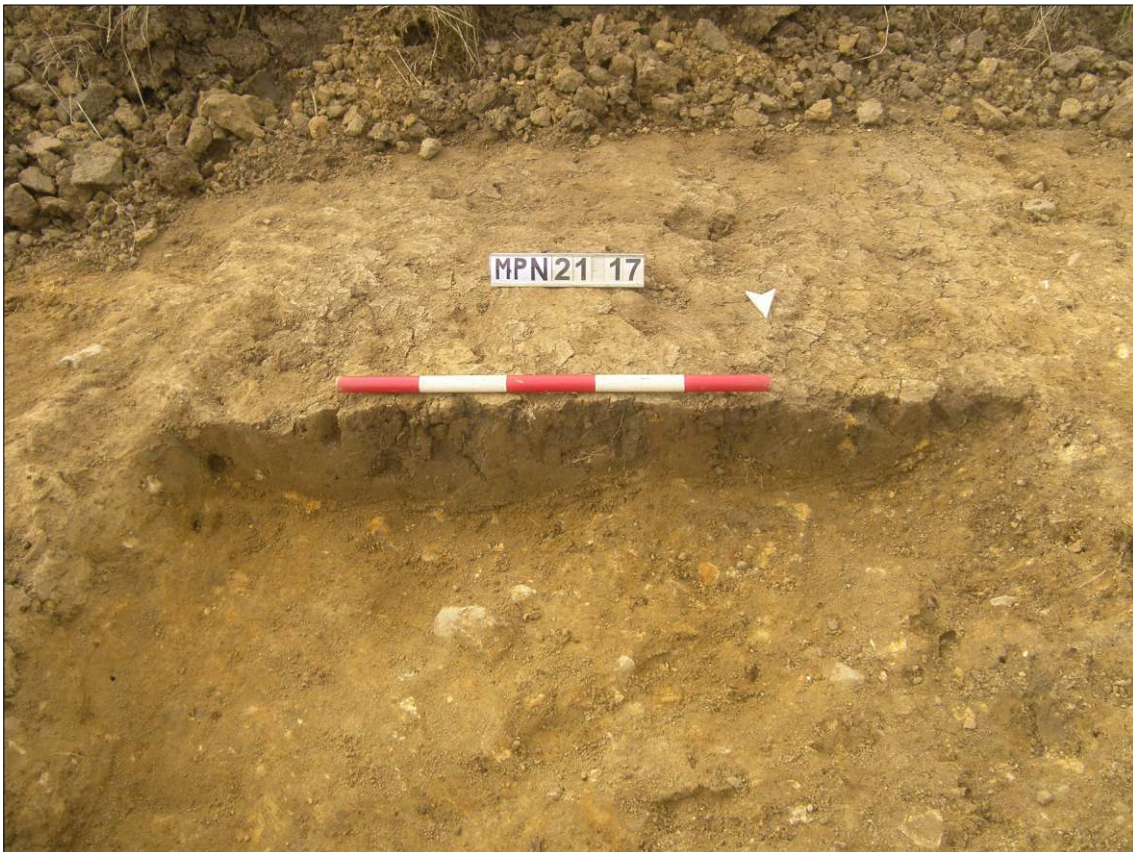
*Plate 4*

*Merchant Place Plot 2, Newton Aycliffe: Ditch 17, north-facing section, scale 0.5m*

- 6.8 Approximately 65m to the east of ditch **4** was a second ditch (**17**) running from north to south. This was observed over a length of 68m, truncated to the north and continuing beyond the stripped area to the south. It cut (and therefore post-dated) the fills of palaeochannel **25** and feature **27**. Ditch **17** was 1.06m wide, 0.19m deep and filled with mid-brownish grey silty clay (**18**) (Plate 4) which did not contain any finds.

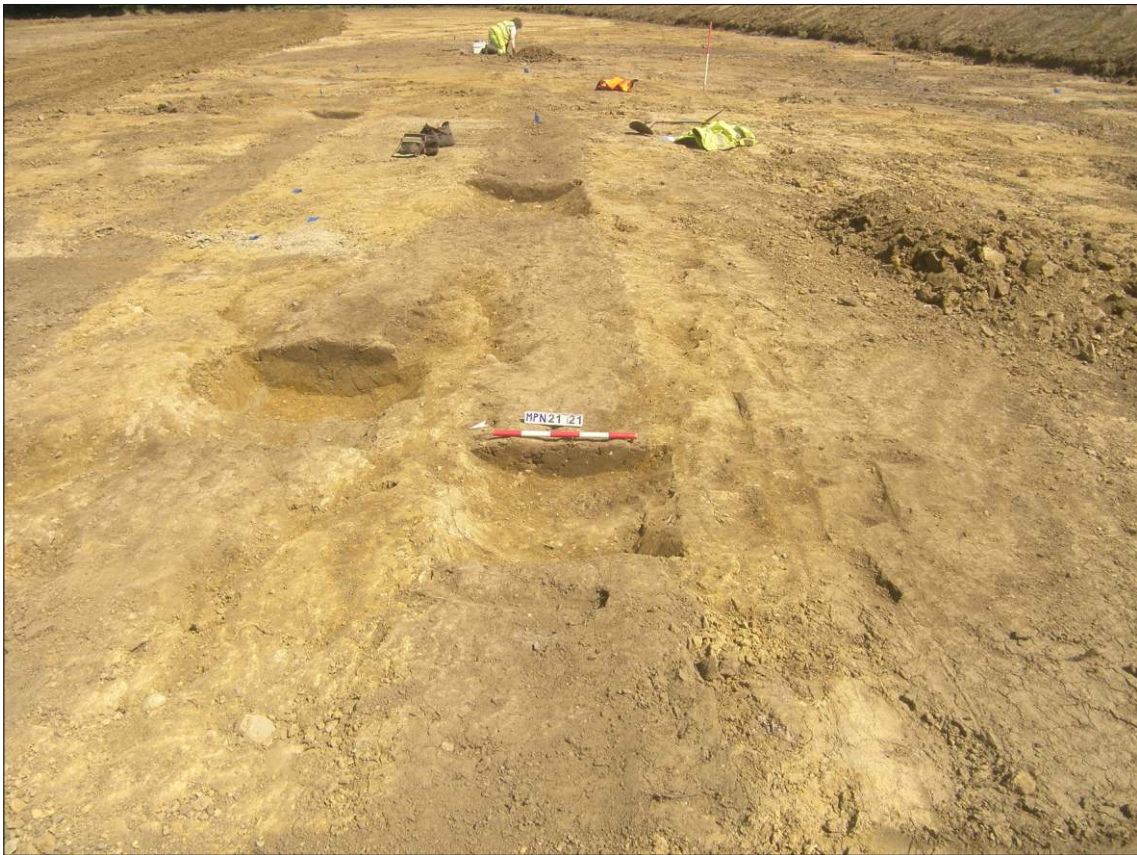
*Plate 5*

*Merchant Place Plot 2, Newton Aycliffe: west-facing section  
across (left to right) ditches 19, 23 and 21, scale 0.5m*

- 6.9 The area between ditches **4** and **17** was crossed from east to west by a group of linear features; **19**, **21** and **23** (Plate 5). These ran approximately at right angles to the longer ditches and, although they did not meet, apparently respected (and were constrained by) them, indicating that all of the features probably represented a single phase of activity. Despite Features **19**, **21** and **23** intercutting, due to the similarity of their fills, no stratigraphic relationship or sequence could be determined. Feature **19** was 0.75m wide and 0.1m deep (Fig. 5, Section 9), Feature **21** was 0.68m wide and 0.14m deep (Plate 6; Fig. 5 Section 12), and Feature **23** 0.76m wide and 0.1m deep (Fig. 5, Section 11). All three were filled with mid-brownish grey silty clay (respectively contexts **20**, **22** and **24**). Fills **22** and **24** both contained fragments of post-medieval ceramic building materials (brick and tile).

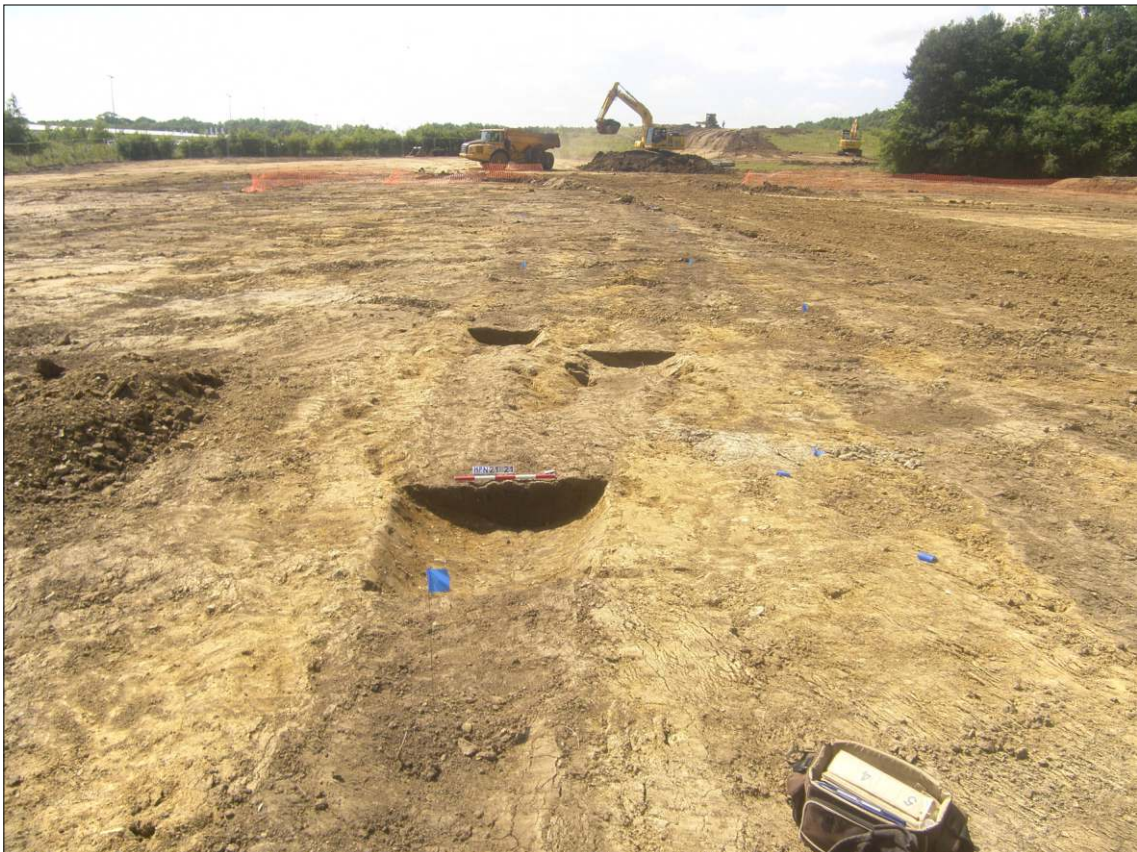
*Plate 6*

*Merchant Place Plot 2, Newton Aycliffe: east-facing section  
across ditch 21 (scale 0.5m) with continuing  
machine-stripping beyond*
