NORTHERN ARCHAEOLOGICAL ASSOCIATES LTD
ONE STRAWBERRY LANE OFFICE DEVELOPMENT, NEWCASTLE UPON TYNE
Negative Watching Brief Report

Site name: One Strawberry Lane Office Development **Grid reference:** NZ 2450 6450

NAA report number: 21-16 **Report date:** 01 March 2021

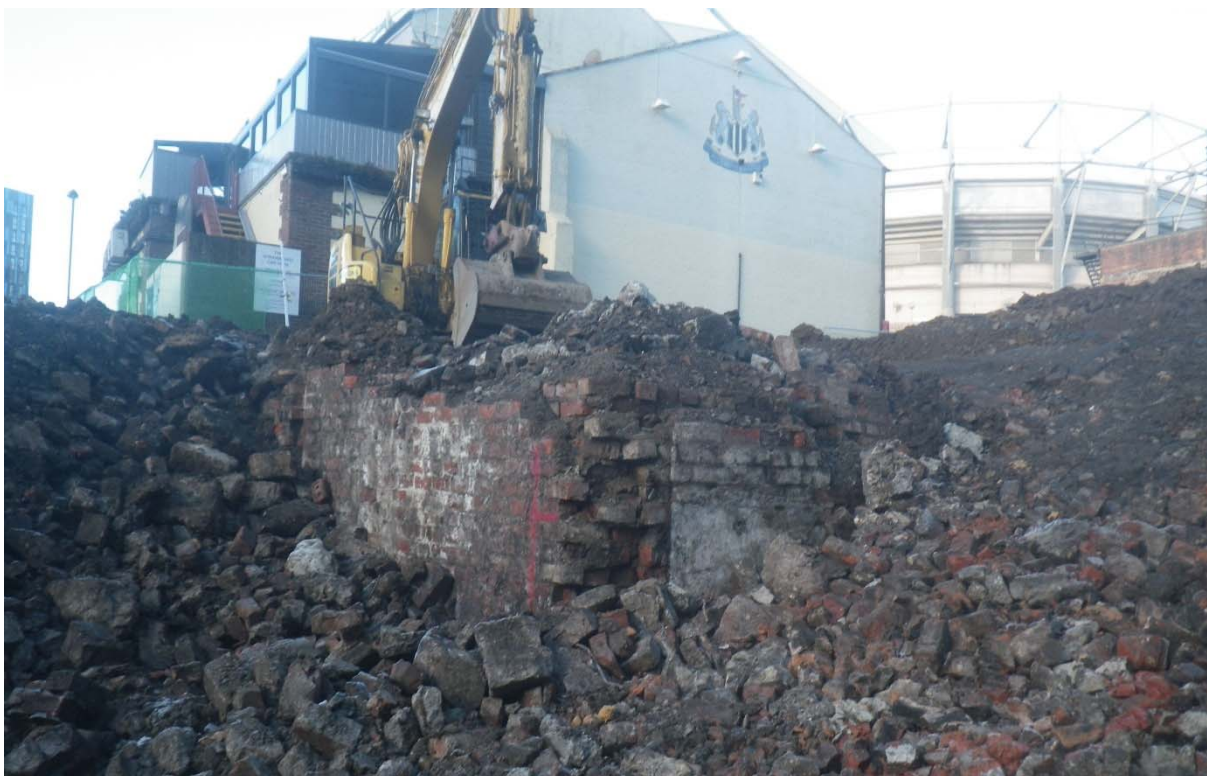
Plot A was situated to the east of The Strawberry public house and fronted onto Strawberry Place at the north end of the development site. The area was 24m from south-west to north-east, was 18m wide, and lay at an elevation of 56.7m aOD. Ground clearance work commenced with the removal of the carpark surface and underlying crushed brick rubble prior to ground reduction by an average of 0.6m, which was followed by consolidation with imported stone and gravel. Until recently, the eastern half of the area was the site of two tenement buildings terraced into the hillside with frontages level with the street to the north. The brick foundations (1, Fig. 2) of these buildings formed part of the boundary wall within the carpark, with a substantial drop of over 3m to the lower level of Plot C (Plate 1).

Plate 1: brick retaining wall for 19th-century properties to the east of The Strawberry in Plot A.

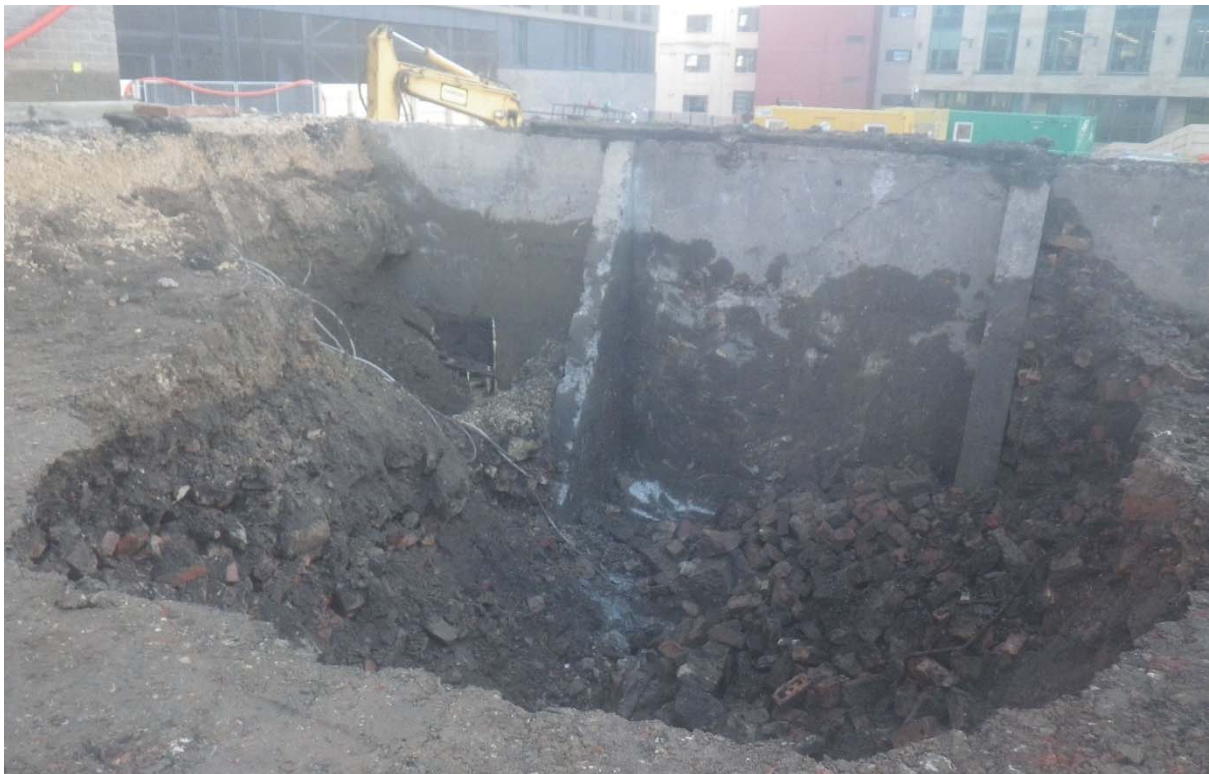
Plate 2: reinforced concrete wall and brick rubble infill in the western half of Plot A.

Ground reduction in the western half of Plot A uncovered the brick rubble infill behind a 20th-century reinforced concrete retaining wall (4, Fig. 2). Any remains of the former building occupying the north-eastern area of Plot A lay below the level of excavation and were not observed during the site works (Plate 2).

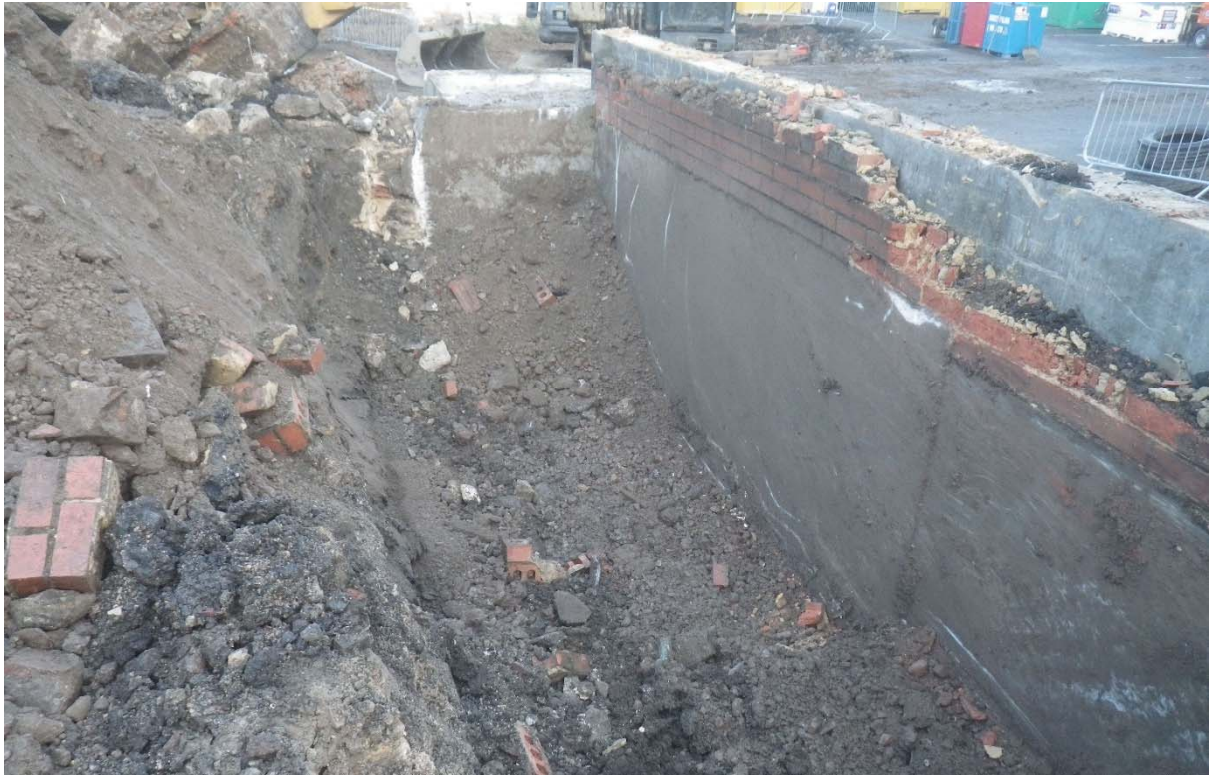
Removal of the modern access ramp in the south of the area uncovered a brick wall (7, Fig. 2), which was located immediately behind the reinforced concrete retaining wall of the carpark access ramp – the intervening area having been infilled with brick rubble. This wall appears to be part of the northern extent of the demolished public baths that occupied the lower half of Strawberry Lane (Plate 3).

Plate 3: remains of 19th-century terrace wall in the southern extent of Plot B, with reinforced concrete wall on the right.

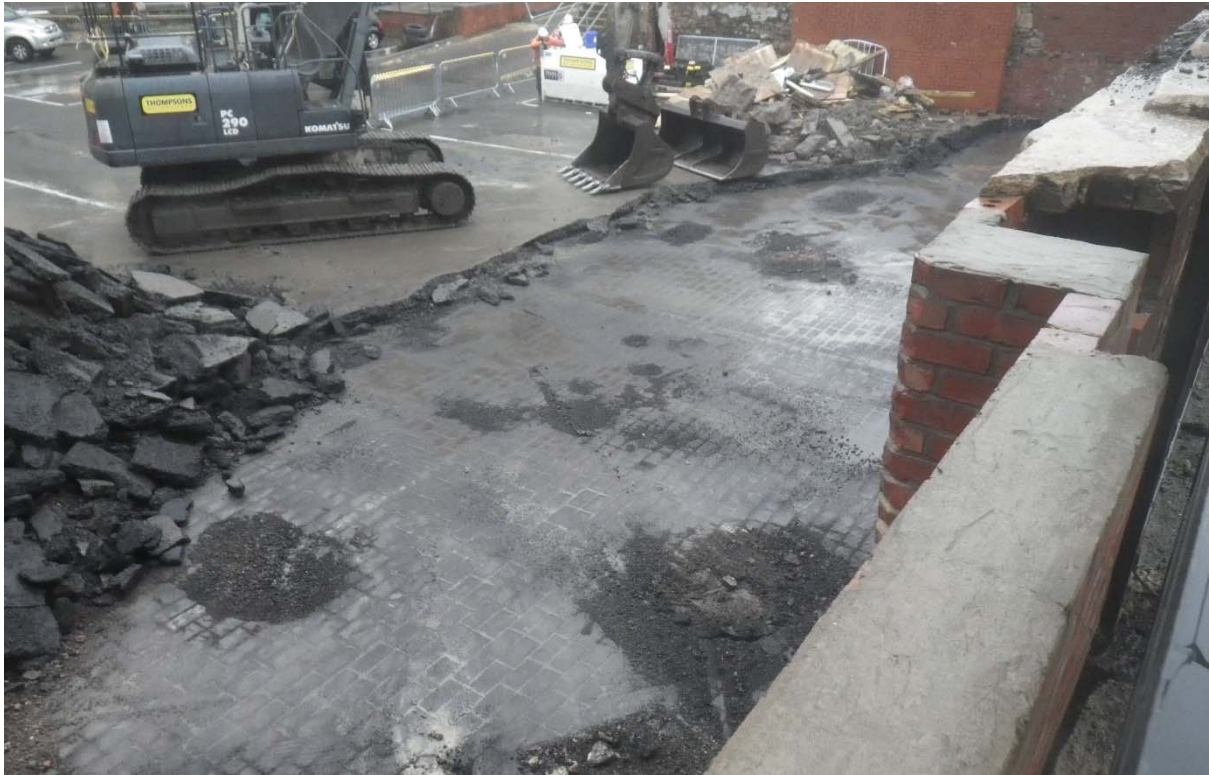
Plot C accounted for the majority of the development site, measuring up to 47m from north-west to south-east and 36m wide. The northern half of the area was terraced into the hillside around the south-east of Plots A and B, to a level of 53.5m aOD. Beneath the modern carpark surface an extensive concrete yard surface (5, Fig. 2) was uncovered (Plate 4). The yard surface lay over a thin bed of crushed brick rubble, which lay directly on the truncated natural clays of the hillside. The concrete was laid in sections and impressed to form a semblance of stone setts, which aided the drainage of the yard. This process had removed all potential deposits within this area (Plate 5).

Plate 4: concrete yard surface beneath the modern carpark in Plot C.

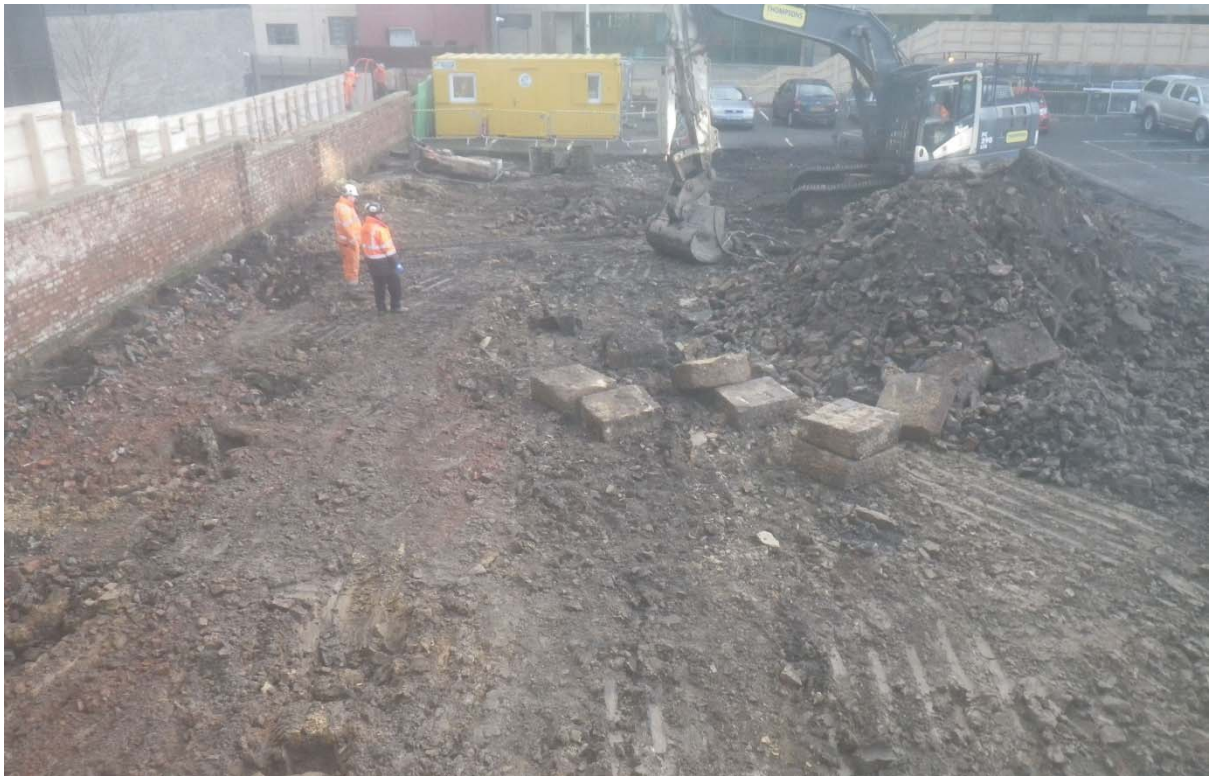
Mill' noted on the 1860 OS map (NAA 2019). The foundations of the sawmill (3, Fig. 2) and its ancillary buildings covered the south-eastern area of the site and the 1m-wide and 0.6m-thick concrete foundations of the main structure were bedded into the underlying clay. Two rows of foundation blocks, each measuring 1.2m by 0.6m, formed the foundations for sandstone plinths with cast-iron pillars within the building footprint.

Plate 5: natural boulder clay beneath the concrete yard surface, with stone pillar supports for the sawmill during removal.

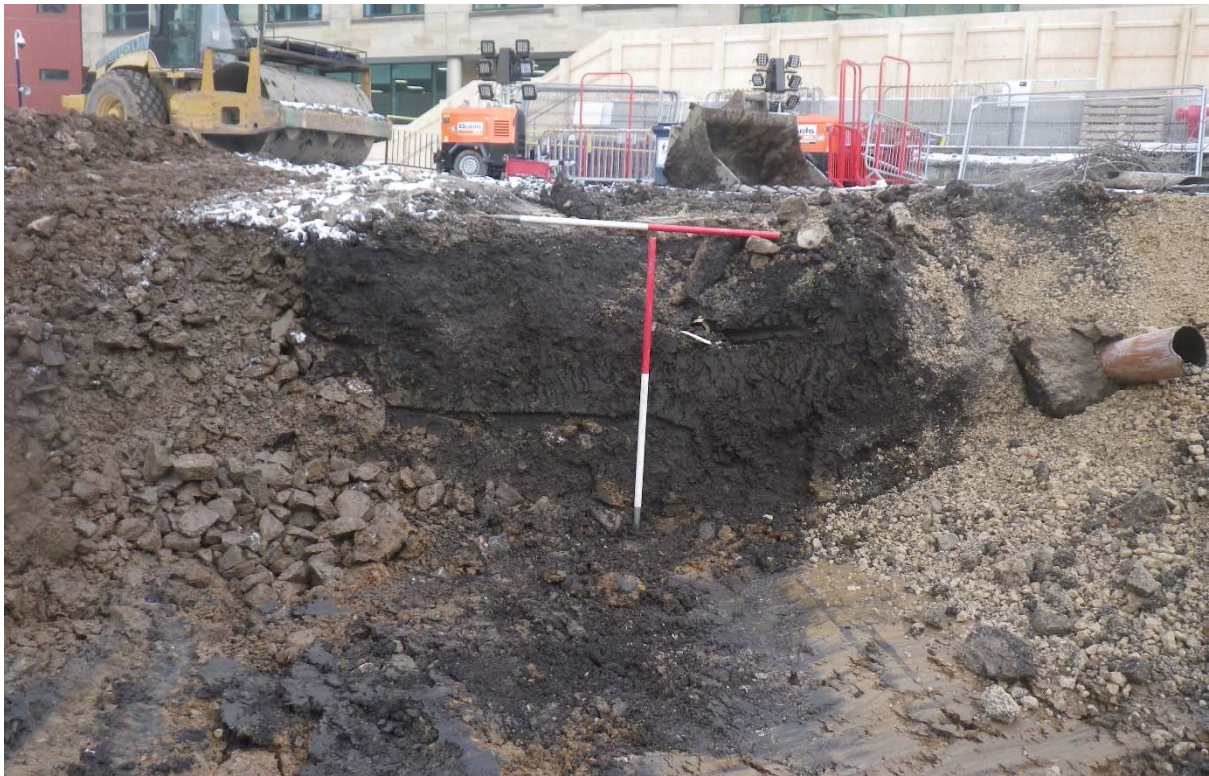
The natural slope of the hillside in the southern extent of the site had not suffered from truncation, and a deposit of the dark garden soil (deposit 2) noted in the north of Plot A remained undisturbed in this area (Plate 6). In this location, garden soil 2 was up to 1m thick in areas where it remained undisturbed by later buildings. It constituted a rich stone-free garden soil, which was gradually removed with a ditching bucket to reveal any possible features within the soil matrix. No pottery sherds or animal bone were visible within this deposit and occasional fragments of clay tobacco pipe stem were the only artefacts noted during the excavation of the material.

Plate 6: depth of garden soil 2 surviving within the walls of the 19th-century sawmill.

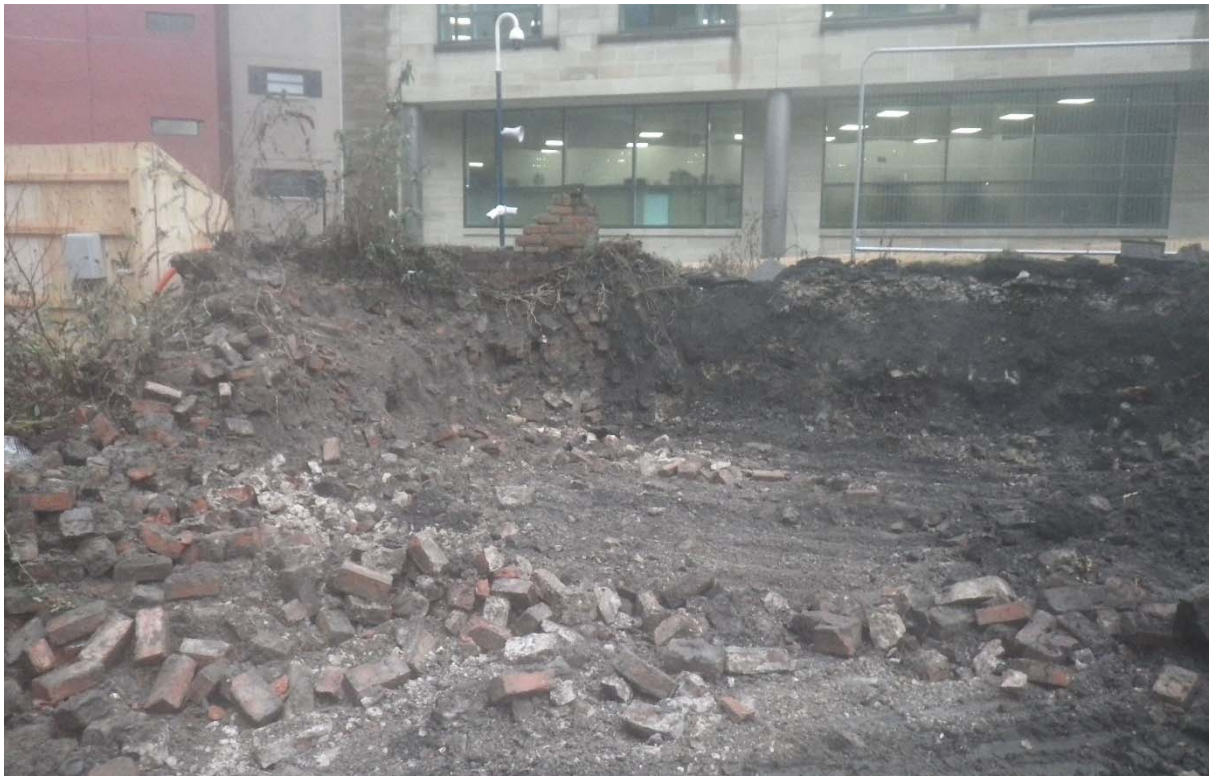
Two partially demolished brick structures (6, Fig. 2) formed the south-east corner of the site and retained the level of the carpark with a surrounding modern earth bank forming a slope to the ground below (Plate 7). This area of the development overlies the tunnel for the underground Metro line and is outside the building footprint. The remains of the sawmill midden and sawdust store were demolished to the required level and the earth bank was removed in order to grade the southern extent of the site. A small amount of pottery sherds and tobacco pipe stems were recovered from the deposits around these structures although no finds pre-dated the 19th century and no animal bone was observed during removal. It seems likely that this midden-like material was deposited as infill behind the retaining walls in this corner of the site rather than being the direct result of occupation in that location.

Plate 7: demolition of the 19th-century midden and removal of the modern earth bank in the southeast on the development.
