ARCHAEOLOGICAL WALKOVER
SURVEY

TEES VALLEY ENERGY RECOVERY
FACILITY (TVERF)

REDCAR

NAA 20/102
November 2020

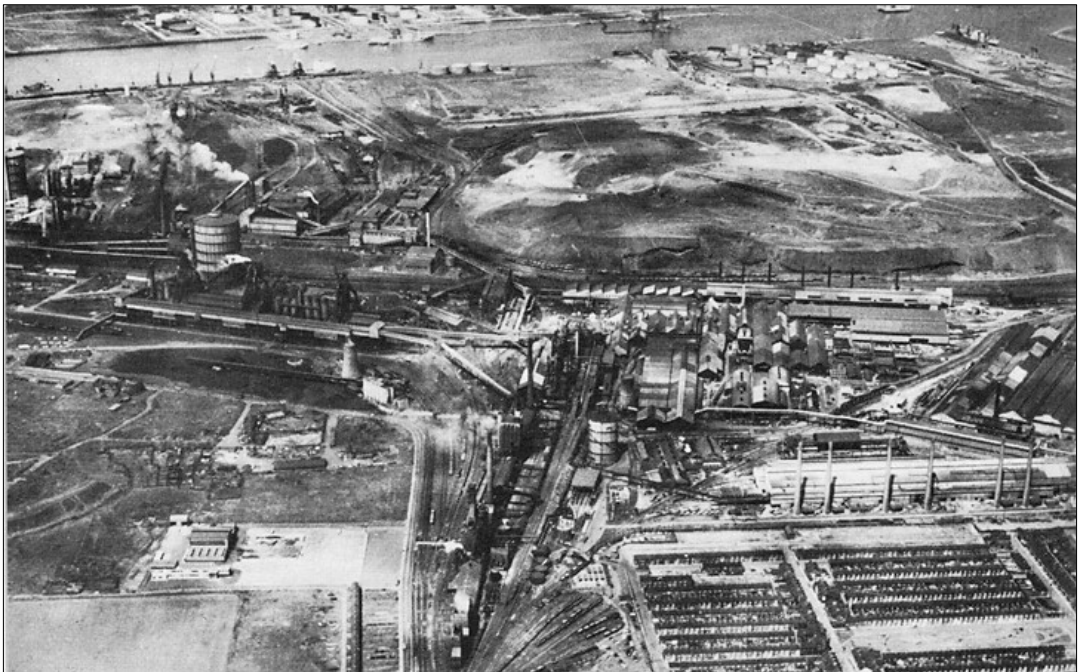
Plate 1: aerial photo of Dorman Long Cleveland Works from mid 1960s; the bank of blast furnaces run up the centre of the photograph

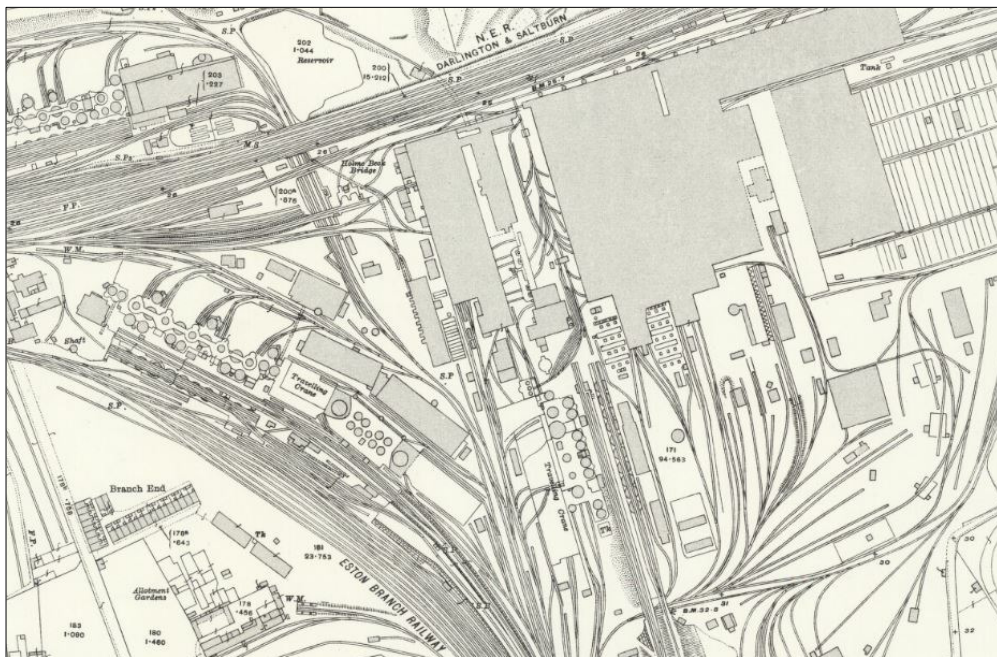
Plate 4: the Cleveland Steel Works, Ordnance Survey 25” to 1-mile mapping 1913; the new arrangement of ‘Yankee Furnaces’ depicted

3.4 The original three furnaces of the Cleveland Works were replaced by two Bessemer furnaces between 1911 and 1913. These were known as ‘Yankee’ furnaces in that they copied American practice. One of these (No. 4) continued in use until 1993. The other was demolished after the First World War and a further furnace (No. 5) was constructed in 1937. In 1947 they were modernised and rebuilt with 18’ 6” hearths and in this form two of them lasted into the 1990s. No. 5 continued in use until 1986. The furnaces were served by a ‘Hi Line’ where the charge was run straight to the top off an elevated rail line. The surviving embankment was part of this rail line and it was carried to the blast furnaces on metal trestles (Daniels 2019, 8). These furnaces were used to produce ferro manganese or spiegle iron, a lustrous, crystalline pig iron containing a large amount of manganese, sometimes 15 percent or more, used in making steel. Manganese and its ferro alloys were of strategic importance in particular to the military as manganese was essential in the production of armour plate.

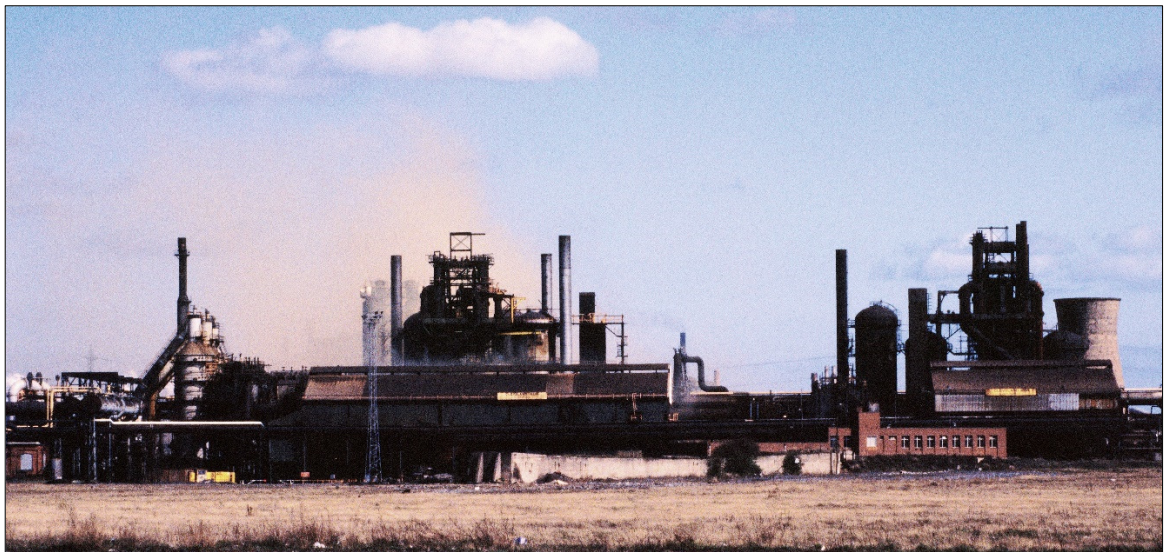
Plate 5: The Cleveland Steel Works in 1993, No 4 is in the middle, No 5 to the right, and gas cleaning plant to the left.

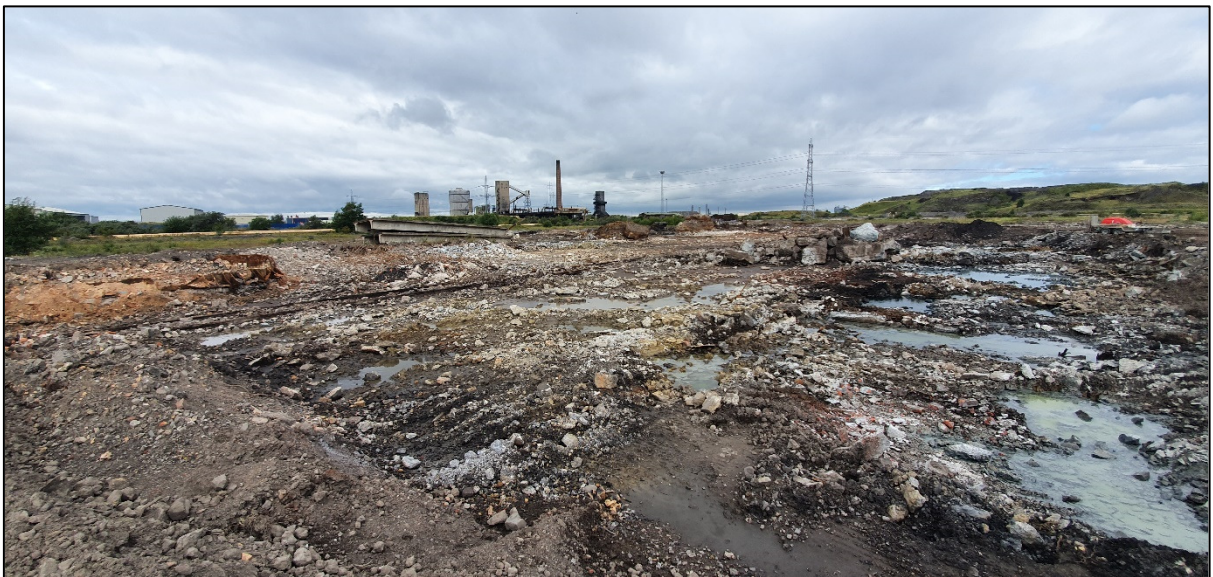
Plate 6: general view of Area B at commencement of watching brief on Ground Investigation (GI) works, 13th July 2020

5.1 During the initial visits to the site, undertaken as part of the watching brief (NAA 2020b), it was clear that some stripping of overburden had taken place across Area B, removing a large quantity of the demolition (and other imported) material which had been previously identified as part of the initial walkover survey undertaken by Tees Archaeology (Daniels 2019, Appendix 1). During that walkover, Tees Archaeology identified remains of blast furnaces, salamander (plug of iron, slag, furnace remains etc from final firing/misfiring), and concrete decking, all partially buried under a spread of demolition debris across the site.

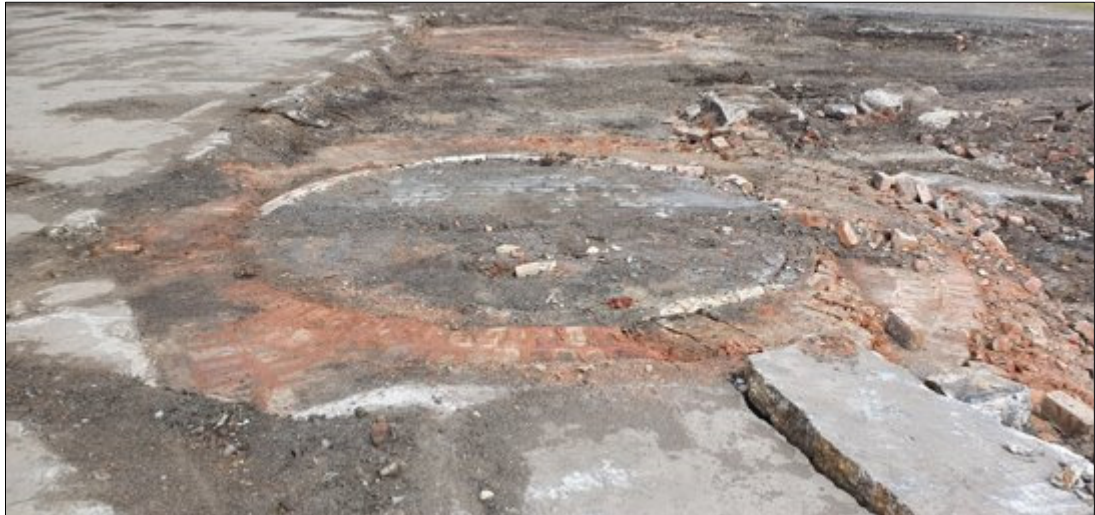
Plate 7: remains of furnaces north of Area B, facing north

- 5.5 No remains of the 19th century Eston Iron Works were identified; these were located north of Area B, and as such outside the direct area of survey, though a brief inspection of their location was carried out. The walkover did identify the remains of two probable furnaces (Plate 3) which lay close to the recorded position of the iron works, but these were probably much later in date, as they were respected by the concrete surfaces of the later industrial complex. The 1978 demolition plan (provided by Prospect Archaeology) indicates these to be positioned in a building marked "*ingot reheating furnace*" for the conversion of puddled wrought-iron bars to merchant bars, through piling, reheating and rolling. It seems most likely that these furnaces relate directly to this building.

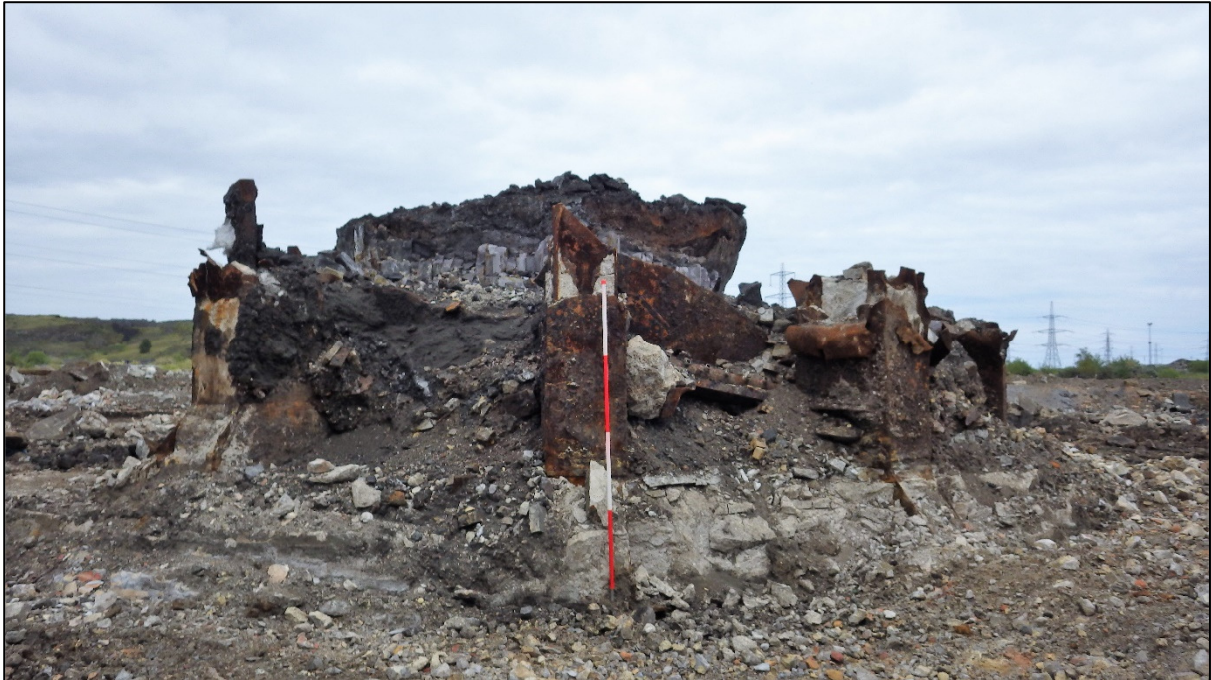
Plate 8: the northern blast furnace base 01 – No. 4. Facing north

- 5.8 The northernmost blast furnace **01** corresponds with the position of No. 4, built in c.1913. The blast furnace was constructed on a thick concrete base c12m in diameter, onto which the iron super-structure was bolted. This latter structure comprised 14 iron I-beams in a radial arrangement, all of which had been sawn off at approximately 1.5m in height. The interior of the furnace was constructed of firebricks, with a scoria brick lining, and an in-situ salamander. The base was largely intact. Of the three bases identified, this was significantly the largest. A large square water-filled void **07**, c. 6m square, lies to the east of the blast furnace, and is clearly visible on the demolition plan of 1978. The function of this void is unclear, but inspection indicated it included stone and concrete in its construction. This appears to correspond with a rectangular structure on both the 25" OS mapping of 1895 and also the demolition plan of 1978, possibly related to the casting beds for the pigs.

- 6.2 Further mitigation and investigation of the remains is recommended, in relation to the two 19th century blast furnaces on the site. Historic England had previously considered No. 4 for scheduling and concluded it was of National Importance. Tees Archaeology has also classed the remains High for Historical Value, Low for Aesthetic value and Medium for communal value (Daniels 2019). Of the recommendations, provided by Tees Archaeology, the following have been completed or are recommended:

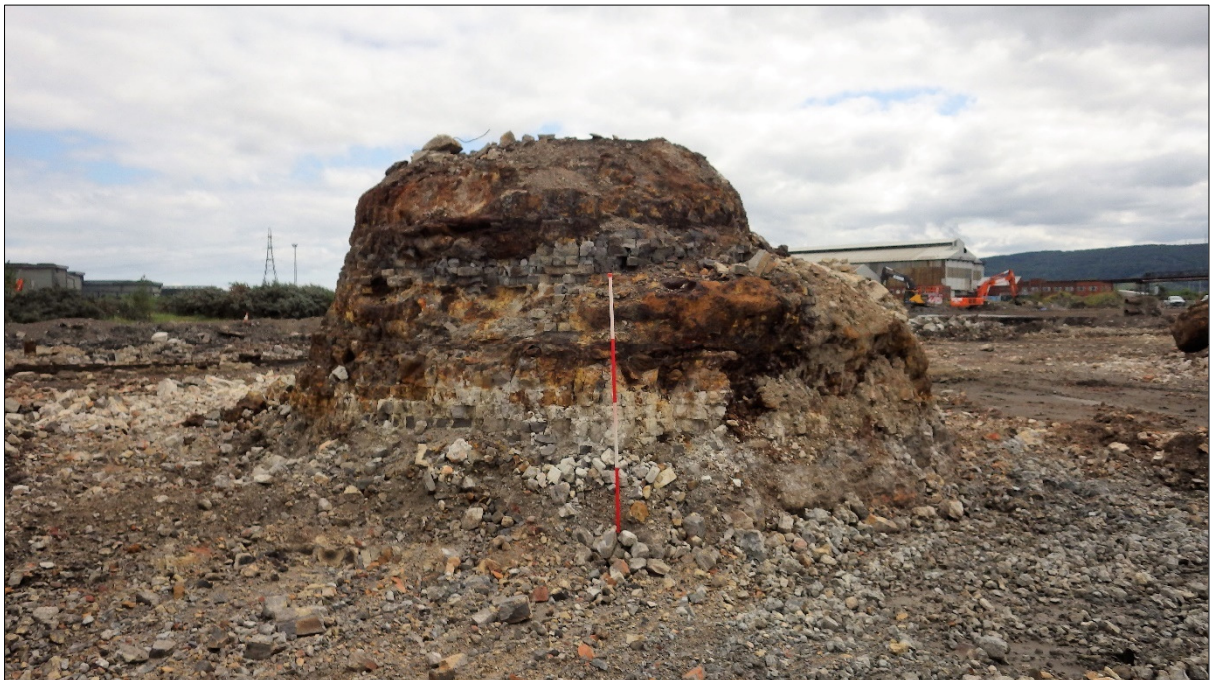
- 5.9 The central blast furnace **02** and the southern blast furnace **03** were by contrast much smaller, at 6.5m in diameter. Both were entirely built of firebrick with no evidence of concrete or iron super-structure, in comparison to **01**. Furnace **02** was the most intact, having its salamander still in situ, and visible evidence of surviving lining just visible towards the top of the stack. Furnace **03** was more damaged, in comparison, with the salamander displaced onto its south-eastern side, and somewhat formless appearance. These two blast furnaces seem to correspond very closely to the positions of the southern two late 19th century blast furnaces shown on the 1893 Ordnance Survey mapping constructed in 1874, with the third blast furnace originally located just north of **01**, and demolished sometime around the latter's construction.

Plate 9: blast furnace 02, facing south

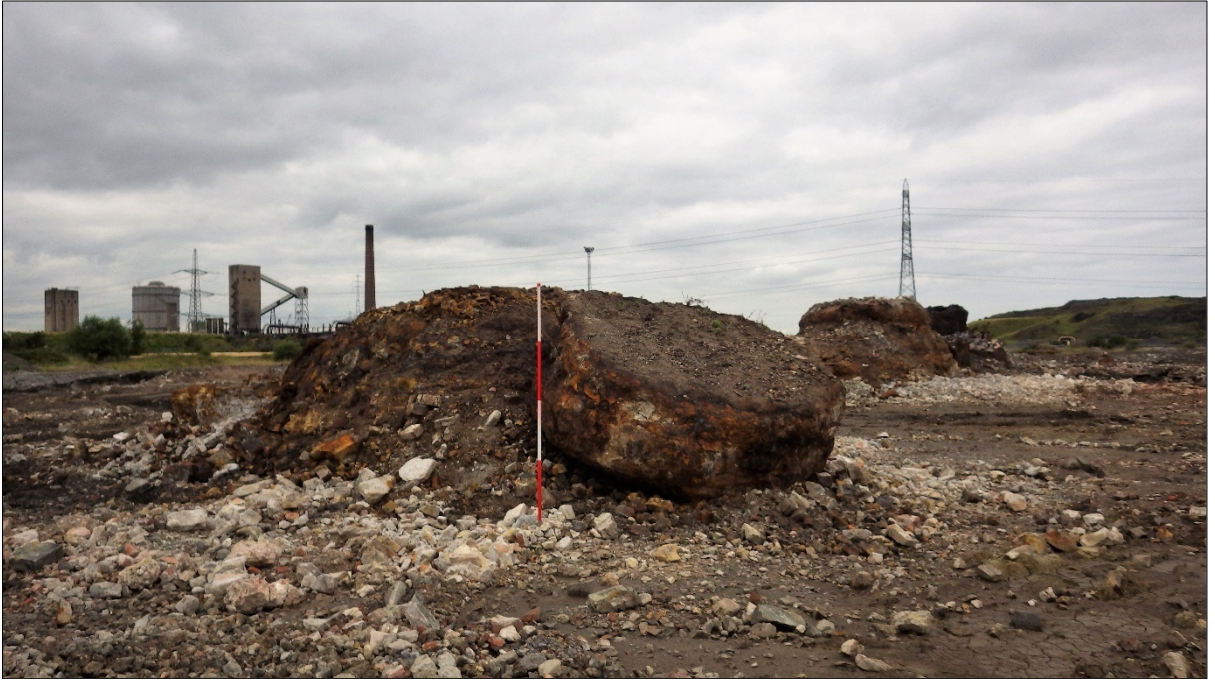
*Plate 10: blast furnace **03**, facing north (furnaces **02** and **01** in the background); displaced salamander in the foreground*

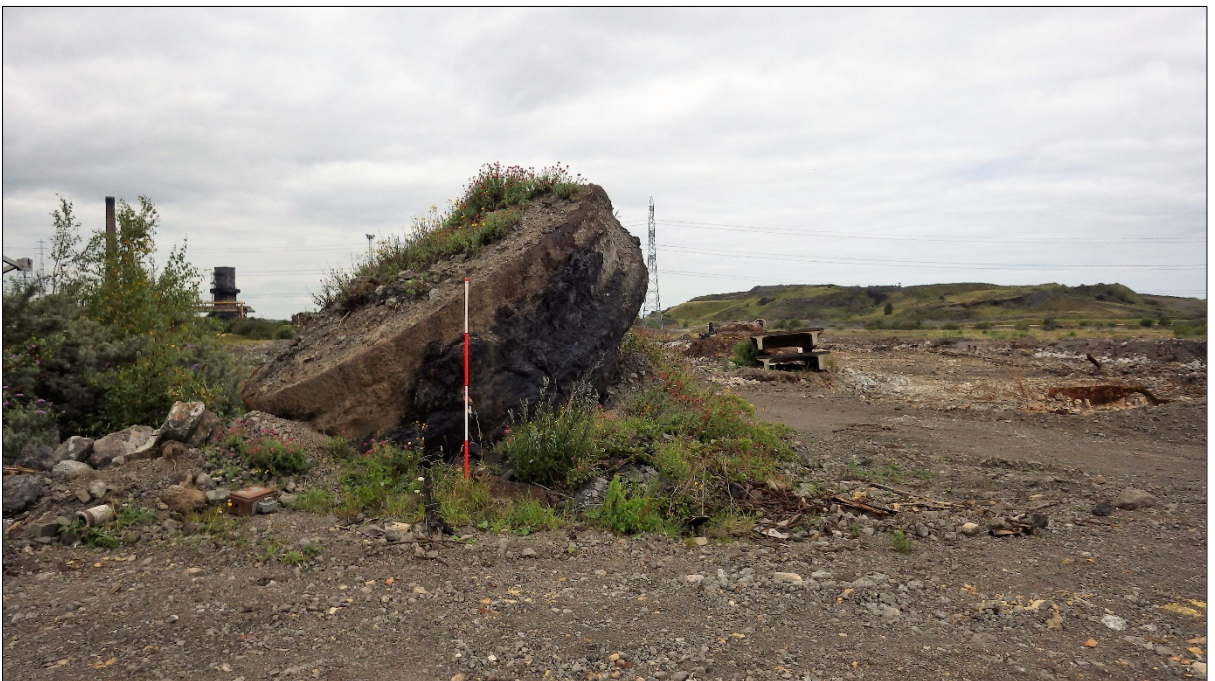
- 5.10 At the very southern end of the site, and just beyond the survey area, is a large, displaced salamander, previously identified by Tees Archaeology during their walkover in 2019 (Daniels 2019, Appendix 1). The salamander clearly does not relate to any of the existing blast furnaces, and may have originally come from No. 5, built in 1937, which was located at the south-western corner of the site. The possibility remains that the blast furnace lies close to, or beneath, this salamander, and has not been exposed by recent stripping, or that the blast furnace has been wholly demolished and removed.

*Plate 11: salamander **04**, facing north*

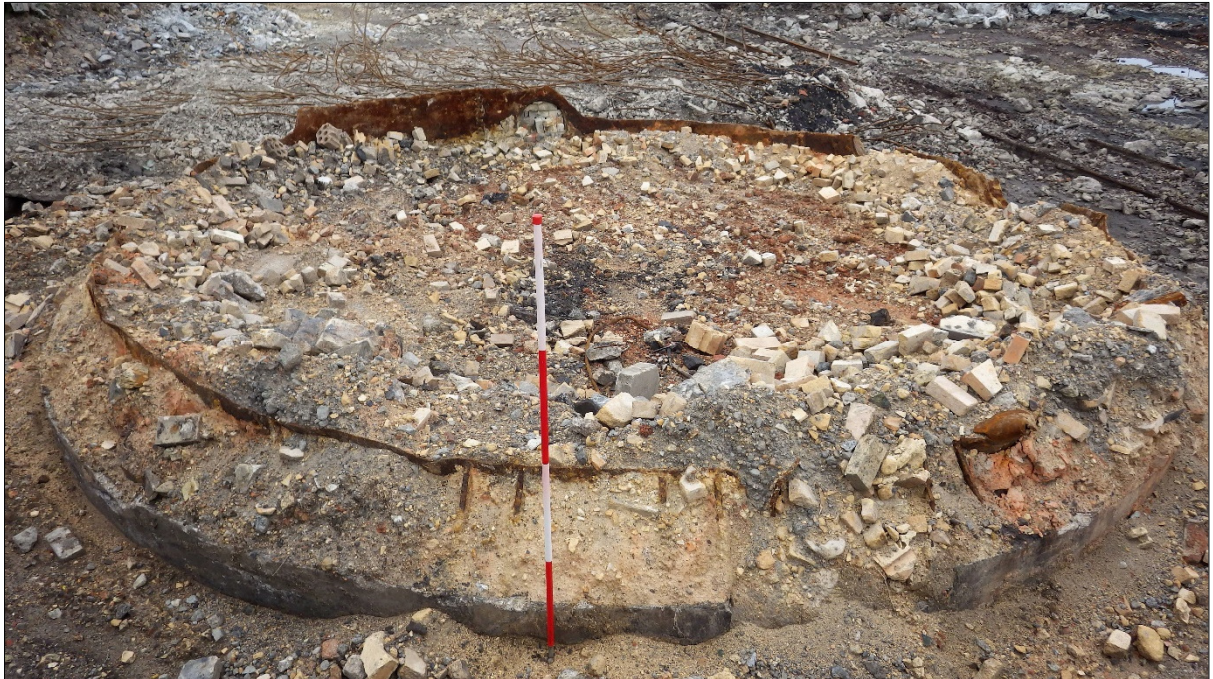
- 5.11 To the north-east of salamander **04**, a large circular iron structure **05** was identified, which lies very close to the blast stove (shown as No.17) on the 1978 demolition plan,

and which would have served No.5 blast furnace. The stove sits on a large circular concrete foundation 14m in diameter, with a circular raised concrete plinth 9m in diameter at its centre, onto which the iron super-structure is bolted. The interior of the stove appears to be heat affected, as would be expected. The walls of the structure had been cut down to the level of the top of the plinth, the whole structure now standing no more than 1m in height.

Plate 12: blast stove 05, facing north

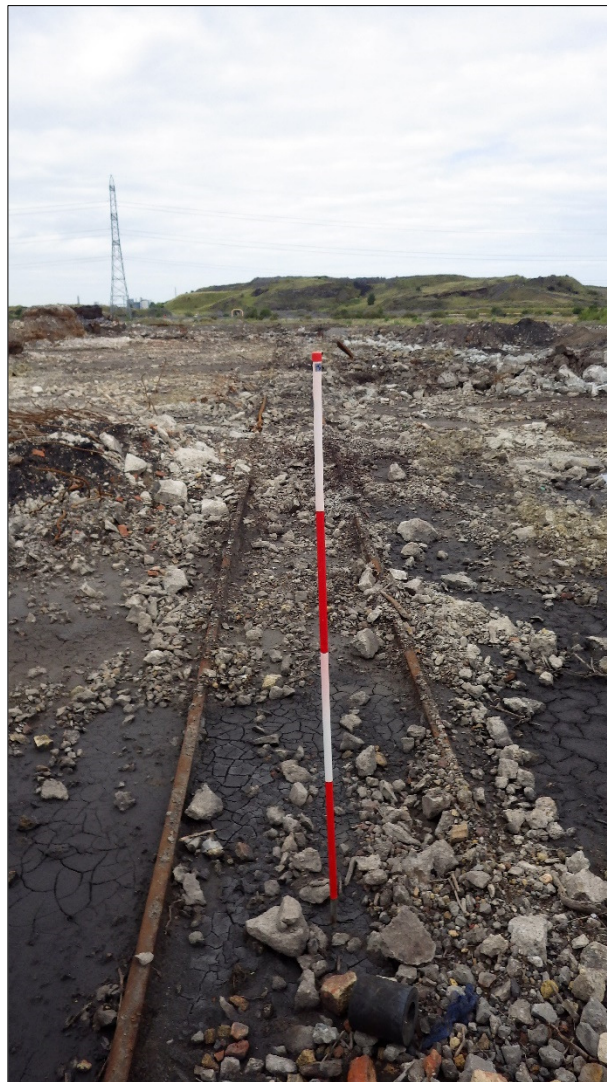
- 5.13 A single section of railway **06**, 105m in length, runs north-south, just east of the blast stove **05**, and exposed in the recently stripped area. The railway survives in reasonably good condition and is 1.4m in width, with the rails laid on substantial concrete foundations with timber sleepers every 2.2m. The railway would have been

located west of (or perhaps beneath) the Hi-Line, which served to provide coal and ore for the respective bunkers which fuelled the blast stoves, and was removed at the time of the demolition in 1994. The position of the Hi-Line is suggested by the large, banked ramp to the south, which lead up to it. This lower railway line, with its position immediately adjacent to the stoves, was probably used to remove fuel ash from the stoves during cleaning for disposal elsewhere on site, and possibly the products of the furnace (pig iron). It seems likely that the slag was removed from the west side, into the main railway network, tipped directly into wagons during the smelting process.

Plate 13: railway line 06, facing north

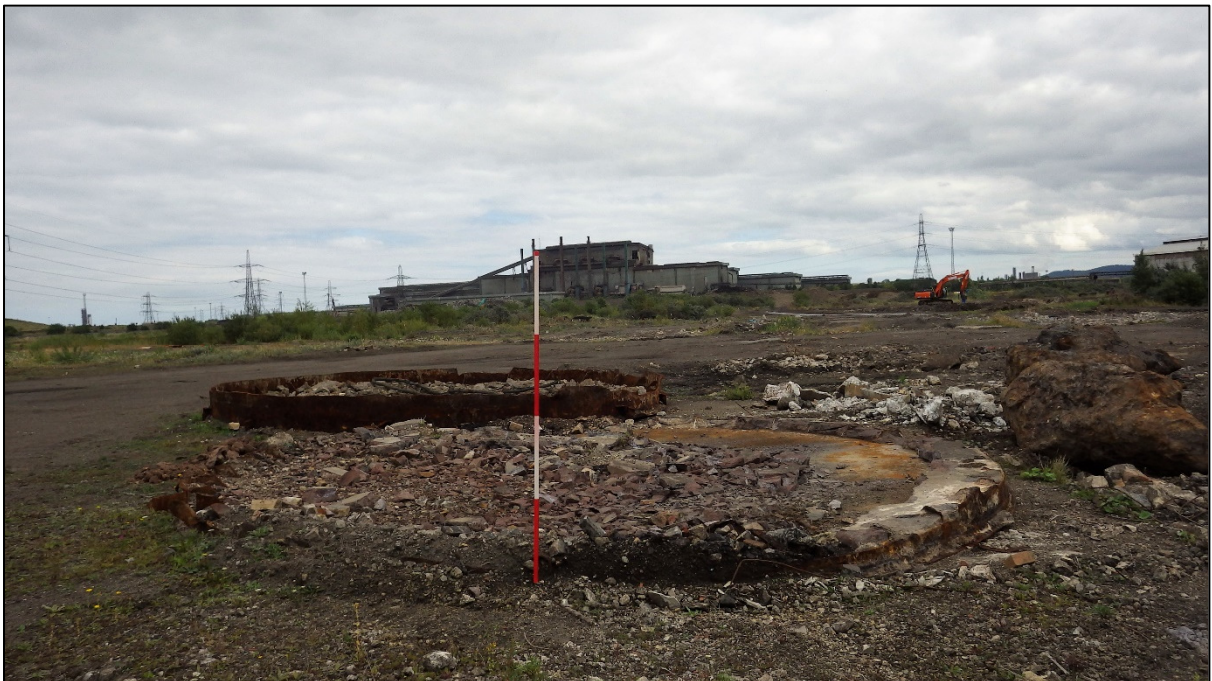
- 5.14 To the north of blast furnace **01**, two circular iron structures **08** and **09** were identified, both no more than 0.5m in height. The structures appeared to be partially or completely displaced, but or at least lie very close to the position of two similar structures shown on the 1978 demolition plan as 'gas washer plant', and visible on the 1993 photograph of the site (Plate 5). The plant, originally built in 1918, was designed to remove impurities (dust and chemicals) from the smoke produced by the blast furnaces, prior to release into the atmosphere. Both structures comprised iron walls affixed to a concrete base and were 7.8m in diameter.

Plate 14: gas washer bases, 08 and 09, facing east
