ARCHAEOLOGICAL WATCHING BRIEF
FINAL REPORT

GRANGE ROAD
FENHAM
NEWCASTLE UPON TYNE

New water main

Report of negative results

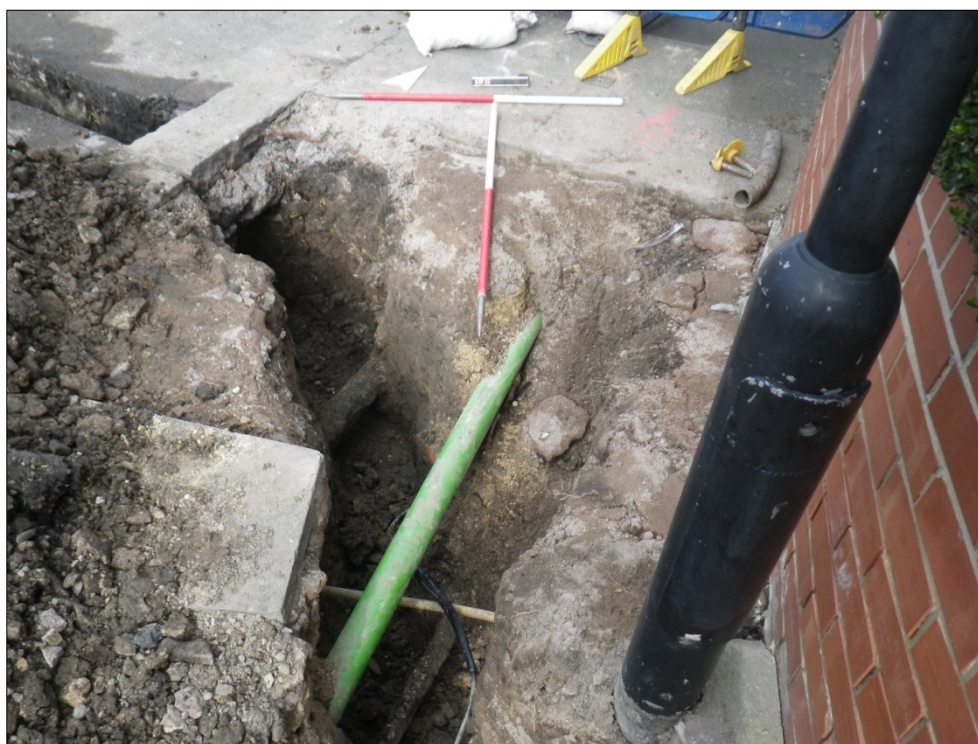
Plate 2: Trench cut through footpath showing existing services

The section of trench within the footpath measured 33.55m in length, 0.5m in width and was excavated to a maximum depth of 0.9m. Unlike the section through the road, natural clay and bedrock were encountered at ever-decreasing depths eastwards to a minimum depth of 0.15m

below present ground levels. Overlying the natural substrate predominantly in the western section was a fine compacted coaly deposit, excavated to a depth of only 0.1m. This was overlain by material with characteristics very similar to those found under the bedding material belonging to the road. This deposit was mainly brown clay with numerous inclusions of laminated stone to a maximum depth of 0.65m.

Cutting these deposits and surviving at various depths below ground level were six services: one within green plastic ducting; an electric cable for street lighting; a water pipe; a plastic yellow gas pipe; plus, a badly rusted pipe of unknown service. Each utility was within its own trench, and all backfilled with grey silty clay that contained fragments of sub-angular yellow sandstone. These service trenches all followed the same south-east/north-west alignment, parallel with Grange Road, except for the gas supply which intersected these at right-angles. In turn these utilities trenches were overlain by a 0.05m layer of coarse reddish-brown sand, the bedding material for the present-day public footpath. The public footpath comprised rectangular flagstone and areas of concrete where flagstone had been removed (Plate 2).

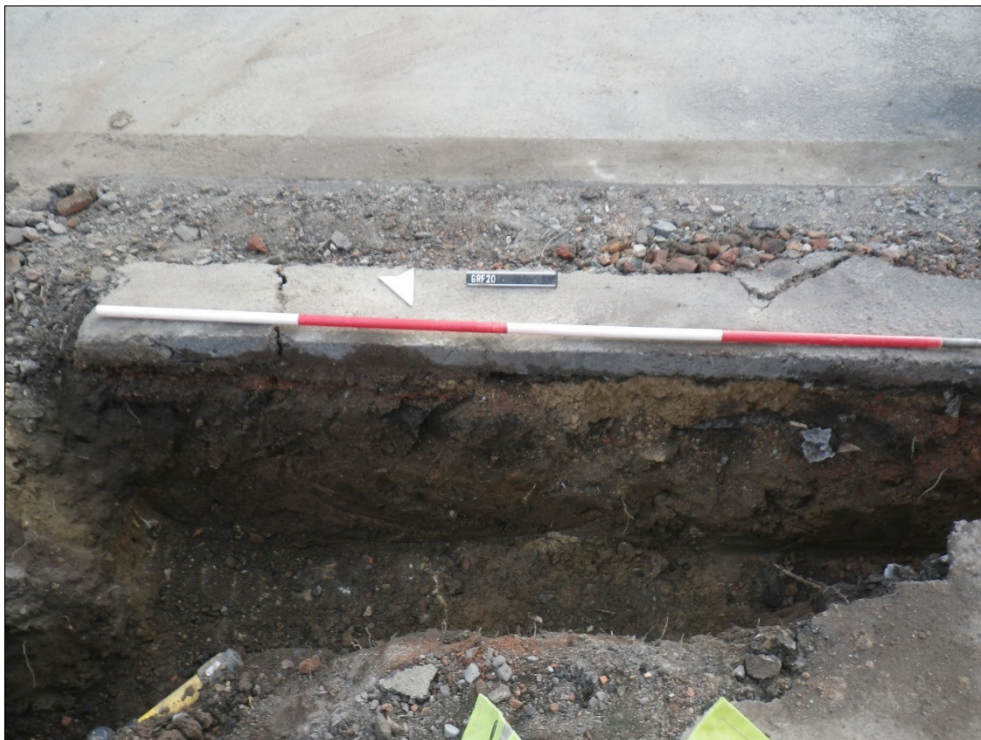
Plate 3: Northeast-facing section of trench within development area

The last section of trench was situated at the entrance to the new housing development. This section measured 4.4m in length to a maximum depth of 0.9m. The natural substrate was again observed at various depths, which increased as the route moved eastwards. As with a majority

of the trench it was again overlain by a 0.4m layer of firm compact brown clay and stone. Sealing this was a continuous thin layer of fine dark-grey silt and sub-angular stone. This material was overlain by a compact regular thick layer of building debris comprising crushed red brick. Cutting these deposits on an oblique easterly alignment was a modern service trench, excavated to a maximum depth of 0.35m, and filled by yellow dolomite chippings. Contained within the back fill was a single stone glazed drainage pipe. Overlying these deposits was the present ground surface comprising tarmac and sub-base to a combined thickness of 0.2m (Plate 3).
