HISTORIC BUILDING  
RECORDING

WHITE KIRKLEY FARM RANGE,  
FROSTERLEY, COUNTY  
DURHAM

NAA 21-86  
May 2022

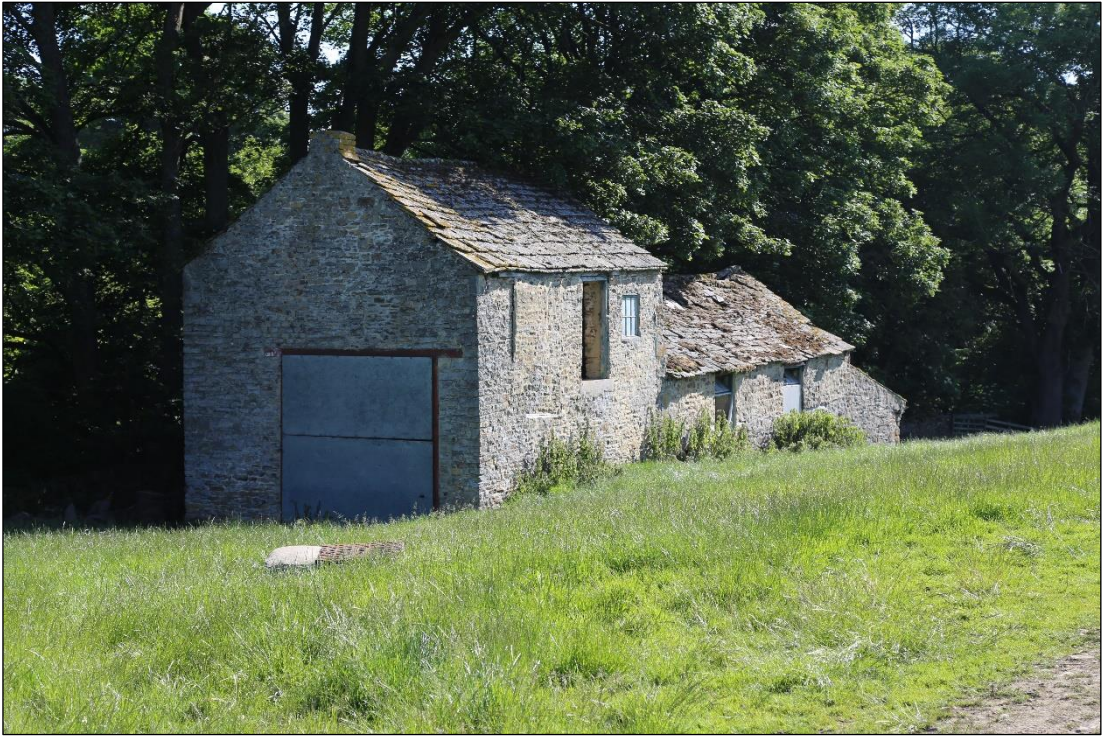
*Plate 10: general view of the farm range looking north-east, with the two-storey barn foremost.*

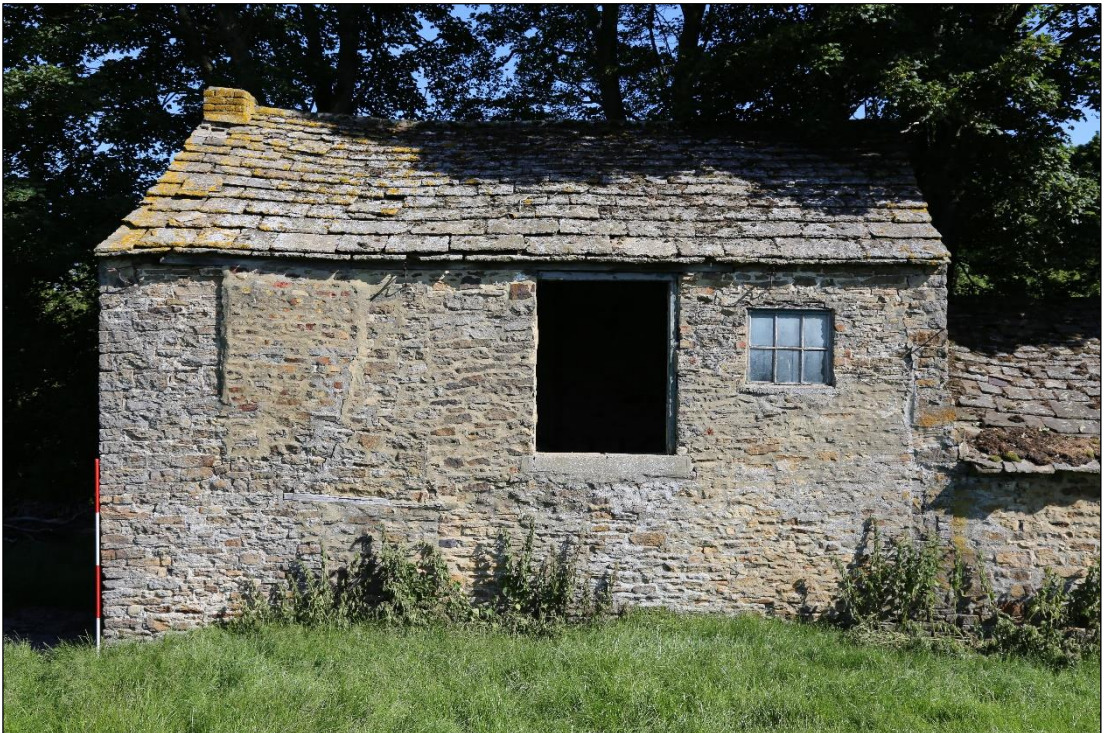
*Plate 11: south-facing elevation (1100) of the barn.*

- 5.8 The south-facing elevation features a single door (1101) and window (1102) at first-floor level. There is also evidence of two earlier blocked openings (1104 and 1105) (Plate 11, Fig. 3). At ground-floor level, at the west end of the building, there is a single blocked door opening (1103), set with a sloping wooden lintel (Plate 12).

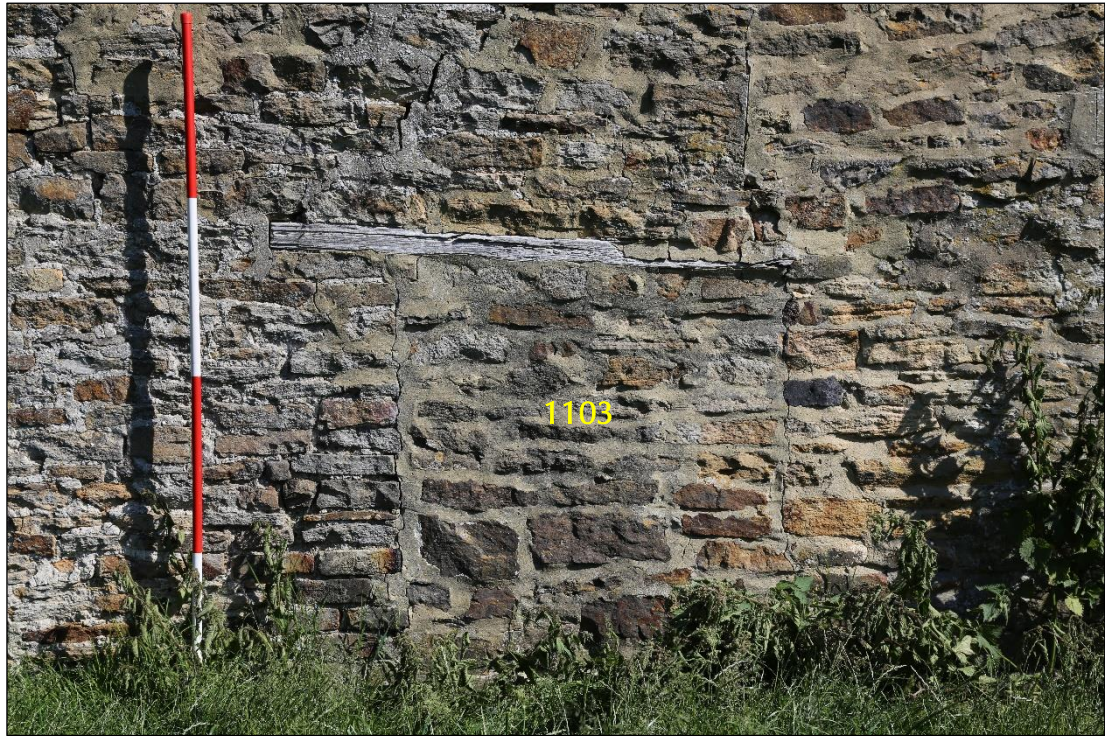
*Plate 12: blocked opening 1103 at ground-floor level within elevation 1100.*

- 6.7 At ground-floor level, the barn has a single blocked opening (1103), the size of a small door, in the south wall. A modern opening (1202) in the west gable may be a replacement of an earlier larger opening.

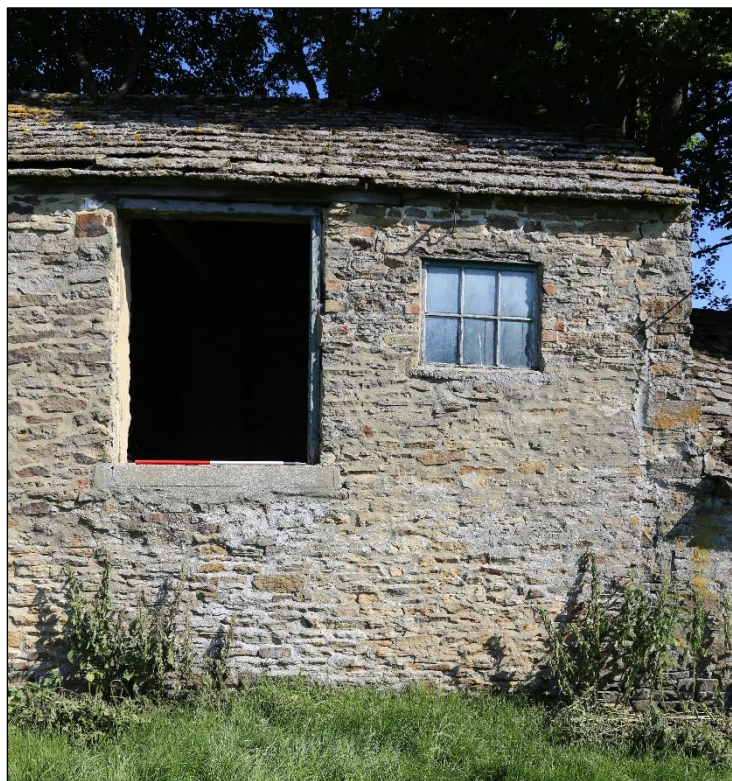
- 5.9 At the first-floor level, there is a fixed six-paned wooden-framed window at the east end, set with a wooden lintel (1102). Off-centre to the west of the window is a large pitching hole (1101) for loading hay (Plate 13). Part of a wooden frame survives, indicating that this may originally have had a door. The pitching hole shares a long wooden lintel with a blocked opening immediately to the west (1104 and 1105). This was originally one opening, measuring c.1.9m wide, which was blocked in two phases. The east side was first infilled using stone rubble (1105) creating an opening c.1.2m wide. The reduced opening was later blocked with bricks (1104) (Plate 14).

*Plate 13: first-floor window 1102 and pitching hole 1101 within elevation 1100.*

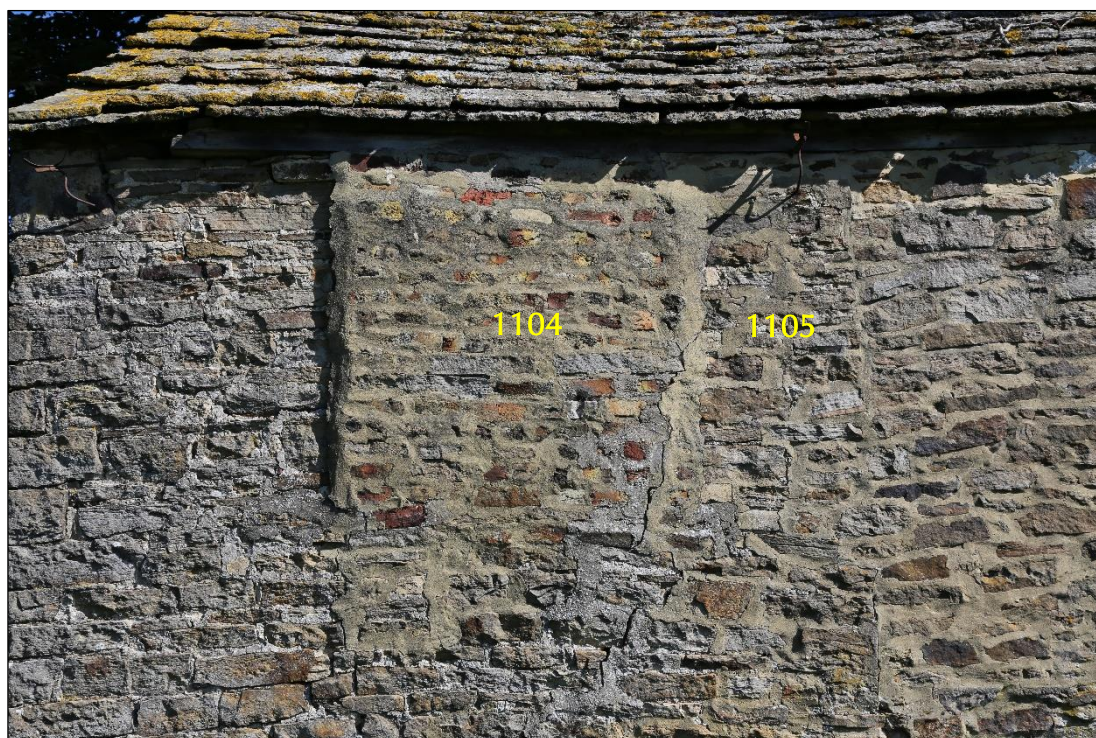
*Plate 14: blocked opening 1104 and 1105 at first-floor level within elevation 1100.*

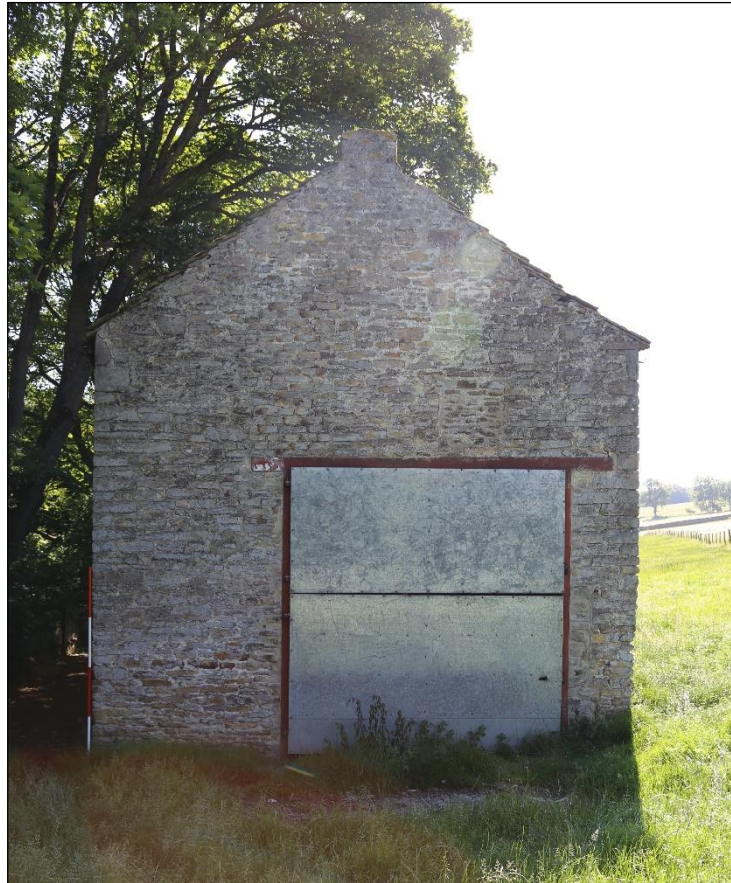
*Plate 15: west-facing elevation (1200) of the barn.*

- 5.10 The gable end elevation has a brick chimney stack projecting from the apex of the roof. There is a large modern opening on the south side (1202) that may be an enlargement of an original door into the barn as there is no further evidence for a large external entrance at ground-floor level. The present door has a steel lintel and frame and a galvanized metal split-door that is hinged to the north and opens outwards. There is a flat concrete platform in front.
- 5.11 Above the door is a small, blocked window (1201) (Plate 15, 16). Evidence from the interior of the building suggests that this had a wooden lintel (Plate 17).

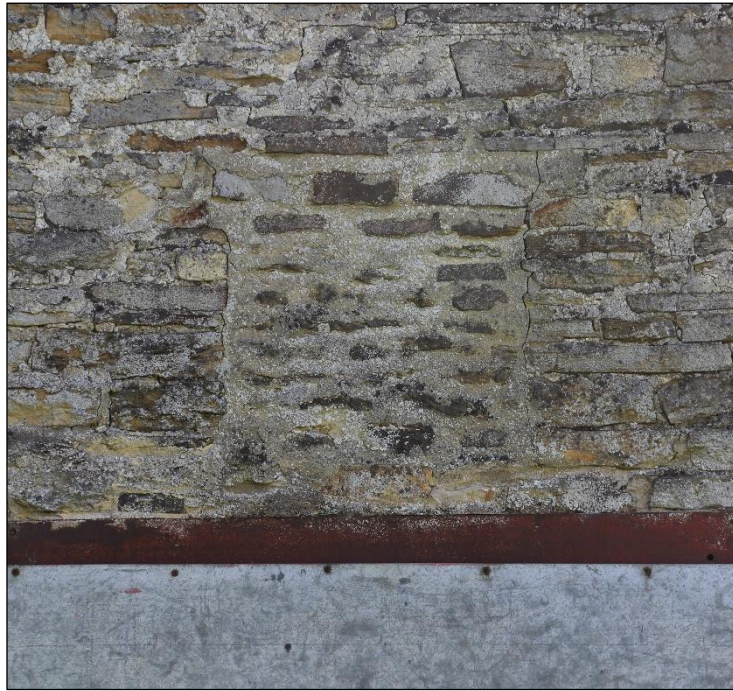
*Plate 16: blocked opening 1201 within elevation 1200.*

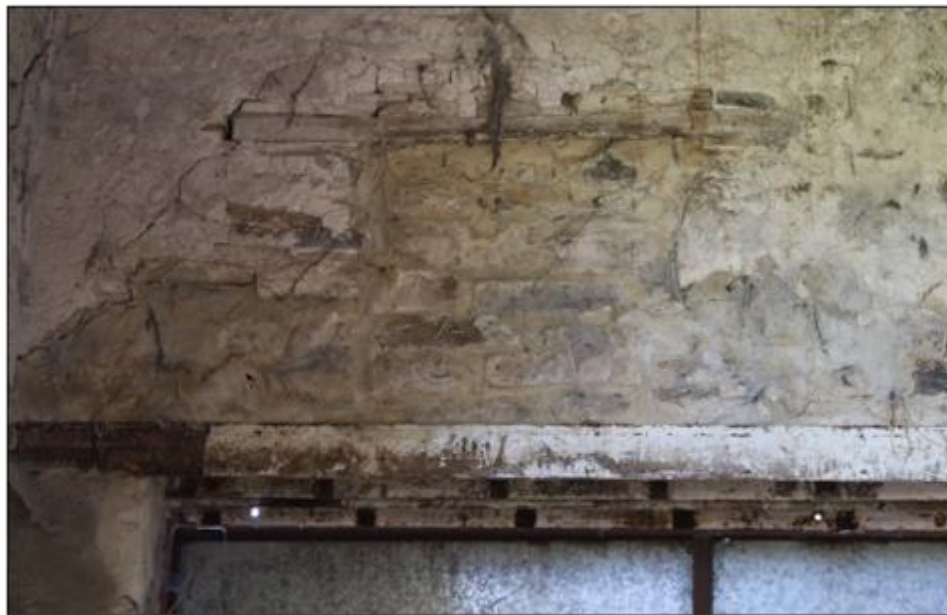
*Plate 17: blocked opening 1201, seen internally with a wooden lintel, within elevation 1600.*

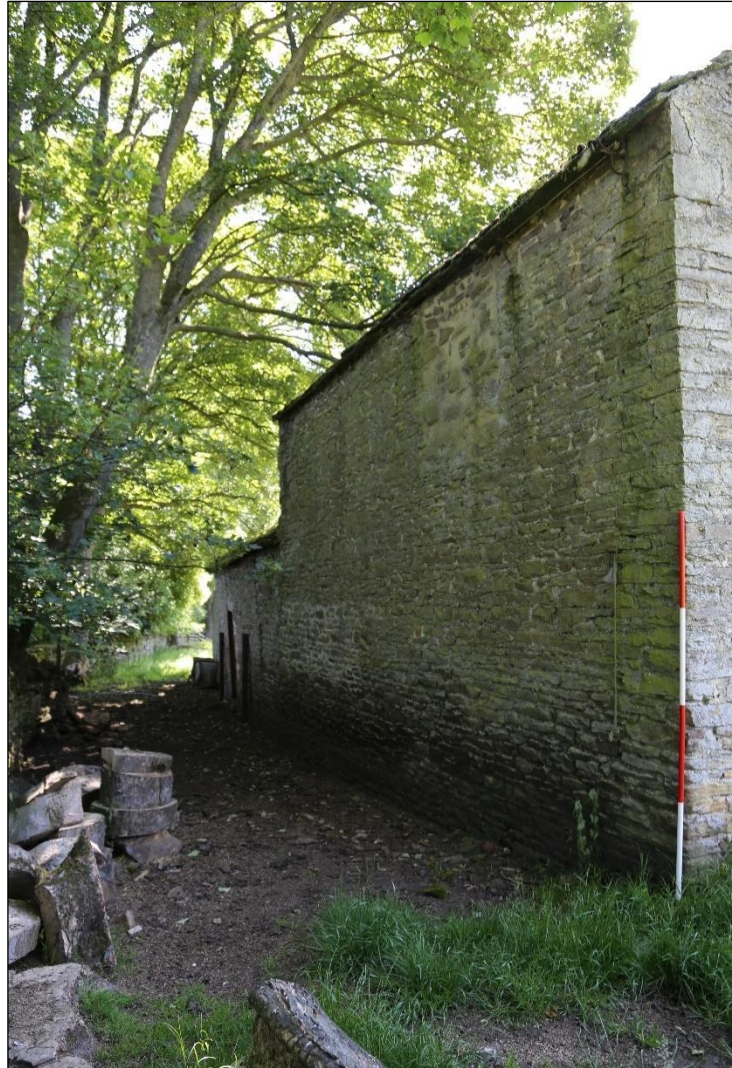
*Plate 18: north-facing elevation (1300) of the barn.*

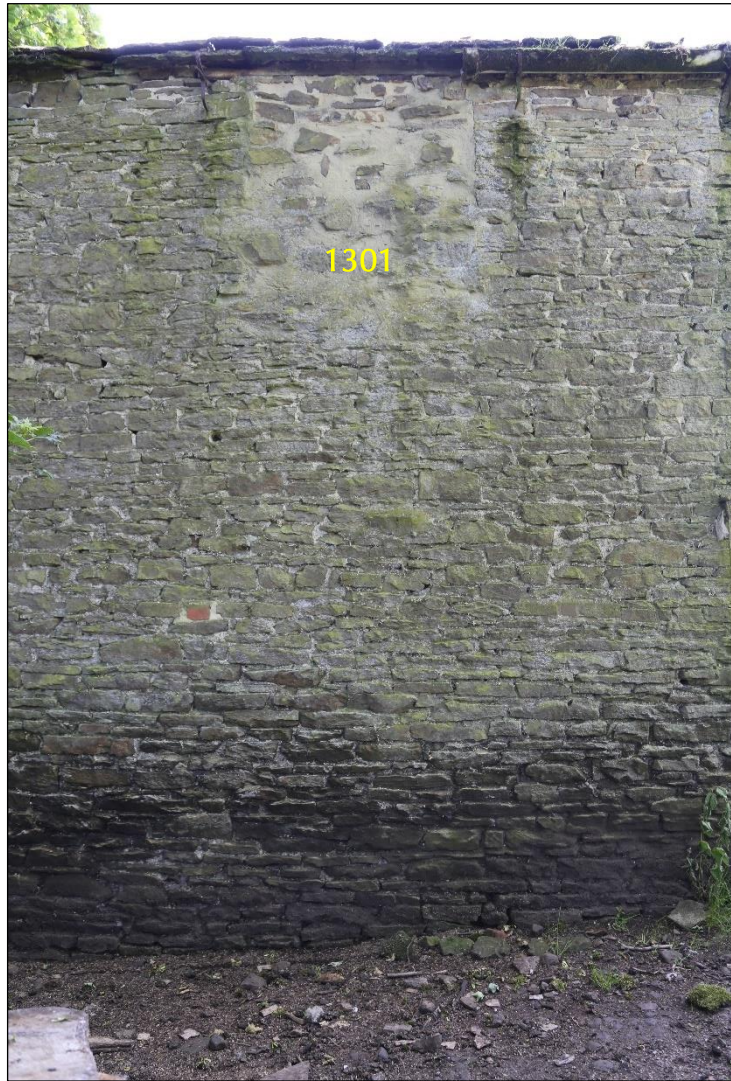
- 5.12 The north-facing elevation is relatively plain with only a single blocked opening (1301) at first-floor level at the west end (Plate 19) This appears to be of a similar size to the surviving pitching hole (1101) in the south-facing elevation (1100).

*Plate 19: first-floor level blocked opening 1301, elevation 1300.*

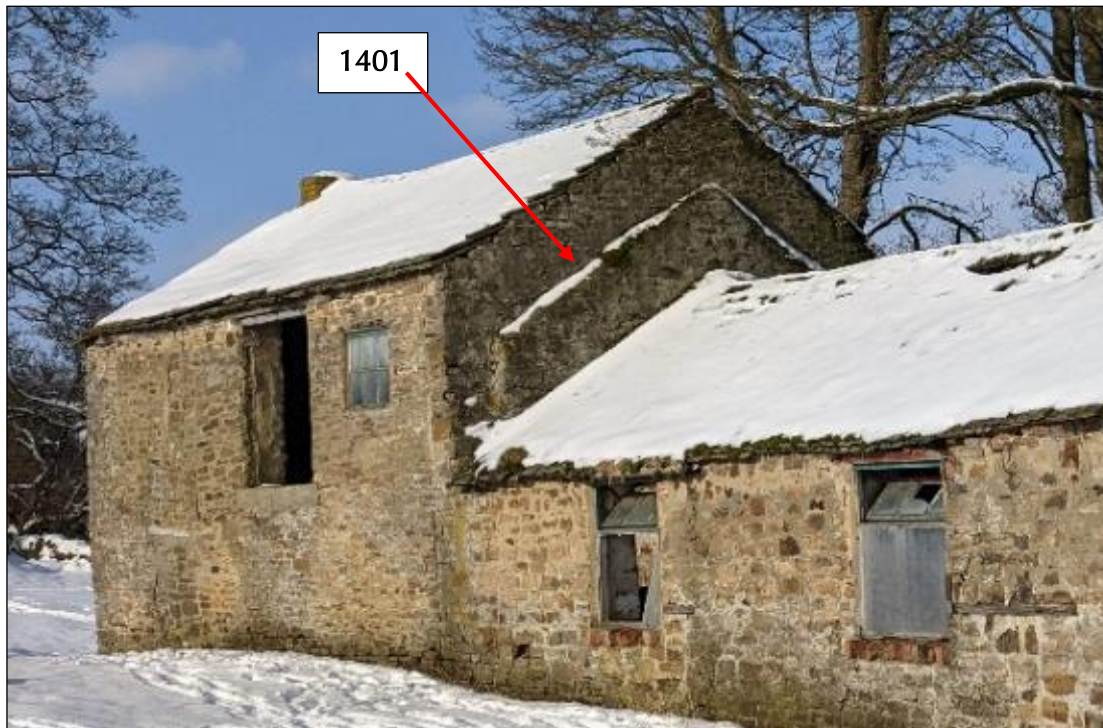
- 5.13 The east-facing elevation is only partly visible above the current roof level of the byre (2000). A protruding wall scar (1401) can be seen, which indicates the original height of the byre (Plate 20).

*Plate 20: east-facing elevation (1400) of the barn showing wall scar 1401 indicating the original height of the byre (image provided by the client).*

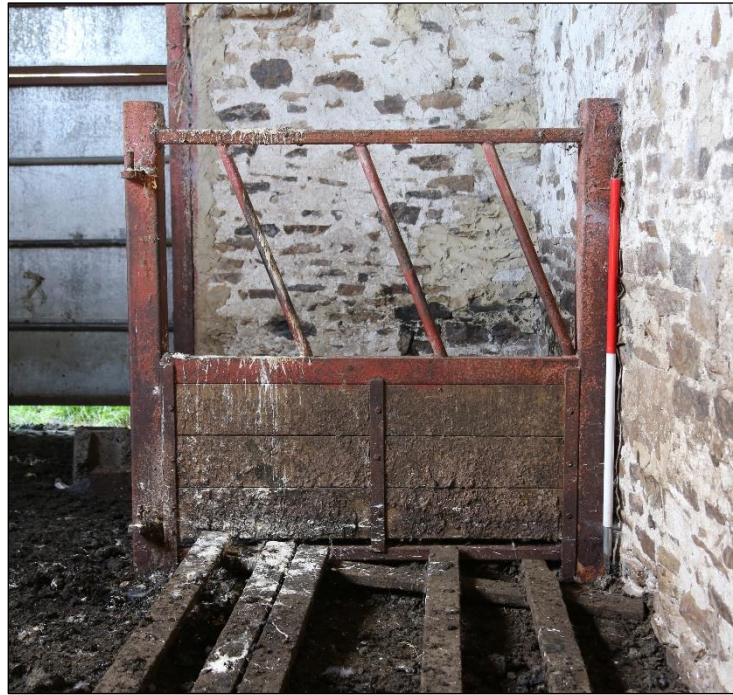
- 5.16 The floor slopes down towards the byre which is accessed through a modern opening in the barn's east gable (1800, 2500). The floor is concrete. Several modern square steel posts survive in situ at ground-floor level. These would have been used to support metal and wood stall-partitions and gates used to divide up the space internally (Plate 21).

*Plate 21: surviving in situ steel posts and partition.*

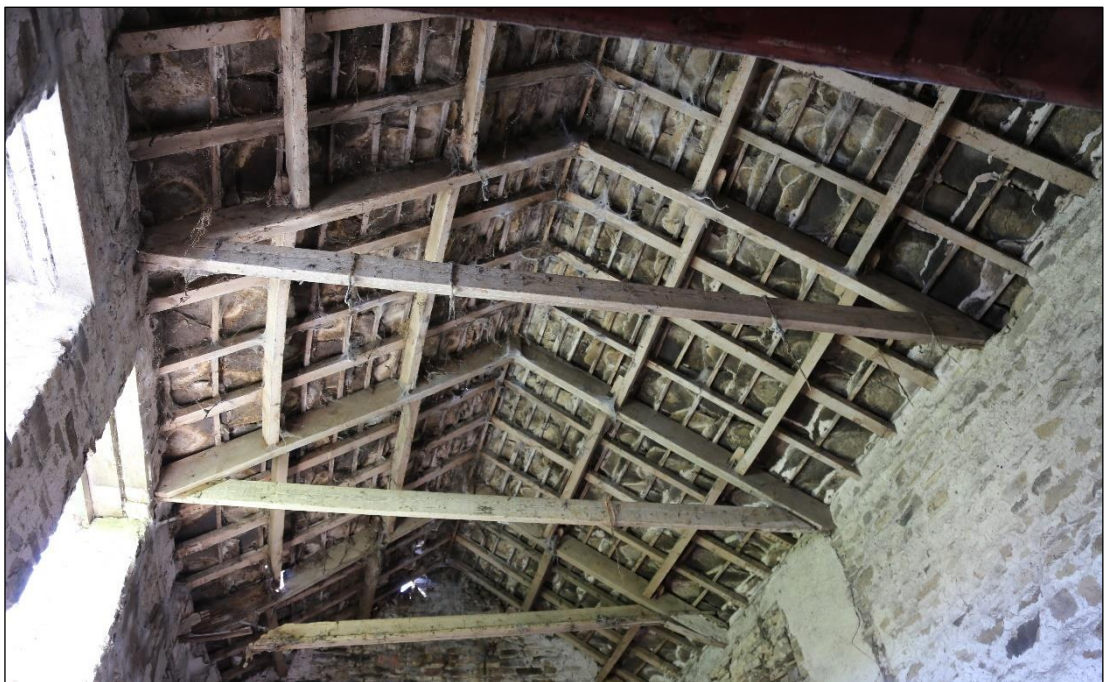
*Plate 22: roof structure within the barn (1000).*

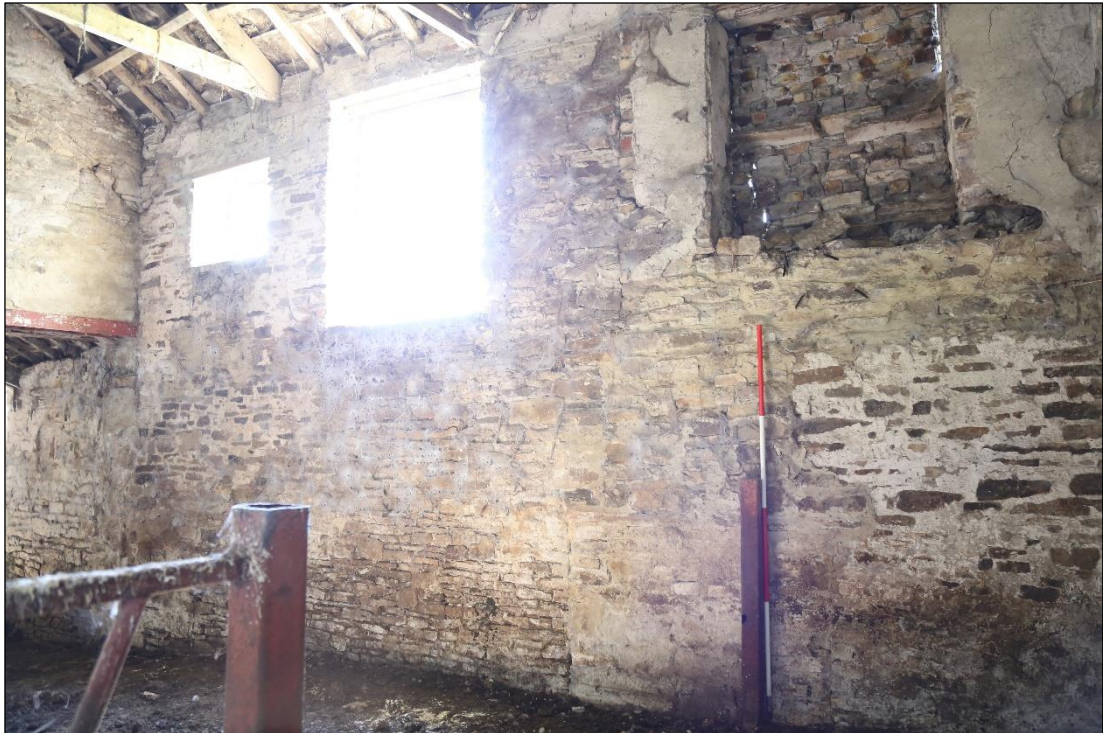
*Plate 23: general view of elevation 1500 showing the current openings (1101, 1102) and the blocked apertures (1103, 1104, 1105) (the ground-floor blocked opening 1103 is to the left of the ranging rod).*

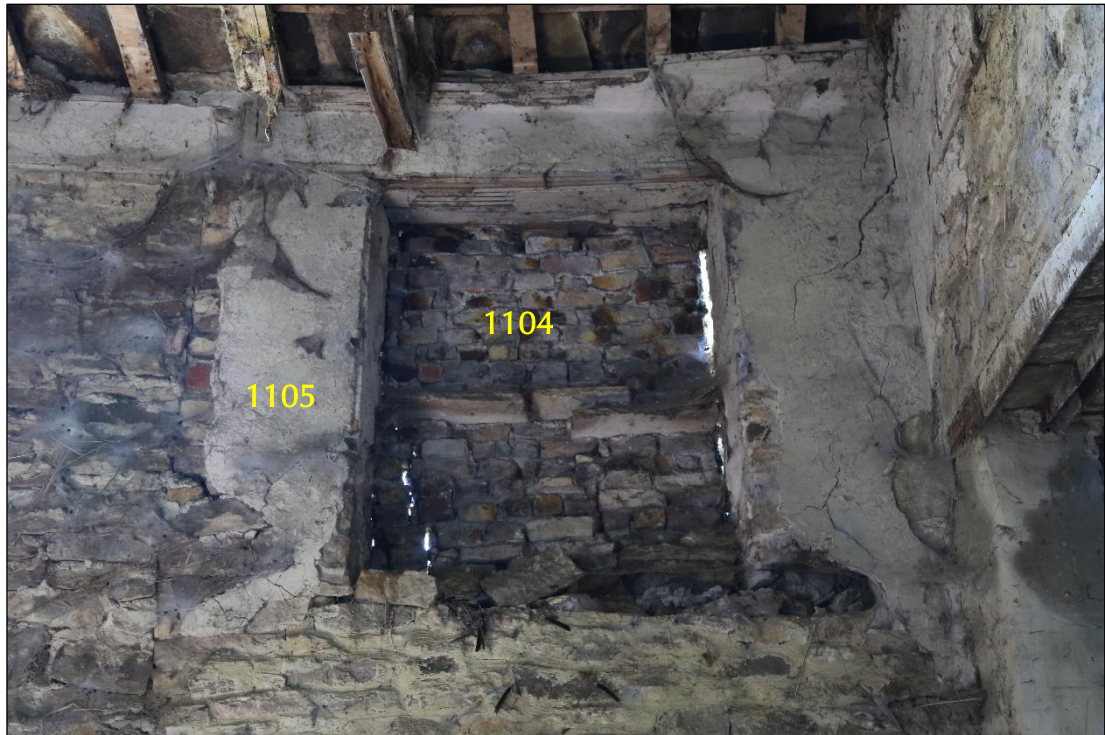
- 5.19 This internal elevation features two phases of blocking at first-floor level (Plate 24). The first phase (1105), to the left, occupies the full depth of the wall and has subsequently been rendered. The second phase (1104) is only one brick deep, forming an alcove. Above this there is evidence for the remains of a lathe and plaster ceiling.
- 5.20 The six-pane window (1102) and pitching hole (1101) have been discussed above (see south-facing exterior elevation 1100, para. 5.9).

*Plate 24: first-floor level blocked opening (1104, 1105) within elevation 1500. The blocking to the left (1105) has been rendered over.*

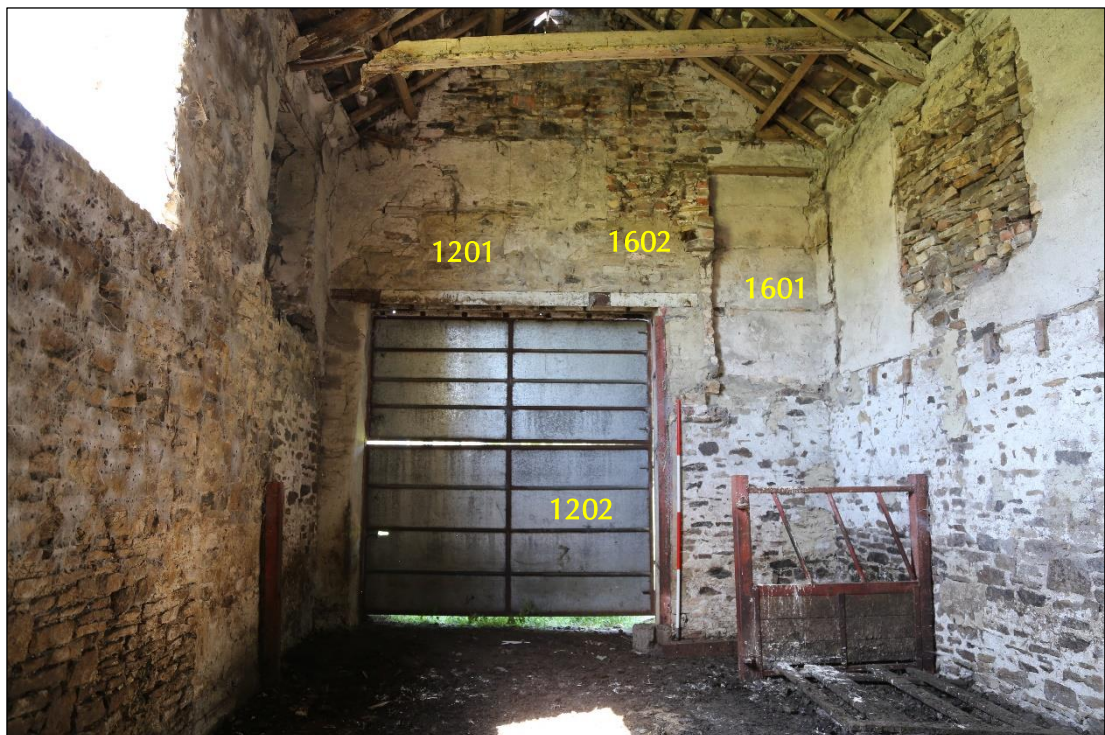
*Plate 25: internal elevation 1600 showing the modern inserted door (1202) alongside the remains of a chimney (1602), an alcove or cupboard (1601) and a blocked opening (1201).*

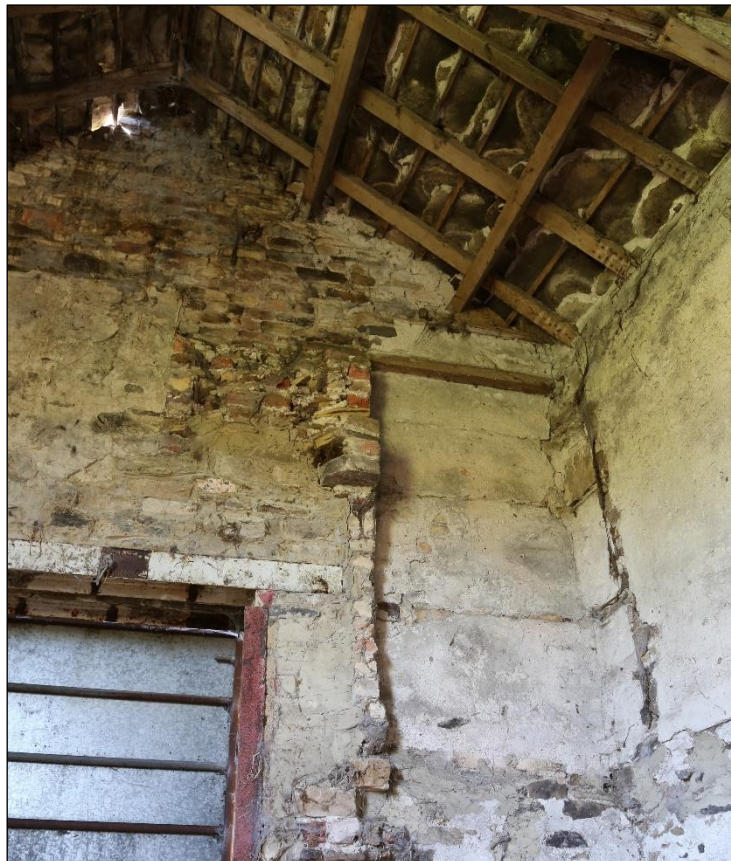
- 5.22 Between the alcove and the end of the modern door are the remains of a brick-built chimney (1602). Much of this has been lost, but enough remains to make some observations. The fireplace and chimney breast are offset to the right of centre. Protruding bricks survive to the same height as the alcove (1601). Several of these are shaped. The wall has been rendered at first-floor level up to this height. Above the render, the inner face of the gable wall is constructed in brick. The chimney stack sits centrally on the apex of the roof; therefore, the chimney structure would have needed to kink to the left in order to join up with the surviving chimney stack. There is no evidence for a second flue, which would have indicated a fireplace on the ground-floor. The chimney may therefore have been offset due to the location of the small-blocked window (1201) to the south.

*Plate 26: detail showing the alcove (1601 right) and the remains of the chimney (1602) and the brick walling above.*

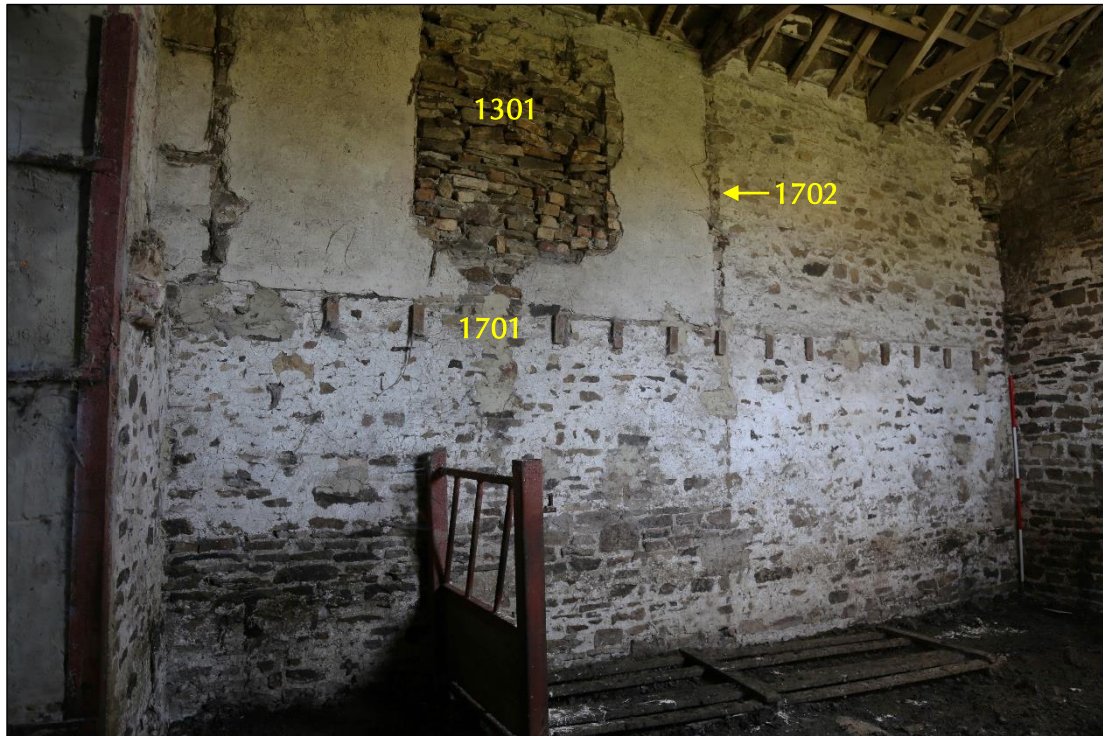
*Plate 27: internal elevation 1700 showing blocked opening 1301 and the sawn-off floor joists (1701).*

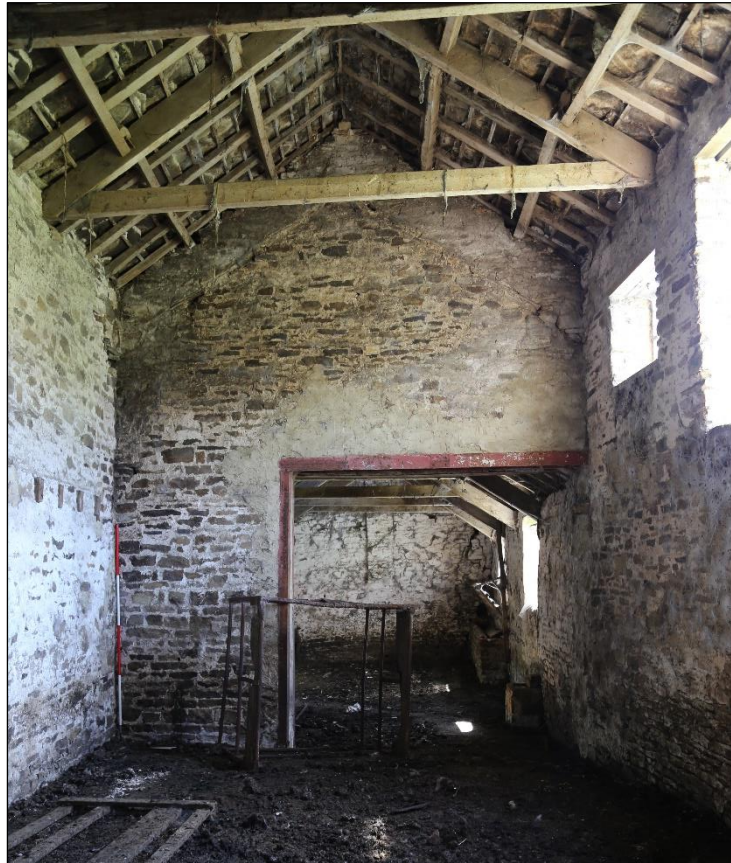
*Plate 30: internal elevation 1800.*

- 5.28 The west-facing internal elevation was originally the end gable wall of the byre (2000), the height of which can be seen as an inverted 'V' (Plates 30 and 31). The height of the byre wall was increased to accommodate the two-storey barn later built up against it. The walls of the barn initially butted up against the byre, forming straight joints. These are keyed-in higher up at the point where the gable was raised in height (Plate 32).

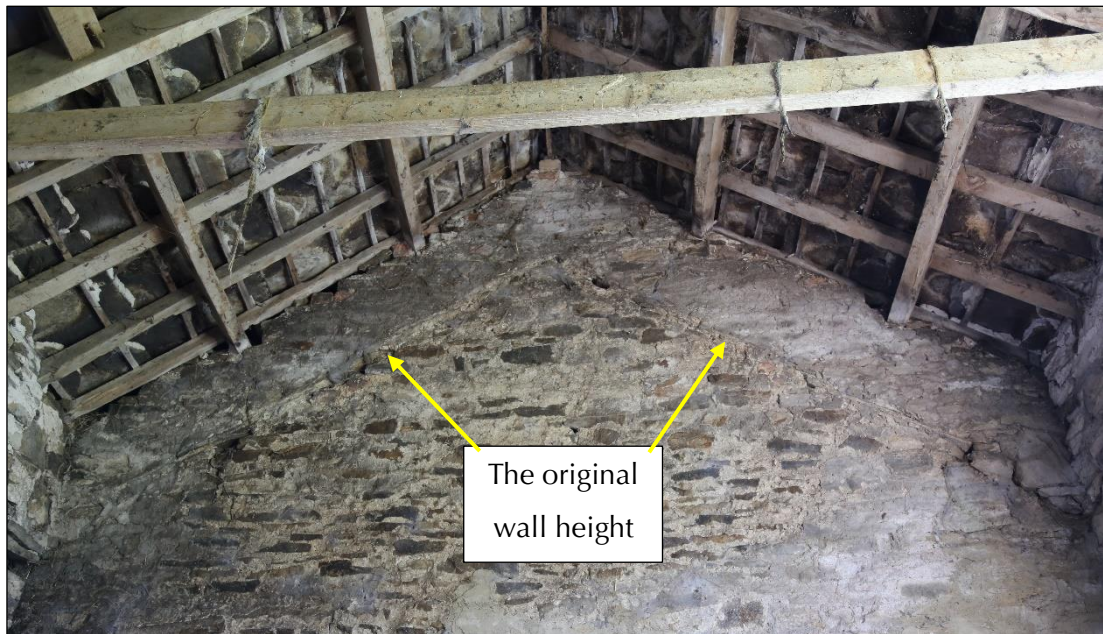
*Plate 31: the top of elevation 1800 showing where it has been increased in height.*

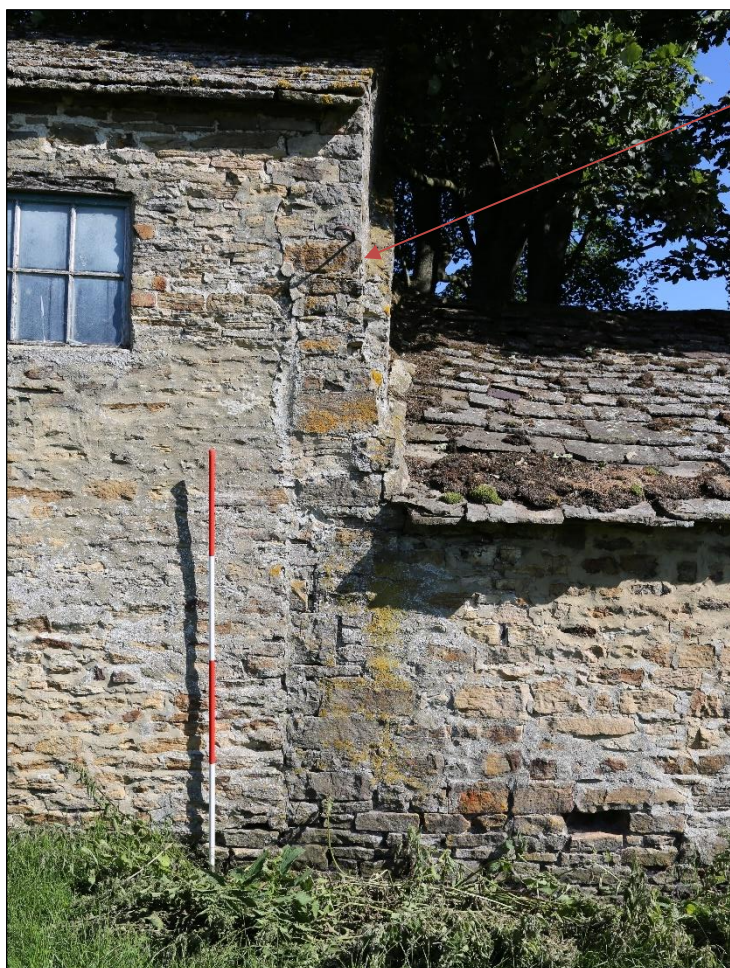
The point above which the barn wall is keyed into the end wall of the byre and the wall is built up.

*Plate 32: the barn (to the left) abutting the end wall of the byre (to the right). Only the top part of the barn wall is keyed into the top of the byre wall, where it has been raised in height.*

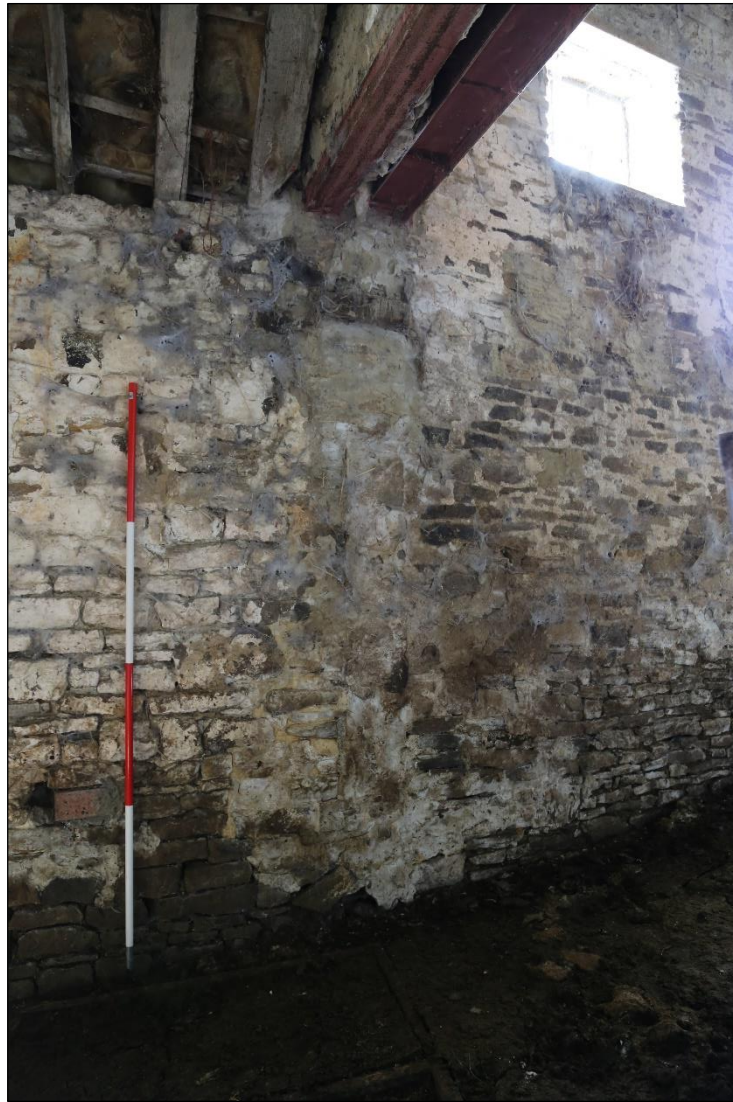
- 5.29 A modern opening has been inserted into the elevation to provide access between the barn and the byre. The ground level slopes down from the barn into the byre suggesting that originally each building had a different floor height. Steel beams, girders and columns have been used to reinforce the modern opening between the two buildings, but it is unknown if this replaced an earlier door. The opening is supported by the external wall to the south. A wall scar at this point marks the end of elevation 2400 and the start of elevation 1500 (Plate 33).

*Plate 33: showing the wall scar at the end of elevation 2400 (to the left) and the start of elevation 1500 (to the right).*

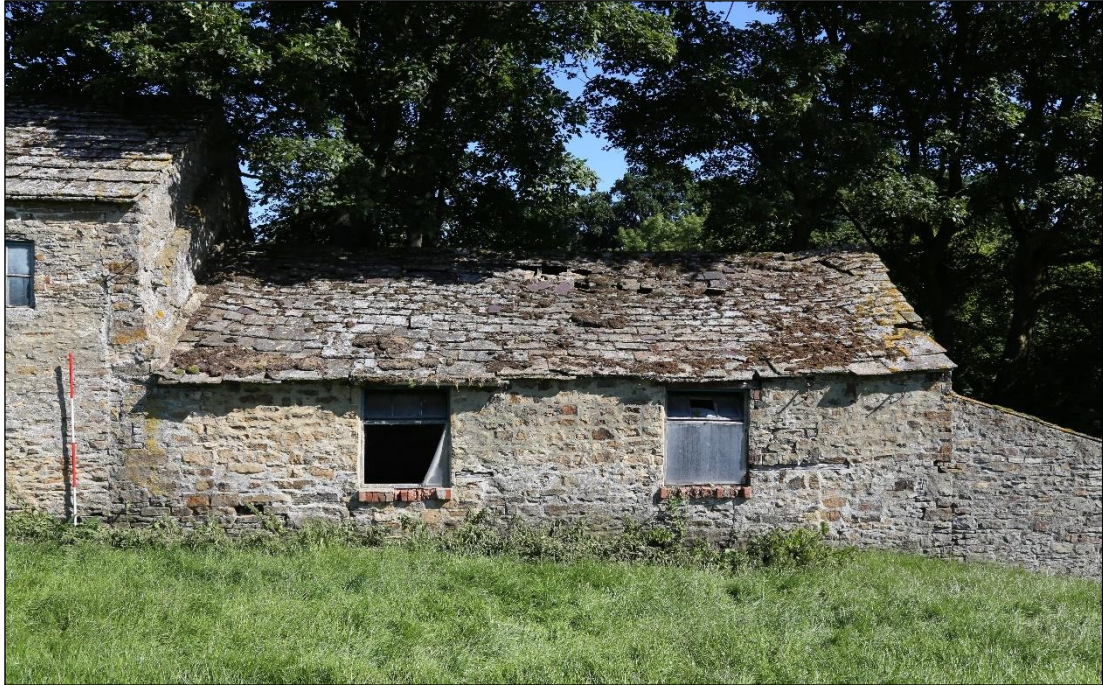
*Plate 34: south-facing elevation (2100) of the byre.*

- 5.33 The south-facing elevation features two window openings (2101 and 2102) and two blocked openings (2103 and 2104). The two blocked openings sit within the lower half of the elevation and would originally have been open down to the exterior ground level. They have wooden lintels and have been blocked with local stone (Plate 34).

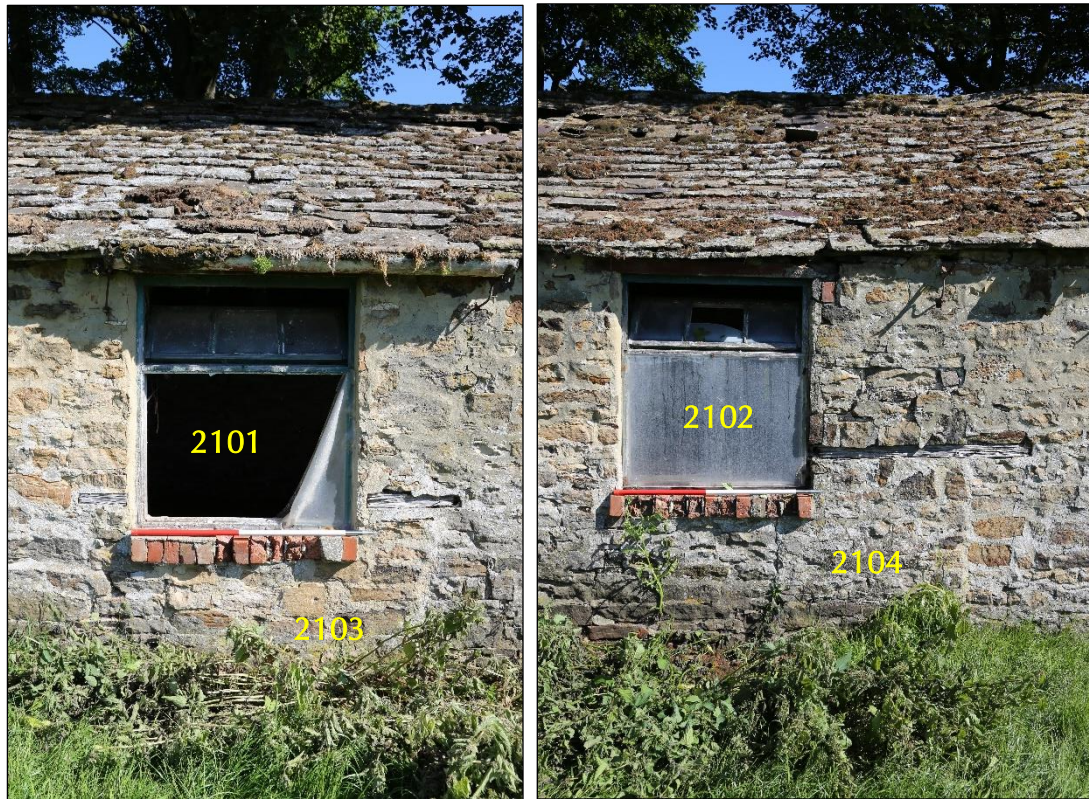
provided a combination of adjustable ventilation and light (University of Gloucestershire *et. al.* 2006, 57). The windows have wooden lintels, and sills that have been made from header bricks laid on edge.

*Plate 35: the current windows (2101, 2102) cutting into the blocked openings (2103, 2104) within elevation 2100.*

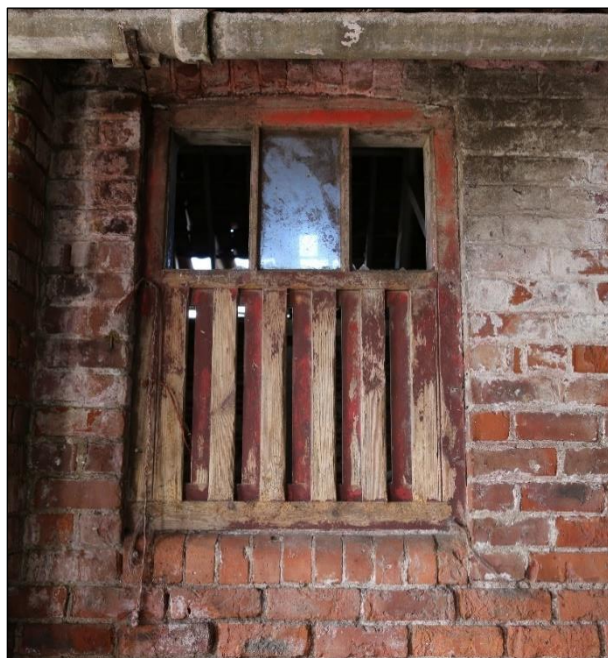
- 5.35 Both 2101 and 2102 have wooden frames. The upper part of each window has three glazed lights, set within a frame that tilts inwards. The lower two thirds of the windows are currently open, partly covered in mesh. They may originally have contained horizontal sliding hit-and-miss ventilators (Plate 36). This form of window achieved wide popularity throughout the North East during the mid- to late 19th century as it

*Plate 36: an example of a hit-and-miss ventilator window from County Durham.*

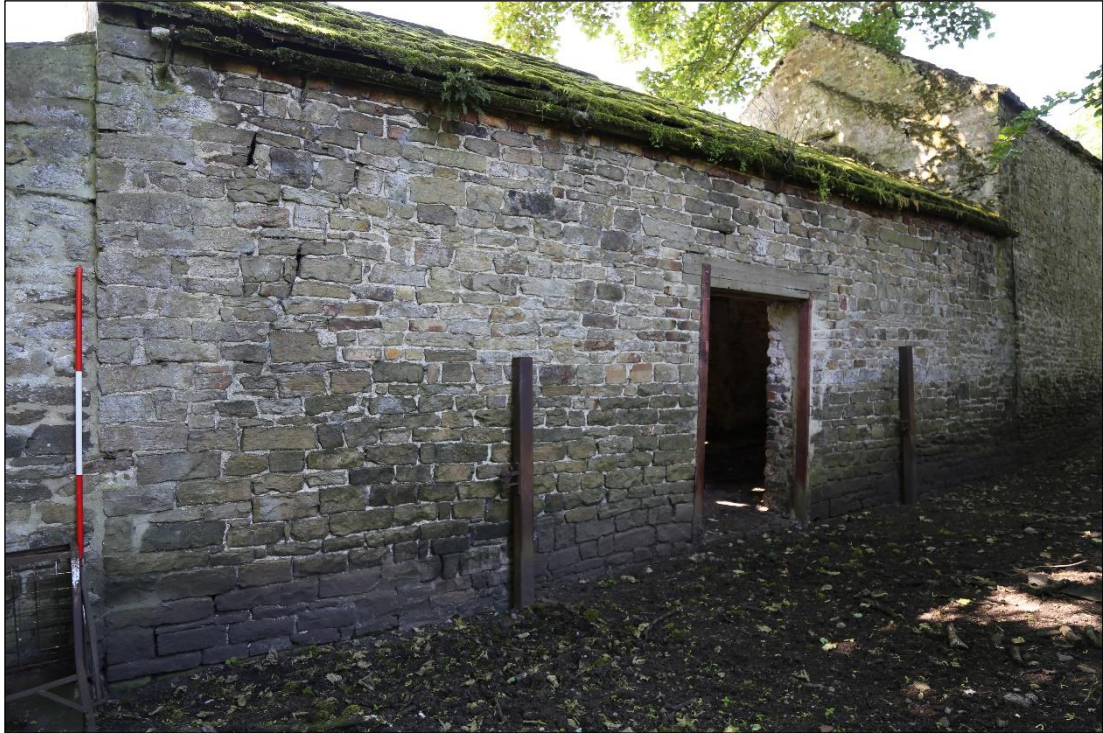
*Plate 37: general view of the north-facing elevation (2200) of the byre. Wall scar 1401, showing the original height of the byre, can be seen in the gable (1400) shared by the byre and barn.*

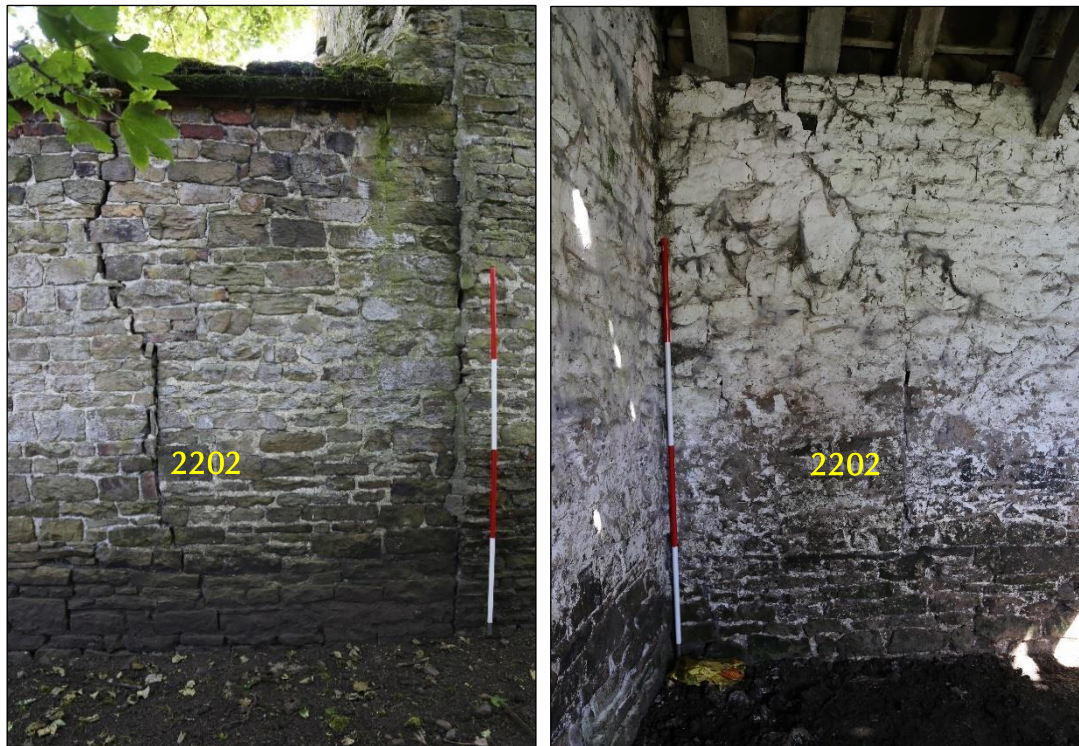
- 5.37 The north-facing elevation features a centrally located modern entrance (2201) and a possible blocked opening (2202) towards the west end. The edges of the possible blocked opening are not as clear as others within the range. Its eastern edge and base are the most discernible (Plate 38).
- 5.38 The modern entrance probably replaced an earlier opening into the byre as there is no evidence of another entrance elsewhere in the building. The doorway has a large wooden lintel. Externally, the sides have been reinforced with steel. Internally, the edges are finished in brick (Plate 39). The replacement of the entrance may have occurred at the same time as the current windows (2101, 2102) were inserted in the opposite, south-facing elevation (2100).

*Plate 38: the possible location of blocked opening 2202 within elevation 2200 (external)/2260 (internal).*

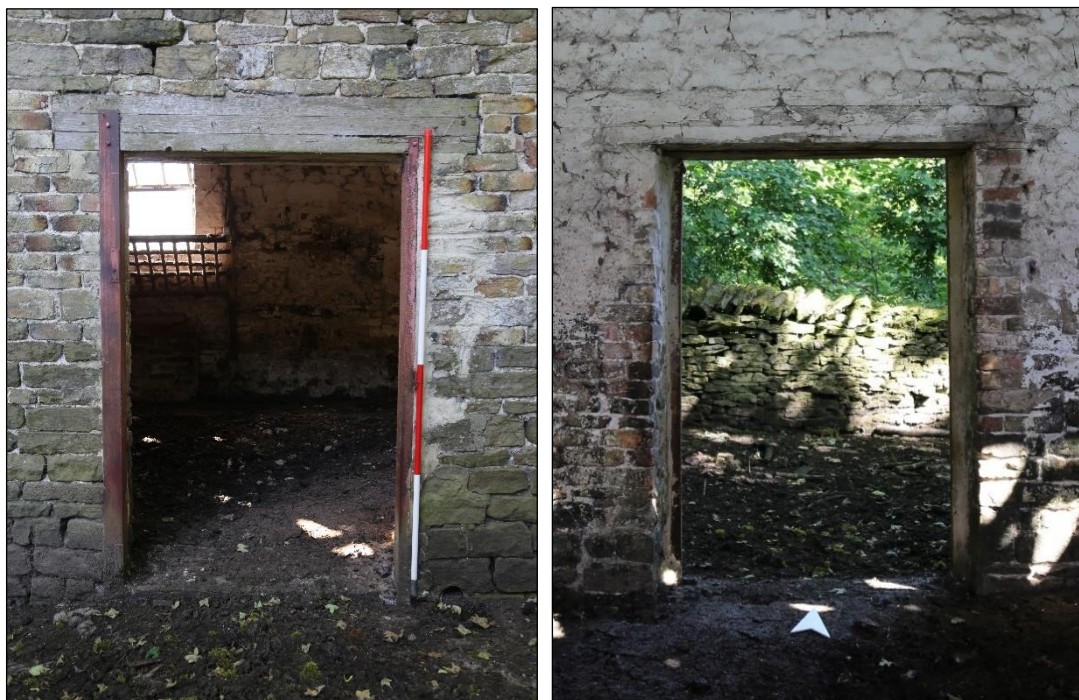
*Plate 39: entrance (2201) into the byre within elevation 2200 (external)/2260 (internal).*
