HISTORIC BUILDING  
RECORDING

WHITE KIRKLEY FARM RANGE,  
FROSTERLEY, COUNTY  
DURHAM

NAA 21-86  
May 2022

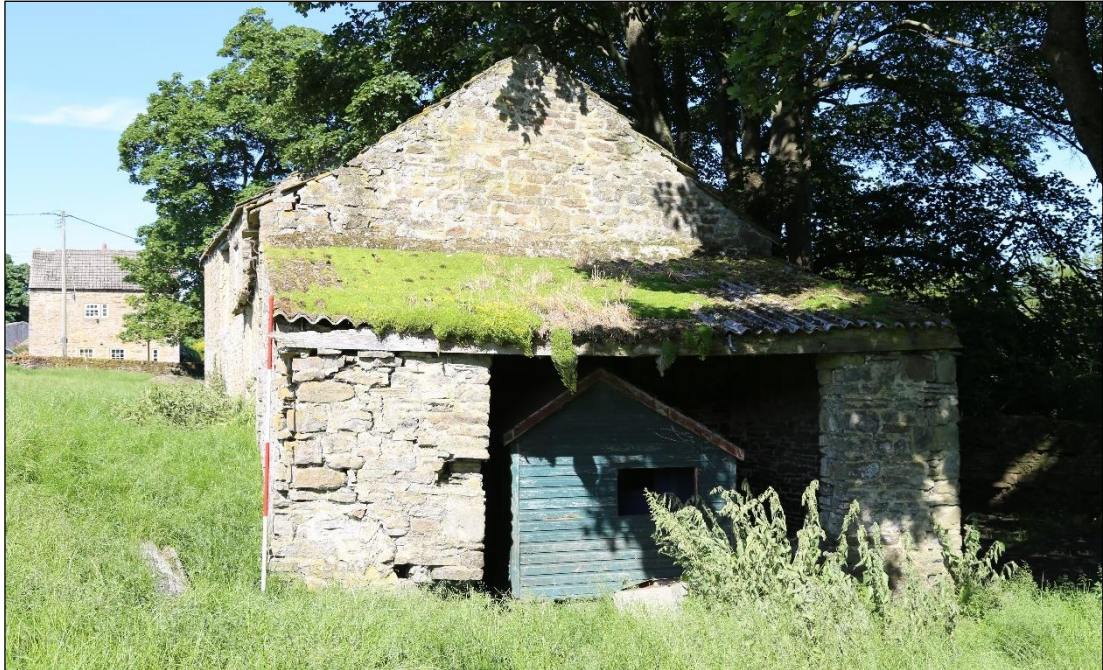
*Plate 40: the east-facing elevation (2300) of the byre and later lean-to (3000).*

- 5.40 The east gable of the byre was reduced to its current height when the barn was added to the west end. There is a small area of brick walling centrally placed towards the top of the elevation. This may be associated with chimney 2701 that can be seen internally. There are no other features of note. The lower half of the elevation was inspected from within the lean-to structure.

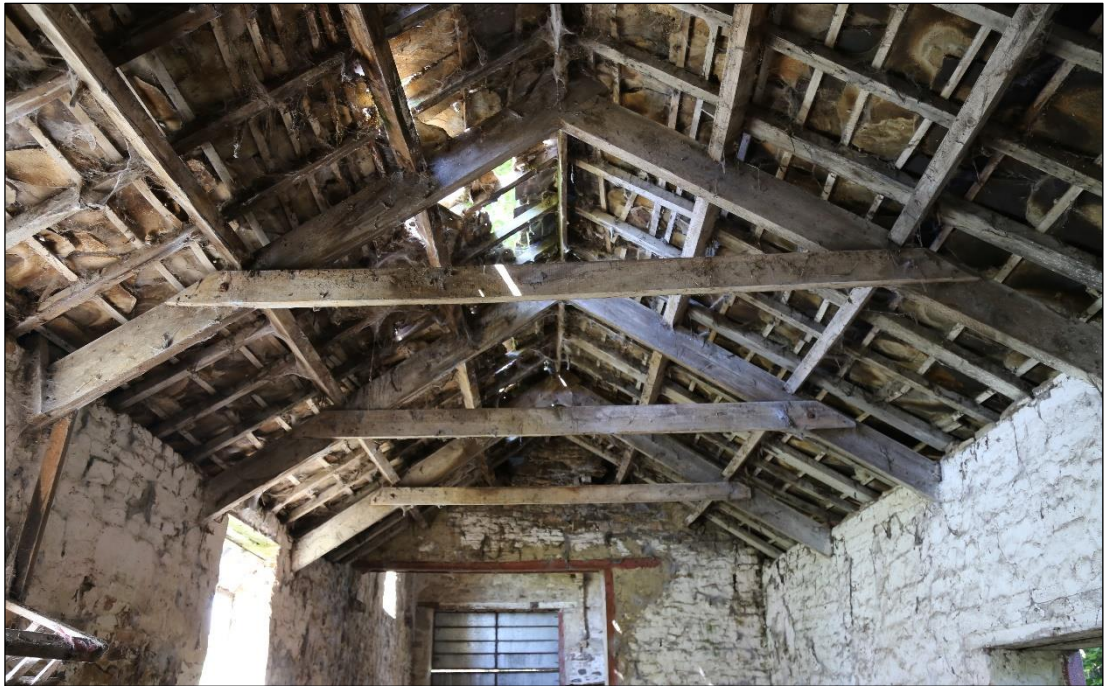
- 5.43 The roof is of timber construction of simple collared trusses, with purlins, battens and common rafters (Plate 41). The collars have been attached part way up the rafters, just below the first set of purlins, which differs from the roof structure of the barn. The rafters have been set within the wall plate that has been built-up with bricks following the reduction of the height of the building. The common rafters also sit on top of the wall plate. The roof is covered with natural limestone slates, which are pegged and set in diminishing courses.

*Plate 41: roof structure within the byre (2000).*

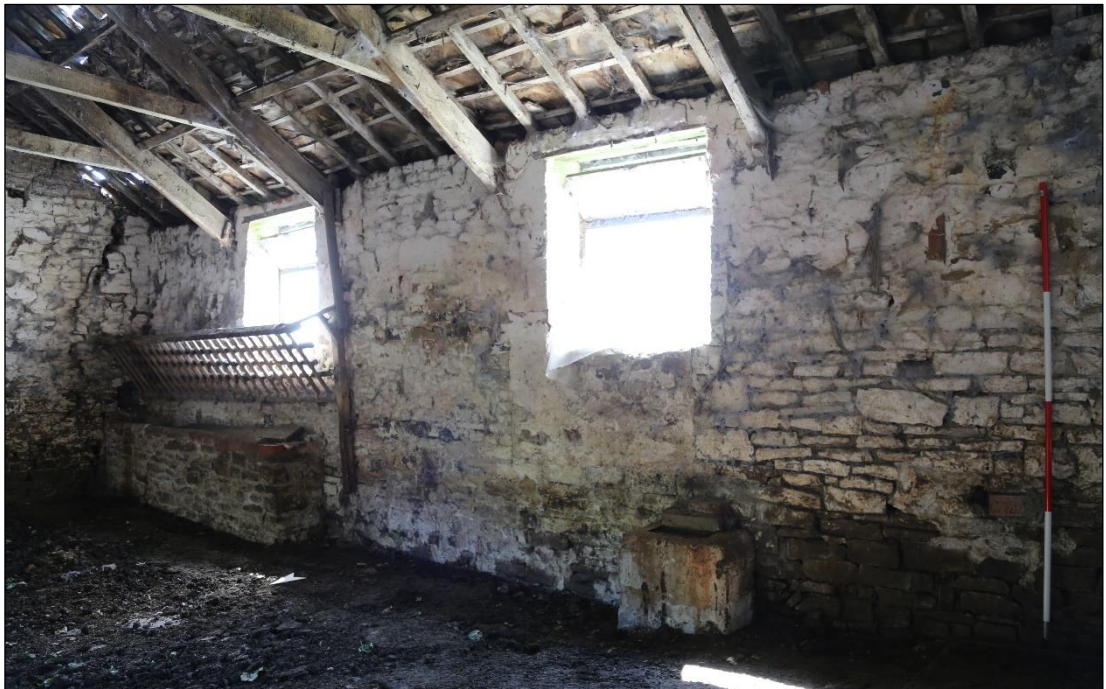
*Plate 42: general view of elevation 2400.*

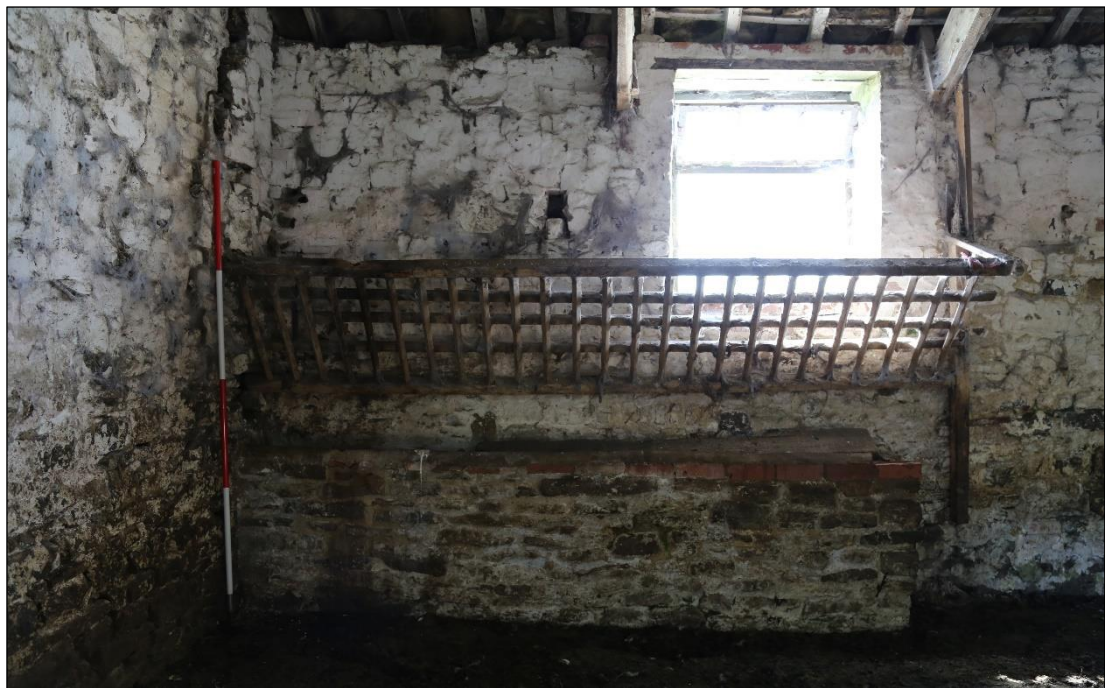
*Plate 44: stone and brick trough with wooden hayrack above at the east end of elevation 2400.*

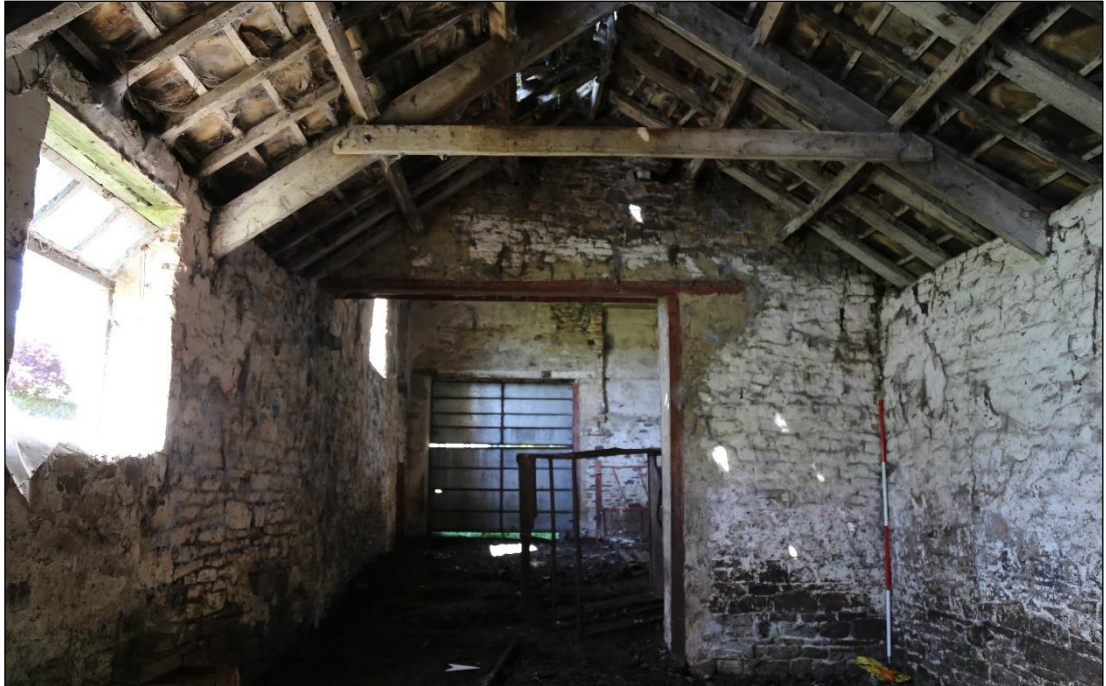
*Plate 45: internal east-facing elevation 2500.*

- 5.47 The east-facing internal elevation was originally the gable wall of the byre and survives to its full height above the current roof structure. When the roof was lowered to its present height, holes were made in the wall to accommodate the new purlins (Plate 46). As previously described (see internal west-facing elevation **1800**, para. 5.29), there is a large modern opening that has been inserted into this elevation (Plate 45).

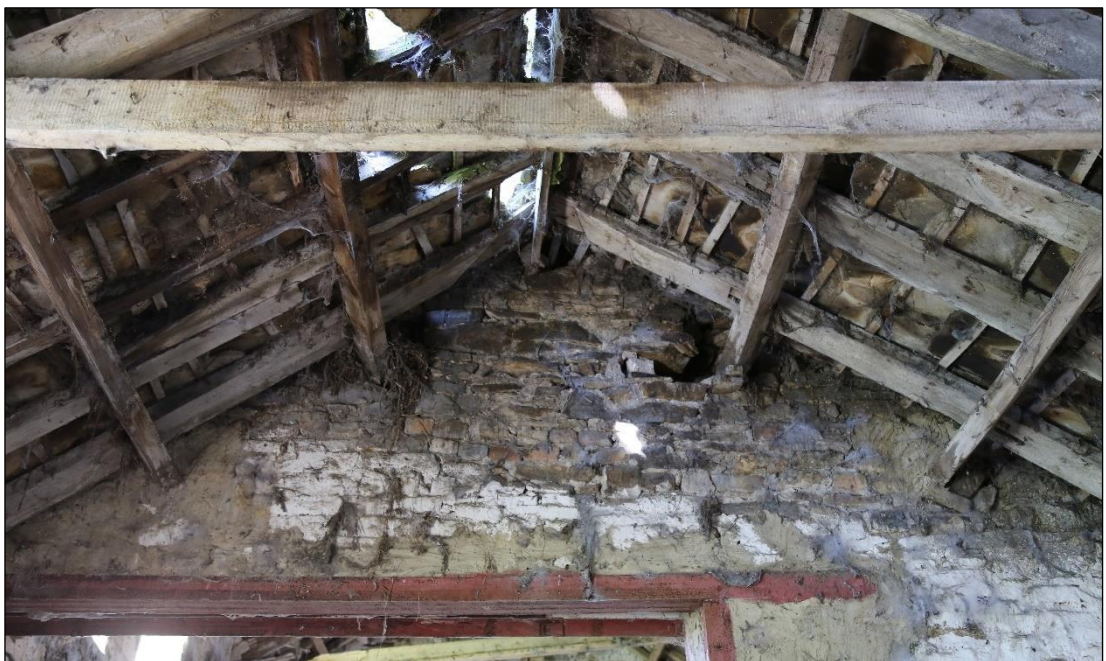
*Plate 46: showing the holes created to accommodate the purlins.*

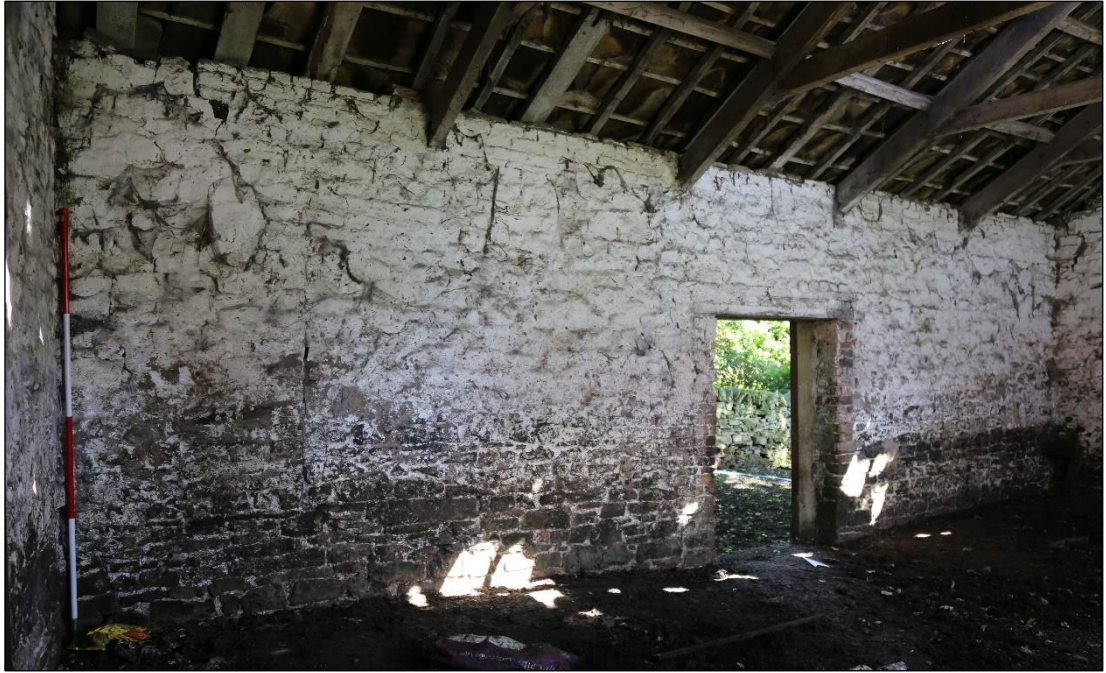
*Plate 47: general view of south-facing elevation 2600.*

- 5.48 The south-facing internal elevation is relatively plain, containing the main entrance (2201) into the building and a possible blocked opening (2202). These have previously been described above (see north-facing exterior elevation 2200, para. 5.37).

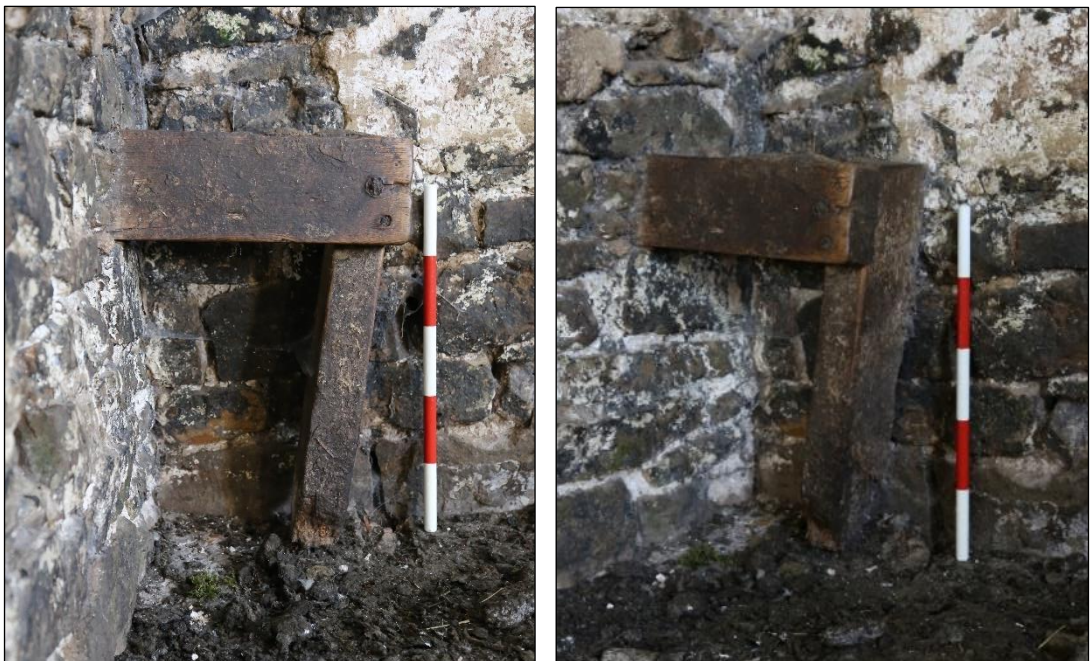
*Plate 48: general views of the surviving wooden structure.*

- 5.49 At the east end there is a small wooden structure (Plate 48). There were probably several of these spaced evenly along this wall (2600) to support a low wooden trough or hay rack.

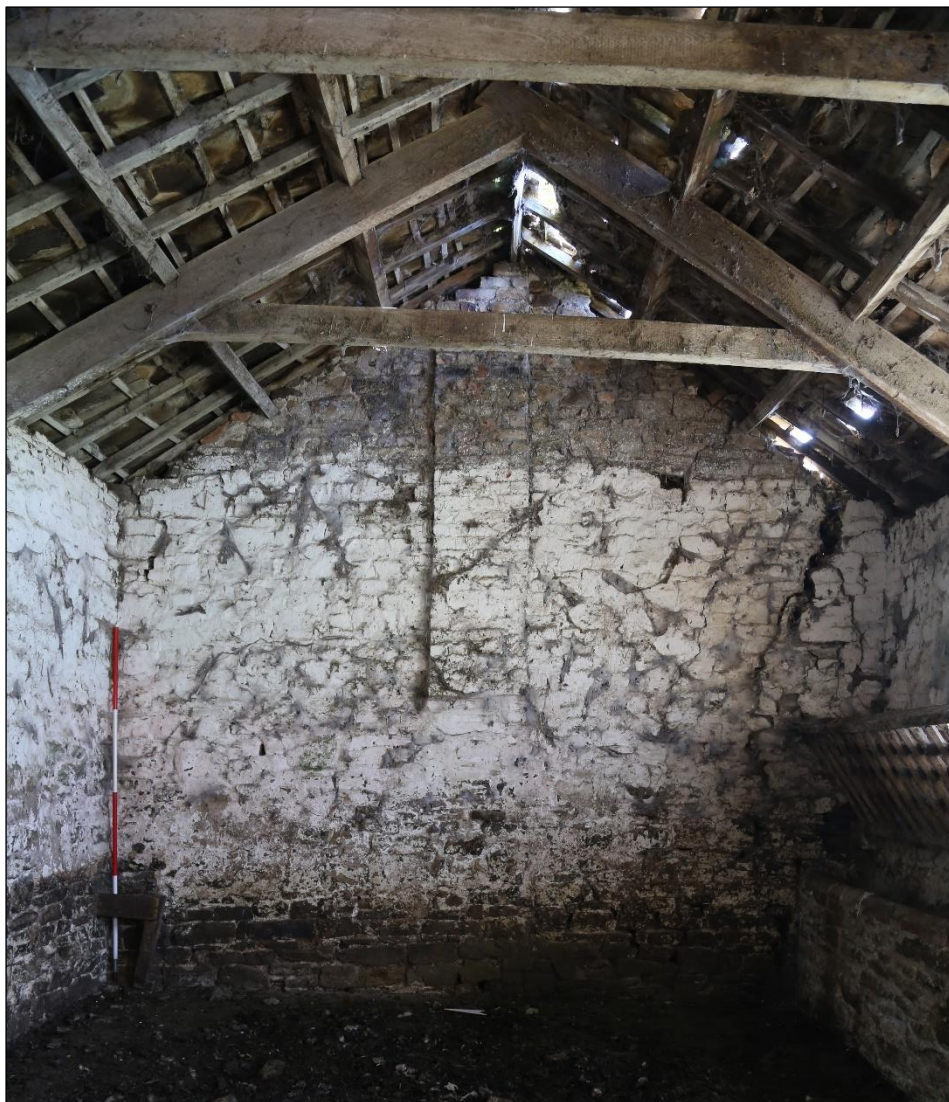
*Plate 49: internal west-facing elevation 2700 showing the remains of a chimney (2701).*

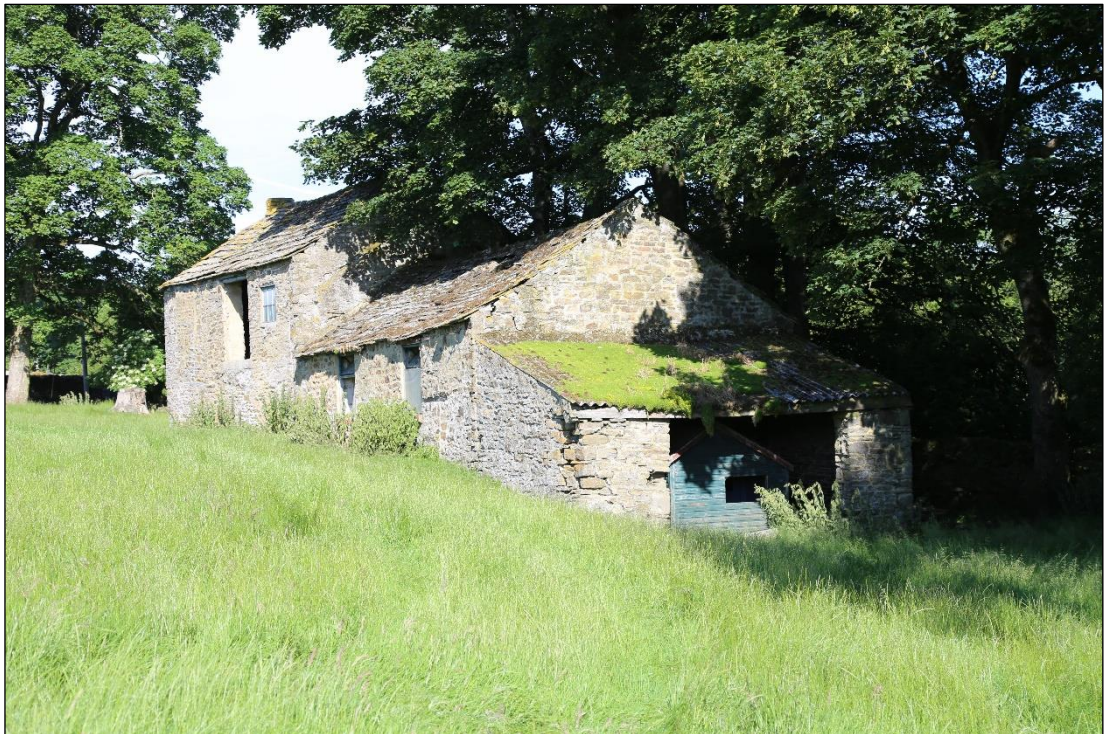
- 5.51 This is a simple single-cell lean-to structure built against the east end of the byre (2000) (Plate 50). It has a large opening at the east end (Plate 51) and may have been built to accommodate a cart or a similar small piece of agricultural machinery.
- 5.52 As with the other structures it has been built from locally sourced limestone which has been laid in random rubble courses. The two side walls (3100 and 3200) have been keyed into the byre wall at only one point on each side (Plates 52 and 53).
- 5.53 The roof is constructed from corrugated asbestos cement sheets resting on steel purlins supported by the side walls.
- 5.54 There are no features of note internally.

*Plate 50: general view of the lean-to attached to the byre at the eastern end of the range.*

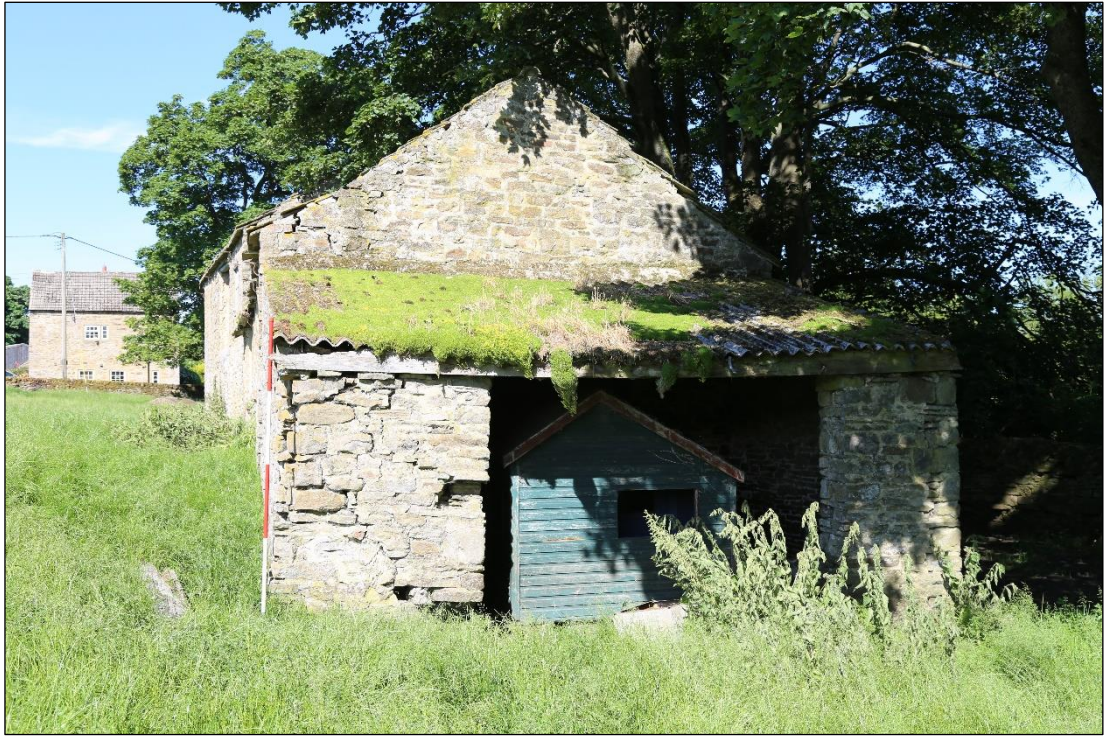
*Plate 51: east-facing elevation 3300.*

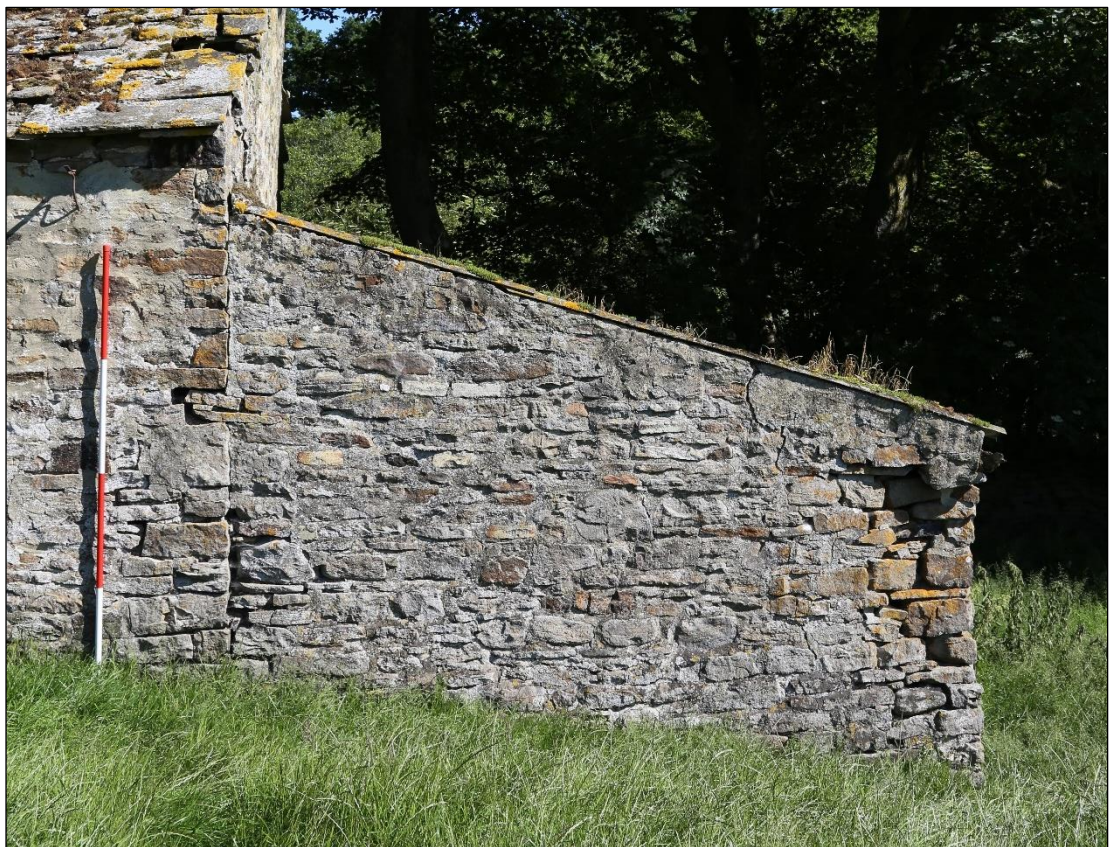
*Plate 52: south-facing elevation 3100.*

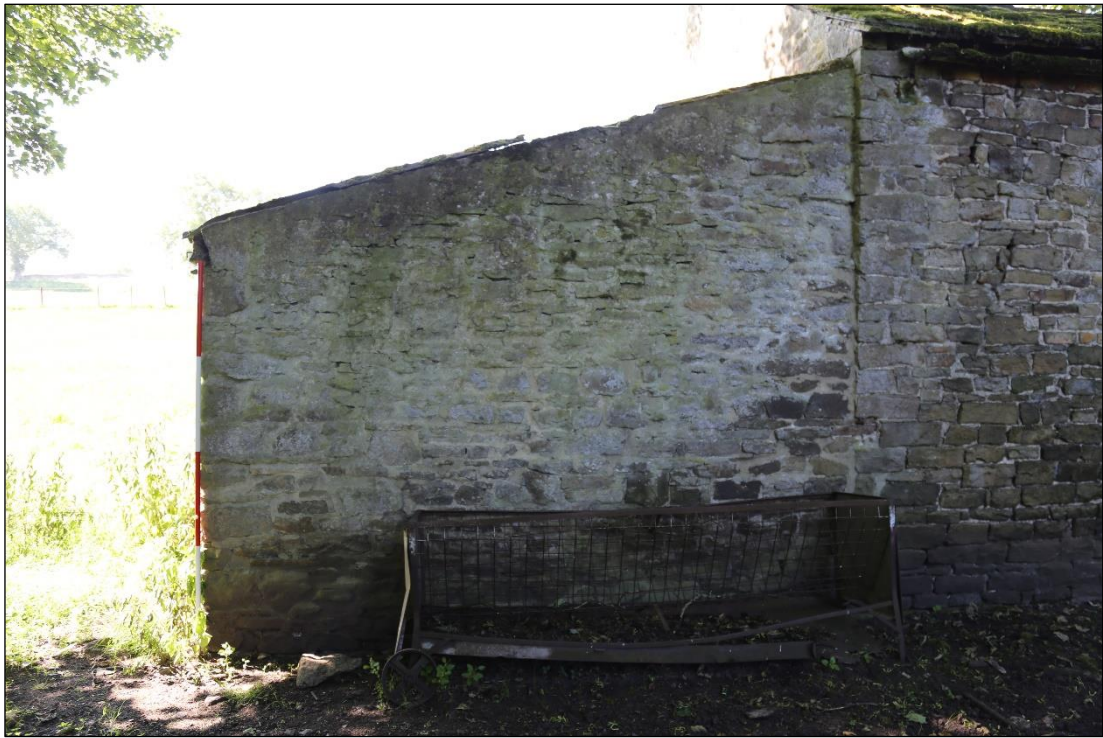
*Plate 53: north-facing elevation 3200.*

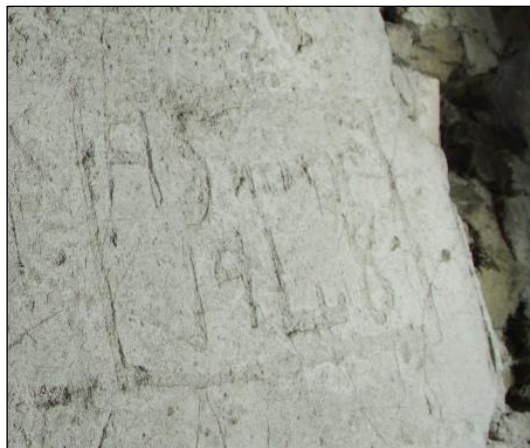
- 8.12 There are five dates that can be discerned from the graffiti. There are three complete dates, A Smith 1948 (Plate 54, Fig. 6-5), B. C. 1948 (Fig. 6-8) and F. C. 1950 (Fig. 6-3), and there are two partial dates, 192? (Fig. 6-7) and 196? (Fig. 6-6). The dates are predominantly found within boxes and associated with names or initials.

*Plate 54: A Smith 1948 surrounded by a border.*

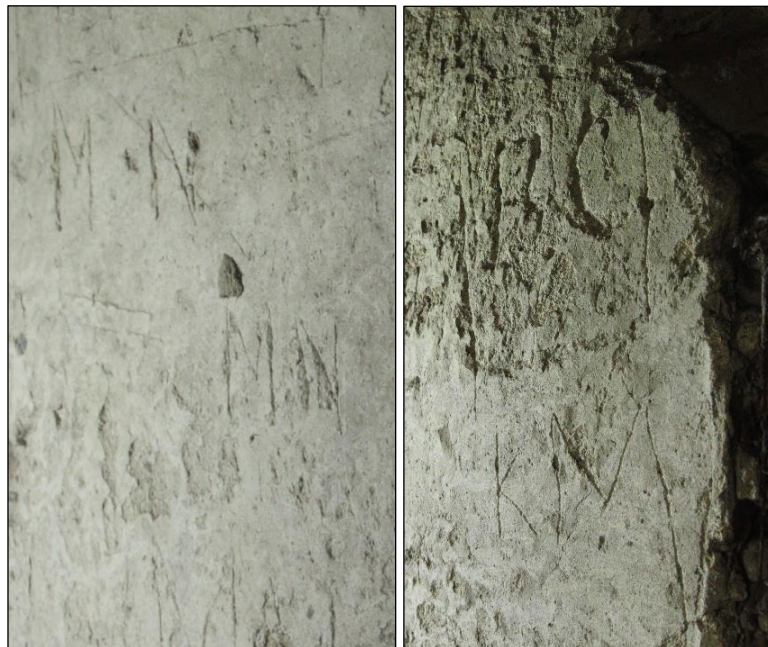
- 8.15 There are a large number of initials and names (both decipherable and indecipherable). Initials include for example M. N. (Plate 55; Fig. 6-9), B. C. (Plate 55; Fig. 6-4 and 6-8), K. M., G. N. (Plate 55; Fig. 6-10) and E. F. (Fig. 6-11). These initials represent people who have not been identified in documents.

*Plate 55: examples of initials, M. N. (left) and B. C., K. M. (right).*

- 7.4 The graffiti observed at first-floor level inside the barn was photographed from ground-floor level. It is recommended that this graffiti is recorded more extensively. At its most basic level, graffiti conveys the message 'I was here' and establishes the presence of a particular individual or group, in a certain place, at a specific time. Such inscriptions are an integral part of a site's history and should be fully recorded if they are to be removed, as one era's scrawl becomes the next generation's written testimony of 'unheard' voices (Giles & Giles 2010).

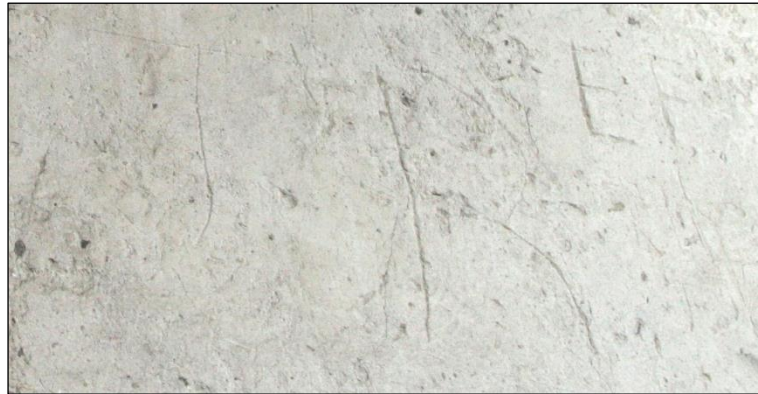
- 8.16 The initials J. R. (Fig. 6-12) can clearly be seen beneath the lower right-hand corner of the window. These are the only initials that could be linked to documented people associated with White Kirkley farm. They might represent one of the Robson family amongst whom there were two John's and a Janet.
- 8.17 The Robson family farmed White Kirkley for over 100 years from the late 1840s through to 1968. The 1871 and 1881 census returns record a John Robson as the household head. The 1901 census shows the farm being run by John's son Robert Robson who had three daughters and a son, including Janet, 8, and John James Robson, 3.

*Plate 56: examples of initials, showing a large J. R. with a smaller E. F. to the top right.*

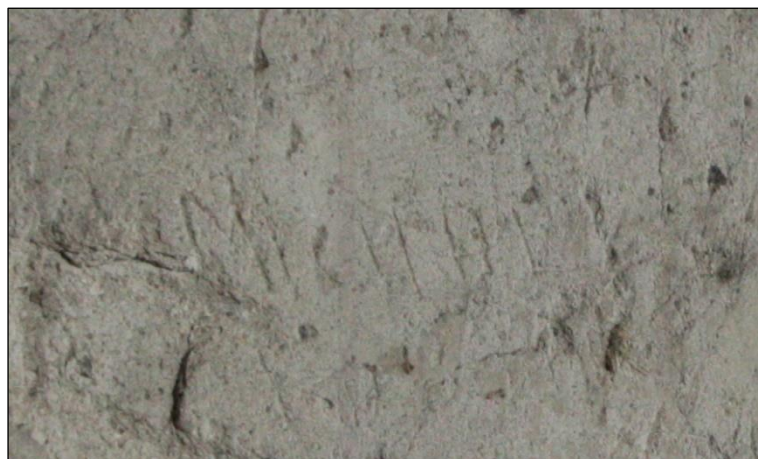
*Plate 57: the name Michael can be deciphered amongst the graffiti.*

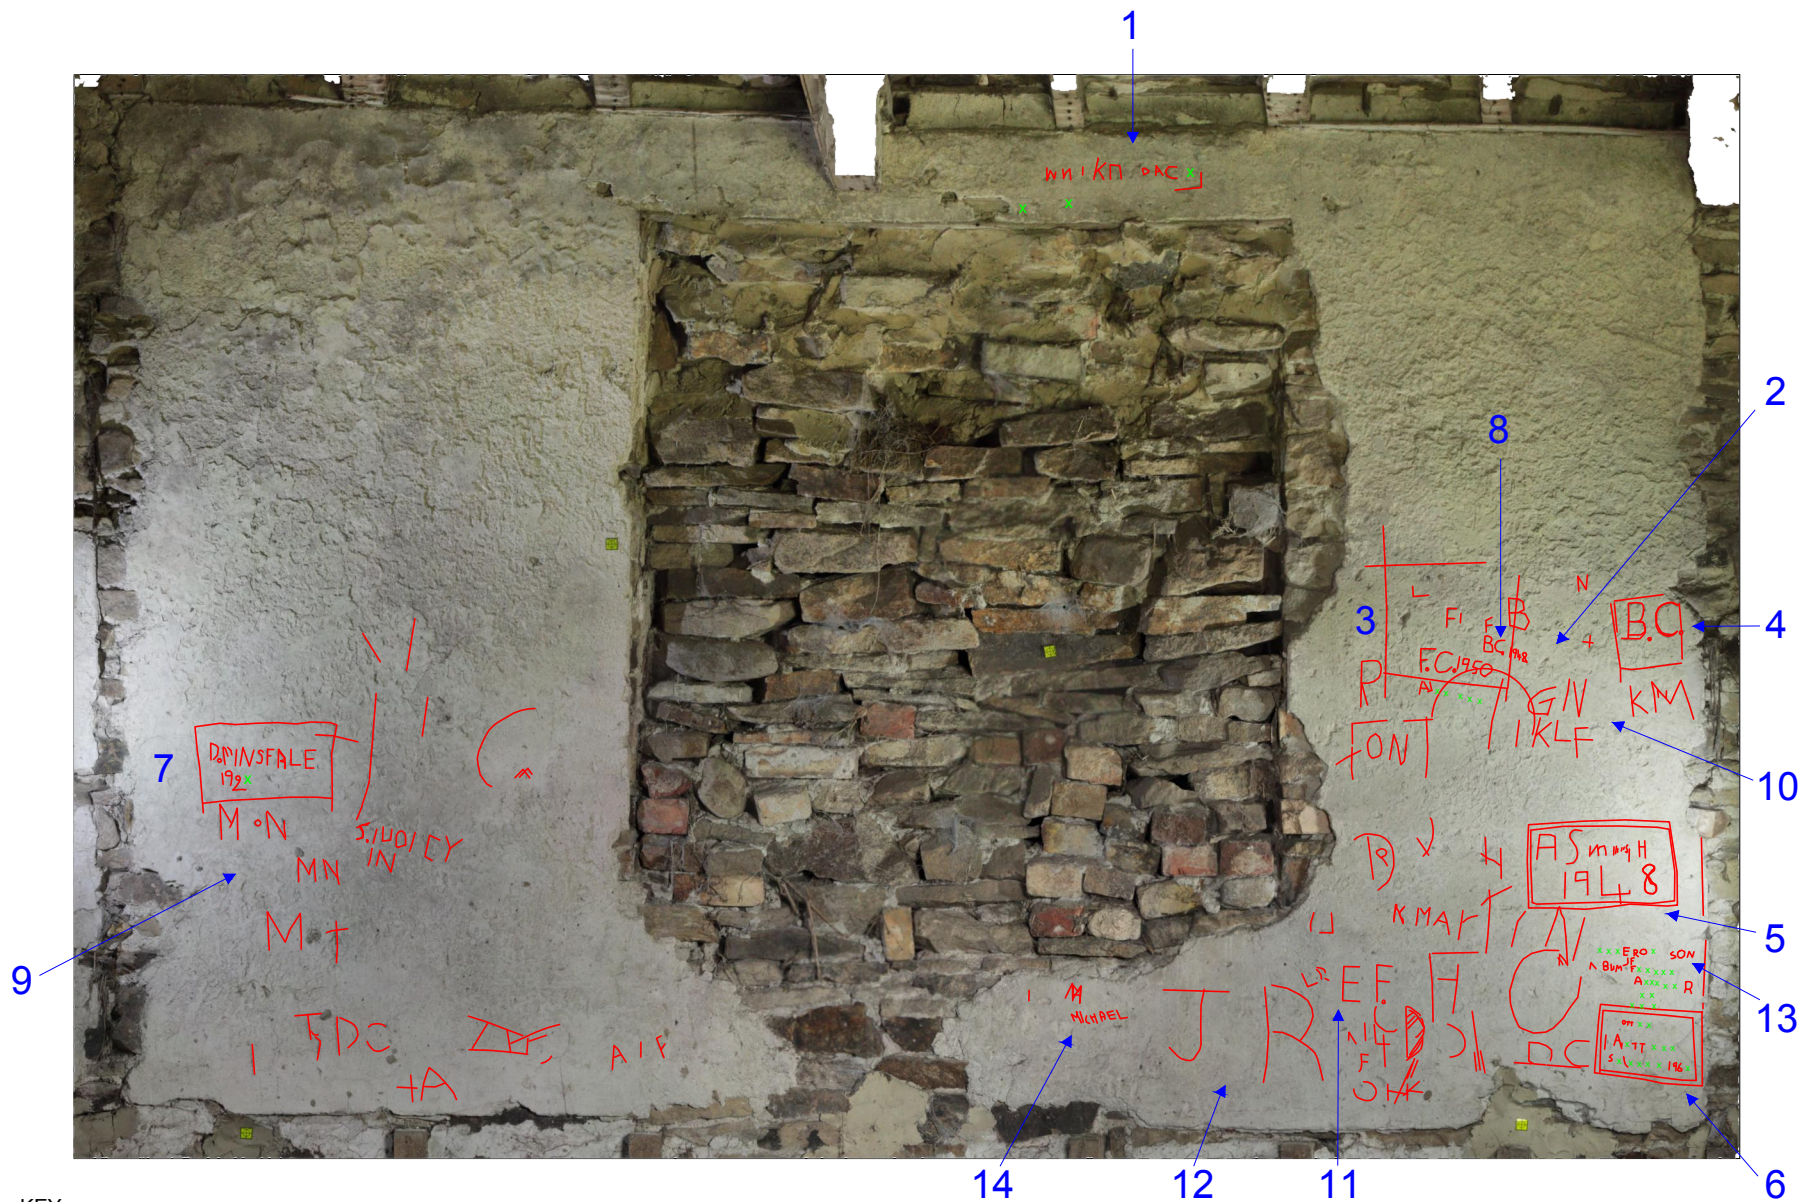
Handwritten annotations on the stone wall:

- Top center:  $WIKN = NC$  (with a small 'x' below it)
- Left side:  $M \cdot N$ ,  $MN$ ,  $M+$ ,  $1$ ,  $FDC$ ,  $TA$ ,  $AIF$
- Right side:  $BC$ ,  $GN$ ,  $KM$ ,  $1KLF$ ,  $AS mag H$ ,  $1948$ ,  $ERD$ ,  $SON$ ,  $ABUT$ ,  $R$ ,  $DC$ ,  $1A$ ,  $17$ ,  $194$
- Bottom center:  $JR$ ,  $REF$ ,  $14$ ,  $FT$ ,  $ONE$
- Bottom right:  $1$ ,  $M$ ,  $MOBEL$
