BARNARD CASTLE WEIR

Negative Watching Brief Report

Development: Repairs to weir across River Tees

Report number: NAA13/103

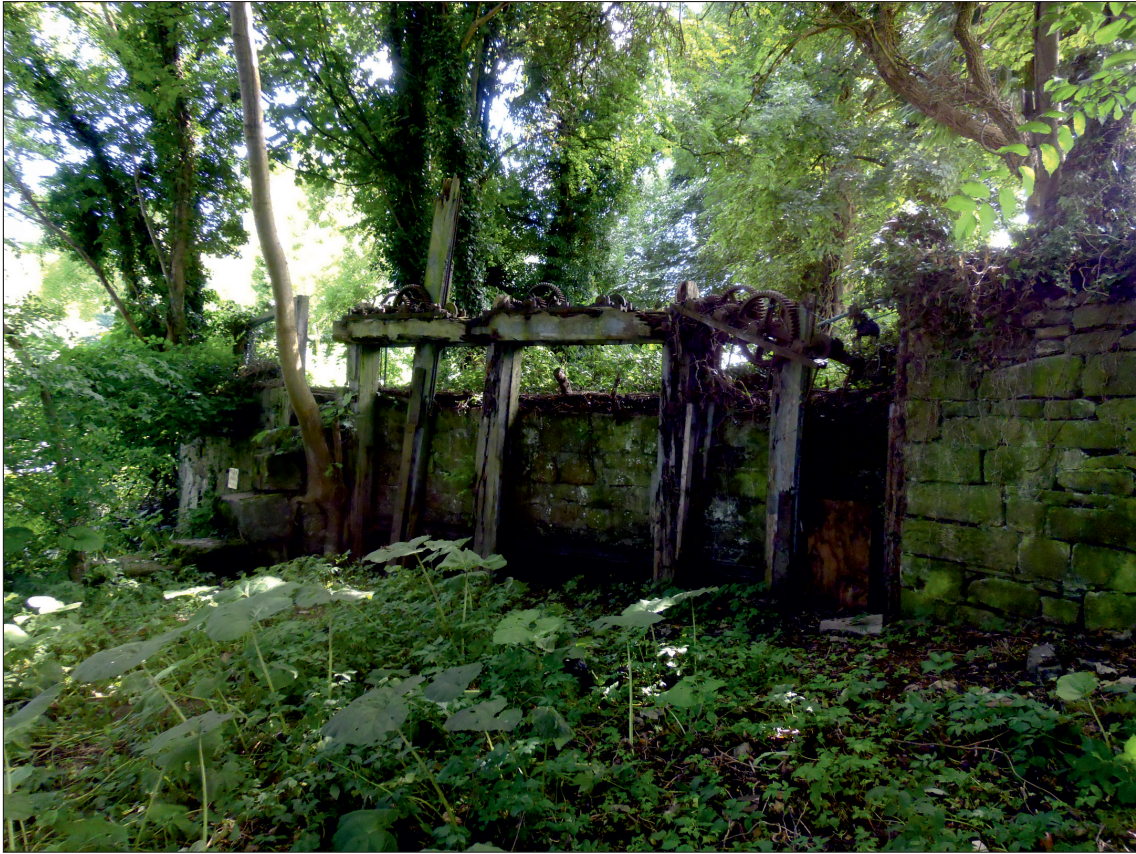
Plate 1

manufacturing), which was built c.1760 (Newcastle University, online). The remains of the sluice and mill-race survive in a relatively intact condition (Plate 1), whilst the mill weir was recorded on Wood's map of 1827 (Pictures in Print, online), and on the early Ordnance Survey maps, such as the First Edition 6-inch map of 1859 (Figure 2), and the subsequent revision at 25-inch (1:2,500) in 1897. Interestingly, one of the main proponents for the Roman ford being in this location features a stone-by-stone plan of the surviving mill weir apron (Brigantes Nation, online), together with a copy of an early 20th-century photograph of the mill weir *in-situ*.

Barnard Castle Weir: sluice-gate for Ullathorne's Mill

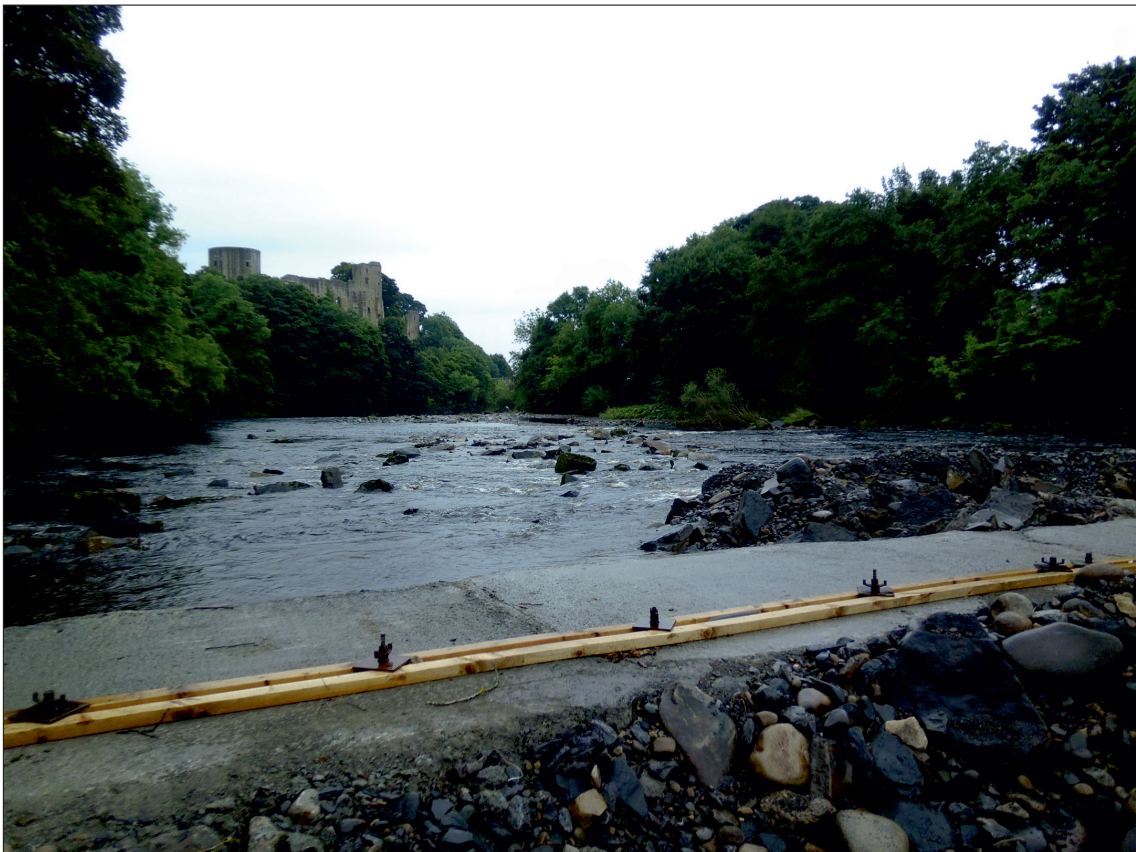
Plate 2

The monitored work comprised the excavation of the river bed down to natural bedrock deposits, to facilitate the construction of a temporary wall allowing the face of the weir to drain (Plate 2). Due to the limited space available, continuous monitoring was not possible, therefore a series of visits was undertaken during the work.

Barnard Castle Weir: temporary wall in River Tees

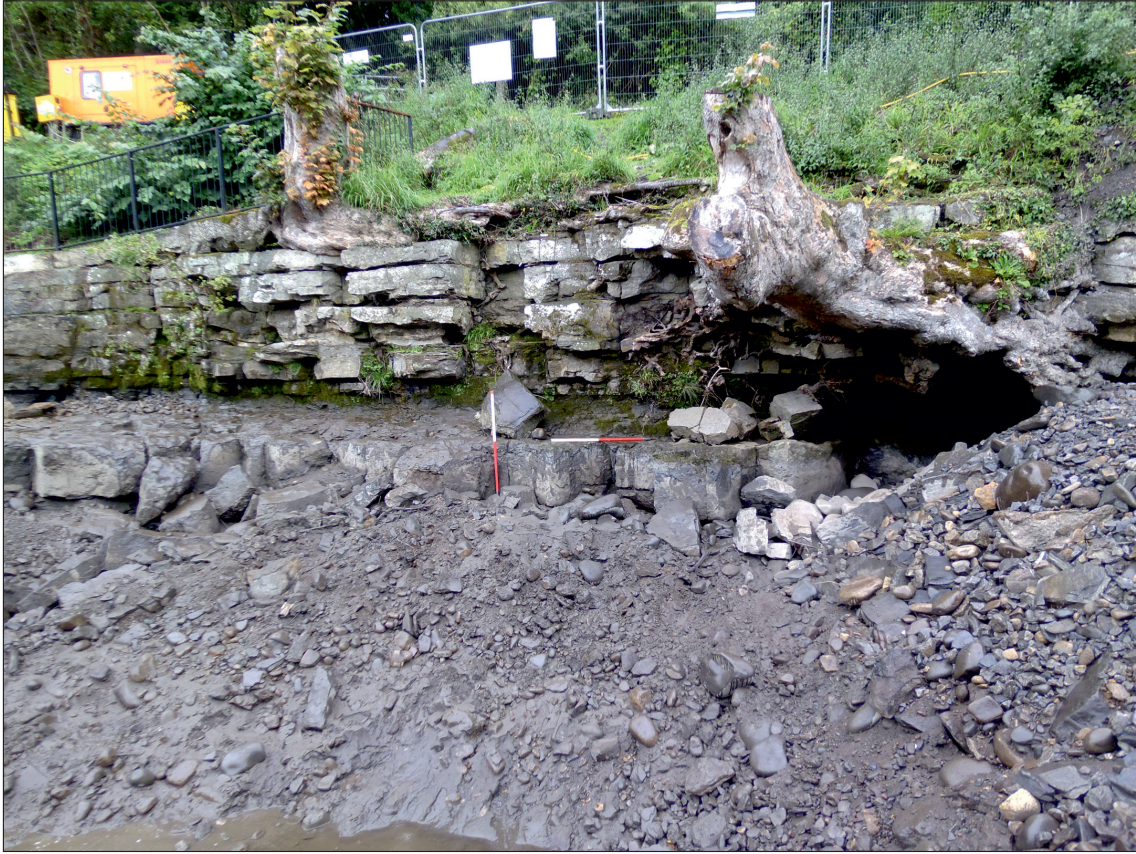
The bedrock was encountered at a depth of up to 4m below the water level, as a series of 'steps' cut by the river through the natural bedding (Plate 3). There was no evidence for any remains associated either with a Roman river crossing or the post-medieval mill weir, and no artefactual evidence was identified except a few sherds of 19th to 20th-century white-ware pottery, which were not retained.

Barnard Castle Weir: natural bedrock
