ARCHAEOLOGICAL EXCAVATION  
AND LANDSCAPE SURVEY  
REPORT

LAND AT STONECROSS  
MANSION, DALTONGATE,  
ULVERSTON, CUMBRIA

NAA 18/26  
March 2018

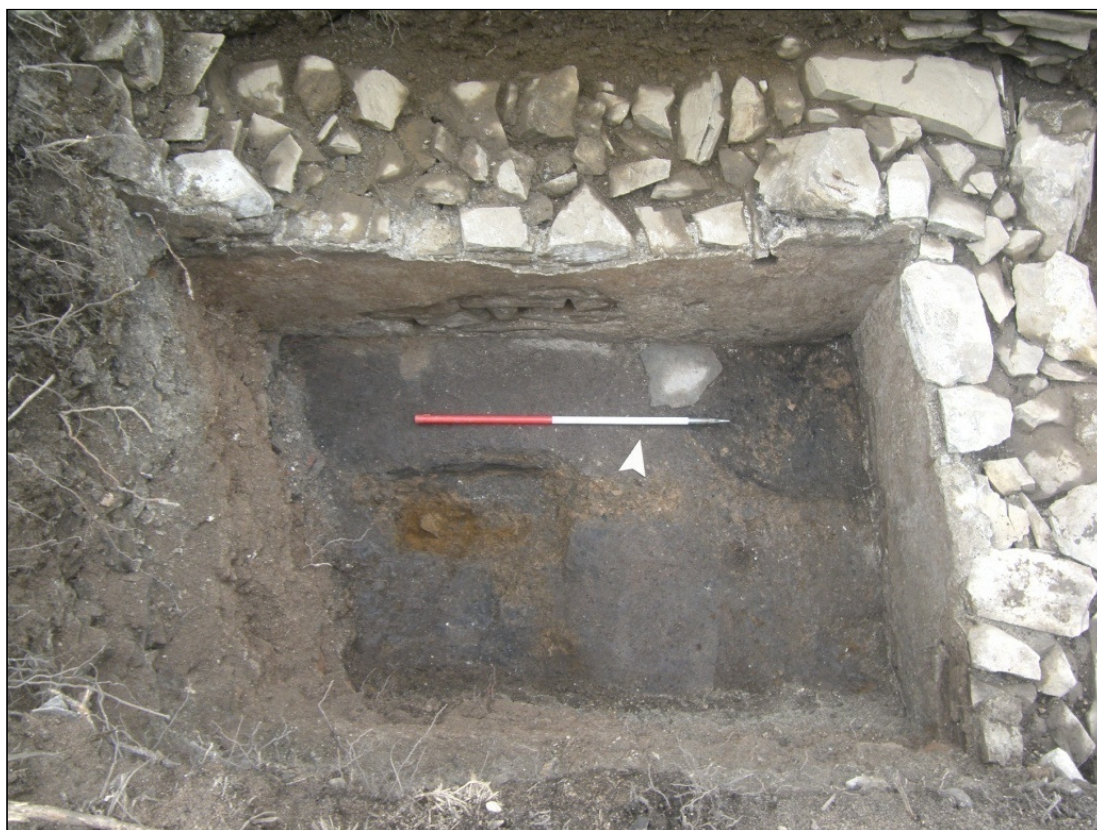
*Plate 1: overview of walls and floor surfaces exposed in Trench 1*

- 7.3 Evaluation trenches 1 and 2 were located to target the possible remains of weaving sheds adjacent to Daltongate (Fig. 2). Significant sub-surface structural remains, including in-situ masonry and floor surfaces, were identified within both trenches with varying degrees of preservation. In areas where levels of preservation were good, the remains of internal features were also identified (Plate 1).

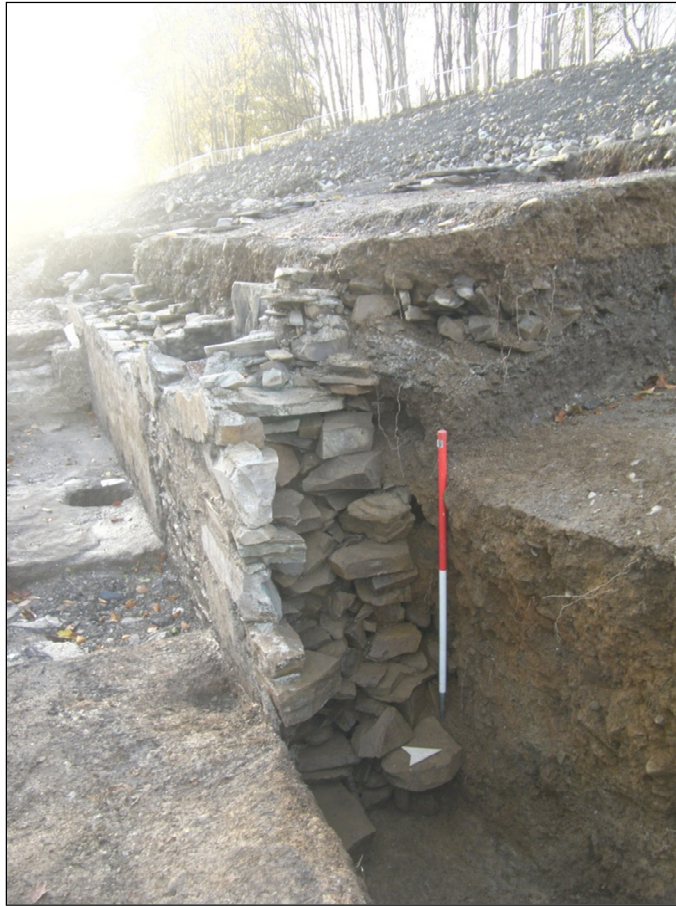
*Plate 2: oblique view of construction cut 1023 containing wall 1060*

roughly squared limestone surrounding a loose core of smaller fragments of limestone rubble (Plate 2). The dimensions of the stone varied greatly, with the observed maximum being approximately 0.7m by 0.3m by 0.2m.

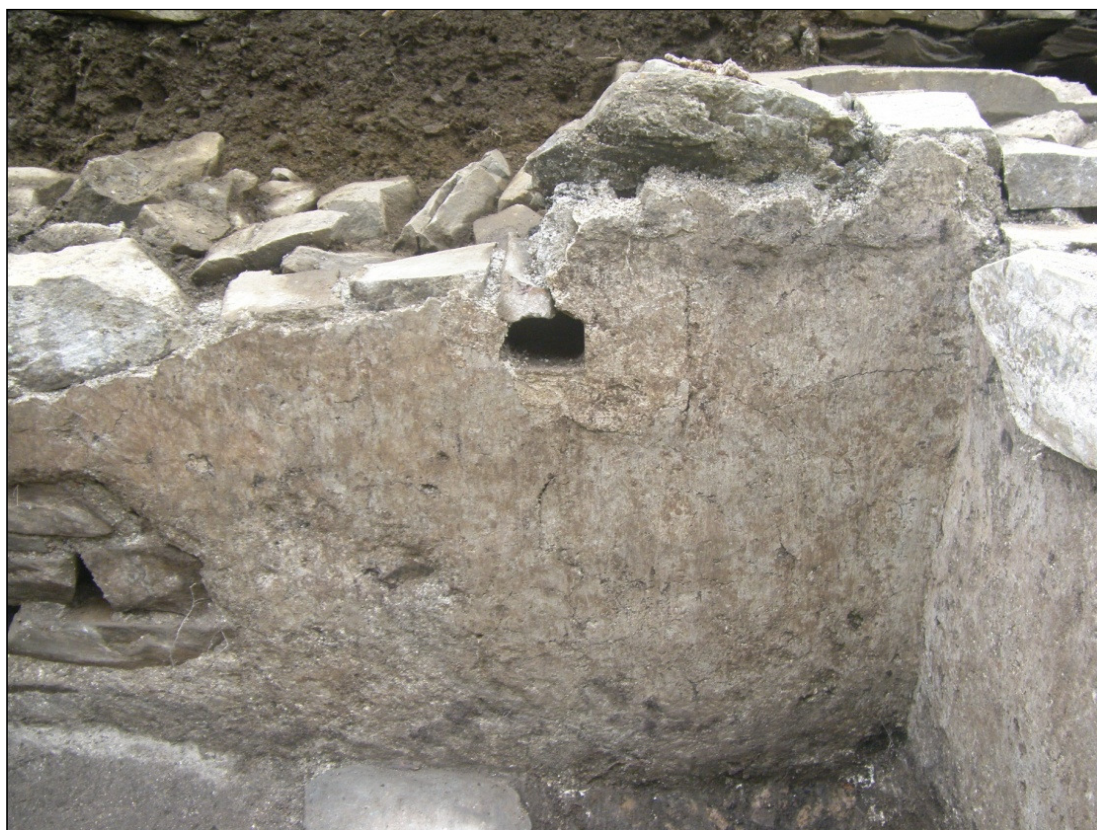
*Plate 3: detail of socket built into wall 1060*

- 7.13 The courses were bonded with lime mortar and the internal face was plastered. It was observed to survive in situ to a maximum height of 1.35m from the base of the construction cut (41.14m AOD). The wall was approximately 0.9 m wide at its base narrowing to 0.6 m at its highest surviving course. There was limited evidence of internal structural features incorporated into it; these comprised a small sub-rectangular socket (Plate 3) and a fireplace with a partial chimney.

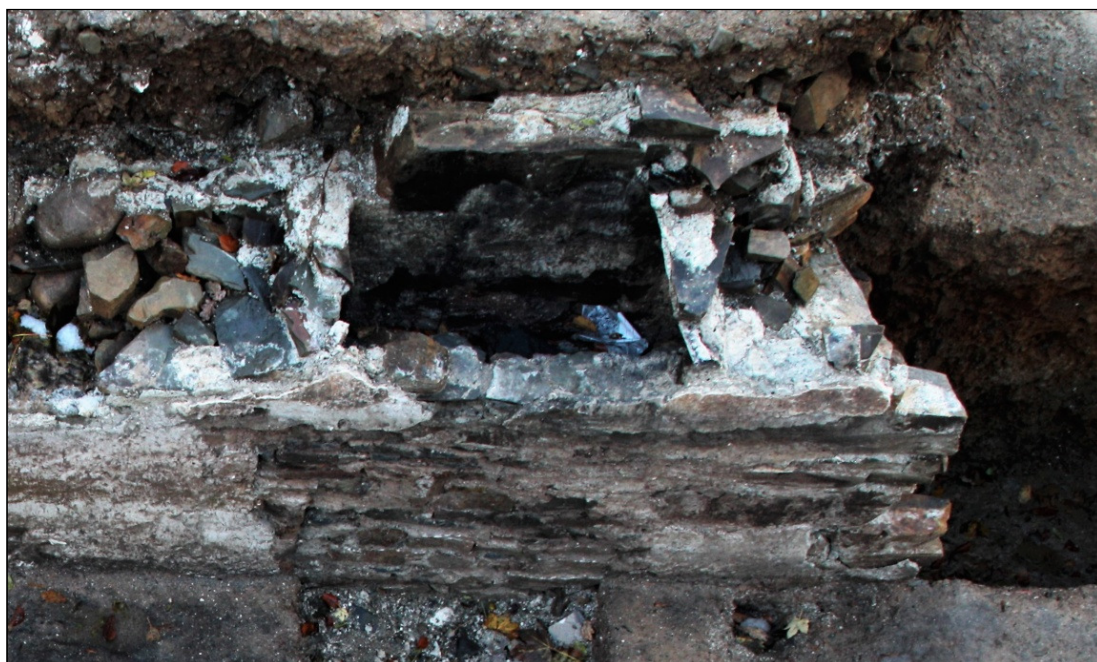
*Plate 4: overview of blocked fireplace and chimney built into wall 1060*

- 7.14 The fireplace and chimney were incorporated into the centre of the north-western wall of the structure (Plate 4). The internal surfaces of the fireplace and chimney were faced with rough plaster and showed evidence of heavy sooting. It had been blocked at a later stage by wall **1068**, which represented deliberate infilling of the aperture. This infilling was part of a later phase of construction that remodelled the interior layout of the structure (group **1075**).

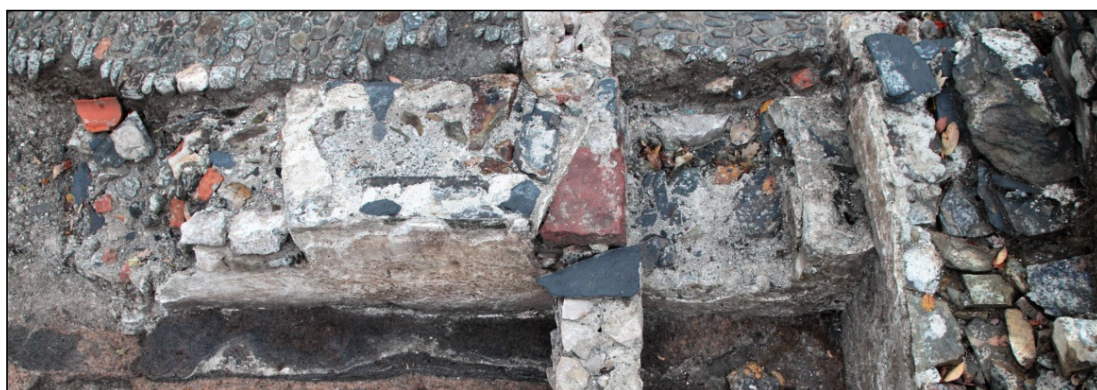
*Plate 5: overview of wall 1080 abutting wall 1060*

- 7.15 A heavily truncated wall (**1080**), surviving for approximately 2.5m on a north-west to south-east alignment, also filled construction cut **1023** and abutted wall **1060** at the western corner of the structure (Plate 5). It was comprised of roughly squared limestone that was heavily mortared around a loose core. A window bay survived demolition at approximately 0.3m above floor level, as did a possible entrance way. Walls **1060** and **1080** together form group **1104**.

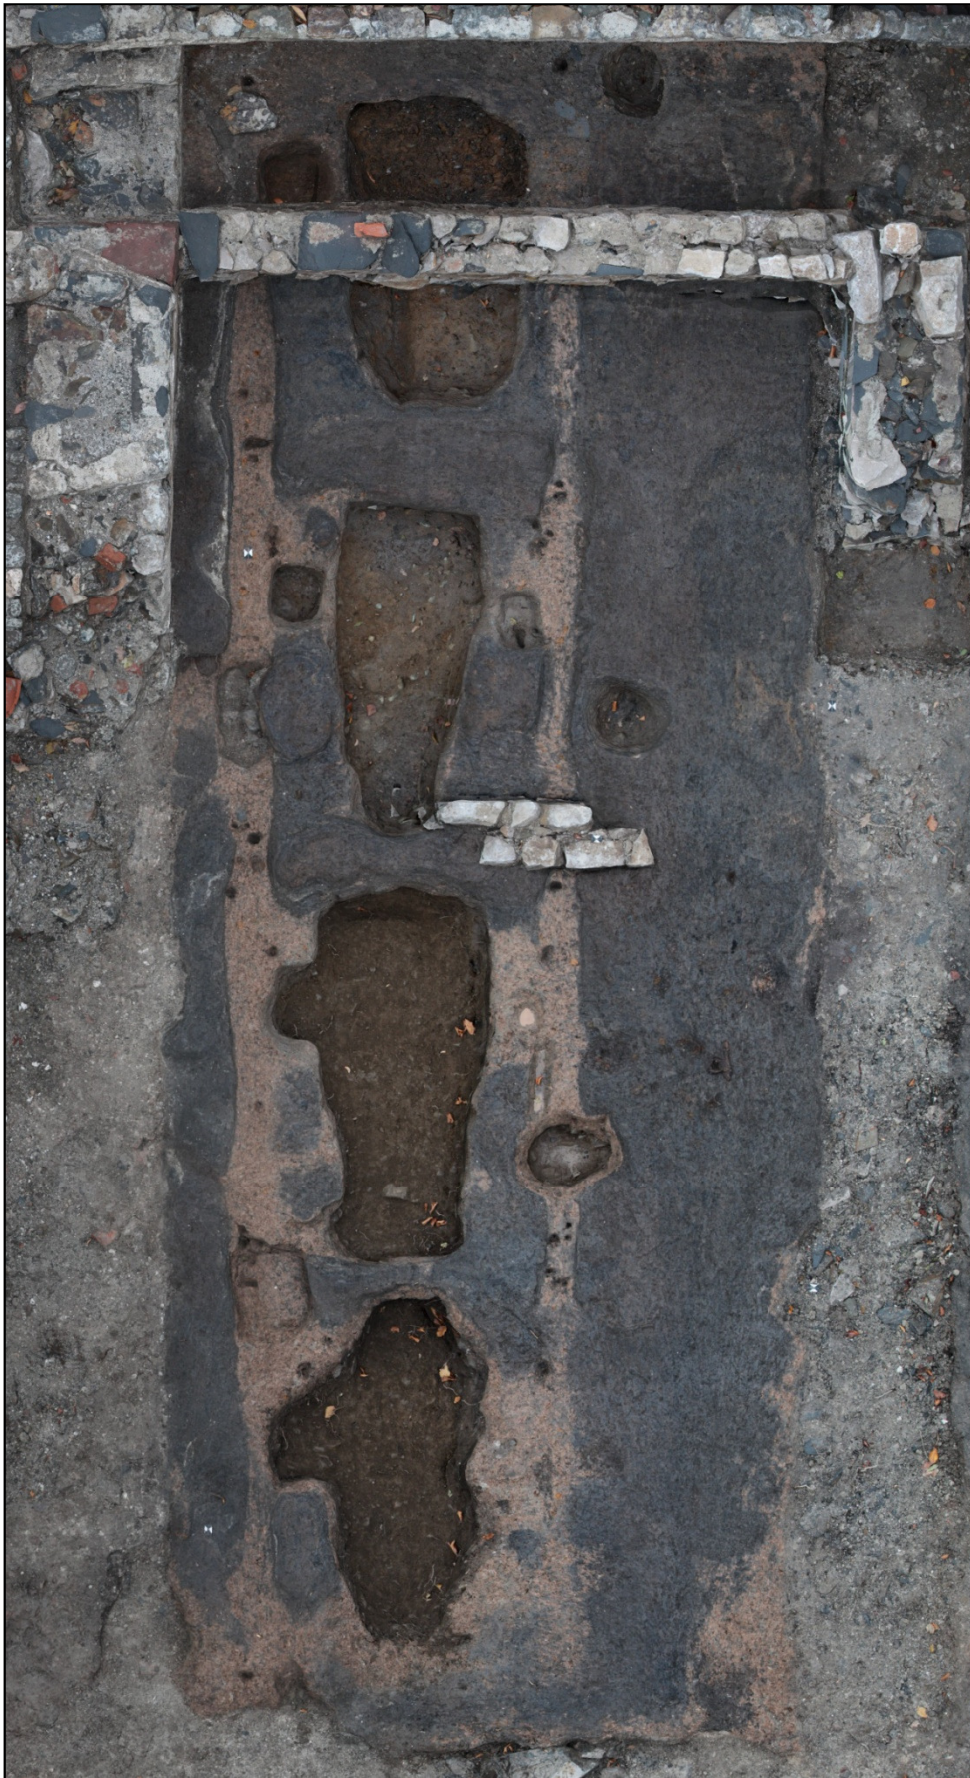
*Plate 7: overview of internal cut features on south-west side of the building and occupational deposit 1062*

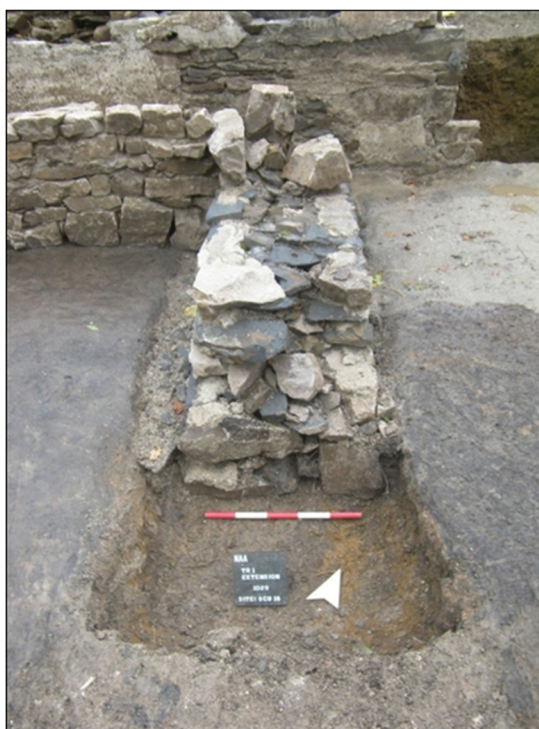
*Plate 7: construction cut 1049 containing wall 1029*

7.22 The internal area of the structure was bisected by construction cut **1049**, which extended for approximately 9m on a north-west to south-east alignment. It was approximately 1m wide, with a maximum observed depth of 0.25m (Plate 7). The layout of the structure suggests this may not have contained a continuous wall line; the cut extends right up to the fireplace incorporated into wall **1060**. Surviving masonry (**1029**) fills part of the cut and, although heavily truncated, there was evidence that it may have been part of a later phase of remodelling of the internal space of the structure. This is due primarily to the fact that the width of the wall does not match the width of the construction cut unlike those in group **1104**.

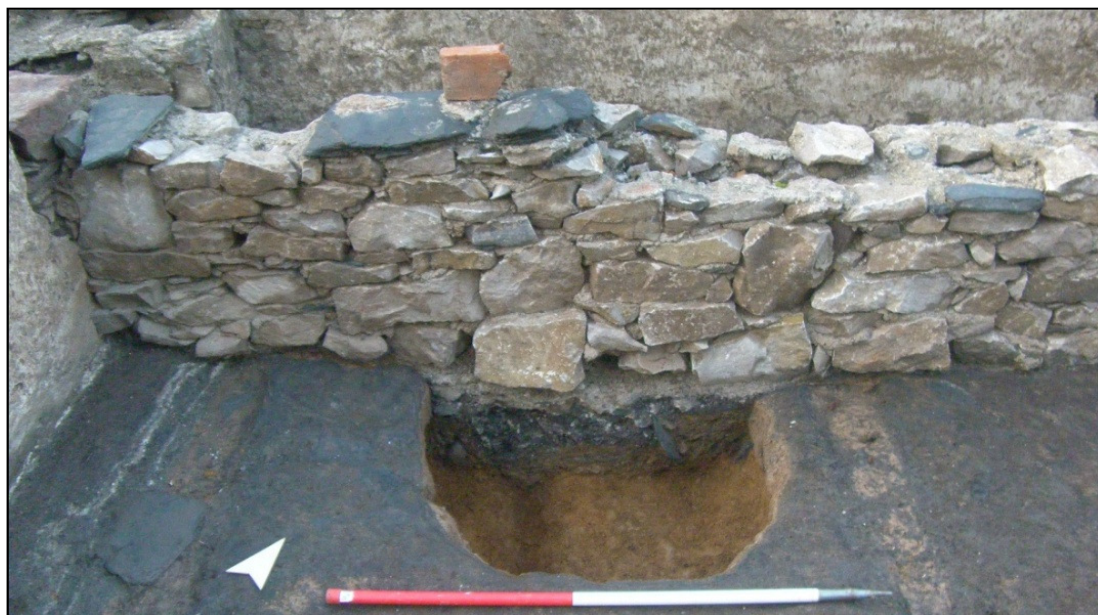
*Plate 8: internal wall 1047 overlying rubble backfill 1028*

- 7.25 Internal wall **1047**, which was observed overlying the backfill (**1028**) of pit **1025** (Plate 8). This wall comprised courses of roughly squared limestone bonded with lime mortar. Truncated remains of the upper courses suggest that brick was also used in its construction and was appended to the lower limestone courses on a bed of slate. A single shaped piece of red sandstone also formed part of this wall, overlying the embrasure within wall **1080**. Wall **1047** ran approximately 3.5m south-west to north-east and was approximately 0.3m wide, survived to a height of 0.65m. It was observed abutting south-east to north-west aligned internal wall **1029**.

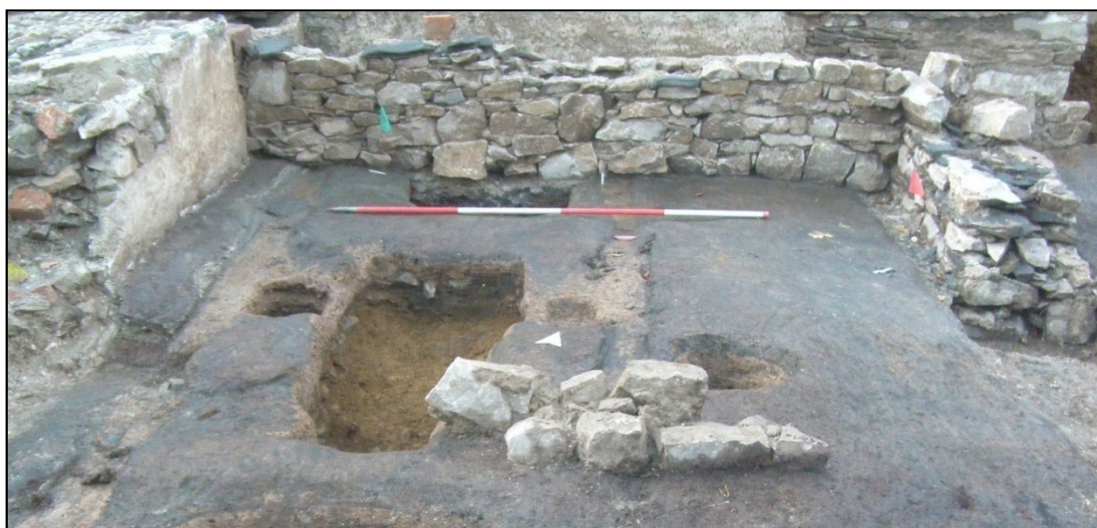
*Plate 10: Internal wall divisions, with wall 1063 in immediate foreground*

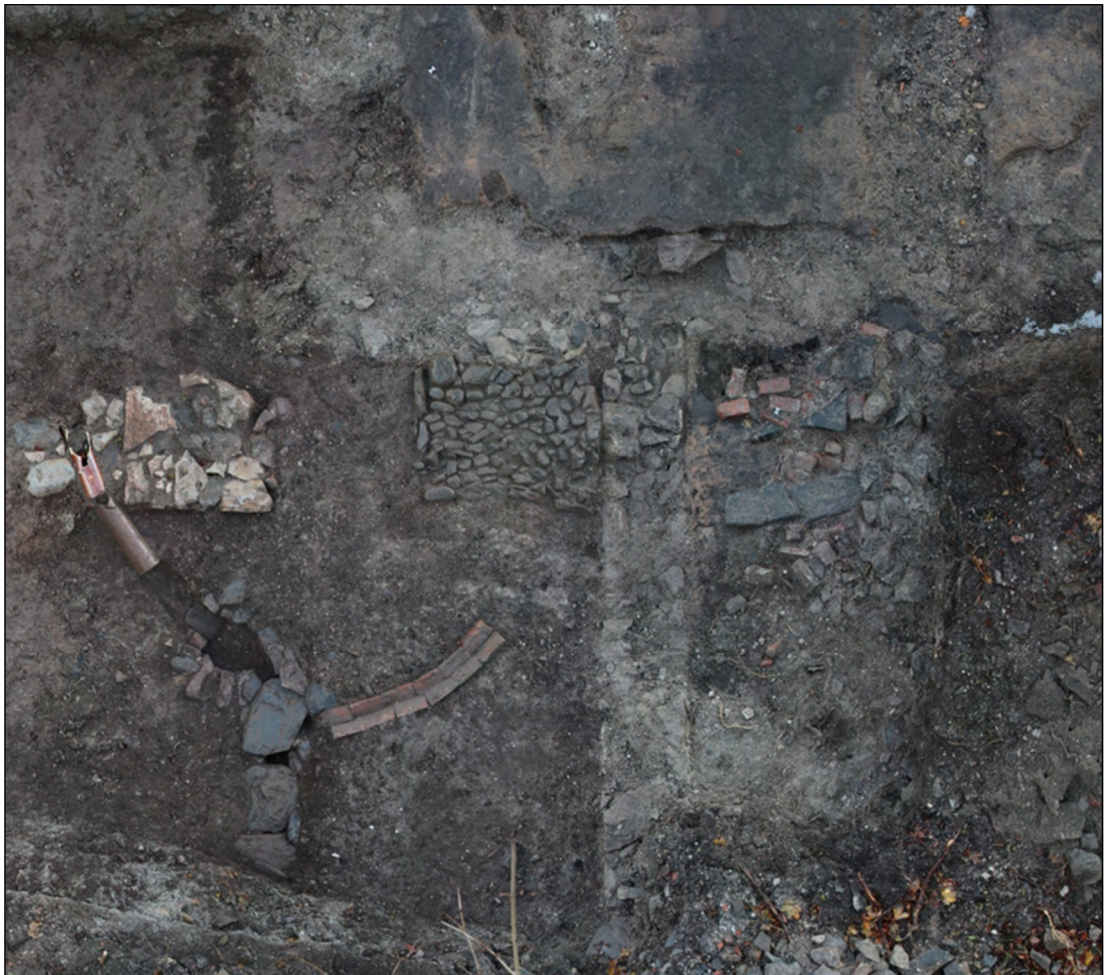
*Plate 11: Remains of unexcavated walls 1094 and 1096*

- 7.29 Several features were also noted that appeared to be external to the structure. Along its south-eastern limit, were the remains of three unexcavated walls, which extended beyond the limit of the excavation (Plate 11). These were observed to run parallel to each other on a north-west to south-east alignment that was perpendicular to construction cut **1023** and abutted this feature. Wall **1107** was thought to be a continuation of wall **1060**. Approximately 3.5m to the south-west, wall **1096** was in line with construction cut **1049** and may represent a continuation of that wall line beyond construction cut **1023**. A further 1.5m to the south-west, wall **1094** abutted construction cut **1023** and appears to have been an external wall.

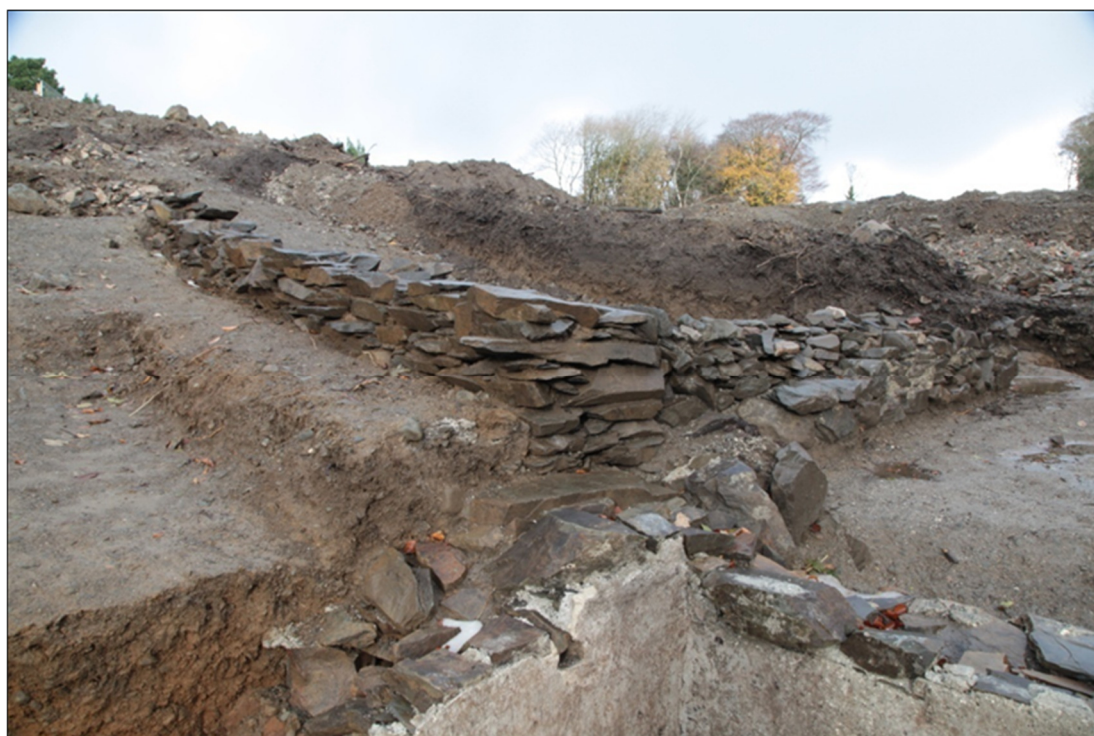
*Plate 12: dry-stone footing 1058 abutting the corner of wall 1060*

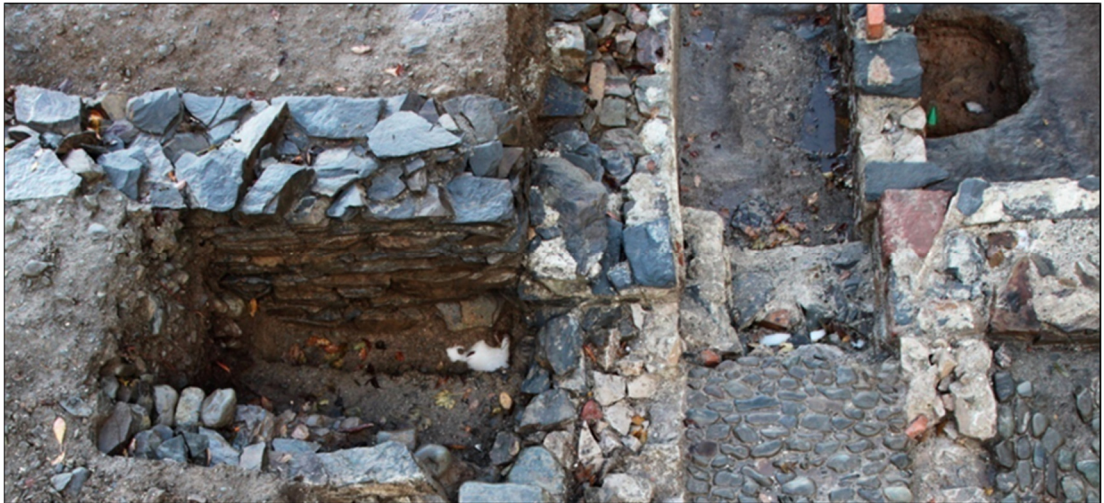
*Plate 13: dry-stone footing 1059 abutting wall 1060*

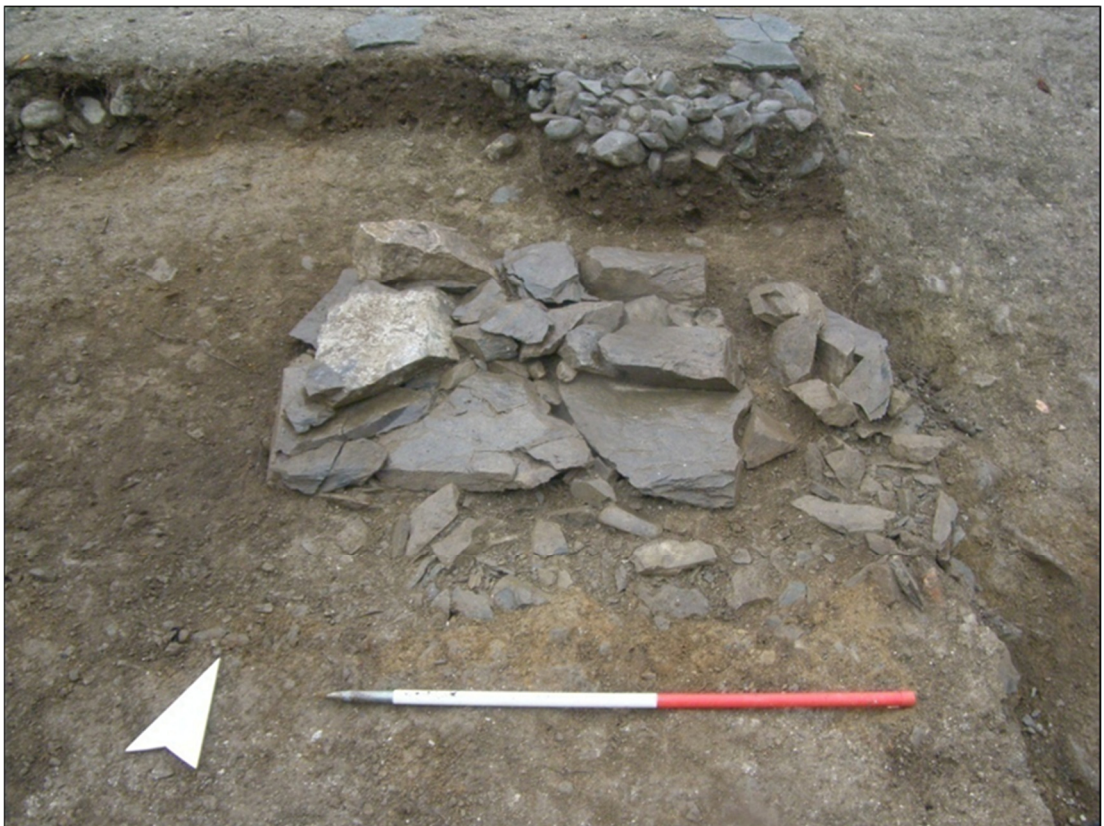
*Plate 14: dry-stone footing or column base 1057, overlain by made ground*

- 7.34 A footing or column base (**1057**) was situated in the approximate centre of the middle terrace, equidistant between footings **1058** and **1059**. This was rectangular in plan, consisting of limestone and slate in a dry unbonded construction, and was approximately 1.3m south-west to northeast by 1m south-east to north-west (Plate 14). This feature was not fully exposed, although there was evidence that **1057** filled a construction cut (**1103**) that cut buried soil **1053**.

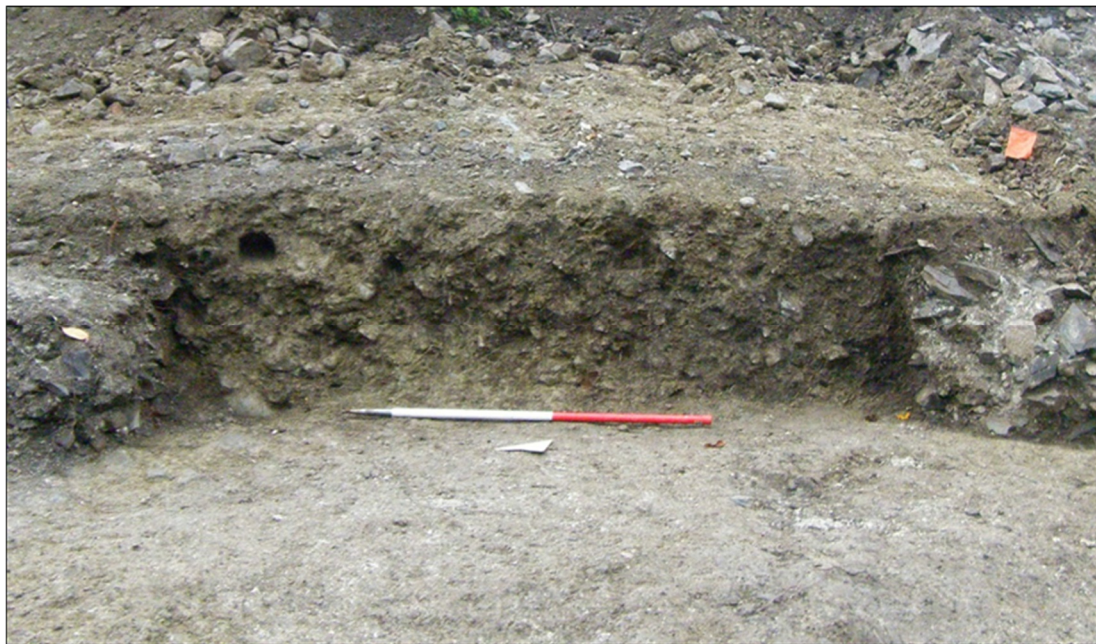
*Plate 15: vertical edge of construction cut 1019*

- 7.35 A construction cut (**1019**) was also observed to cut buried soil **1053**, which formed the back edge of the middle terrace. The cut extended approximately 6.4m south-east to north-west and 9.5m south-west to northeast and was observed to a maximum depth of 1.1m. The north-western edge of the cut was vertical in profile, suggesting that it might once have been partially filled by an external wall, although no in-situ masonry survived (Plate 15).

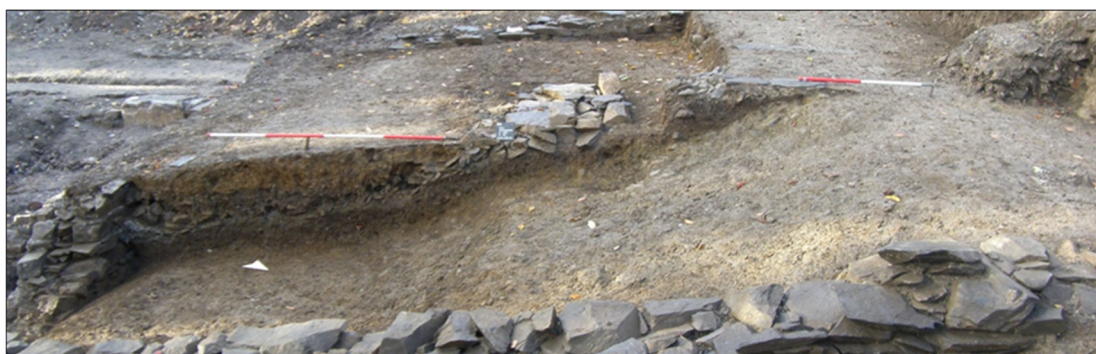
*Plate 16: section across the middle terrace*

- 7.36 Footings **1058** and **1059**, in combination with wall **1060**, retain made ground comprising redeposited natural and rubble layers forming group (**1084**). These deposits had been heavily truncated from above, presumably during 19th-century landscaping following the demolition of the building. A machine trench was dug through these deposits to the natural geology, which revealed a partial stratigraphic sequence (Plate 16).

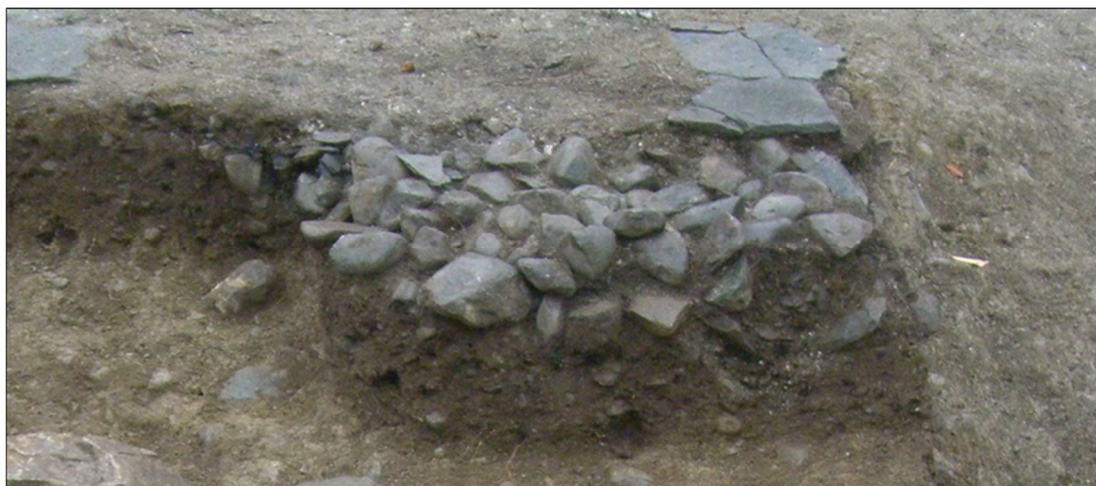
*Plate 17: an unstructured deposit of cobbles (1054)*

- 7.41 Also included in group **1084** was deposit **1054**, which consisted of unstructured cobbles in a matrix of sandy silt with frequent lime mortar inclusions and overlaid construction cut **1019** (Plate 17). Due to heavy truncation, this deposit was physically separated from the other layers of made ground within the group. However, it clearly formed part of the levelling event across the enclosed area within the middle terrace. The deposit was not fully exposed but was observed to a maximum thickness of 0.15m in section. No other limits were determined.

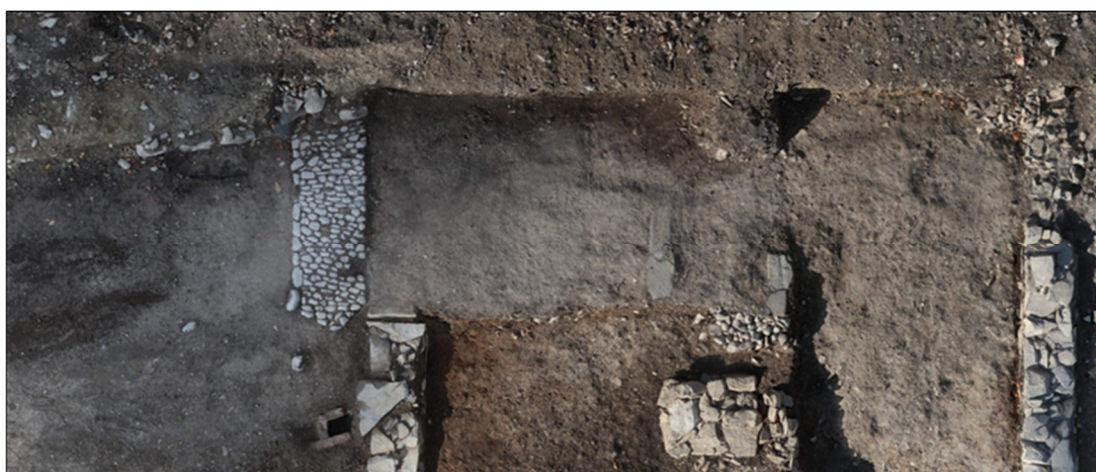
*Plate 18: an overview of layer 1055*

- 7.42 Sealing **1054** was layer **1055**, which comprised mid-grey, sandy clay with frequent gravel inclusions. This deposit formed a relatively level bedding deposit for potential floor surfaces (Plate 18). It extended to the vertical cut of **1019** to the northwest and was heavily truncated across its south-eastern extent, measuring approximately 2.5m from north-west to south-east. The north-east to south-west extent of the deposit was unclear, and it appeared to extend beyond the enclosed area and extend under an external cobbled surface (**1064**) and across the top of made ground (**1092**) to the west of the structure. Where excavated, layer **1055** was observed to a maximum thickness of 0.03m; as a result, it may simply represent an interface between the made ground or natural geology below it and the various floor surfaces above.

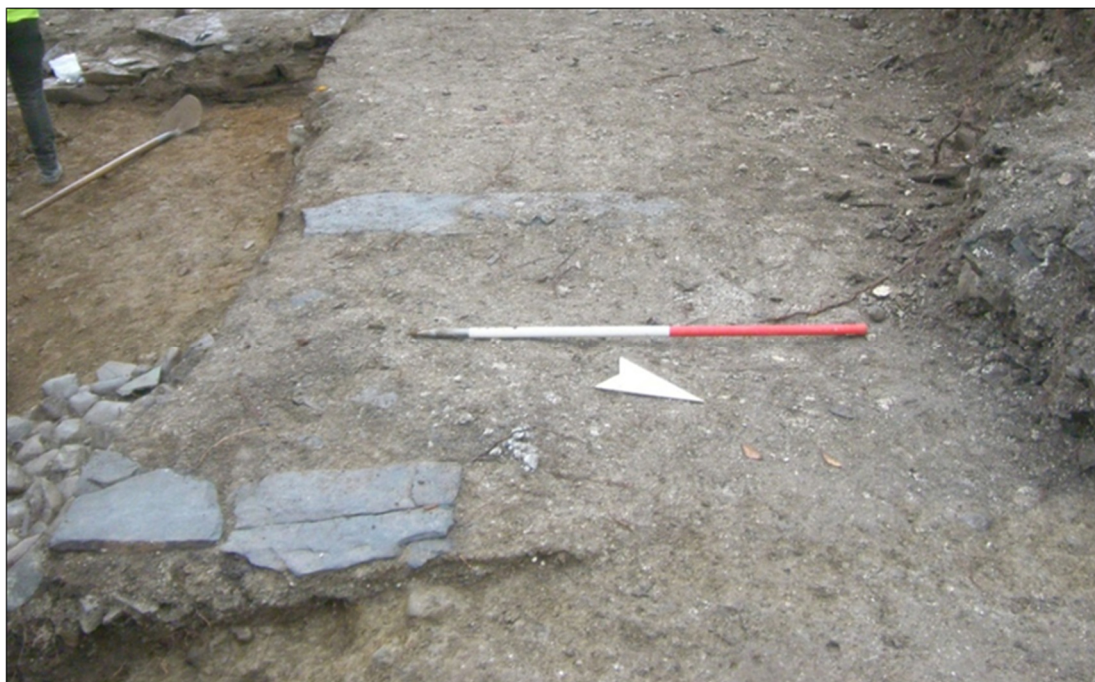
*Plate 19: truncated floor surface 1056*

- 7.43 A heavily truncated internal floor surface (**1056**) overlay layer **1055** (Plate 19). This consisted of five slate files separated into two groups. All the tiles were roughly 0.2m

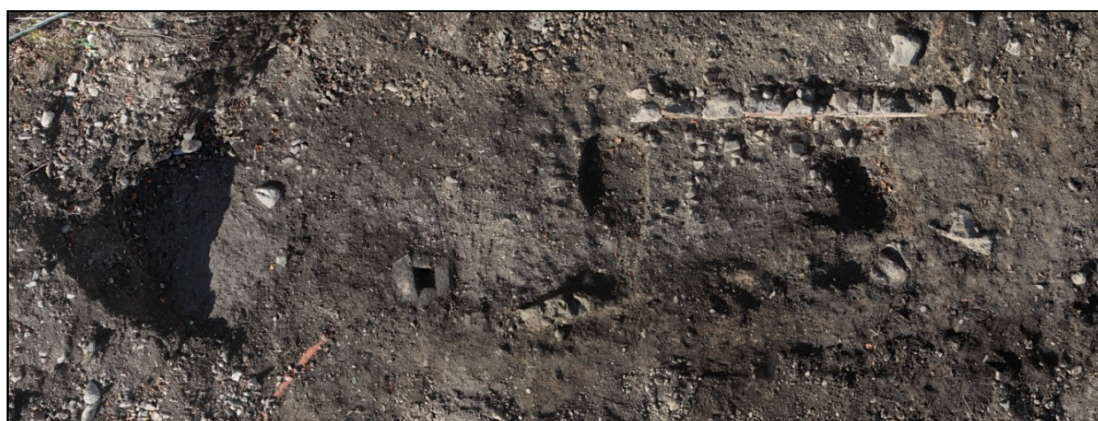
*Plate 20: upper terrace*

- 7.44 The remains on the upper terrace were built up from construction cut **1074**; a sub-rectangular box cut into the slope of the hill that created a level platform approximately 2.5 m south-east to north-west by 10 m south-west to north-east (Plate 20).

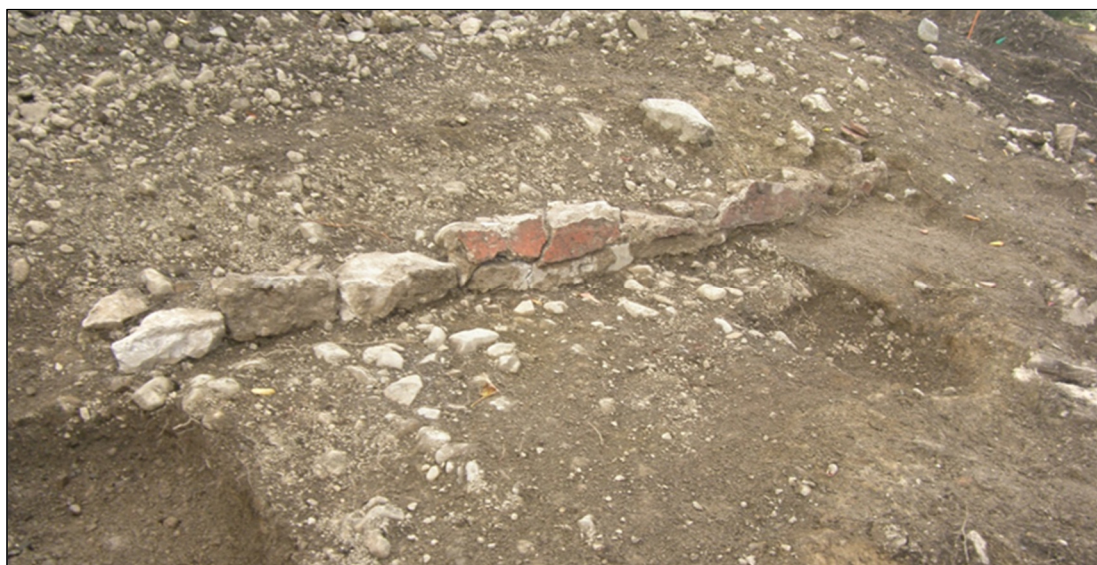
*Plate 21: truncated wall 1069 with painted plaster applied to internal face.*

- 7.46 The remains of a wall (**1069**) were built up against the north-western limit of compacted surface **1070** (Plate 21). This wall comprised roughly squared limestone blocks bonded with lime mortar. The wall extended approximately 4m south-west to north-east, with a maximum width of 0.3 m, and survived to a maximum height of 0.35 m. The south-eastern face was finished with painted lime plaster, which was light reddish brown in colour (Plate 21).

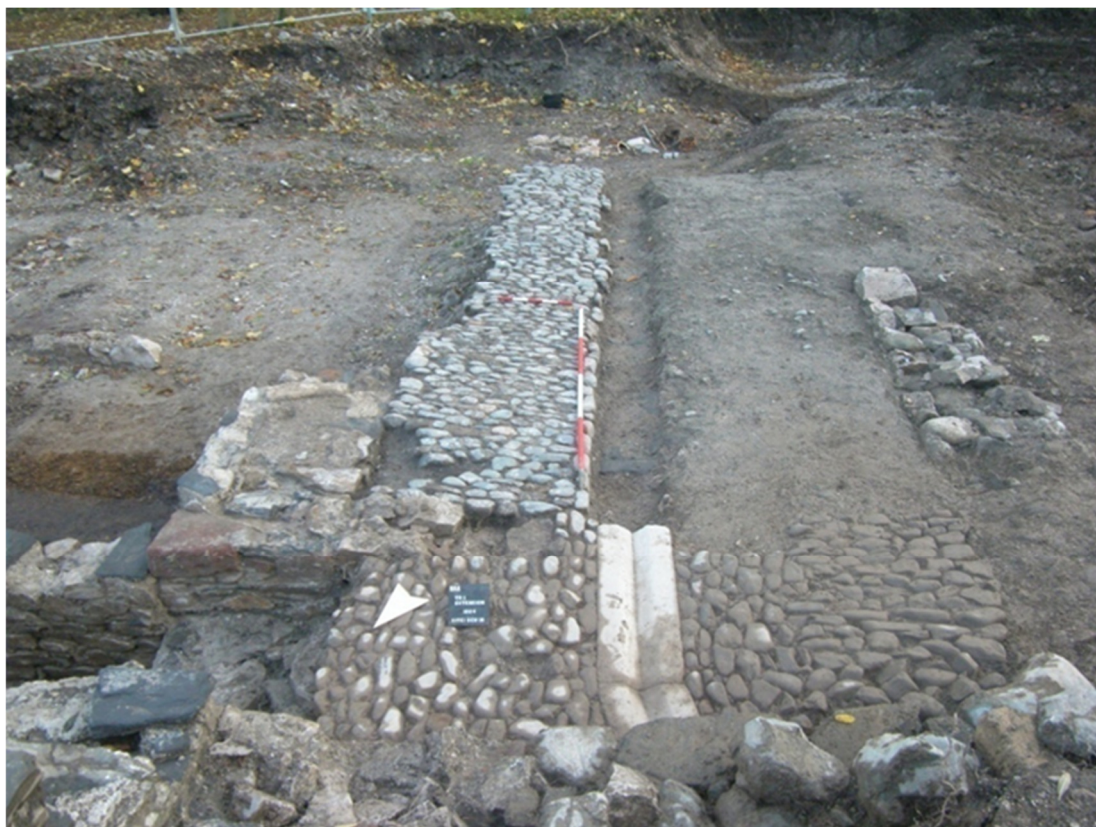
*Plate 23: metalled surface (1024) abutting incorporated drainage channel (1066)*

- 7.52 The partially enclosed area between the building remains and boundary wall **1067** was covered by metalled surface **1024** (Plate 23). This truncated surface comprised a single layer of natural cobbles between 0.08m and 0.2m in diameter, which extended for approximately 8m north-east to south-west and 2.5m north-west to south-east at its widest. It was observed to abut drainage channel **1066**, boundary wall **1067**, wall **1080** and footings **1083** and **1093**.

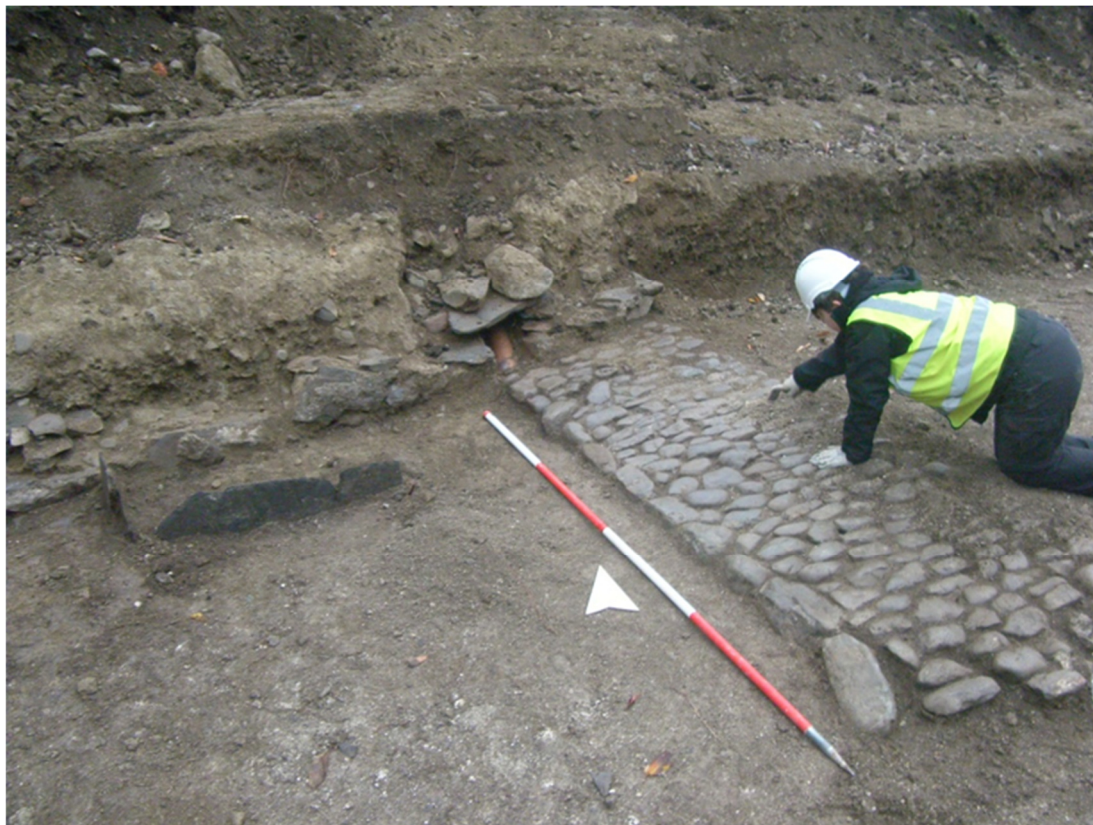
*Plate 24: overview of wall (1078), slate 'box' (1079) and cobbled surface (1064)*

- 7.56 The remains of a rectangular, open-ended 'box' (**1079**) were bonded with lime mortar to the south-eastern face of boundary wall **1078** (Plate 24). This feature appeared to have been constructed of roughly squared and split slate, with two sections remaining in situ. Its dimensions were approximately 0.75m by 0.3m in plan, and it was observed to be roughly 0.2m deep where the remains survived best. The purpose of this feature is unclear, but it may have comprised or contained some form of trough.

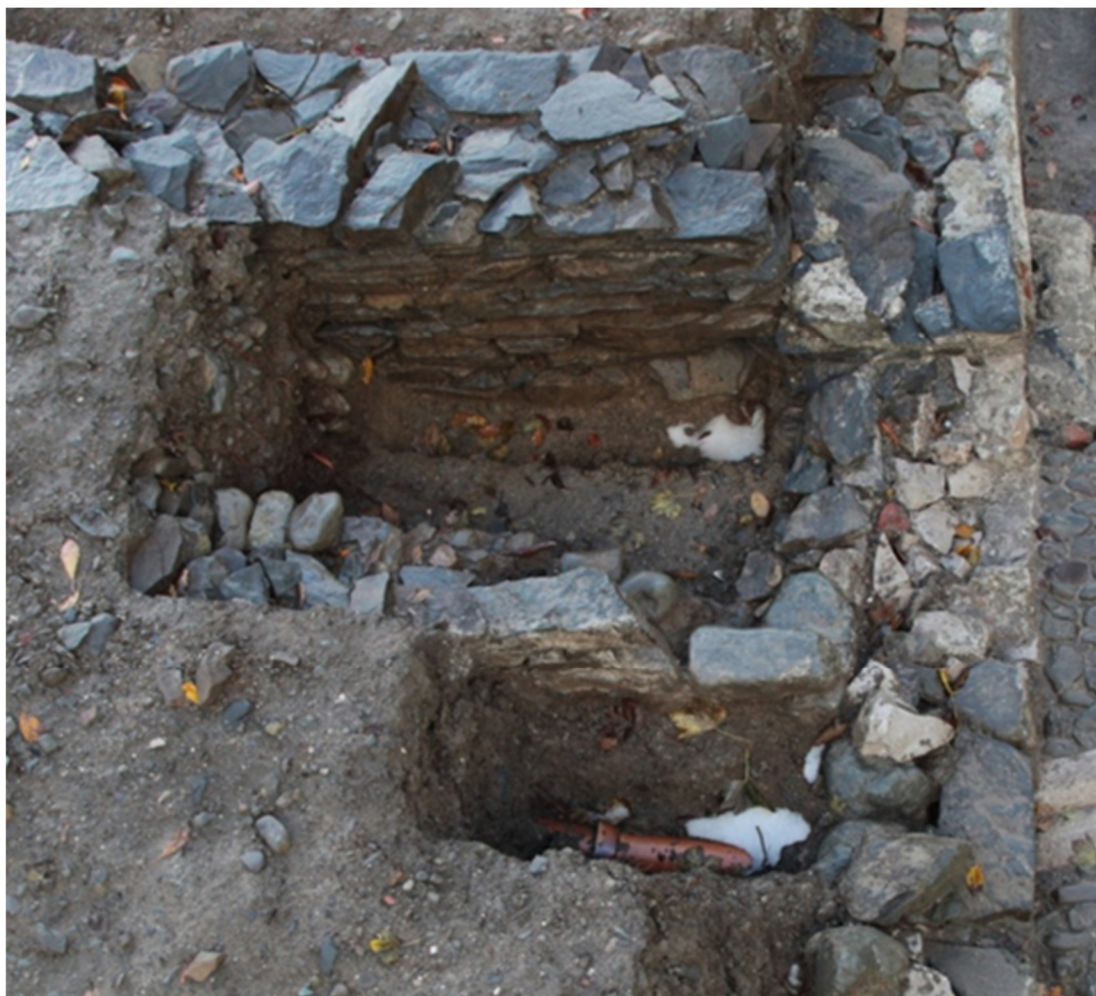
*Plate 25: wall (1082) running parallel with footing (1059)*

- 7.58 Within the yard area on the middle terrace, wall **1082** abutted the north-western faces of boundary wall **1067** and wall footing **1093** (Plate 25). It was only partially uncovered at its south-eastern limit and was observed running roughly parallel with footing **1059**. It comprised natural boulders and cobbles bonded with lime mortar; additional mortar or degraded plaster was observed appended to the south-west face of the wall.

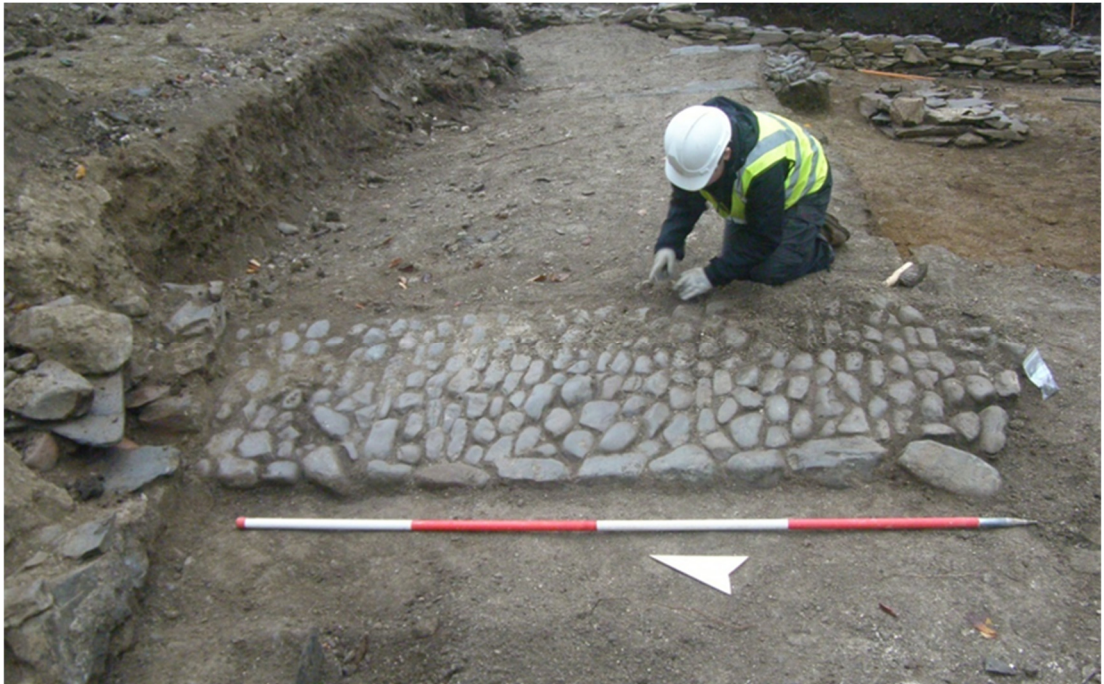
*Plate 26: cobbled surface (1064)*

- 7.60 Above layer **1055**, an external surface (**1064**) was observed to abut boundary wall **1078**. This comprised rounded natural cobbles of approximately 0.15m diameter that were pressed into compacted clay-sand (**1055**). This metalled surface was rectangular in plan with a south-east to north-west aligned kerb of larger cobbles (Plate 26). It measured approximately 1m by 2.5m, was no more than 0.1m thick, and was truncated along its south-east extent. The surface was sealed by demolition material (**1022**).

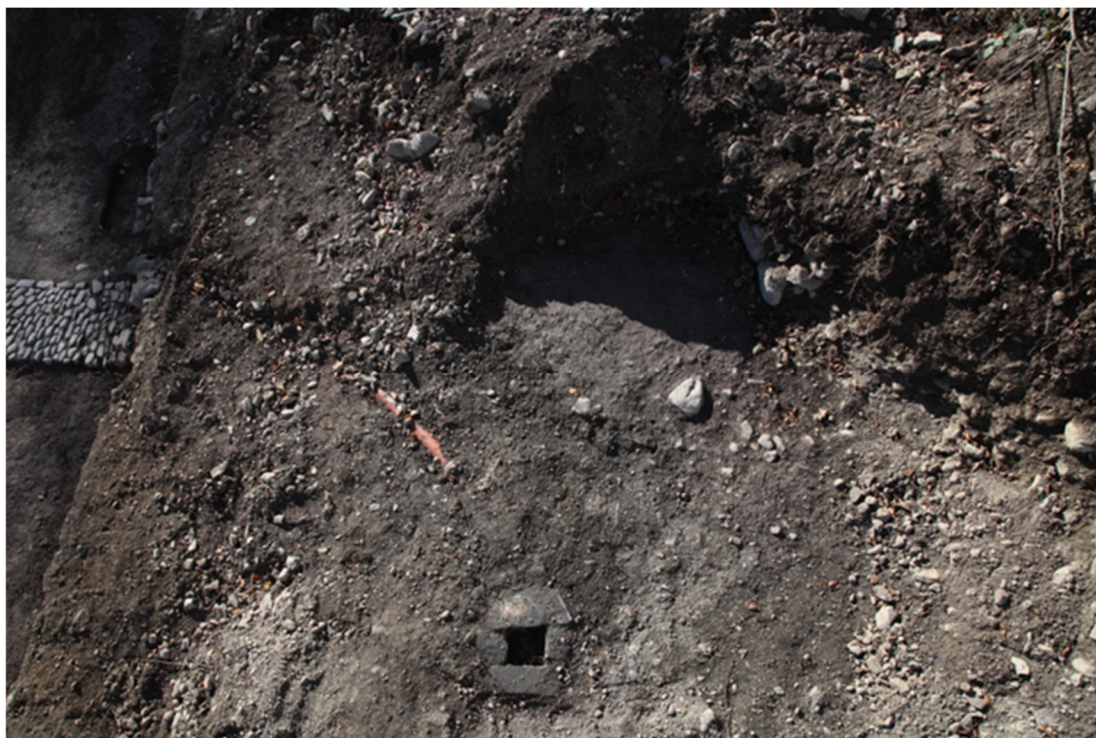
*Plate 27: overview of external surface on upper terrace*
