ARCHAEOLOGICAL EXCAVATION  
AND LANDSCAPE SURVEY  
REPORT

LAND AT STONECROSS  
MANSION, DALTONGATE,  
ULVERSTON, CUMBRIA

NAA 18/26  
March 2018

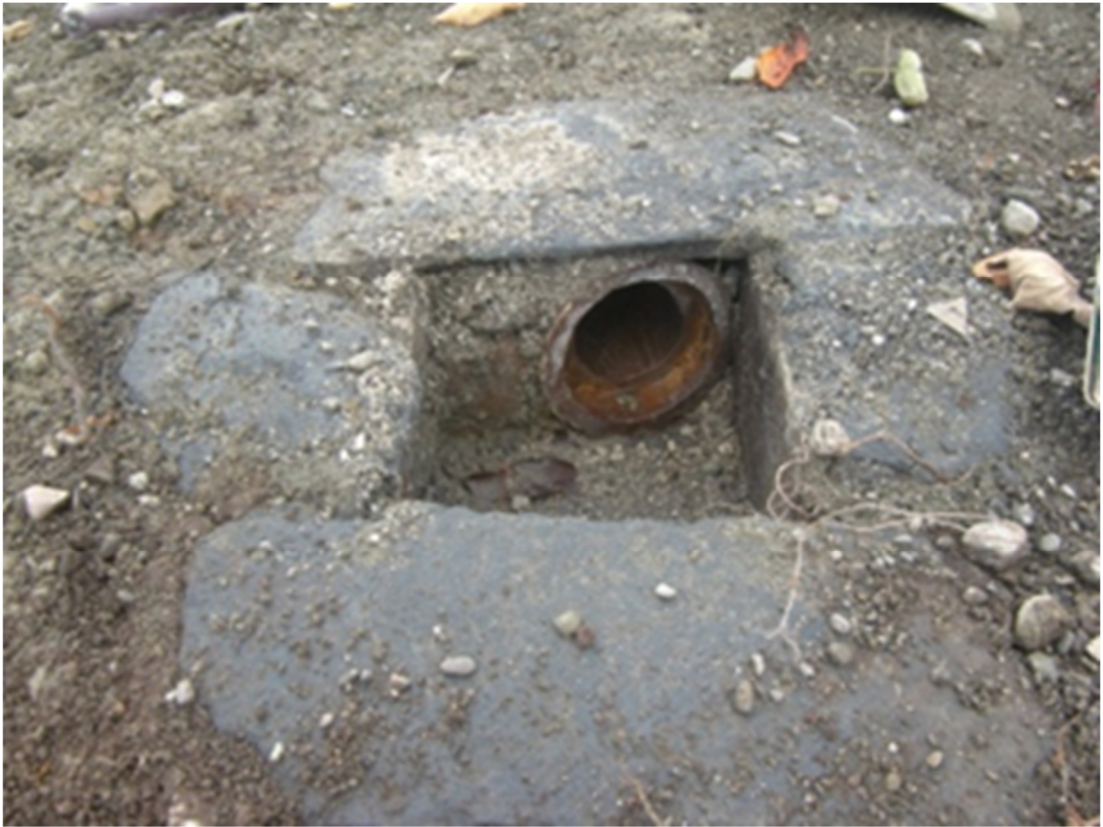
*Plate 28: drain inlet (1071)*

- 7.63 The yard areas across all three terraces appeared to be connected by a drainage system. On the upper terrace, this comprised a drain inlet (**1071**) constructed of brick and slate, which funnelled into salt glazed collar pipe drains (Plate 28). A second drain inlet (**1087**) was identified on the middle terrace, consisting of a box drain, approximately 0.4m wide, which was constructed of brick and slate and also fed into salt glazed collar pipe drains (Plate 29). A partially exposed drain, comprising sections of similar salt glazed collar pipe drain, ran downhill from drain inlet **1087**. This drain was approximately 0.35m in length, with an internal diameter of c.0.08m. This drainage system made up drainage group **1090** and was overlaid by made ground **1092** on the middle terrace.

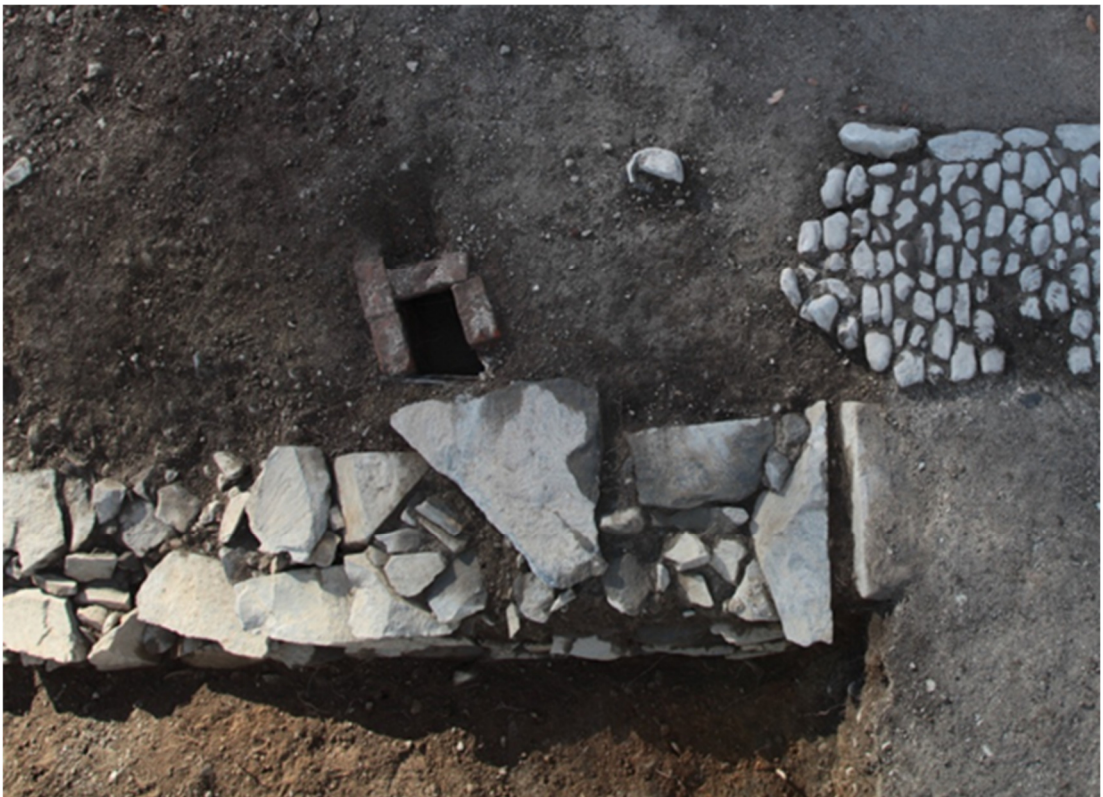
*Plate 29: overview of drain inlet (1087)*

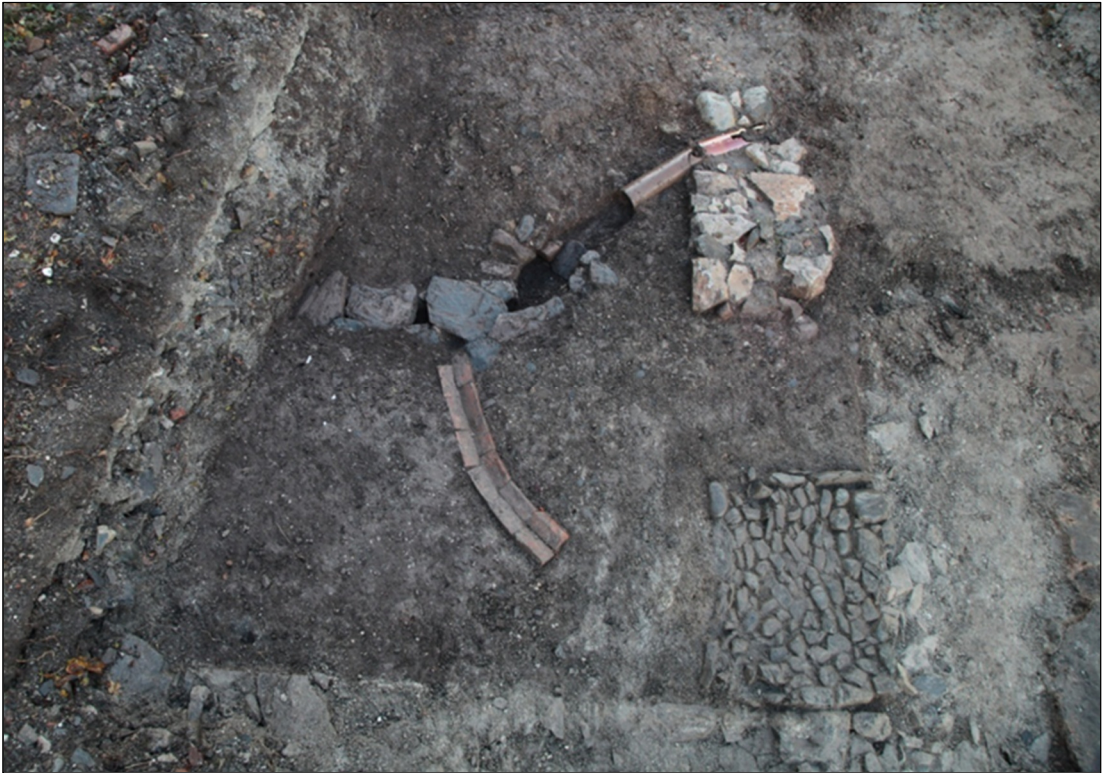
*Plate 30: metallised surface 1095, foundation 1097, drain 1089 and drainage channel 1088*

- 7.65 A probable foundation (**1097**) was identified to the south-east of drainage channel **1066**, which comprised natural cobbles and roughly squared limestone bonded with lime mortar (Plate 30). This masonry was observed to be sub-rectangular in plan, measuring approximately 1.2m by 0.9m. The remains of a heavily truncated drain were incorporated into the masonry at its south-western limit. These were also thought to be part of drainage group **1090**.

- 7.66 A box drain (**1089**) constructed of slate and brick was also recorded on the lower terrace, which extended beyond the south-eastern limit of the excavation, heading towards Daltongate (Plate 30). The construction of the drain was notable in comparison to the tapered salt glazed pipes encountered elsewhere. Feeding this drain was drainage channel **1088**, comprising twelve bricks arranged in six pairs that described a shallow arc, and the salt glazed drain pipe incorporated into masonry (**1097**), which presumably connected to drainage group **1090** on the higher terraces.

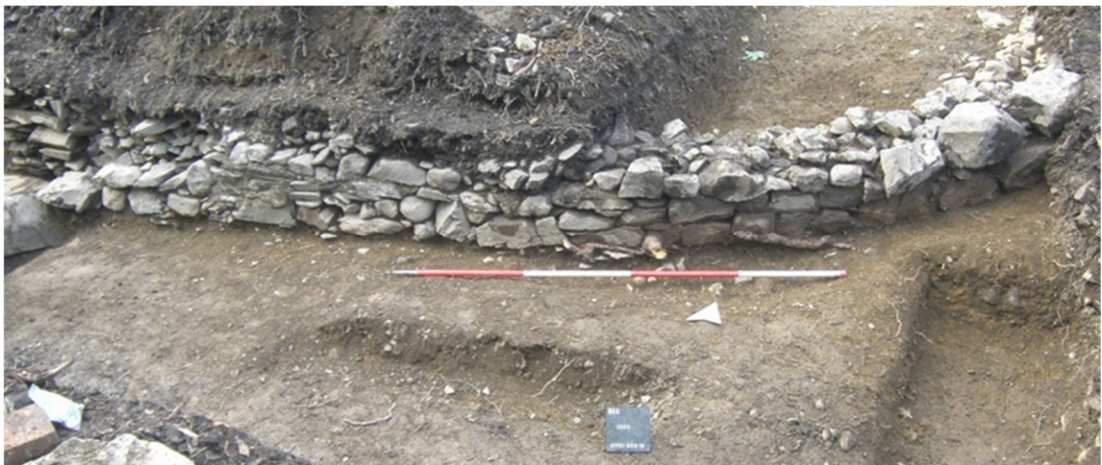
*Plate 31: dry-stone wall (1005)*

7.67 A further external area was identified on the north-eastern side of the building remains, which sat apart from those on the south-western side. This comprised dry-stone wall **1005**, which was observed to abut wall footing **1058** and described an arc over 6 metres from the south-west to the north that followed the natural slope of the hill (Plate 31). It extended beyond the limits of the excavation and survived to a maximum height of 0.6m.

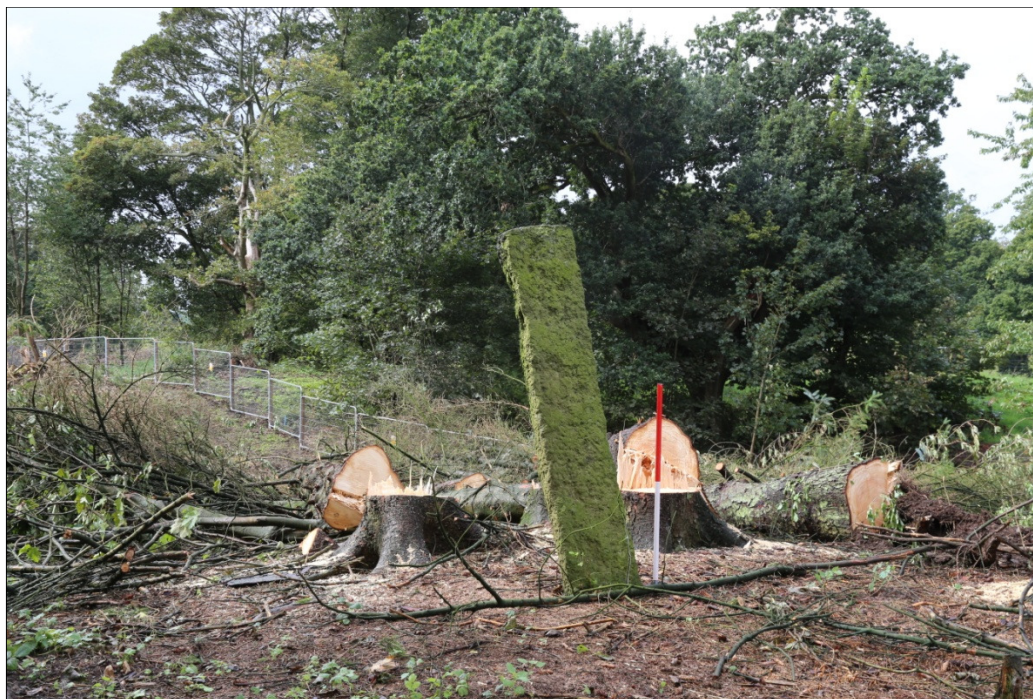
*Plate 32: standing stone, as identified in during the landscape survey*

- 7.70 Trench 3 was located to investigate a standing stone identified on the top of a small hill overlooking Daltongate (Plate 32).

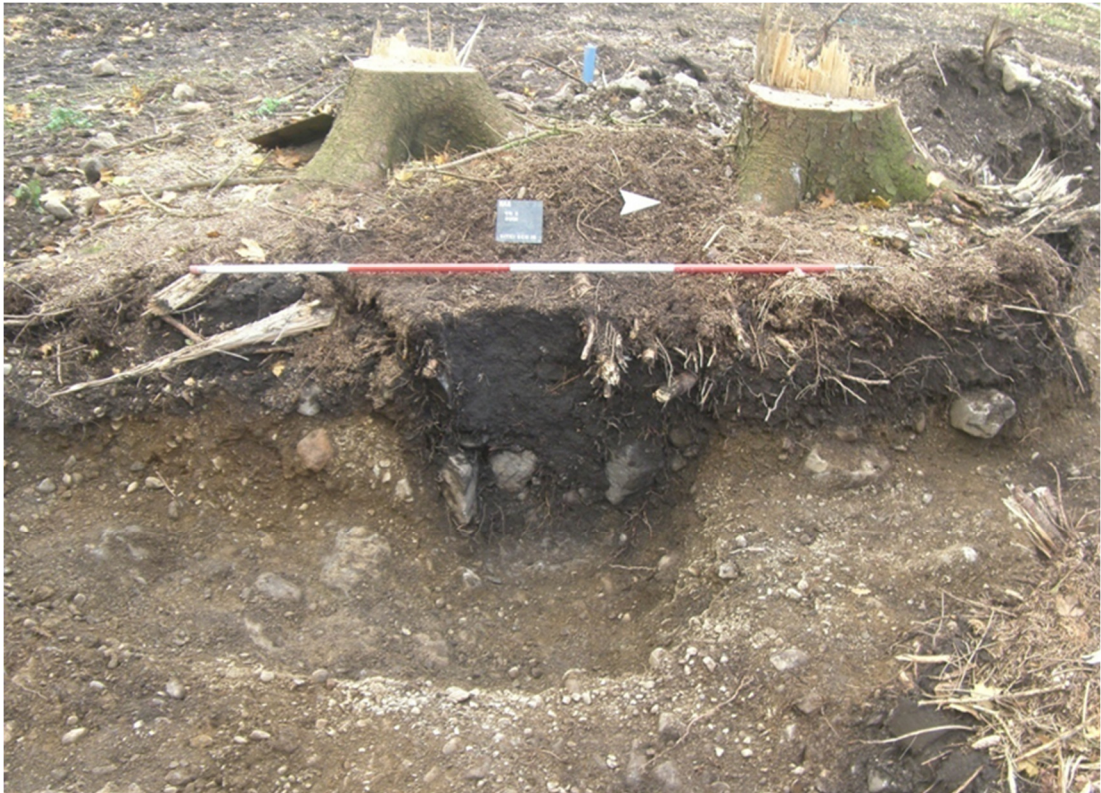
*Plate 33: truncated stone-hole (3001)*

- 7.71 After the removal of the standing stone under archaeological supervision an area approximately 5m by 4m was stripped. Upon consultation with CCCHES and Persimmon Homes Ltd, the stripped area was expanded by a further 5m by 5m, covering the peak of the hill.
- 7.72 The natural geology (**1002**), comprising yellowish-brown sand and gravel tills, was observed at an average depth of 0.4m below the level of the current topsoil. The stripped area had until recently been heavily wooded and disturbance to the geology caused by tree roots was easily observable.

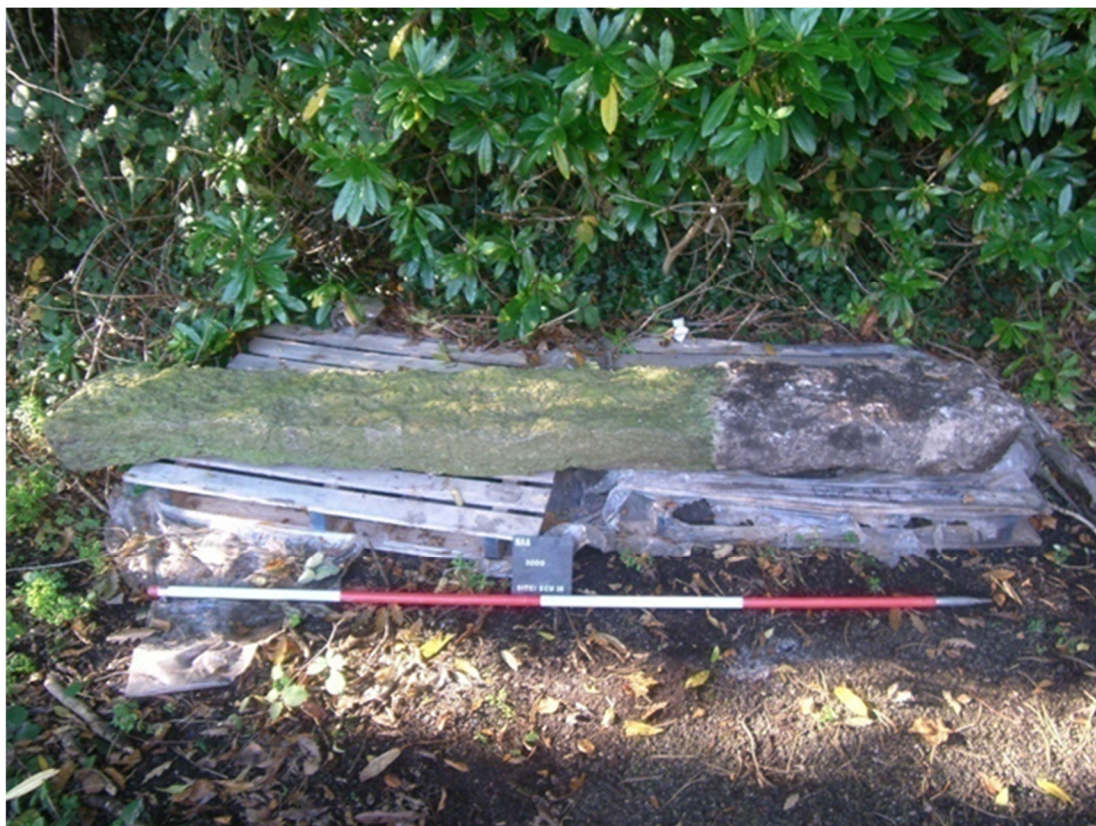
*Plate 34: standing stone (3000) after removal*
