**ARCHAEOLOGICAL
MONITORING OF BOREHOLE
STARTER PITS**

**AELFLEDA TERRACE
WHITBY
NORTH YORKSHIRE**

Project No.: 1129
Text: Greg Speed
Illustrations: Dawn Knowles
Edited by: Richard Fraser

prepared for
J N BENTLEY LTD
on behalf of
YORKSHIRE WATER

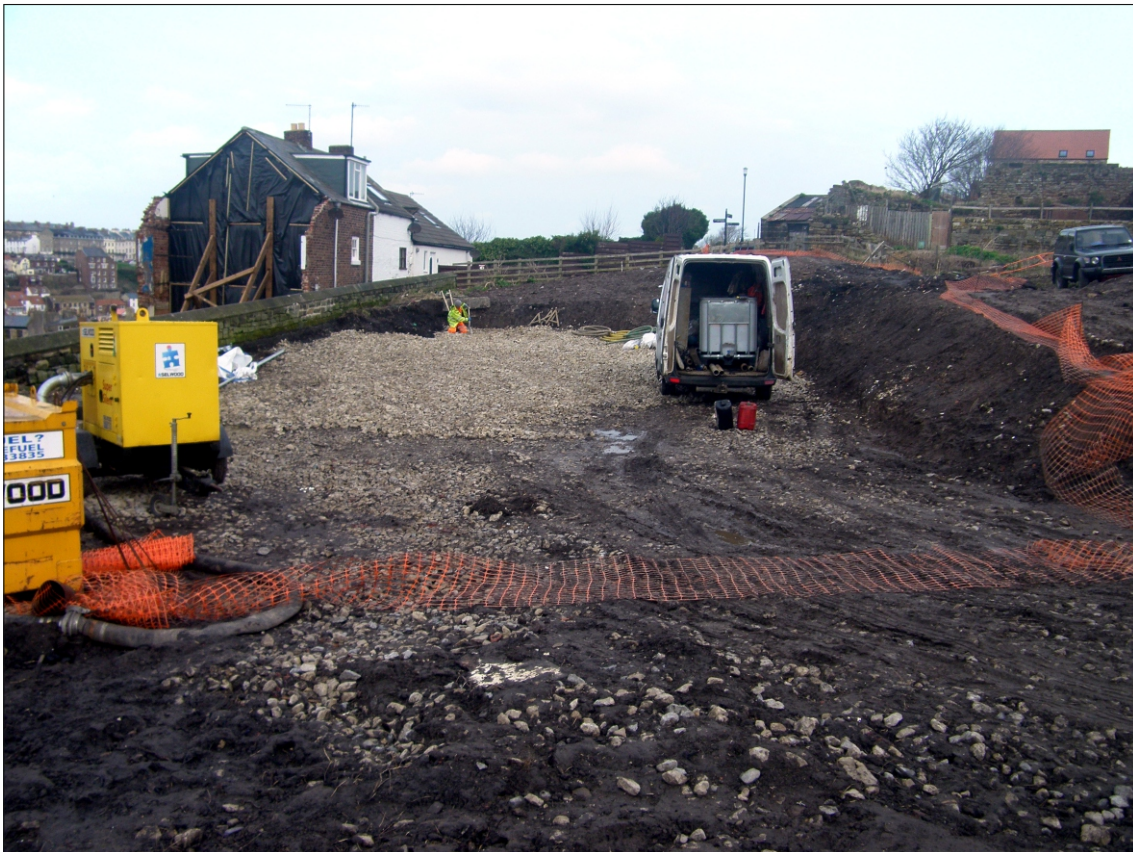
Plate 1

- 3.3 Starter Pits 1 and 2 were located within the previously stripped compound area (Plate 1). Both encountered 0.4m of large ballast (the compound surface) directly overlying mid brown sandy boulder clay.

Aelfleda Terrace, Whitby: Compound Area, starter pit 1 under excavation, starter pit 2 located adjacent to plant on left, facing north

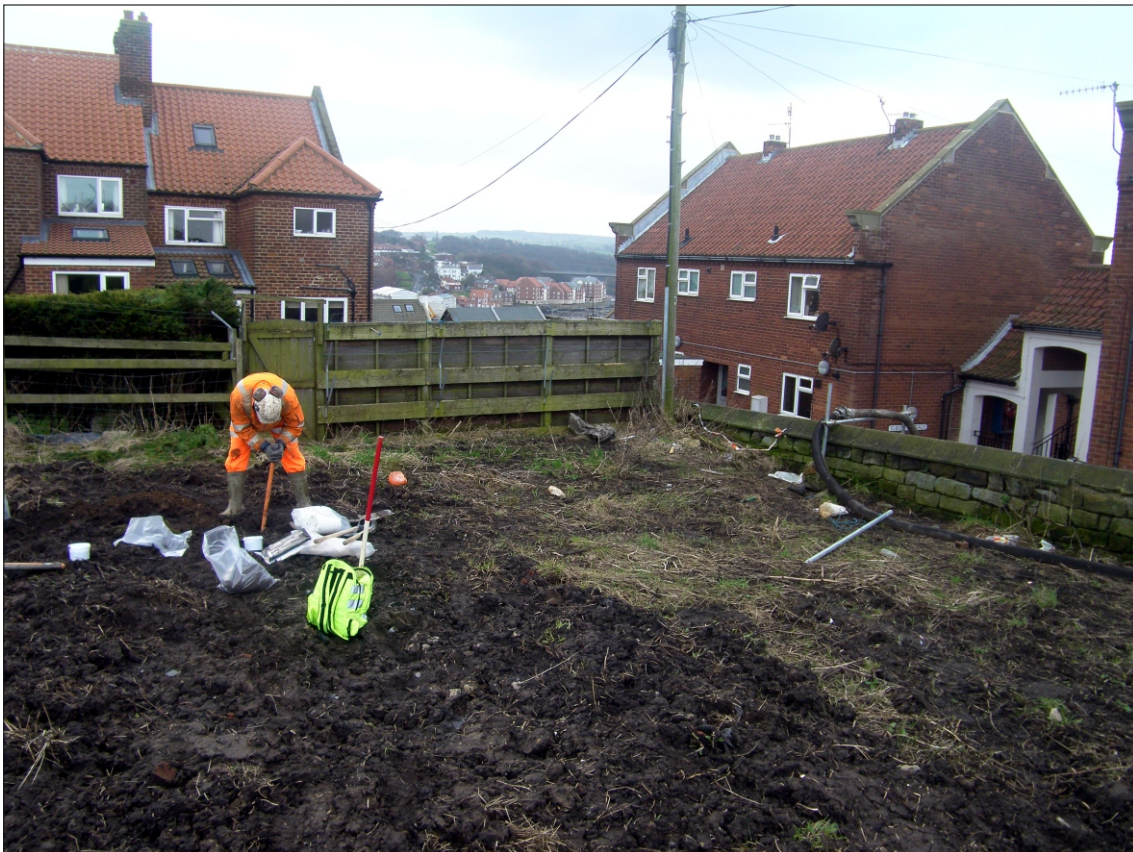
Plate 2

- 3.4 Starter Pit 3 was located to the south of the compound, within the level area at the south-western corner of the field (Plate 2). At this location, 0.45m of topsoil overlay stony yellow-brown natural clayey sand.

Aelfleda Terrace, Whitby: south-west corner of field showing starter pit 3, facing south-west
