**ARCHAEOLOGICAL SURVEY,
TRIAL TRENCHING
AND WATCHING BRIEF
REPORT**

**CAM HIGH ROAD,
UPPER WENSLEYDALE,
YORKSHIRE DALES
NATIONAL PARK**

NAA 13/82
July 2013

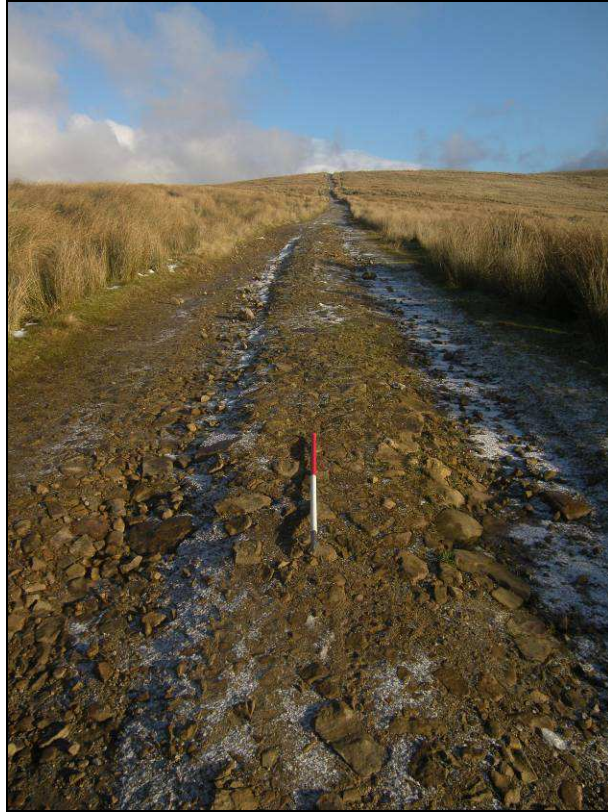
Plate 3: Survey Area 1, Cam High Road, facing north-east

- 5.1 A topographic survey and road profile were undertaken in three discrete areas along Cam High Road (Figure 2) as part of the current phase of works. Survey Area 1 (Figure 3) indicates that the road occupies a slight shelf within a landscape sloping gently southwards. The central track bed is approximately 2.85m in width, and preserves on its surface a distinct area of cobbling that may be a remnant of an earlier road surface. There were also shallow depressions showing where the road was being worn, but these had not yet formed distinct wheel ruts. The north side of the road contains a shallow road side ditch, with gentle sloping sides, which appears to have been recut in the recent past. The south side of the road appears to also have a faint trace of a ditch, though this does not appear to extend to the full width of the survey area, the north-eastern side perhaps having been buried by (later) road metalling. This could suggest that the track bed and ditches at this point were established at an earlier (? Roman) period, and were subsequently altered by the installation of a later (? turnpike) period of cobbling.

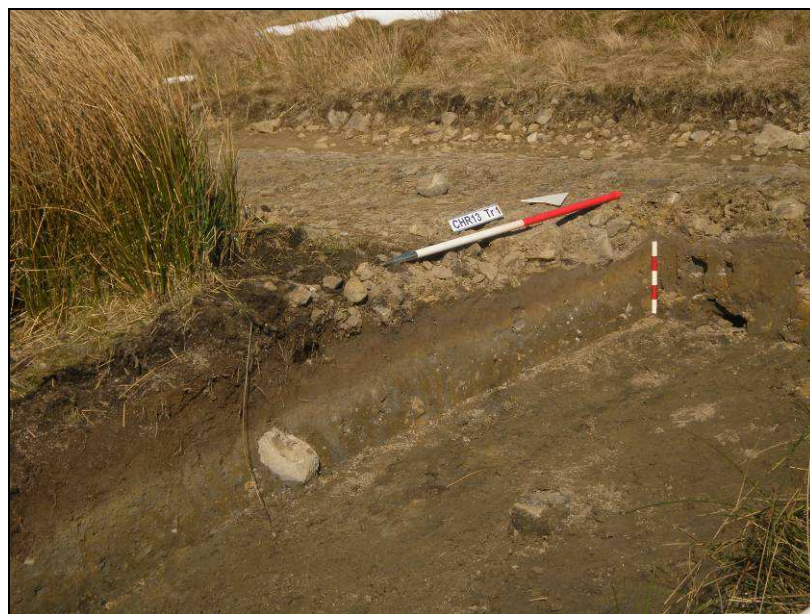
Plate 4: Trench 1, showing road deposits, facing north

- 5.6 The earliest material associated with road construction was a bedding layer (4). It comprised light grey sandy silt that had a maximum thickness of 0.14m and was 2.4m wide which continued beyond the extent of the trench to the east and west upon the course of the later road surface. This material appeared to have been deposited to produce a terrace upon the bank side for construction of the overlying road surface 5. The road was 2.6m wide and comprised a 0.2m thick deposit of sub-rounded limestone cobbles (individually up to 0.2m in size) that were compacted in a sandy matrix which probably represented the heavily worn remains of the turnpike road. It also included quantities of uniform angular gravel that represented recent attempts to resurface and repair the existing track.

- 5.7 The revetment (28) was identified 3.5m to the north of road surface 5, beyond the location of a later ditch (20; discussed below), and was aligned parallel to it. It had been constructed in a slight cutting (23) that was 0.9m wide with a 'U'-shaped profile to a depth of 0.2m that continued for the full width of the trench. The revetment (28) comprised a number of sub-rounded cobbles that were individually up to 0.15m in size set within a light yellow and grey clay matrix which would have limited land slip onto either the surface of the turnpike road or into any earlier phase of ditch 20 to the south.

- 5.9 Ditch 20 was aligned parallel to the track at a distance of c.1m. It was 1.8m wide and 0.65m deep with a stepped 'V'-shaped profile which suggested it was excavated, or re-excavated, by mechanical means. It was filled primarily by dark grey brown clayey silt (22) which was overlain by mid-grey brown silty clay (21). The upper level of the ditch remained open and functioned as a drain.

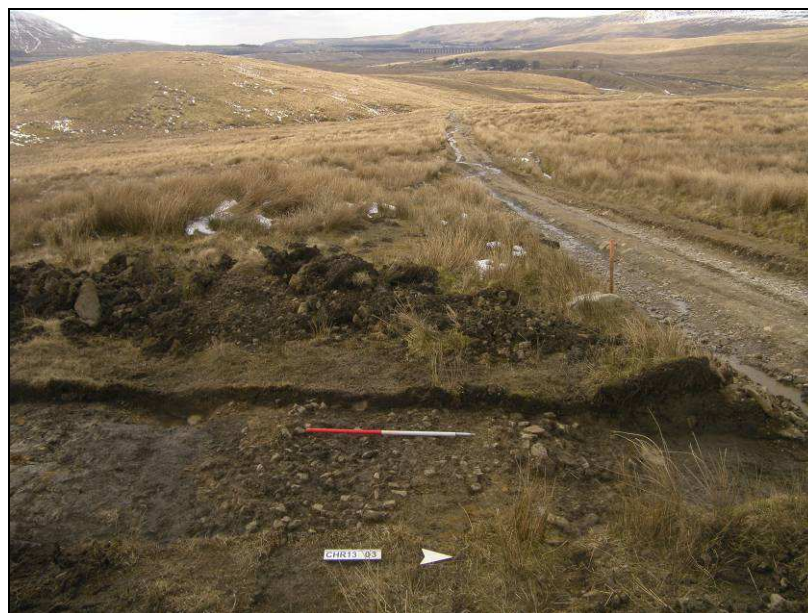
Plate 5: Trench 2, possible Roman road, facing west

- 5.14 The existing track surface (18) was 3.25m wide by 0.2m deep and was constructed from material equivalent to that outlined within Trench 1 (discussed above). During investigations a 0.06m thick deposit of mid-brown orange sandy clay (29) was identified which appeared to pre-date the existing track and may have represented material deposited during levelling to the route of the turnpike road prior to its construction.

- 6.3 Perhaps the clearest indication of this was the section of earlier road surface uncovered in Trench 2, tentatively identified as a Roman road surface, and comprising a broadly 2m wide metalled track with shallow flanking ditches. The road surface lay south of the current track alignment and appears to mark the straightening of a meander in the road, perhaps some 50m in length, where the track climbs the side of Broad Ray before joining with the Pennine Way. The interpretation of the surviving metalled surface as a Roman road is, perhaps, open to question. No dating was recovered from the surface of the track, and its dimensions are relatively small in comparison to other examples, which tend to be 5-6m in width, and have stone foundations, which this did not. It seems likely that this track pre-dates the turnpike, but its origins remain unclear.

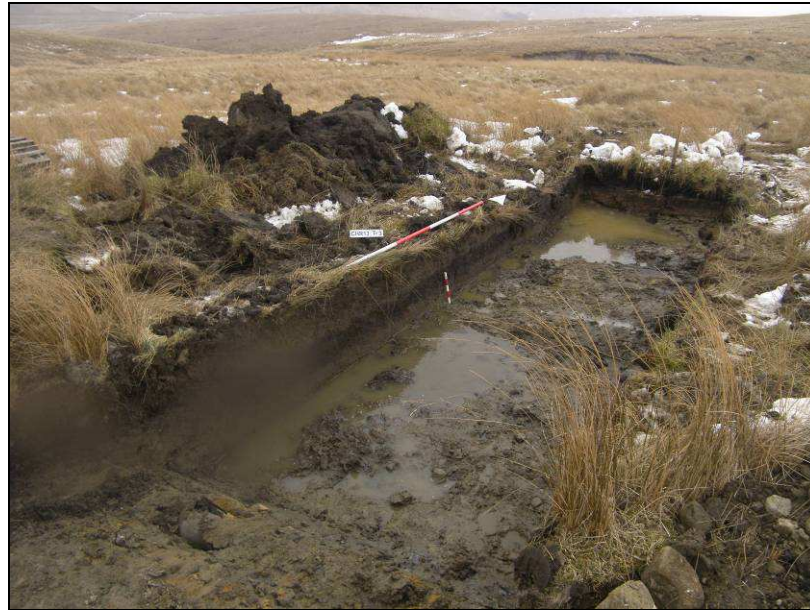
Plate 6: Trench 3, facing south-east

- 5.18 The existing track (10) was 3.5m wide and had a maximum thickness of 0.3m. It was formed by material equivalent to that described above (5.6 and 5.14) and again probably represented the heavily worn and repaired remains of the turnpike road.

- 5.19 Ditch 11 was situated 1.5m to the south and was slightly uphill of the track surface. It was 3.3m wide with a 'V'-shaped profile to a depth of 0.6m and also appeared to have been excavated by machine. The ditch was filled by dark brown silt (12) that was indistinguishable from the overlying topsoil (8).

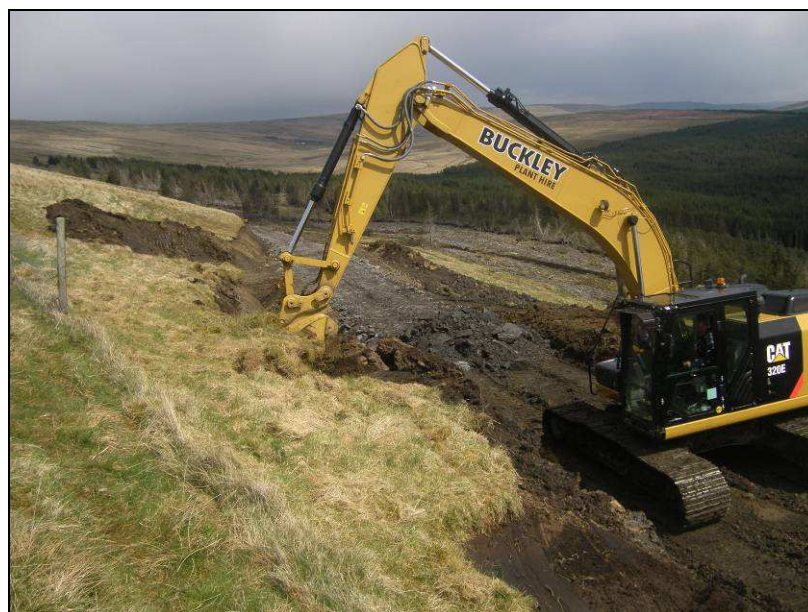
Plate 7: Construction of the new track, facing east

- 5.21 A watching brief was undertaken on a section of new track that ran from Cam High Road (NGR 381042, 481330) to Cam Plantation (NGR 381183, 481391) (Figure 9). The works took six days and consisted of excavation along the side of a steep slope, followed by filling with stone from a quarry at the edge of Cam Plantation. The topsoil was a dark brown peat with a clay component and was generally around 0.20m deep. There was no subsoil and the topsoil lay directly on top of natural yellow clay.

- 5.22 No archaeological deposits were discovered on the slope itself. Where the new road intersected with Cam High Road a section of the road was removed to allow a drainage pipe to be placed. This allowed a profile of the road to be drawn and analysed (Figure 9). The current metalled surface (35) was a yellowish white limestone and appeared to be modern in date. No earlier surfaces were recognised though there were several different layers of road construction material (36-39). The layers immediately below the current wearing surface appeared to have been in a cut (44) and deposited with a mechanical excavator and as such are thought to be modern. Further upslope a series of layers (43, 42, 41 and 36) were partially excavated but no dateable material or previous surfaces were located. The layers respectively comprised re-deposited natural clay providing a base for a sandstone road which was overlain by colluvial material and topsoil. A series of intercutting road terraces and roadside ditches were observed as upstanding earthworks immediately upslope to the northwest for a distance of 25m which indicated that the course of the road had moved over time.
