DESK BASED ASSESSMENT AND SURVEY

WOODHEAD TUNNELS SURFACE ROUTE

Project name		Woodhead Tunnels			Project number	
Report title		Woodhead Tunnels, Surface Route. Desk based Assessment and Survey			553	
Report No.		14/54				
Version	Date	Filename	NAA_0553_Rpt_14-54_DBA-Survey.pdf			
v.1	July 2014	Description	Desk Based Assessment and Survey of Surface Route			
			Prepared by	Edited by	Approved by	
		Name	Paul G Johnson	Richard Fraser	Mary Fraser

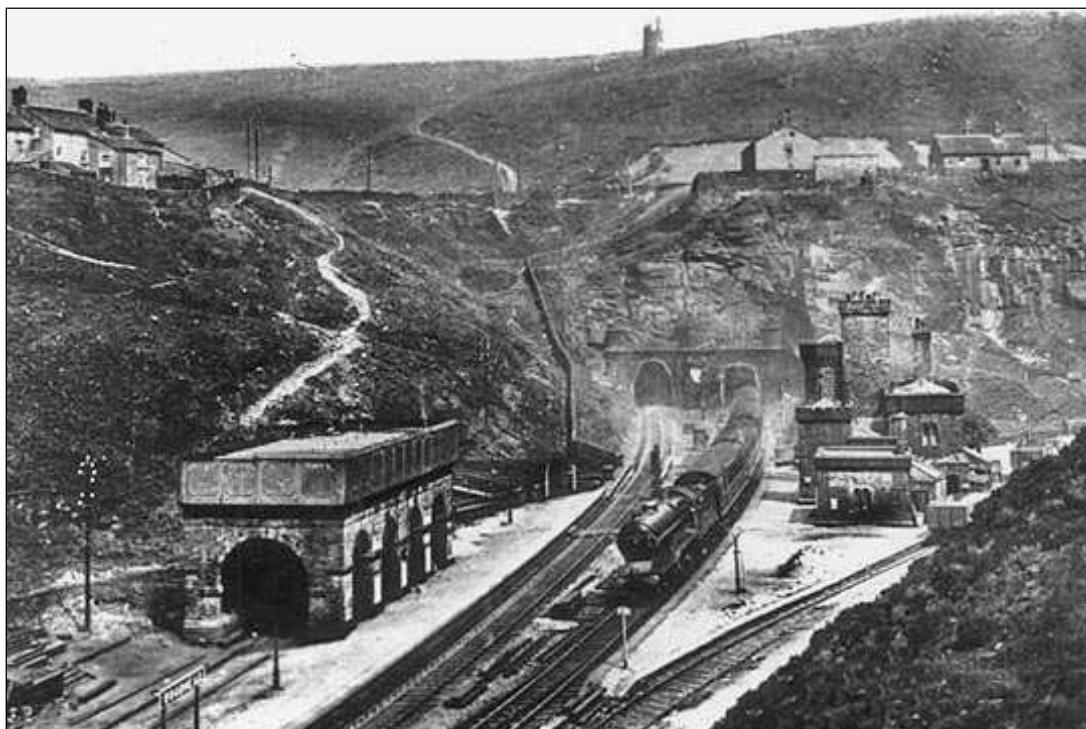
Plate 1: Woodhead Tunnel, western portals

- 5.36 Sites 30 and 32, comprise the former site of Woodhead Station and the remains of the two portals of the 19th century tunnels at their western end. The station was opened on 8 April 1844 and was served by stopping passenger trains operating on the route from Manchester London Road to Sheffield Victoria. The station was replaced by a new station serving the 1950s tunnel in 1953, which was built slight to the west of the original and this station was closed in July 1964, but the line remained open for passenger trains until 1970 and to freight traffic until 1981. The architecture of both the original station and tunnel portal was overtly ostentatious, both comprising heavily castellated structures executed in the Gothic style (Plates 1 and 2). The original station was demolished in the 1950s, and the castellations removed from the portal when the tunnels were modified to carry electricity cables shortly afterwards. Sites 31 and 33 were the counterparts of these structures at the Dunford Bridge end of the tunnel and were essentially similar structures suffering similar fates.

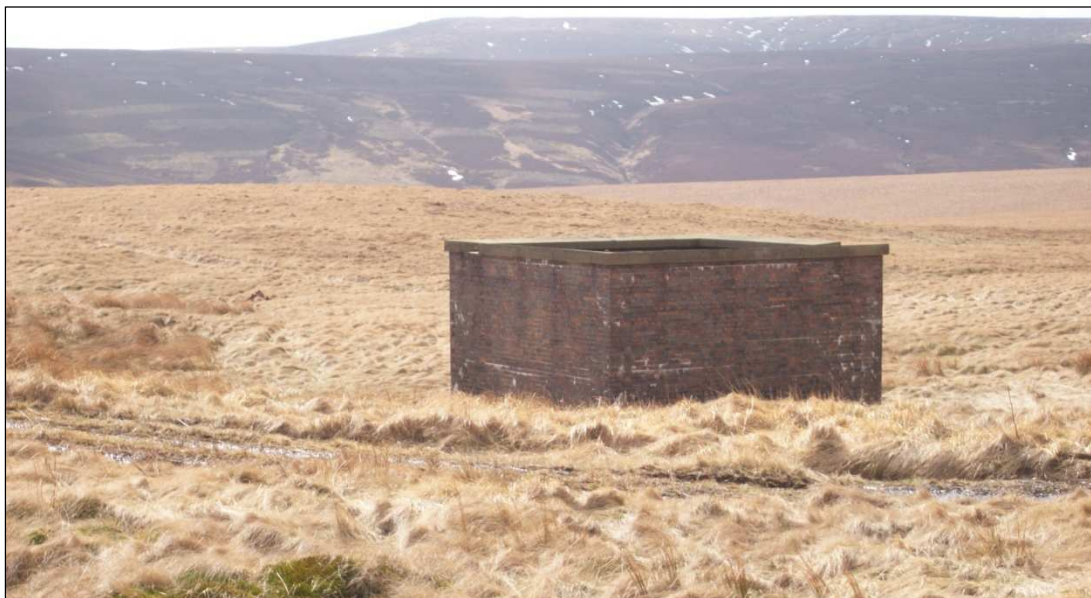
Plate 3: ventilation tower on site of 1950s construction shaft, from the north

- 5.40 Site 49 is the extant ventilation shaft, formerly a construction shaft, for the 1950s railway tunnel at Woodhead. It survives as a square brick-built structure in poor condition (Plate 3). The third Woodhead tunnel was authorised by the Railway Executive in November 1948. It was originally designed to be built as two tracks to the south of the original 'down' tunnel, and separated from it by 77 feet except for the westernmost 200 yards where it curved to emerge close to the existing tunnel portal. A temporary camp for 1100 workers was established at Dunford Bridge in 1949 as work on the tunnel commenced.

- 5.42 When completed the new tunnel was 131 feet longer than those to the north. The construction shaft was left open for ventilation purposes, and a square brick tower built at the top. In addition an 8-foot diameter stope was bored, 1,205 yards from the Dunford Bridge portal, to connect with the easternmost (No.5) shaft of the Victorian tunnels to assist with ventilation, although the requirements for this were lessened by the fact that the new tunnel was to house an electric railway. A brick tower was built at the top of this shaft, which was backfilled below the point of its intersection with the new stope. Construction Shaft 2, which had previously been enlarged in 1910 to assist with the ventilation of the Victorian tunnels was left open but the remaining 1840s shafts were made safe.

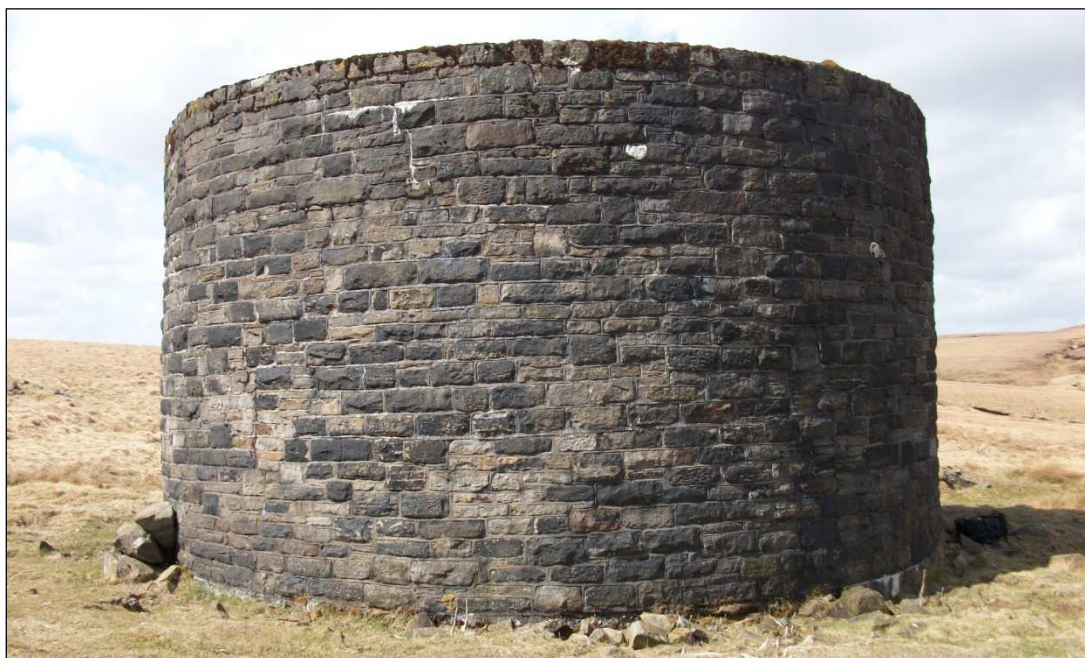
Plate 5: ventilation tower, construction shaft 2 from the south-east

- 5.49 Construction Shaft 2 was enlarged in about 1915, and is now surmounted by a circular ventilation tower built in the same period (Plate 5). The original spoil heaps survive in part, the finger-mounds being best preserved to the east of the shaft. However, the remainder have been reworked and by the deposition of later debris, and it is likely that the majority of the remains of the original shaft-head structures were removed, or at least compromised, during the later construction works.

- 5.75 The present ventilation tower at Construction Shaft 2, which is an early 20th century structure, will be dismantled, and a new, albeit smaller, tower built upon the site once shaft-capping works have been completed. The brick ventilation tower near Construction Shaft 3 will be dismantled and not replaced. Proposals for the brick-built ventilation tower over Construction Shaft 5 are unclear at present; but it may be possible to backfill the shaft without altering the tower.

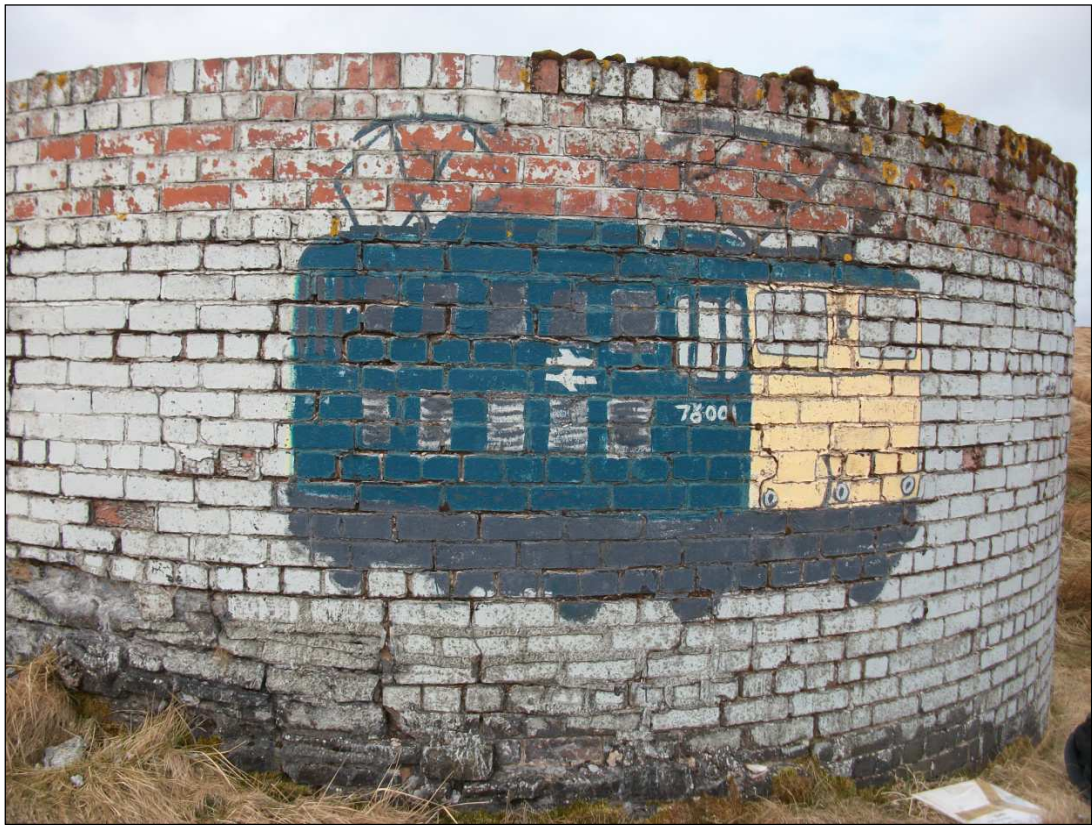
Plate 7: mural on ventilation tower, construction shaft 5

- 5.51 Construction Shaft 5, located towards the eastern end of the 19th century bores, was significantly altered in the 1950s. This shaft was intercepted by a bore running from the later tunnel in order to assist in its ventilation. Once achieved, the shaft below the level of intersection was backfilled, and the 1840s spoil heaps show considerable evidence of having been quarried, probably to use the arisings to backfill the bulk of the shaft, and as a consequence their original form is not clearly discernible. Similarly there were no readily identifiable building components that might relate to the construction of the original shaft, although it is accepted that the fragmentary remains of some may survive beneath later debris. This shaft is presently surmounted by a brick-built ventilation tower clearly of 1950s date (Plate 7).

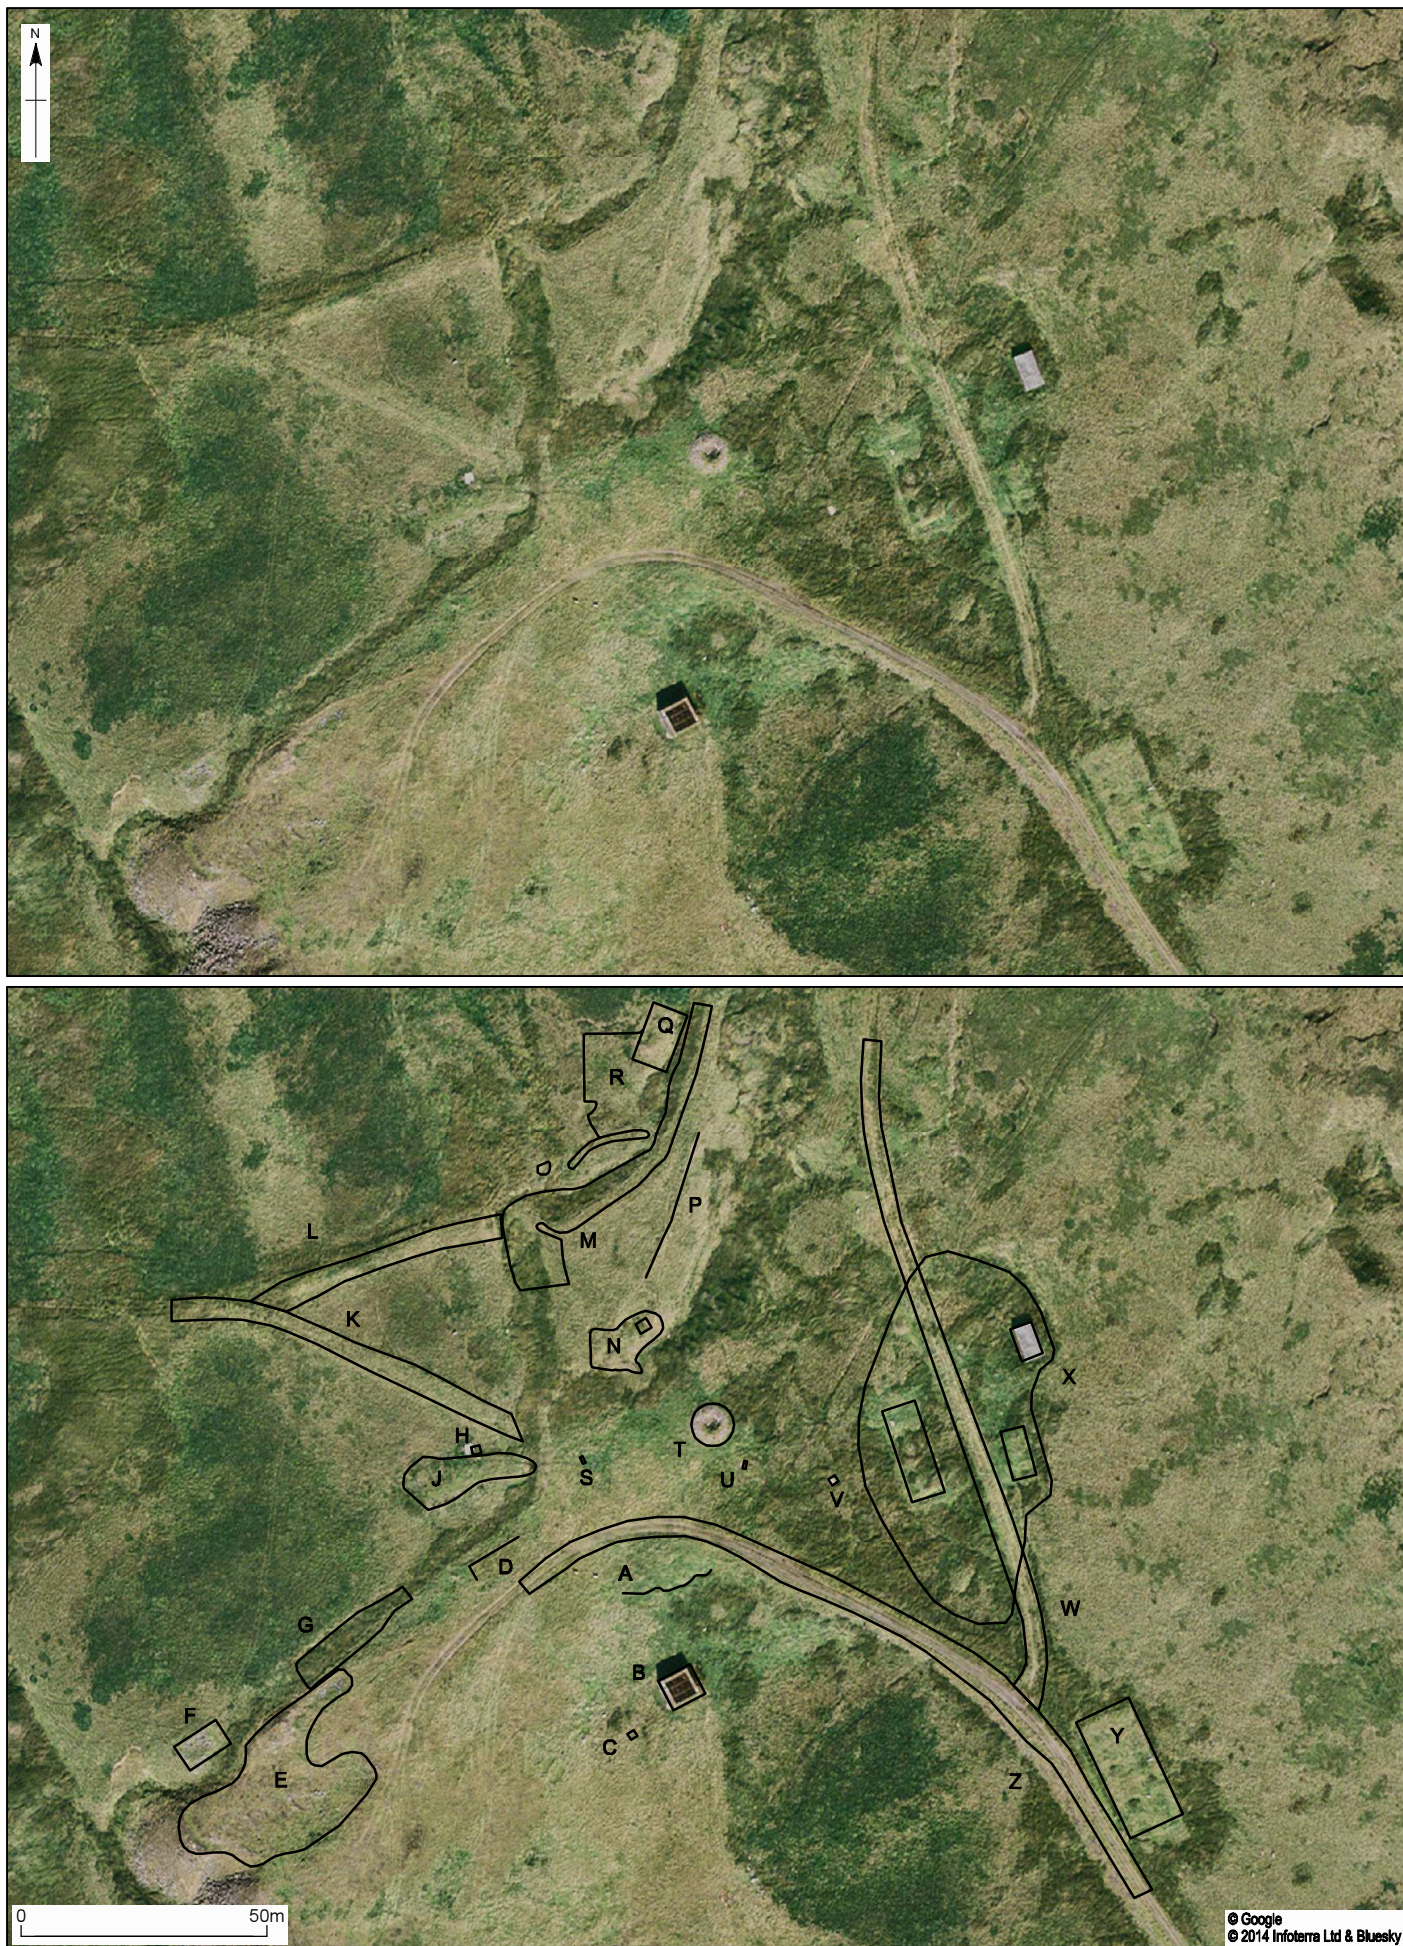
Woodhead Tunnels: site of 1840s Construction Shaft 3 and 1950s construction works

- 5.58 Access to the 1950s works was by a trackway (Z), c. 5.5m wide, leading south-eastwards to Goddard Lane. There is a further track (W), 3.5m wide, leading eastwards, up the scarp towards Construction Shaft 4. However it would seem unlikely that this was the principal route used for coaling or otherwise supplying shaft 3 as a consequence of the slope involved. In addition there is no easy means of access from shaft 2 in the west, and a former supply route leading from Goddard Lane in the 1840s would seem probable, the same route being used again for the later construction programme. Both tracks are built upon a rubble base, and are surfaced with coarse gravel, and as a consequence, appear to be contemporary, but this impression is likely to be the result of the continued maintenance of both tracks for recreational purposes.

- 5.59 Other features that are most likely to be attributable to the 1840s construction programme include a series of bothies, or workers 'cottages'. Structure Q is the bi-cameral structure located to the north of the shaft already identified by Morris as Building 3. Morris' Building 2 (Structure F) was also re-examined as part of this study. It lay on the periphery of the study zone, to the west of the 1950s shaft and was situated alongside an area of scoops and hollows (Features E) which appear to project from under the 1950s spoil, which may be indicative of activity originating in the 19th century. Structure F contained stone-built features which may represent the remains of 'furniture'.

- 5.60 A number of features in the vicinity of Structure Q were also noted. Feature R is a rectangular peat cutting situated to the west of the building, possibly used as a source of fuel. Feature M possibly represents a water management feature and comprises a 2m deep channel cut into the slope below the building. It is associated with a bank at its western end. Immediately to its west is a low bank (Feature L) which may have been a low dam that has been breached at some point. Taken together, features L and M may be the remains of some attempt to channel surface water away from the top of Construction Shaft 3 and facilitate the drainage the construction works. Feature P on the other hand, appears to be a leat designed to supply, rather than dispose of, water. It leads toward an area of structural remains, comprising drystone walls standing to about 0.5m, located to the north-west of Construction Shaft 3, perhaps the boiler house. The remains of a possible sluice or other water management feature (G) partially survive in the vicinity of Feature E and Structure F. This comprises a series of substantial steel or iron poles, two of which are equipped with unusual flared, cross-shaped heads. There was a narrowing of a stream channel at this point, which has subsequently been breached.

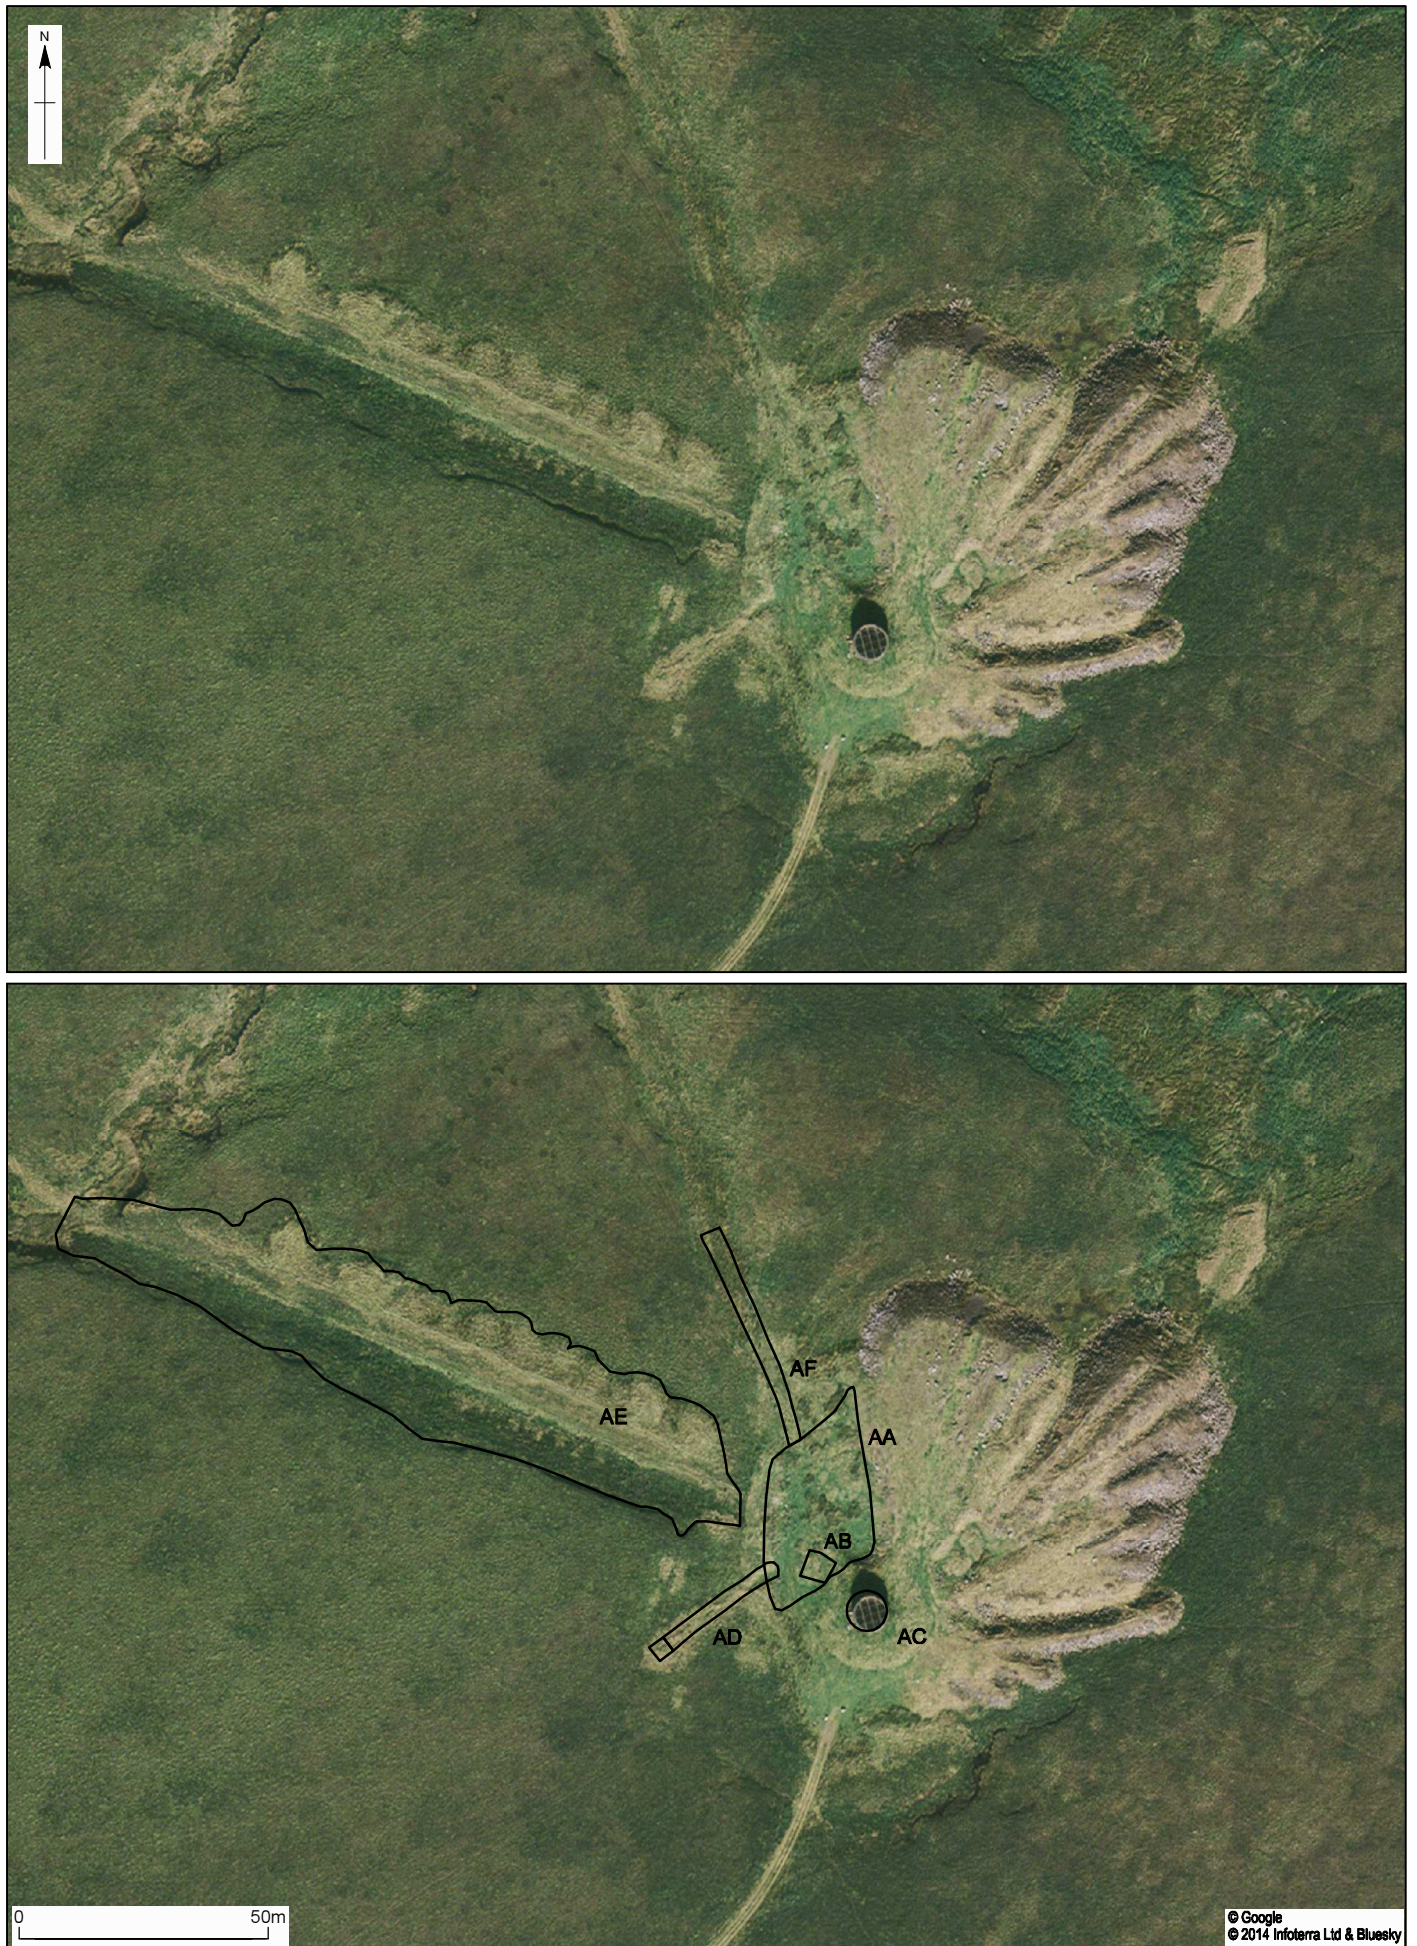
- 5.67 Construction Shaft 2 was excavated in an elevated position on the eastern slope of one of the two highest points of the route, to the west of Construction Shaft 3 and the 1950s shaft. An air-shaft tower (Structure AC), which is approximately 3m high, now sits over the shaft, which was enlarged from 10- to 16 feet in diameter between 1912 and 1915 (Ball 1916, 307 and NAA 2013, 4), the tower being associated with this event rather than being a mid 19th century structure. It was built of cement-mortared, coursed gritstone blocks of various shapes and sizes and sits upon a concrete ring-beam which is eroding, predominantly on its western side. As a consequence of this erosion, the masonry of the structure has cracked in several places, and in at least one case, the crack extends through the blocks of the masonry rather than through the bonding. Some baulks of timber have also been incorporated into the structure at low level, these now being in poor condition.

- 5.68 The tower sits amidst a complex of spoil-heaps, predominantly situated to the east of the tower, which undoubtedly contain the remains of ancillary structures such as the engine house which are difficult to definitively identify on the surface. The spoil tips have clearly been reworked, the dendritic pattern of spoil from the 1840s excavations having been infilled over a considerable

section of the heap. However, the remains of a number of possible structures, including sections of mortared walling, survive in an area (AA) to the north of the shaft. This area has been subjected to a significant degree of disturbance with ground levels being considerably lower than the surrounding zones; and it is likely that this, and the infilling of the finger-mounds, occurred when the shaft was enlarged in the early 20th century. Within this area there is a small patch, c. 5m square, patch of recently disturbed soil (AB).

- 5.69 There are, however, a number of visible features which can be attributed to the original construction programme with a greater degree of confidence. A chimney-base, and a 25m length of flue (AD) survive to the west of the shaft. The flue is double walled and sealed with stone cap-stones but its remains have been truncated within the area that has been subjected disturbance (AA). The chimney-base is a stone-built structure approximately 2m square, and both features were undoubtedly associated with the former boiler-house once supplying a steam pumping-engine.

- 5.78 Construction Shaft 2 will be sealed in a similar manner (National Grid drawing number NG 78-MM-1046). The excavation trench will be slightly larger as a result of local topographic conditions and the need to maintain a 45-degree batter on the trench sides. The current design requires the excavation of a square trench, approximately 20m square at surface level but tapering to 10m at its base. In this case, the 20th century masonry tower is built upon a brick shaft-head structure which extends beyond the level of the bedrock to ground level, both being approximately 4.8m in diameter. The tower and the shaft will be demolished to bedrock level, and capped with a 10m square concrete slab. Once the shaft is capped, the trench will be backfilled with arisings and reprocessed demolition debris and a new tower, built with stone recovered from the existing tower, will be built on a new foundation slab above the centre-line of the shaft. The new tower will be approximately 3m in diameter, and half filled with granular material. The tower will be topped with a new cover frame and grill to deter intruders. Although the new tower will be narrower than the existing tower, it will act in as a prominent landscape feature in a manner identical to the existing structure.
